**SLN2557G [SDM669E] - Submitted by: A-PAC Adjusters & Surveyors Pte Ltd (HQ)**

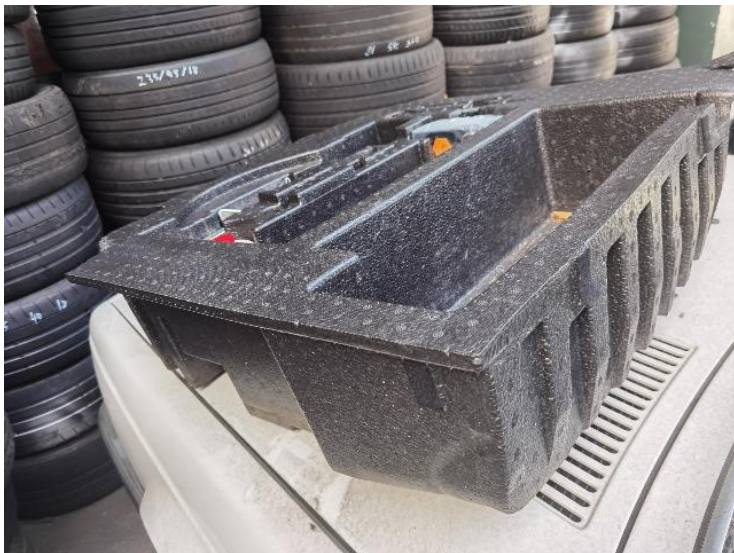
**3/44: Rear Boot Sponge Storage - Cut**

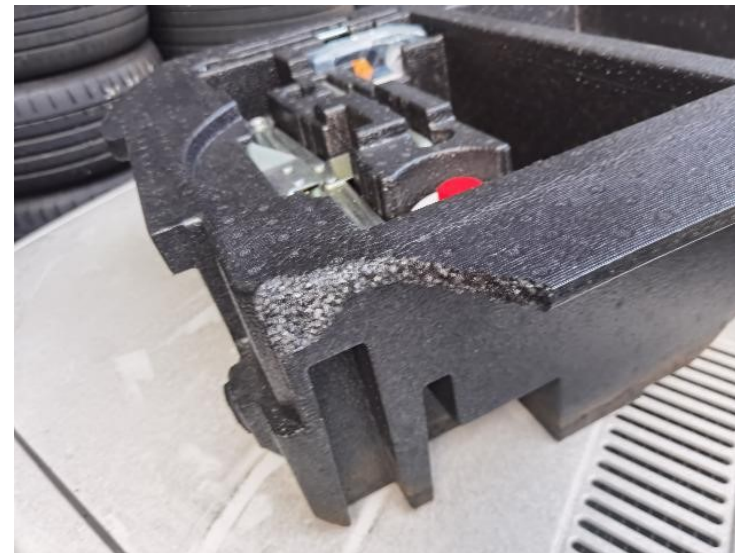
**4/44: Rear Boot Sponge Storage - Cut**

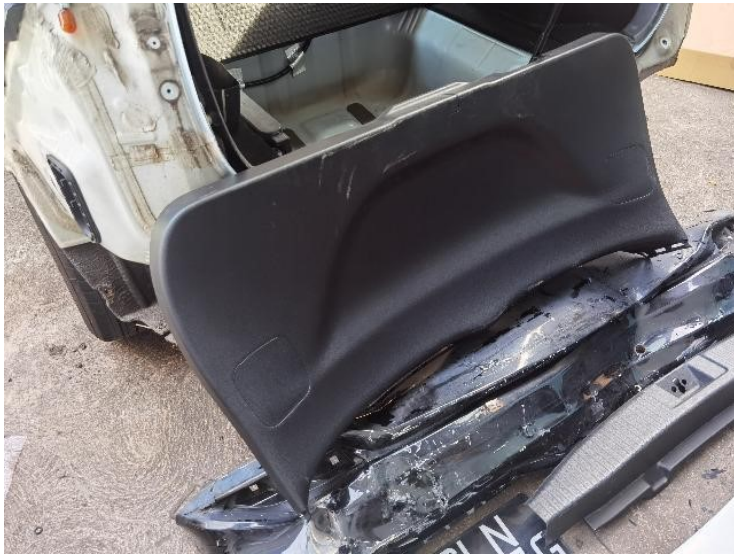
**5/44: Tailgate Inner Trim - Studs Cracked**

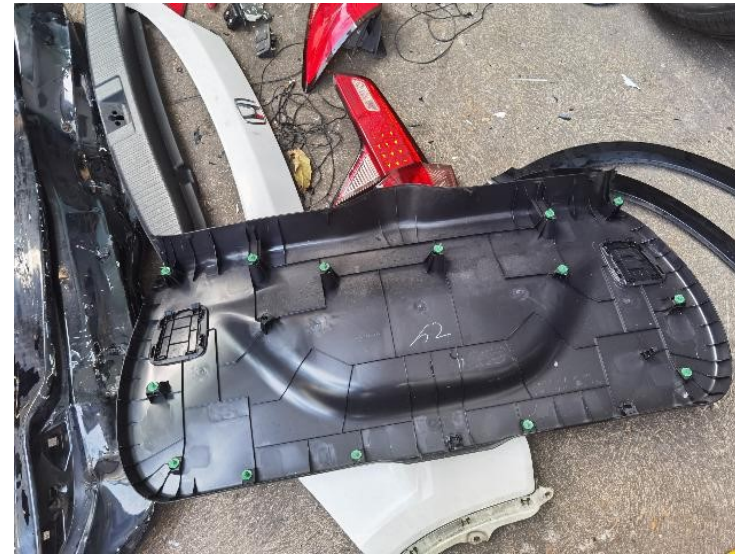
**6/44: Tailgate Inner Trim - Studs Cracked**

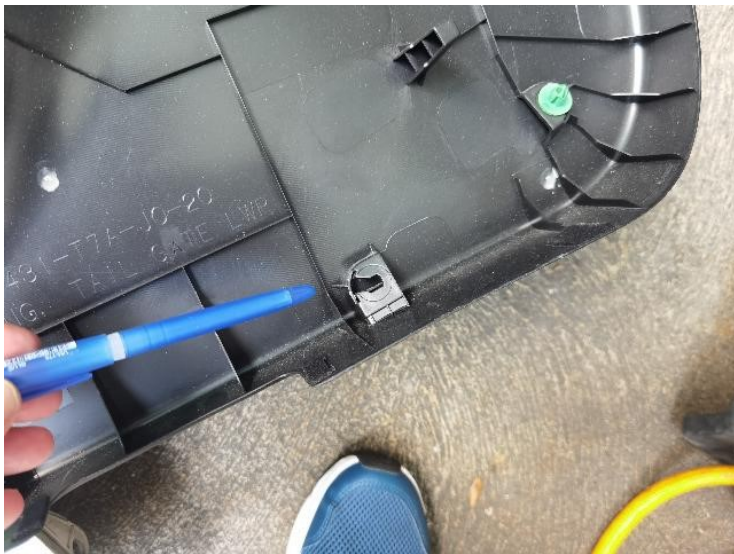
**7/44: Tailgate Inner Trim - Studs Cracked**

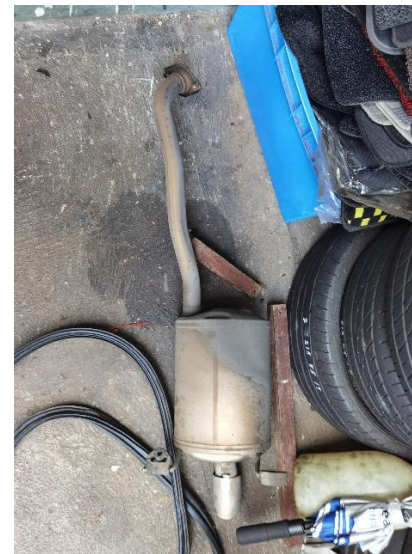
**8/44: Rear Exhaust Assembly - Bent**

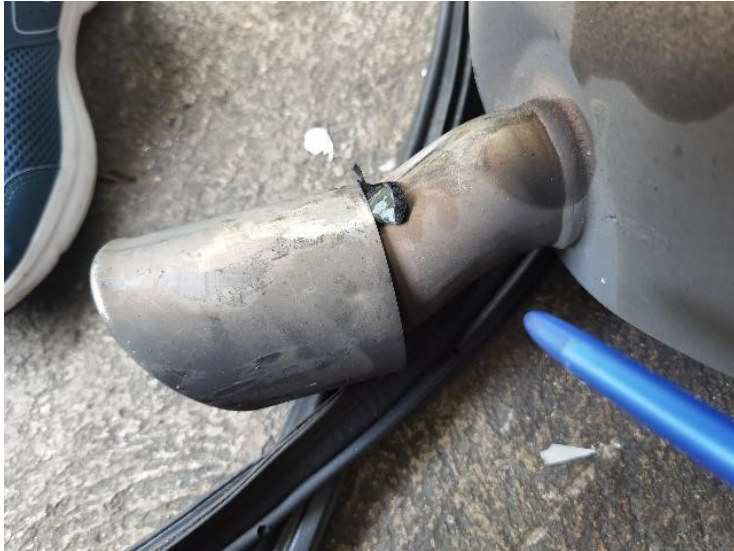
**9/44: Rear Exhaust Assembly - Bent**

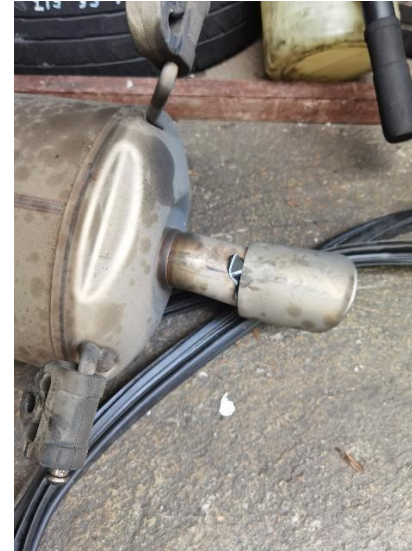
**10/44: Rear Exhaust Assembly - Bent**

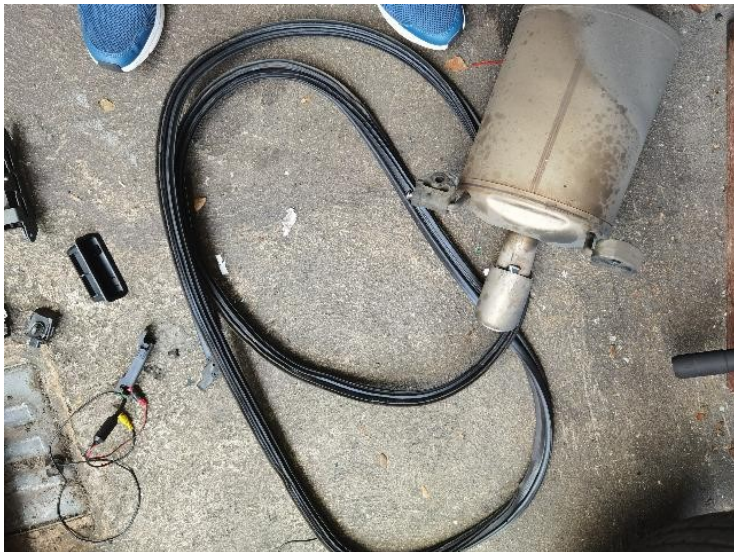
**11/44: Tailgate Weather Moulding - Deformed**

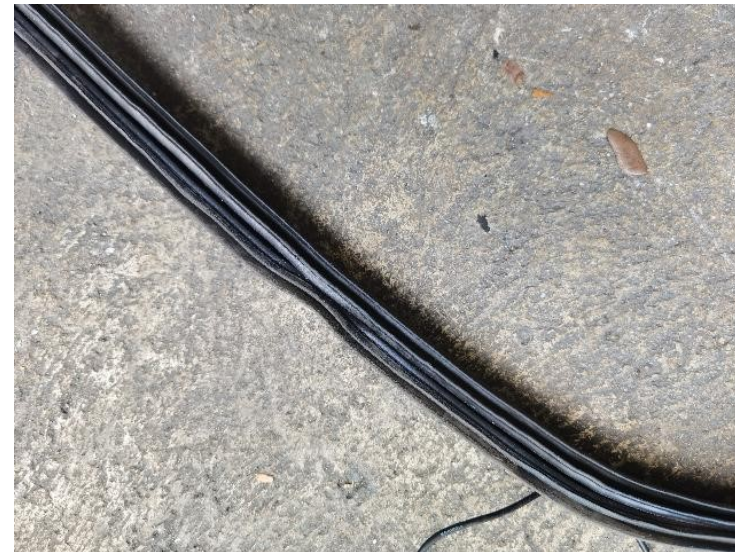
**12/44: Tailgate Weather Moulding - Deformed**

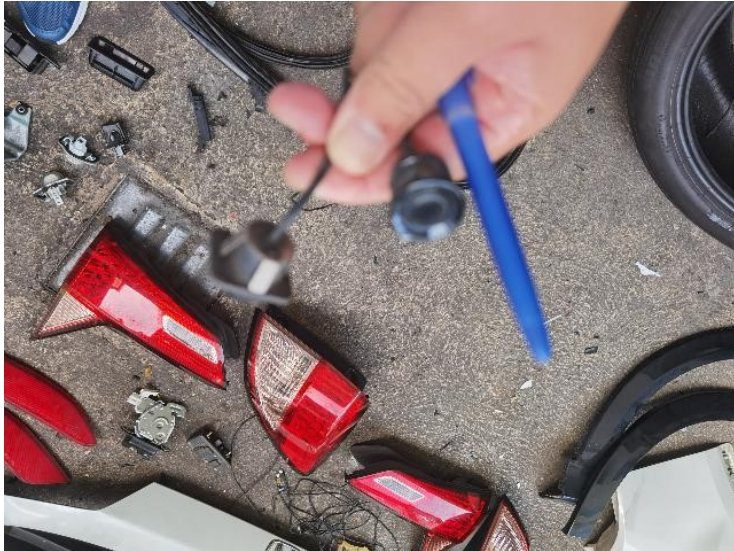
**13/44: Reverse Sensoer - Cracked**

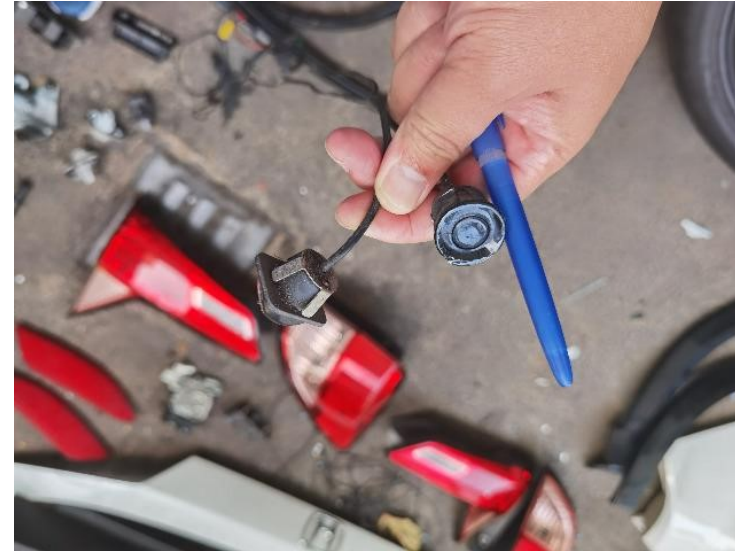
**14/44: Reverse Sensoer - Cracked**

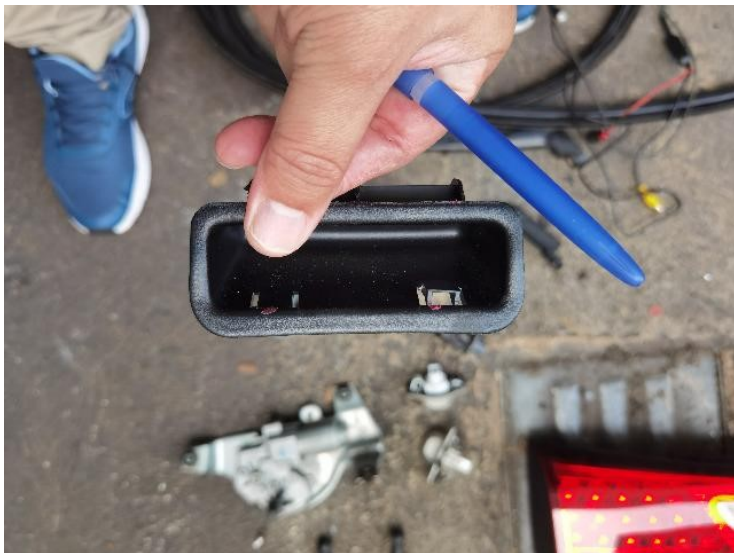
**15/44: Tailgate Handle Grib - Cracked**

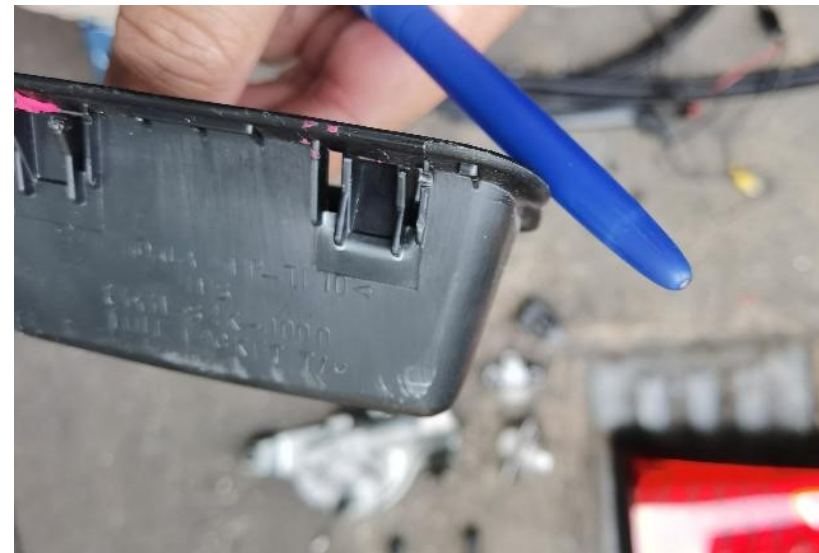
**16/44: Tailgate Handle Grib - Cracked**

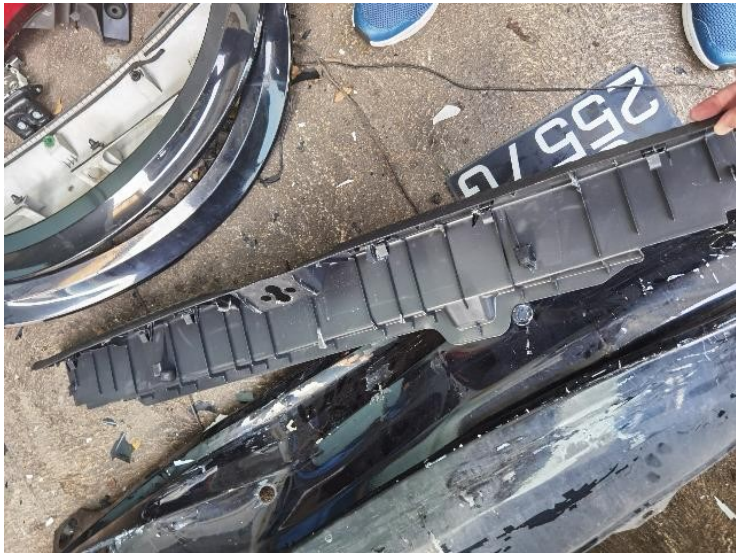
**17/44: Rear End Panel Garnish - Dented/Deformed**

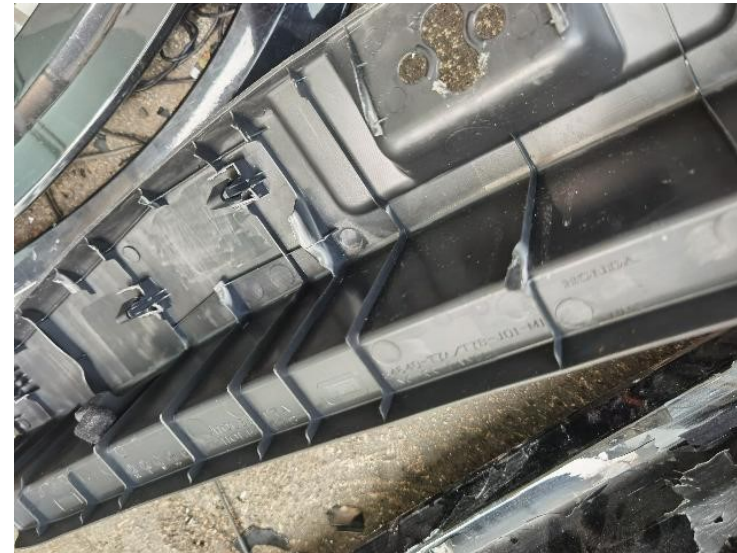
**18/44: Rear End Panel Garnish - Dented/Deformed**

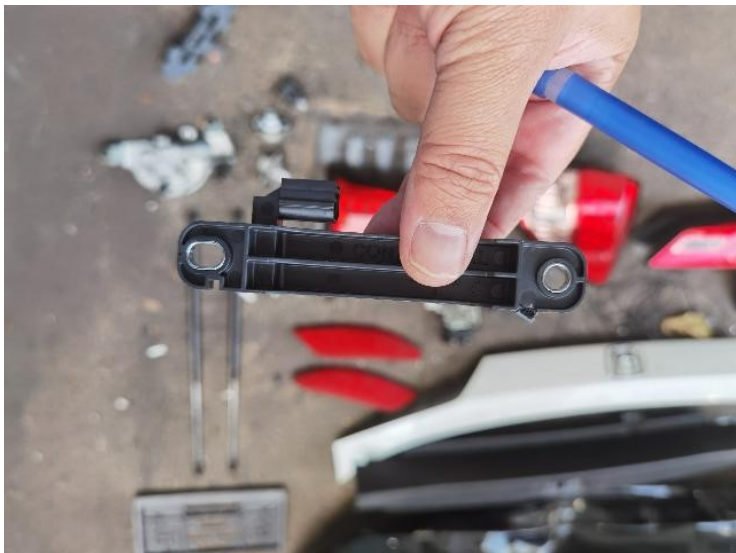
**19/44: Tailgate Sensor - Cracked**

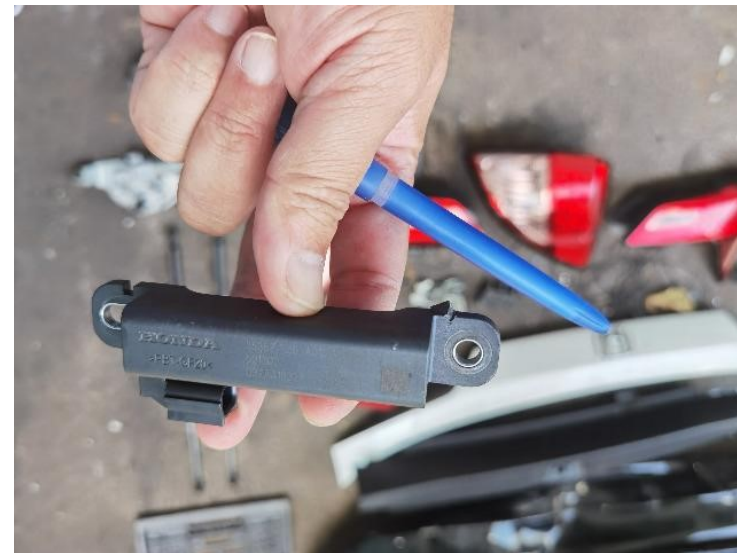
**20/44: Tailgate Sensor - Cracked**

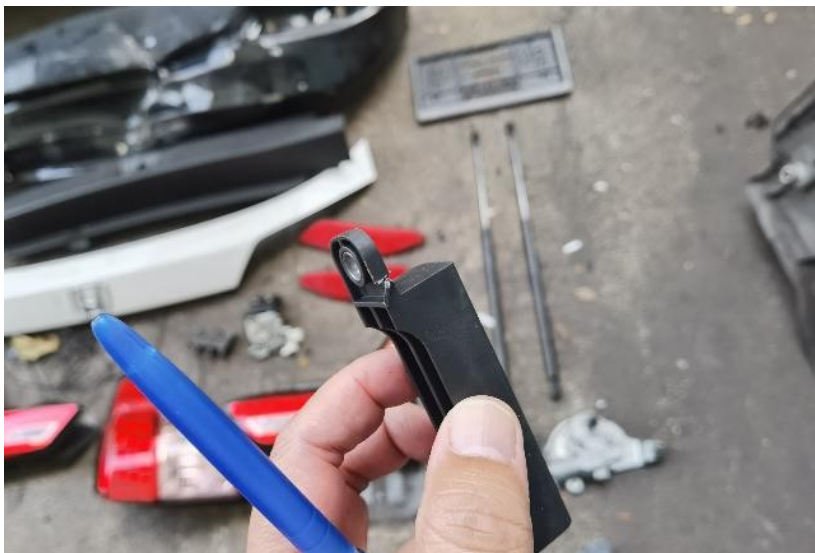
**21/44: Tailgate Sensor - Cracked**

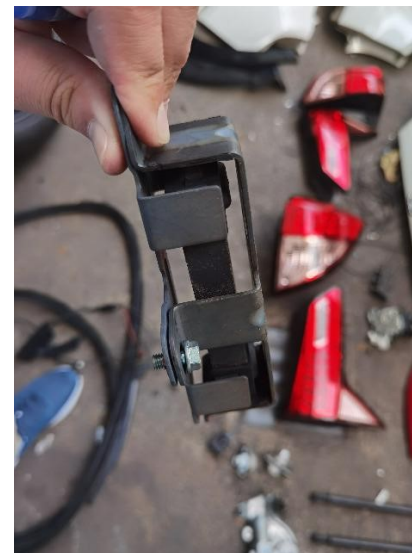
**22/44: Tailgate Sensor Bracket - Cracked**

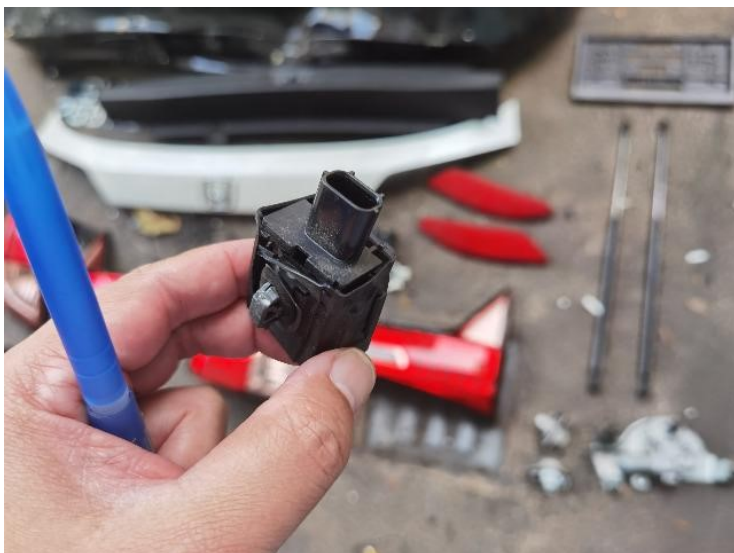
**23/44: Tailgate Sensor - Electrical Plug Cracked**

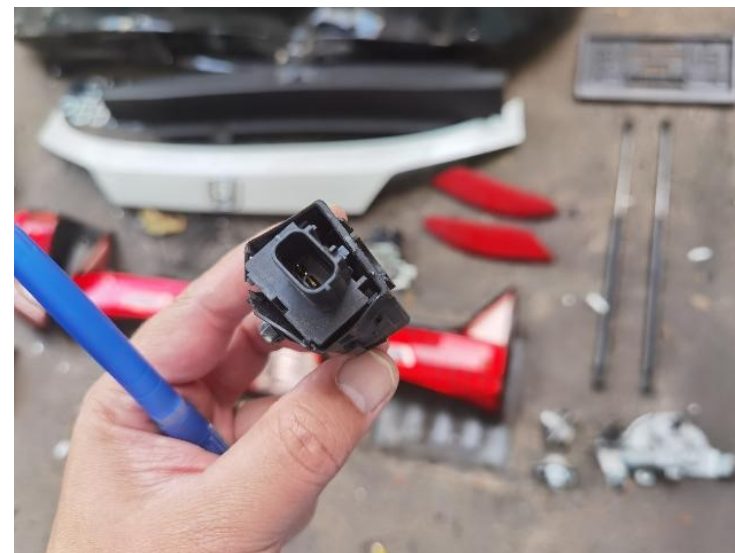
**24/44: Tailgate Sensor - Electrical Plug Cracked**

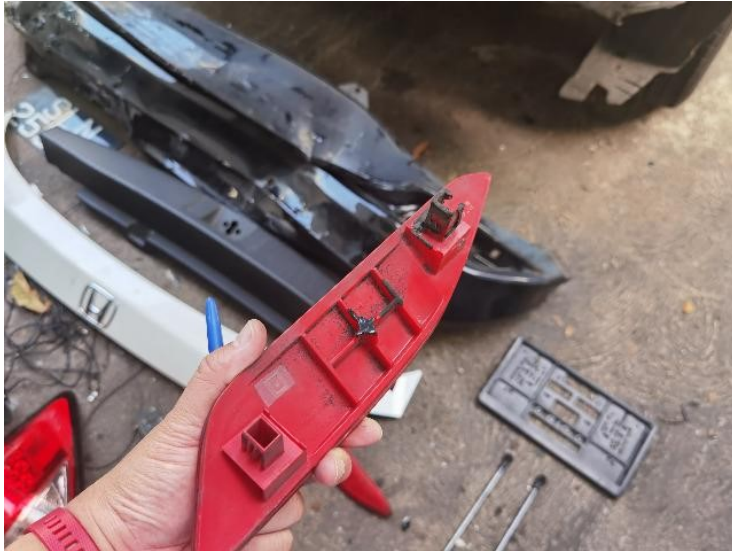
**25/44: Rear Bumper Reflector LH - Stud Cracked**

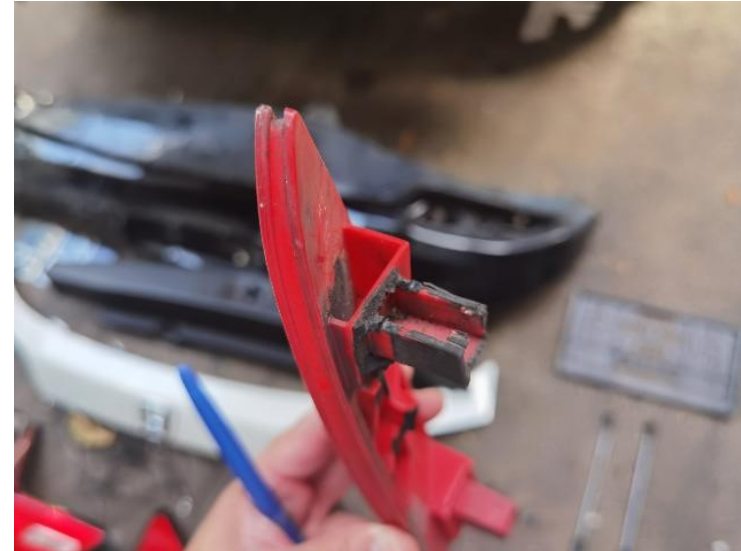
**26/44: Rear Bumper Reflector LH - Stud Cracked**

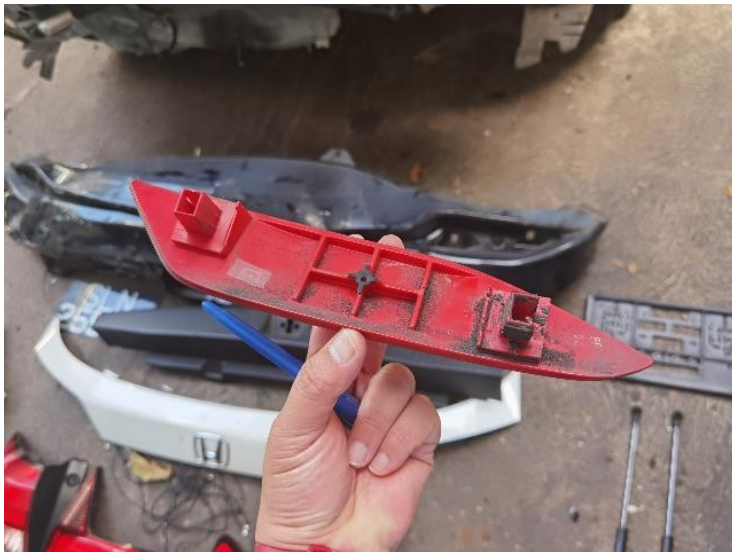
**27/44: Rear Bumper Reflector RH - Stud Cracked**

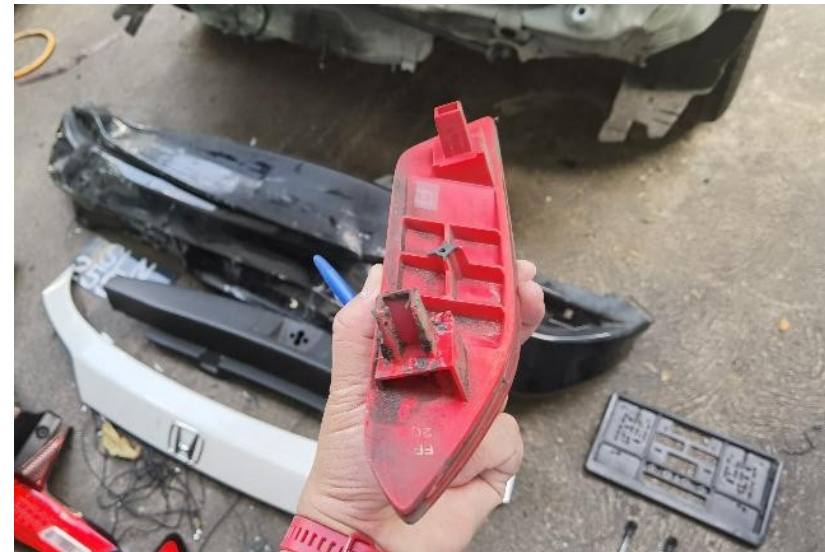
**28/44: Rear Bumper Reflector RH - Stud Cracked**

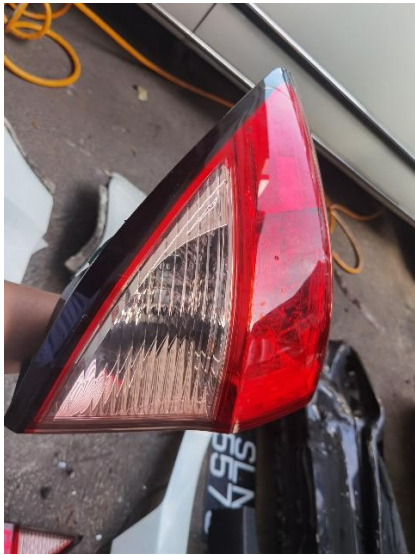
**29/44: Taillamp LH - Studs Cracked**

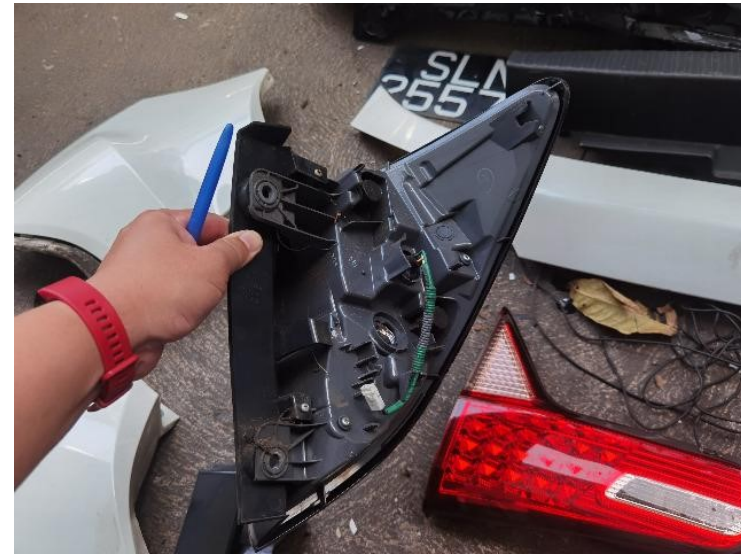
**30/44: Taillamp LH - Studs Cracked**

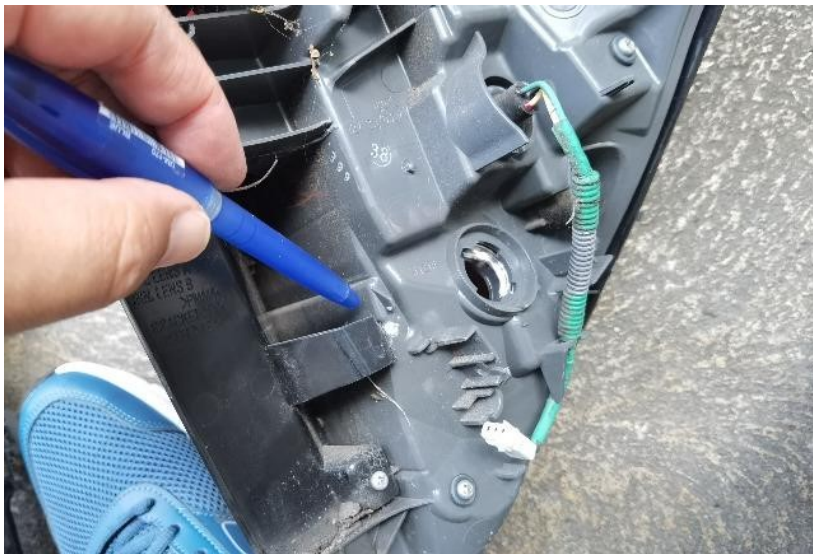
**31/44: Taillamp LH - Studs Cracked**

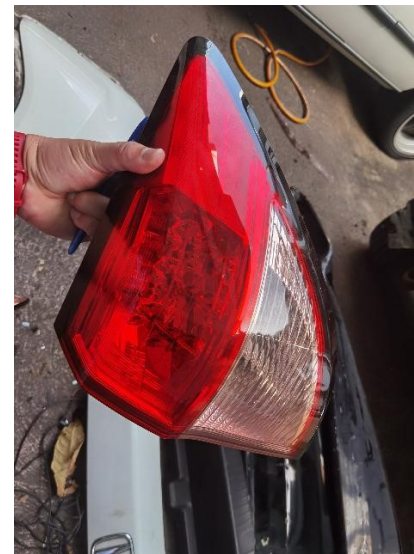
**32/44: Taillamp RH - Studs Cracked**

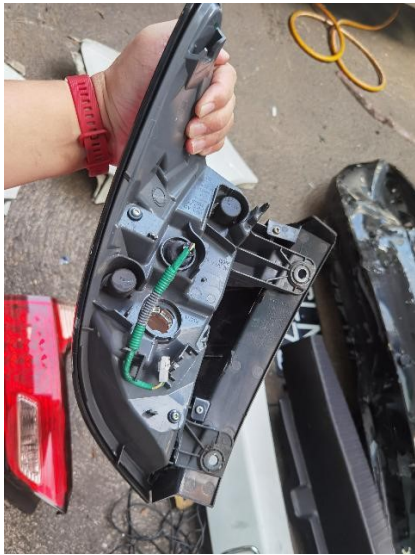
**33/44: Taillamp RH - Studs Cracked**

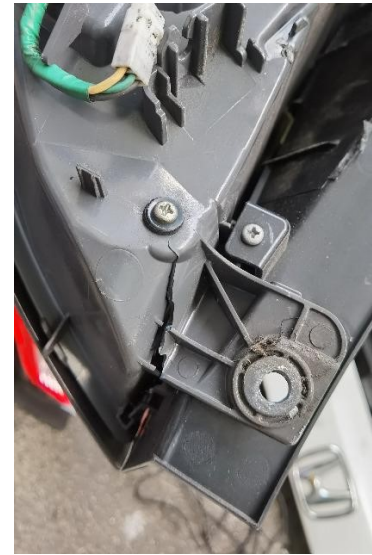
**34/44: Taillamp RH - Studs Cracked**

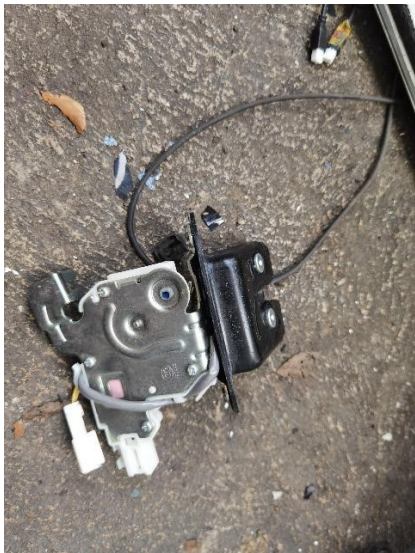
**35/44: Tailgate Lock Assembly - Jammed**

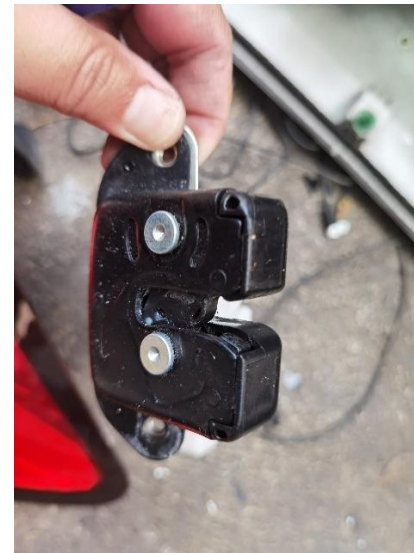
**36/44: Tailgate Lock Assembly - Jammed**

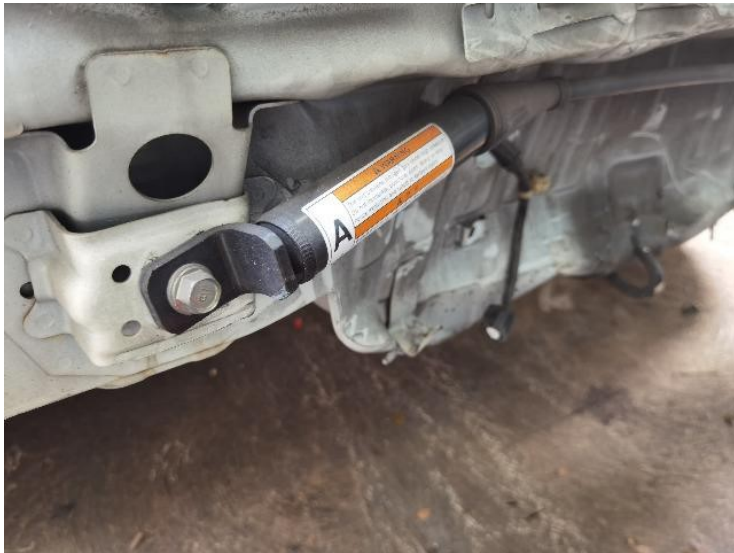
**37/44: Rear End Panel - Dented/Deformed**

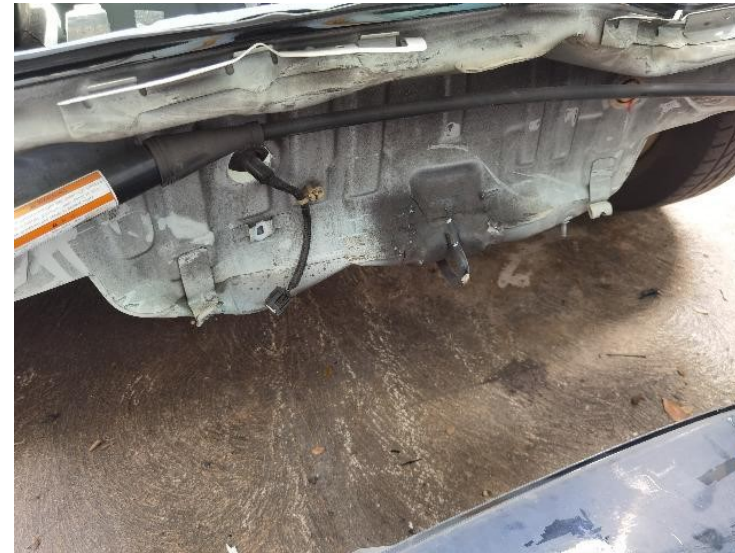
**38/44: Rear End Panel - Dented/Deformed**

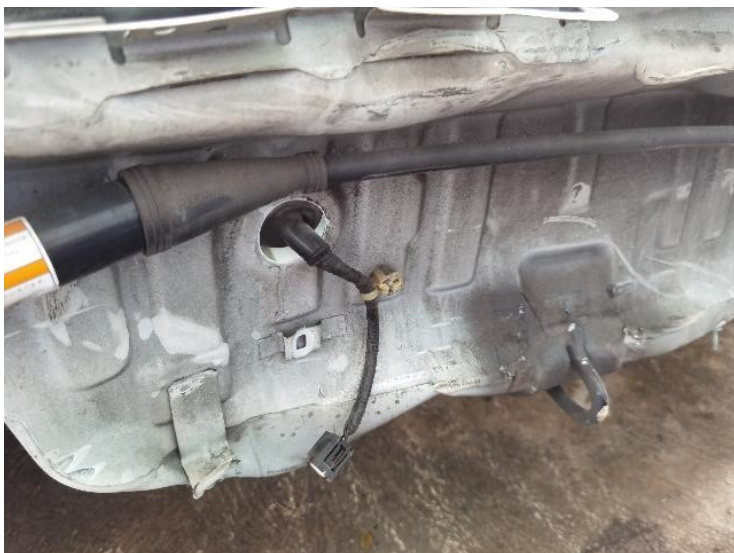
**39/44: Rear End Panel - Dented/Deformed**

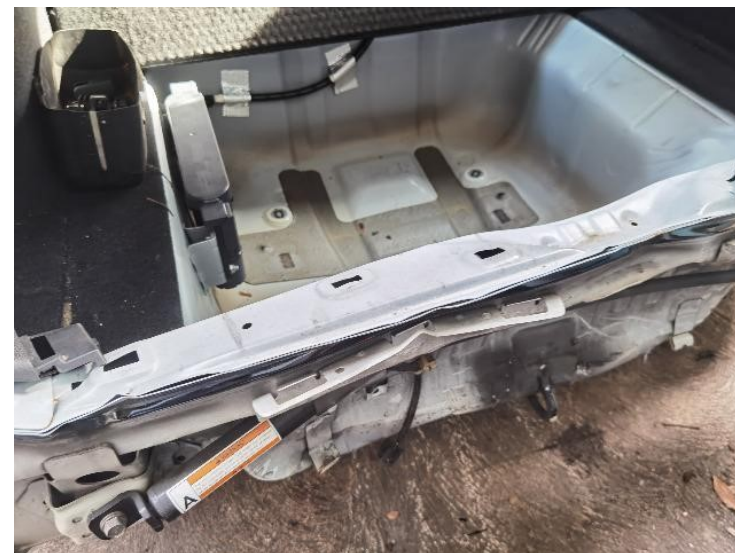
**40/44: Rear End Panel - Dented/Deformed**

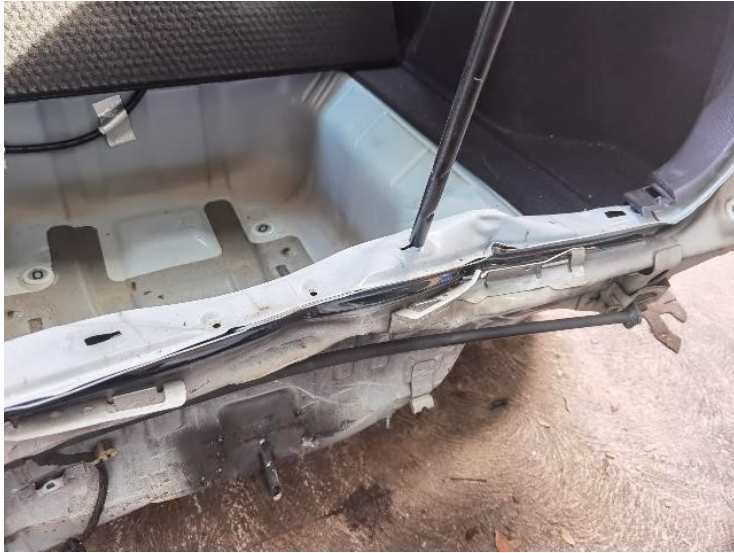
**41/44: Rear End Panel - Dented/Deformed**

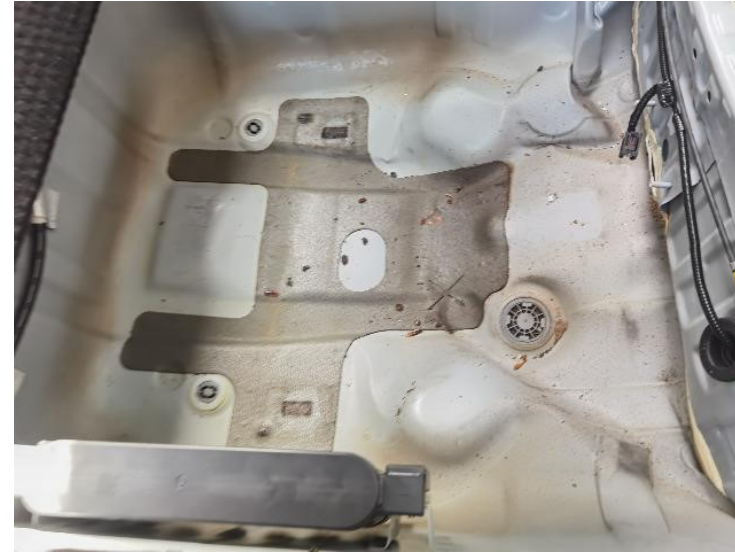
**42/44: Spare Tyre Wheel - Dented**

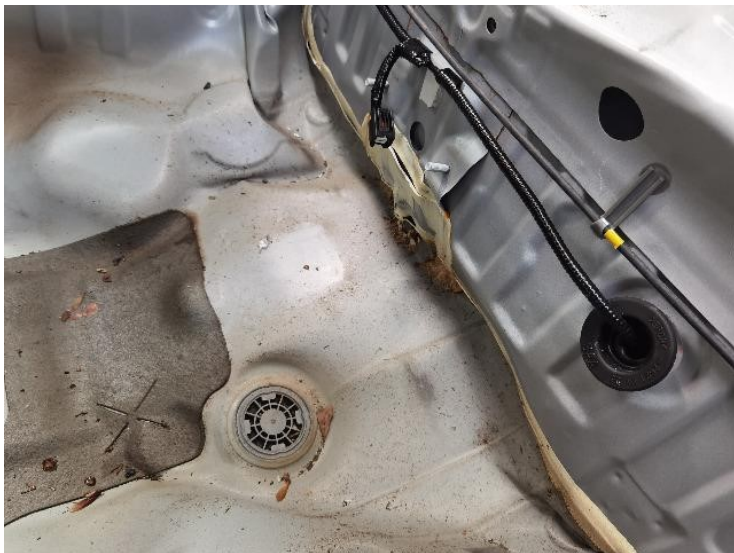
**43/44: Spare Tyre Wheel - Dented**

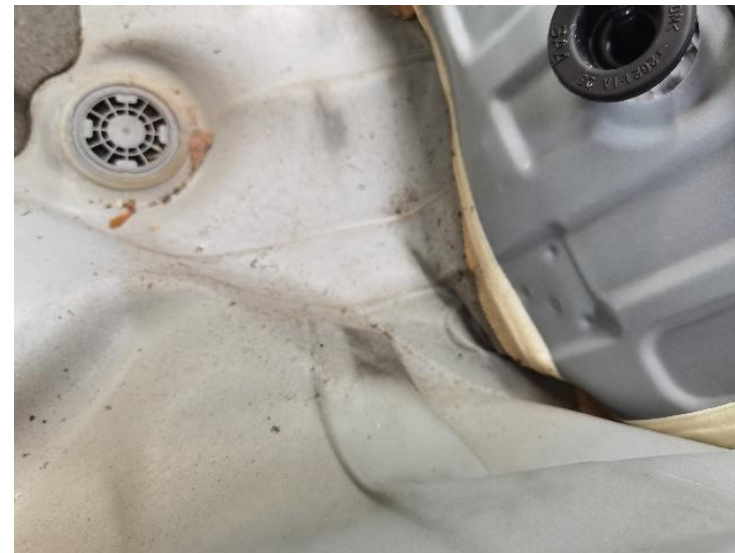
**44/44: Spare Tyre Wheel - Dented**
