**SINCERE**  
APPRAISAL SERVICES PTE LTD

## VEHICLE DAMAGE INSPECTION REPORT

Our Ref: 48/TP/2022

Reg No:	SJM3663E	Make &	Nissan
Reg date:	21/2/2017	Model	Qashqai
Colour:	White	Engine No:	HRA2352545A
Type:	Motor Car	Chassis No:	SJNFEAJ11U1819828
Type of Claims:	Third Party	Odometer No:	NA
		Engine Cap:	1197cc

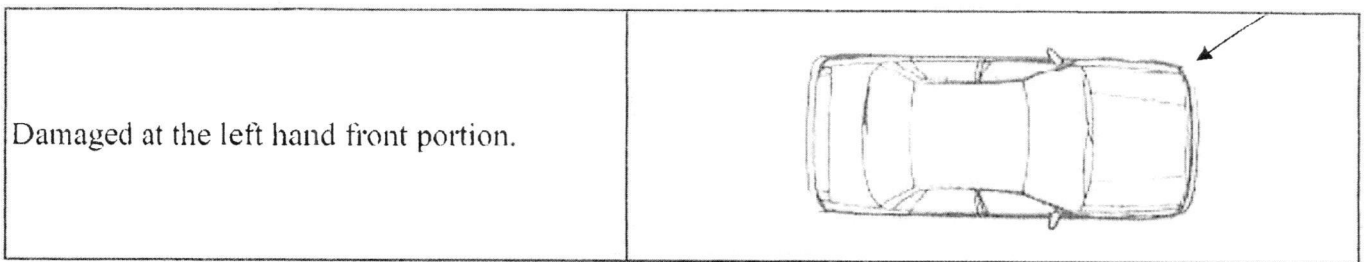
### POINT OF IMPACT

Our visual inspection of the vehicle revealed that the damages noted are at the left hand front portion.

We have inspected the actual damages found on the vehicle and recommend the replacement of parts and repairs accordingly. The estimated repair cost is \$6,974.20. The repairer has agreed to undertake the repairs at our adjusted lump sum amount of \$4,600.00.
