Your Ref: S1M03HL2
Our Ref: CS4/ASM22006520/D

04 August 2022

AXA Insurance Pte Ltd

MECHANICAL INSPECTION REPORT OF YOUR INSURED VEHICLE SBP 1133K INVOLVED IN AN ACCIDENT ON 30 AUGUST 2021

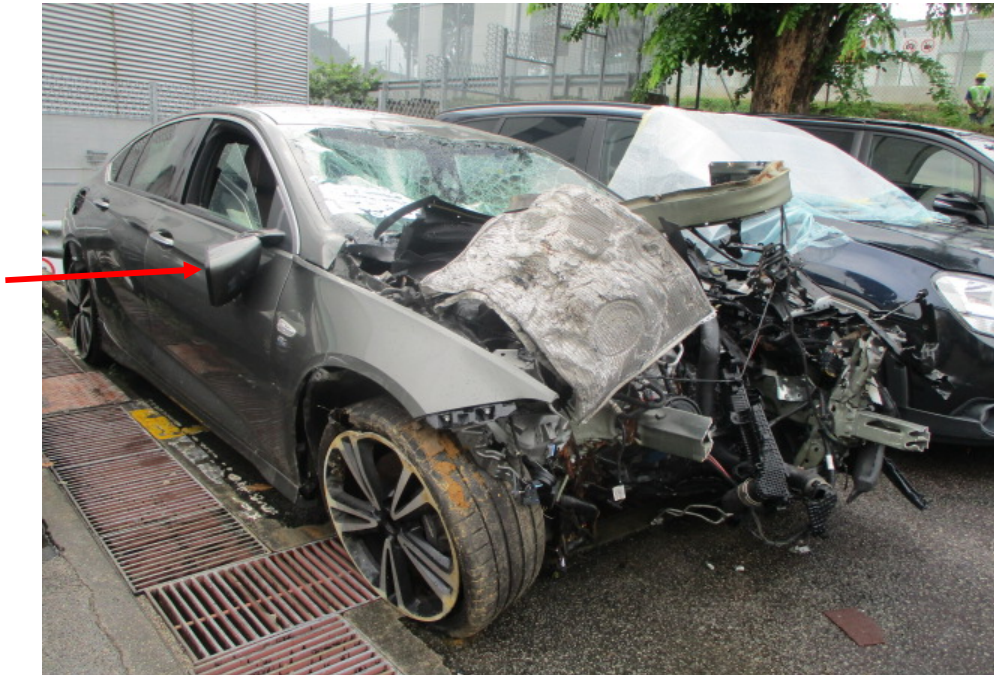
5. Apart for the frontal portion, I had also observed that the right side wing mirror was broken and the roof panel of the Insured Vehicle was dented. The undercarriage parts at the front left wheel and front right wheel were also damaged.

Photo 1 shows a general view of the front right body of the Insured Vehicle at the time of my inspection. The Insured Vehicle was observed to have sustained extensive collision damage at its frontal portion. Almost all the parts and components within the engine compartment were seen to be damaged/affected. Its right side wing mirror (arrowed) was also observed to be damaged.

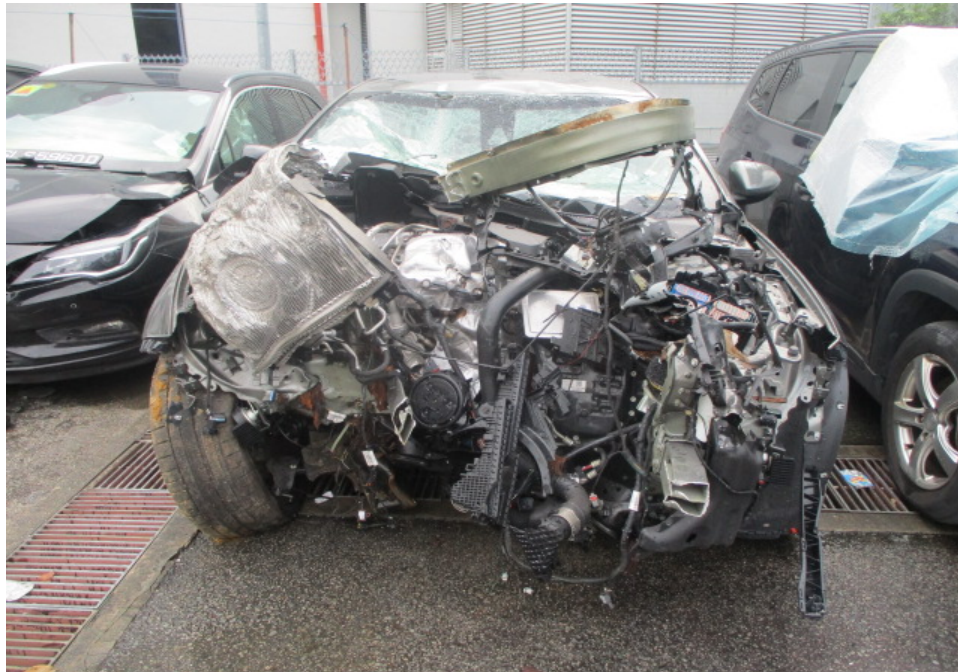
4. The Insured Vehicle was observed to have sustained extensive collision damage at its frontal portion. Almost all the parts and components within the engine compartment were also seen to be damaged/affected. These parts and components include the engine control module, engine fuse box, intake manifold, exhaust manifold, radiator, cooling fan and engine wiring harness amongst others. The front windscreen was further observed to be badly cracked.

Photo 2 shows a general view of the frontal body of the Insured Vehicle at the time of my inspection. The Insured Vehicle was observed to have sustained extensive collision damage at its frontal portion. Almost all the parts and components within the engine compartment were seen to be damaged/affected.

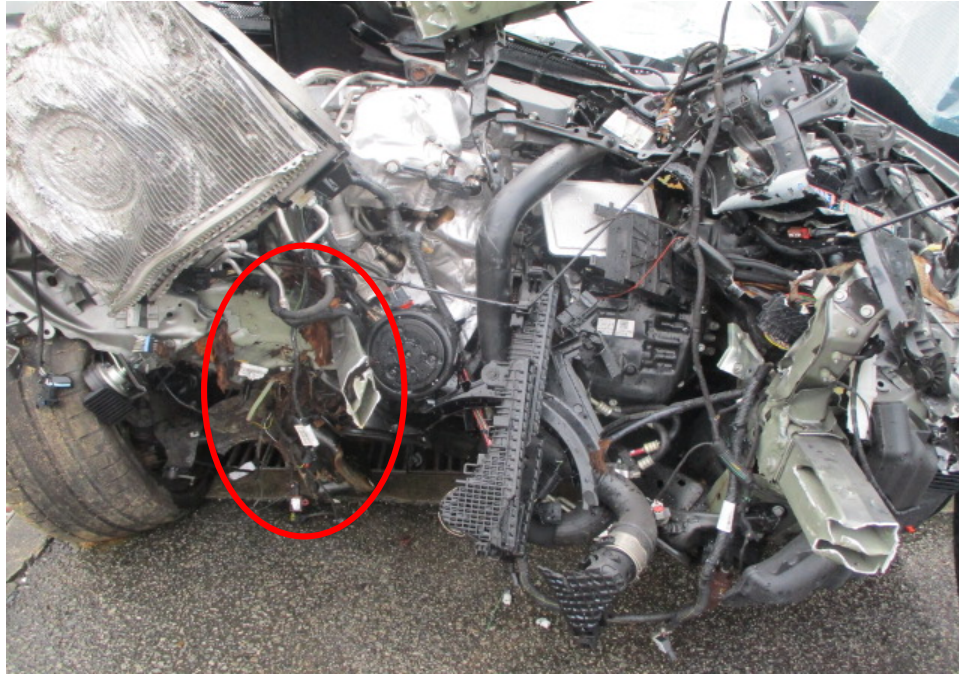
Photo 3 shows a closer view of the damaged parts and components within the engine compartment of the Insured Vehicle. Damaged parts and components include the radiator, aircon condenser, cooling fan, engine control module, air intake manifold, exhaust manifold, hoses, engine fuse box and engine wiring harness amongst others. The front right chassis frame was also observed to be crumpled (circled).

9. My examination of the Insured Vehicle's engine compartment revealed that the various parts and components within the engine compartment, like the exhaust manifold, intake manifold, radiator, aircon condenser, cooling fan, engine control module, engine wiring harness, reservoir tanks etc, were damaged as a result of the accident. Checks on the various operating fluids like the engine oil, brake fluid and engine coolant for the level of the fluids or for any contamination/impurities in the fluids could not be carried out. Refer to photograph 1 – 5 above.

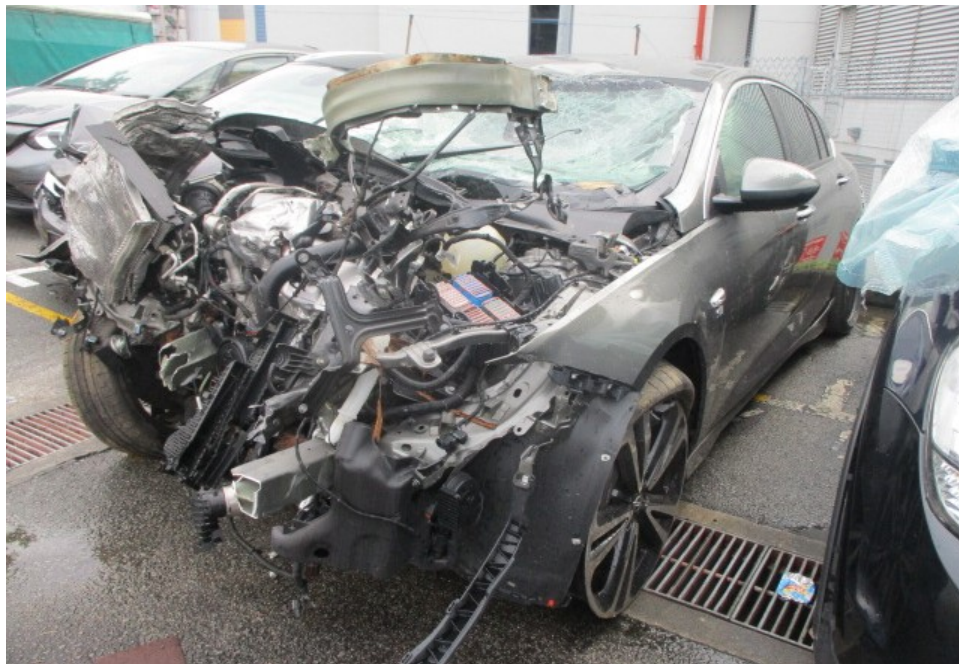
Photo 4 shows a general view of the front left body of the Insured Vehicle at the time of my inspection. The Insured Vehicle was observed to have sustained extensive collision damage at its frontal portion. Almost all the parts and components within the engine compartment were seen to be damaged/affected.

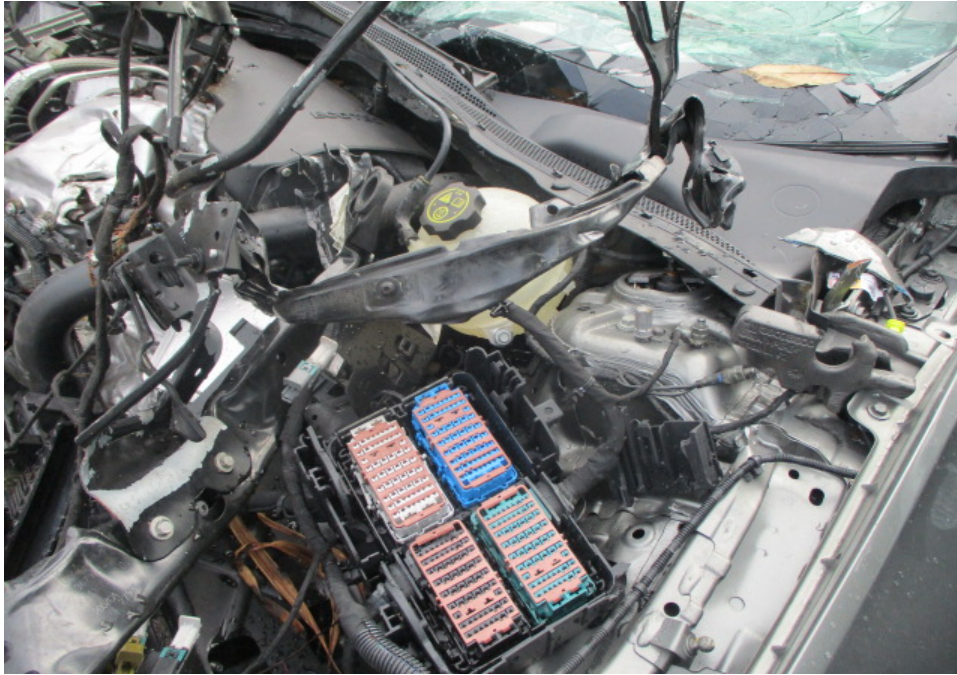
Photo 5 shows the engine fuse box, engine wiring harness, pipes and hoses within the engine compartment of the Insured Vehicle that were found to be damaged.

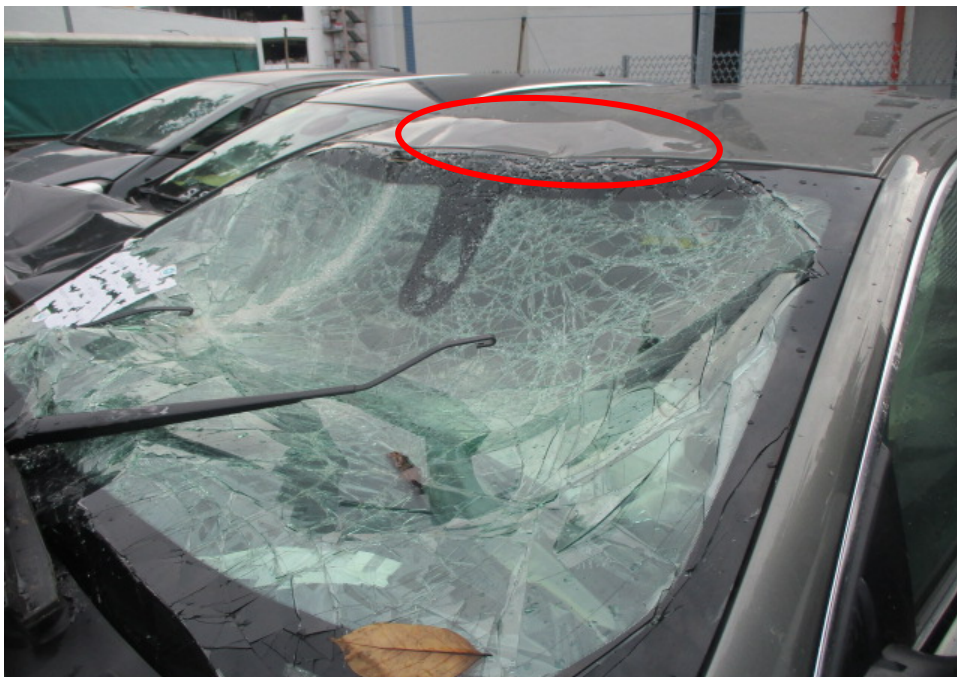
Photo 6 shows the front windscreen of the Insured Vehicle badly cracked. The roof panel was also observed to be dented (circled).

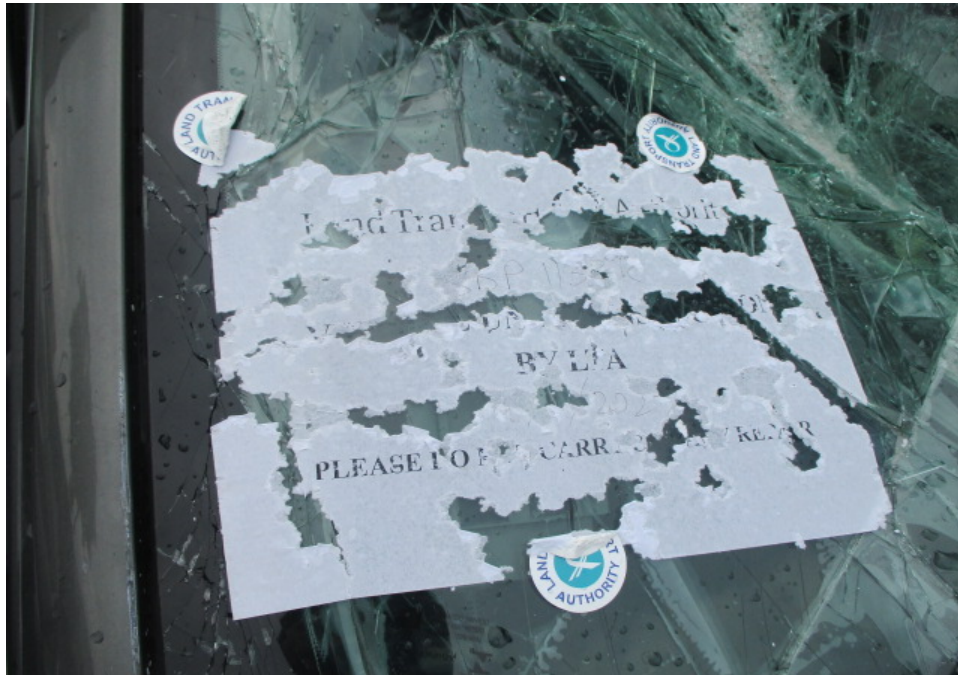
6. LTA's "do not carry out any repair" notices were pasted on the front windscreen and rear right door window of the Insured Vehicle. Such notices are normally pasted on vehicles that have had its chassis and/or structure badly damaged. See photo 1 – 8 below.

Photo 7 shows the LTA's "do not carry out any repair" notice that was pasted on the front windscreen of the Insured Vehicle. Such notices are normally pasted on vehicles that have had its chassis and/or structure badly damaged.

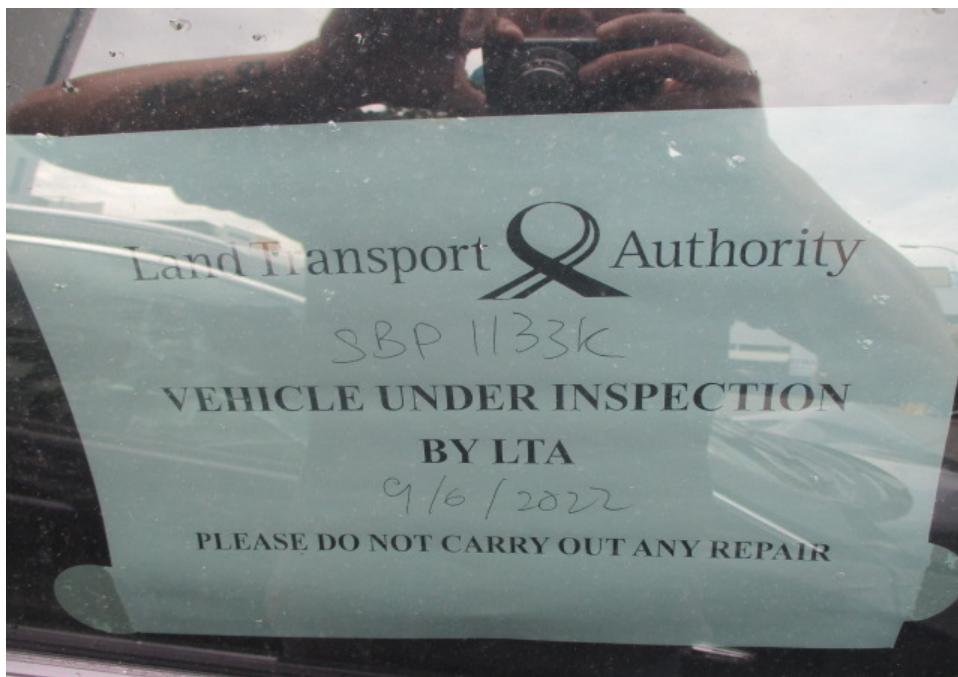
Photo 8 shows the LTA's "do not carry out any repair" notice that was pasted on the rear right door window of the Insured Vehicle. Such notices are normally pasted on vehicles that have had its chassis and/or structure badly damaged.

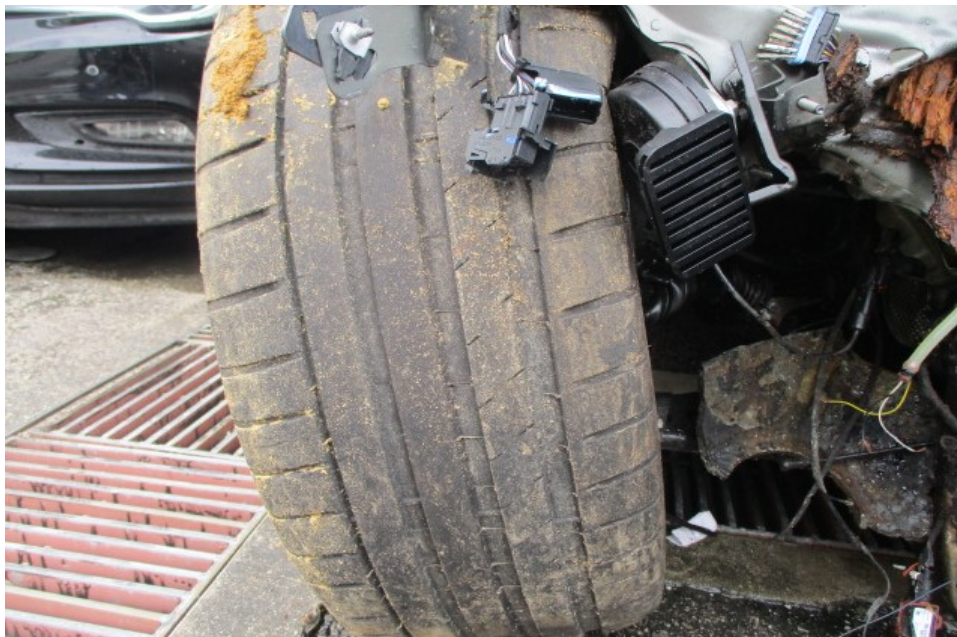
8. All 4 tyres and wheel rims that were fitted on the Insured Vehicle were observed to be damaged. The 4 tyres were found to be punctured with hole on the outer sidewall while the 4 wheel rims were found to be broken/dented. The tread pattern of the 4 tyres were clearly visible, indicating that the tyres fitted on the Insured Vehicle were all in serviceable condition. The tyre brand, tyre size and remaining tread depth of the 4 tyres were recorded as follows: -

Photo 9 shows the condition of the Insured Vehicle's front right tyre. The front right tyre of the Insured Vehicle was found to be in serviceable condition given that the tread pattern was clearly visible.

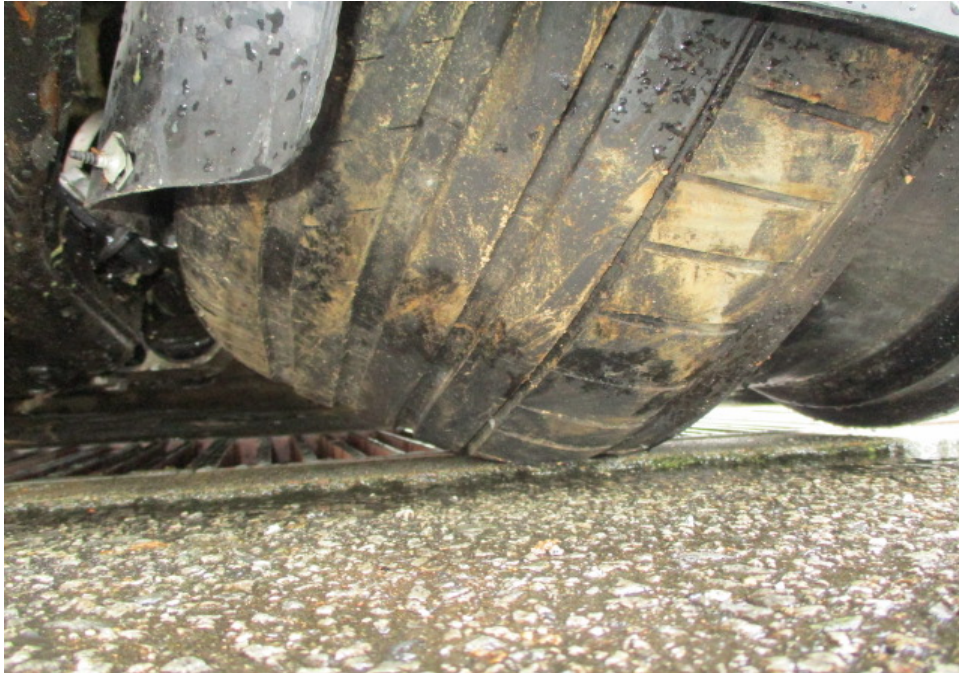
Photo 10 shows the condition of the Insured Vehicle's front left tyre. The front left tyre of the Insured Vehicle was found to be in serviceable condition given that the tread pattern was clearly visible.

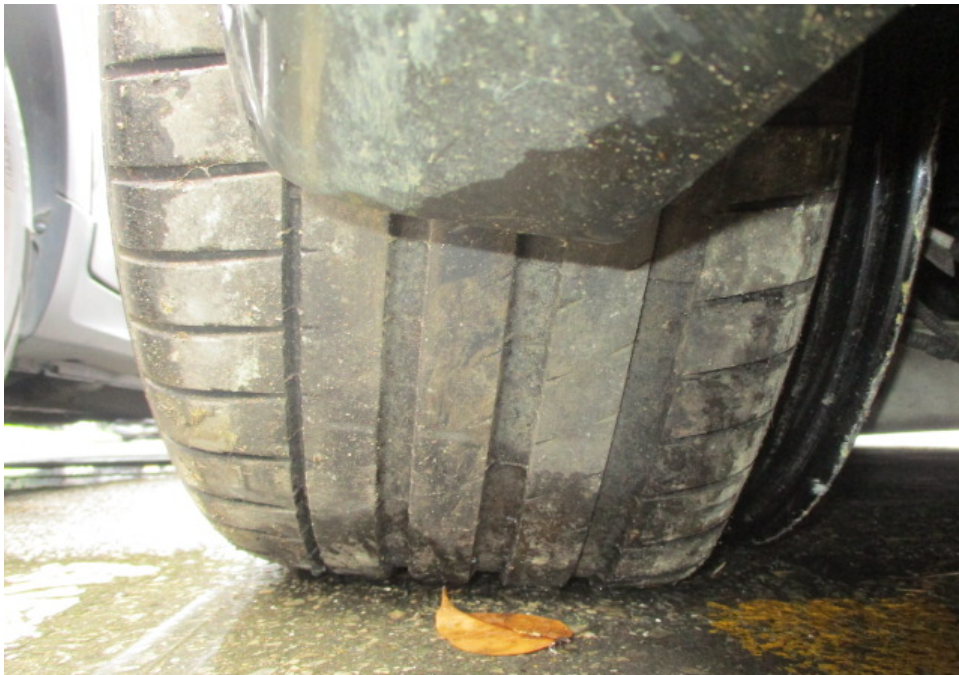
Photo 11 shows the condition of the Insured Vehicle's rear left tyre. The rear left tyre of the Insured Vehicle was found to be in serviceable condition given that the tread pattern was clearly visible.

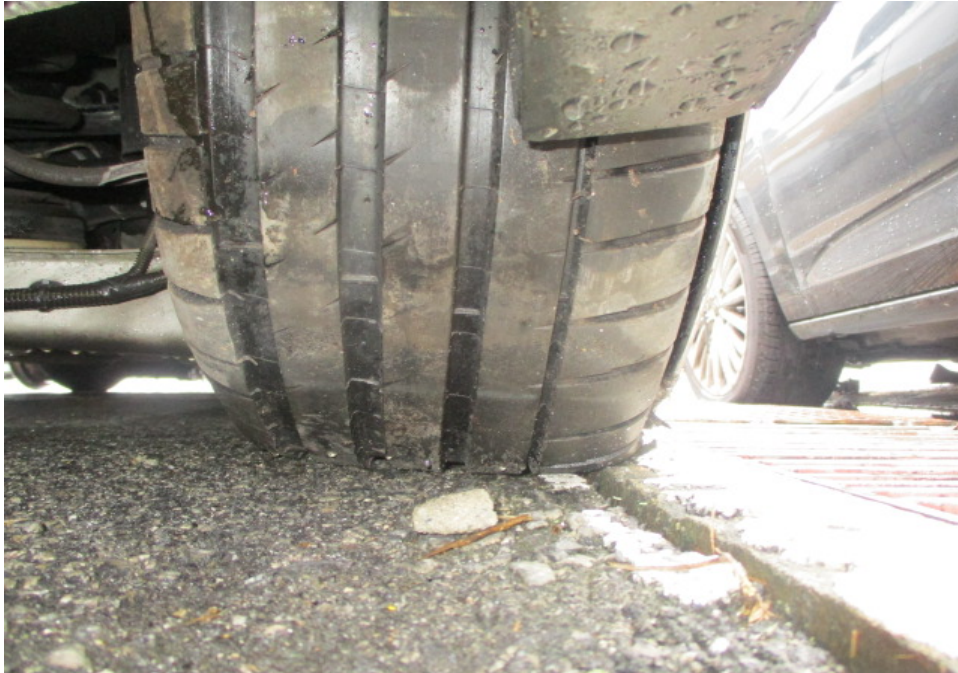
Photo 12 shows the condition of the Insured Vehicle's rear right tyre. The rear right tyre of the Insured Vehicle was found to be in serviceable condition given that the tread pattern was clearly visible.

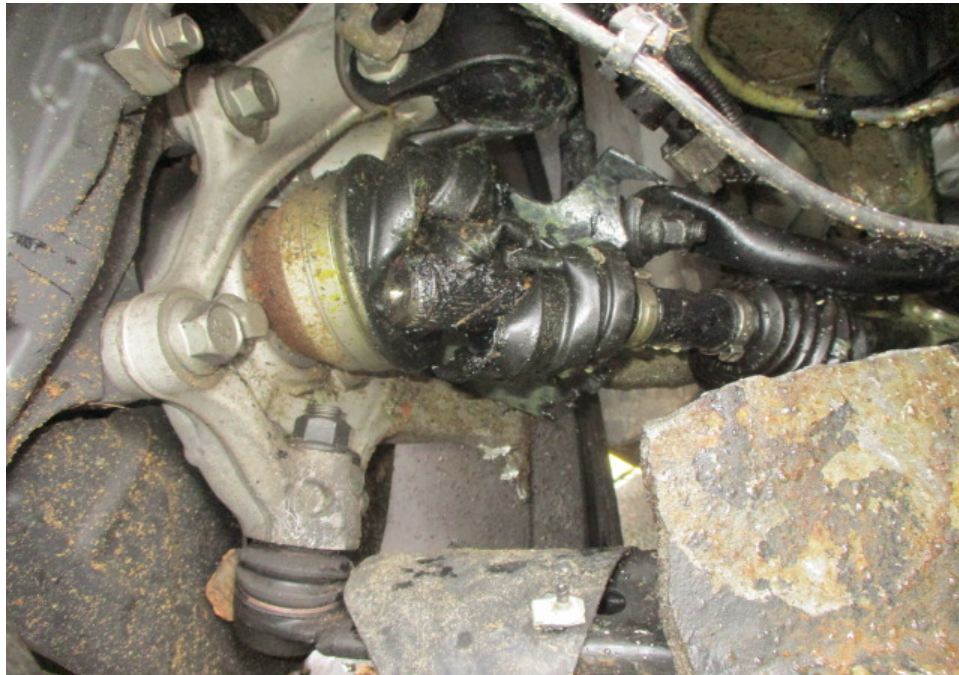
12. In any case, the Insured Vehicle's undercarriage parts at the front right wheel and front left wheel were found to be damaged and this had already prevented me from carrying out any meaningful tests to the steering system and braking system. The condition of Insured Vehicle's steering system and braking system at the material time of accident was thus unable to be establish. See photo 13 – 15 below.

Photo 13 shows the condition of the undercarriage parts at the front right wheel of the Insured Vehicle. The undercarriage parts at the front right wheel of the Insured Vehicle were found to be damage as a result of the accident. The damage had prevented me from carrying out any meaningful tests to the steering system and braking system of the Insured Vehicle.

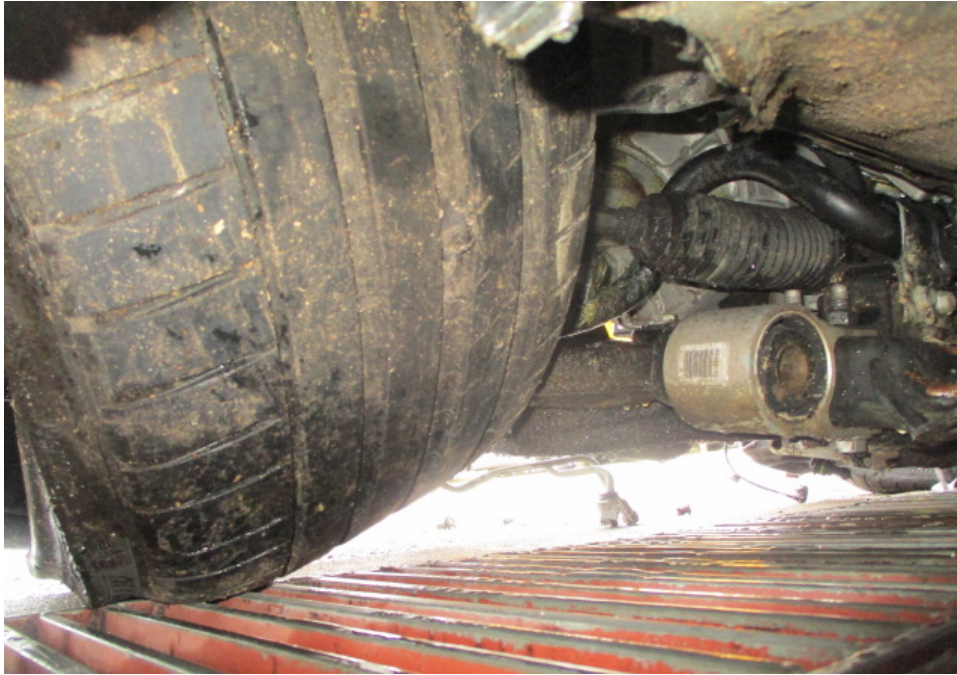
Photo 14 shows the condition of the undercarriage parts at the front left wheel of the Insured Vehicle. The undercarriage parts at the front left wheel of the Insured Vehicle were found to be damage as a result of the accident. The damage had prevented me from carrying out any meaningful tests to the steering system and braking system of the Insured Vehicle.

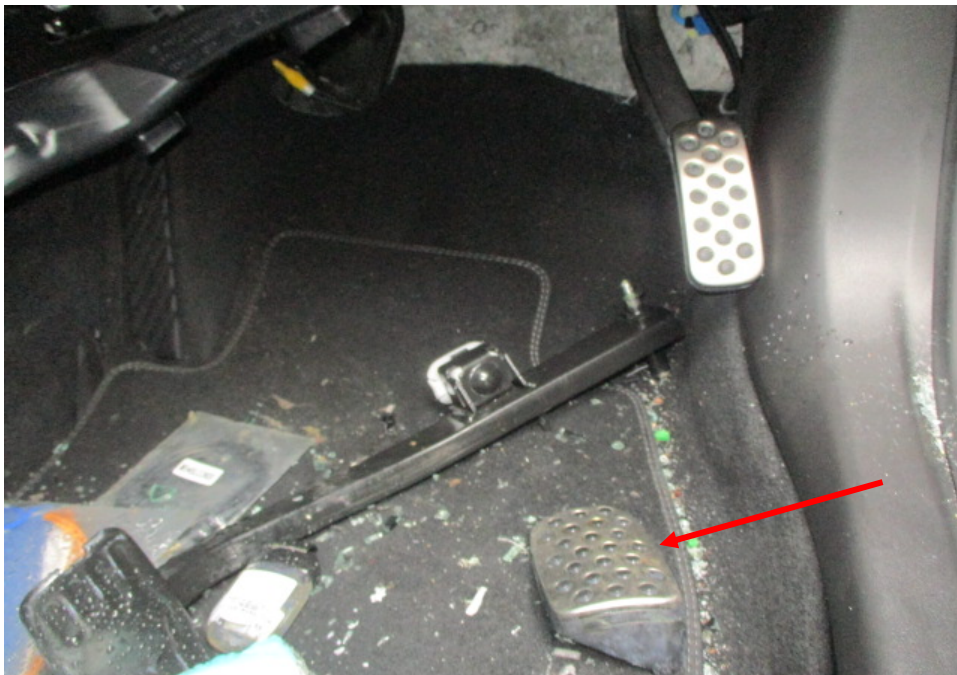
Photo 15 shows the foot brake pedal (arrowed) of the Insured Vehicle. The foot brake pedal was dislodged, which prevented me from carrying any meaningful test to the braking system of the Insured Vehicle.

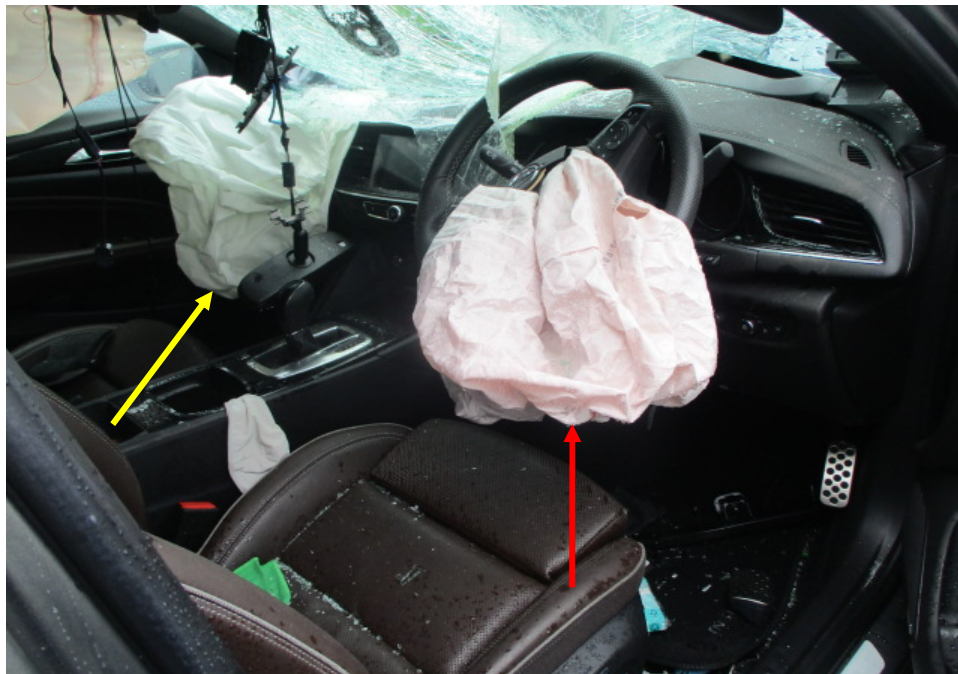
14. The driver's airbag, front left passenger airbag, left curtain airbag and front left passenger seat airbag were all activated. As for the seat belts, I had found the front left passenger seat belt, rear left passenger seat belt and rear right passenger seat belt were all activated, in an unworn locked position. The driver's seat belt was not activated. See photo 16 – 18 below.

Photo 16 shows the interior compartment of the Insured Vehicle at the time of my inspection. The driver's airbag (red arrow) and front left passenger airbag (yellow arrow) were activated.

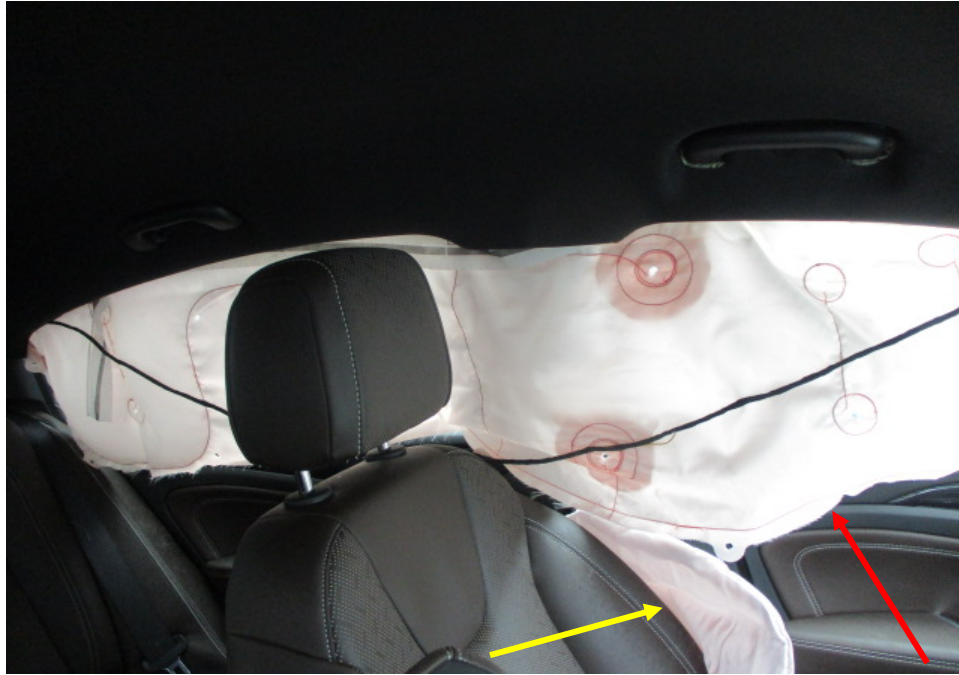
Photo 17 shows the interior compartment of the Insured Vehicle at the time of my inspection. The left curtain airbag (red arrow) and front left passenger seat airbag (yellow arrow) were activated.

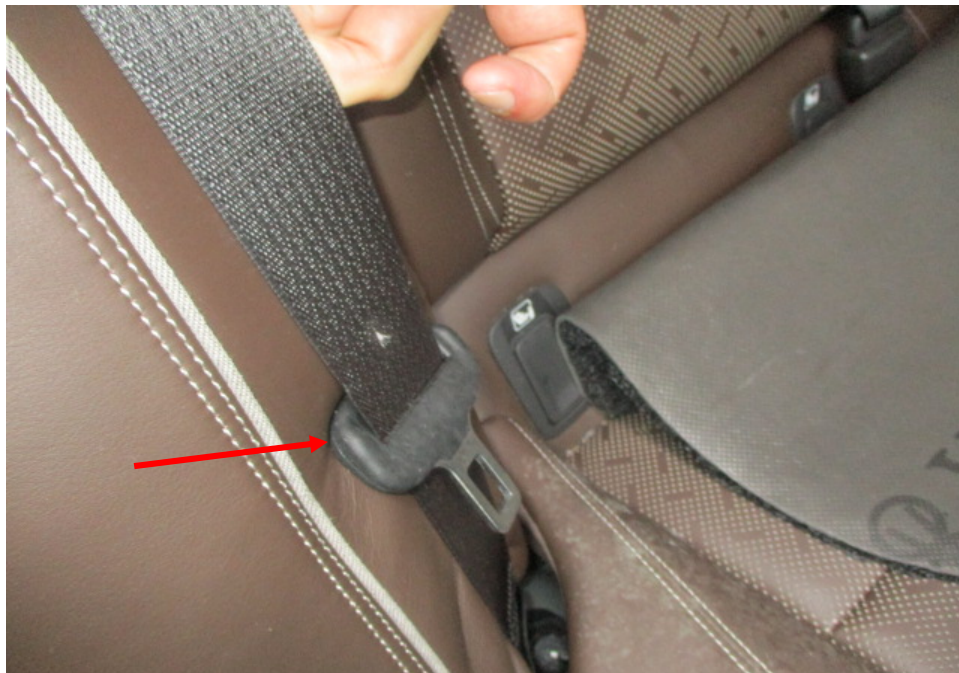
Photo 18 shows the rear passenger seat of the Insured Vehicle at the time of my inspection. The rear right passenger seat belt (arrowed) was activated in an unworn locked position. Apart for this, I had found the rear left passenger seat belt and front left passenger seat belt activated in a similar unworn locked position. As for the driver's seat belt, I had found it to be not activated.
