Vehicle No.	SHA 2667M
Insured Veh.	SJJ 2670G
Claim No.	SNM22D204402/C02
Policy No.	DMPCSNW00163082102
Accident Date	22/06/2022
Inspection Date	22/06/2022

Make & Model	HYUNDAI I40	c.c	1685
Engine No.	HIDDEN	Year of Reg.	2016
Chassis No.	KMHLB41UMGU085531	Colour	BLUE
Odometer	545360 KM	Steering	IN ORDER
Brakes	IN ORDER	Modification	NIL
General	GOOD

ADJUSTMENT ON REPAIR COST FOR VEHICLE NO. SHA 2667M

PHOTOGRAPHS FOR VEHICLE NO. SHA 2667M

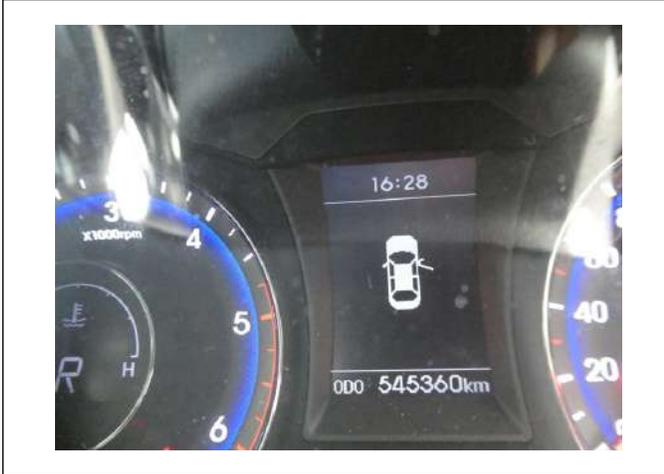
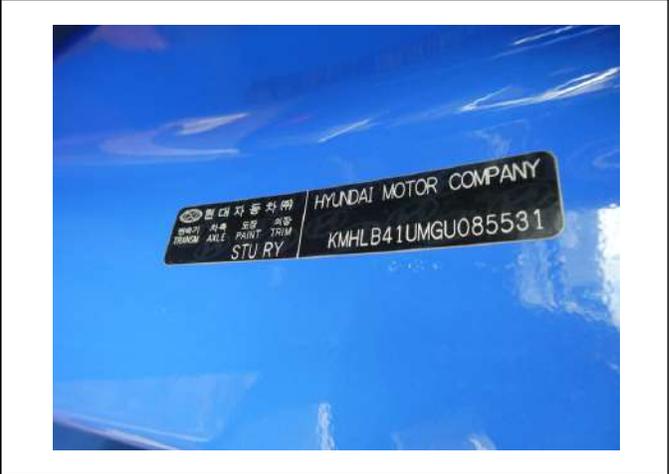
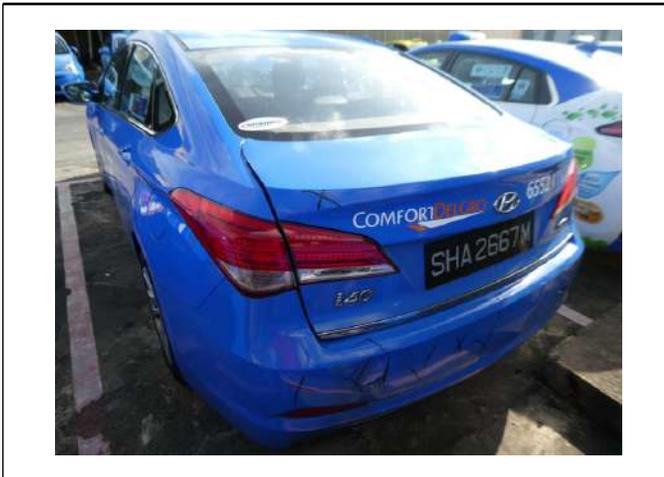
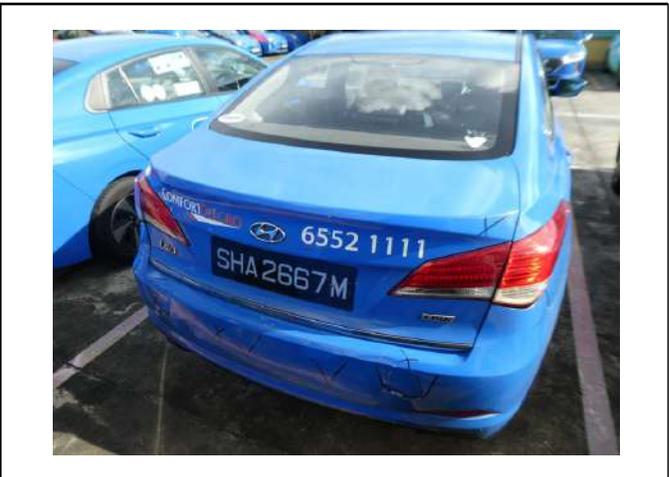
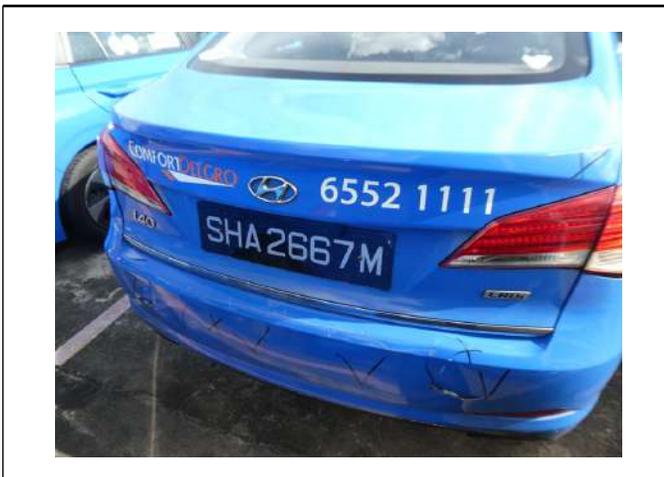
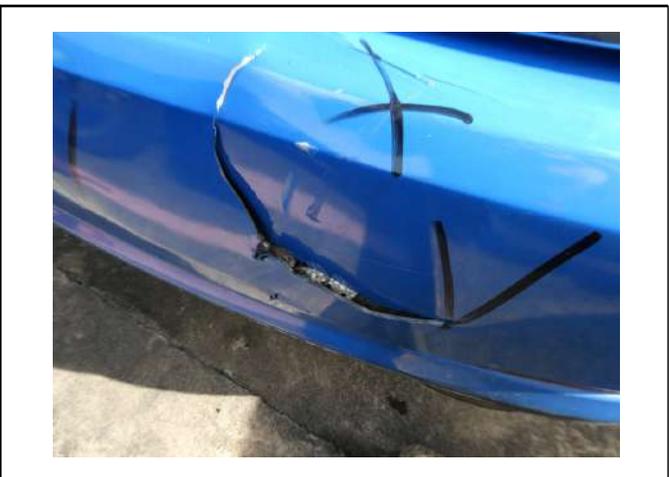
INSPECTION

THE VEHICLE SUSTAINED DAMAGES AT THE REAR PORTION.
DAMAGES SEE DETAILS.

Qty	Description of Parts	Condition	Estimate By Workshop (\$)	Our Adjusted (\$)
<u>REPLACEMENT OF PARTS</u>				
1	COVER ASSY -RR BUMPER	CRACKED	553.00	553.00
1	COVER-RR BUMPER LWR	CUT	228.00	228.00
1	ABSORBER -RR BUMPER ENERGY	CRACKED	119.50	119.50
1	BEAM -RR BUMPER	NOT NECESSARY	428.40	-
10	BUMPER COVER CLIP REAR	NECESSARY	22.00	22.00
1	STAY RR BUMPER LH	NOT NECESSARY	160.60	-
1	STAY RR BUMPER RH	NOT NECESSARY	160.60	-
	LESS 20% DISCOUNT		-334.42	-184.50
			1,337.68	738.00
<u>SPECIAL NETT ITEMS</u>				
1	REVERSE SENSOR ASSY (SN)	NOT NECESSARY	135.70	-
			135.70	-
<u>LABOUR</u>				
	PANEL BEATING.		300.00	280.00
	SPRAYPAINT CHARGE.		300.00	250.00
	REMOVE/REFIX REVERSE SENSOR .		50.00	30.00
			650.00	560.00
GRAND TOTAL			2,123.38	1,298.00

RECOMMENDED COST OF LUMP SUM REPAIRS (TO ITS PRE-ACCIDENT CONDITION)			1,050.00
---------------------------------------------------------------------------------	--	--	-----------------
