Your Ref: SNM22D204547/C01
Our Ref : CS4/CTI22006716/P

4th August 2022

**TECHNICAL INVESTIGATION REPORT OF ACCIDENT INCIDENT INVOLVING
THE INSURED VEHICLE SGN 9U ON 28th JUNE 2022**

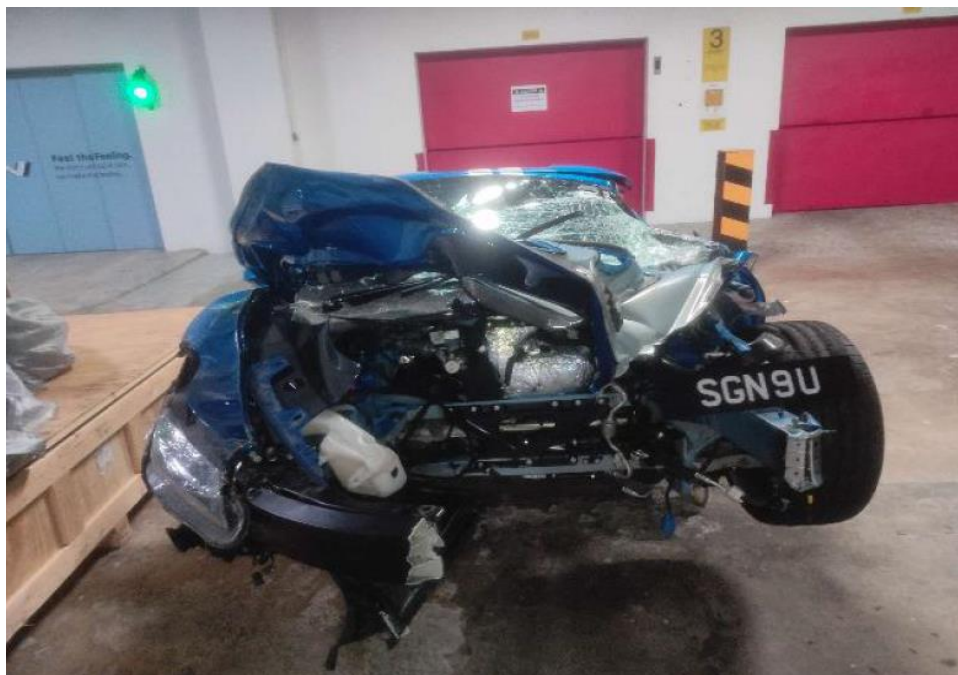
Photo 1 shows the general view of the front portion of the Insured Vehicle at the time of our inspection. Its front windscreen, front bonnet, and bumper portion, as well as its right door panel and its undercarriage components was amongst the body parts that were damaged, and its airbags was deployed as a result of the accident.

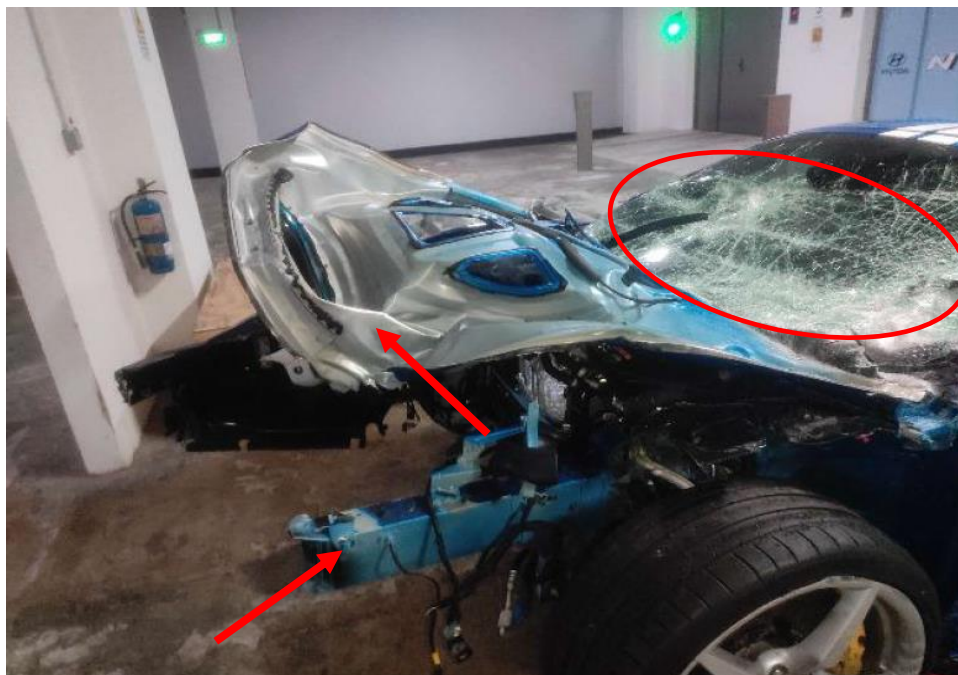
Photo 2 shows the close up view of the front portion of the Insured Vehicle at the time of our inspection. Its front windscreen (circled) and front bonnet (arrowed) was the body parts that were damaged as a result of the accident.

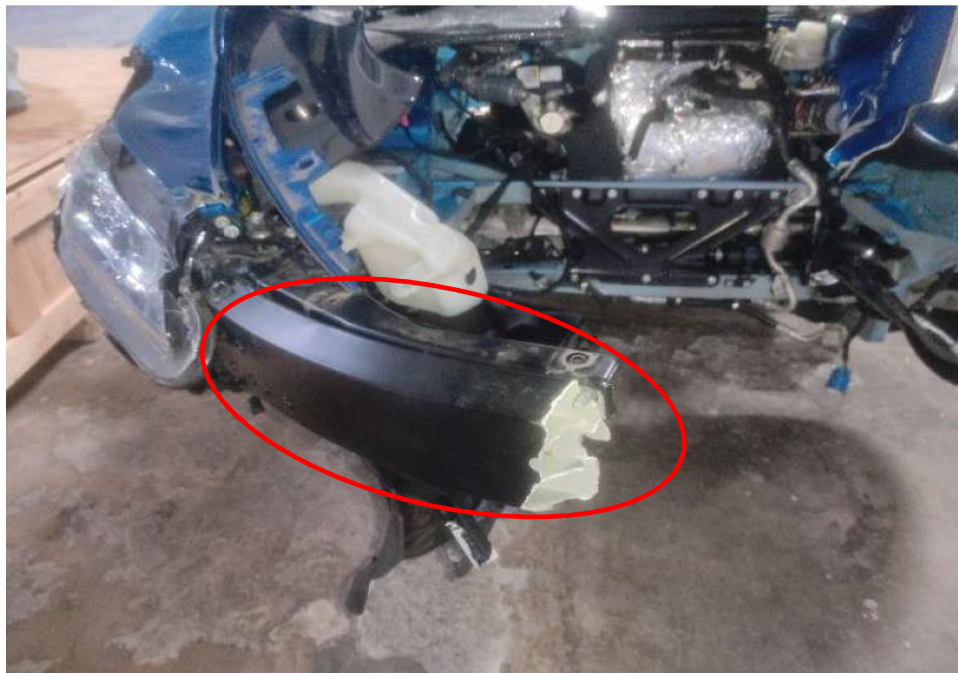
Photo 3 shows the close up view of the front portion of the Insured Vehicle at the time of our inspection. Its front bumper (circled) was the body parts that were damaged as a result of the accident.

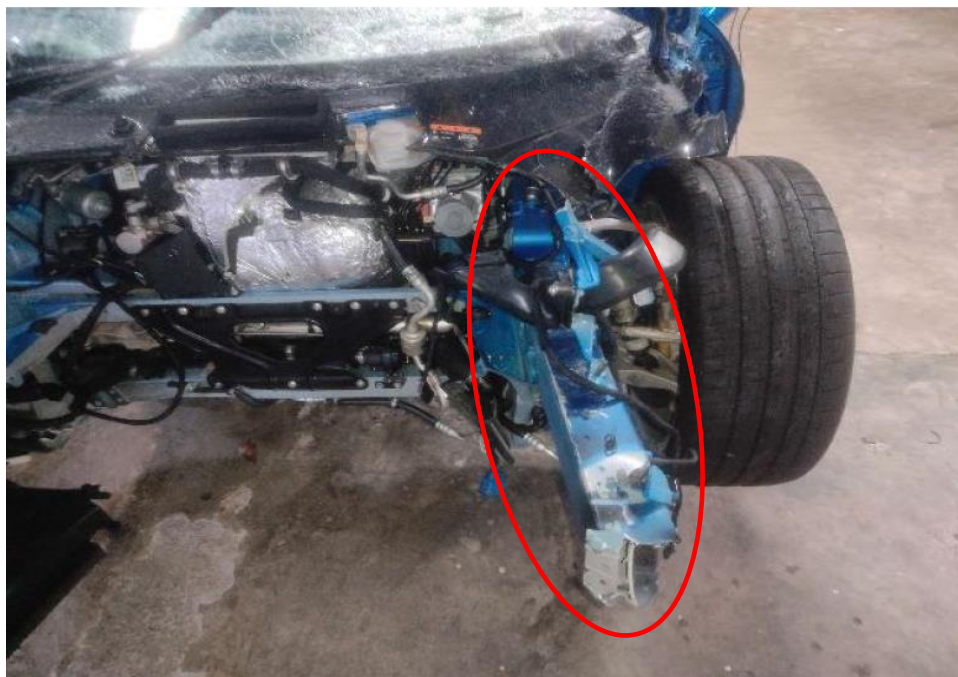
Photo 4 shows the close up view of the front portion of the Insured Vehicle at the time of our inspection. Its front vehicle chassis (circled) was the body parts that were damaged as a result of the accident.

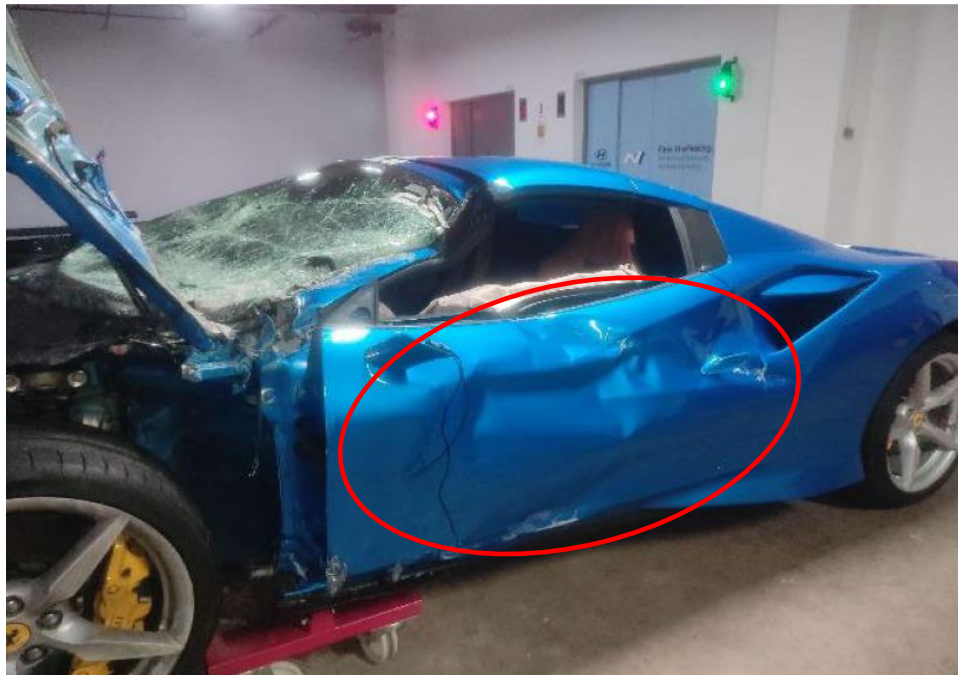
Photo 5 shows the close up view of the left portion of the Insured Vehicle at the time of our inspection. Its left door panel (circled) was the body parts that were damaged as a result of the accident.

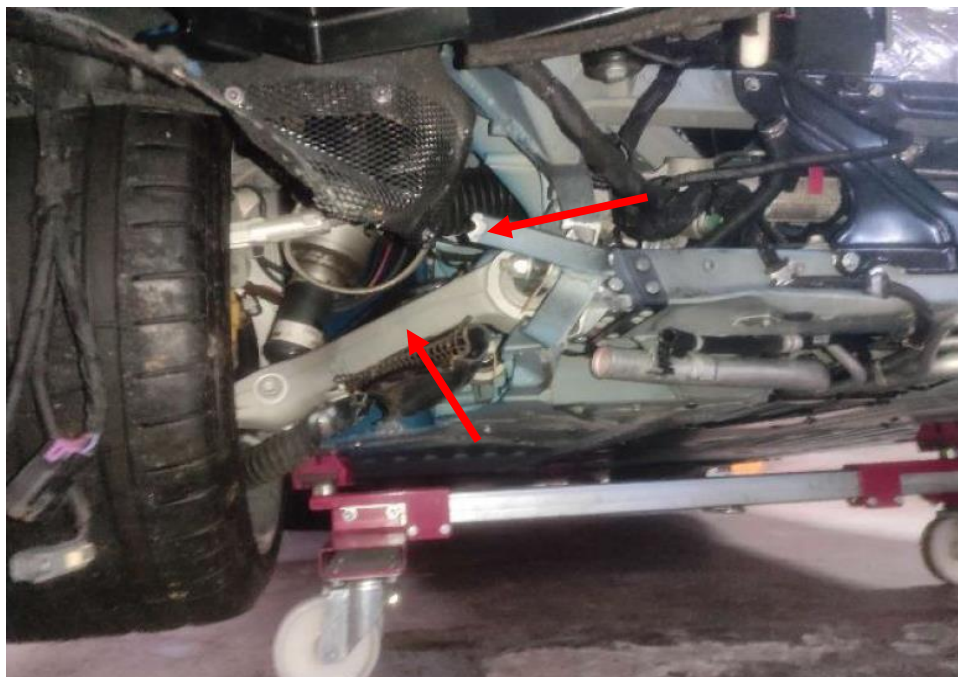
Photo 6 shows the close up view of the undercarriage portion of the Insured Vehicle at the time of our inspection. Its undercarriage suspension components (arrowed) were also damaged as a result of the accident.

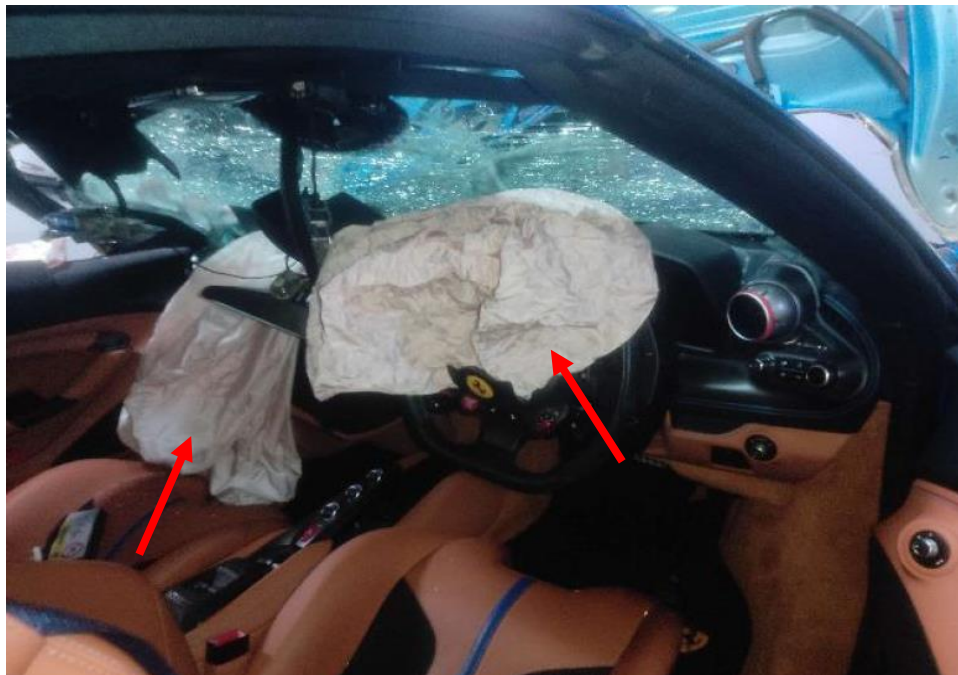
Photo 7 shows the close up view of the interior portion of the Insured Vehicle at the time of our inspection. Its airbag's deployed (circled) as a result of the accident.

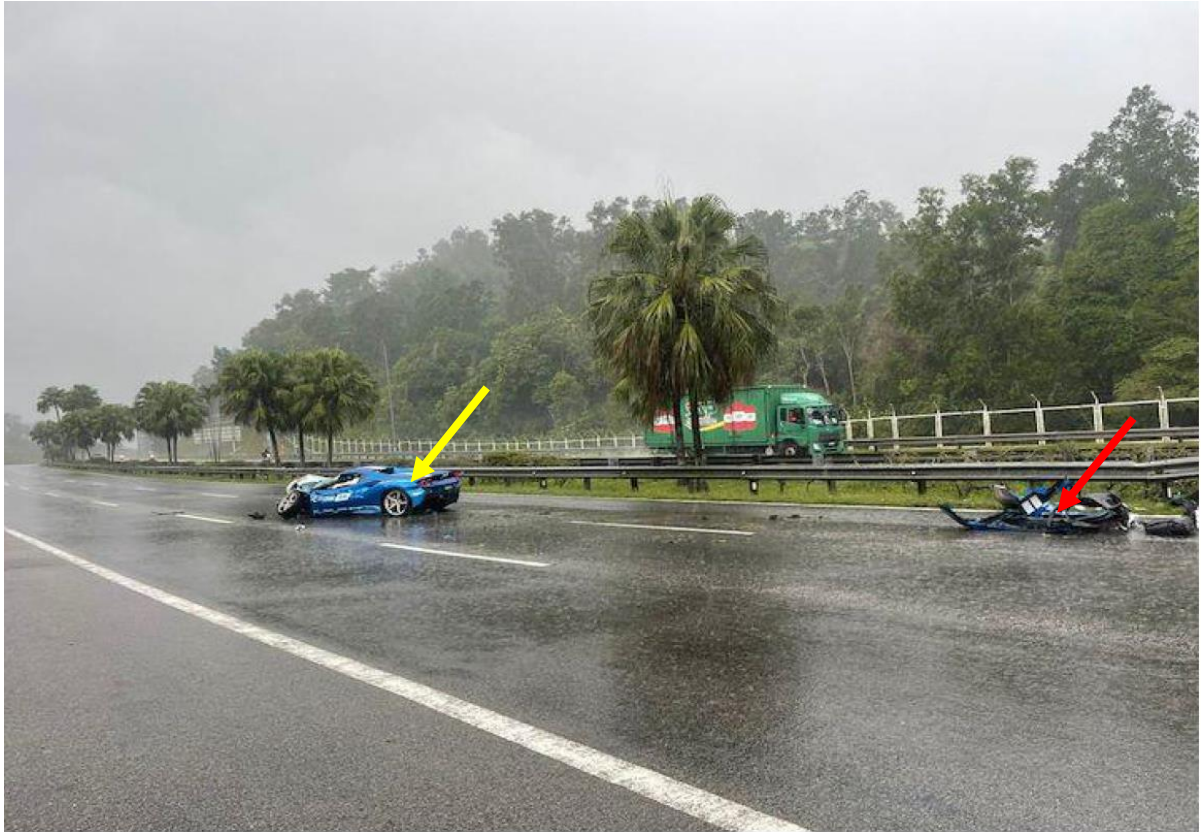
Photo 8 shows accident location on the highway from Malaysia customs towards Singapore Customs. We noticed the location of the barrier where the Insured Vehicle had skidded and crashed into (red arrow) and where the Insured Vehicle had bounced back after the crashing into the barrier and landed in between lanes 1 and 2 (yellow arrow). In general, the information that could be gathered from this photograph had corresponded to the events that were related to us by Mr Ke on the location when the accident happened.

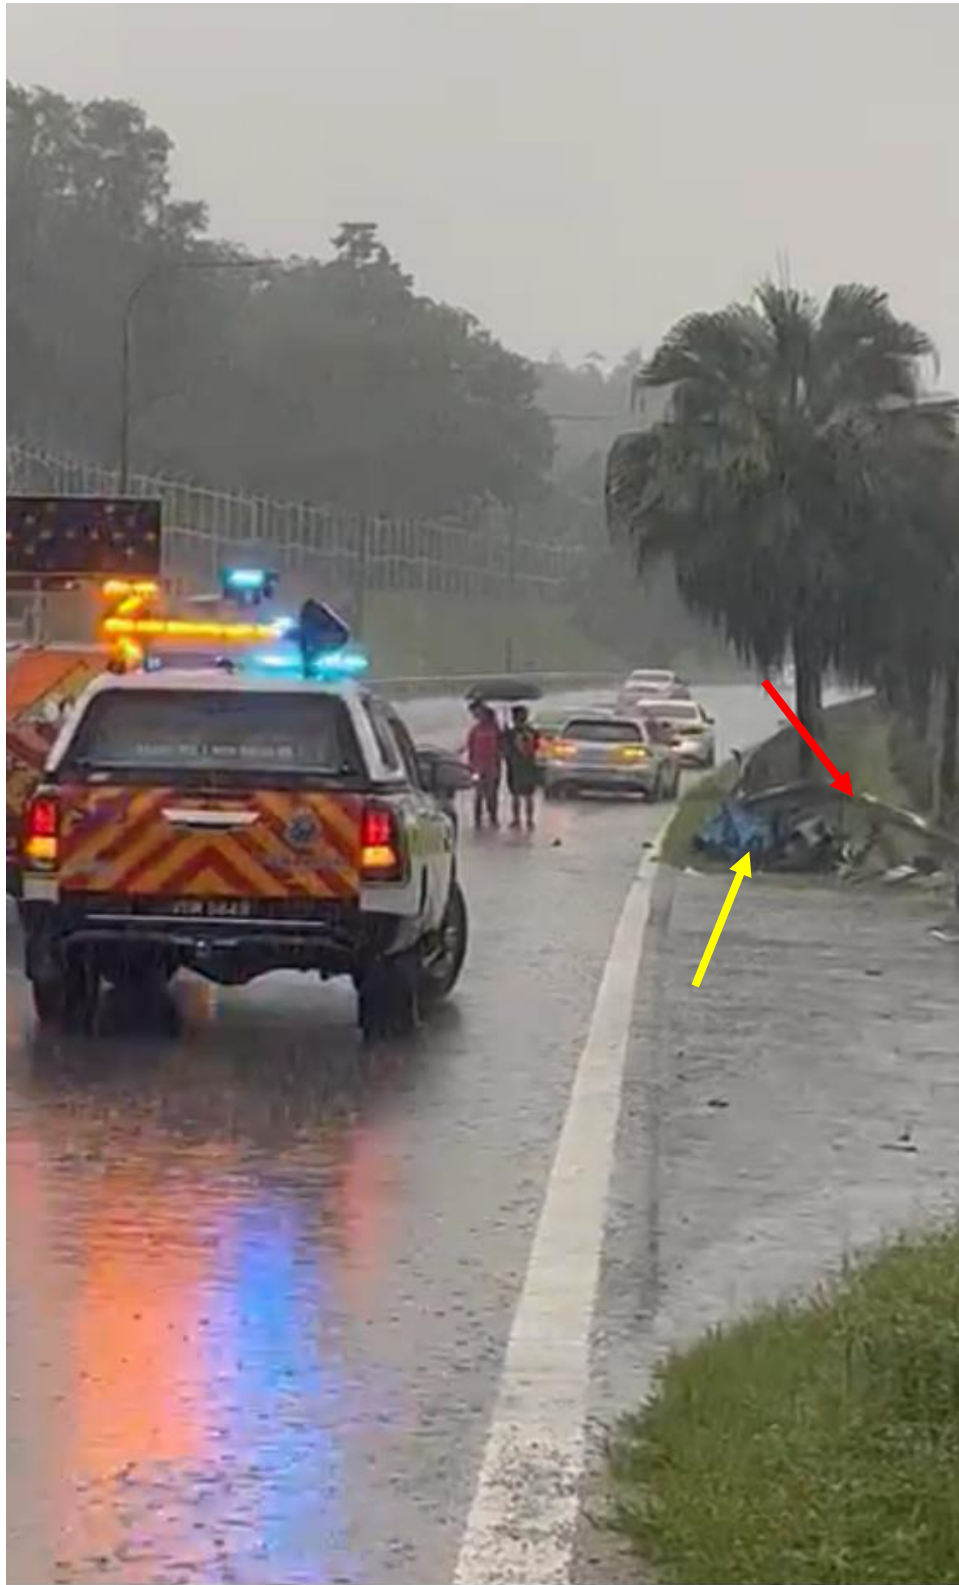
Photo 9 shows the location where the Insured Vehicle had crashed into the barrier (red arrow), and we also observed the damages parts (yellow arrow) of the Insured Vehicle that had fallen off the as a result of the accident. In general, the information that could be gathered from this photograph had corresponded to

the events that were related to us by Mr Ke, location when the accident happened.

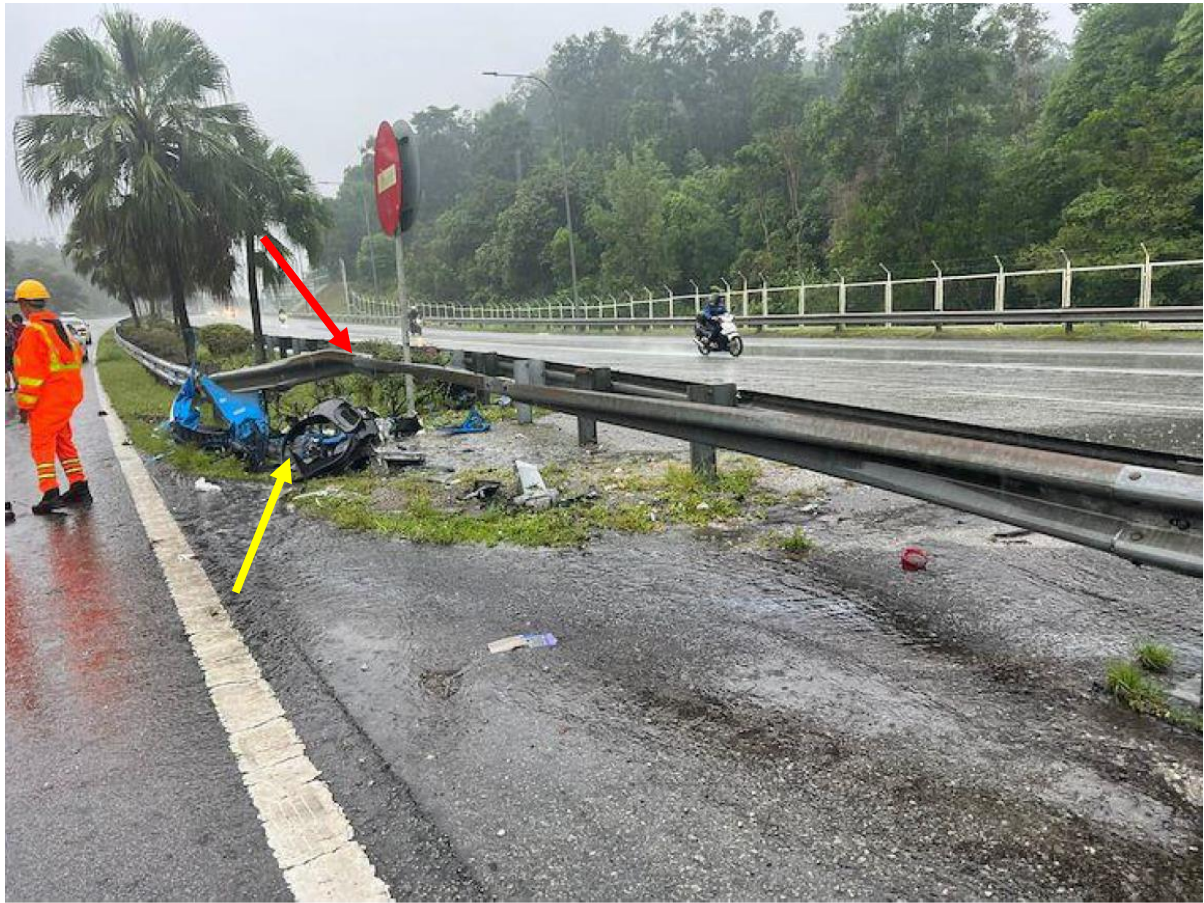
Photo 10 shows the close up location where the Insured Vehicle had crashed into the barrier (red arrow), and we also observed the damages parts (yellow arrow) of the Insured Vehicle that had fallen off the as a result of the accident. In general, the information that could be gathered from this photograph had corresponded to the events that were related to us by Mr Ke, location when the accident happened.

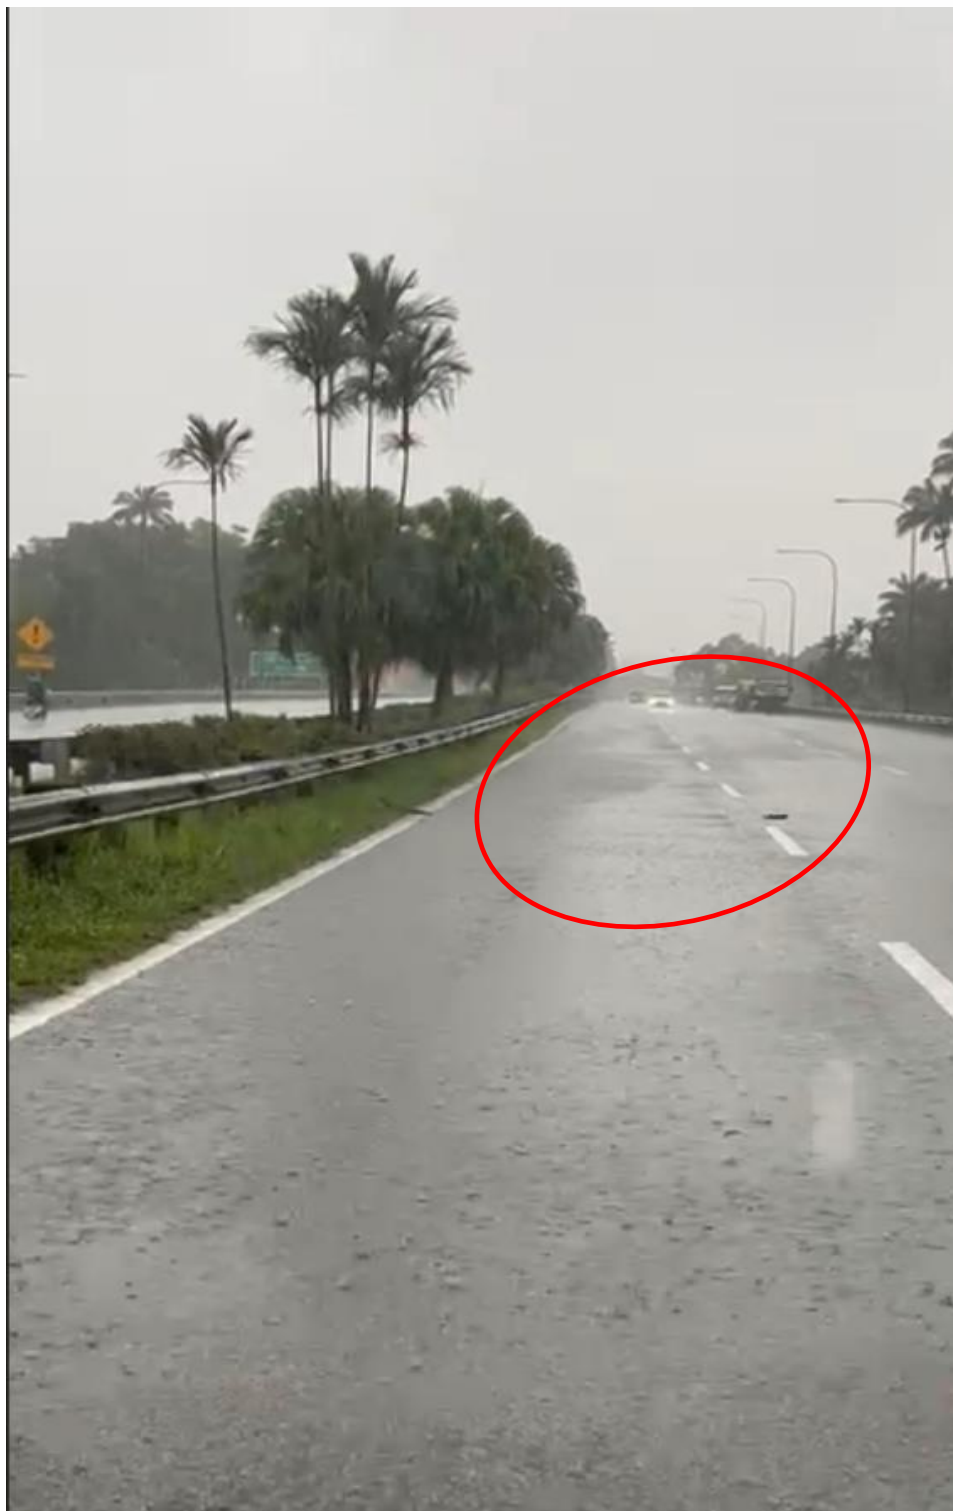
Photo 11 shows the location where the Insured Vehicle had likely hit a water puddle resulting in the Insured Vehicle losing control and skidded. We have observed that there was visible water ponding on lanes 2 and 1 where the mentioned vehicle was travelling on (circled). The water ponding was due to the result of the heavy rain. In general, the information that could be gathered from this photograph had corresponded to the events that were related to us by Mr Ke, location when the accident happened.

18. Having investigated and technically analysed the damages to the Insured Vehicle, the incident scene and the face-to-face statement taking with the Insured driver. We are of the view that the cause of damage to the Insured Vehicle and government property was of an accident where the Insured Vehicle drove into a water puddle due to water ponding in the path where it was travelling on which was caused by bad weather and road conditions as a result of the heavy rain resulting it to lose control and skidded.

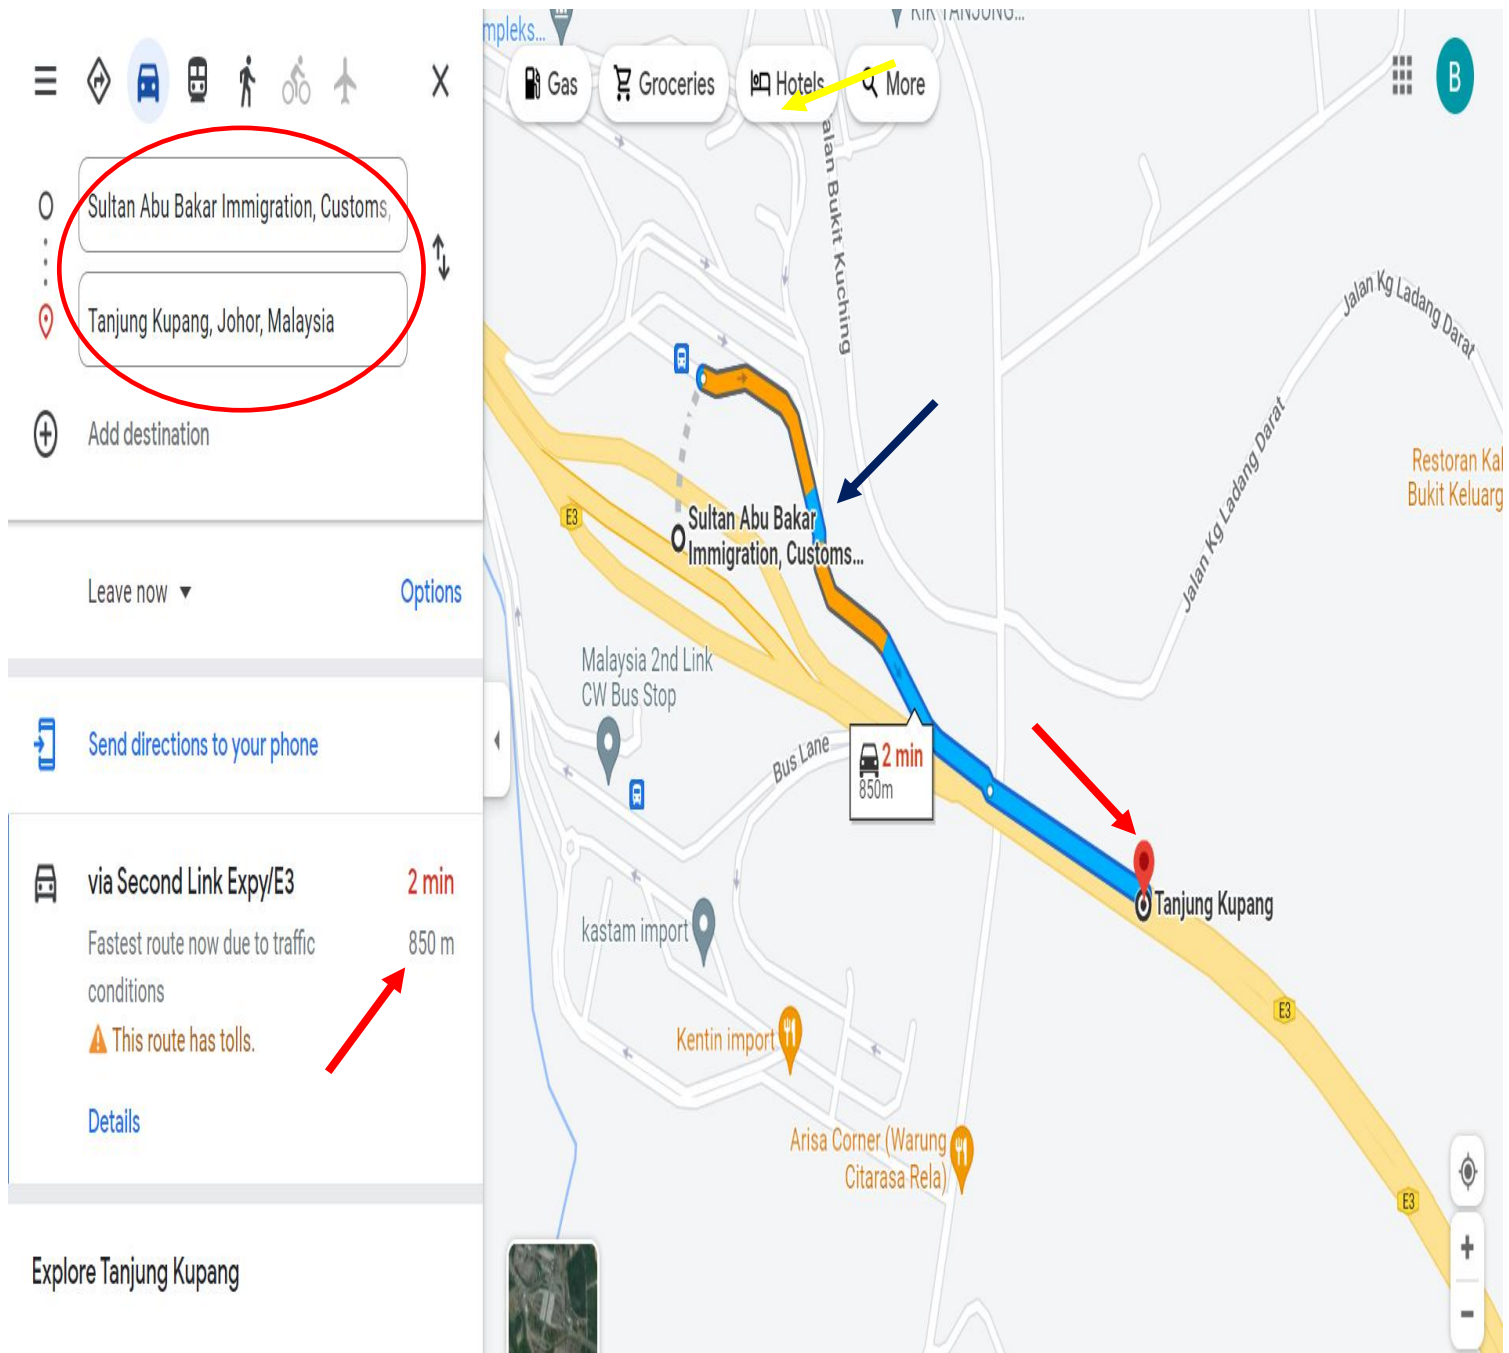
Photo 12 shows the routed route from Malaysia Customs start off point (black arrow) to Tanjung Kupang which was about 850 meters ahead (incident point) (red arrow). In general, the information that could be gathered from this photograph had corresponded to the events that were related to us by Mr Ke, location when the accident happened.

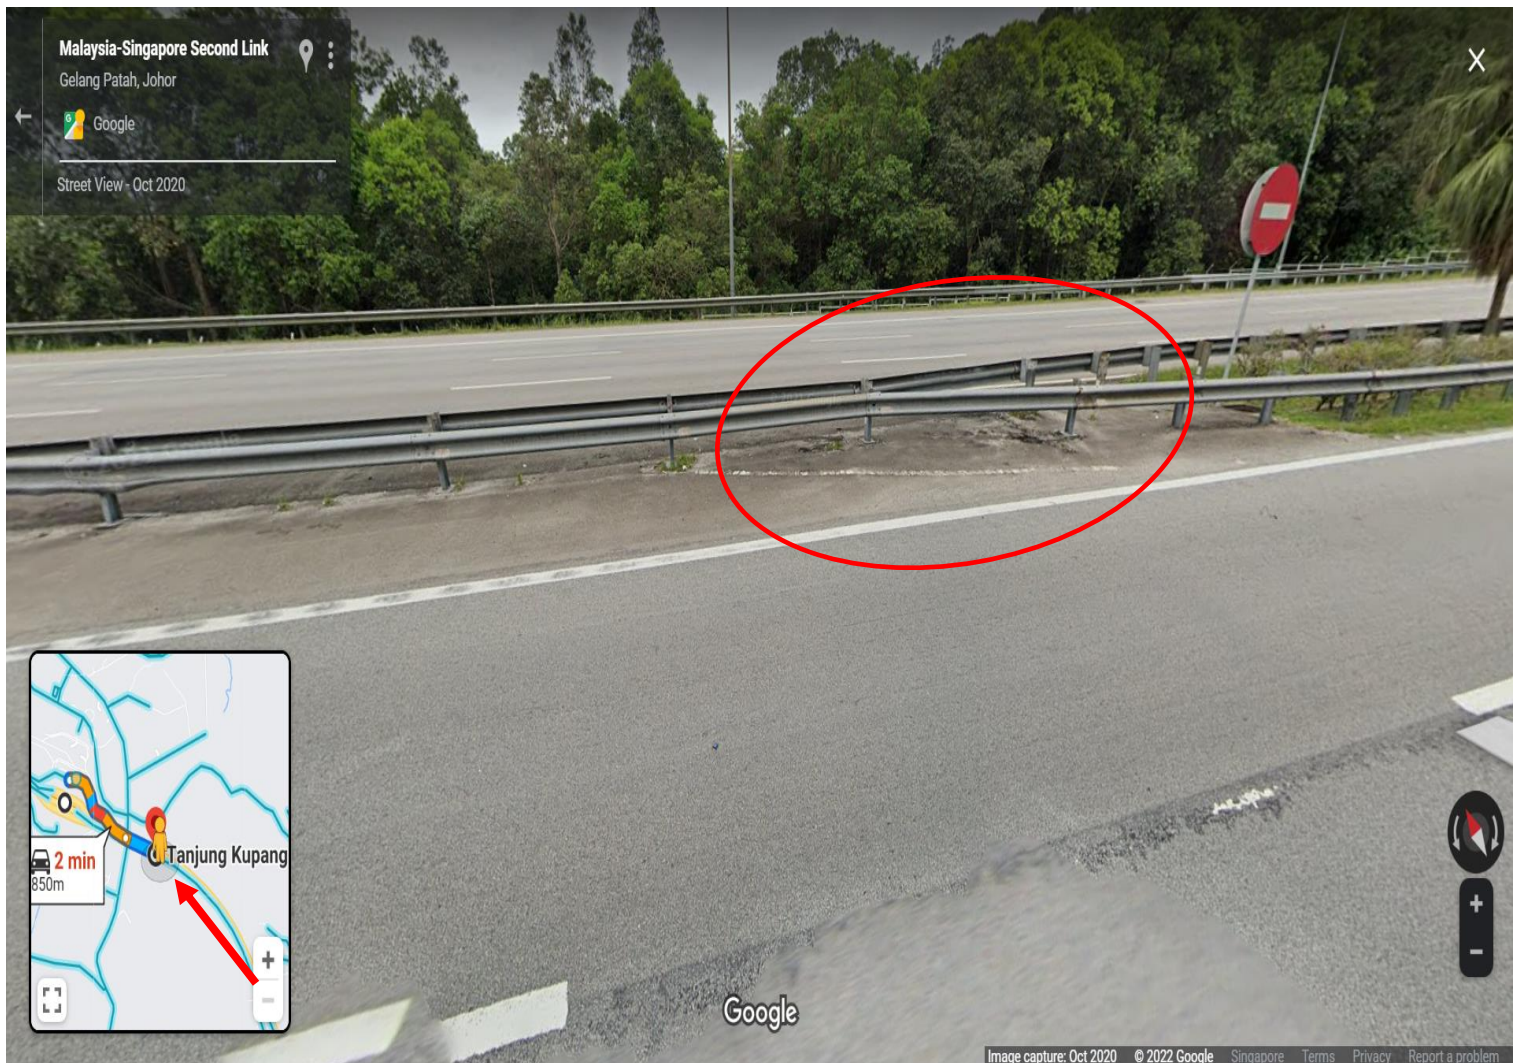
Photo 13 shows the routed route from Malaysia Customs start off point to Tanjung Kupang impact point which was about 850 meters ahead (red arrow). The barrier impact point where to the Insured Vehicle had crashed into (circled) In general, the information that could be gathered from this photograph had corresponded to the events that were related to us by Mr Ke, location when the accident happened.
