# NEW AUTO SPEC APPRAISAL

## Vehicle Survey Report

| Our Reference No. | : <u>WC7966D21102019</u> | Date Of Survey | : <u>21-10-2019</u> |

| Vehicle Reg. No. | : <u>WC7966D</u> | Engine Number | : <u>Hidden</u> |

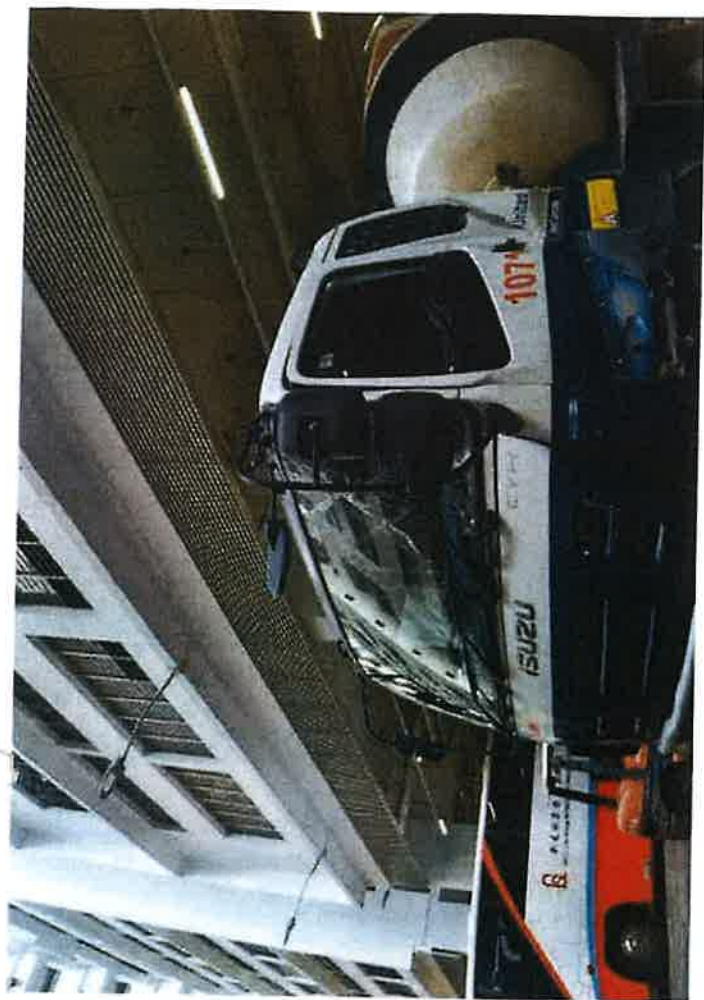
Point Of Impact

Front portion of the vehicle  
(For more detail of the damages, please refer photographs attached)
