# Precise Appraiser Pte Ltd

VEHICLE DAMAGE ASSESSMENT REPORT

Ref No	: 2022/02001	Date of Report	: 10/2/2022
Claim Type	: Third Party	Date of Request	: 5/2/2022
Third party vehicle	: SMX3854C	Date of Accident	: 22/1/2022
Insured Vehicle	:	Date of Inspection	: 5/2/2022
Your Reference No	:

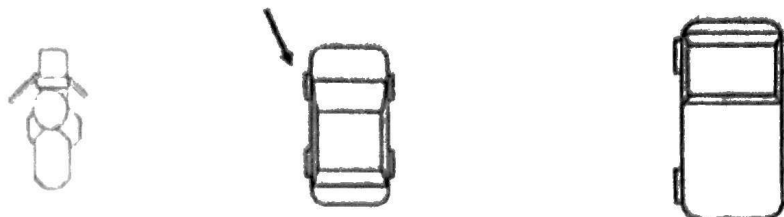
At the time of inspection, this vehicle sustained damages to the Front Lh Portion.

Front lh fender, front lh door dented, lh rocker panel scratch, front lh sport rim grazed, front lh undercarriage push in etc.
