Your Ref: Porsche Macan GTS  
(chassis number WP1ZZZ95ZMLB63510)  
Our Ref : CI/TP22006789/D

18 July 2022

**INSPECTION REPORT OF AN UNREGISTERED PORSCHE MACAN GTS  
MOTOR CAR WITH CHASSIS NUMBER WP1ZZZ95ZMLB63510**

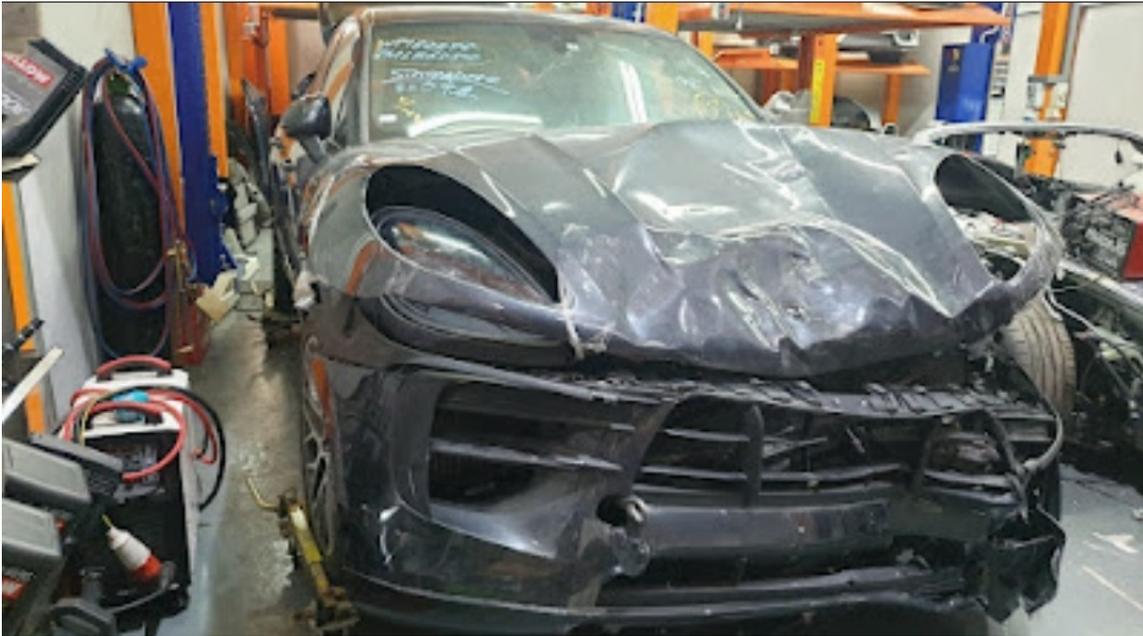
**Photo 1** shows the front right body of the Motor Car (photograph provided to me). The Motor Car was observed to have sustained damage at its frontal portion. The front bumper, front bumper centre lower grille, front bumper right grille, radiator grille, front sensor unit, front bonnet and front right headlamp were amongst the body parts that were observed to have been damaged. The photographs provided to me were unclear whether any airbag(s) of the Motor Car was activated. However, given the extent of damage at the frontal portion, it is possible that the driver's airbag and/or front left passenger airbag of the Motor Car was activated.

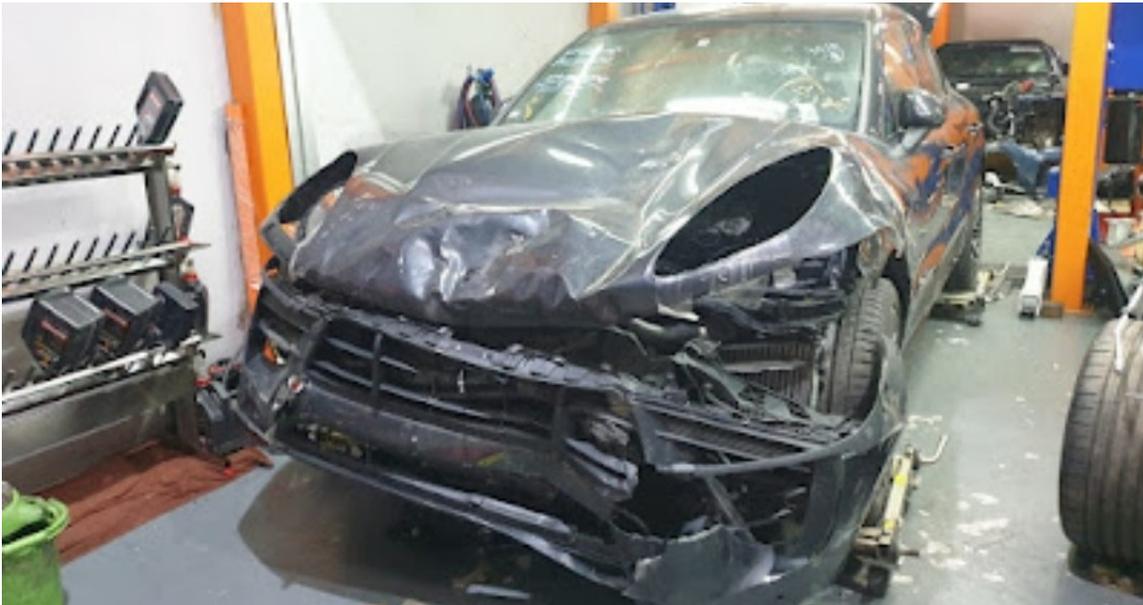
**Photo 2** shows the front left body of the Motor Car (photograph provided to me). The Motor Car was observed to have sustained damage at its frontal portion. The front bumper, front bumper lower lip, front bumper left grille, front bonnet, front bonnet locks, front left intercooler and front left headlamp were amongst the body parts that were observed to have been damaged. The photographs provided to me were unclear whether any airbag(s) of the Motor Car was activated. However, given the extent of damage at the frontal portion, it is possible that the driver's airbag and/or front left passenger airbag of the Motor Car was activated.

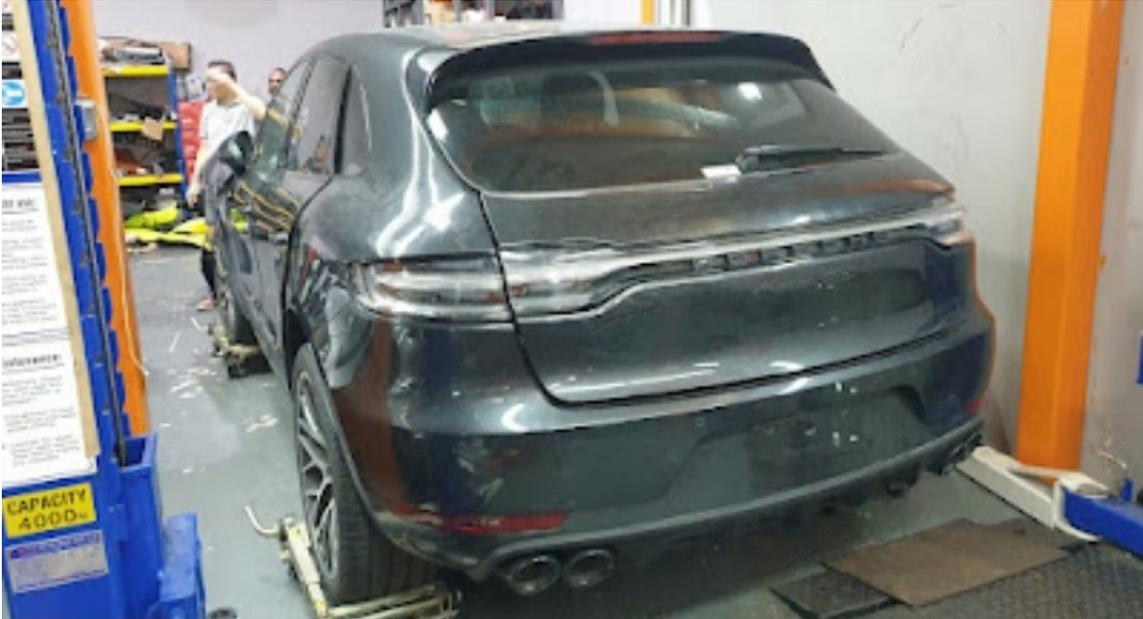
**Photo 3** shows the rear left body of the Motor Car (photograph provided to me). Apart for the frontal portion, there was no physical damage observed to other areas of the Motor Car.

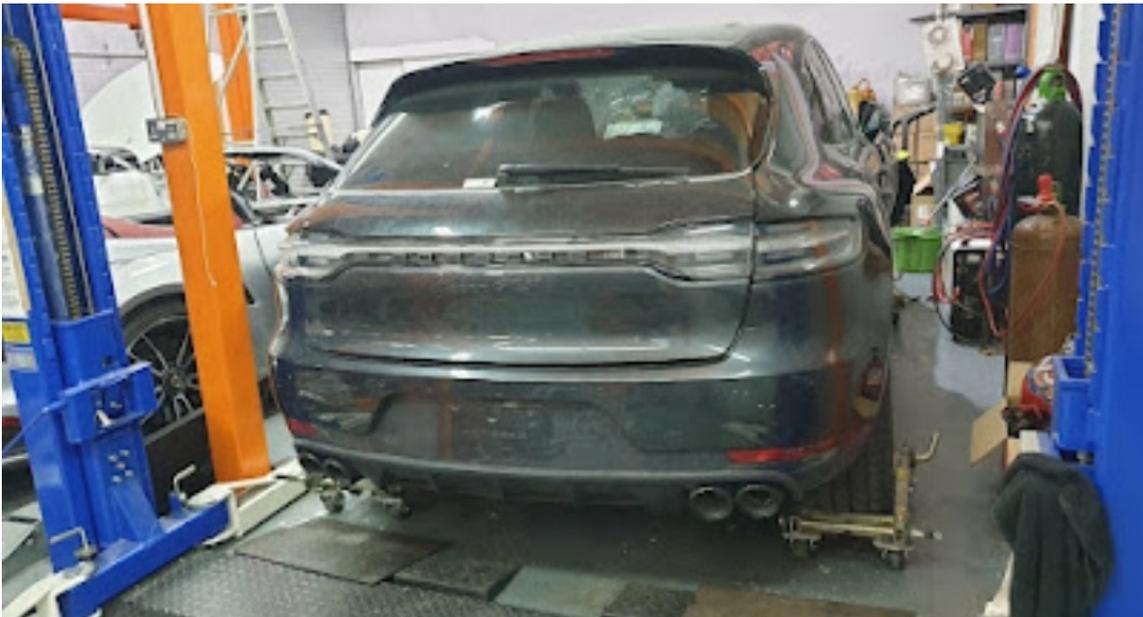
**Photo 4** shows the rear right body of the Motor Car (photograph provided to me). Apart for the frontal portion, there was no physical damage observed to other areas of the Motor Car.

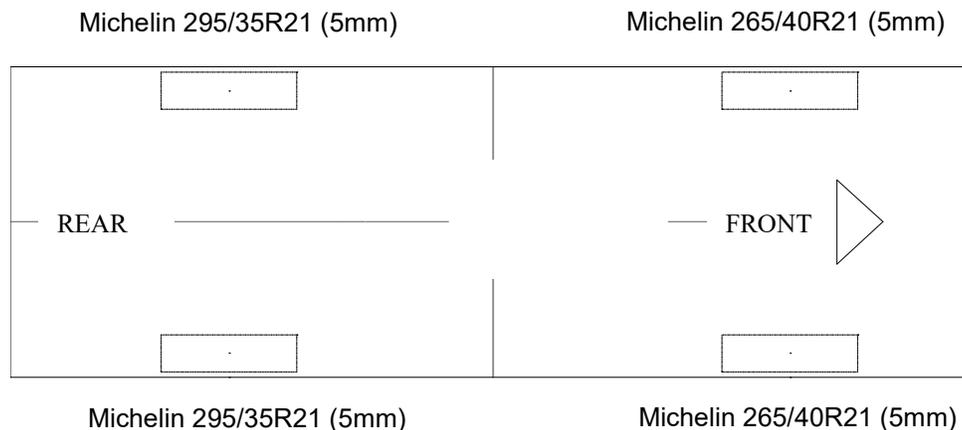
8. It was fitted with 21inch sport wheel rims that were wrapped with tyres that were observed to be of serviceable condition. The tyres were also sufficiently inflated for vehicular operation. The tyre brand, tyre size and approximate remaining tread depth of the 4 tyres of the Motor Car were recorded as follows: -

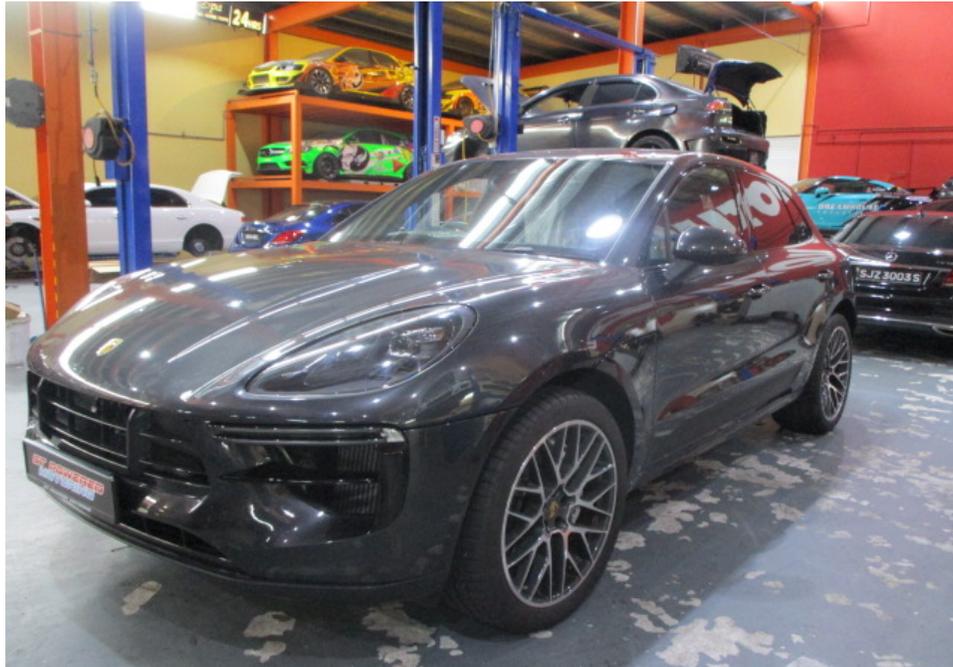
**Photo 5** shows a general view of the front left body of the Motor Car at the time of my inspection. The Motor Car was observed to be in a relatively good general condition with no loose exterior fittings observed. The body parts at the frontal portion of the Motor Car were visually examined and it was observed that the repair/restoration works carried out to the damaged area of the Motor Car (refer to photograph 1 & 2 above) were reasonably adequate and in order.

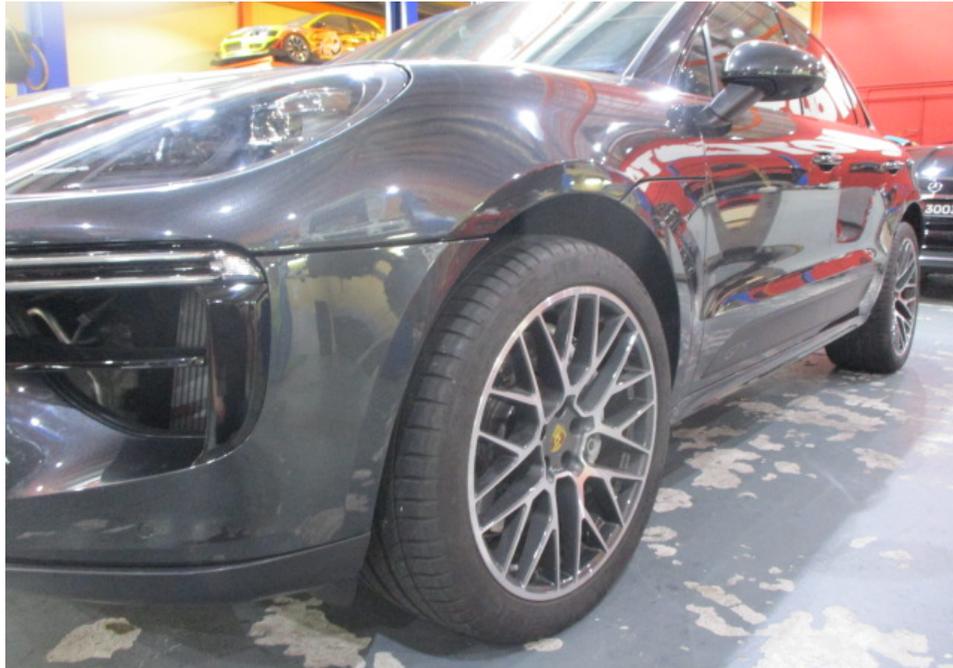
**Photo 6** shows a closer view of the Motor Car's front bonnet, front left headlamp, front left wheel rim and front left fender. The body parts at the frontal portion of the Motor Car were visually examined and it was observed that the repair/restoration works carried out to the damaged area of the Motor Car (refer to photograph 1 & 2 above) were reasonably adequate and in order.

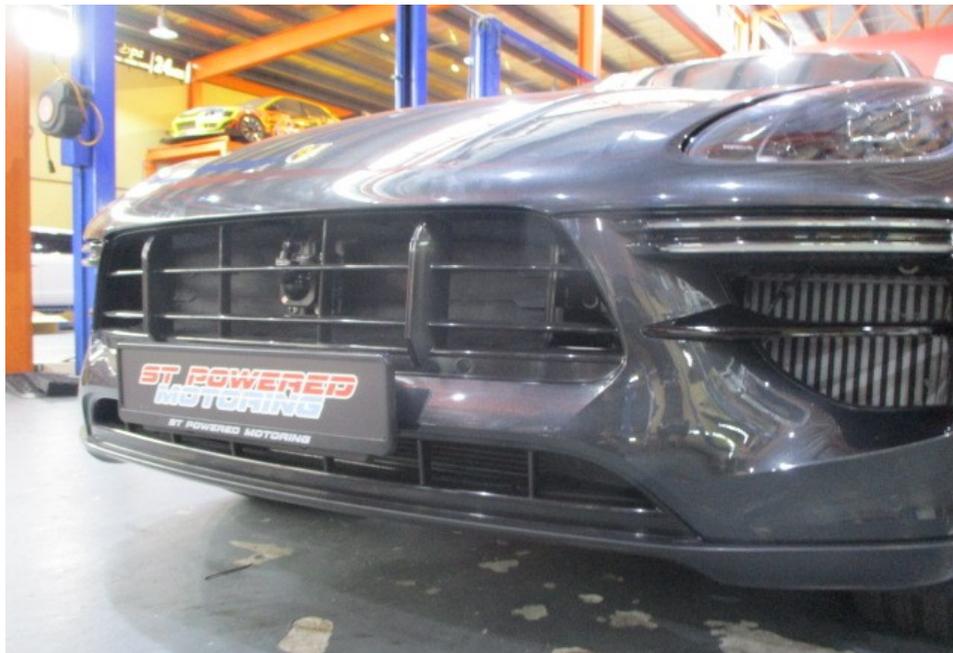
**Photo 7** shows a closer view of the Motor Car's front bumper, front bumper lower lip, front bumper centre lower grille, front bumper left grille, radiator grille, front sensor unit, front left intercooler and front left day light. The body parts at the frontal portion of the Motor Car were visually examined and it was observed that the repair/restoration works carried out to the damaged area of the Motor Car (refer to photograph 1 & 2 above) were reasonably adequate and in order.

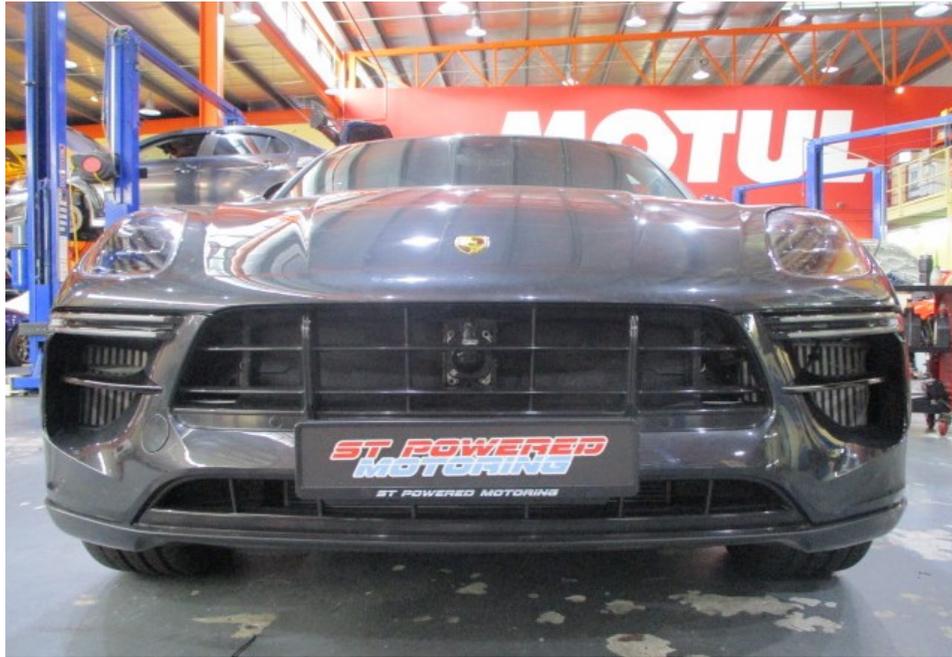
**Photo 8** shows a general view of the frontal body of the Motor Car at the time of my inspection. The Motor Car was observed to be in a relatively good general condition with no loose exterior fittings observed. The body parts at the frontal portion of the Motor Car were visually examined and it was observed that the repair/restoration works carried out to the damaged area of the Motor Car (refer to photograph 1 & 2 above) were reasonably adequate and in order.

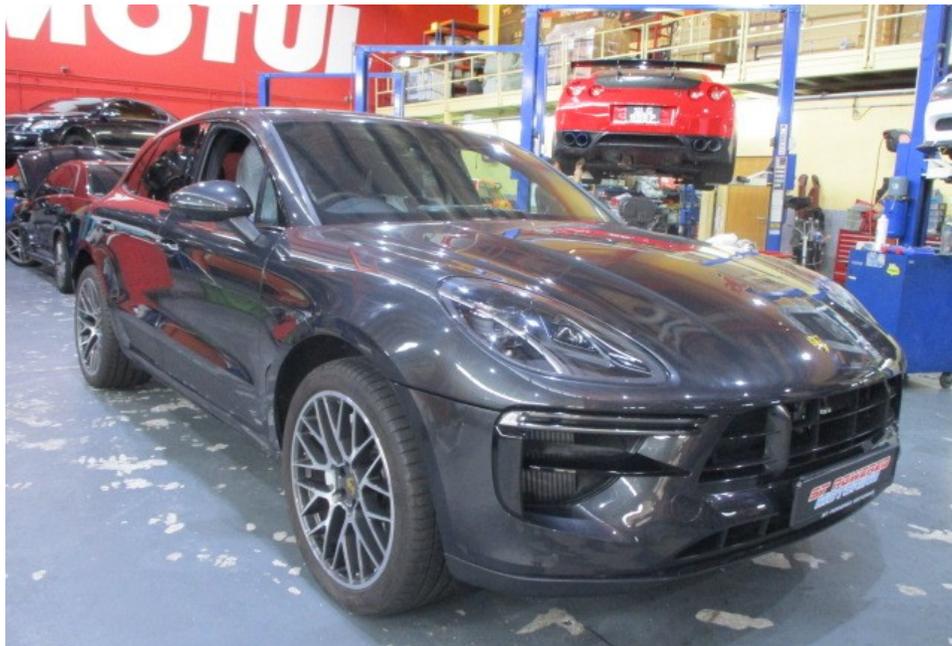
**Photo 9** shows a general view of the front right body of the Motor Car at the time of my inspection. The Motor Car was observed to be in a relatively good general condition with no loose exterior fittings observed. The body parts at the frontal portion of the Motor Car were visually examined and it was observed that the repair/restoration works carried out to the damaged area of the Motor Car (refer to photograph 1 & 2 above) were reasonably adequate and in order.

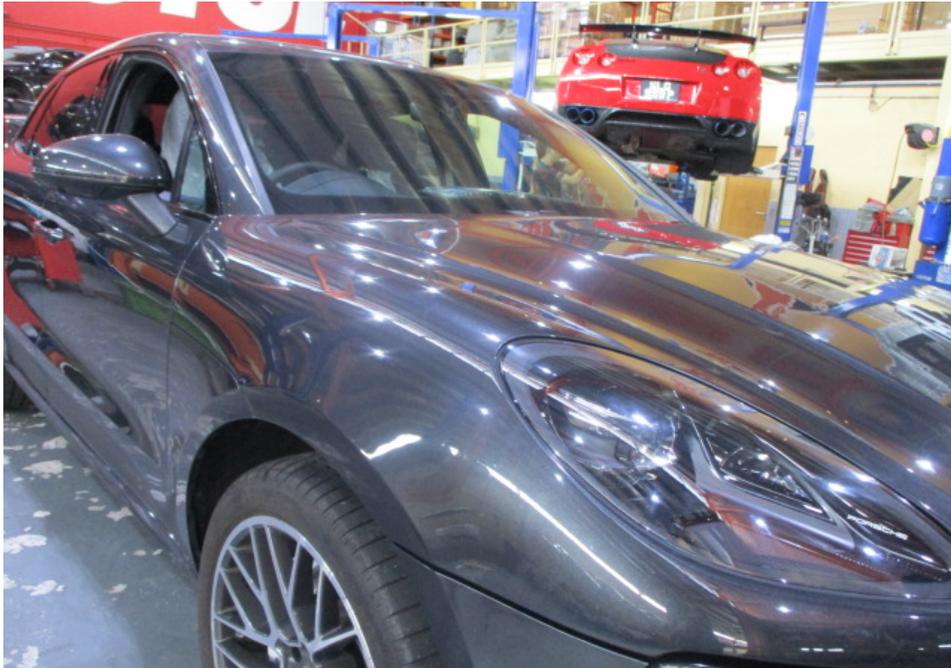
**Photo 10** shows a closer view of the Motor Car's front bonnet, front right headlamp and front right wheel rim. The body parts at the frontal portion of the Motor Car were visually examined and it was observed that the repair/restoration works carried out to the damaged area of the Motor Car (refer to photograph 1 & 2 above) were reasonably adequate and in order.

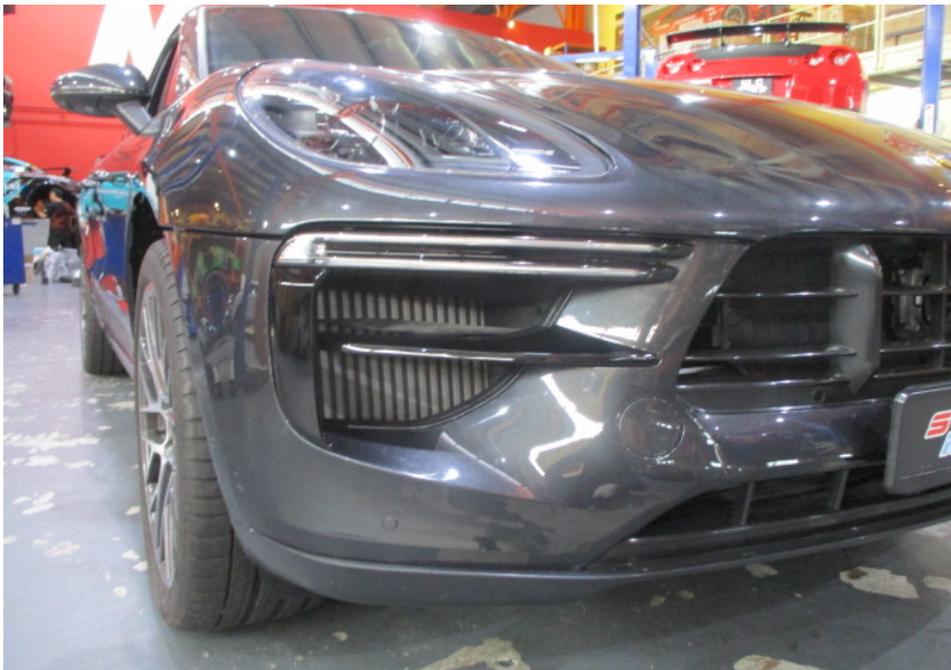
**Photo 11** shows a closer view of the Motor Car's front bumper, front bumper right grille, front right day light and front right headlamp. The body parts at the frontal portion of the Motor Car were visually examined and it was observed that the repair/restoration works carried out to the damaged area of the Motor Car (refer to photograph 1 & 2 above) were reasonably adequate and in order.

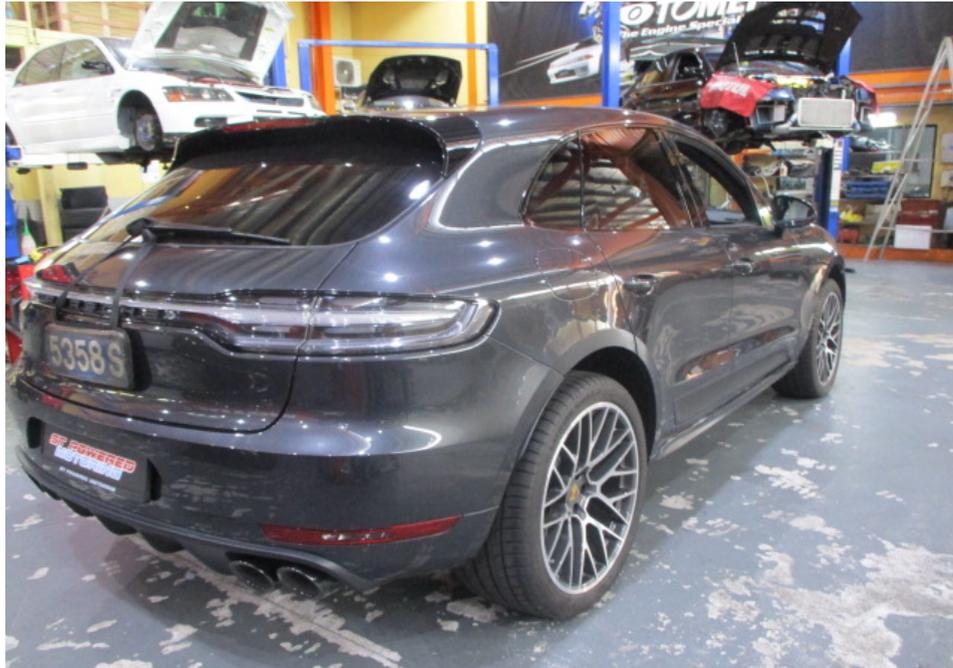
**Photo 12** shows a general view of the rear right body of the Motor Car at the time of my inspection. The Motor Car was observed to be in a relatively good general condition with no loose exterior fittings observed. The mileage of the Motor Car recorded at the time of my inspection was 6,750km.

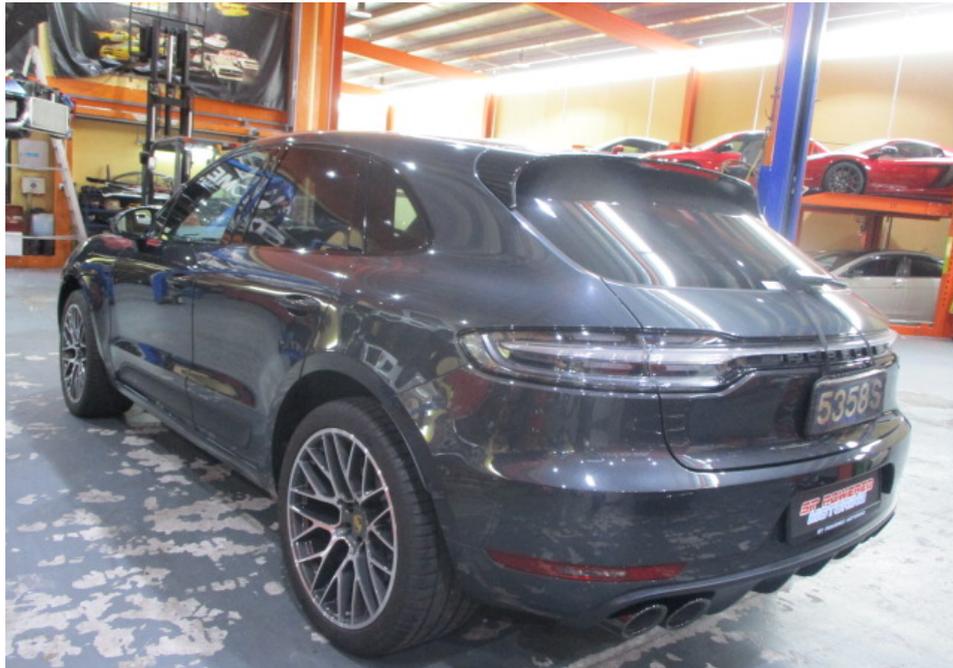
**Photo 13** shows a general view of the rear left body of the Motor Car at the time of my inspection. The Motor Car was observed to be in a relatively good general condition with no loose exterior fittings observed. The mileage of the Motor Car recorded at the time of my inspection was 6,750km.

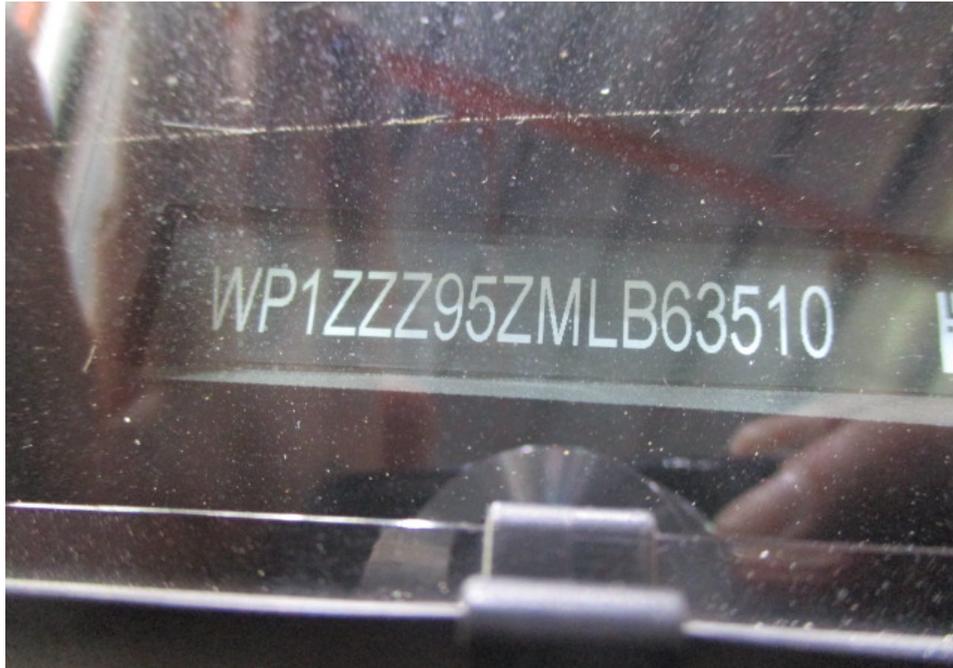
**Photo 14** shows the chassis number of the Motor Car. The chassis number recorded was WP1ZZZ95ZMLB63510.

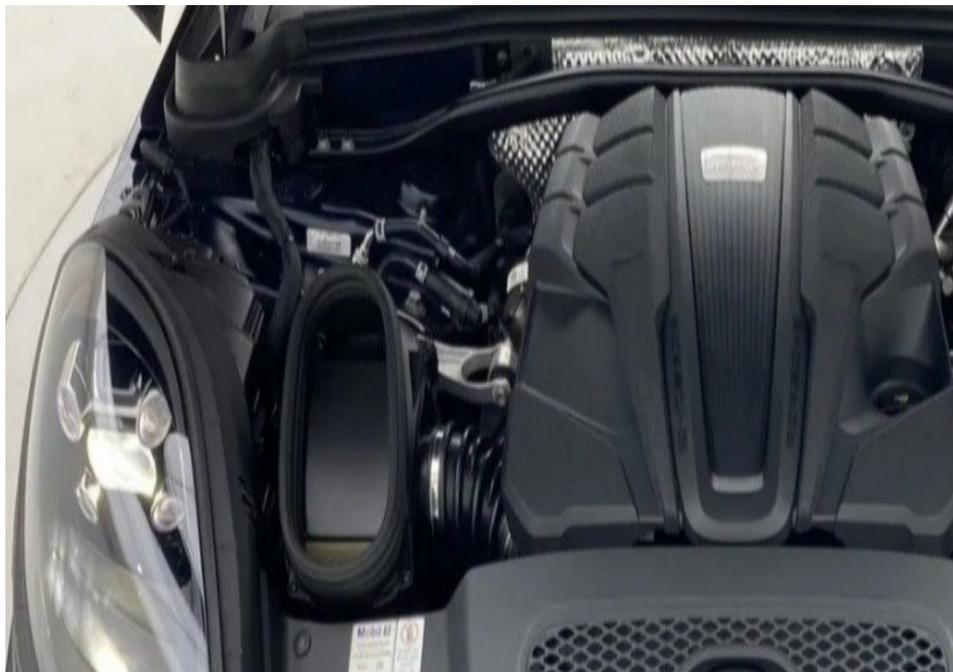
**Photo 15** shows a general view of the engine compartment of the Motor Car at the time of my inspection. The various parts and components inside the engine compartment were all observed to be intact and properly fitted. There was also no sign(s) or indication(s) of fluid leak and/or fluid stain found inside the engine compartment. The repair/restoration works carried out to the various parts within the engine compartment like the front bonnet locks, front support panel and front support panel top garnish amongst others were reasonably adequate and in order.

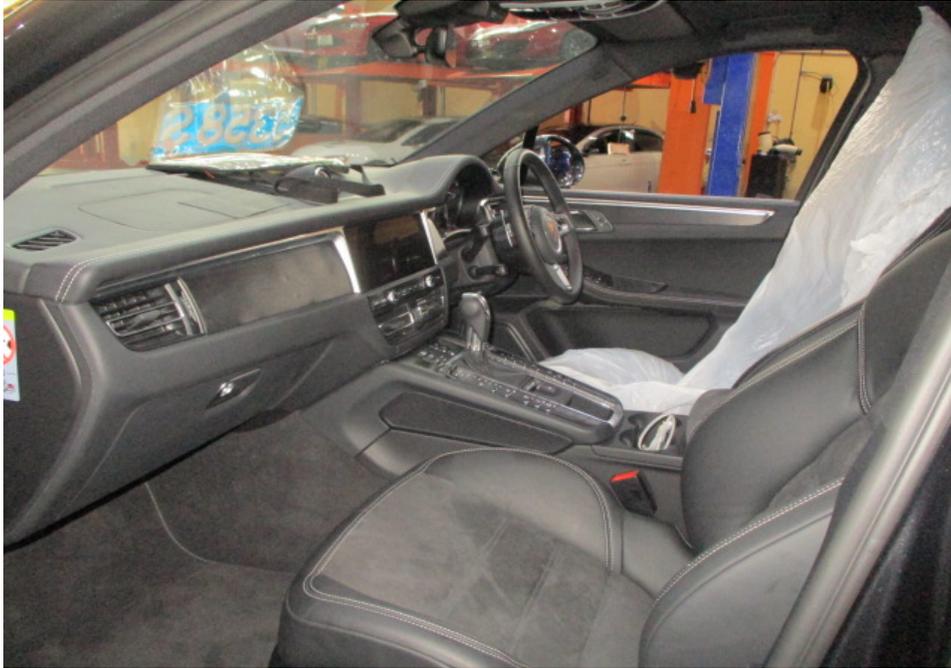
**Photo 16** shows the interior compartment of the Motor Car. The front dashboard, steering wheel, seats, upholstery and trims etc were all observed to be intact and properly fitted.

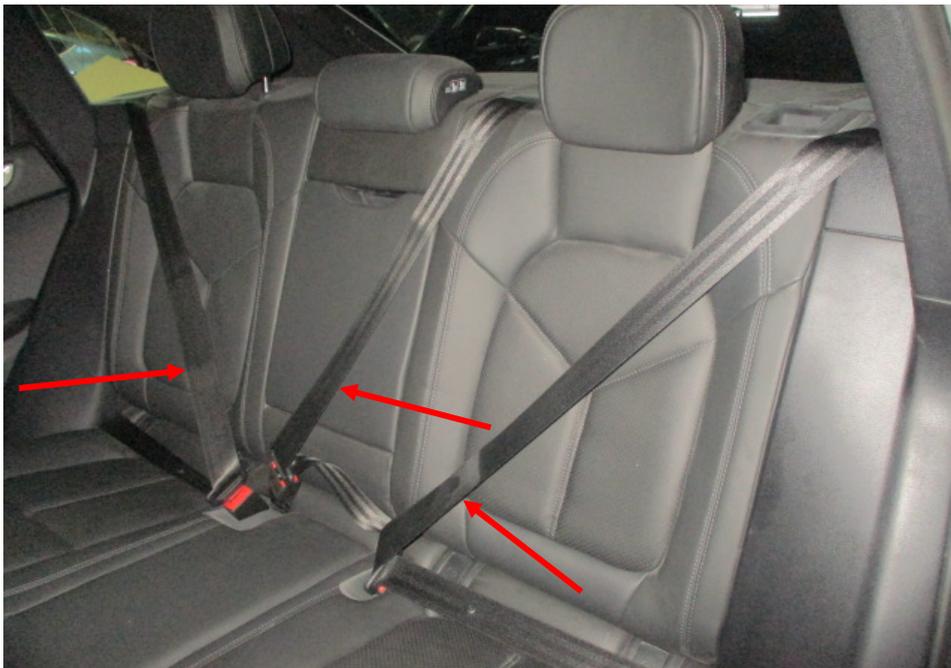
**Photo 17** shows the rear seats of the Motor Car. All the seats of the Motor Car were secured via seat rails to the floorboard. They were also fitted with a retractable seat belt reel and a pre-tensioner. The seat belts (arrowed) were tested and were able to be fastened into the respective pre-tensions that were fitted on the side of each individual seat.

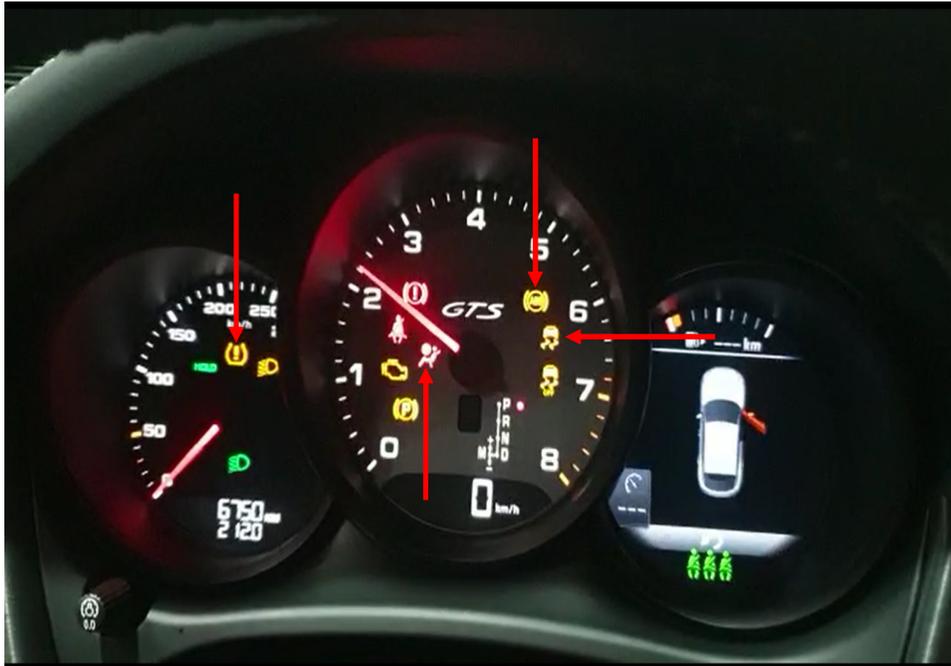
**Photo 18** shows the warning lights for the various electronic safety features appearing on the instrument panel of the Motor Car during its self-test when the engine is cranked, in particular the ABS, SRS, TPM and TCS lights (arrowed).

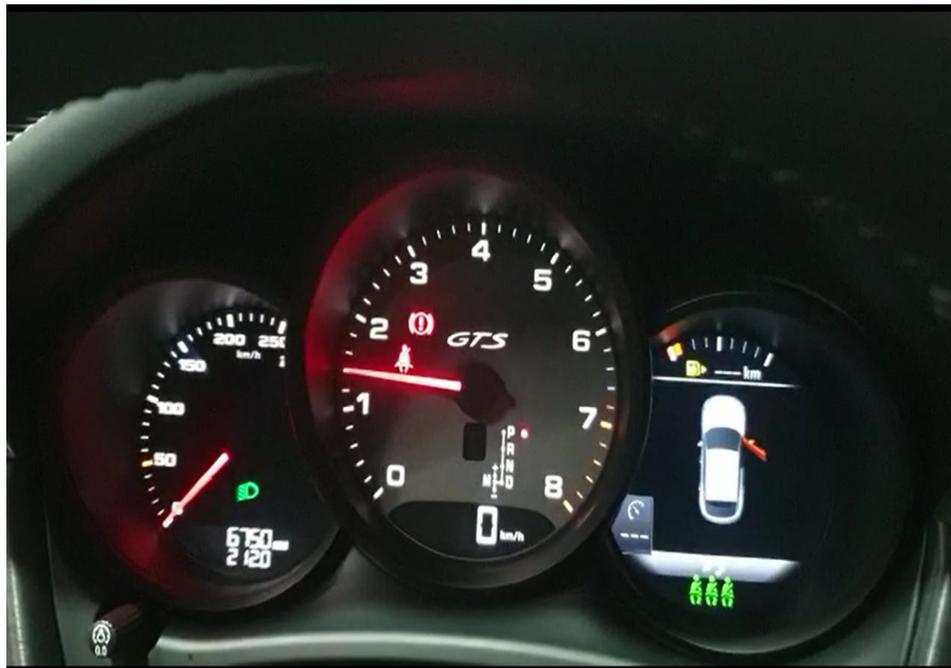
**Photo 19** shows the respective warning lights no longer illuminated, indicating that there is no fault detected to the ABS, SRS, TPM and TCS systems of the Motor Car during the self-test. These electronic systems were hence in working condition at the time of my inspection.

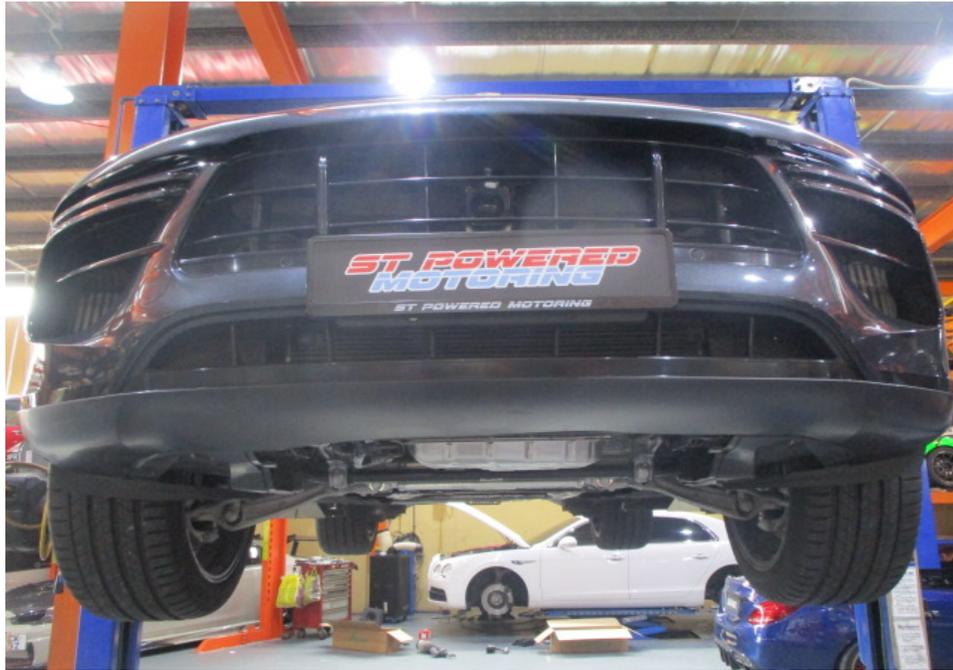
**Photo 20** shows the Motor Car hoisted up for checks on its undercarriage. There was no sign(s) or indication(s) of fluid leakage and/or fluid stain(s) on the underside of the Motor Car. The undercarriage components of the Motor Car were also all observed to be intact and secured in an appropriate manner.

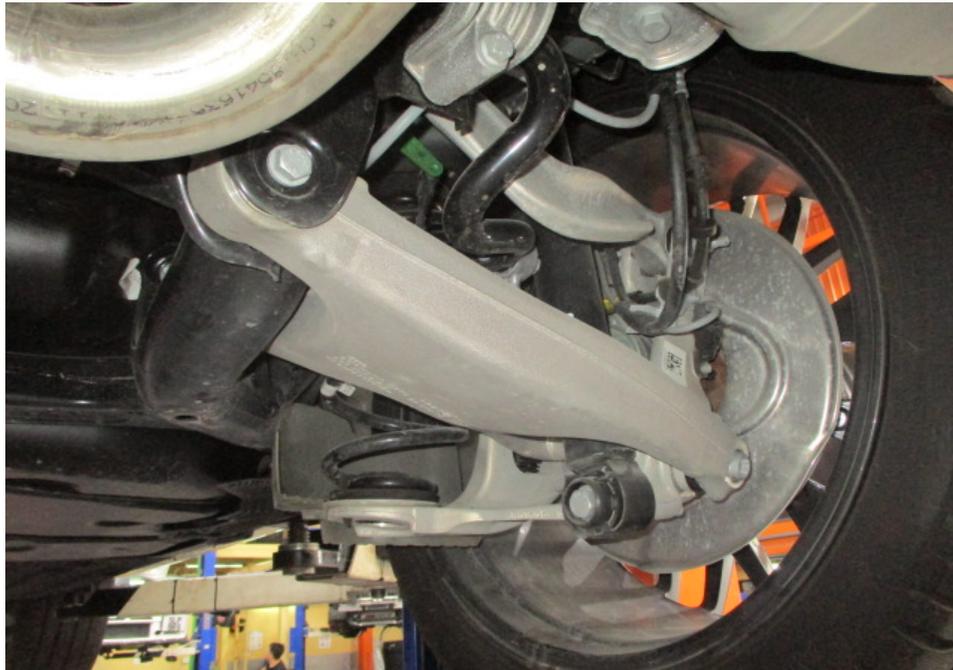
**Photo 21** shows a general view of the control arms and linkages at the rear right wheel of the Motor Car. I did not observe any fluid leak and/or fluid stain on the underside of the Motor Car. All of the Motor Car's undercarriage components were observed to be intact and secured in an appropriate manner.

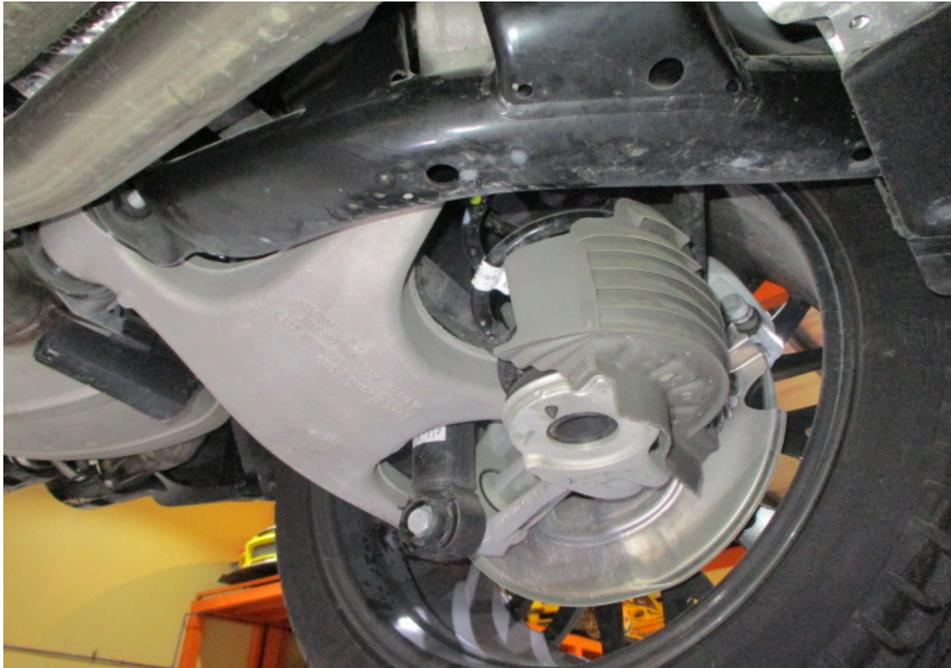
**Photo 22** shows a general view of the control arms and linkages at the rear left wheel of the Motor Car. I did not observe any fluid leak and/or fluid stain on the underside of the Motor Car. All of the Motor Car's undercarriage components were observed to be intact and secured in an appropriate manner.

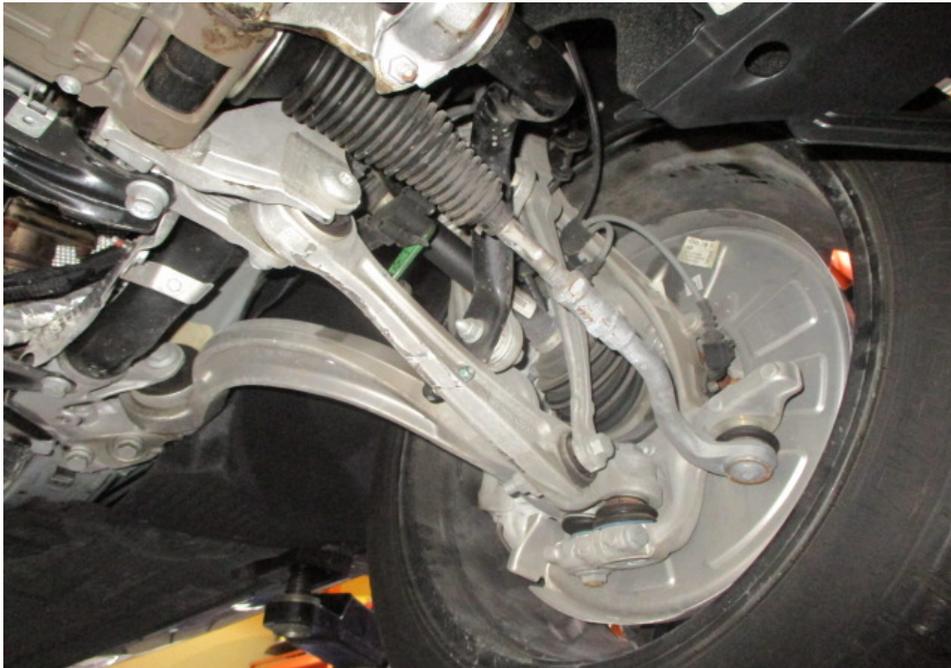
**Photo 23** shows a general view of the control arms and linkages at the front left wheel of the Motor Car. I did not observe any fluid leak and/or fluid stain on the underside of the Motor Car. All of the Motor Car's undercarriage components were observed to be intact and secured in an appropriate manner.

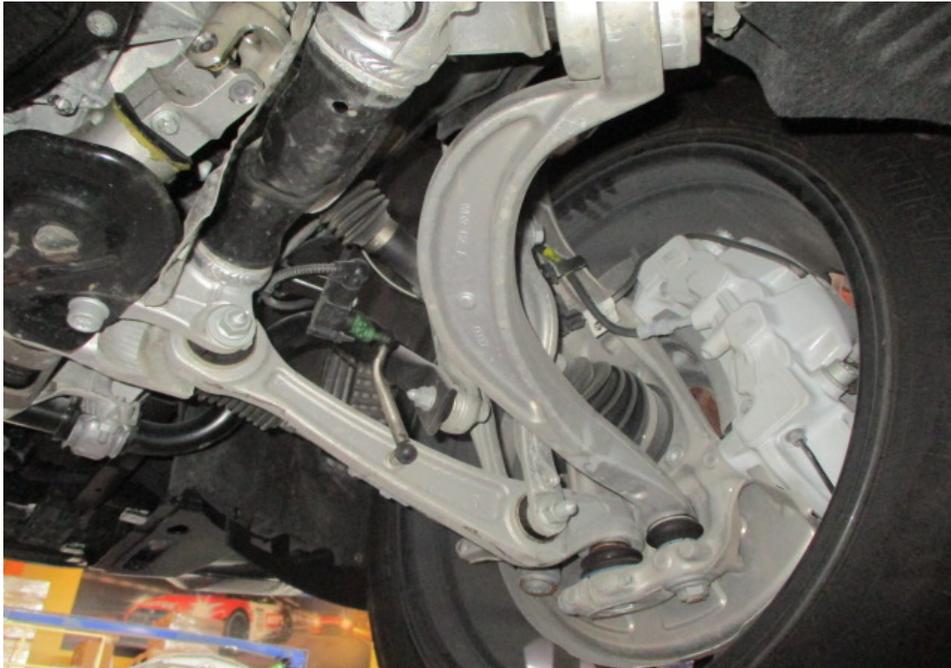
**Photo 24** shows the various undercarriage components at the front right wheel of the Motor Car. The mechanical components, control arms and linkages were all found to be intact and secured in an appropriate manner. I also did not observe any fluid leak and/or fluid stain on the underside of the Motor Car.

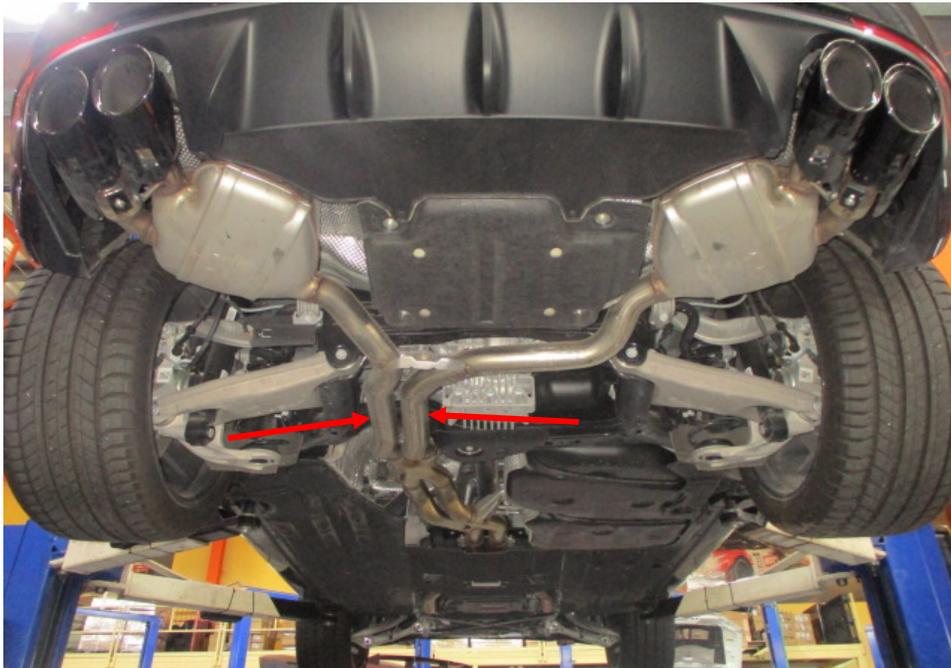
**Photo 25** shows the rear section of the Motor Car's exhaust system. My examination of the Motor Car's exhaust system revealed no sign(s) or indication(s) of any cut or weld marks along its exhaust pipes (arrowed), on its rear mufflers, on its centre resonator box and on its catalytic converters.

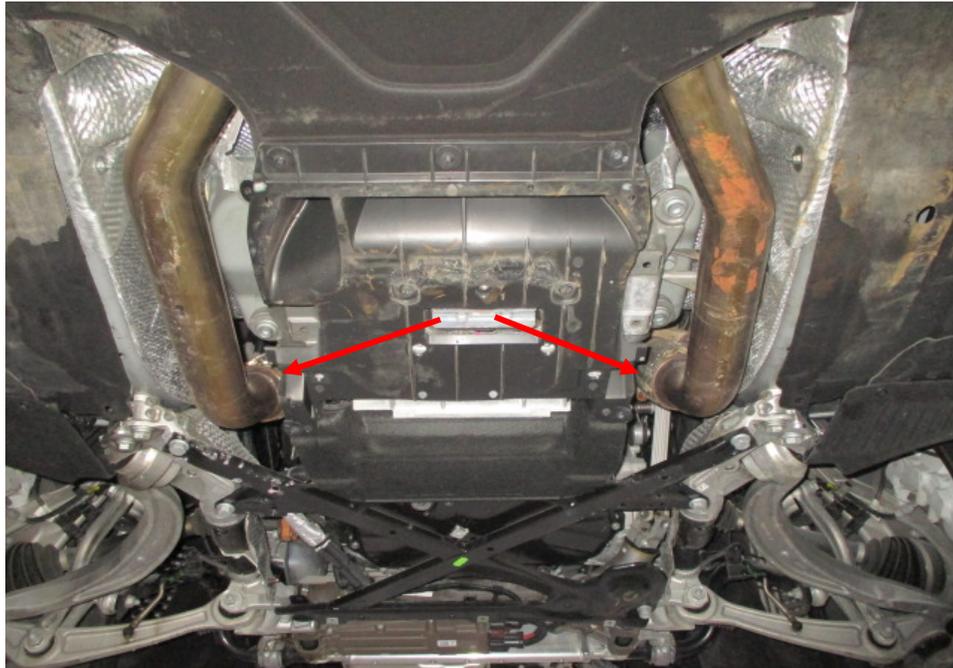
**Photo 26** shows the front section of the Motor Car's exhaust system. My examination of the Motor Car's exhaust system revealed no sign(s) or indication(s) of any cut or weld marks along its exhaust pipes, on its rear mufflers, on its centre resonator box and on its catalytic converters (arrowed).

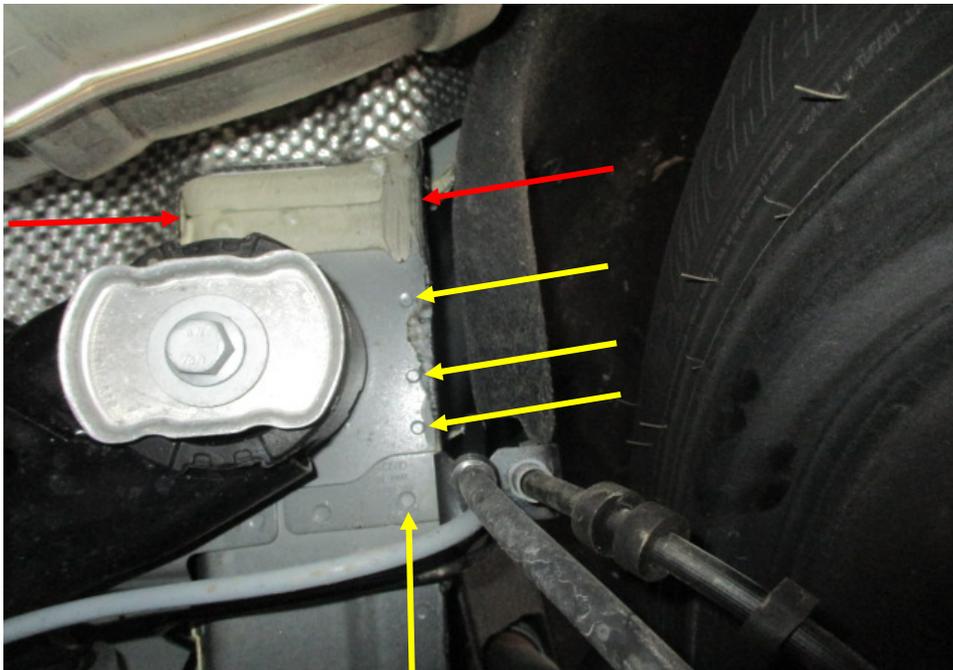
**Photo 27** shows the chassis/structural body at the underside rear right of the Motor Car. I did not find any weld marks other than original spot weld marks (yellow arrow) on the chassis/structural body of the Motor Car. The original factory sealant (red arrow) at the joints along the chassis/structural body was untouched, indicating no work was done on the chassis/structural body of the Motor Car and that the chassis/structural body was originally fitted.

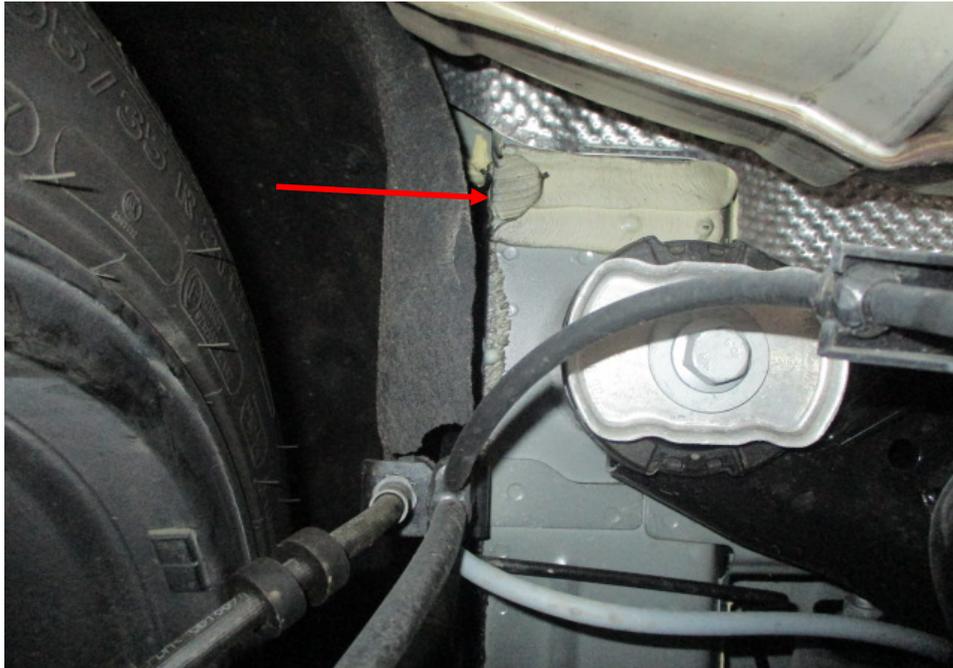
**Photo 28** shows the chassis/structural body at the underside rear left of the Motor Car. The original factory sealant (arrowed) at the joints along the chassis/structural body was observed to be untouched. In general, I had found no work was carried out on the chassis/structural body of the Motor Car. The chassis/structural body of the Motor Car was originally fitted.

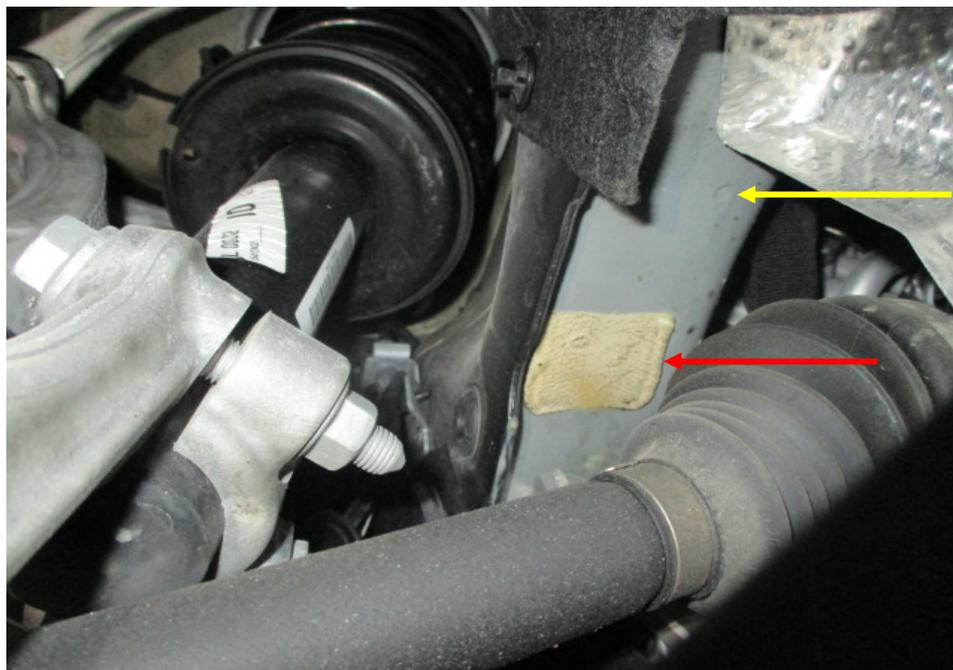
**Photo 29** shows the chassis/structural body at the underside front left of the Motor Car. I did not find any weld marks other than original spot weld marks (yellow arrow) on the chassis/structural body of the Motor Car. The original factory sealant (red arrow) at the joints along the chassis/structural body was untouched, indicating no work was done on the chassis/structural body of the Motor Car and that the chassis/structural body was originally fitted.

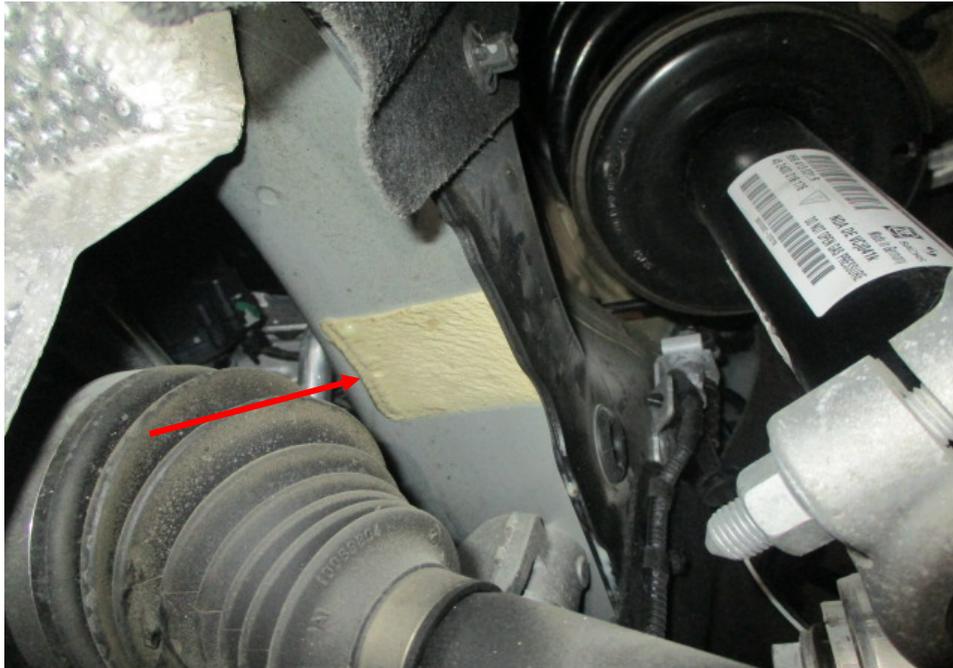
**Photo 30** shows the chassis/structural body at the underside front right of the Motor Car. The original factory sealant (arrowed) at the joints along the chassis/structural body was observed to be untouched. In general, I had found no work was carried out on the chassis/structural body of the Motor Car. The chassis/structural body of the Motor Car was originally fitted.
