Your Ref: Porsche Macan GTS  
(chassis number WP1ZZZ95ZMLB63510)  
Our Ref : CI/TP22006789/D

18 July 2022

**INSPECTION REPORT OF AN UNREGISTERED PORSCHE MACAN GTS  
MOTOR CAR WITH CHASSIS NUMBER WP1ZZZ95ZMLB63510**

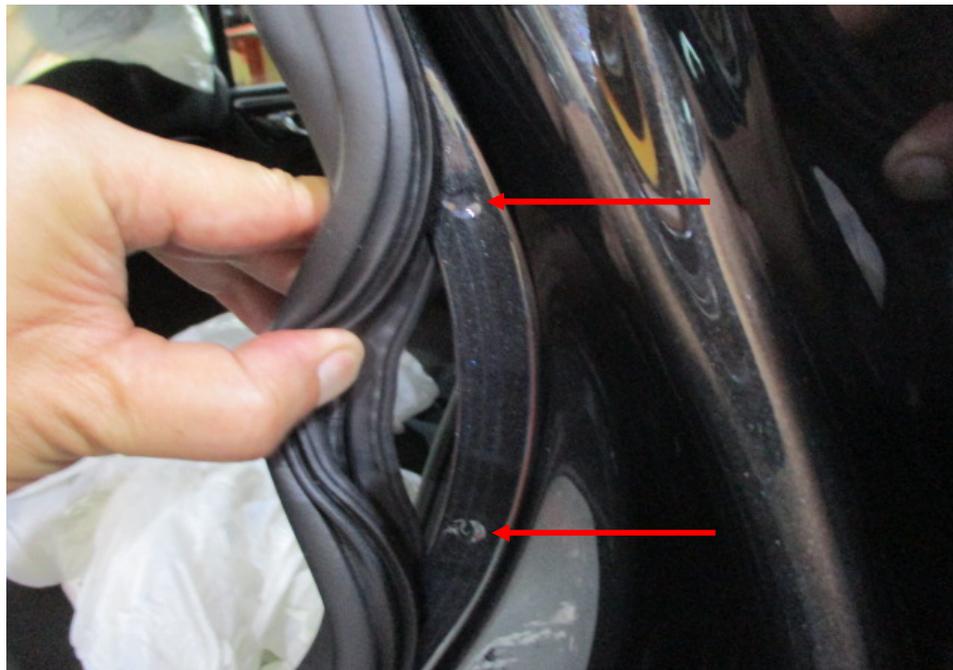
**Photo 31** shows the left side "C" pillar of the Motor Car. I did not find any weld marks other than original spot weld marks (arrowed) on the left side "C" pillar of the Motor Car which, indicates that there was no re-welding works carried out. In general, I had found all the non-detachable body panels of the Motor Car to be originally fitted at the time of my inspection.

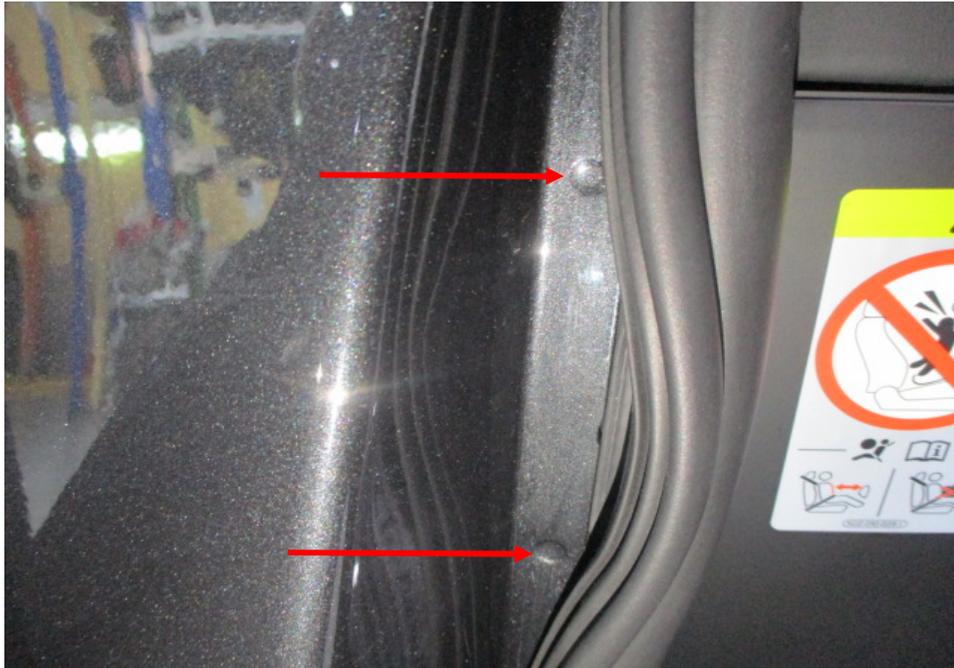
**Photo 32** shows the left side "A" pillar of the Motor Car. I did not find any weld marks other than original spot weld marks (arrowed) on the left side "A" pillar of the Motor Car which, indicates that there was no re-welding works carried out. In general, I had found all the non-detachable body panels of the Motor Car to be originally fitted at the time of my inspection.

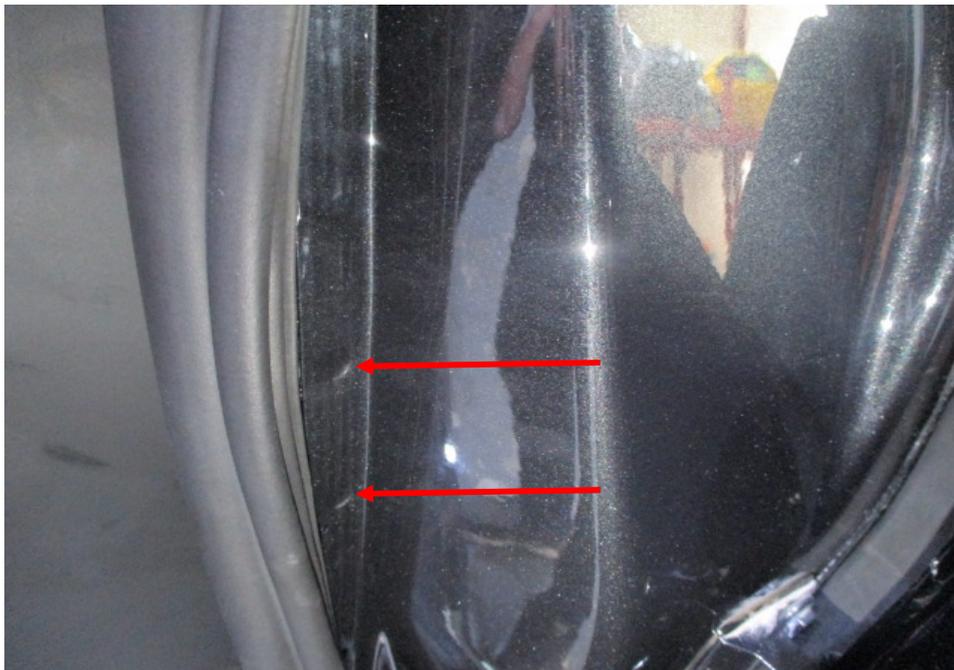
**Photo 33** shows the right side "A" pillar of the Motor Car. I did not find any weld marks other than original spot weld marks (arrowed) on the right side "A" pillar of the Motor Car which, indicates that there was no re-welding works carried out. In general, I had found all the non-detachable body panels of the Motor Car to be originally fitted at the time of my inspection.

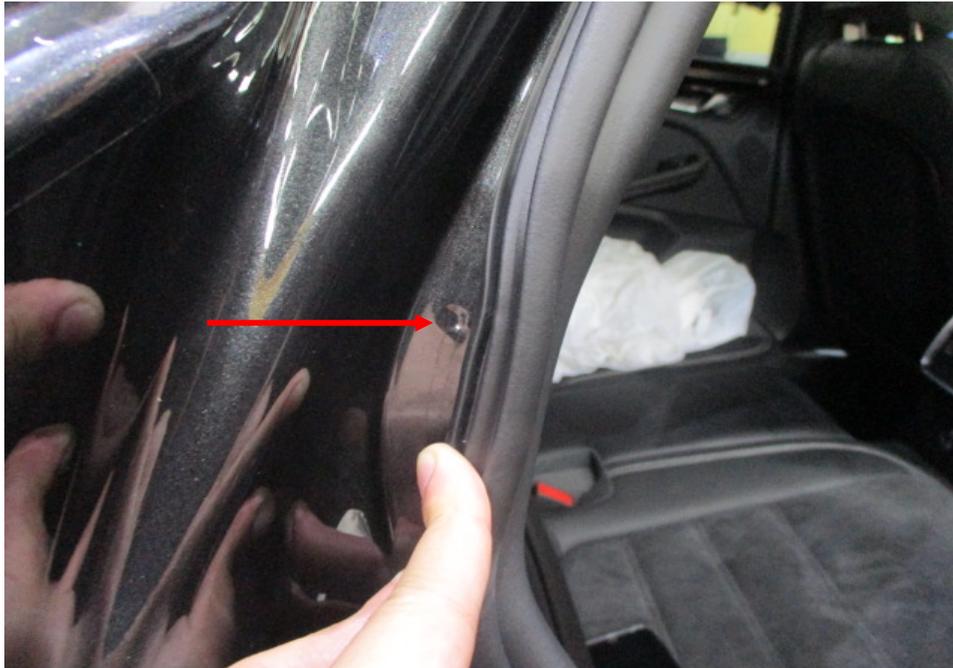
**Photo 34** shows the right side "C" pillar of the Motor Car. I did not find any weld marks other than original spot weld marks (arrowed) on the right side "C" pillar of the Motor Car which, indicates that there was no re-welding works carried out. In general, I had found all the non-detachable body panels of the Motor Car to be originally fitted at the time of my inspection.
