Your Ref: Mercedes Benz A45s
(chassis number W1K1770542N233460)
Our Ref : CI/TP22006936/D

22 July 2022

**INSPECTION REPORT OF AN UNREGISTERED MERCEDES BENZ A45s
MOTOR CAR WITH CHASSIS NUMBER W1K1770542N233460**

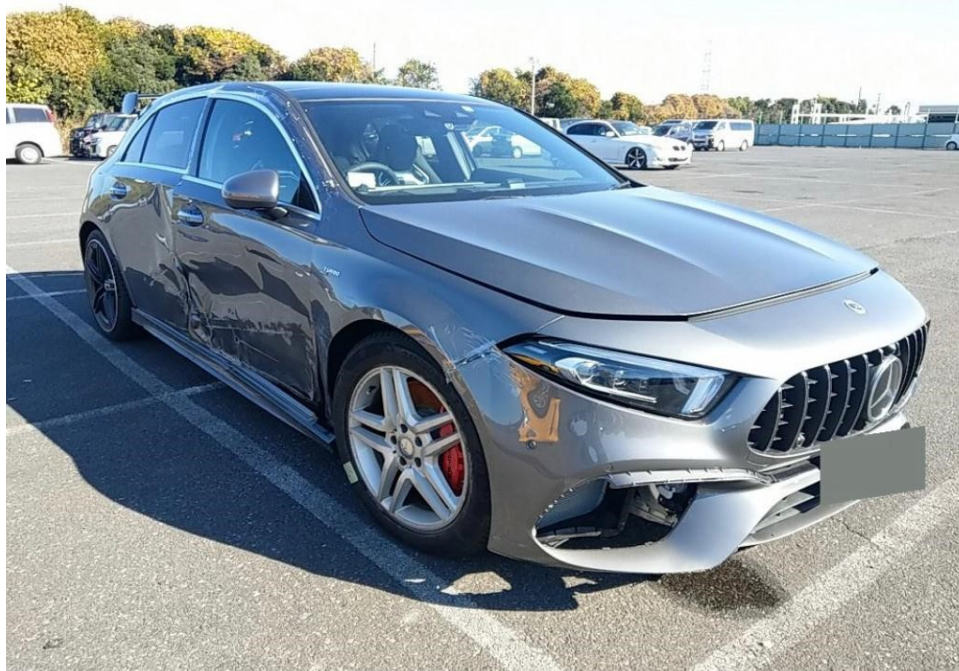
Photo 1 shows the front right body of the Motor Car (photograph provided to me). The photographs provided to me had showed damage to the right side portion of the Motor Car. The front bumper, front bumper right lower grille, front right fender, front right door, rear right door and right side rocker panel garnish were amongst the body parts that were observed to have been damaged. The airbag(s) was not deployed as seen from the photographs that were provided to me.

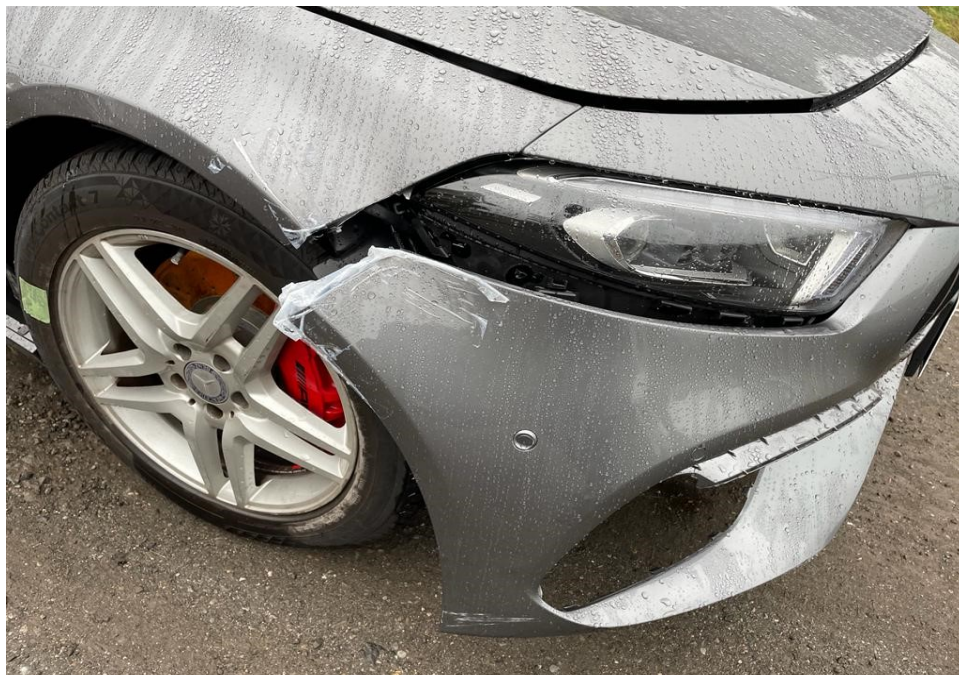
Photo 2 shows a closer view of the damaged front bumper and front bumper right lower grille of the Motor Car (photograph provided to me).

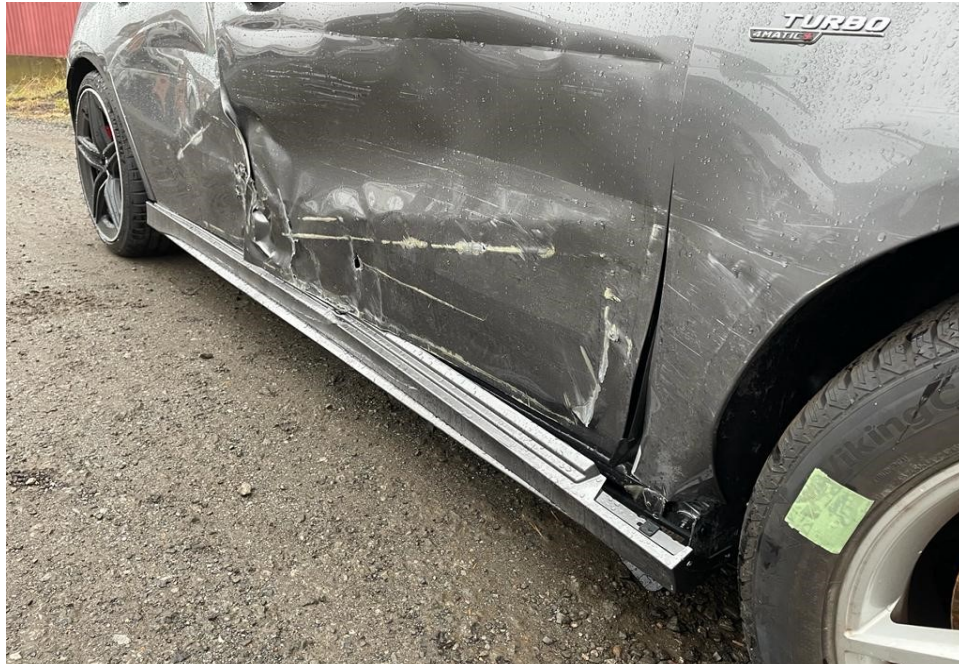
Photo 3 shows a closer view of the damaged front right fender, front right door, rear right door and right side rocker panel garnish of the Motor Car (photograph provided to me).

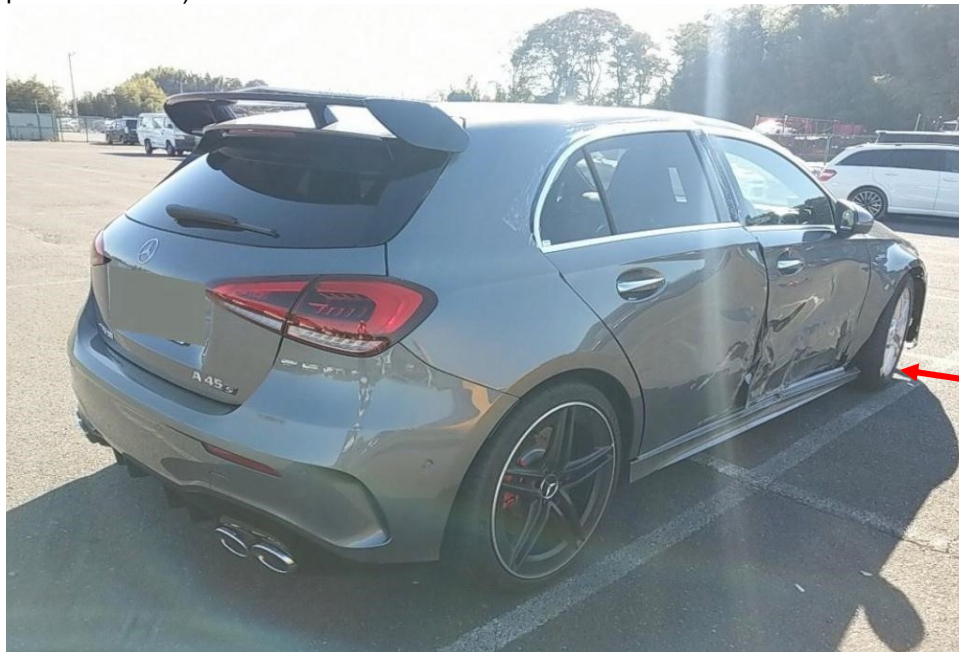
Photo 4 shows the rear right body of the Motor Car (photograph provided to me). The photographs provided to me had showed damage to the right side portion of the Motor Car. The front right door, rear right door and right side rocker panel garnish were amongst the body parts that were observed to have been damaged. The front right wheel (arrowed) was orientated slightly towards the left as compared to the front left wheel (refer to photograph 5 below), which was orientated in a straight direction. This would indicate damage to the undercarriage parts at the front right wheel of the Motor Car given that the front right wheel rim was seen to be different from the other wheel rims that were fitted on the Motor Car.

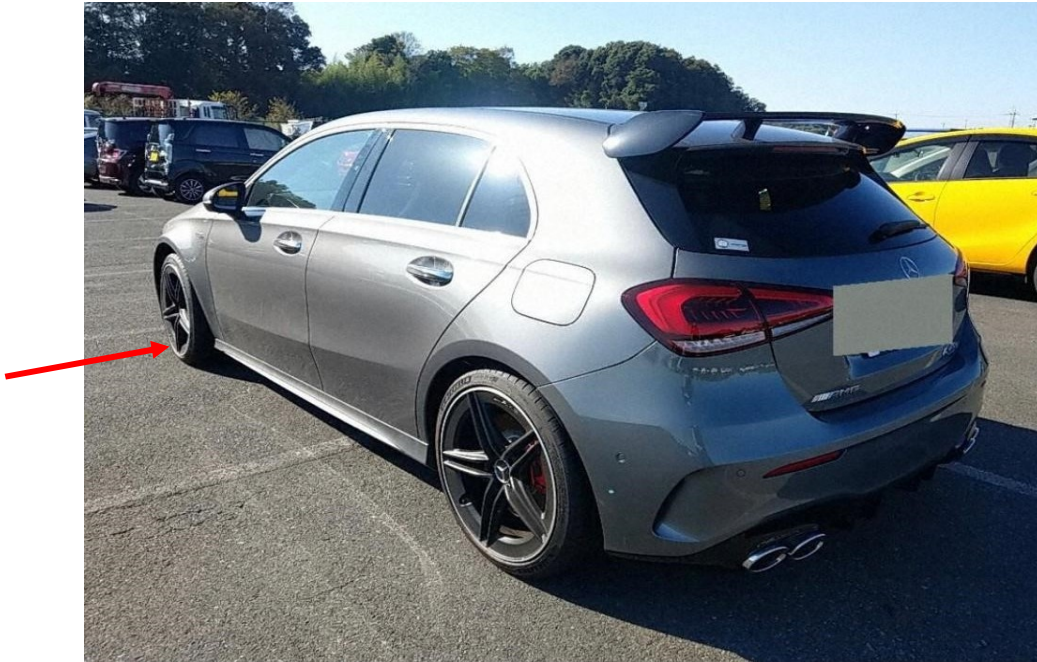
Photo 5 shows the rear left body of the Motor Car (photograph provided to me). Apart for the right side portion, there was no physical damage observed to other areas of the Motor Car. The front left wheel (arrowed) was orientated in a straight direction as compared to the front right wheel (refer to photograph 4 above), which was orientated slightly towards the left. This would indicate damage to the undercarriage parts at the front right wheel of the Motor Car given that the front right wheel rim was seen to be different from the other wheel rims that were fitted on the Motor Car.

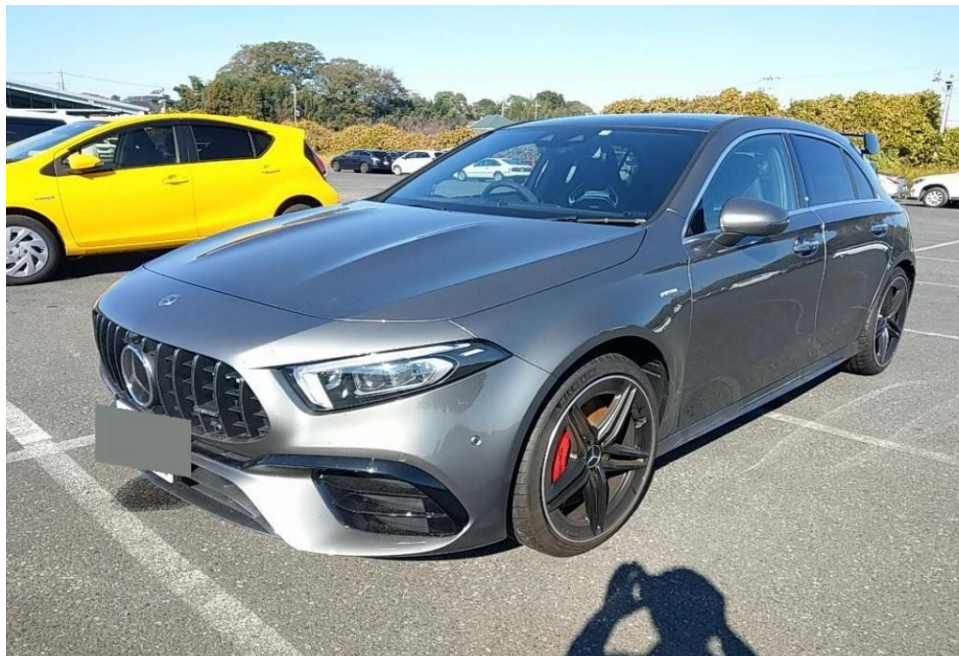
Photo 6 shows the front left body of the Motor Car (photograph provided to me). Apart for the right side portion, there was no physical damage observed to other areas of the Motor Car. The airbag(s) was not deployed as seen from the photographs that were provided to me.

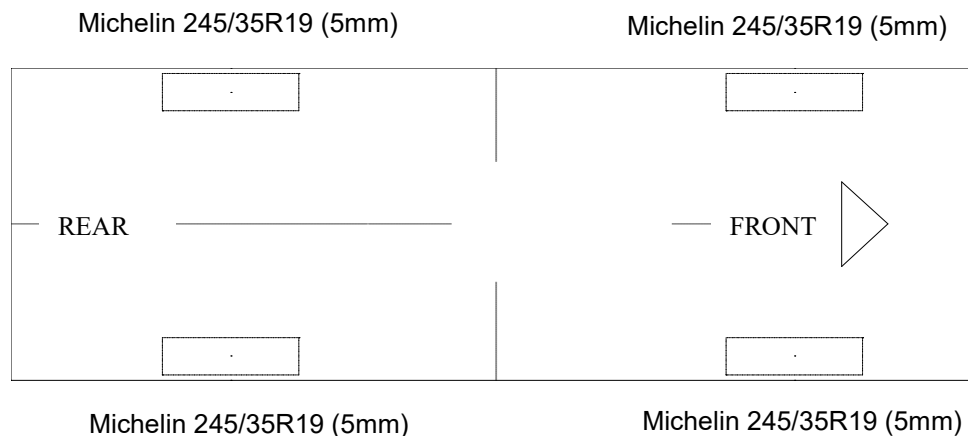
9. It was fitted with 19inch sport wheel rims that were wrapped with tyres that were observed to be of serviceable condition. The tyres were also sufficiently inflated for vehicular operation. The tyre brand, tyre size and approximate remaining tread depth of the 4 tyres of the Motor Car were recorded as follows: -

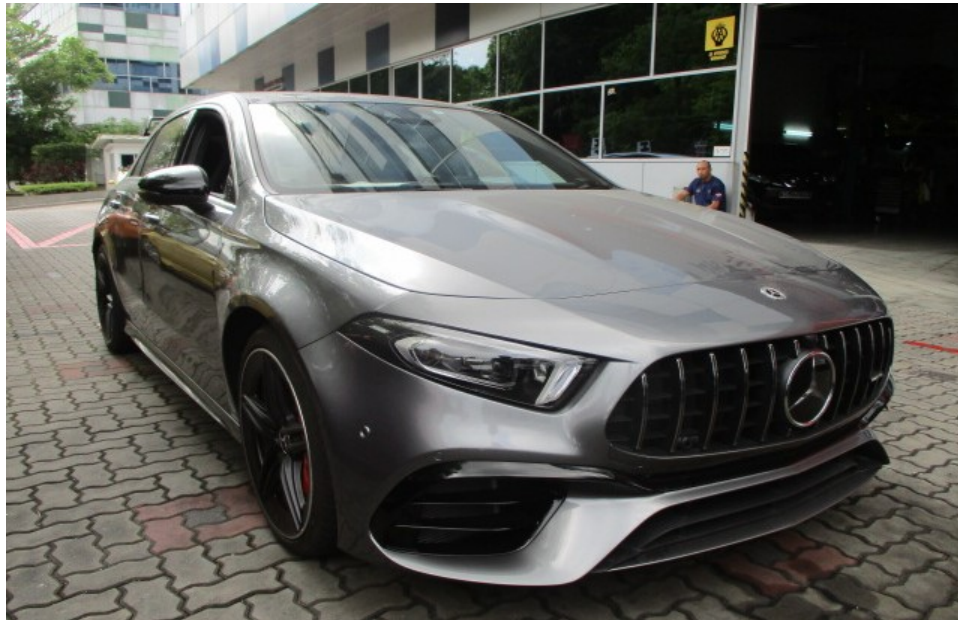
23. The body parts at the right side portion of the Motor Car as well as the undercarriage parts at the front right wheel of the Motor Car were visually examined and it was noted that the repair/restoration works carried out to the damaged area of the Motor Car (refer to photograph 1 - 3 above) were reasonably adequate and in order.

Photo 7 shows a general view of the front right body of the Motor Car at the time of my inspection. The Motor Car was observed to be in a relatively good general condition with no loose exterior fittings observed. The body parts at the right side portion of the Motor Car were visually examined and it was observed that the repair/restoration works carried out to the damaged area of the Motor Car (refer to photograph 1 - 3 above) were reasonably adequate and in order.

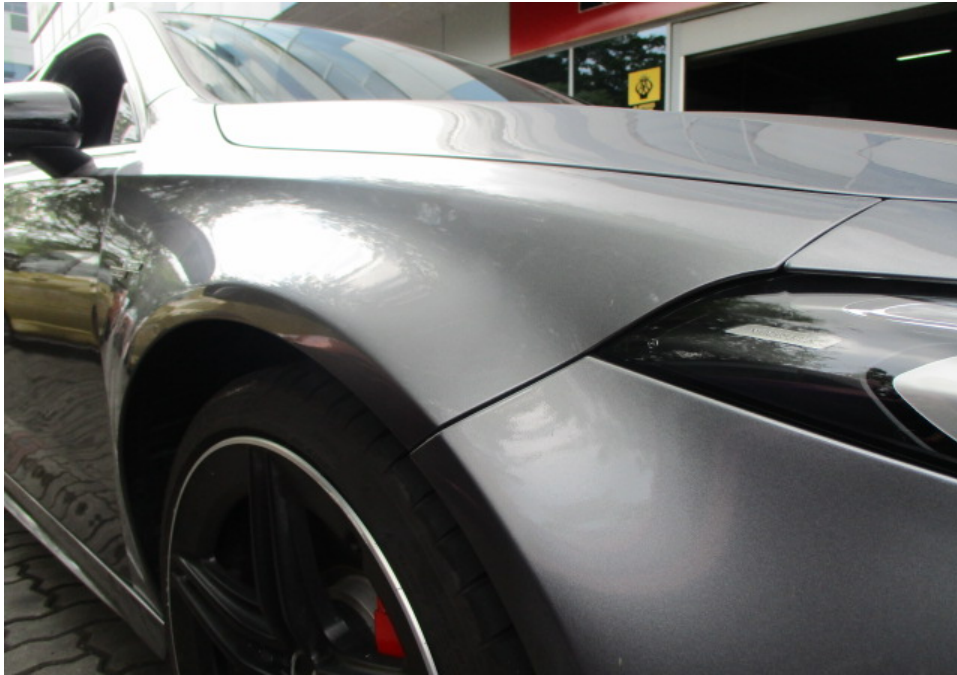
Photo 8 shows a closer view of the Motor Car's front bumper, front right headlamp and front right fender. The body parts at the right side portion of the Motor Car were visually examined and it was observed that the repair/restoration works carried out to the damaged area of the Motor Car (refer to photograph 1 - 3 above) were reasonably adequate and in order.

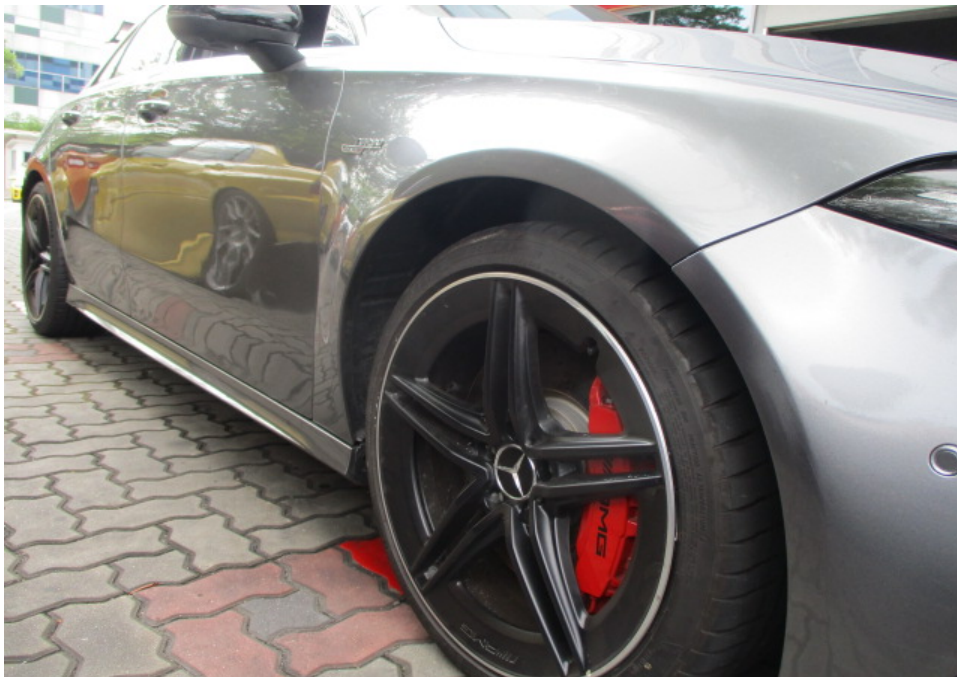
Photo 9 shows a closer view of the Motor Car's front bumper, front right wheel rim, front right fender and right side rocker panel garnish. The body parts at the right side portion of the Motor Car were visually examined and it was observed that the repair/restoration works carried out to the damaged area of the Motor Car (refer to photograph 1 - 3 above) were reasonably adequate and in order.

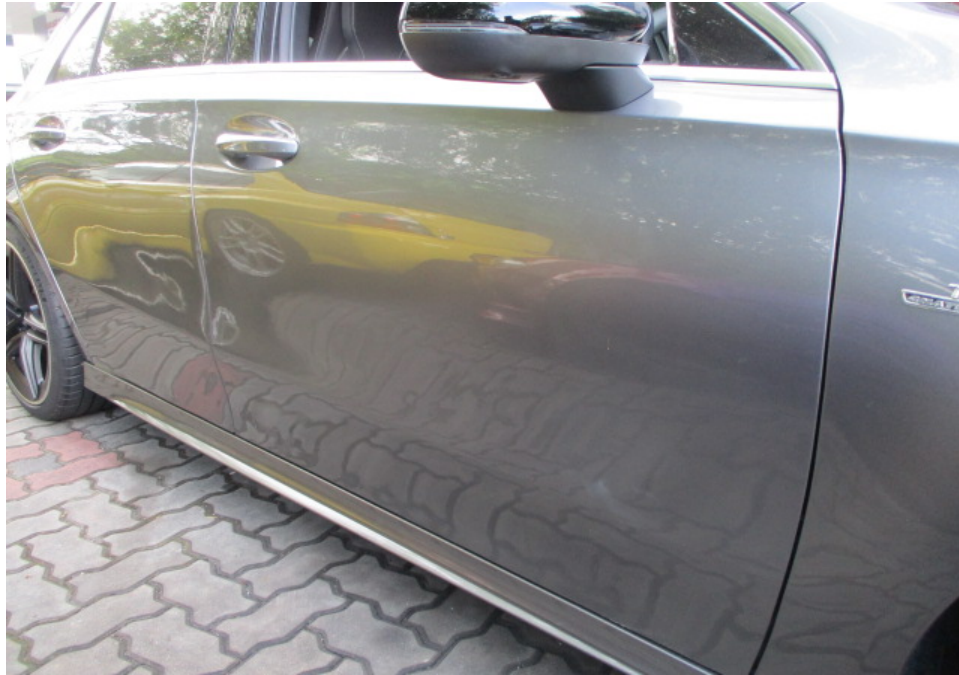
Photo 10 shows a closer view of the Motor Car's front right door, rear right door and right side rocker panel garnish. The body parts at the right side portion of the Motor Car were visually examined and it was observed that the repair/restoration works carried out to the damaged area of the Motor Car (refer to photograph 1 - 3 above) were reasonably adequate and in order.

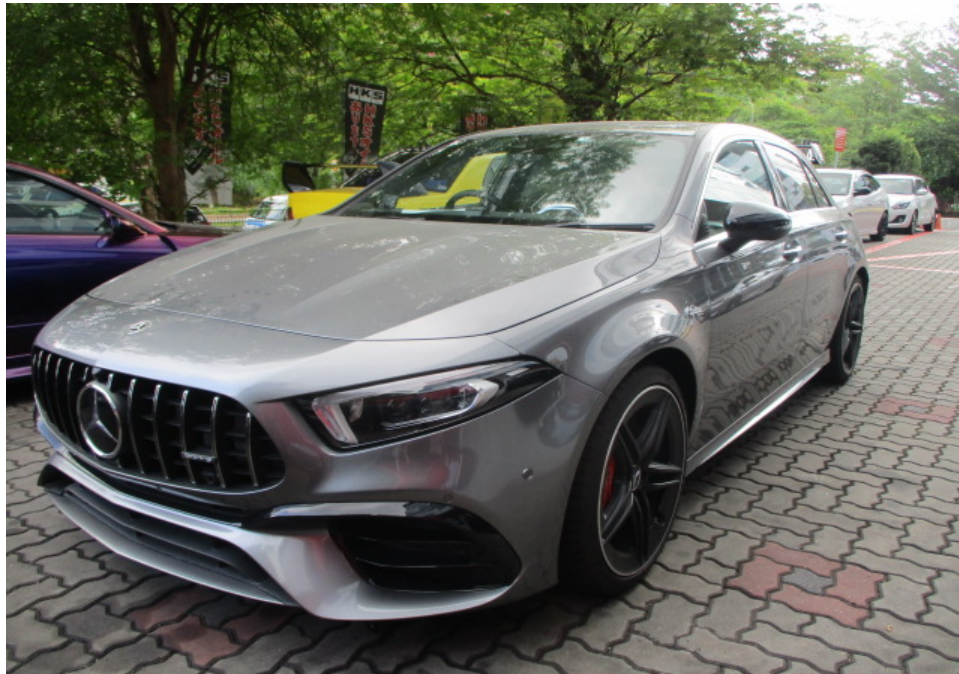
Photo 11 shows a general view of the front left body of the Motor Car at the time of my inspection. The Motor Car was observed to be in a relatively good general condition with no loose exterior fittings observed. The mileage of the Motor Car recorded at the time of my inspection was 388km.

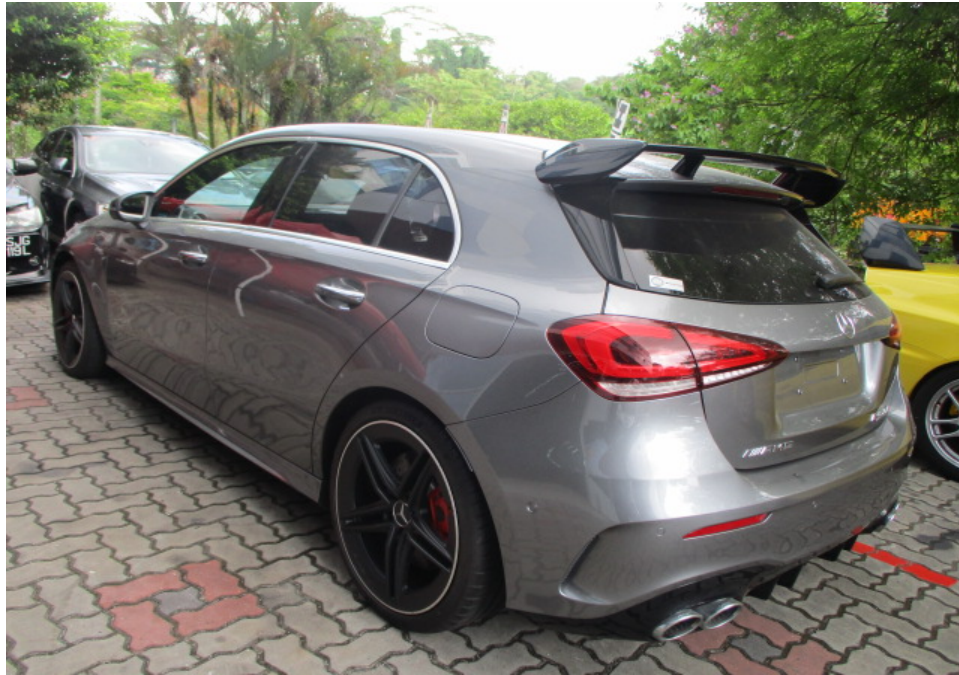
Photo 12 shows a general view of the rear left body of the Motor Car at the time of my inspection. The Motor Car was observed to be in a relatively good general condition with no loose exterior fittings observed. The mileage of the Motor Car recorded at the time of my inspection was 388km.

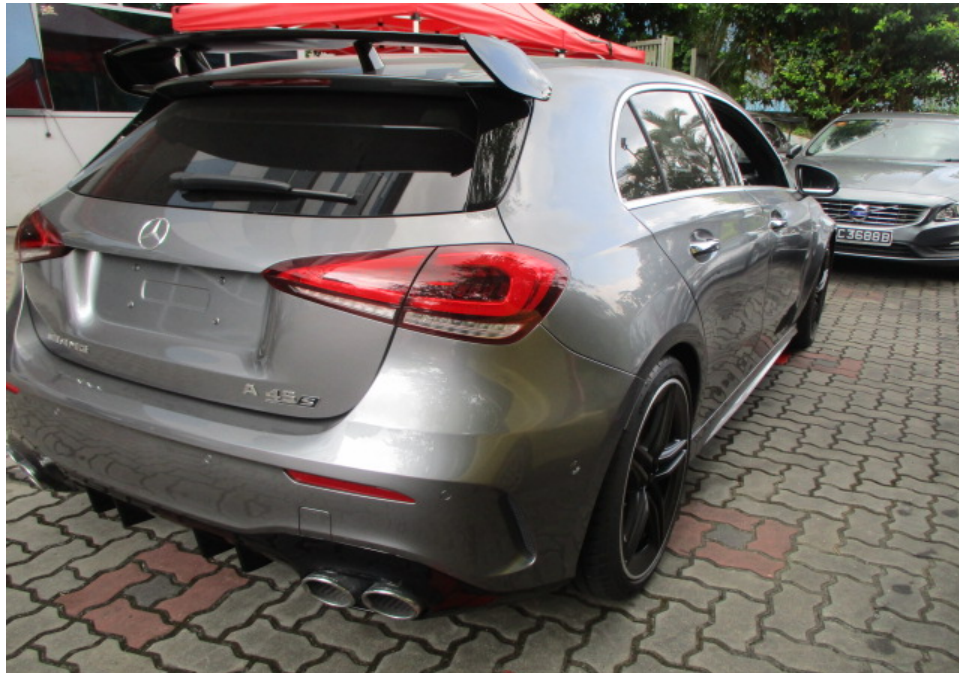
Photo 13 shows a general view of the rear right body of the Motor Car at the time of my inspection. The Motor Car was observed to be in a relatively good general condition with no loose exterior fittings observed. The mileage of the Motor Car recorded at the time of my inspection was 388km.

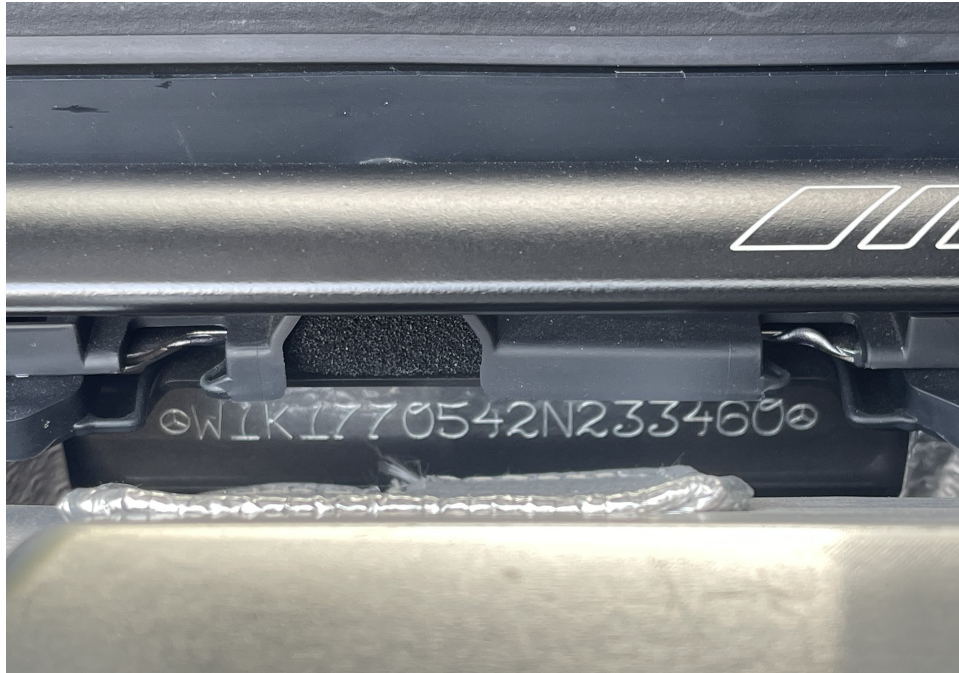
Photo 14 shows the chassis number of the Motor Car. The chassis number recorded was W1K1770542N233460.

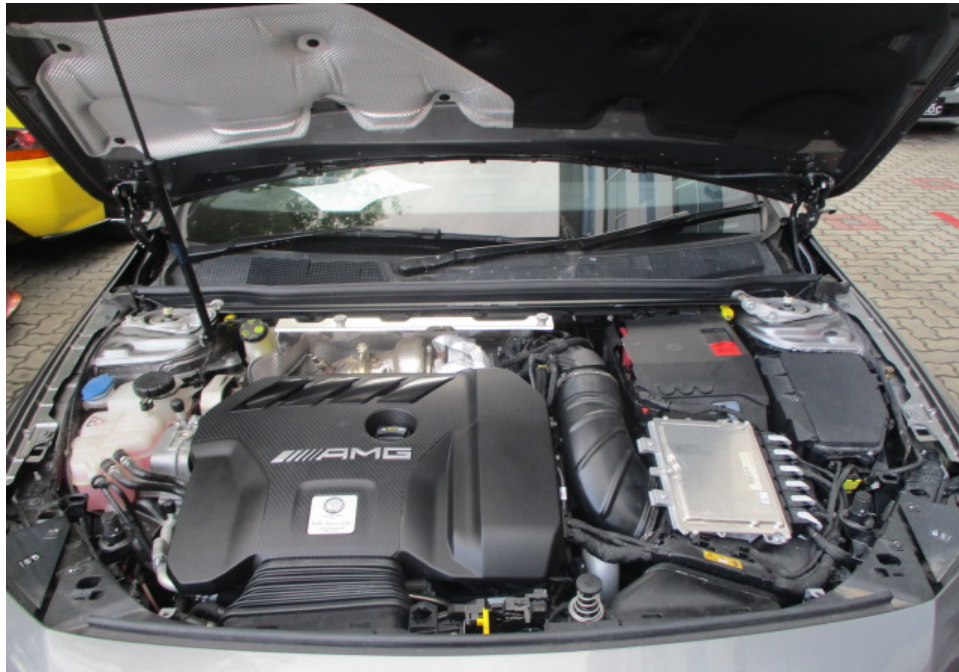
15. My examination of the engine compartment of the Motor Car revealed that the various parts and components inside the engine compartment were all intact and properly fitted. The engine oil, brake fluid and engine coolant were all found to be of sufficient level for operating purposes. Visually, there was also no contamination found to these fluids.

Photo 15 shows a general view of the engine compartment of the Motor Car at the time of my inspection. The various parts and components inside the engine compartment were all observed to be intact and properly fitted. There was also no sign(s) or indication(s) of fluid leak and/or fluid stain found inside the engine compartment.

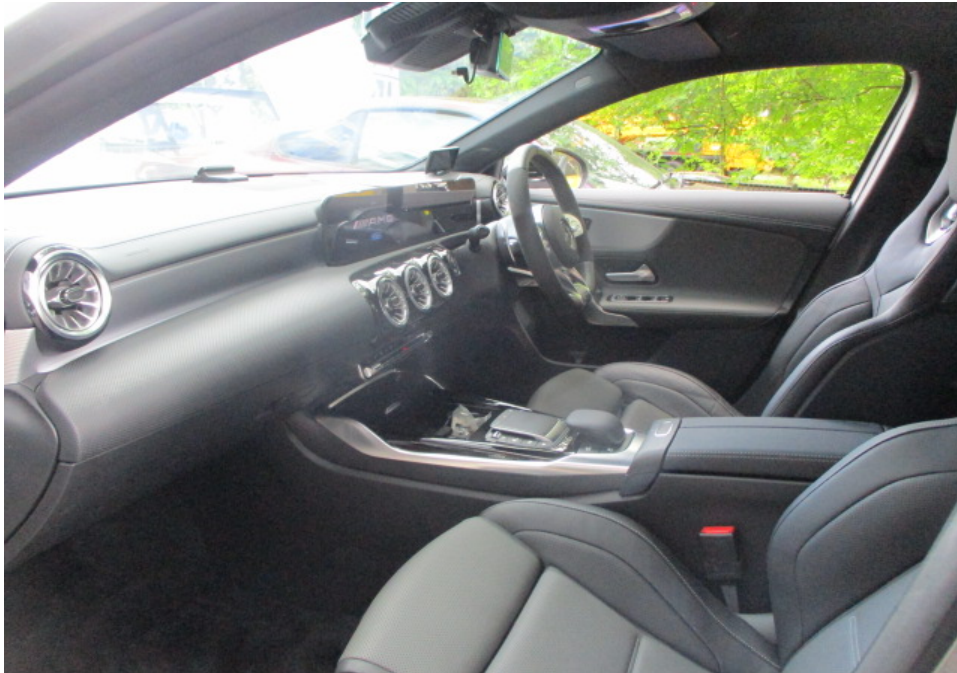
Photo 16 shows the interior compartment of the Motor Car at the time of my inspection. The various parts and components, trims, carpet, and upholstery inside the interior compartment were all observed to be intact and properly fitted.

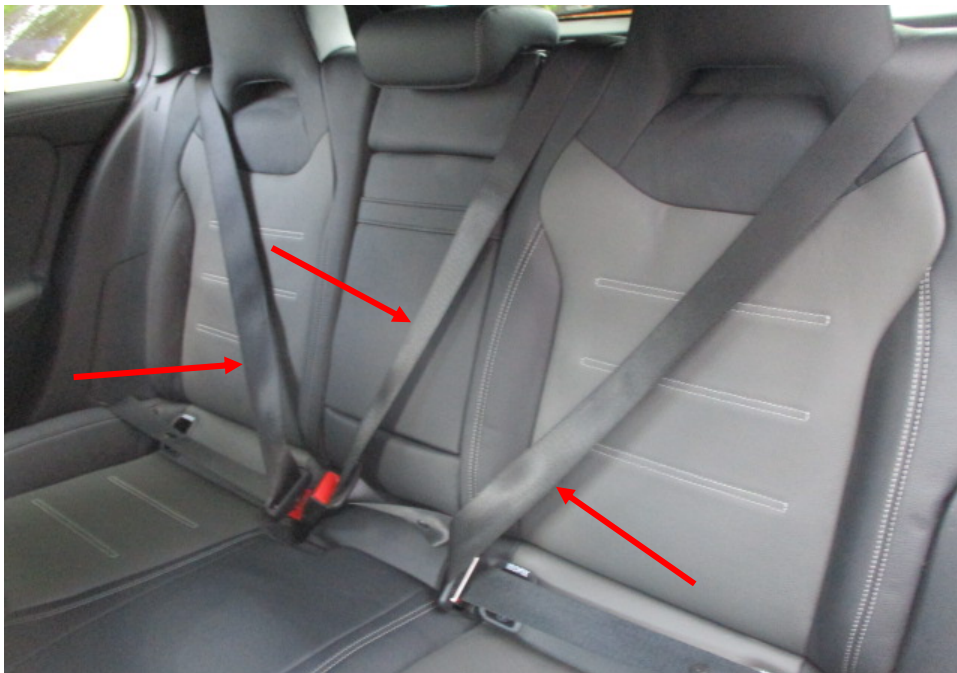
13. The seats of the Motor Car were found to be secured to the floorboard of the Motor Car via seat rails bolted onto the floorboard. Retractable seat belt reels and pre-tensioners were fitted on all seats of the Motor Car. The seat belts were tested and were able to be fastened securely into the respective pre-tensioners that were fixed to the side of all the seats.

Photo 17 shows the rear seats of the Motor Car. All the seats of the Motor Car were secured via seat rails to the floorboard. They were also fitted with a retractable seat belt reel and a pre-tensioner. The seat belts (arrowed) were tested and were able to be fastened into the respective pre-tensions that were fitted on the side of each individual seat.

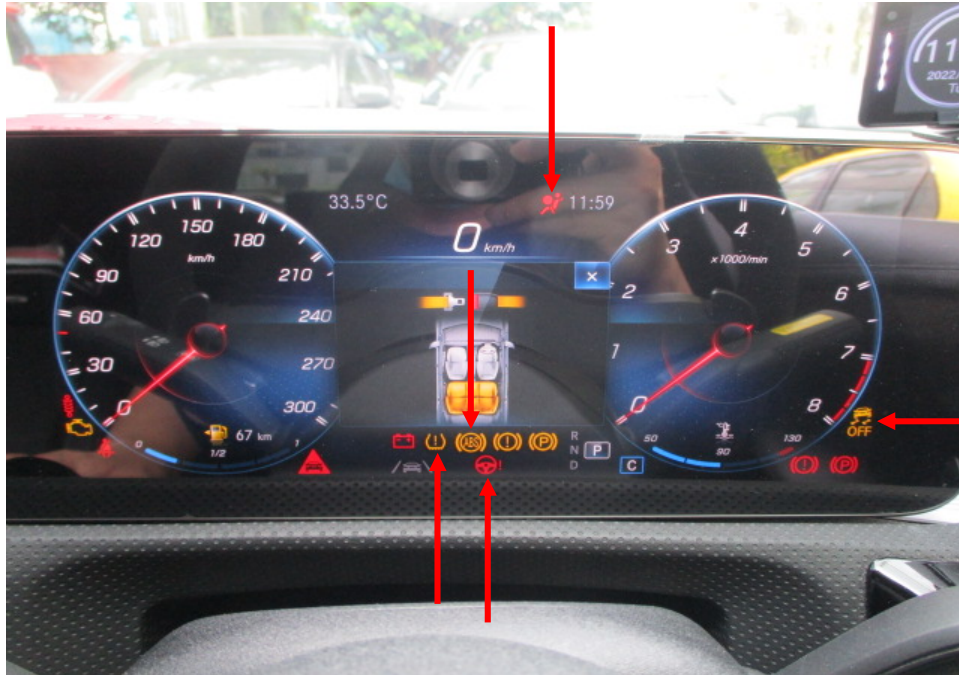
Photo 18 shows the warning lights for the various electronic safety features appearing on the instrument panel of the Motor Car during its self-test when the engine is cranked, in particular the ABS, SRS, EPS, TPM and TCS lights (arrowed).

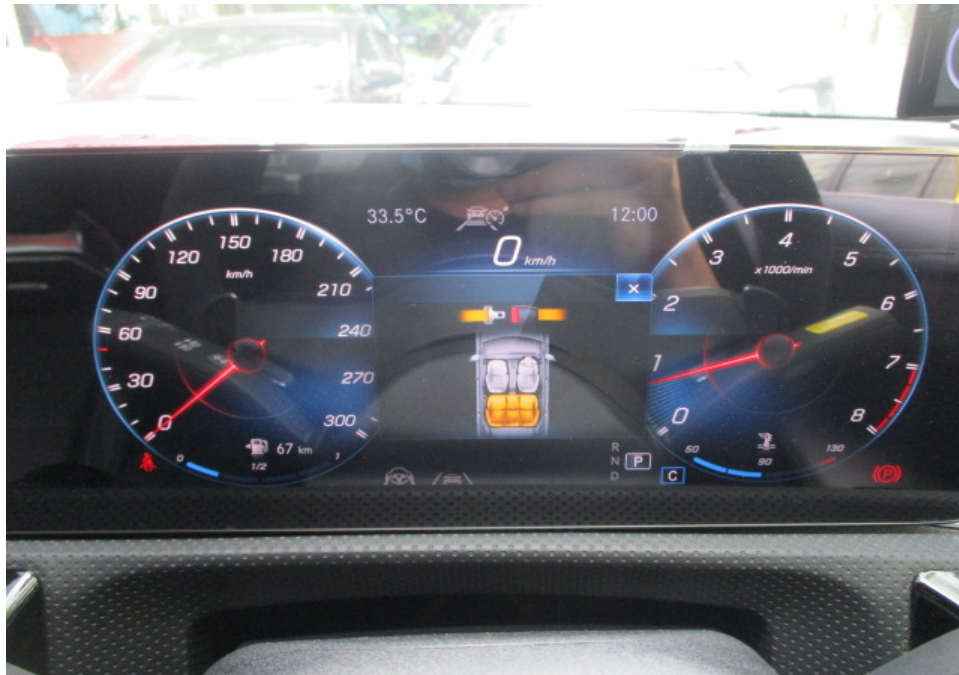
14. The Motor Car's automatic self-test of the functionality of its various electronic safety features like the Anti-Lock Brake System (ABS), Supplemental Restraint System (SRS), Electric Power Steering (EPS), Tyre Pressure Monitor (TPM) and Traction Control System (TCS) during cranking of the engine had indicated that these electronic systems were in working condition. This was determined from the respective warning lights disappearing from the instrument panel after the self-test.

Photo 19 shows the respective warning lights no longer illuminated, indicating that there is no fault detected to the ABS, SRS, EPS, TPM and TCS systems of the Motor Car during the self-test. These electronic systems were hence in working condition at the time of my inspection.

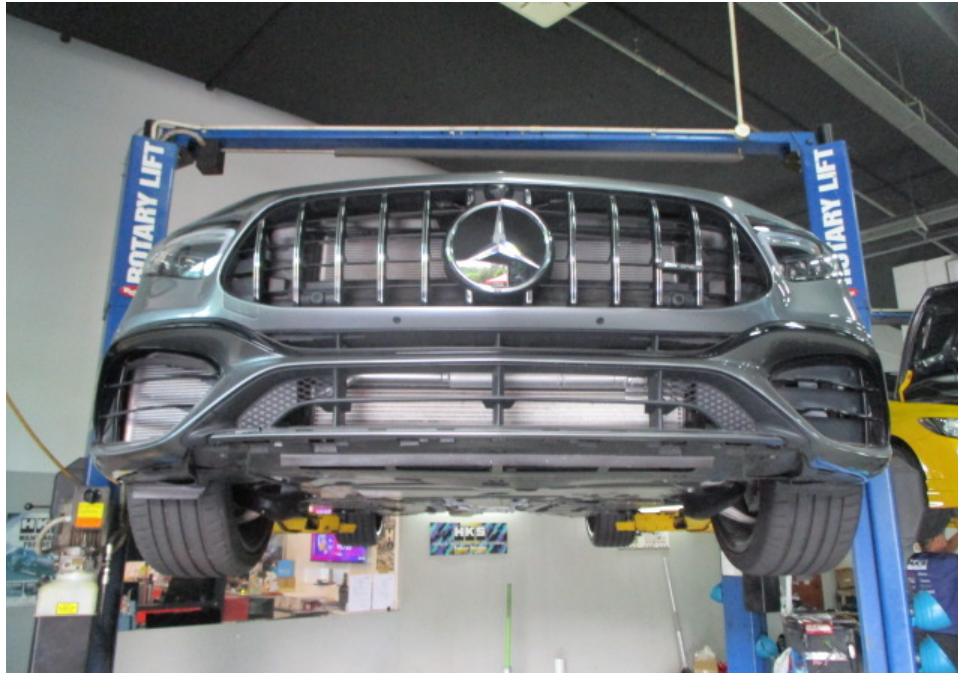
16. My checks on the underside of the Motor Car revealed no sign(s) or indication(s) of fluid leakage and/or fluid stain(s). The engine block and automatic transmission assembly were both secured properly. All undercarriage components of the Motor Car were also observed to be intact and secured in an appropriate manner.

Photo 20 shows the Motor Car hoisted up for checks on its undercarriage. There was no sign(s) or indication(s) of fluid leakage and/or fluid stain(s) on the underside of the Motor Car. The undercarriage components of the Motor Car were also all observed to be intact and secured in an appropriate manner.

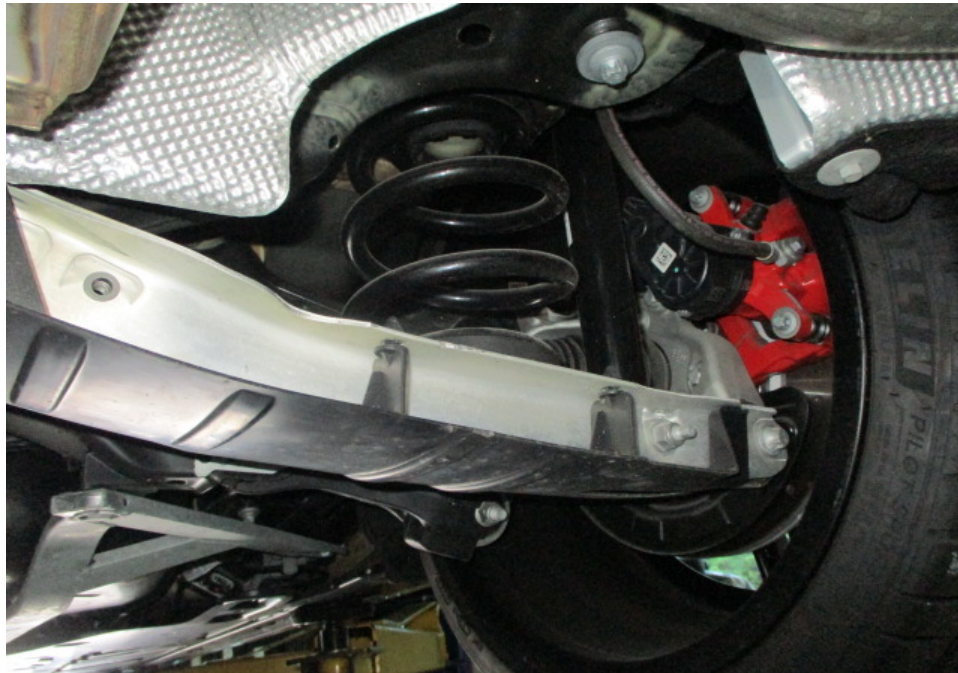
Photo 21 shows a general view of the control arms and linkages at the rear right wheel of the Motor Car. I did not observe any fluid leak and/or fluid stain on the underside of the Motor Car. All of the Motor Car's undercarriage components were observed to be intact and secured in an appropriate manner.

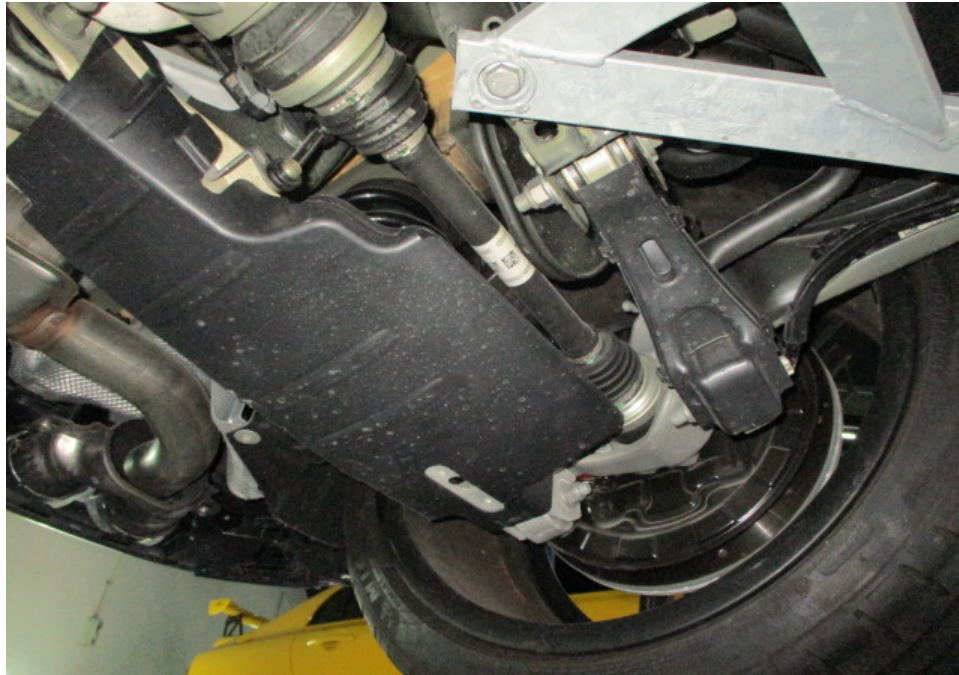
Photo 22 shows a general view of the control arms and linkages at the rear left wheel of the Motor Car. I did not observe any fluid leak and/or fluid stain on the underside of the Motor Car. All of the Motor Car's undercarriage components were observed to be intact and secured in an appropriate manner.

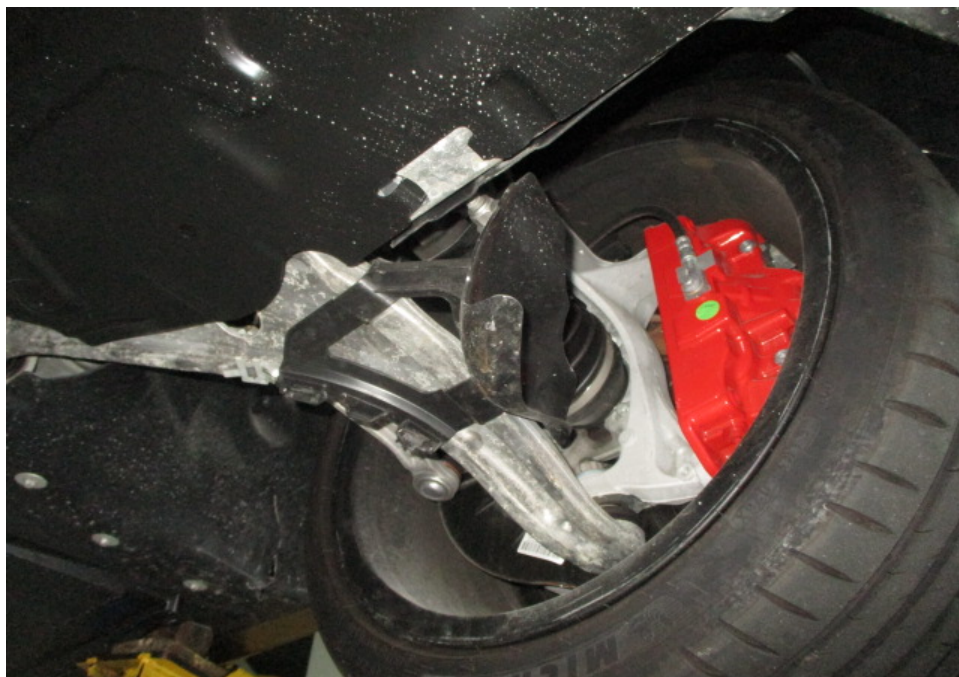
Photo 23 shows the various undercarriage components at the front left wheel of the Motor Car. The mechanical components, control arms and linkages were all found to be intact and secured in an appropriate manner.

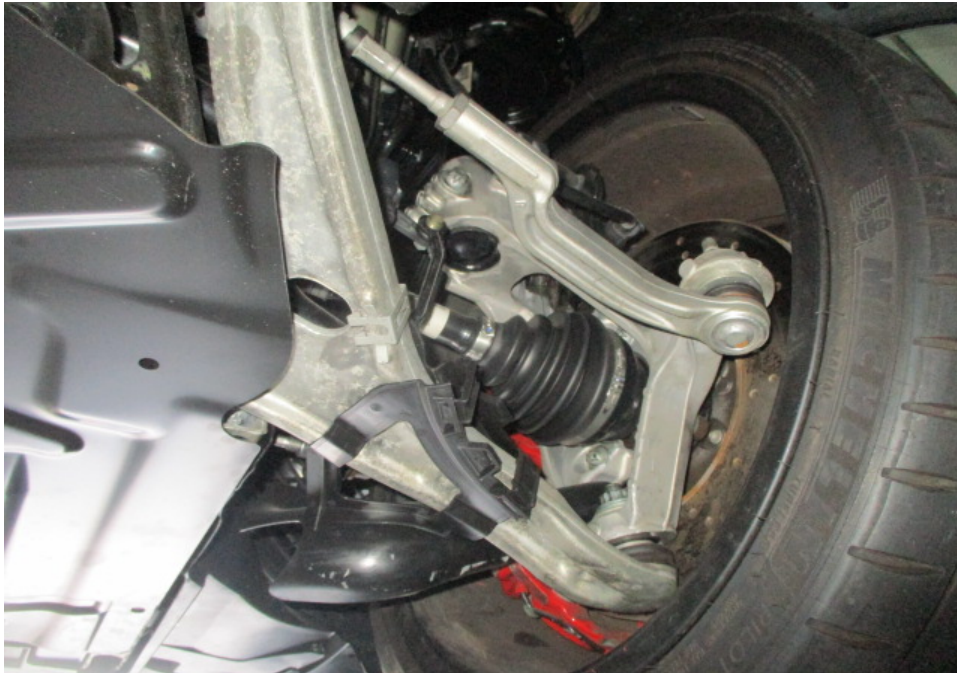
Photo 24 shows the various undercarriage components at the front right wheel of the Motor Car. The mechanical components, control arms and linkages were all found to be intact and secured in an appropriate manner. I also did not observe any fluid leak and/or fluid stain on the underside of the Motor Car.

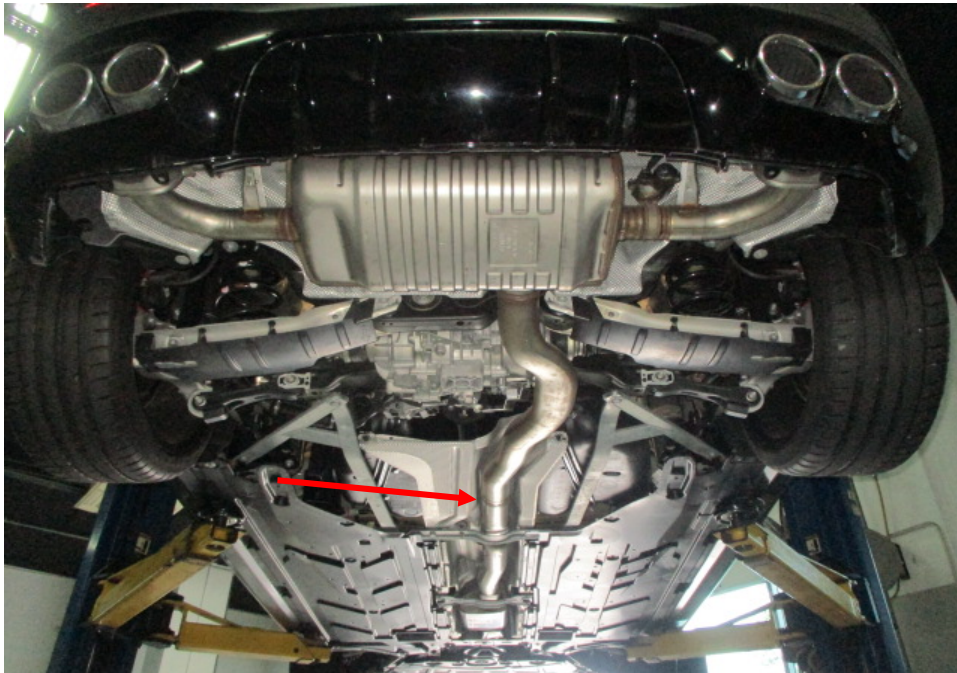
Photo 25 shows the rear section of the Motor Car's exhaust system. My examination of the Motor Car's exhaust system revealed no sign(s) or indication(s) of any cut or weld marks along its exhaust pipes (arrowed), on its rear muffler, on its centre resonator box and on its catalytic converter.

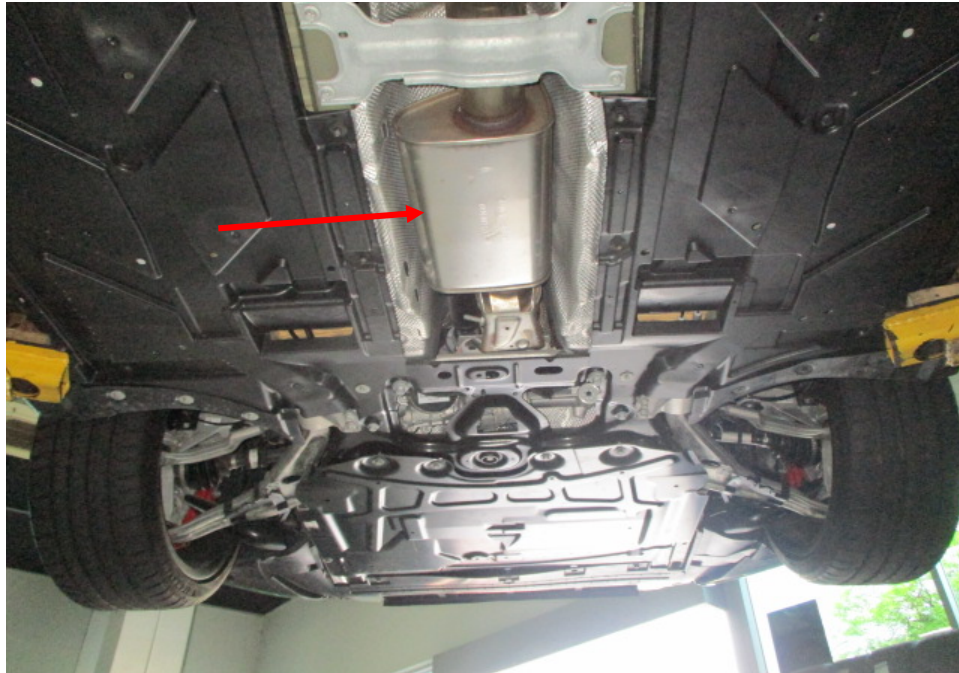
Photo 26 shows the front section of the Motor Car's exhaust system. My examination of the Motor Car's exhaust system revealed no sign(s) or indication(s) of any cut or weld marks along its exhaust pipes, on its rear muffler, on its centre resonator box (arrowed) and on its catalytic converter.

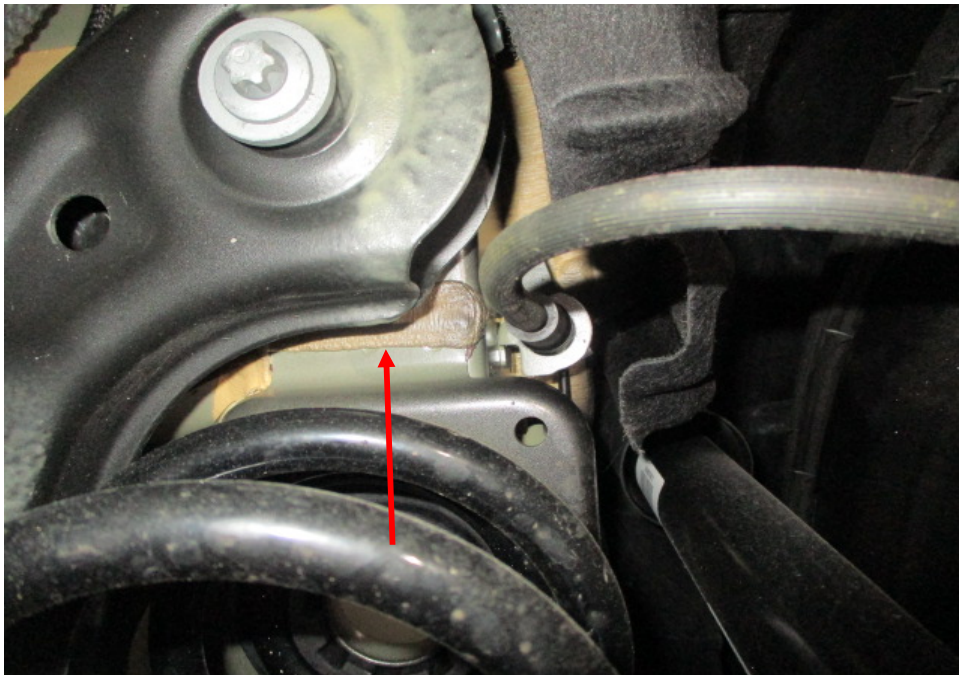
12. Visually, I did not find any weld marks, other than the original spot weld marks, on the chassis/structural body of the Motor Car. The original factory sealant at the joints along the chassis/structural body was also untouched, again indicating that no replacement of the chassis/structural body was carried out; and that the chassis/structural body was originally fitted.

Photo 27 shows the chassis/structural body at the underside rear right of the Motor Car. I did not find any weld marks other than original spot weld marks on the chassis/structural body of the Motor Car. The original factory sealant (arrowed) at the joints along the chassis/structural body was untouched, indicating no work was done on the chassis/structural body of the Motor Car and that the chassis/structural body was originally fitted.

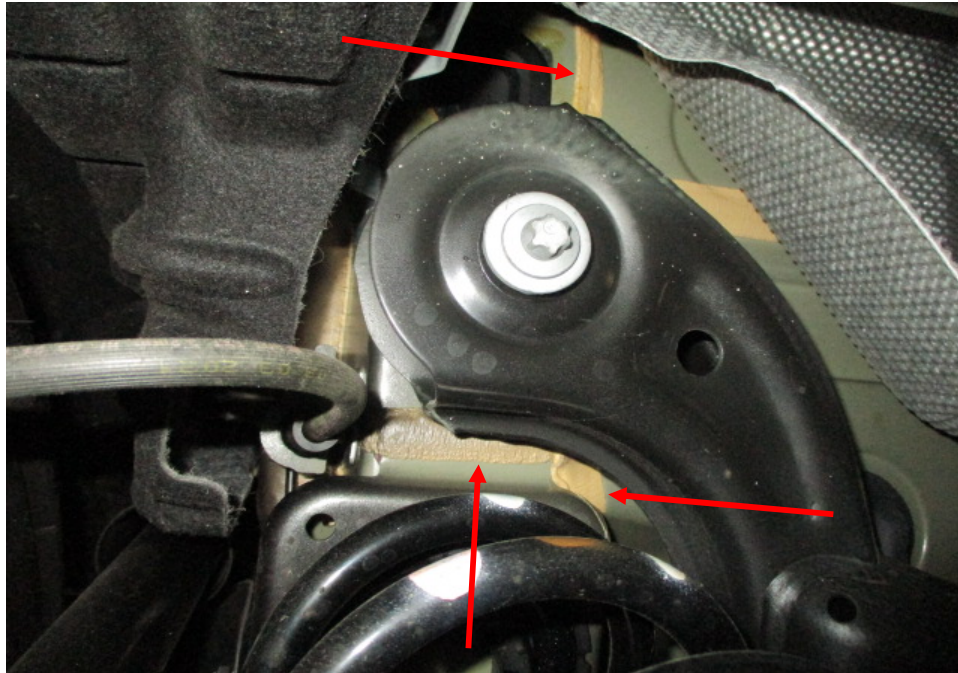
Photo 28 shows the chassis/structural body at the underside rear left of the Motor Car. The original factory sealant (arrowed) at the joints along the chassis/structural body was observed to be untouched. In general, I had found no work was carried out on the chassis/structural body of the Motor Car. The chassis/structural body of the Motor Car was originally fitted.

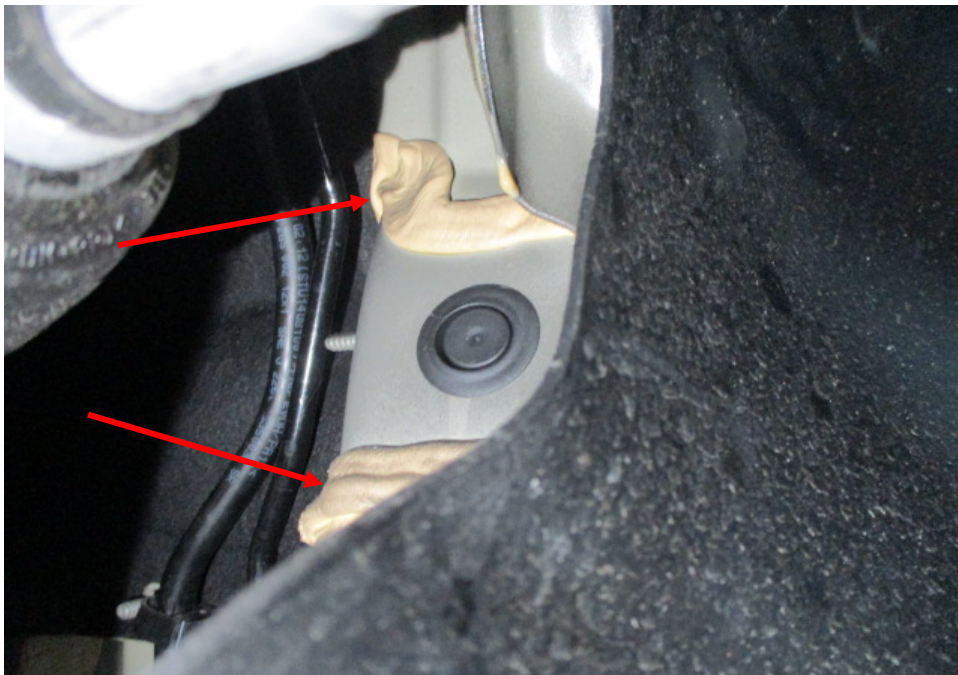
Photo 29 shows the chassis/structural body at the underside front left of the Motor Car. I did not find any weld marks other than original spot weld marks on the chassis/structural body of the Motor Car. The original factory sealant (arrowed) at the joints along the chassis/structural body was untouched, indicating no work was done on the chassis/structural body of the Motor Car and that the chassis/structural body was originally fitted.
