Your Ref: Mercedes Benz A45s
(chassis number W1K1770542N233460)
Our Ref : CI/TP22006936/D

22 July 2022

**INSPECTION REPORT OF AN UNREGISTERED MERCEDES BENZ A45s
MOTOR CAR WITH CHASSIS NUMBER W1K1770542N233460**

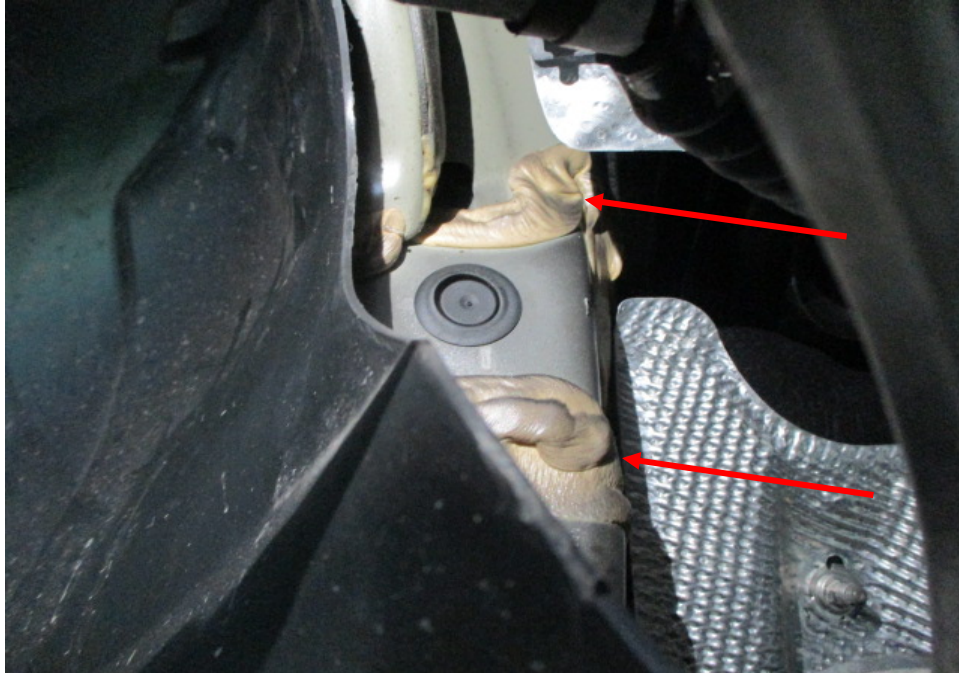
Photo 30 shows the chassis/structural body at the underside front right of the Motor Car. The original factory sealant (arrowed) at the joints along the chassis/structural body was observed to be untouched. In general, I had found no work was carried out on the chassis/structural body of the Motor Car. The chassis/structural body of the Motor Car was originally fitted.

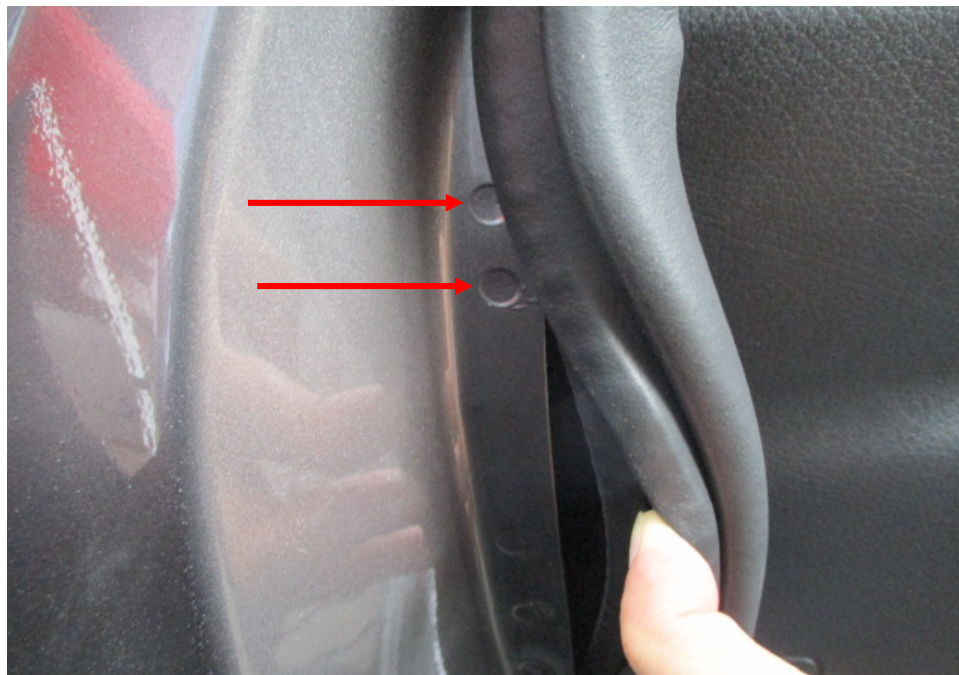
Photo 31 shows the left side "A" pillar of the Motor Car. I did not find any weld marks other than original spot weld marks (arrowed) on the left side "A" pillar of the Motor Car which, indicates that there was no re-welding works carried out. In general, I had found all the non-detachable body panels of the Motor Car to be originally fitted at the time of my inspection.

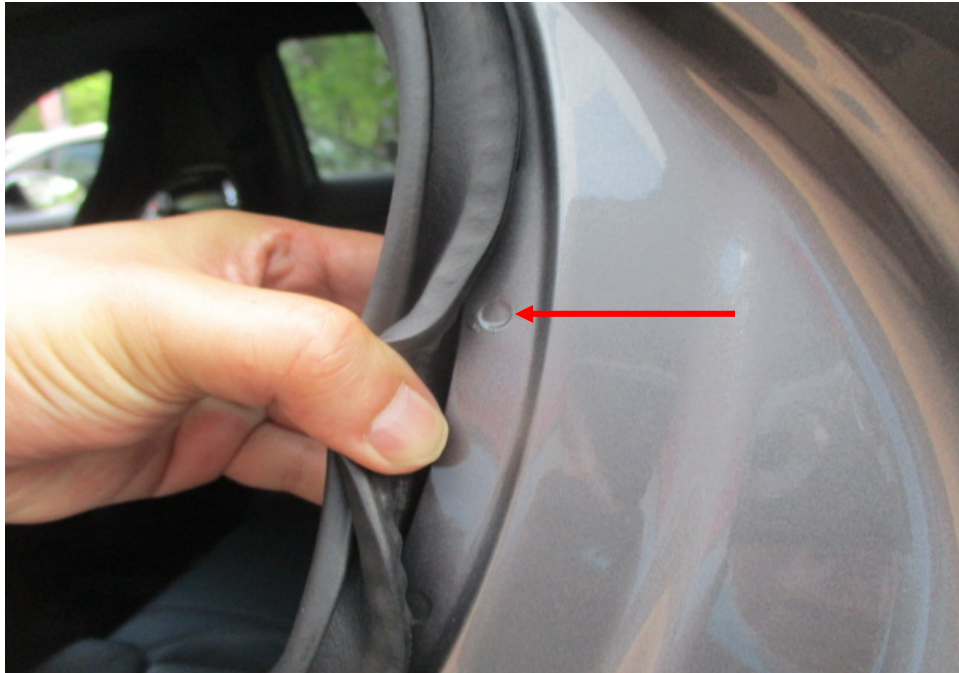
Photo 32 shows the left side “C” pillar of the Motor Car. I did not find any weld marks other than original spot weld marks (arrowed) on the left side “C” pillar of the Motor Car, which indicates that there was no re-welding works carried out. In general, I had found all the non-detachable body panels of the Motor Car to be originally fitted at the time of my inspection.

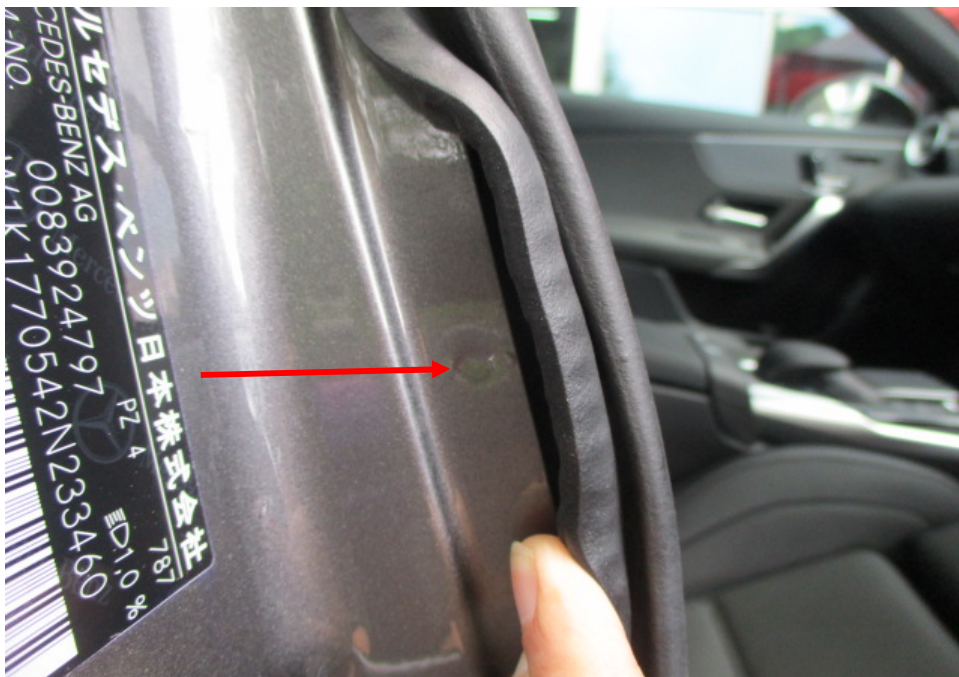
Photo 33 shows the right side “B” pillar of the Motor Car. I did not find any weld marks other than original spot weld marks (arrowed) on the right side “B” pillar of the Motor Car, which indicates that there was no re-welding works carried out. In general, I had found all the non-detachable body panels of the Motor Car to be originally fitted at the time of my inspection.

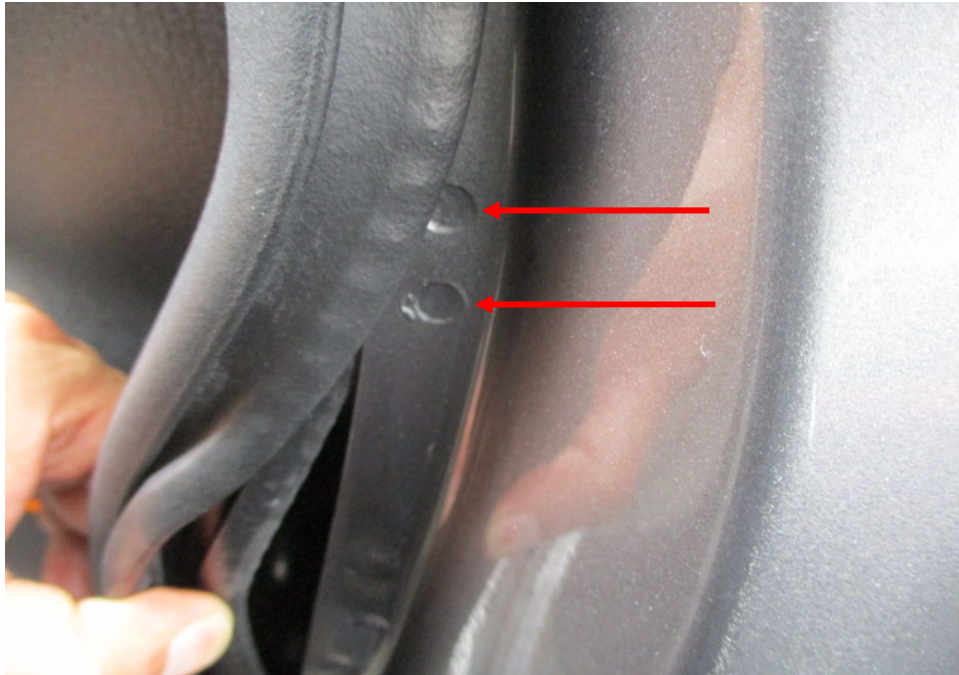
Photo 34 shows the right side "A" pillar of the Motor Car. I did not find any weld marks other than original spot weld marks (arrowed) on the right side "A" pillar of the Motor Car which, indicates that there was no re-welding works carried out. In general, I had found all the non-detachable body panels of the Motor Car to be originally fitted at the time of my inspection.
