VEHICLE APPRAISAL REPORT

Name of Workshop : Leng Wang Motor
Place of inspection : Blk 3007 Ubi Road 1, #01-414 Singapore 408701
Date of Assignment : 28 February 2022
Date of Accident : 25 February 2022
Date of Inspection : 28 February 2022

Registration No.	: SKB 9462A	Chassis Frame No.	: KMHEC41CMBA259304
Make / Model	: Hyundai i45 2.4(A)	Engine No. (Logcard)	: G4KEAU223318
Year of Manufacture/Reg	: 2010	Odometer Reading	: 255,049 KM
Colour	: White		
Class / Type	: Saloon

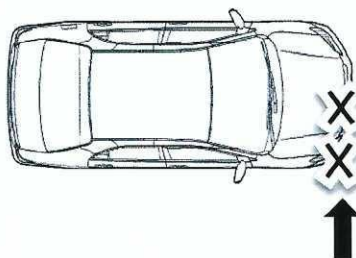
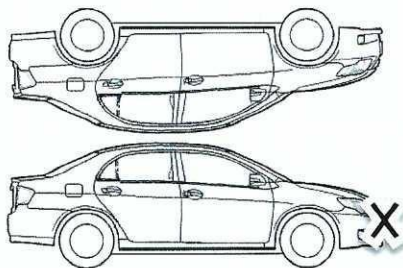
Damages sustained were consistent with the subject vehicle being involved in a collision with another vehicle and the impact was delivered **Squarely to the RH front** of the vehicle.

The general area of damages is at the **Front portion**
(Please refer to the parts list and photographs as attached for more information)

The estimated repair costs submitted by Messrs **Leng Wang Motor** is \$ 8,363.90 .
We have adjusted the cost to \$ 5,514.04 and the repairer has agreed to undertake the repairs at a **Contract Lump Sum of \$ 4,400.00** to a acceptable quality and standards.
However, we have not given authorization and instruction to the repairer to proceed with the repairs.
