| Our Reference | : | KAAS/KT/6353/9462/TP/02.22 |

## VEHICLE APPRAISAL REPORT

| Registration No. | : SKB 9462A | Chassis Frame No. | : KMHEC41CMBA259304 |
| Make / Model | : Hyundai i45 2.4(A) | Engine No. ( Logcard ) | : G4KEAU223318 |

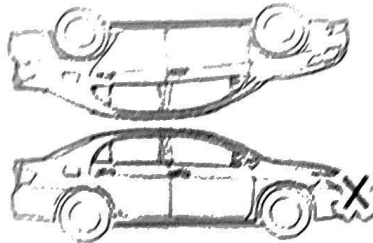
Damages sustained were consistent with the subject vehicle being involved in a collision with another vehicle and the impact was felt from the front of the vehicle.

Squarely to the RH front

Front portion

The estimated repair costs submitted by Messrs **Leng Wang Motor** is \$ 8,363.90 .  
 We have adjusted the cost to \$ 5,514.04 and the repairer has agreed to undertake the repairs at a  
 Contract Lump Sum of \$ 4,400.00 to a acceptable quality and standards.  
 However, we have not given authorization and instruction to the repairer to proceed with the repairs.
