Your Ref: Toyota Alphard
(chassis number AGH309013543)
Our Ref : CI/TP22007012/D

23 July 2022

INSPECTION REPORT OF AN UNREGISTERED TOYOTA ALPHARD MOTOR CAR WITH CHASSIS NUMBER AGH309013543

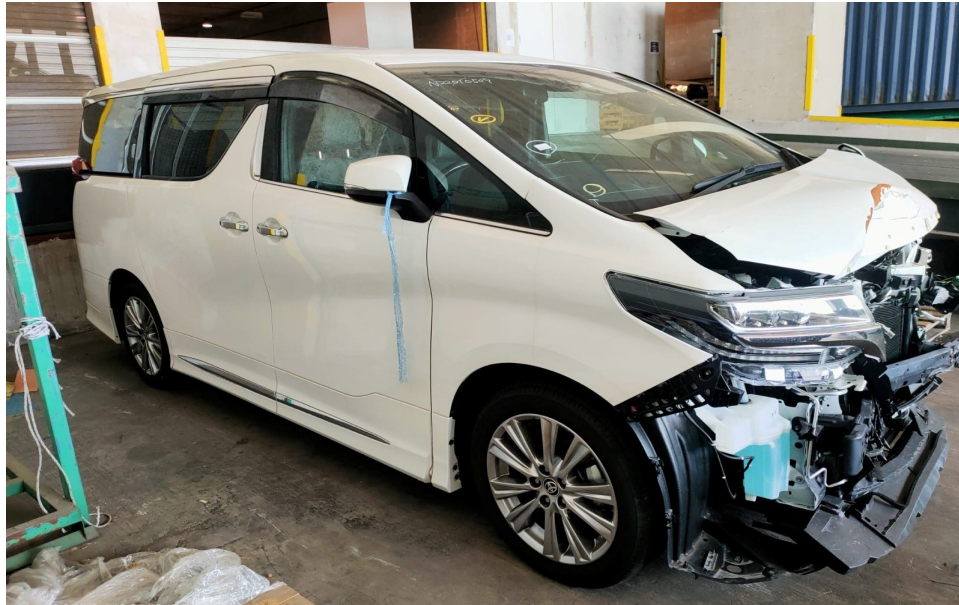
Photo 1 shows the front right body of the Motor Car (photograph provided to me). The photographs provided to me had showed damage to the frontal portion of the Motor Car. The front bumper, front bumper sensors, front bumper right chrome moulding, front bumper right lower grille, front right fog lamp, front right fender, front right headlamp and front bonnet were amongst the body parts that were observed to have been damaged. The airbag(s) of the Motor Car was not deployed as seen from the photographs that were provided to me.

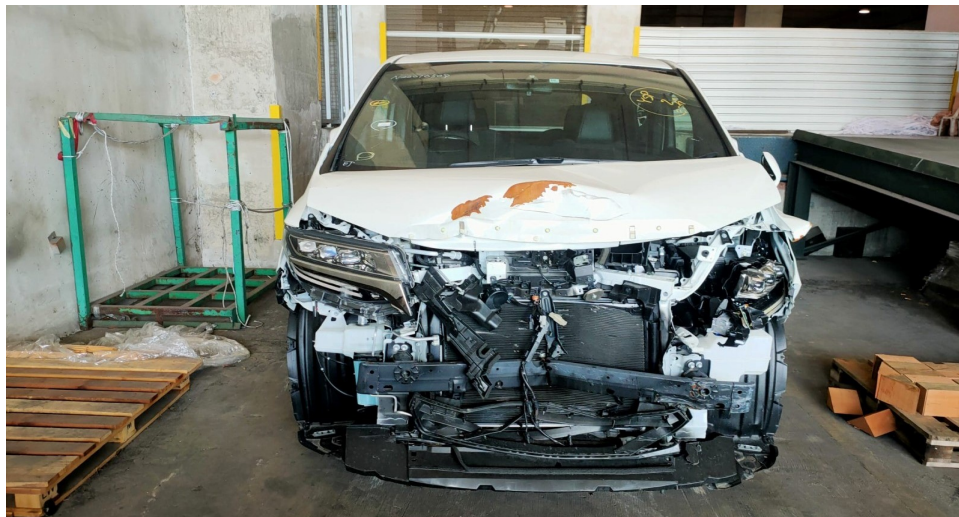
Photo 2 shows the front body of the Motor Car (photograph provided to me). The photographs provided to me had showed damage to the frontal portion of the Motor Car. The front bumper, front bumper reinforcement, front bumper centre lower grille, front bumper left chrome moulding, front bumper left lower grille, front bumper right chrome moulding, front bumper right lower grille, front bumper sensors, radiator grille, front emblem, front air guides, front headlamps, front fog lamps, front bonnet, front bonnet chrome moulding, front bonnet lock, front bonnet hinges, front support panel, front support panel top garnish, front left headlamp top panel, front right headlamp top panel, aircon condenser, radiator and front fenders were amongst the body parts that were observed to have been damaged. The airbag(s) of the Motor Car was not deployed.

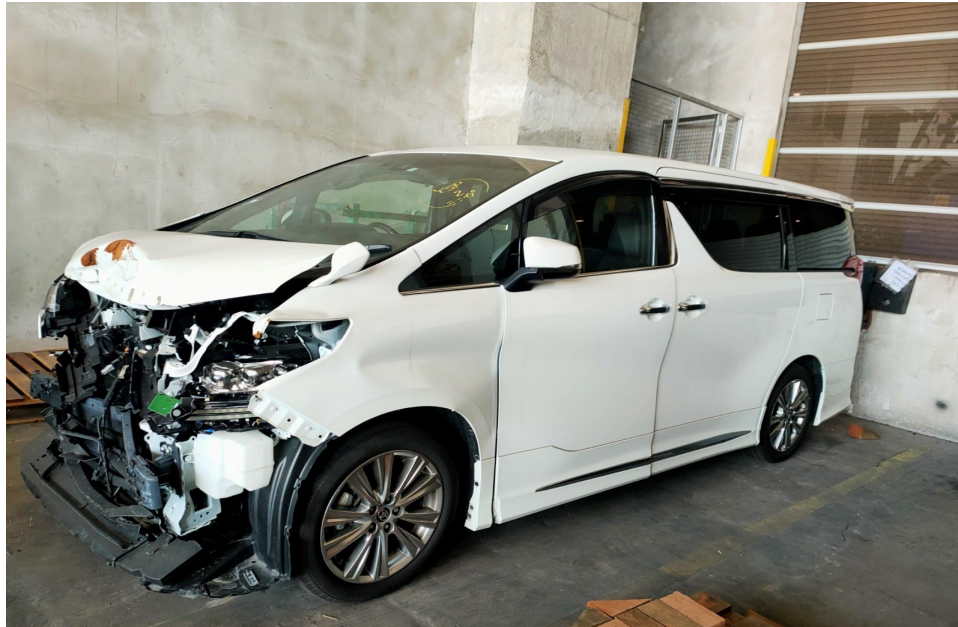
Photo 3 shows the front left body of the Motor Car (photograph provided to me). The photographs provided to me had showed damage to the frontal portion of the Motor Car. The front bumper, front bumper sensors, front bumper left chrome moulding, front bumper left lower grille, front left fog lamp, front left fender, front left headlamp, front left headlamp top panel, radiator grille, front bonnet and front bonnet lock were amongst the body parts that were observed to have been damaged. The airbag(s) of the Motor Car was not deployed as seen from the photographs that were provided to me.

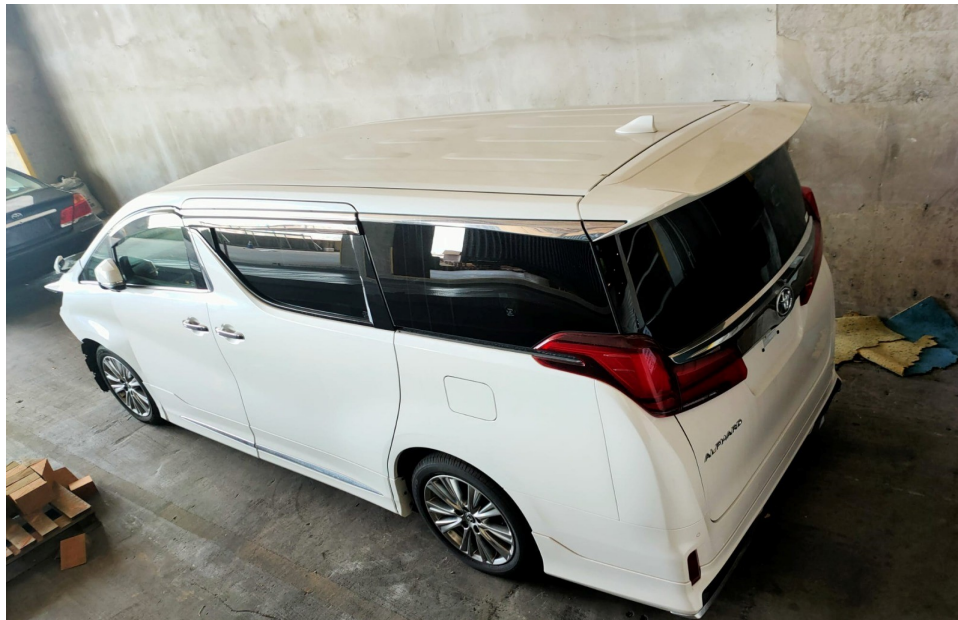
Photo 4 shows the rear left body of the Motor Car (photograph provided to me). Apart for the frontal body, the photographs provided to me did not show physical damage to other areas of the Motor Car.

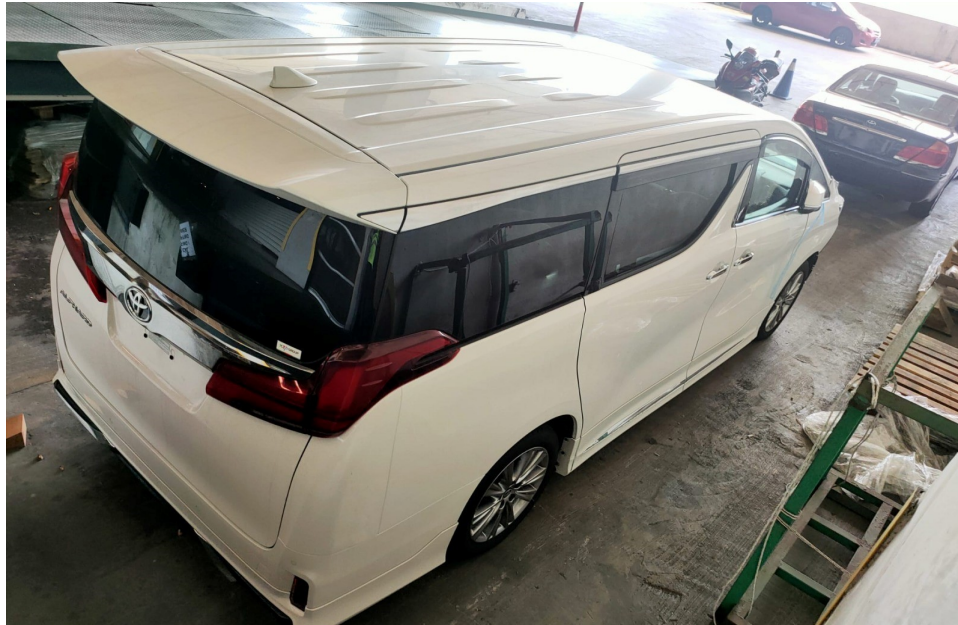
Photo 5 shows the rear right body of the Motor Car (photograph provided to me). Apart for the frontal body, the photographs provided to me did not show physical damage to other areas of the Motor Car.

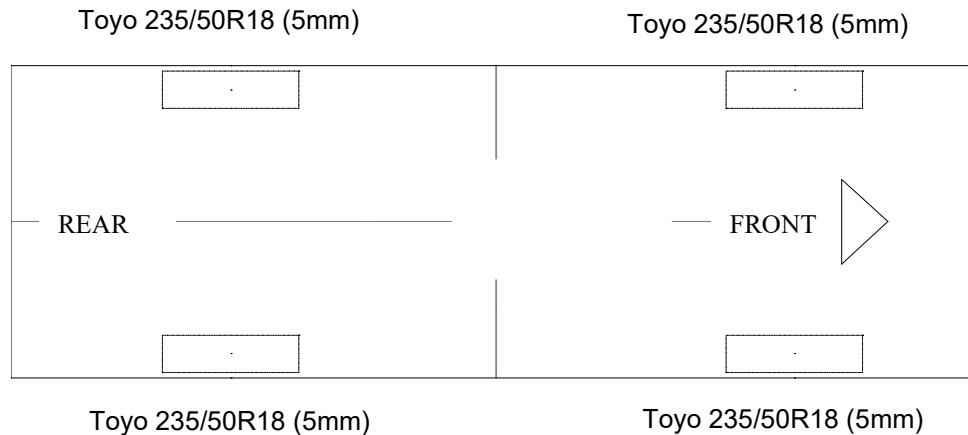
8. It was fitted with 18inch sport wheel rims that were wrapped with tyres that were observed to be of serviceable condition. The tyres were also sufficiently inflated for vehicular operation. The tyre brand, tyre size and approximate remaining tread depth of the 4 tyres of the Motor Car were recorded as follows: -

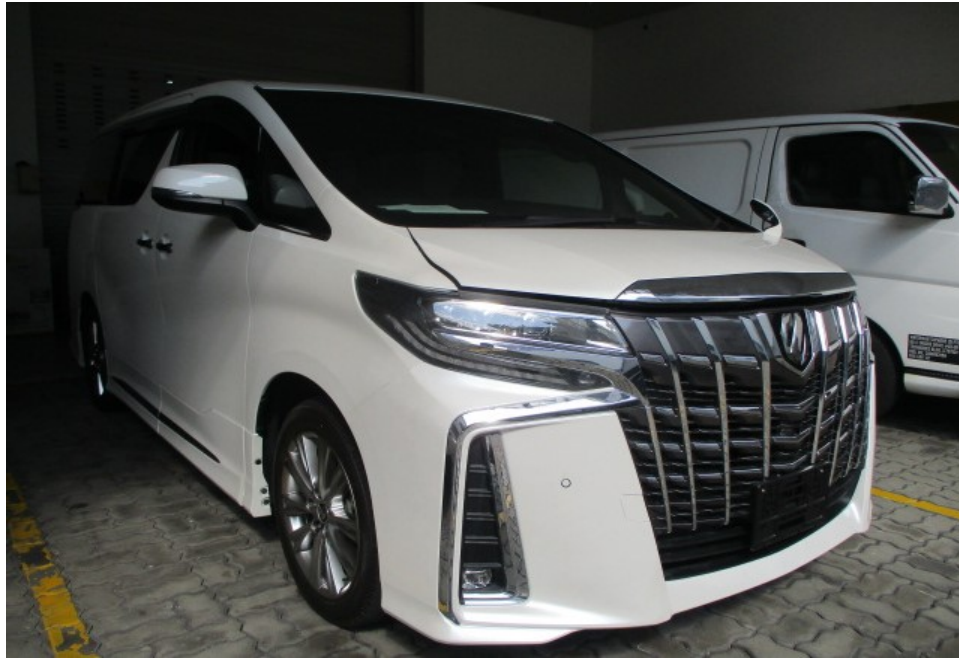
Photo 6 shows a general view of the front right body of the Motor Car at the time of my inspection. The Motor Car was observed to be in a relatively good general condition with no loose exterior fittings observed. The body parts at the frontal portion of the Motor Car were visually examined and it was observed that the repair/restoration works carried out to the damaged area of the Motor Car (refer to photograph 1 - 3 above) were reasonably adequate and in order.

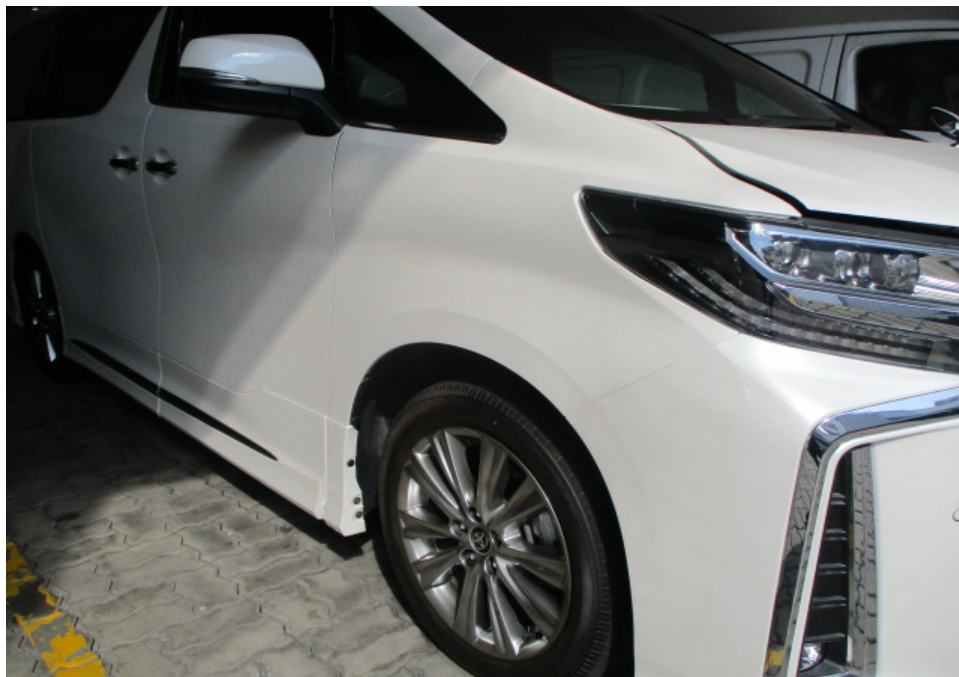
Photo 7 shows a closer view of the Motor Car's front right headlamp, front right fender and front right wheel rim. The body parts at the frontal portion of the Motor Car were visually examined and it was observed that the repair/restoration works carried out to the damaged area of the Motor Car (refer to photograph 1 - 3 above) were reasonably adequate and in order.

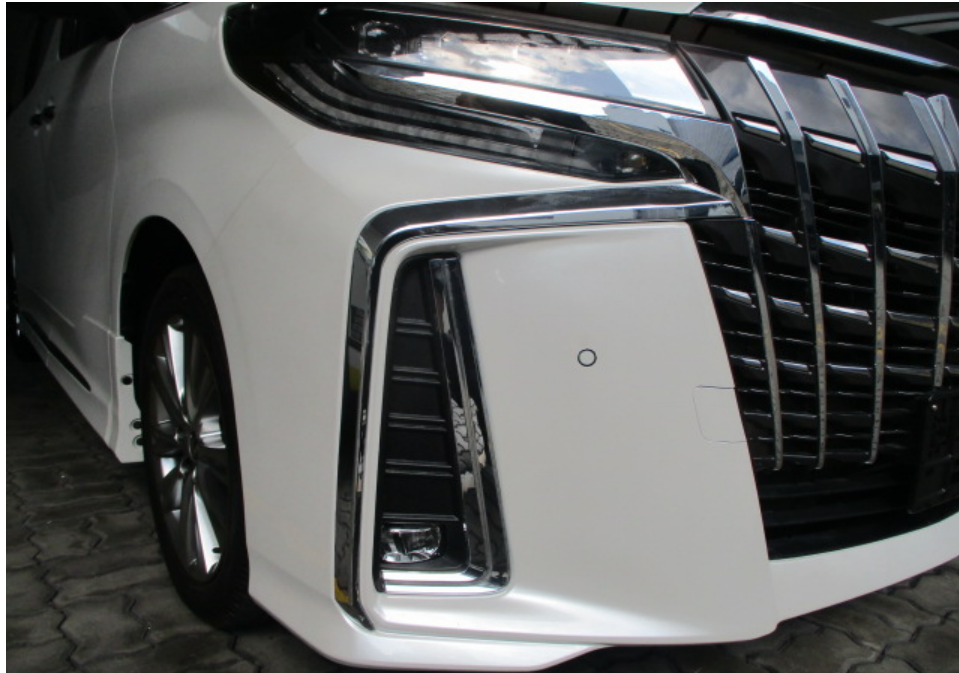
Photo 8 shows a closer view of the Motor Car's front bumper, front bumper right sensor, front bumper right chrome moulding, front bumper right lower grille and front right fog lamp. The body parts at the frontal portion of the Motor Car were visually examined and it was observed that the repair/restoration works carried out to the damaged area of the Motor Car (refer to photograph 1 - 3 above) were reasonably adequate and in order.

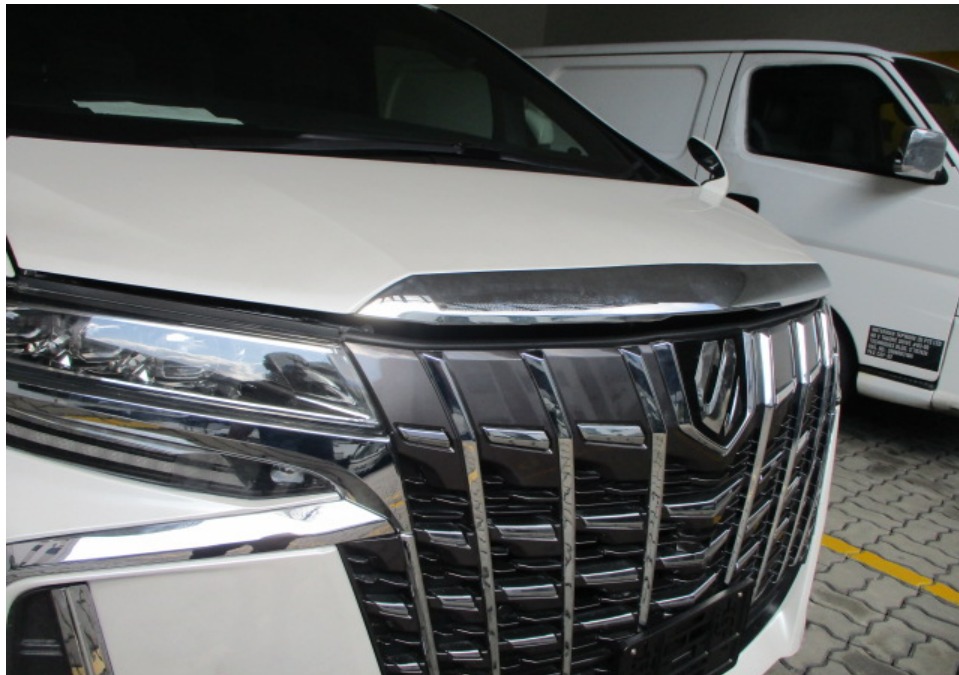
Photo 9 shows a closer view of the Motor Car's front right headlamp, front bonnet, front bonnet chrome moulding and radiator grille. The body parts at the frontal portion of the Motor Car were visually examined and it was observed that the repair/restoration works carried out to the damaged area of the Motor Car (refer to photograph 1 - 3 above) were reasonably adequate and in order.

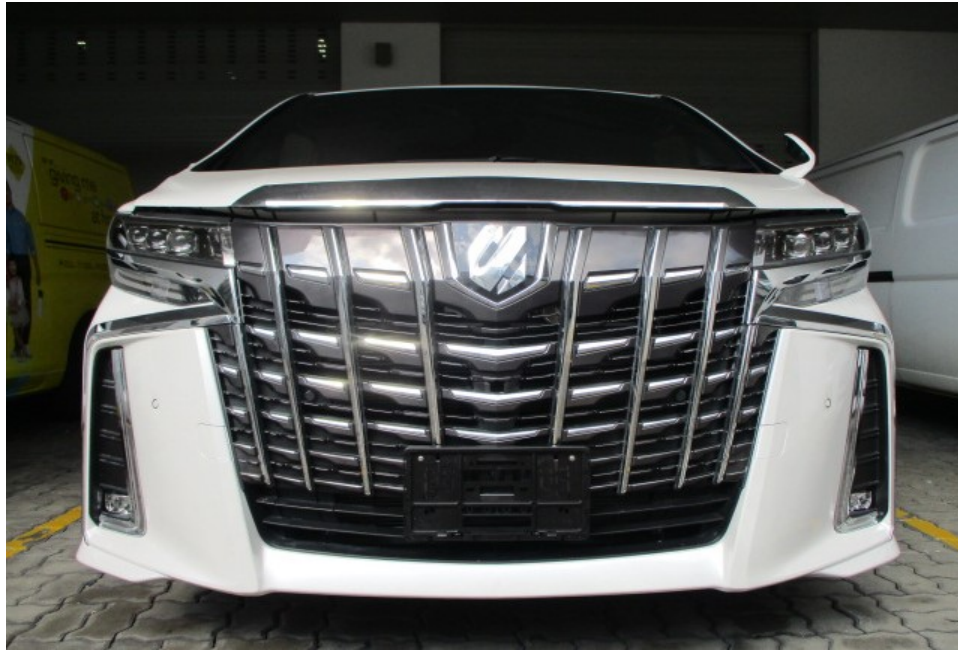
Photo 10 shows a closer view of the Motor Car's front body at the time of my inspection. The Motor Car was observed to be in a relatively good general condition with no loose exterior fittings observed. The body parts at the frontal portion of the Motor Car were visually examined and it was observed that the repair/restoration works carried out to the damaged area of the Motor Car (refer to photograph 1 - 3 above) were reasonably adequate and in order.

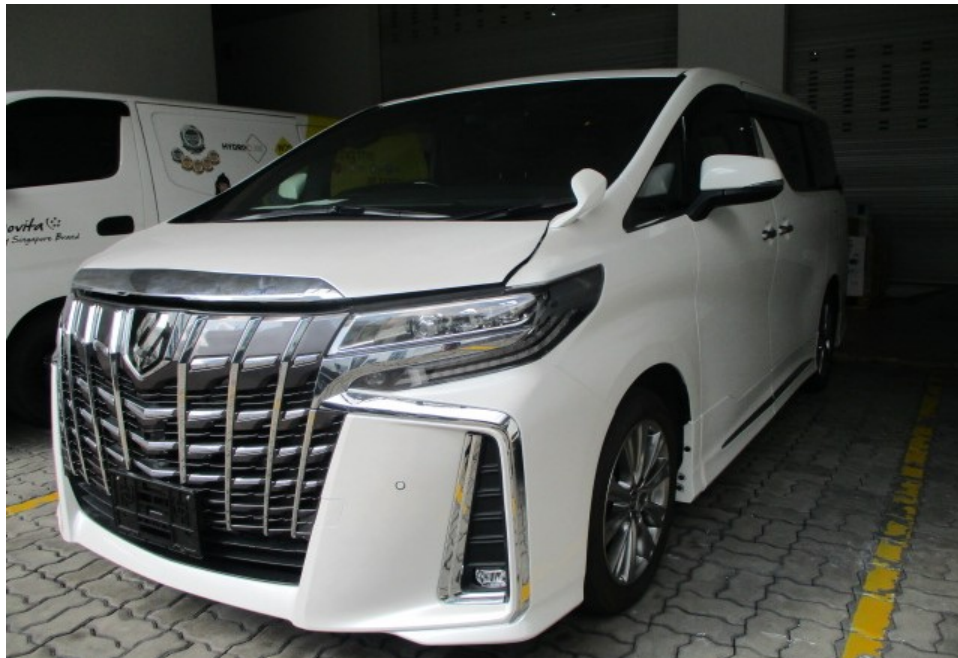
Photo 11 shows a general view of the front left body of the Motor Car at the time of my inspection. The Motor Car was observed to be in a relatively good general condition with no loose exterior fittings observed. The body parts at the frontal portion of the Motor Car were visually examined and it was observed that the repair/restoration works carried out to the damaged area of the Motor Car (refer to photograph 1 - 3 above) were reasonably adequate and in order.

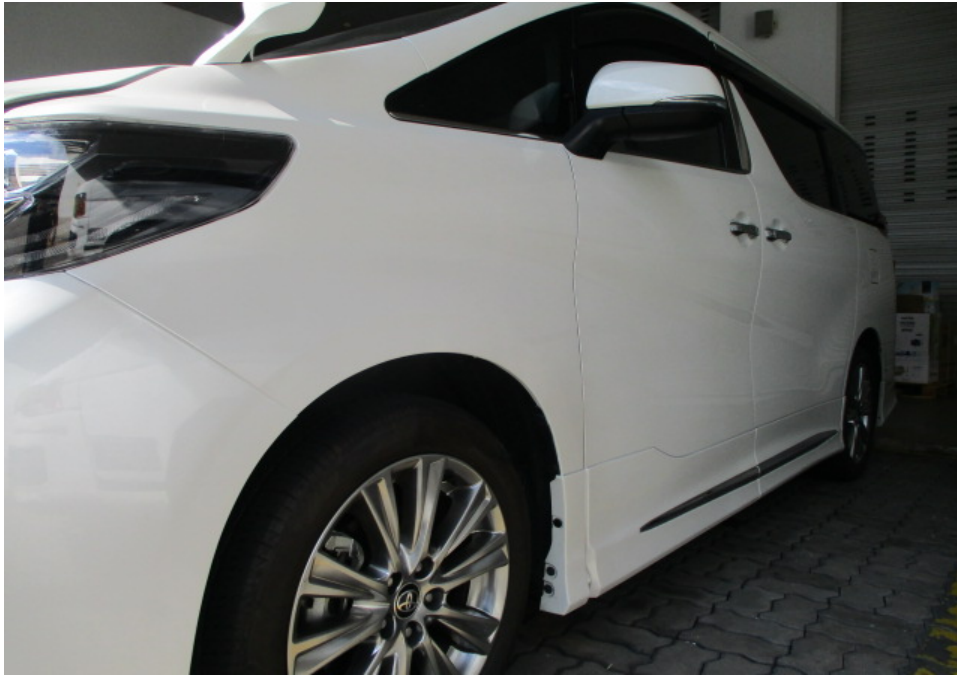
Photo 12 shows a closer view of the Motor Car's front left fender, front left wheel rim and front left door. The body parts at the frontal portion of the Motor Car were visually examined and it was observed that the repair/restoration works carried out to the damaged area of the Motor Car (refer to photograph 1 - 3 above) were reasonably adequate and in order.

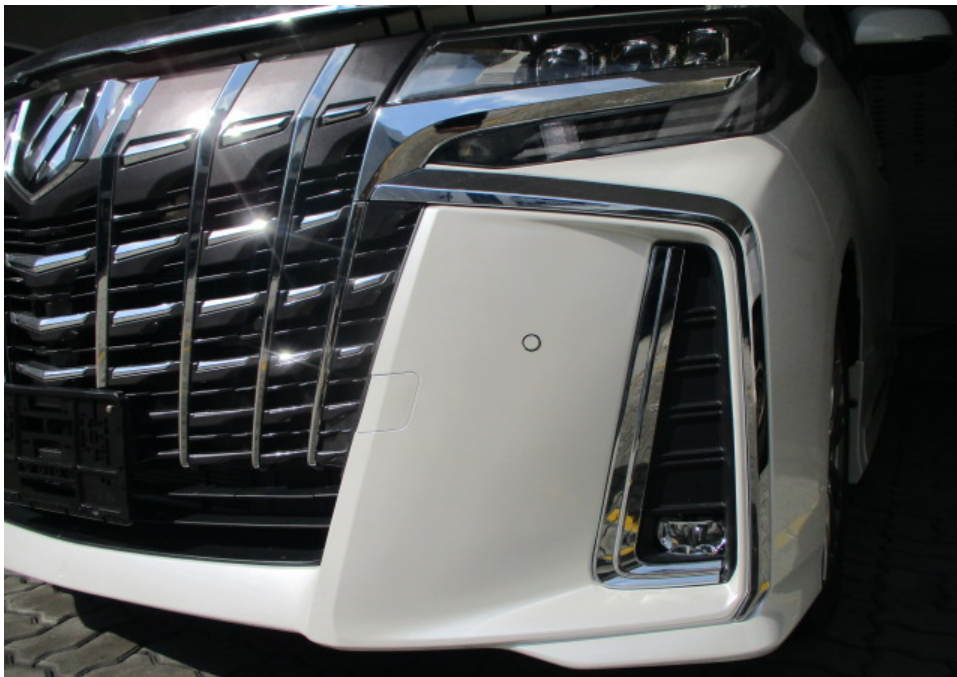
Photo 13 shows a closer view of the Motor Car's front bumper, front bumper left sensor, front bumper left chrome moulding, front bumper left lower grille, front left fog lamp and radiator grille. The body parts at the frontal portion of the Motor Car were visually examined and it was observed that the repair/restoration works carried out to the damaged area of the Motor Car (refer to photograph 1 - 3 above) were reasonably adequate and in order.

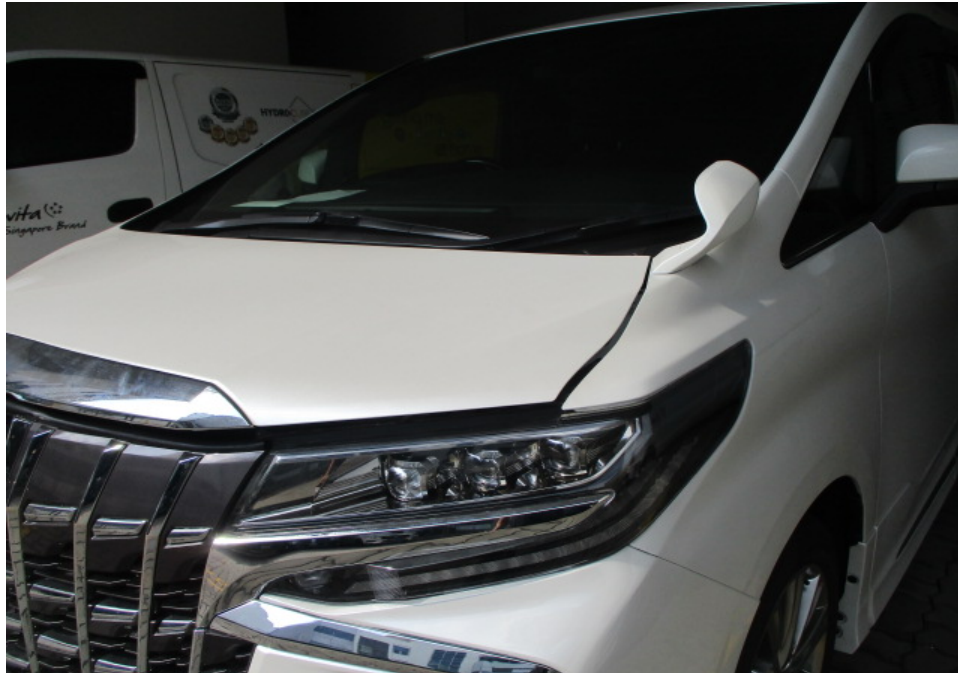
Photo 14 shows a closer view of the Motor Car's front left headlamp, front left fender, front bonnet and front bonnet chrome moulding. The body parts at the frontal portion of the Motor Car were visually examined and it was observed that the repair/restoration works carried out to the damaged area of the Motor Car (refer to photograph 1 - 3 above) were reasonably adequate and in order.

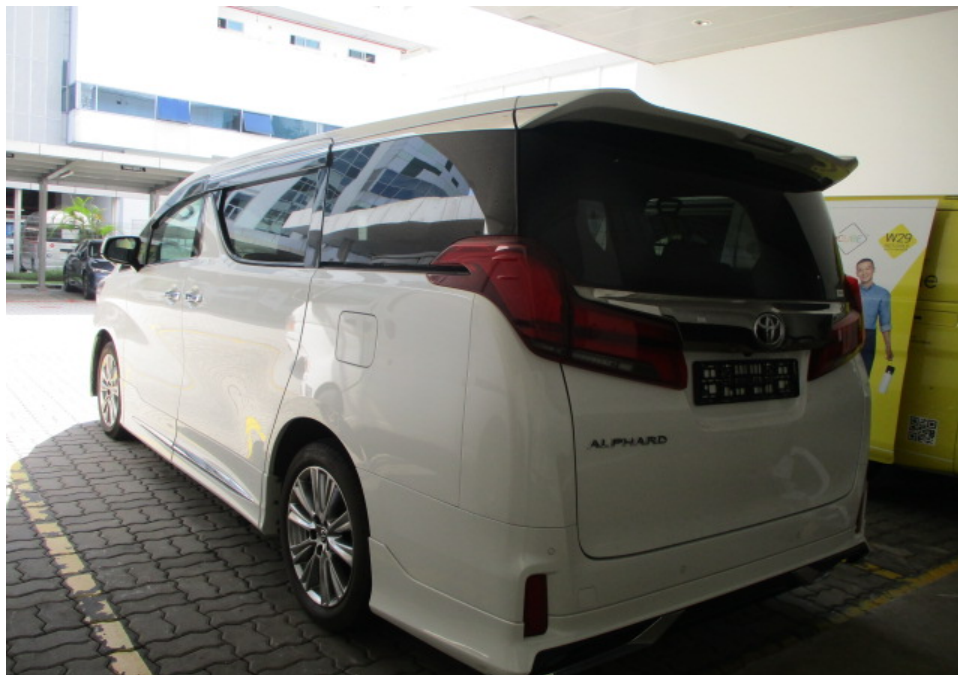
Photo 15 shows a general view of the rear left body of the Motor Car at the time of my inspection. The Motor Car was observed to be in a relatively good general condition with no loose exterior fittings observed. The mileage of the Motor Car recorded at the time of my inspection was 9,570km.

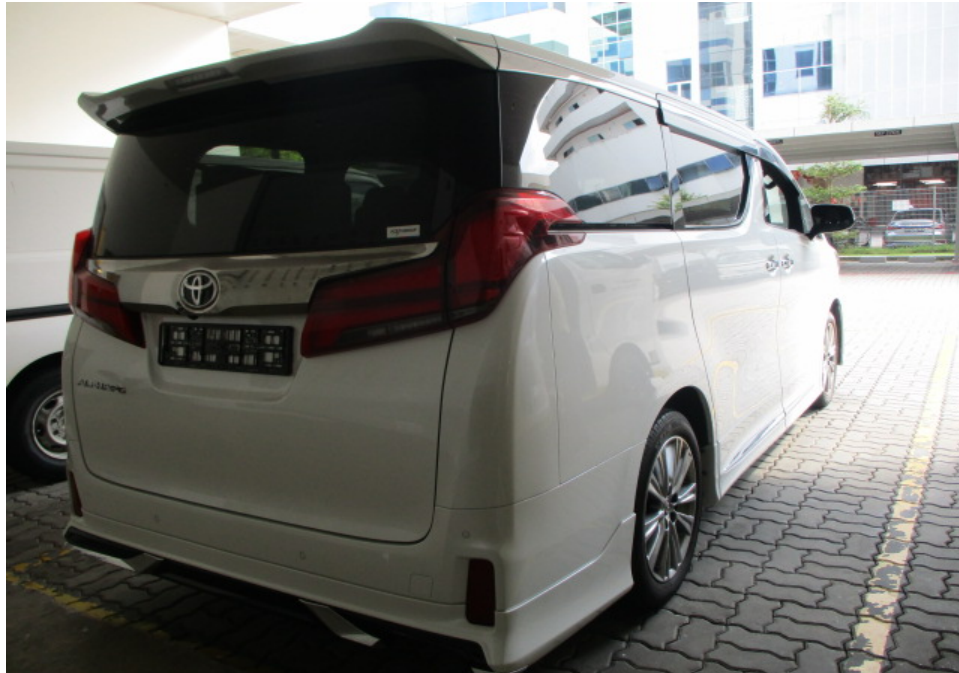
Photo 16 shows a general view of the rear right body of the Motor Car at the time of my inspection. The Motor Car was observed to be in a relatively good general condition with no loose exterior fittings observed. The mileage of the Motor Car recorded at the time of my inspection was 9,570km.

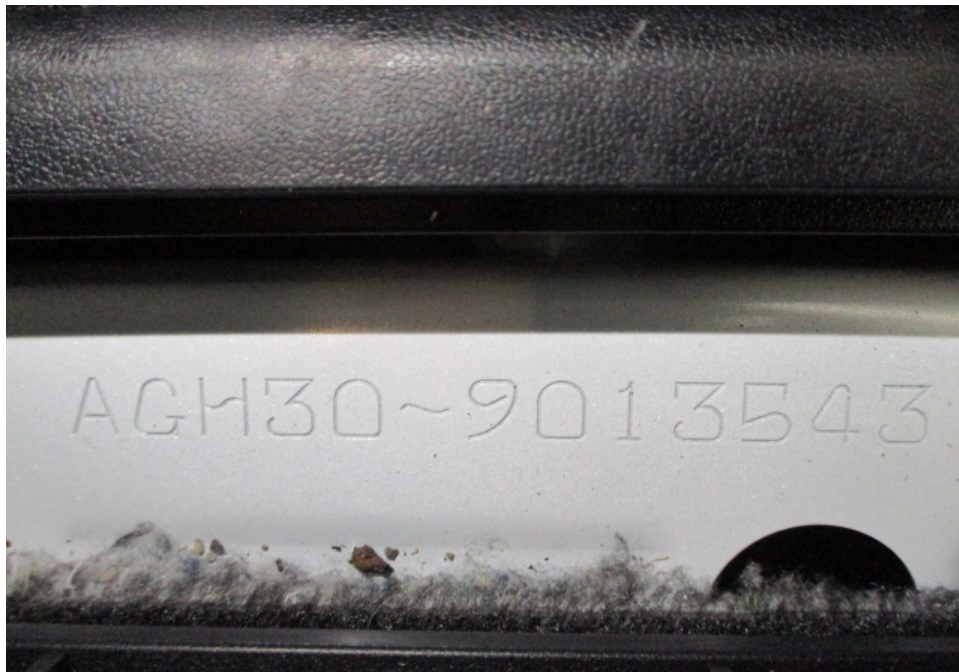
Photo 17 shows the chassis number of the Motor Car. The chassis number recorded was AGH309013543.

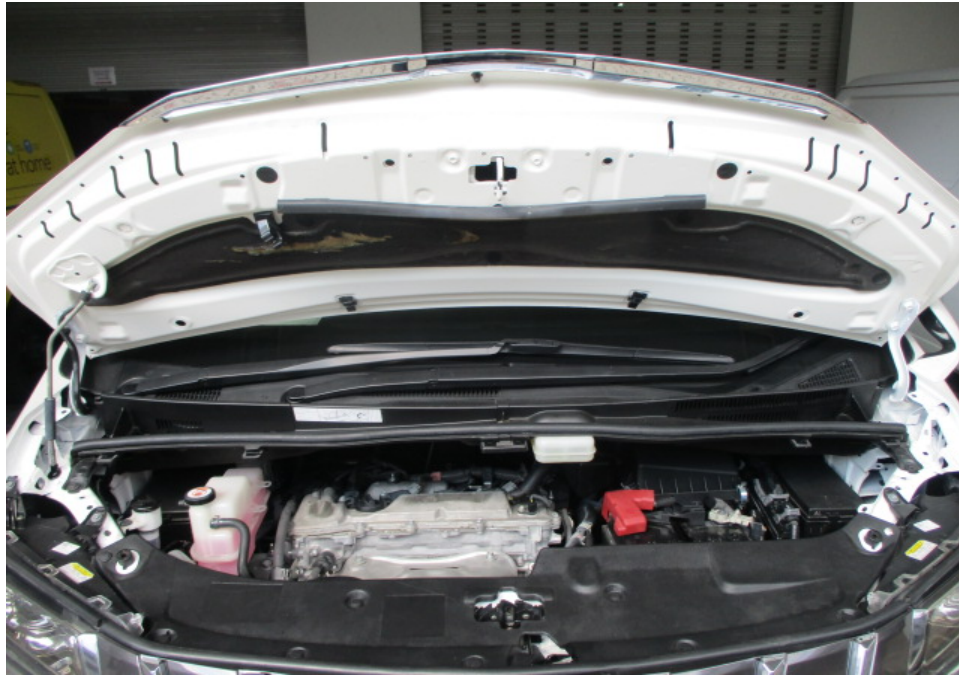
Photo 18 shows a general view of the engine compartment of the Motor Car at the time of my inspection. The various parts and components inside the engine compartment were all observed to be intact and properly fitted. There was also no sign(s) or indication(s) of fluid leak and/or fluid stain found inside the engine compartment. The repair/restoration works carried out to the various parts within the engine compartment like the front bonnet lock, front support panel, front support panel top garnish, aircon condenser and radiator amongst others were reasonably adequate and in order.

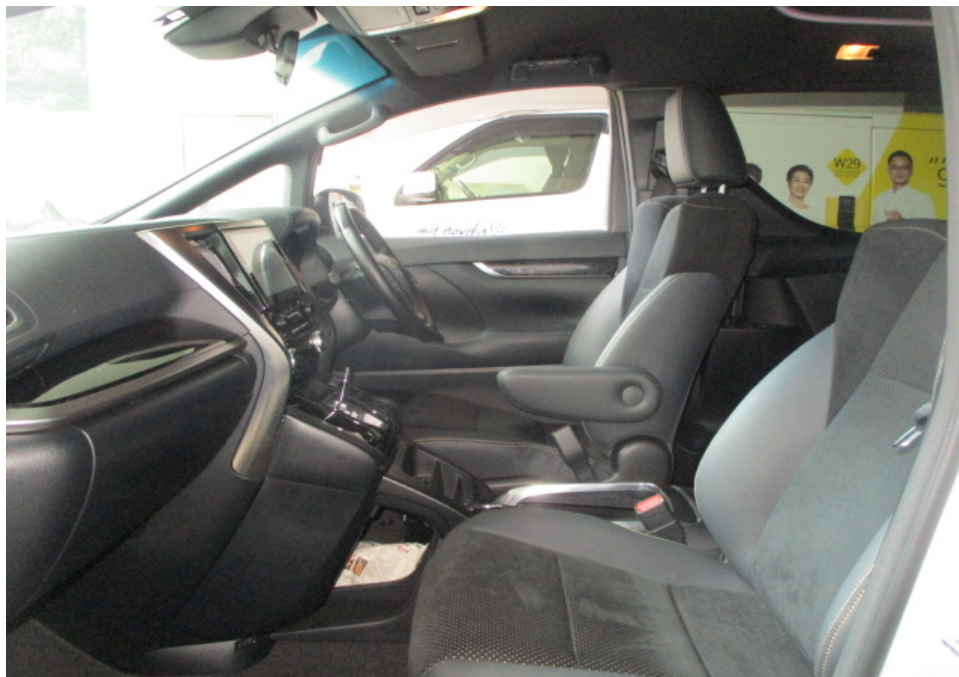
Photo 19 shows the interior compartment of the Motor Car at the time of my inspection. The various parts and components, trims, carpet, and upholstery inside the interior compartment were all observed to be intact and properly fitted.

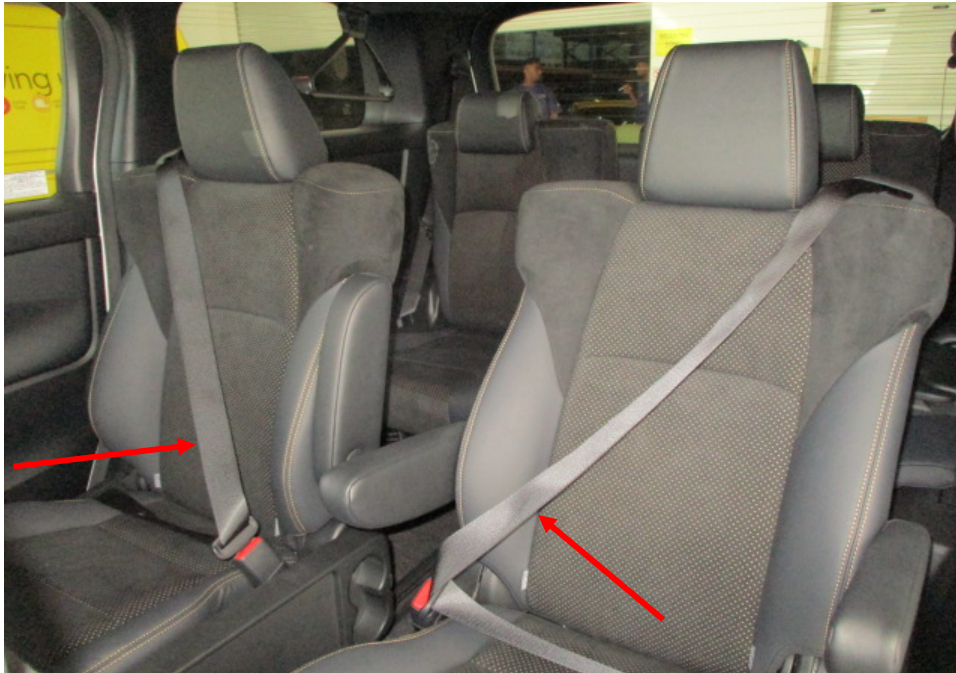
Photo 20 shows the rear seats at the 1st row of the Motor Car. All the seats of the Motor Car were secured via seat rails to the floorboard. They were also fitted with a retractable seat belt reel and a pre-tensioner. The seat belts (arrowed) were tested and were able to be fastened into the respective pre-tensions that were fitted on the side of each individual seat.

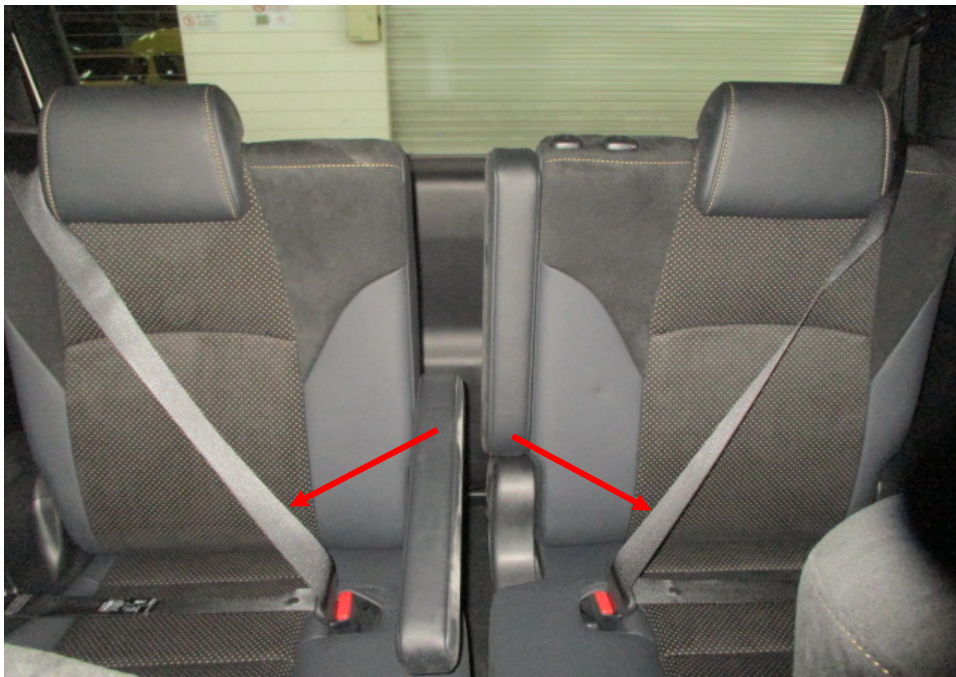
Photo 21 shows the rear seats at the 2nd row of the Motor Car. All the seats of the Motor Car were secured via seat rails to the floorboard. They were also fitted with a retractable seat belt reel and a pre-tensioner. The seat belts (arrowed) were tested and were able to be fastened into the respective pre-tensions that were fitted on the side of each individual seat.

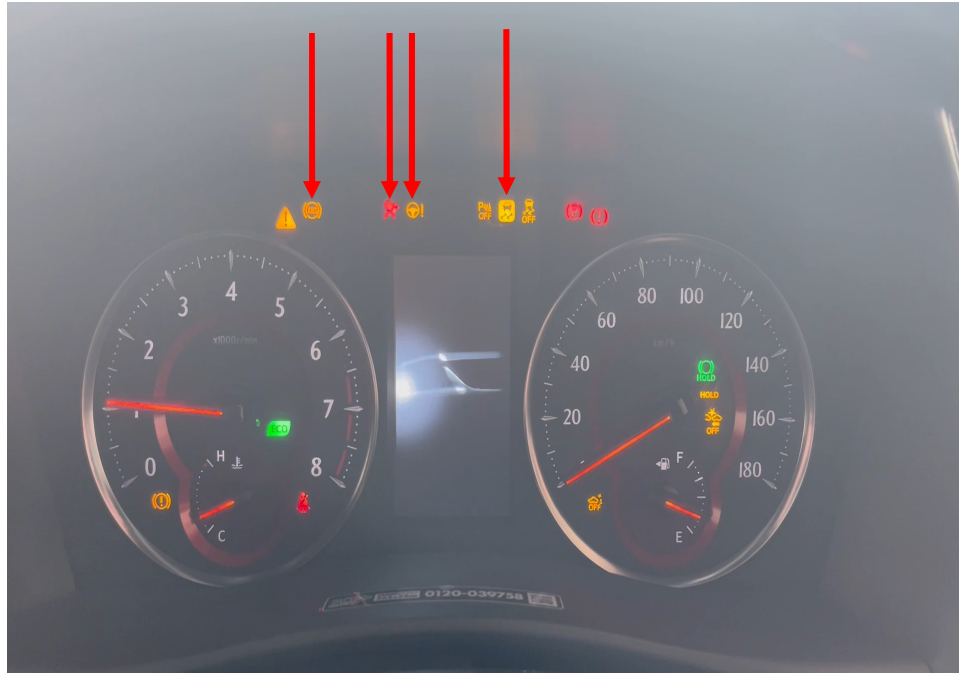
Photo 22 shows the warning lights for the various electronic safety features appearing on the instrument panel of the Motor Car during its self-test when the engine is cranked, in particular the ABS, SRS, EPS, VSC lights (arrowed).

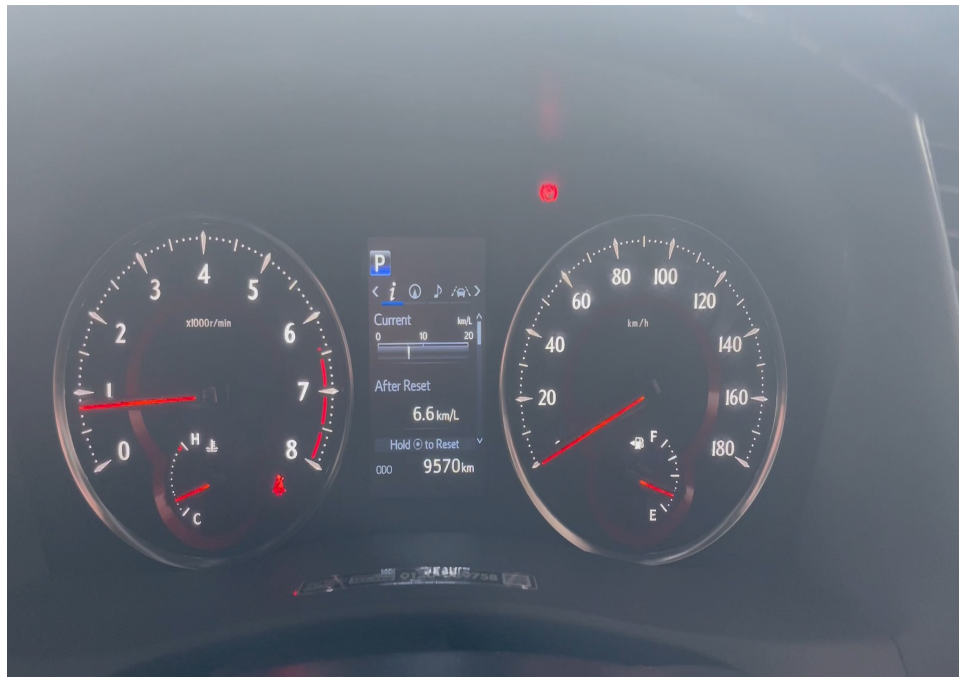
Photo 23 shows the respective warning lights no longer illuminated, indicating that there is no fault detected to the ABS, SRS, EPS, VSC systems of the Motor Car during the self-test. These electronic systems were hence in working condition at the time of my inspection.

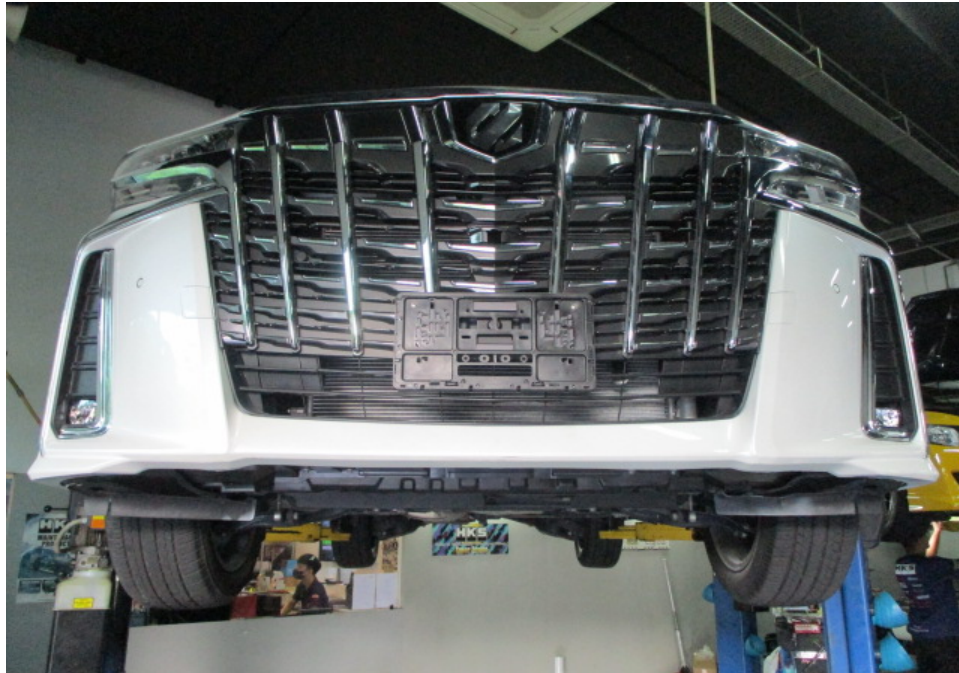
Photo 24 shows the Motor Car hoisted up for checks on its undercarriage. There was no sign(s) or indication(s) of fluid leakage and/or fluid stain(s) on the underside of the Motor Car. The undercarriage components of the Motor Car were also all observed to be intact and secured in an appropriate manner.

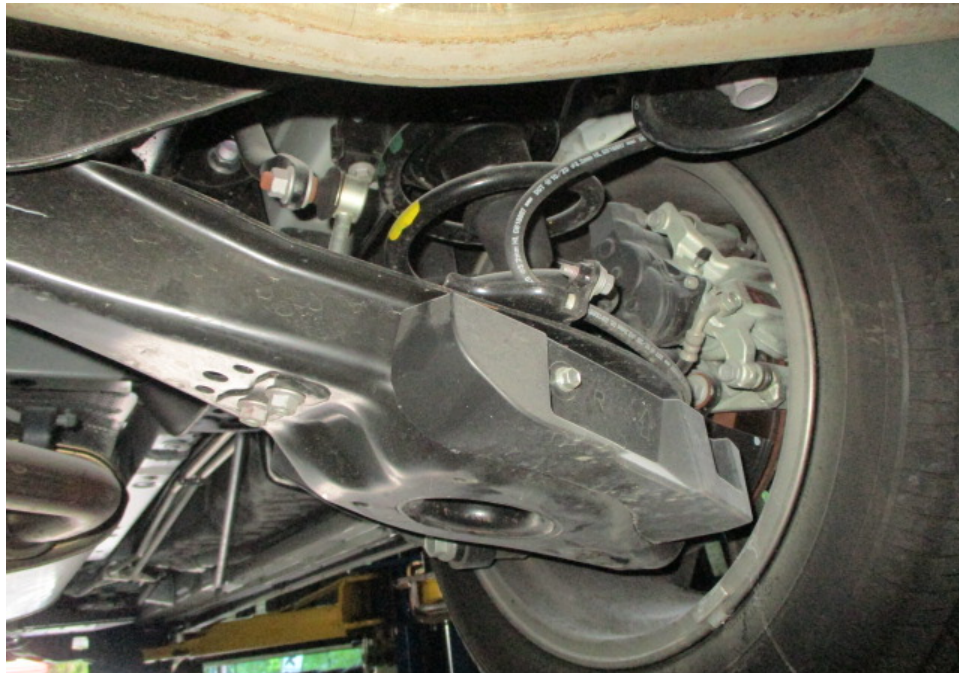
Photo 25 shows a general view of the control arms and linkages at the rear right wheel of the Motor Car. I did not observe any fluid leak and/or fluid stain on the underside of the Motor Car. All of the Motor Car's undercarriage components were observed to be intact and secured in an appropriate manner.

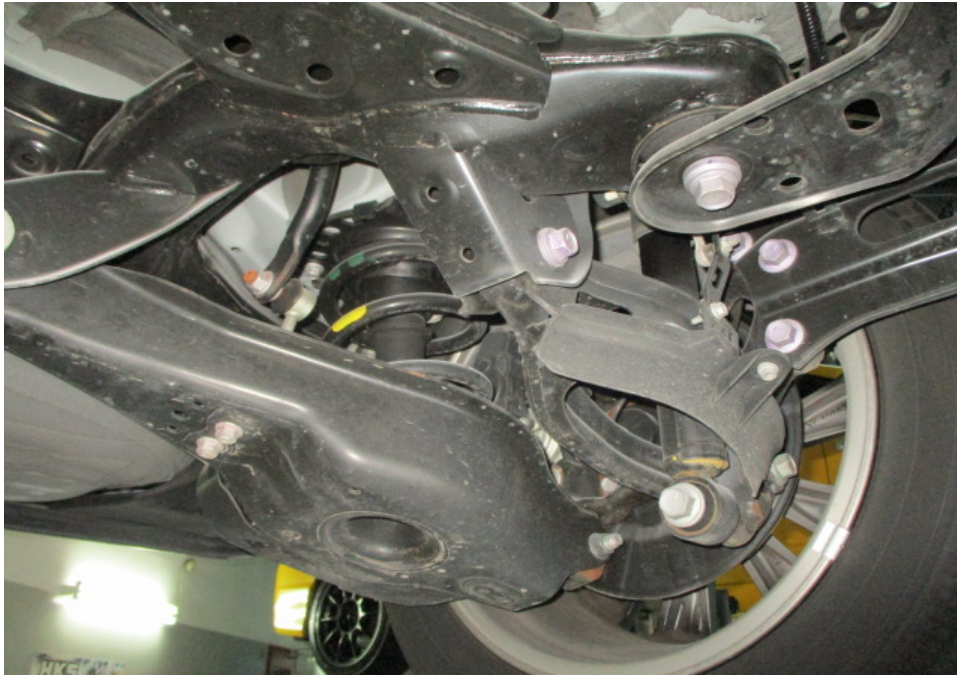
Photo 26 shows a general view of the control arms and linkages at the rear left wheel of the Motor Car. I did not observe any fluid leak and/or fluid stain on the underside of the Motor Car. All of the Motor Car's undercarriage components were observed to be intact and secured in an appropriate manner.

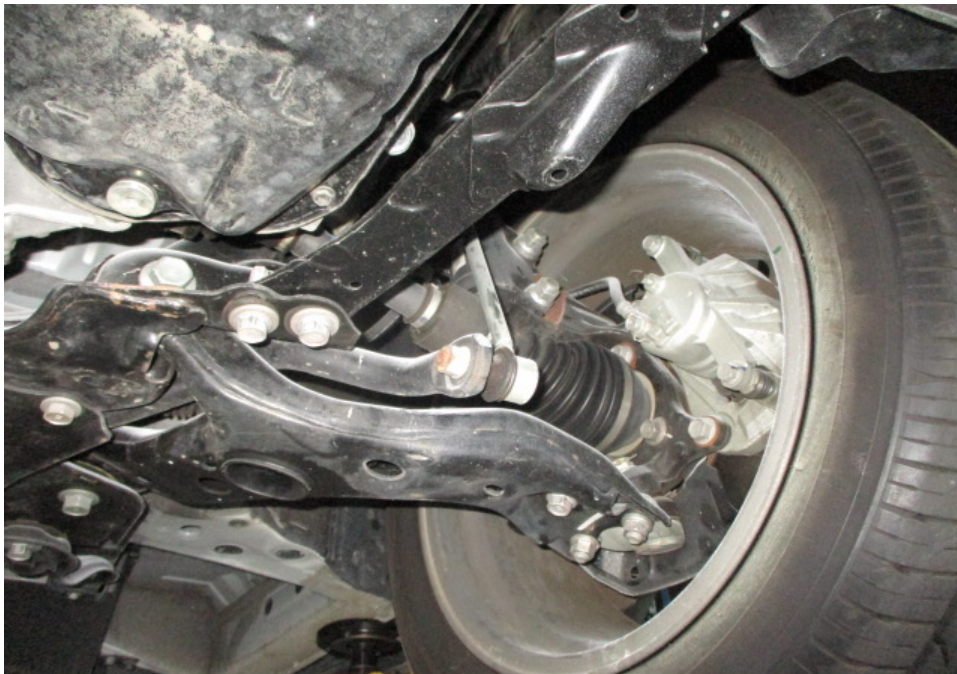
Photo 27 shows the various undercarriage components at the front left wheel of the Motor Car. The mechanical components, control arms and linkages were all found to be intact and secured in an appropriate manner.

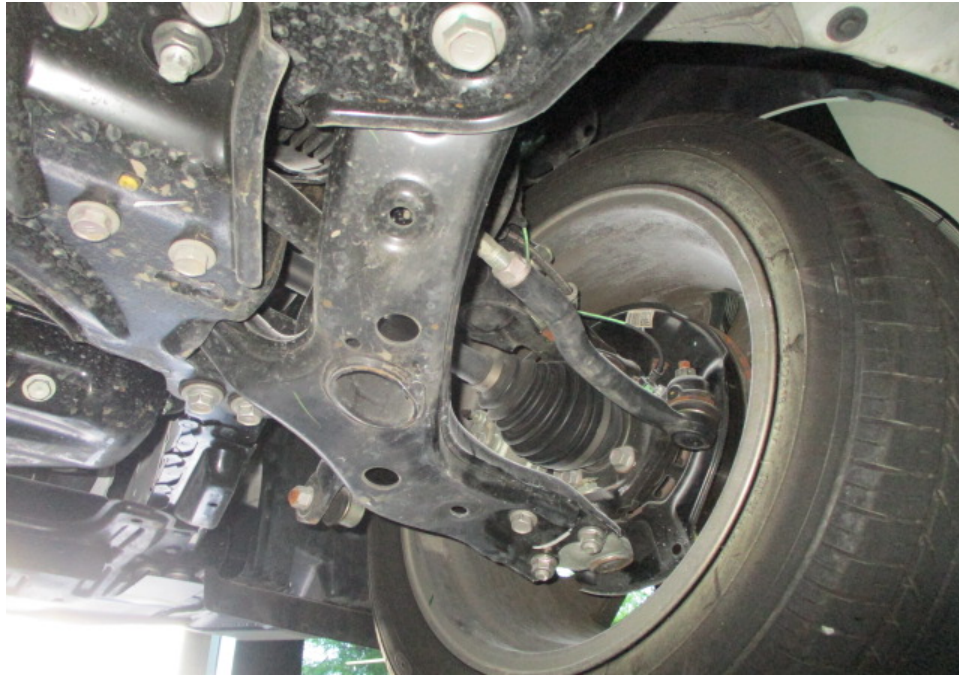
Photo 28 shows the various undercarriage components at the front right wheel of the Motor Car. The mechanical components, control arms and linkages were all found to be intact and secured in an appropriate manner. I also did not observe any fluid leak and/or fluid stain on the underside of the Motor Car.

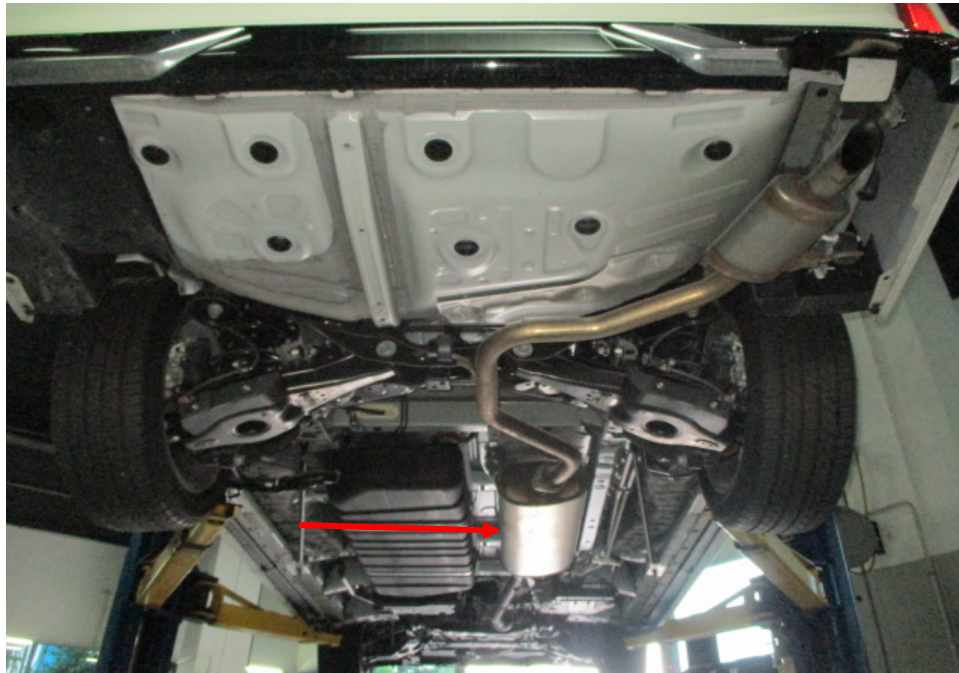
Photo 29 shows the rear section of the Motor Car's exhaust system. My examination of the Motor Car's exhaust system revealed no sign(s) or indication(s) of any cut or weld marks along its exhaust pipes, on its rear muffler, on its centre resonator box (arrowed) and on its catalytic converter.

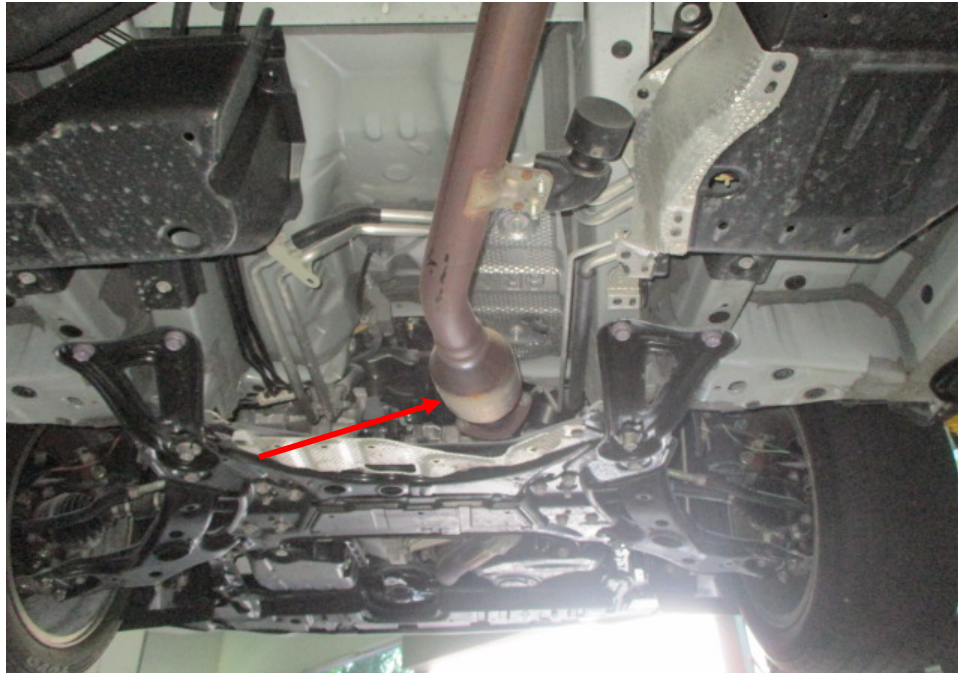
Photo 30 shows the front section of the Motor Car's exhaust system. My examination of the Motor Car's exhaust system revealed no sign(s) or indication(s) of any cut or weld marks along its exhaust pipes, on its rear muffler, on its centre resonator box and on its catalytic converter (arrowed).
