Your Ref: Toyota Alphard
(chassis number AGH309013543)
Our Ref : CI/TP22007012/D

23 July 2022

INSPECTION REPORT OF AN UNREGISTERED TOYOTA ALPHARD MOTOR CAR WITH CHASSIS NUMBER AGH309013543

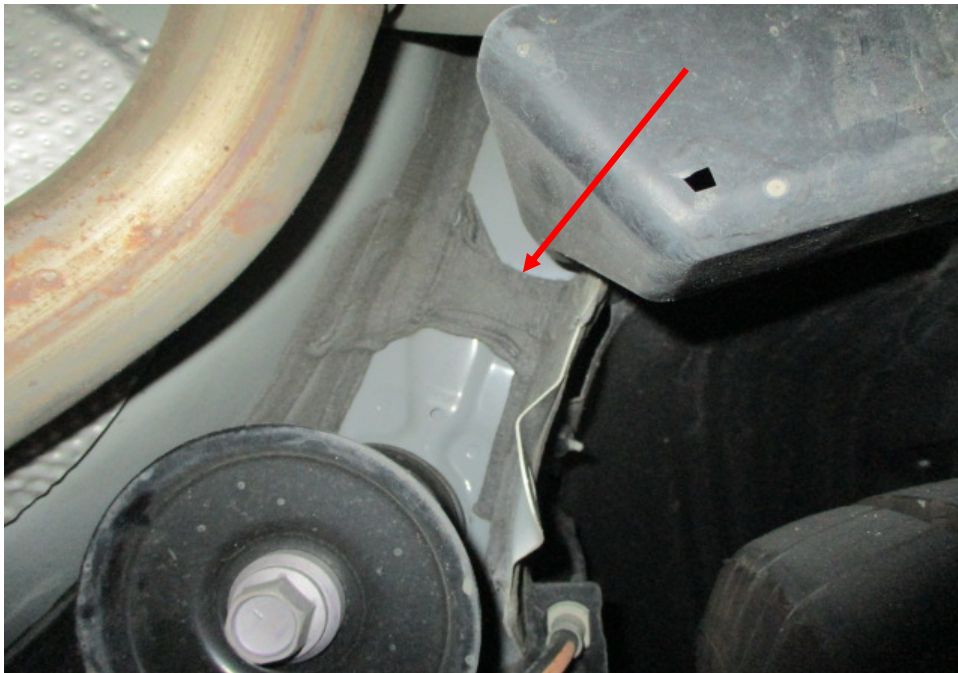
Photo 31 shows the chassis/structural body at the underside rear right of the Motor Car. I did not find any weld marks other than original spot weld marks on the chassis/structural body of the Motor Car. The original factory sealant (arrowed) at the joints along the chassis/structural body was untouched, indicating no work was done on the chassis/structural body of the Motor Car and that the chassis/structural body was originally fitted.

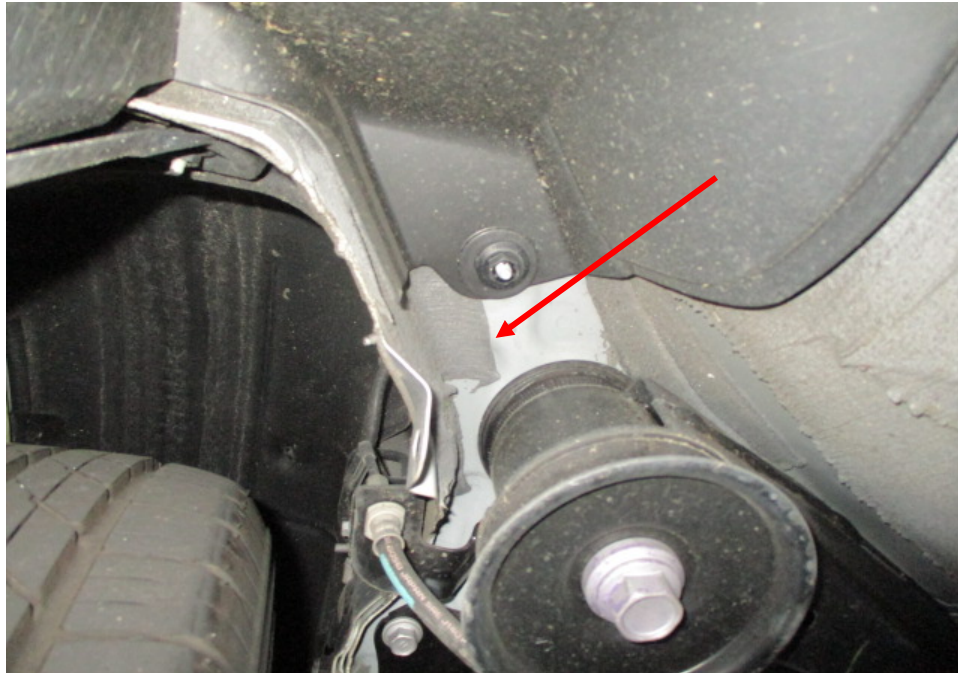
Photo 32 shows the chassis/structural body at the underside rear left of the Motor Car. The original factory sealant (arrowed) at the joints along the chassis/structural body was observed to be untouched. In general, I had found no work was carried out on the chassis/structural body of the Motor Car. The chassis/structural body of the Motor Car was originally fitted.

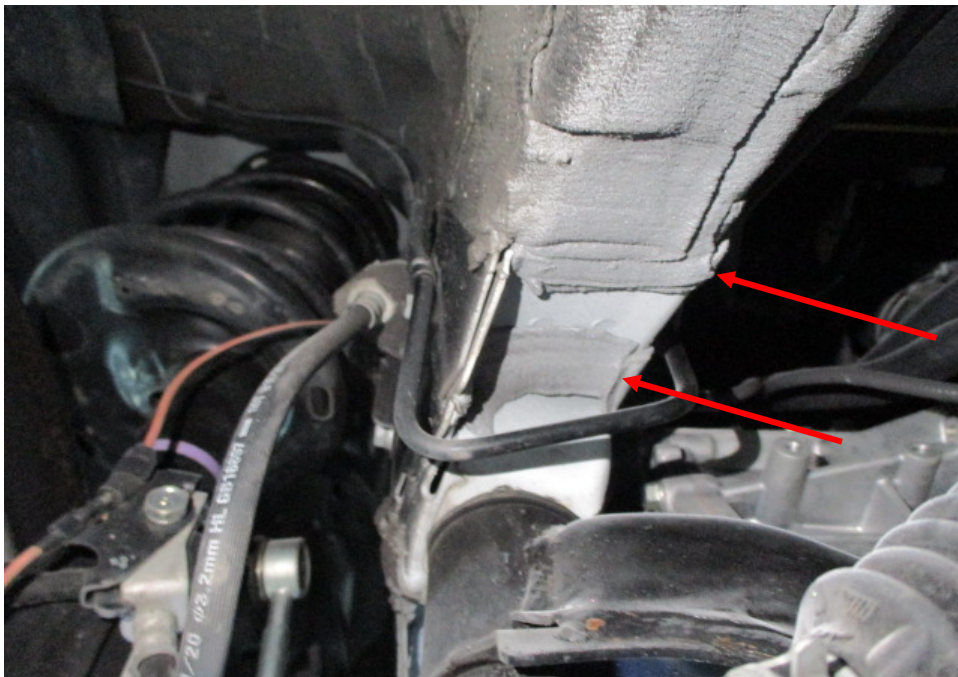
Photo 33 shows the chassis/structural body at the underside front left of the Motor Car. I did not find any weld marks other than original spot weld marks on the chassis/structural body of the Motor Car. The original factory sealant (arrowed) at the joints along the chassis/structural body was untouched, indicating no work was done on the chassis/structural body of the Motor Car and that the chassis/structural body was originally fitted.

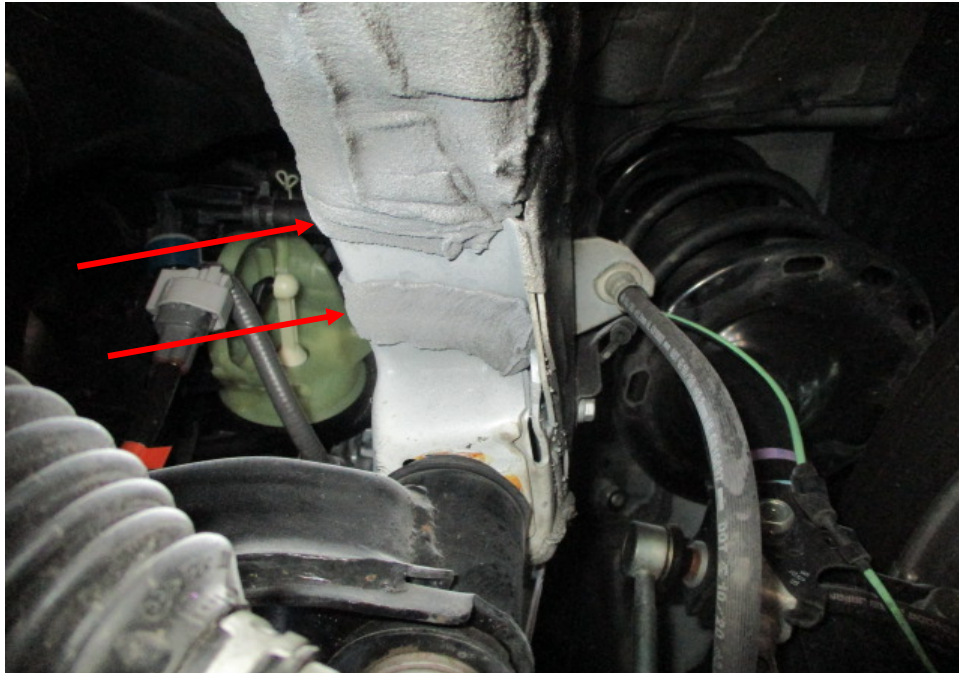
Photo 34 shows the chassis/structural body at the underside front right of the Motor Car. The original factory sealant (arrowed) at the joints along the chassis/structural body was observed to be untouched. In general, I had found no work was carried out on the chassis/structural body of the Motor Car. The chassis/structural body of the Motor Car was originally fitted.

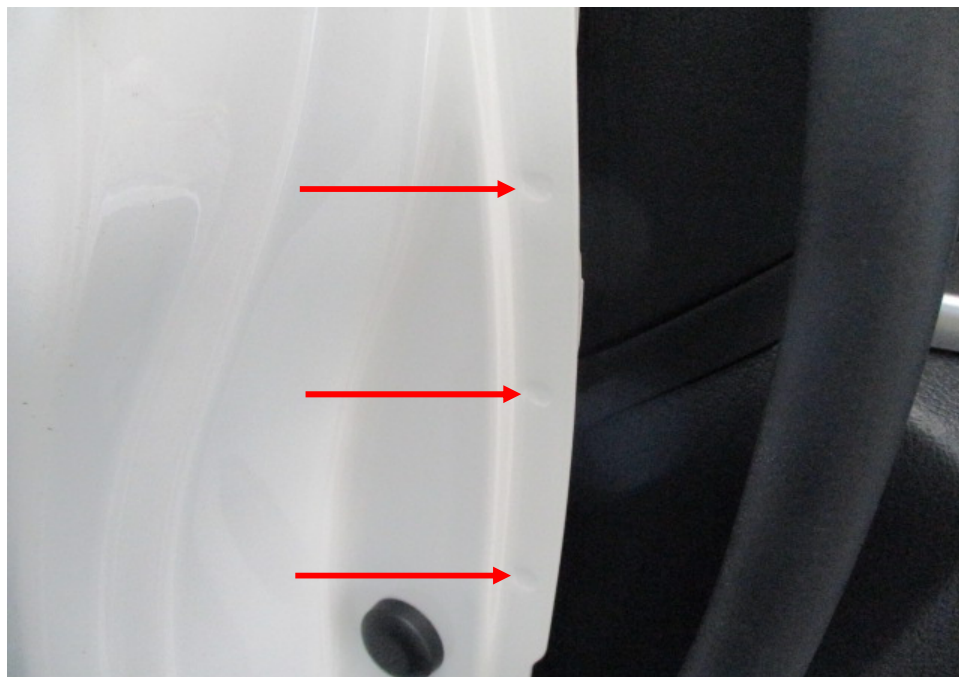
Photo 35 shows the left side "A" pillar of the Motor Car. I did not find any weld marks other than original spot weld marks (arrowed) on the left side "A" pillar of the Motor Car which, indicates that there was no re-welding works carried out. In general, I had found all the non-detachable body panels of the Motor Car to be originally fitted at the time of my inspection.

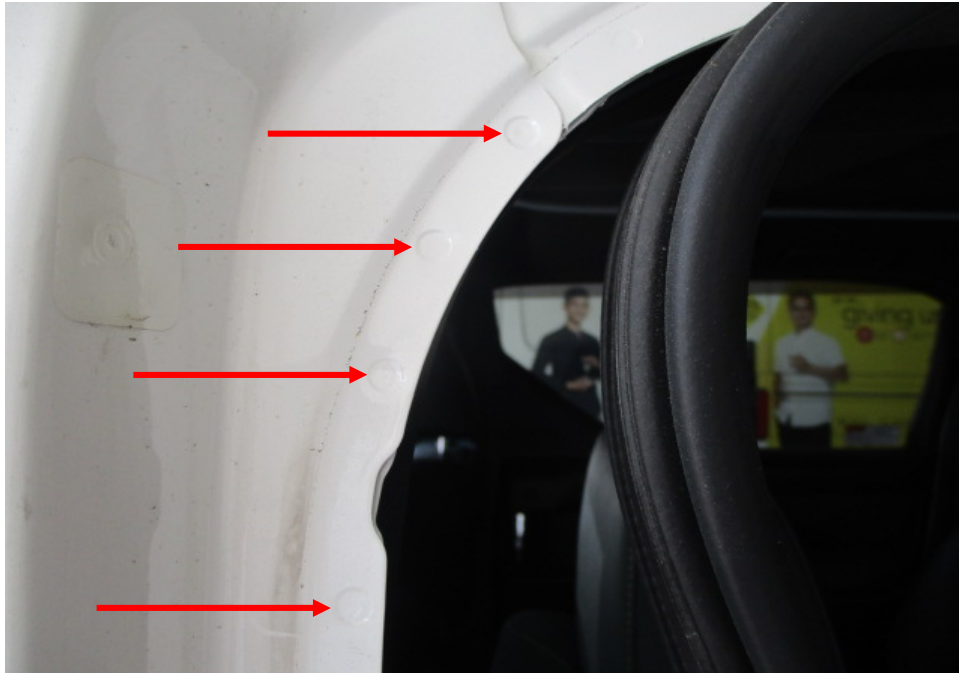
Photo 36 shows the left side “B” pillar of the Motor Car. I did not find any weld marks other than original spot weld marks (arrowed) on the left side “B” pillar of the Motor Car, which indicates that there was no re-welding works carried out. In general, I had found all the non-detachable body panels of the Motor Car to be originally fitted at the time of my inspection.

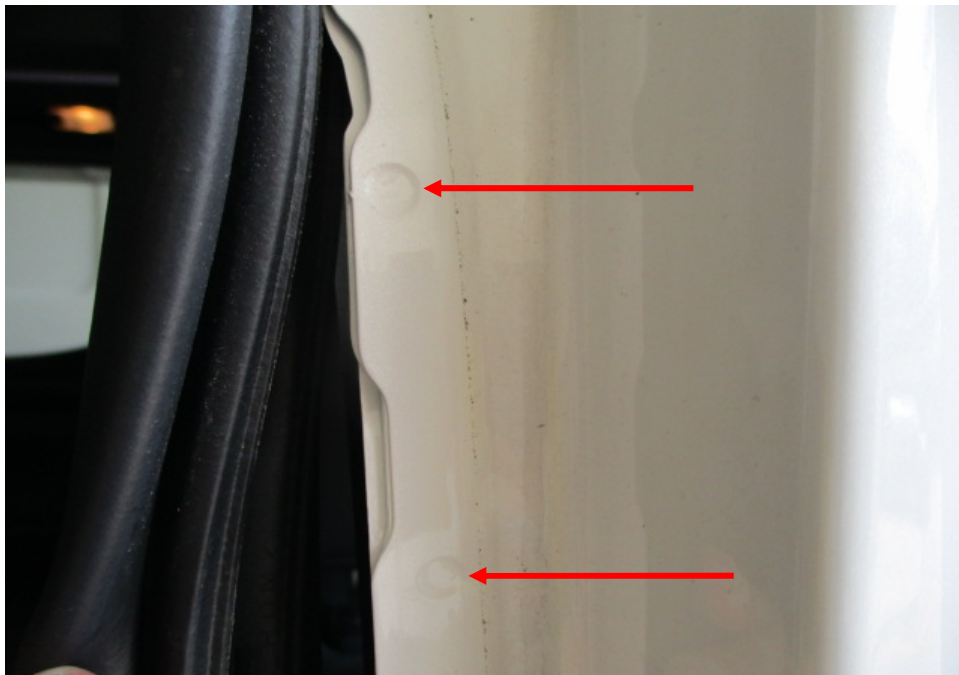
Photo 37 shows the right side “B” pillar of the Motor Car. I did not find any weld marks other than original spot weld marks (arrowed) on the right side “B” pillar of the Motor Car, which indicates that there was no re-welding works carried out. In general, I had found all the non-detachable body panels of the Motor Car to be originally fitted at the time of my inspection.

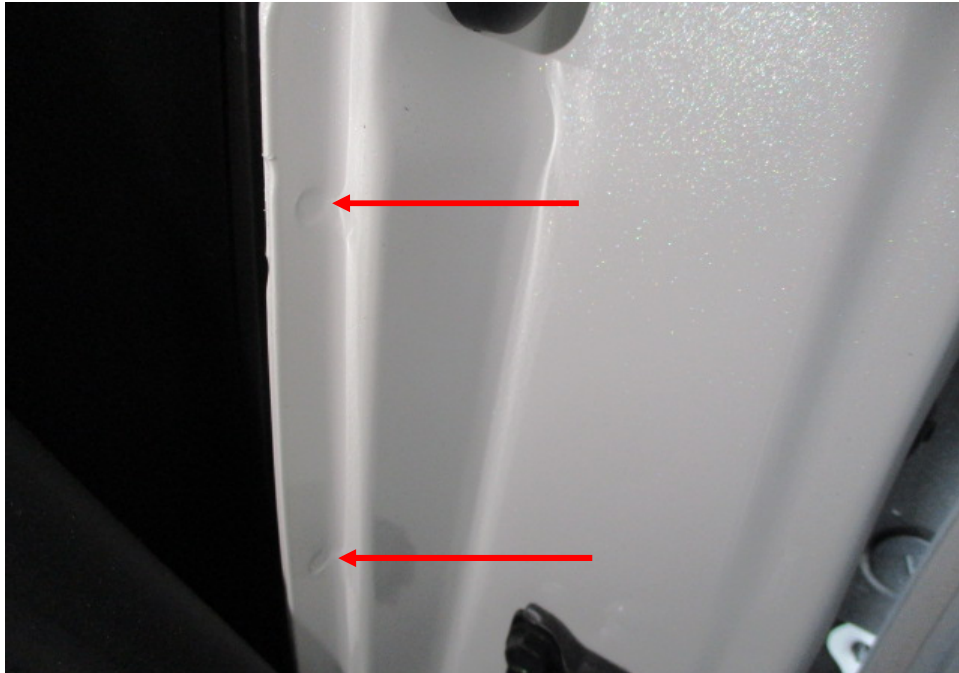
Photo 38 shows the right side "A" pillar of the Motor Car. I did not find any weld marks other than original spot weld marks (arrowed) on the right side "A" pillar of the Motor Car which, indicates that there was no re-welding works carried out. In general, I had found all the non-detachable body panels of the Motor Car to be originally fitted at the time of my inspection.
