**From:** Shiau Chan (LKKAUTO)  
**Sent:** Friday, 25 November 2022 11:35 AM  
**To:** 'Pauline Tham'  
**Cc:** Jenny Lew; Albert Chua; SUR; Bryan Ang (LKKAUTO)  
**Subject:** RE: YREF : SME9965B - DOA 26/07/2022, OREF : SNM22D205205/C02

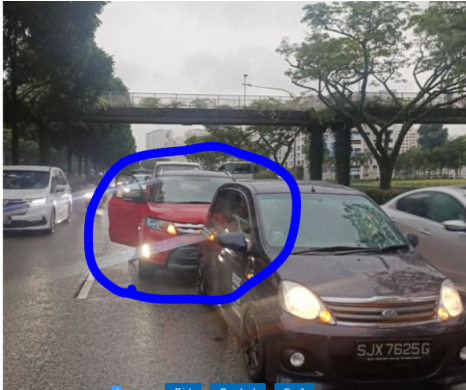
1. Noted that the survey report stated 2 headlamps were damage from the accident.  
However, scene photograph show most most likely only 1 headlamp might be affected

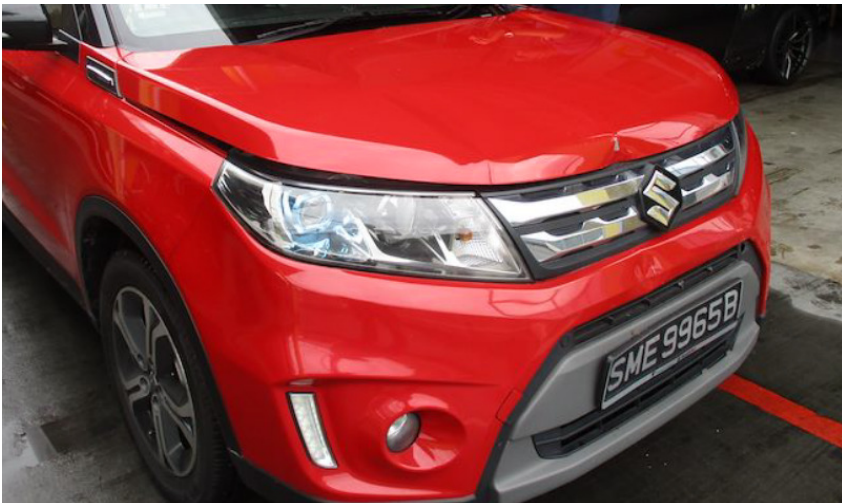
2. Third party front photographs

We would like to check on the repair of the frontal damages consistency

1. Headlamps x 2
2. Aircon condenser

Please help to check with surveyor if the photographs were the same at the time of accident before we check with insured to confirm.
