# **ST Appraisal Services**

Date : 18<sup>th</sup> May 2022

Our Ref : TP / ATP GBC3825C/ 05.08/22

### **DAMAGED VEHICLE (GBC 3825 C) INSPECTION REPORT (WITHOUT PREJUDICE)**

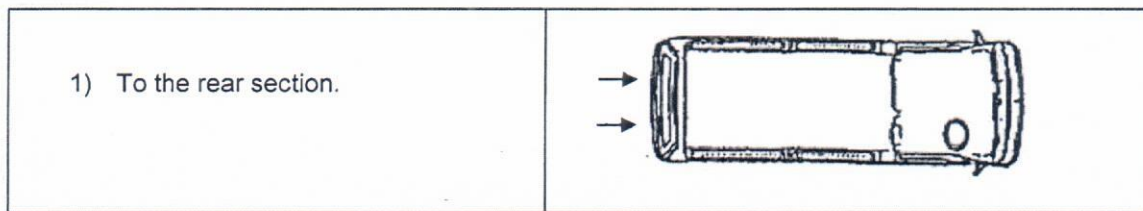
**(E) Point of Impact**

The impact of the collision has damaged/affected the tail gate, rear bumper, rear end panel, tail lamp, parking sensor and etc.

Our adjusted cost of lump sum repair is **\$7,300.00** and an estimated **7** days is required to repair the vehicle. Please refer to the Annex for a detailed account of the cost estimates.
