Your Ref: DMPC2200326H/CT  
Our Ref : CS4/ICS22007322/N

4 August 2022

**TECHNICAL INVESTIGATION REPORT OF FIRE INCIDENT INVOLVING THE  
INSURED VEHICLE SMD 9920K ON 31 JULY 2022**

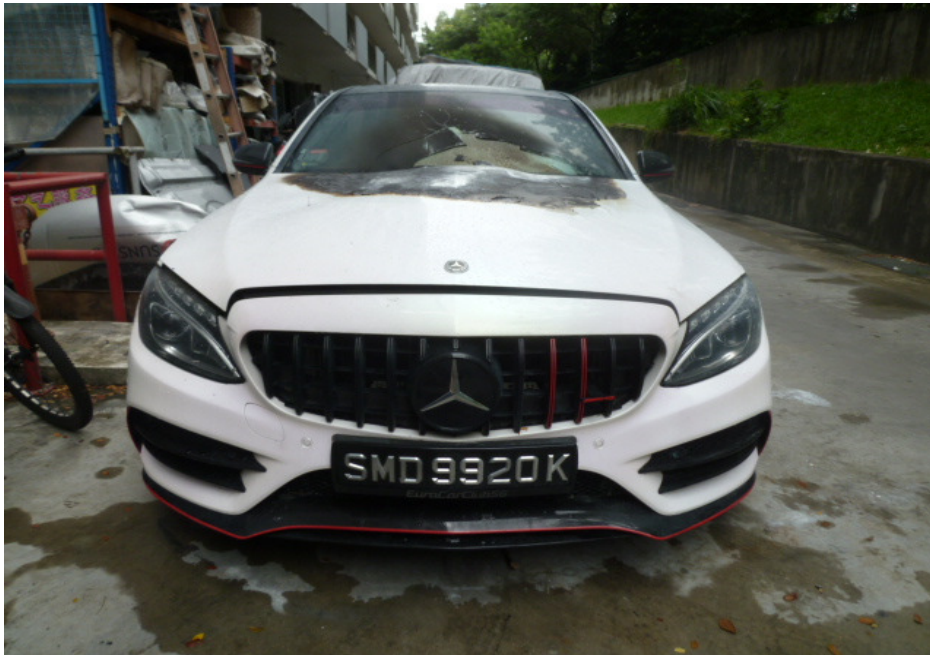
**Photo 1** shows the general view of the frontal portion of the Insured Vehicle at the time of our inspection. The exterior body of the Insured Vehicle had sustained visible fire damage. This included its front windscreen, front bonnet, front windscreen wiper garnish and front windscreen wipers.

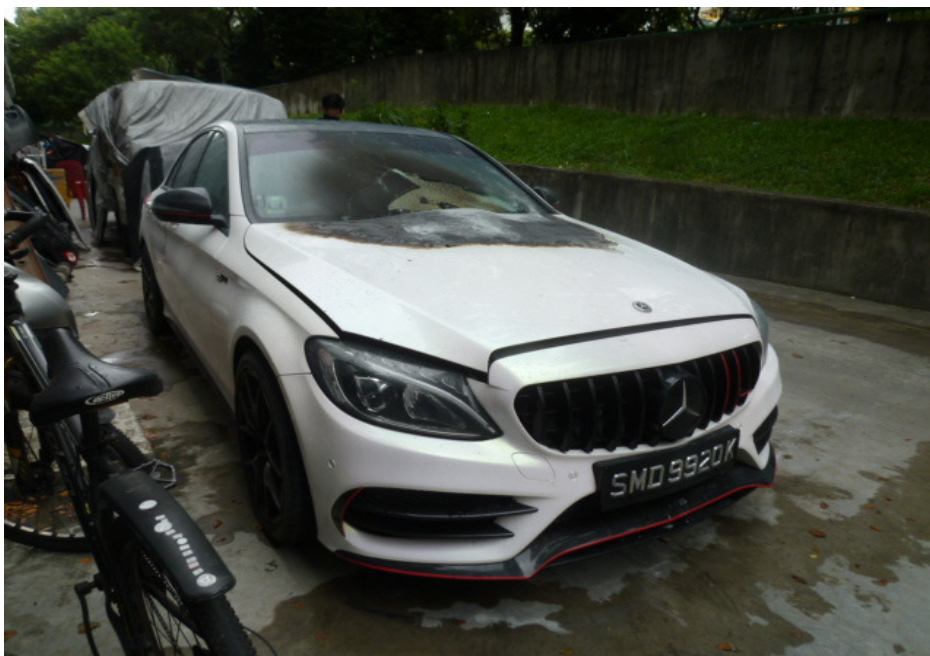
**Photo 2** shows the general view of the right frontal portion of the Insured Vehicle at the time of our inspection. The exterior body of the Insured Vehicle had sustained visible fire damage. This included its front windscreen, front bonnet, front windscreen wiper garnish and front windscreen wipers.

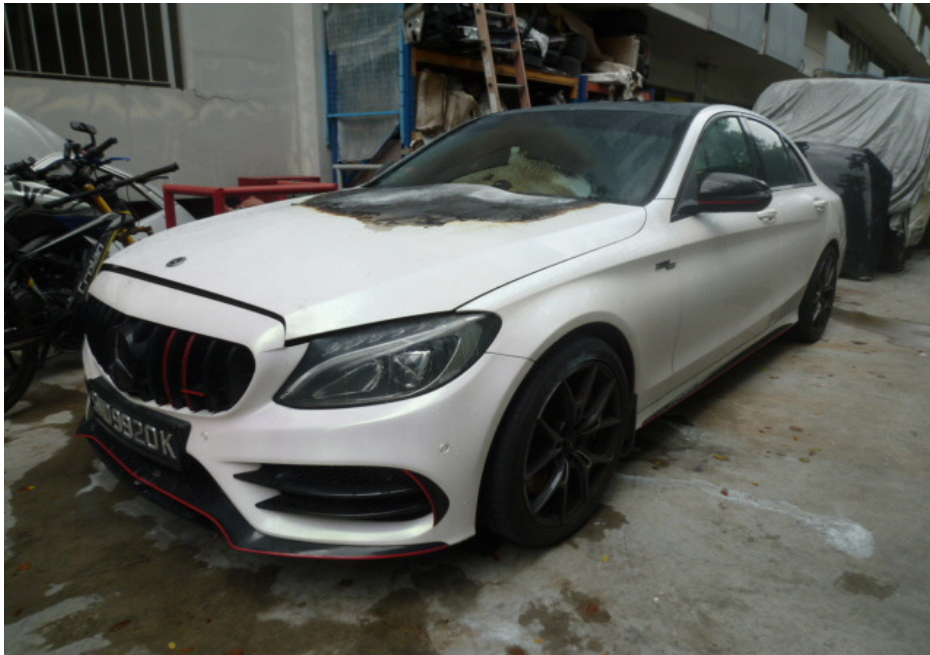
**Photo 3** shows the general view of the left portion of the Insured Vehicle at the time of our inspection. The exterior body of the Insured Vehicle had sustained visible fire damage. This included its front windscreen, front bonnet, front windscreen wiper garnish and front windscreen wipers.

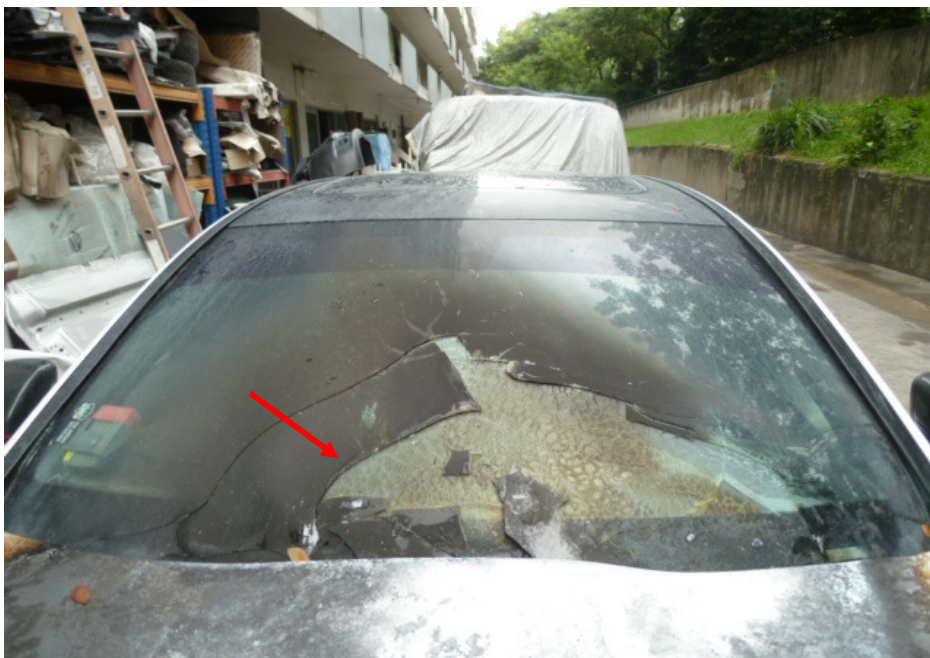
**Photo 4** shows a closer view of the front windscreen of the Insured Vehicle at the time of our inspection. The front windscreen had sustained extensive fire damage (arrowed).

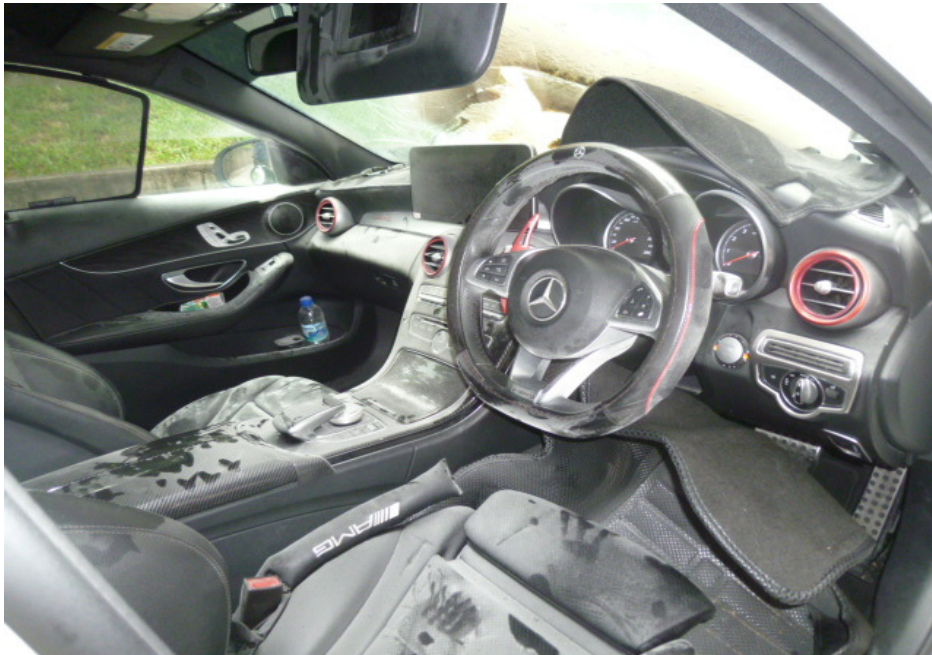
**Photo 5** shows the interior compartment of the Insured Vehicle at the time of our inspection. The interior compartment of the Insured Vehicle was observed to be relatively unaffected by the fire.

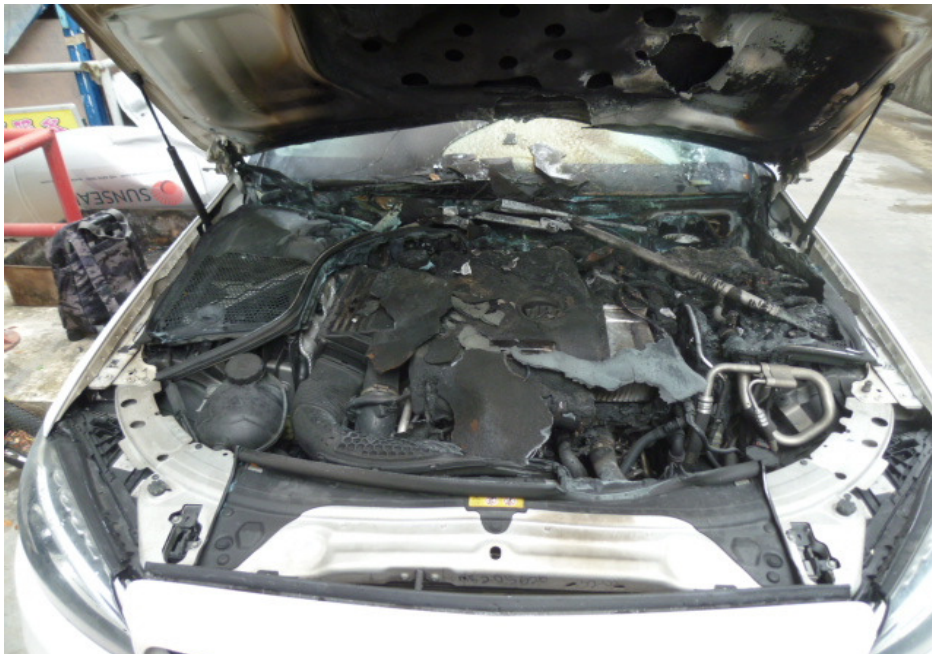
**Photo 6** shows a general view of the engine compartment of the Insured Vehicle at the time of our inspection. Most of the components inside the engine compartment were found to be severely burnt and/or melted as a result of the fire.

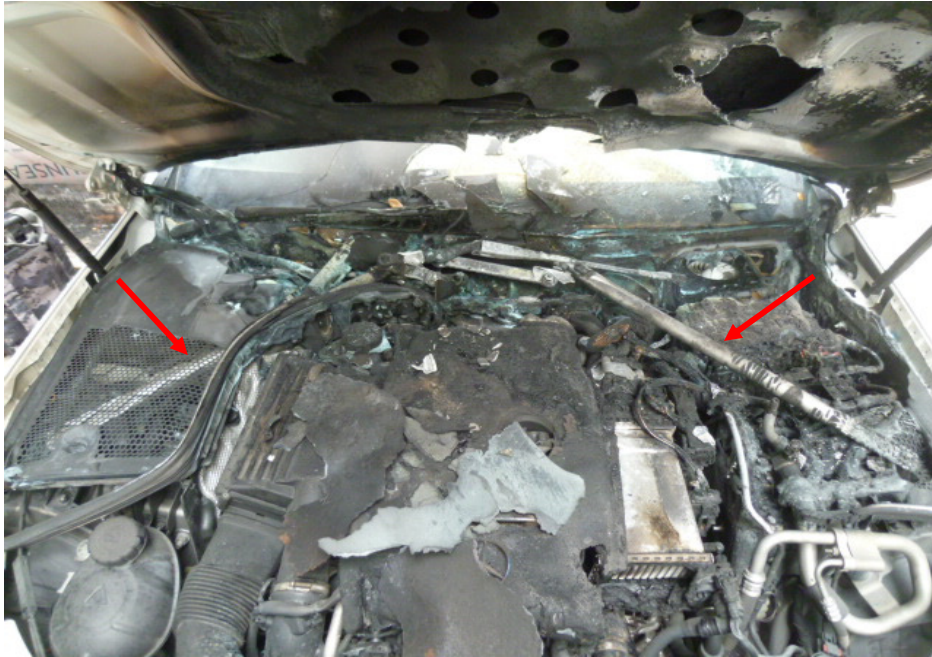
**Photo 7** shows the engine strut bar (arrowed) fitted on the Insured Vehicle. However it had sustained minor fire damage.

32. Although the engine strut bar and alloy rims fitted on the Insured Vehicle were not the standard type for the Insured Vehicle, we are of the view that these parts did not cause and/or contribute to the fire incident.

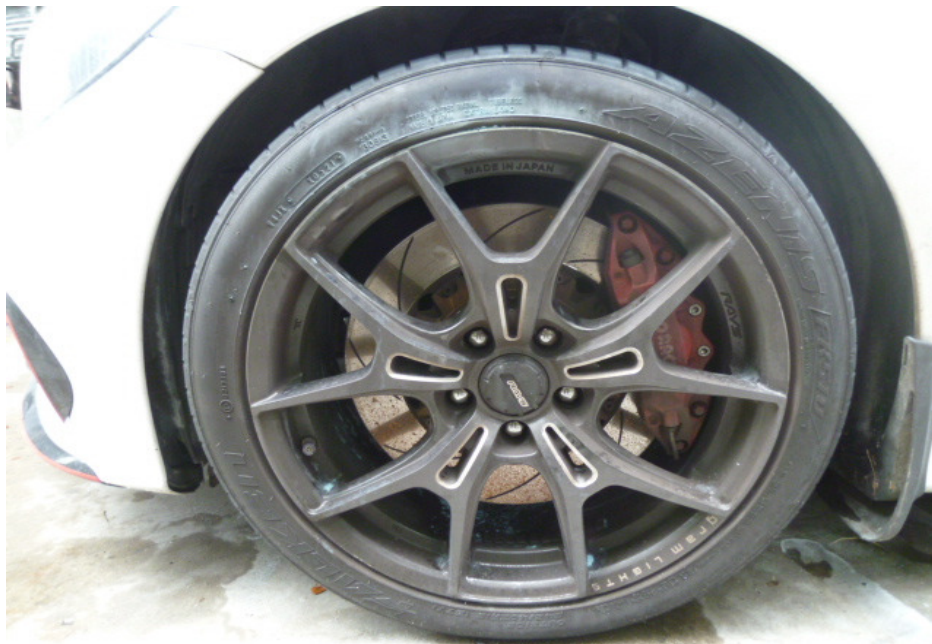
**Photo 8** shows the non-standard rim found to be fitted on the Insured Vehicle at the time of our inspection. The 18- inch alloy rims fitted on the Insured Vehicle were not the standard type for the Insured Vehicle.

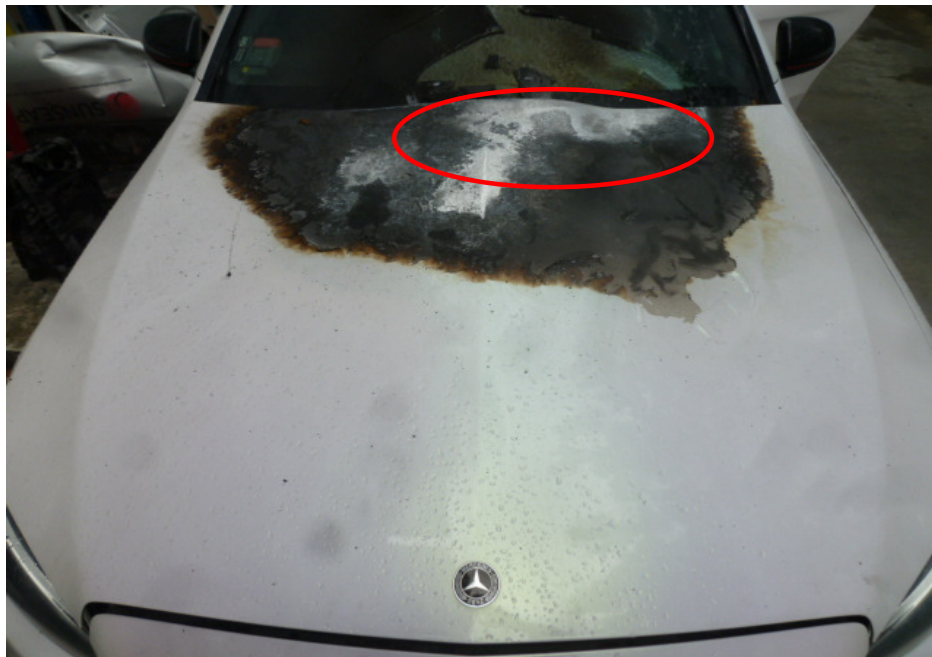
8. For this particular case, the fire appears to have originated within the engine compartment of the Insured Vehicle, somewhere around the rear centre portion of the engine compartment. This can be determined from the whitish burn marks on the rear centre portion of the front bonnet of the Insured Vehicle and also the rust that had developed on the underside of the front bonnet, at the bottom centre portion.

9. The whitish burn marks are a result of exposure to prolonged heat intensity. Rust would normally start to develop around these areas soon after a fire as prolonged exposure to high heat intensity usually causes steel/metal material body parts to be exposed to natural environmental condition. The rust that had developed on the underside of the front bonnet, around the bottom centre portion, is an indication that the rear centre portion of the engine compartment had sustained exposure to prolonged high heat intensity. See photos 9 - 12 below.

**Photo 9** shows the burn pattern and whitish burn marks that were found on the rear centre portion of the front bonnet of the Insured Vehicle (circled). Such whitish burn marks are a result of exposure to prolonged heat intensity, which may indicate where the fire had started. Rust would also begin to develop on these areas soon after the fire.

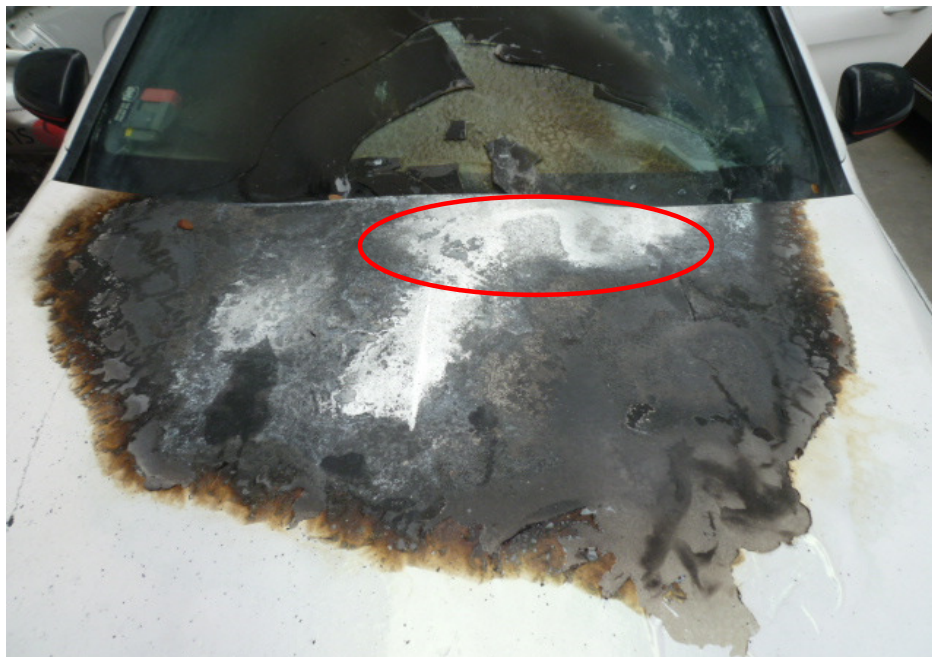
**Photo 10** shows a closer view of the burn pattern and whitish burn marks that were found on the rear centre portion of the front bonnet of the Insured Vehicle (circled).

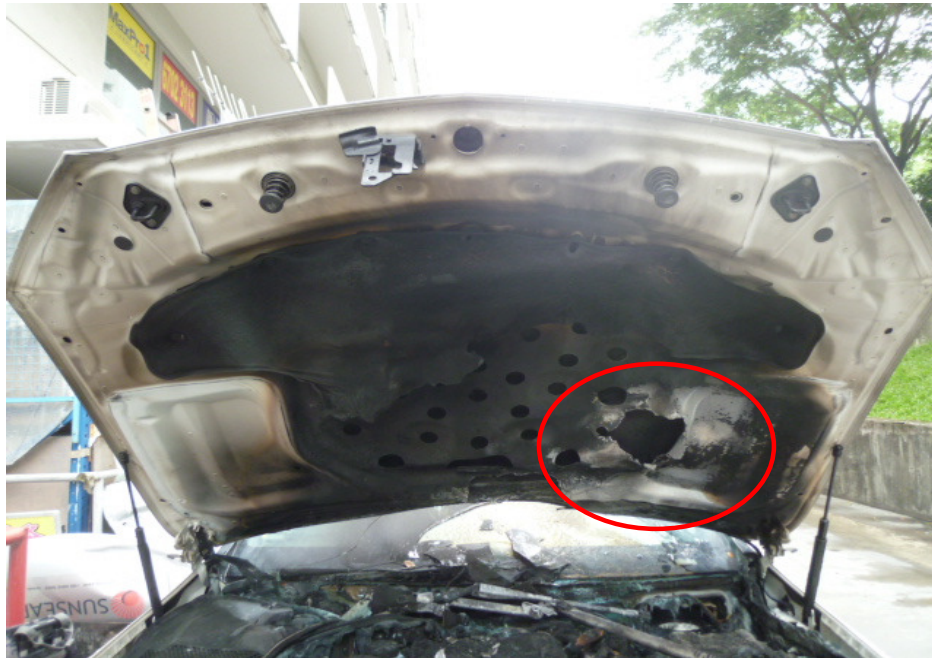
**Photo 11** shows the rust that had developed on the underside of the front bonnet, around the bottom centre portion (circled). The development of rust is an indication that this area was subjected to prolonged exposure to high heat intensity, which had caused the steel/metal material of the front bonnet to be exposed to natural environmental condition. Hence the fire to the Insured Vehicle can be determined to have originated towards the rear centre portion of the engine compartment.

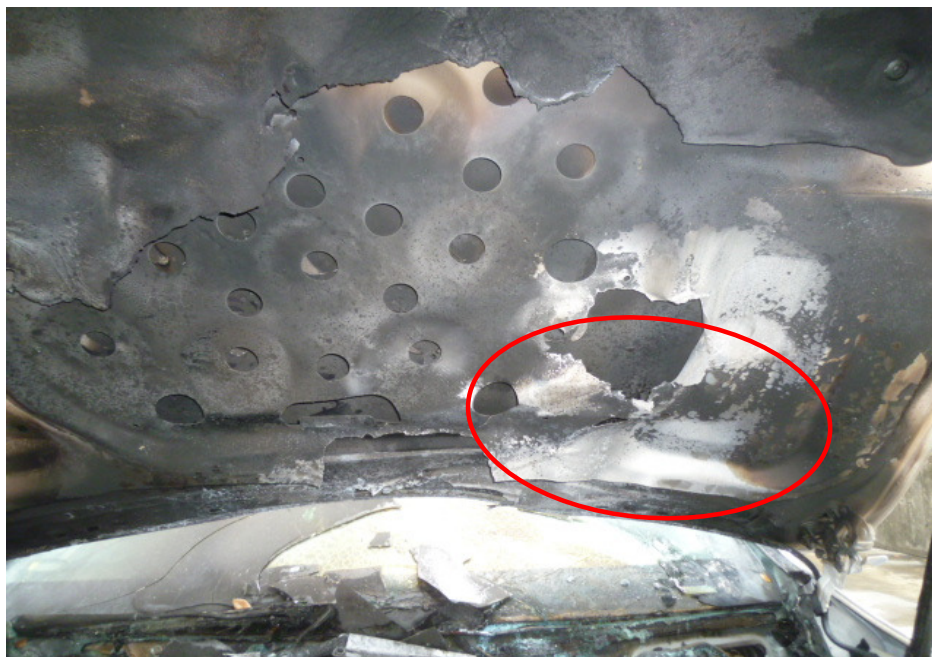
**Photo 12** shows a closer view of the rust that had developed on the underside of the front bonnet, around the bottom centre portion (circled).

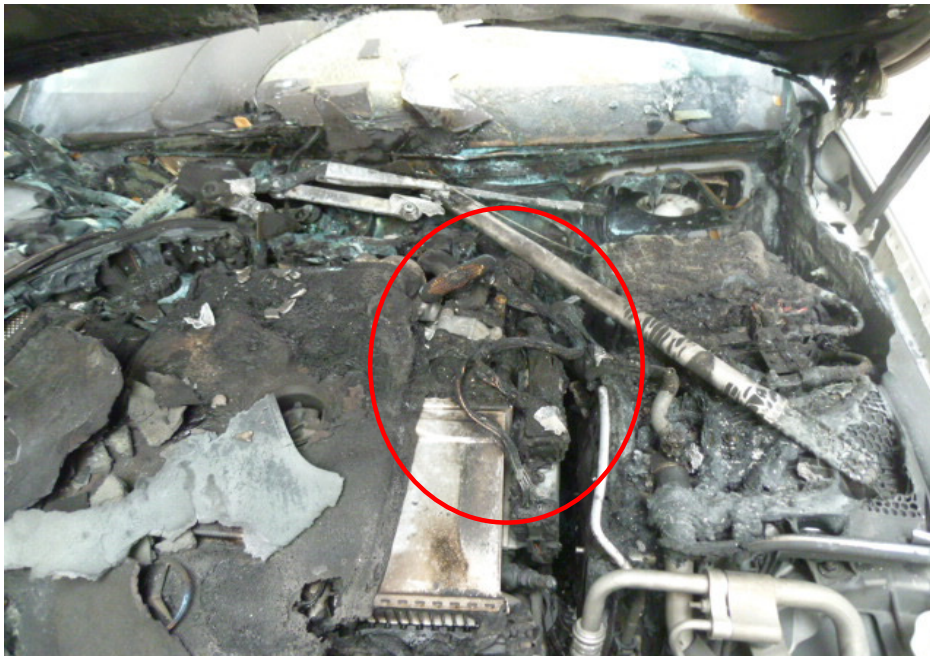
10. Upon closer examination of the rear centre portion of the engine compartment which was where the fire to the Insured Vehicle had likely started, we had found several stretches of wirings with greenish residue. These wirings were original factory fitted wirings leading from the Engine Control Module (ECM) of the Insured Vehicle. The presence of greenish residue indicates internal heating of copper wires, a sign of an electrical short circuit occurring. The greenish residue is normally left behind from oxidation as a result of chemical reaction involving the copper wires. This physical evidence would appear to suggest that the cause of fire to the Insured Vehicle could have possibly been due to electrical in nature. See photos 13 – 17 below.

**Photo 13** shows the wirings around the rear centre portion of the engine compartment which is near to the vicinity where the fire to the Insured Vehicle had likely started. We observed greenish residue on the wirings leading from the Engine Control Module (ECM) of the Insured Vehicle (circled). The presence of greenish residue indicates internal heating of copper wires, a sign of an electrical short circuit occurring. The greenish residue is normally left behind from oxidation as a result of chemical reaction involving the copper wires.

29. Having investigated and technically analysed the damages of burnt nature to the Insured Vehicle, we are of the view that the cause of fire to the Insured Vehicle was of electrical in nature. For this particular case, the fire had originated along the wirings inside the engine compartment, somewhere around the rear centre portion of the engine compartment. The wirings were original factory fitted wirings leading from the Engine Control Module (ECM) of the Insured Vehicle.

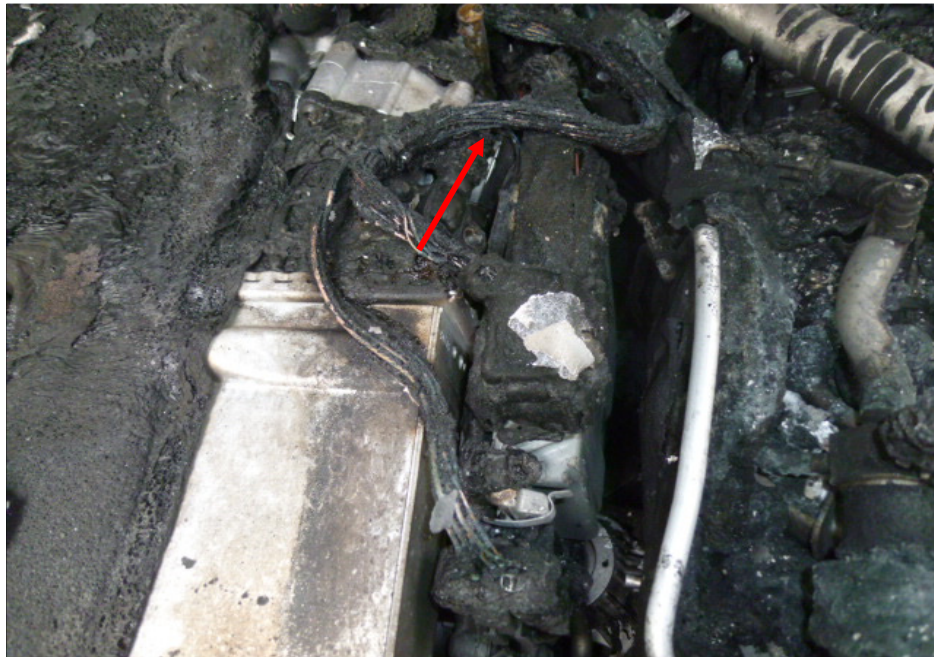
**Photo 14** shows a closer view of the greenish residue on some of the burnt wirings leading from the ECM (arrowed).

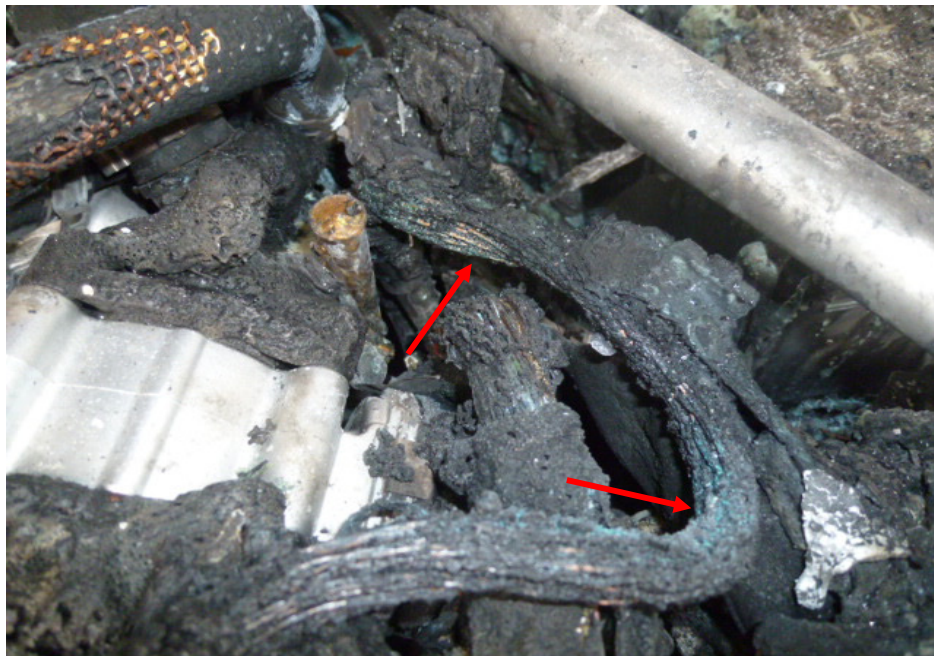
**Photo 15** shows a closer view of the greenish residue on the wirings leading from the ECM of the Insured Vehicle (red arrows). The presence of such greenish residue suggests occurrence of an electrical short circuit.

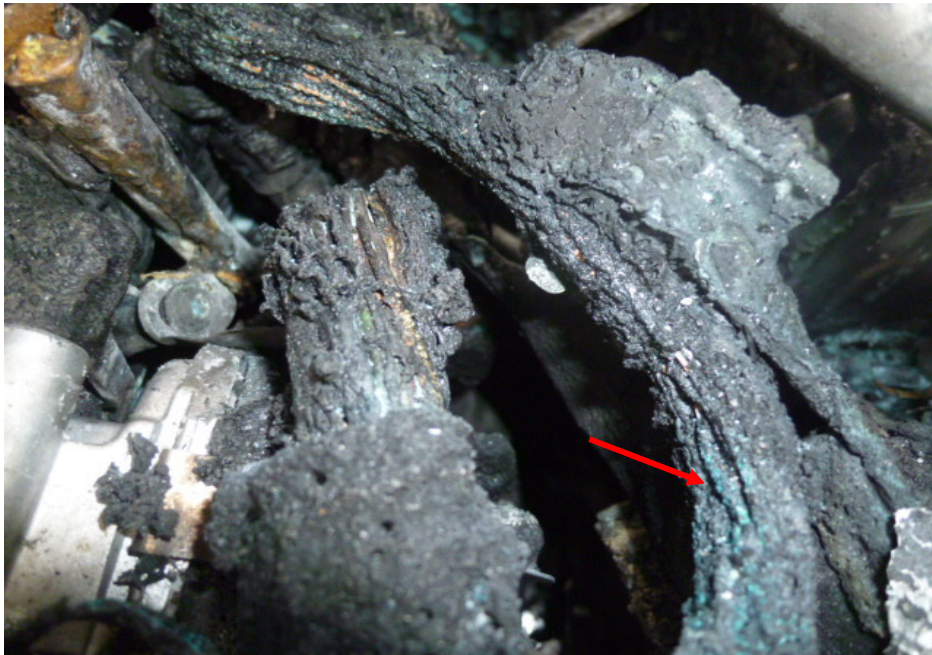
**Photo 16** shows a close up view of the greenish residue on the wirings leading from the ECM of the Insured Vehicle (red arrows). The presence of such greenish residue suggests occurrence of an electrical short circuit.

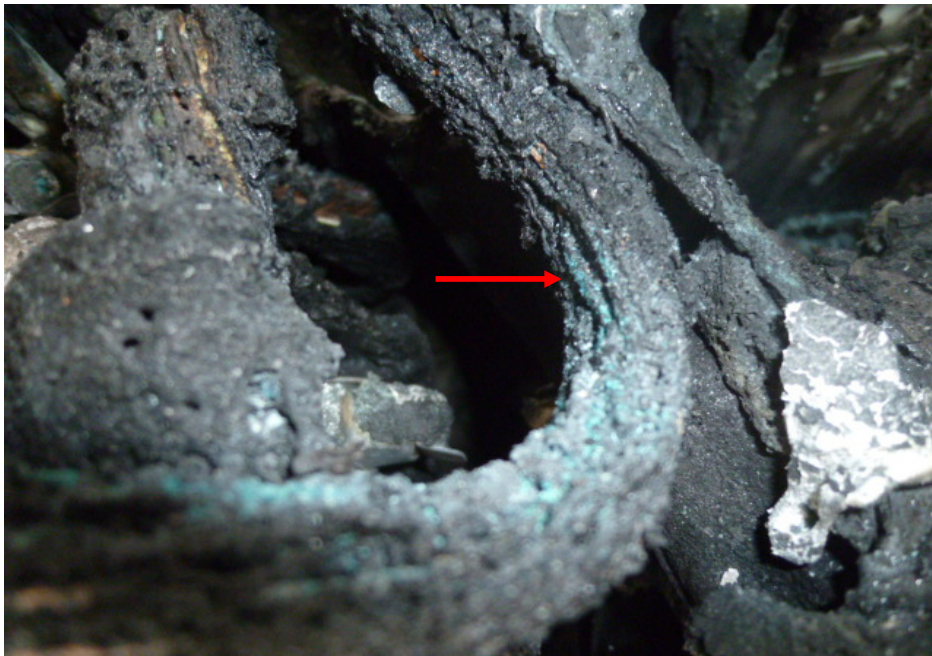
**Photo 17** shows a close up view of the greenish residue on the wirings leading from the ECM of the Insured Vehicle (red arrows). The presence of such greenish residue suggests occurrence of an electrical short circuit.

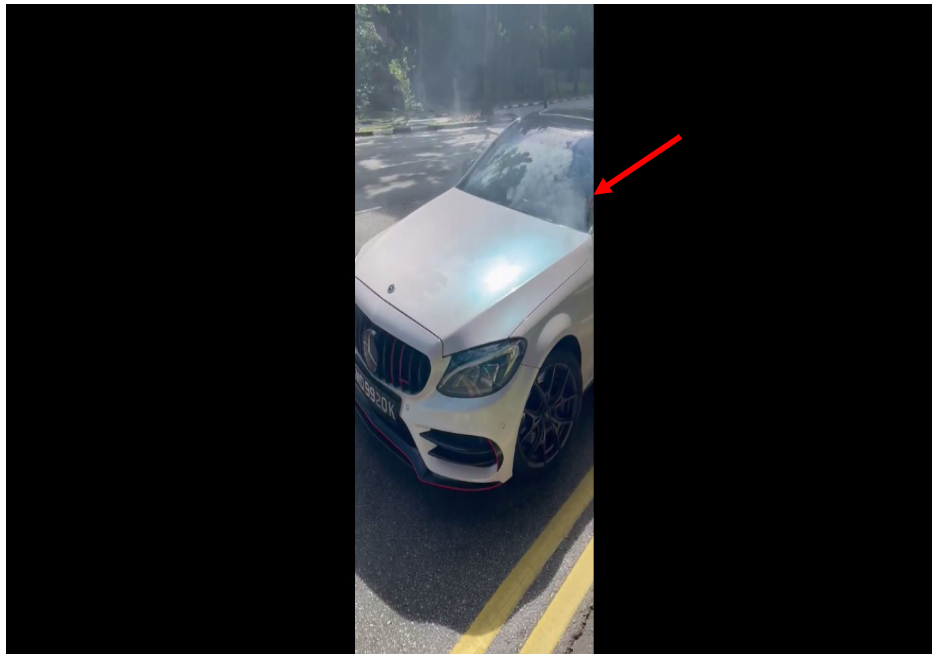
**Photo 18** shows a screenshot taken from the video recording that was provided by Mr Song. The Insured Vehicle could be seen with white smoke emitting from the rear centre portion of the front bonnet (arrowed).

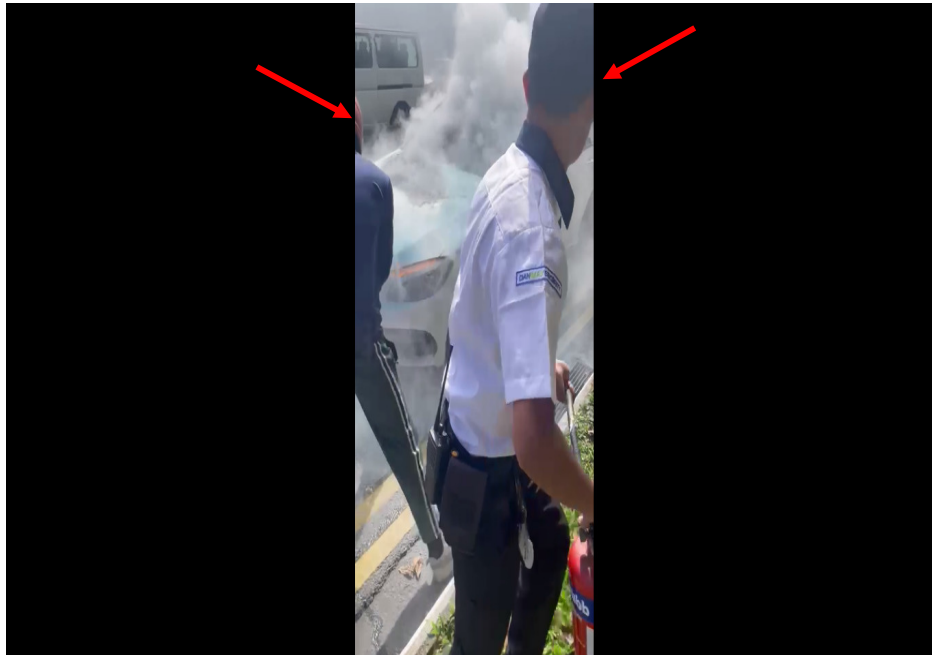
**Photo 19** shows a screenshot taken from the video recording that was provided by Mr Song. In general, the information that could be gathered from this screenshot had corresponded to the events that were related to us by Mr Song which is the delivery rider and condo security guard were attempting to put out the fire to the Insured Vehicle with fire extinguishers (arrowed).

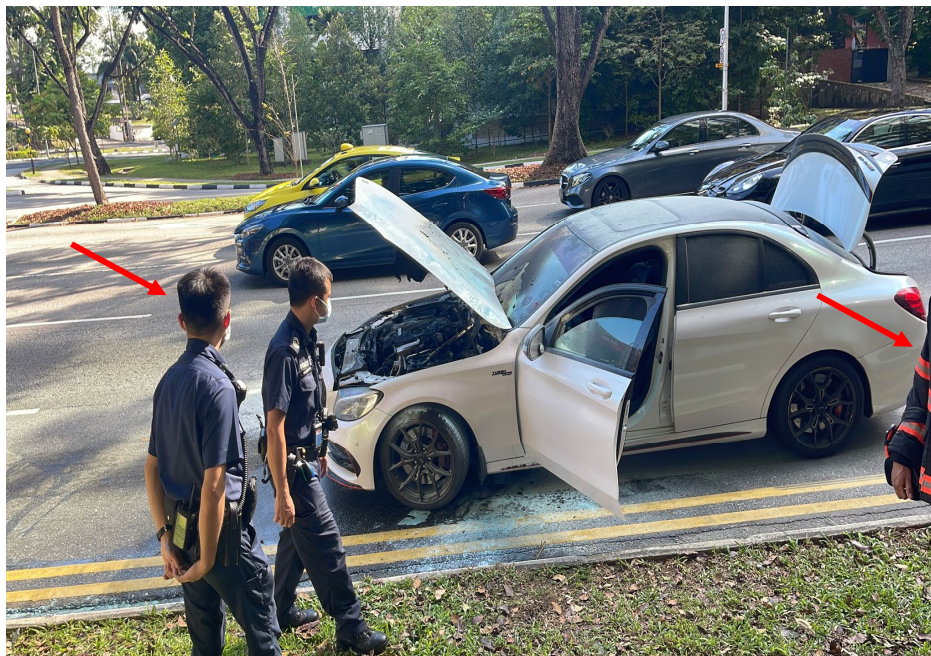
**Photo 20** shows the Insured Vehicle after the fire was extinguished. In general, the information that could be gathered from this photograph had corresponded to the events that were related to us by Mr Song which is the police and SCDF had responded to the incident (arrowed).

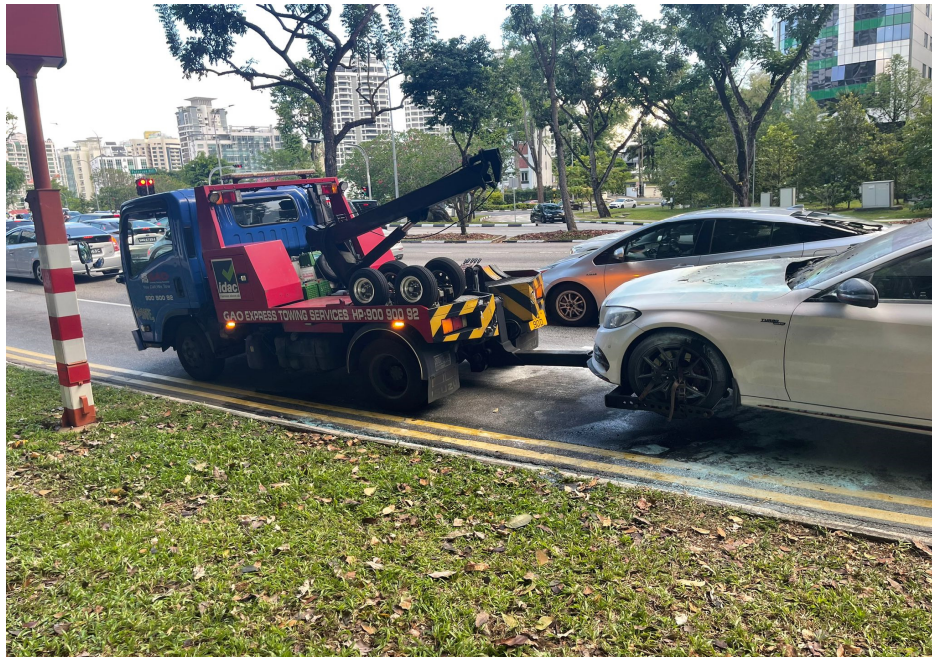
**Photo 21** shows the Insured Vehicle being prepped to be towed to YTA post-incident. The extent of fire damage was similar to what we observed when we inspected the Insured Vehicle. The background seen from the photograph had also corresponded to the incident occurring along Paterson Hill.

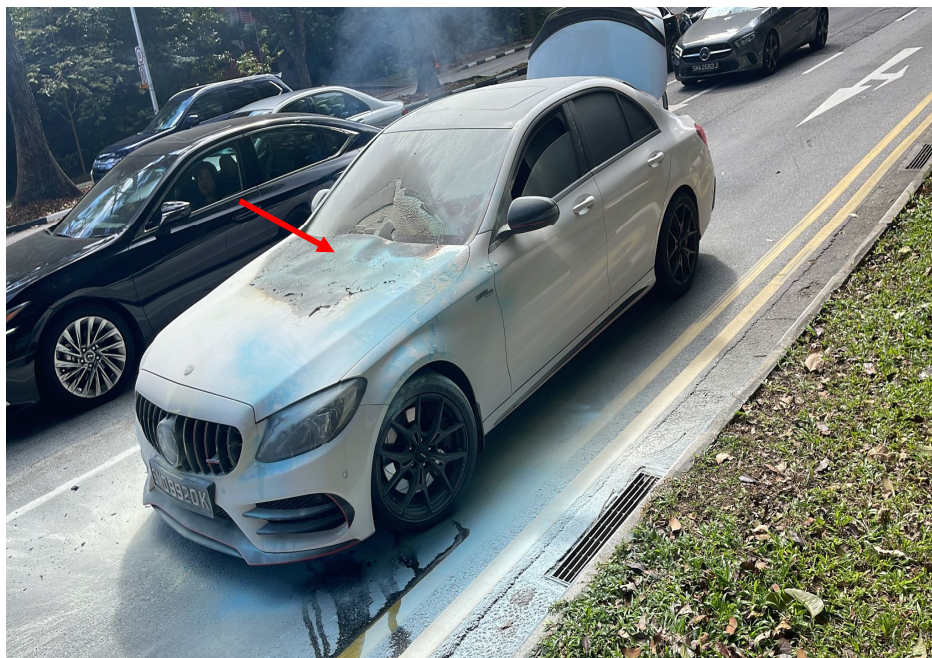
**Photo 22** shows the Insured Vehicle at the incident location after the fire was extinguished. The severity of damage of the frontal portion had corresponded to the events that were related to us by Mr Song, which is the fire had started from the engine compartment of the Insured Vehicle (arrowed).
