Your Ref: DMPC2200326H/CT
Our Ref : CS4/ICS22007322/N

4 August 2022

**TECHNICAL INVESTIGATION REPORT OF FIRE INCIDENT INVOLVING THE
INSURED VEHICLE SMD 9920K ON 31 JULY 2022**

Vehicle Registration No.	: SMD 9920K
Make / Model	: MERCEDES BENZ C200 AMG A
Chassis No	: WDD2050422R171783
Year of Registration	: May 2017
Mileage	: N.A (battery melted)

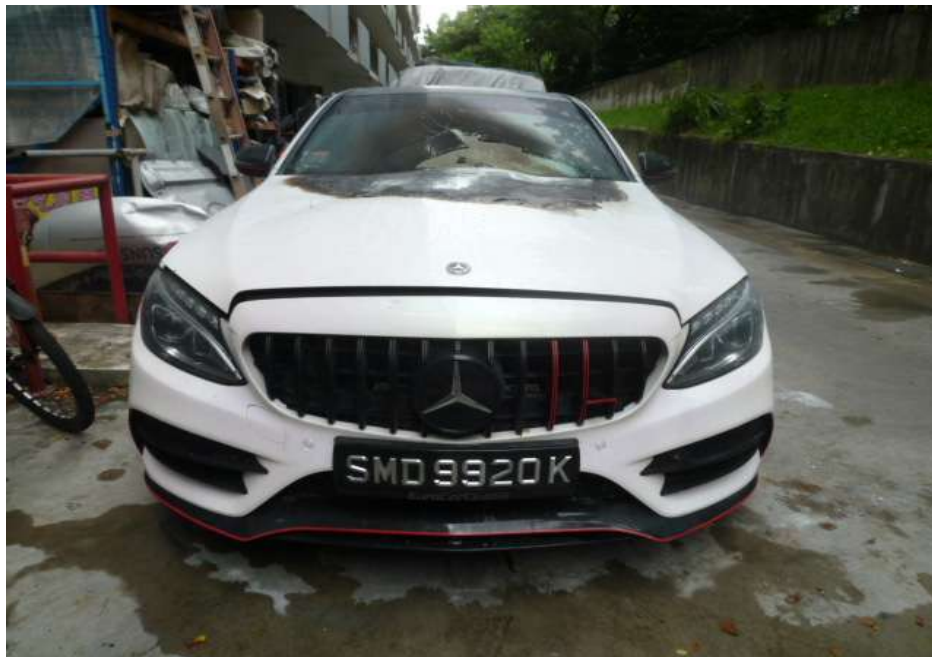
Photo 1 shows the general view of the frontal portion of the Insured Vehicle at the time of our inspection. The exterior body of the Insured Vehicle had sustained visible fire damage. This included its front windscreen, front bonnet, front windscreen wiper garnish and front windscreen wipers.

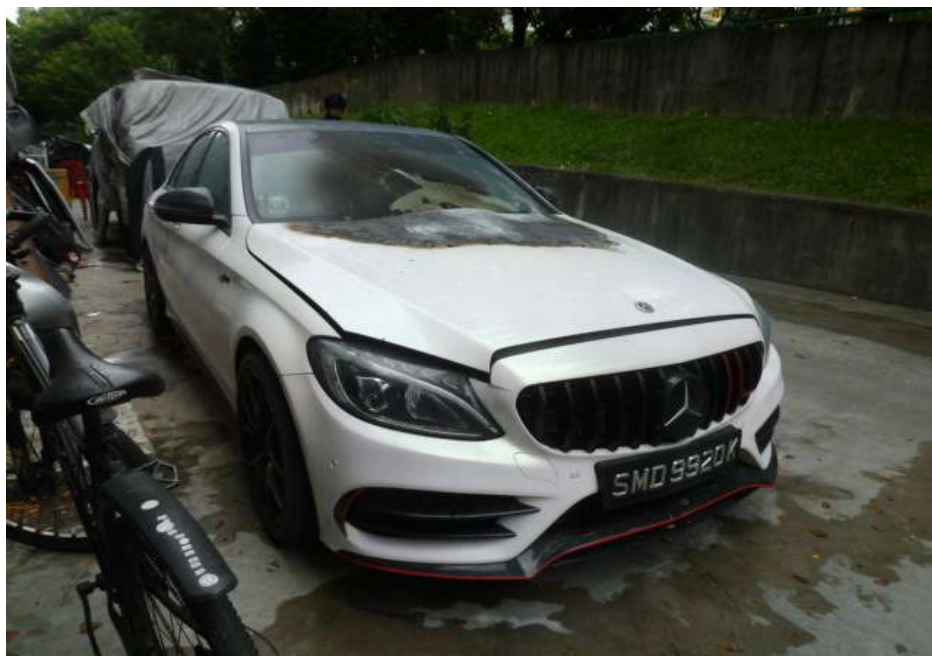
Photo 2 shows the general view of the right frontal portion of the Insured Vehicle at the time of our inspection. The exterior body of the Insured Vehicle had sustained visible fire damage. This included its front windscreen, front bonnet, front windscreen wiper garnish and front windscreen wipers.

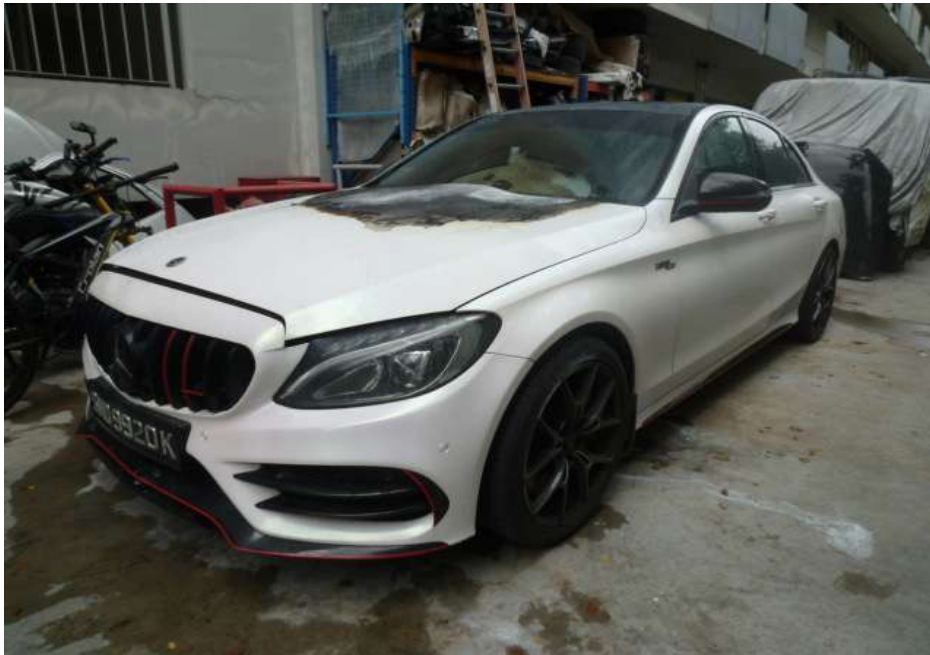
Photo 3 shows the general view of the left portion of the Insured Vehicle at the time of our inspection. The exterior body of the Insured Vehicle had sustained visible fire damage. This included its front windscreen, front bonnet, front windscreen wiper garnish and front windscreen wipers.

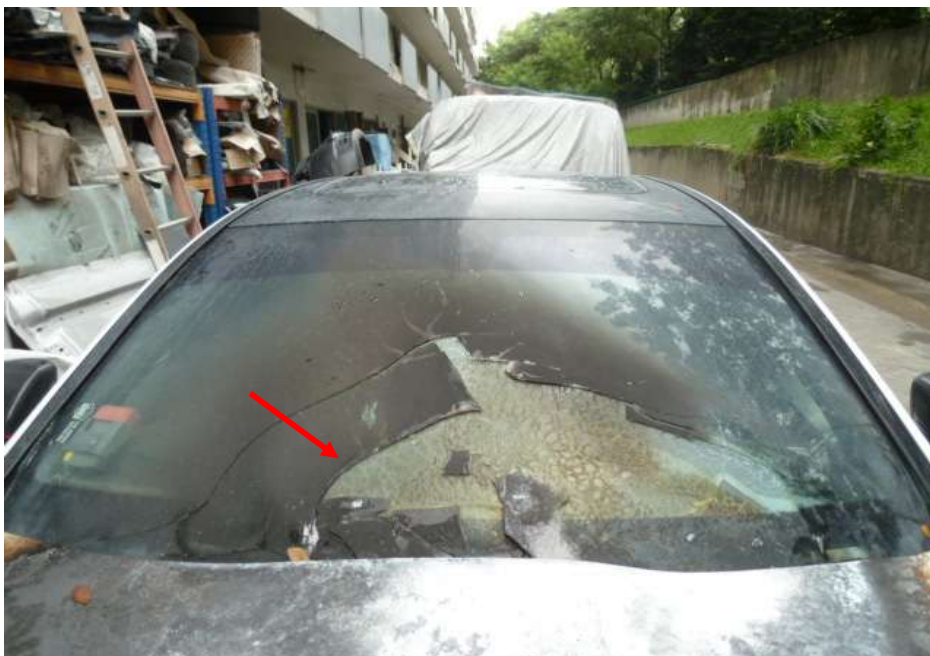
Photo 4 shows a closer view of the front windscreen of the Insured Vehicle at the time of our inspection. The front windscreen had sustained extensive fire damage (arrowed).

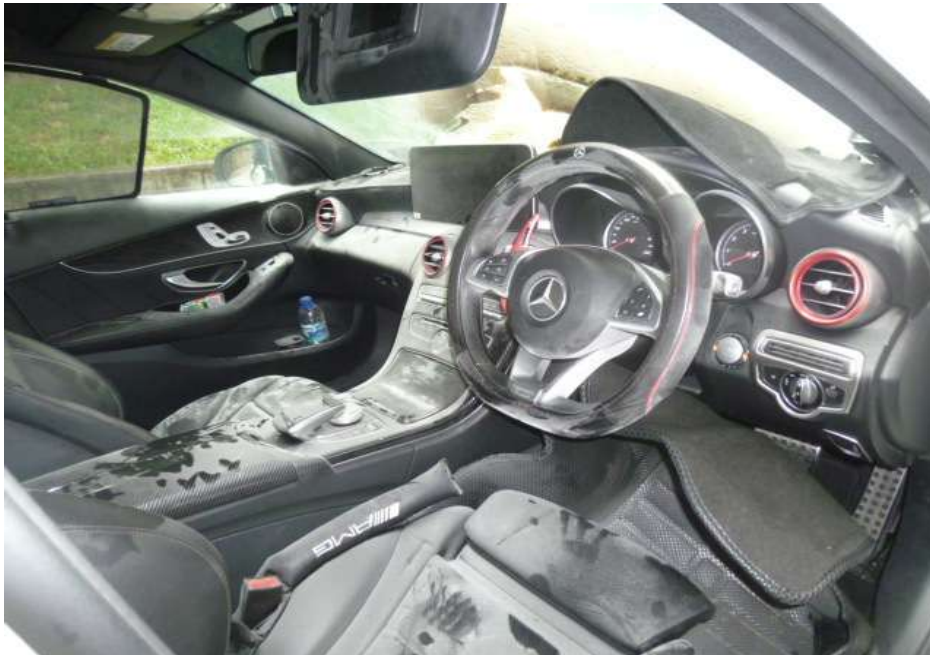
Photo 5 shows the interior compartment of the Insured Vehicle at the time of our inspection. The interior compartment of the Insured Vehicle was observed to be relatively unaffected by the fire.

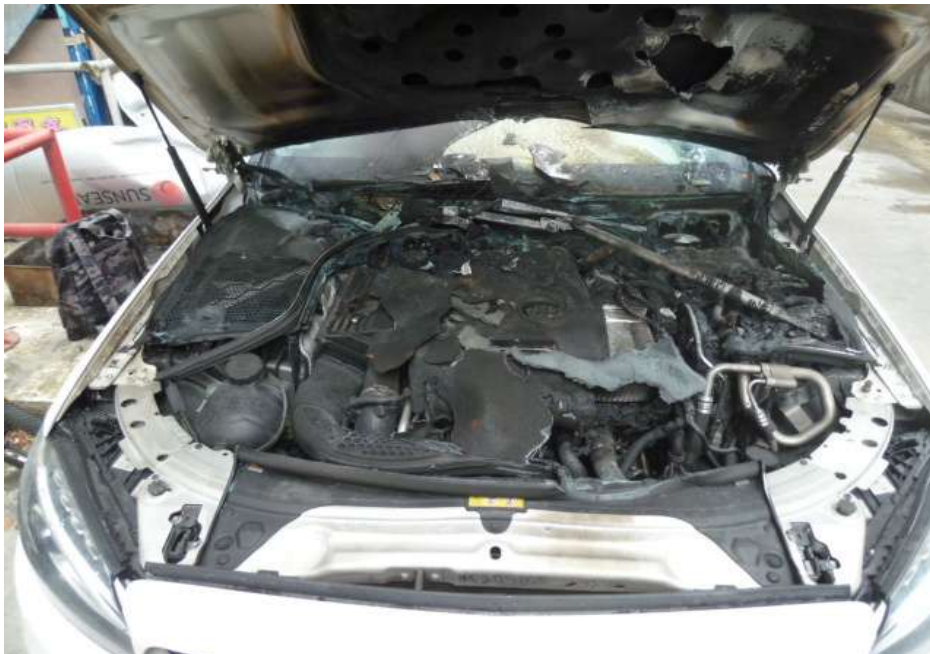
Photo 6 shows a general view of the engine compartment of the Insured Vehicle at the time of our inspection. Most of the components inside the engine compartment were found to be severely burnt and/or melted as a result of the fire.

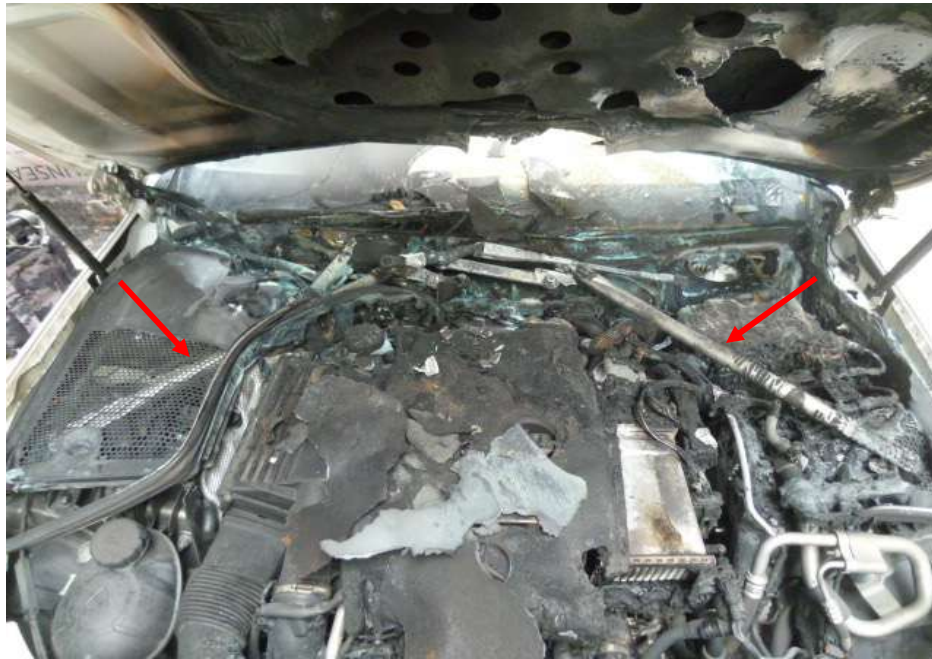
Photo 7 shows the engine strut bar (arrowed) fitted on the Insured Vehicle. However it had sustained minor fire damage.

32. Although the engine strut bar and alloy rims fitted on the Insured Vehicle were not the standard type for the Insured Vehicle, we are of the view that these parts did not cause and/or contribute to the fire incident.

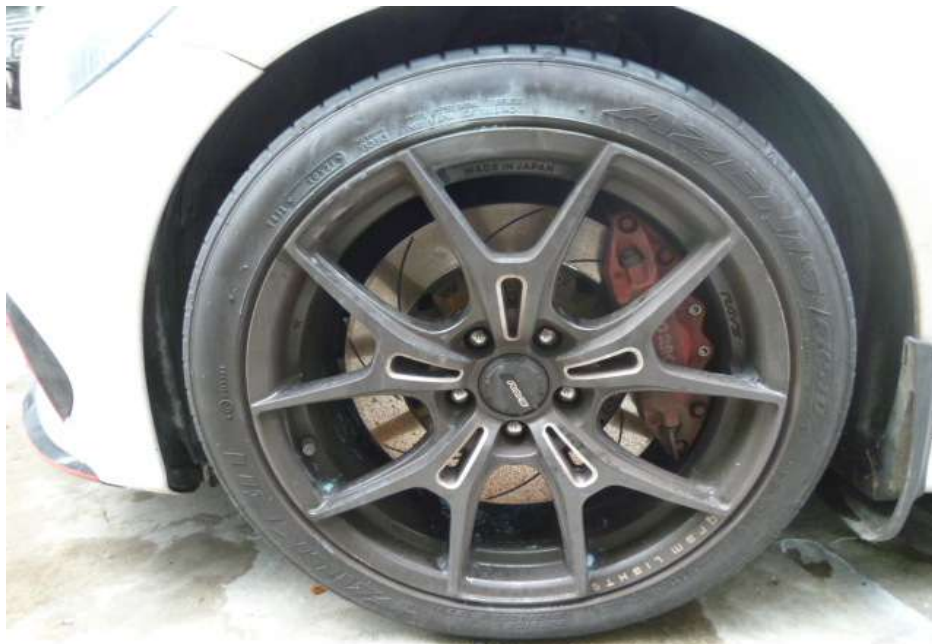
Photo 8 shows the non-standard rim found to be fitted on the Insured Vehicle at the time of our inspection. The 18- inch alloy rims fitted on the Insured Vehicle were not the standard type for the Insured Vehicle.

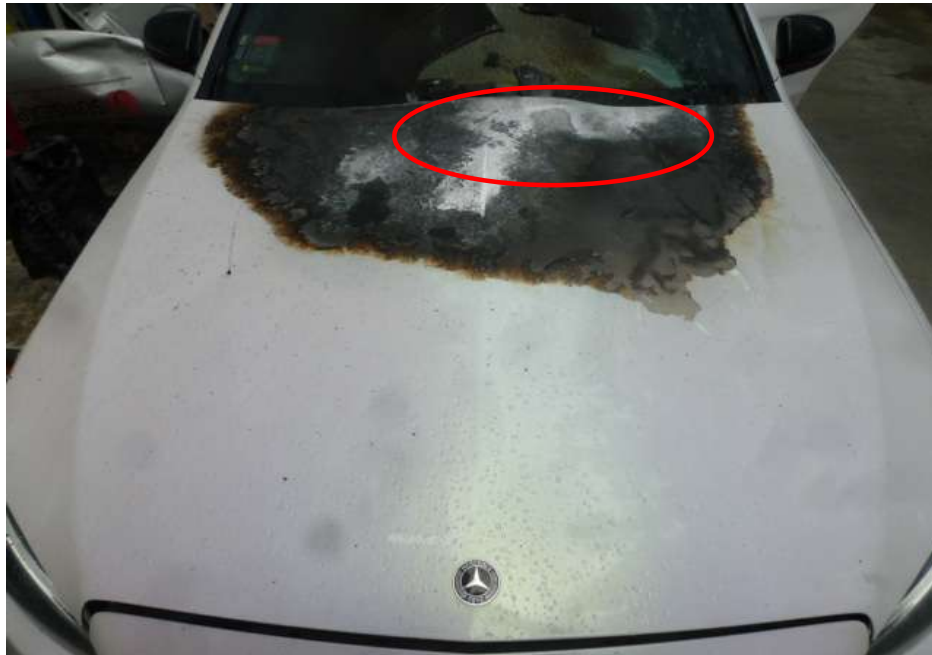
8. For this particular case, the fire appears to have originated within the engine compartment of the Insured Vehicle, somewhere around the rear centre portion of the engine compartment. This can be determined from the whitish burn marks on the rear centre portion of the front bonnet of the Insured Vehicle and also the rust that had developed on the underside of the front bonnet, at the bottom centre portion.

9. The whitish burn marks are a result of exposure to prolonged heat intensity. Rust would normally start to develop around these areas soon after a fire as prolonged exposure to high heat intensity usually causes steel/metal material body parts to be exposed to natural environmental condition. The rust that had developed on the underside of the front bonnet, around the bottom centre portion, is an indication that the rear centre portion of the engine compartment had sustained exposure to prolonged high heat intensity. See photos 9 - 12 below.

Photo 9 shows the burn pattern and whitish burn marks that were found on the rear centre portion of the front bonnet of the Insured Vehicle (circled). Such whitish burn marks are a result of exposure to prolonged heat intensity, which may indicate where the fire had started. Rust would also begin to develop on these areas soon after the fire.

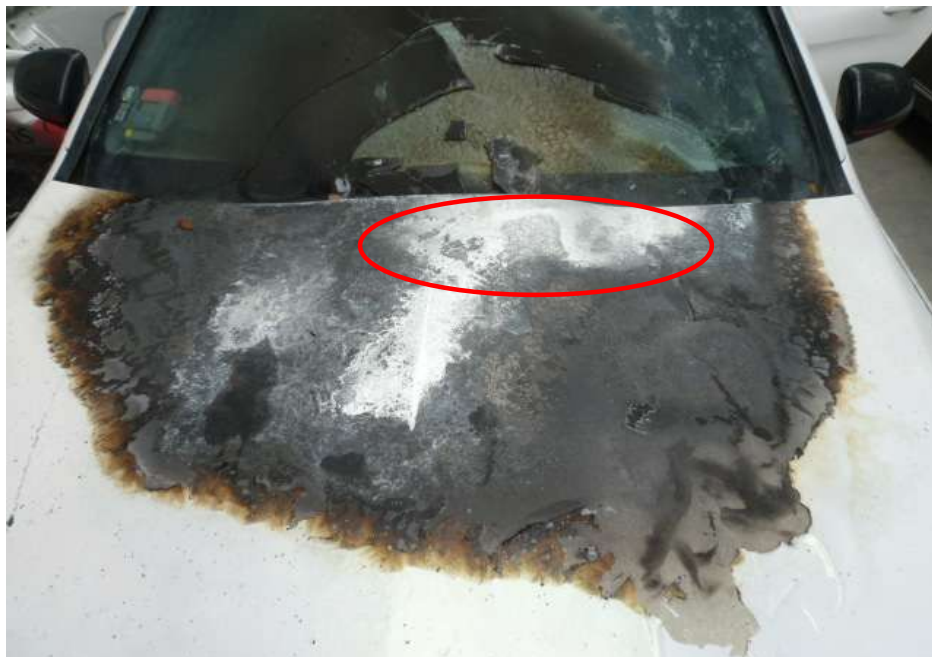
Photo 10 shows a closer view of the burn pattern and whitish burn marks that were found on the rear centre portion of the front bonnet of the Insured Vehicle (circled).

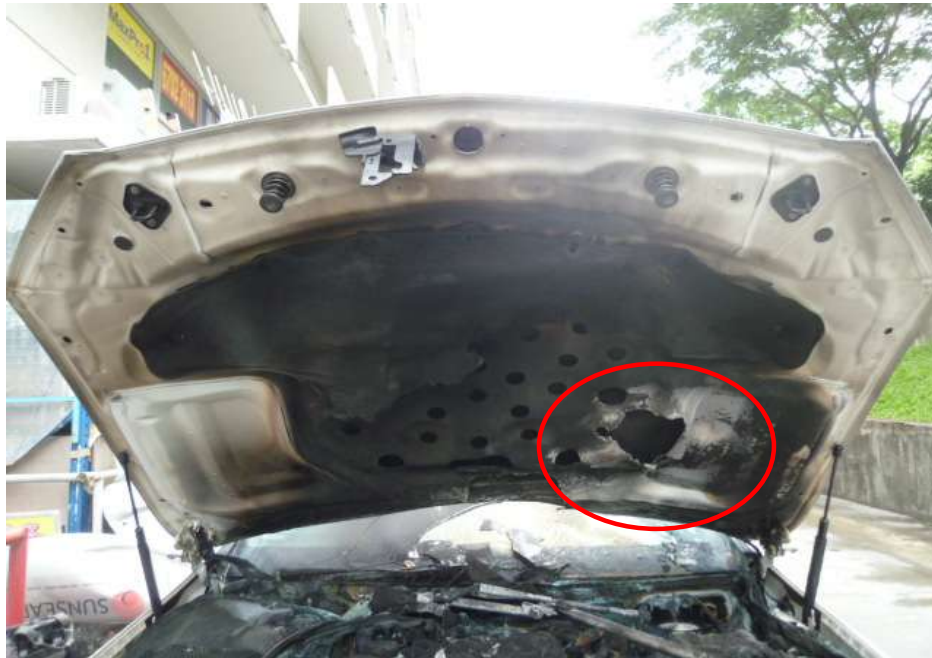
Photo 11 shows the rust that had developed on the underside of the front bonnet, around the bottom centre portion (circled). The development of rust is an indication that this area was subjected to prolonged exposure to high heat intensity, which had caused the steel/metal material of the front bonnet to be exposed to natural environmental condition. Hence the fire to the Insured Vehicle can be determined to have originated towards the rear centre portion of the engine compartment.

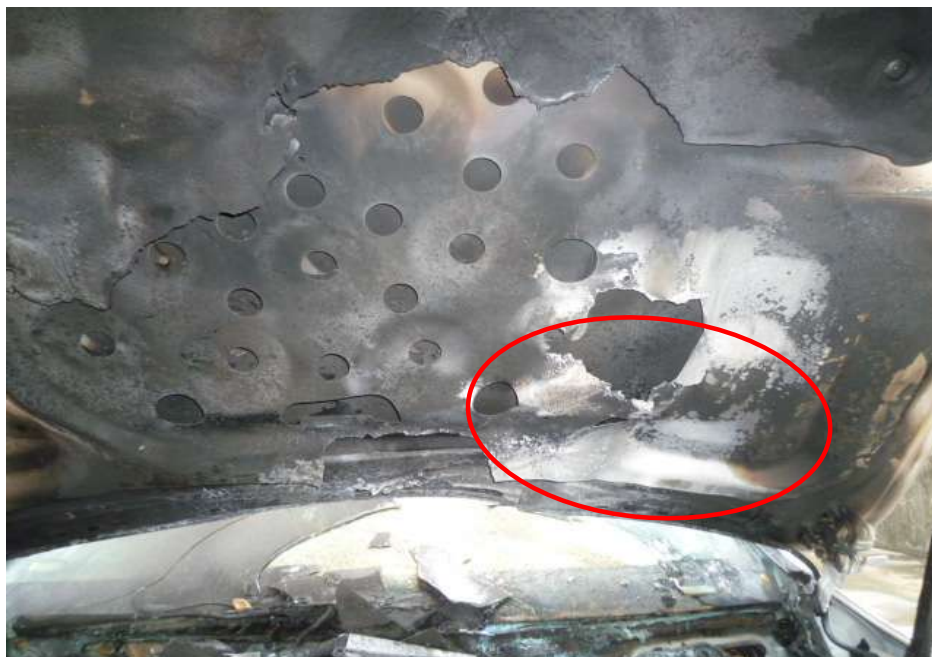
Photo 12 shows a closer view of the rust that had developed on the underside of the front bonnet, around the bottom centre portion (circled).

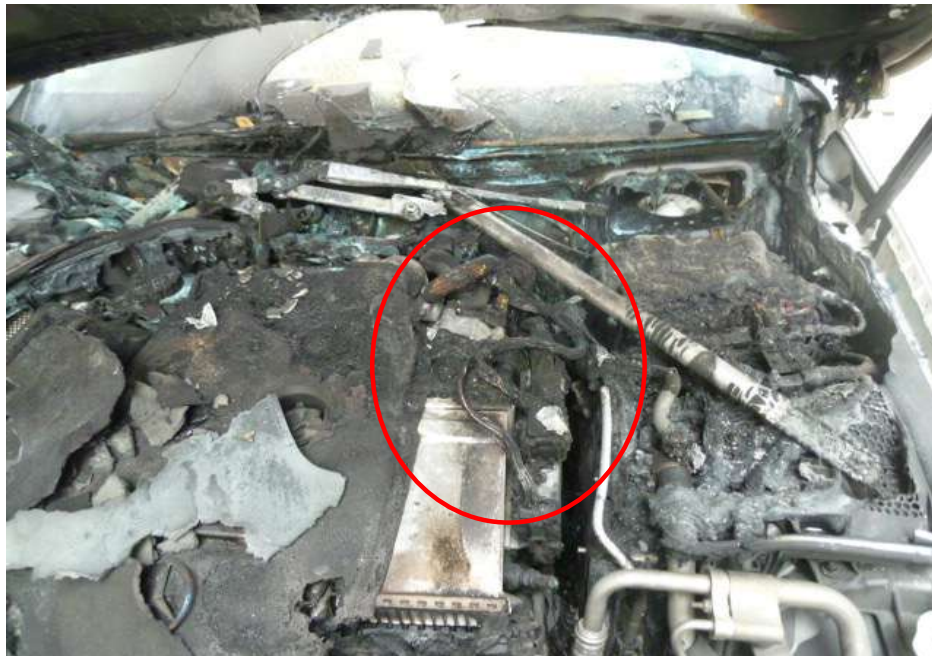
10. Upon closer examination of the rear centre portion of the engine compartment which was where the fire to the Insured Vehicle had likely started, we had found several stretches of wirings with greenish residue. These wirings were original factory fitted wirings leading from the Engine Control Module (ECM) of the Insured Vehicle. The presence of greenish residue indicates internal heating of copper wires, a sign of an electrical short circuit occurring. The greenish residue is normally left behind from oxidation as a result of chemical reaction involving the copper wires. This physical evidence would appear to suggest that the cause of fire to the Insured Vehicle could have possibly been due to electrical in nature. See photos 13 – 17 below.

Photo 13 shows the wirings around the rear centre portion of the engine compartment which is near to the vicinity where the fire to the Insured Vehicle had likely started. We observed greenish residue on the wirings leading from the Engine Control Module (ECM) of the Insured Vehicle (circled). The presence of greenish residue indicates internal heating of copper wires, a sign of an electrical short circuit occurring. The greenish residue is normally left behind from oxidation as a result of chemical reaction involving the copper wires.

29. Having investigated and technically analysed the damages of burnt nature to the Insured Vehicle, we are of the view that the cause of fire to the Insured Vehicle was of electrical in nature. For this particular case, the fire had originated along the wirings inside the engine compartment, somewhere around the rear centre portion of the engine compartment. The wirings were original factory fitted wirings leading from the Engine Control Module (ECM) of the Insured Vehicle.

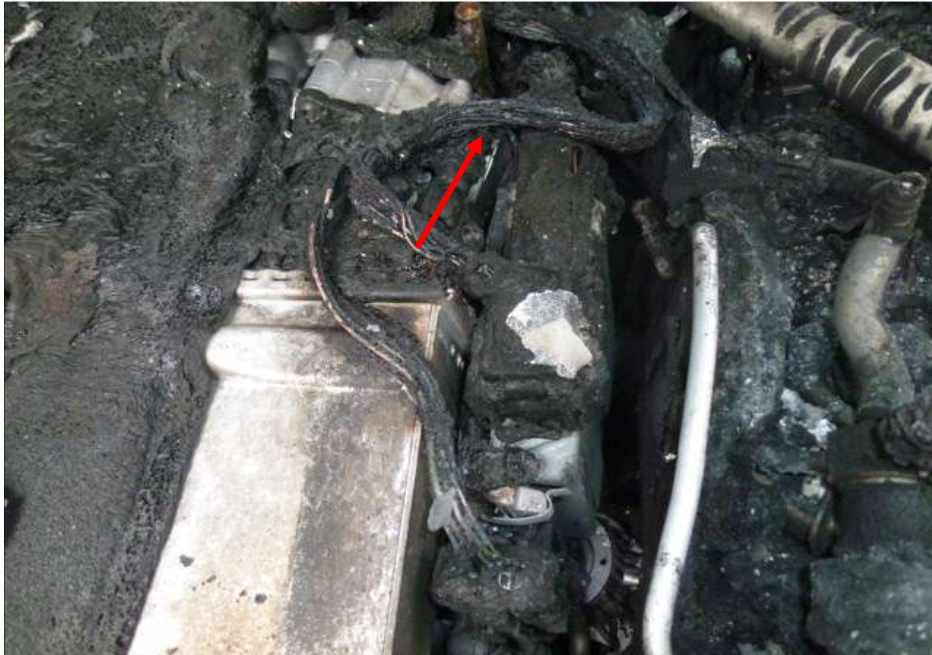
Photo 14 shows a closer view of the greenish residue on some of the burnt wirings leading from the ECM (arrowed).

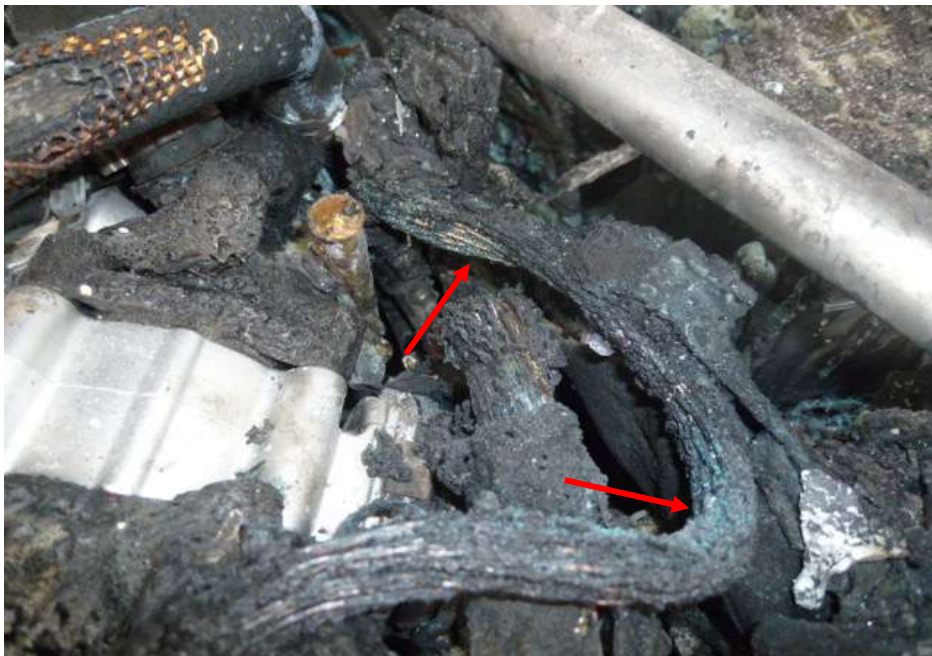
Photo 15 shows a closer view of the greenish residue on the wirings leading from the ECM of the Insured Vehicle (red arrows). The presence of such greenish residue suggests occurrence of an electrical short circuit.

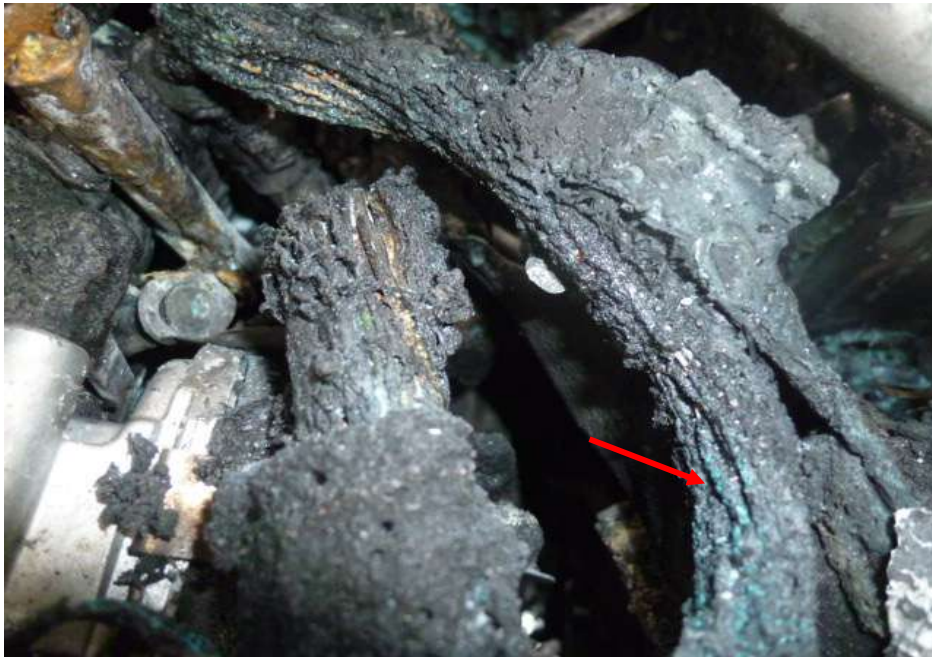
Photo 16 shows a close up view of the greenish residue on the wirings leading from the ECM of the Insured Vehicle (red arrows). The presence of such greenish residue suggests occurrence of an electrical short circuit.

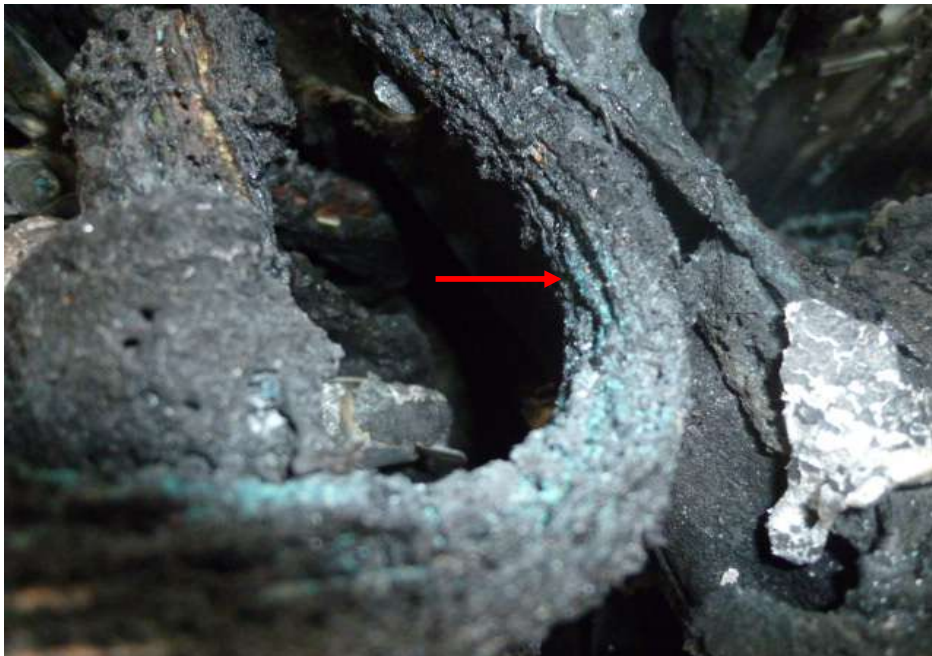
Photo 17 shows a close up view of the greenish residue on the wirings leading from the ECM of the Insured Vehicle (red arrows). The presence of such greenish residue suggests occurrence of an electrical short circuit.

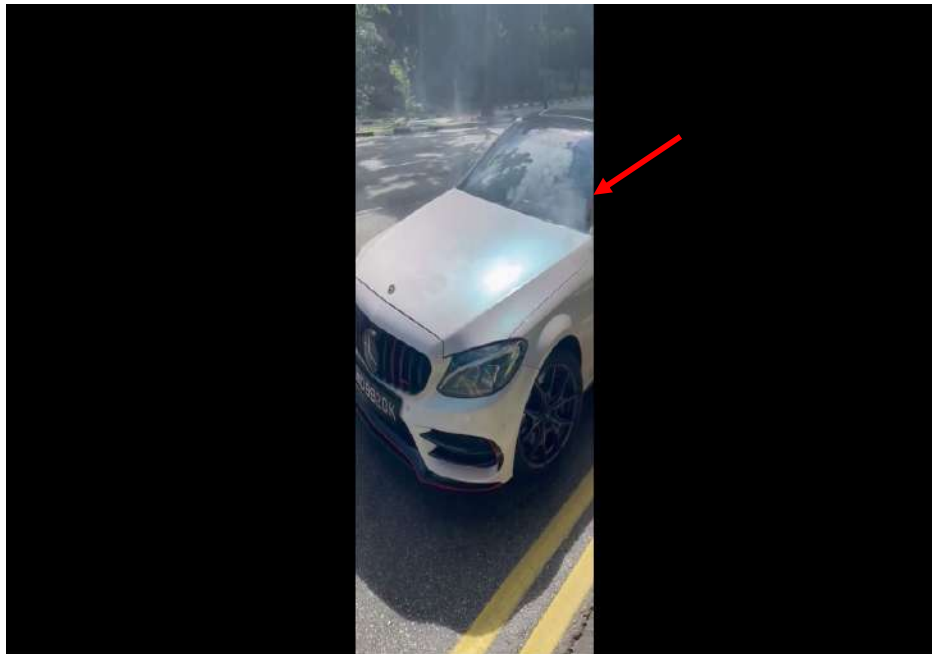
Photo 18 shows a screenshot taken from the video recording that was provided by Mr Song. The Insured Vehicle could be seen with white smoke emitting from the rear centre portion of the front bonnet (arrowed).

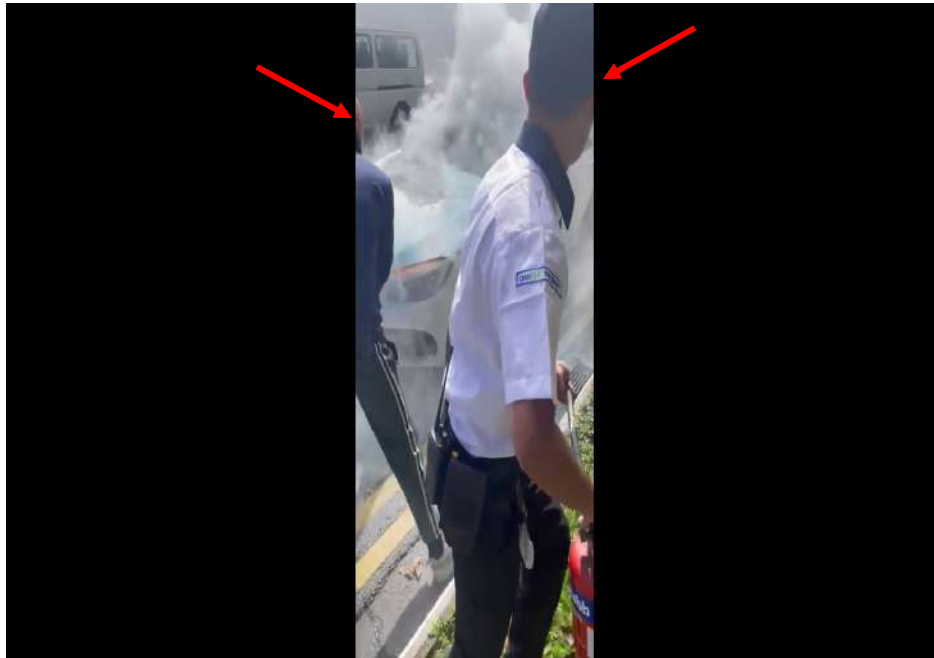
Photo 19 shows a screenshot taken from the video recording that was provided by Mr Song. In general, the information that could be gathered from this screenshot had corresponded to the events that were related to us by Mr Song which is the delivery rider and condo security guard were attempting to put out the fire to the Insured Vehicle with fire extinguishers (arrowed).

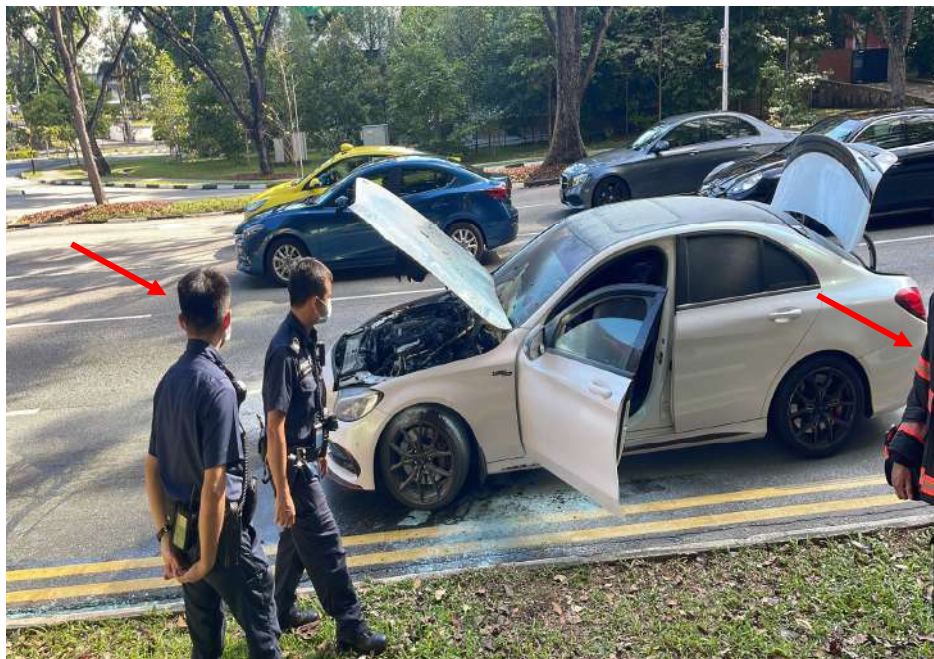
Photo 20 shows the Insured Vehicle after the fire was extinguished. In general, the information that could be gathered from this photograph had corresponded to the events that were related to us by Mr Song which is the police and SCDF had responded to the incident (arrowed).

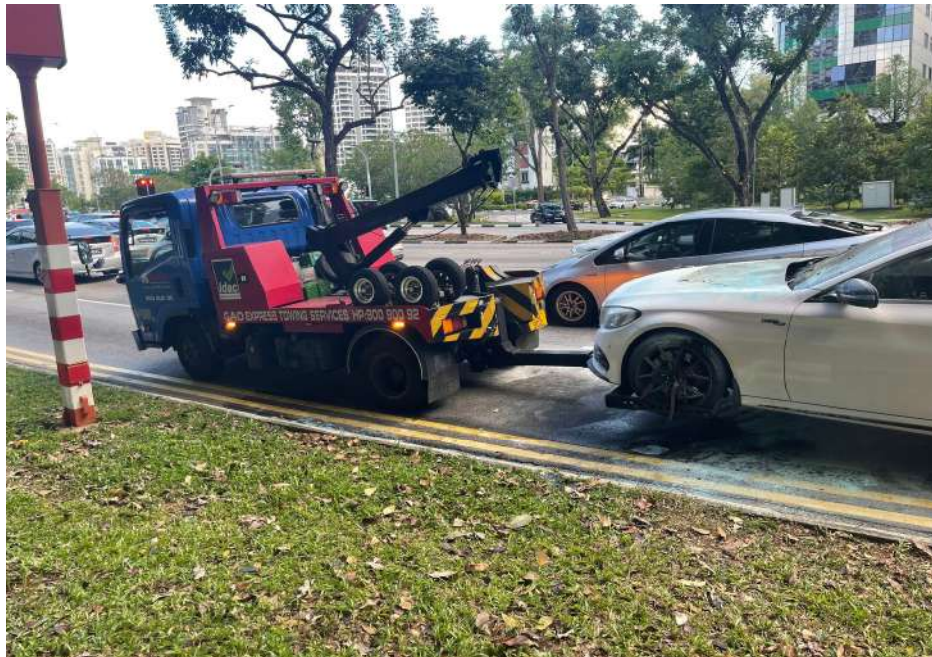
Photo 21 shows the Insured Vehicle being prepped to be towed to YTA post-incident. The extent of fire damage was similar to what we observed when we inspected the Insured Vehicle. The background seen from the photograph had also corresponded to the incident occurring along Paterson Hill.

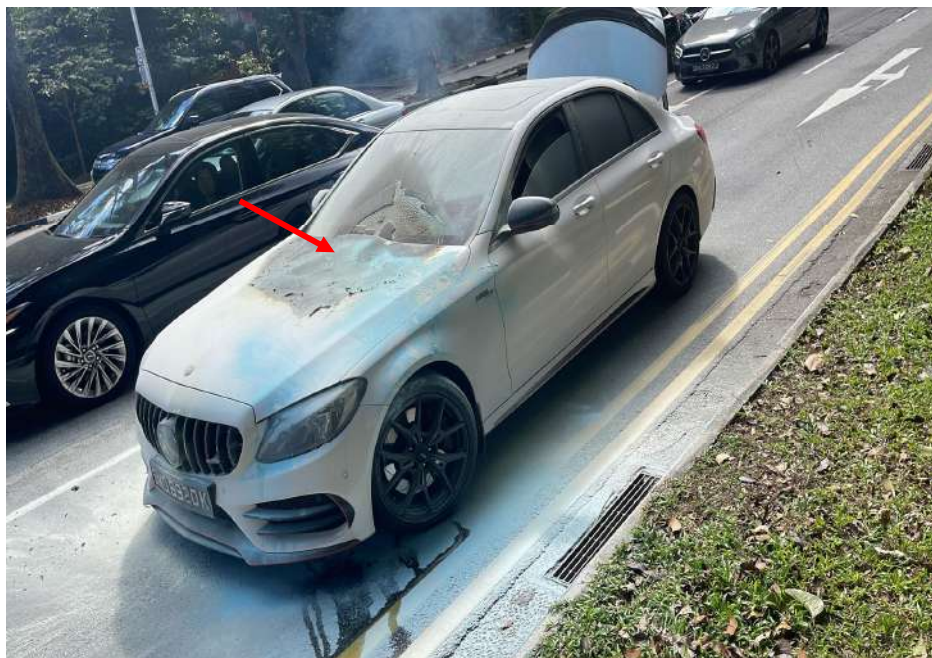
Photo 22 shows the Insured Vehicle at the incident location after the fire was extinguished. The severity of damage of the frontal portion had corresponded to the events that were related to us by Mr Song, which is the fire had started from the engine compartment of the Insured Vehicle (arrowed).
