# GARAGE 13 PTE LTD

## NOTIFICATION OF ACCIDENT

**RE: Road Traffic Accident on 26/9/2021  
Han Zhong Liang**

### Section A: Damaged Parts Assessment

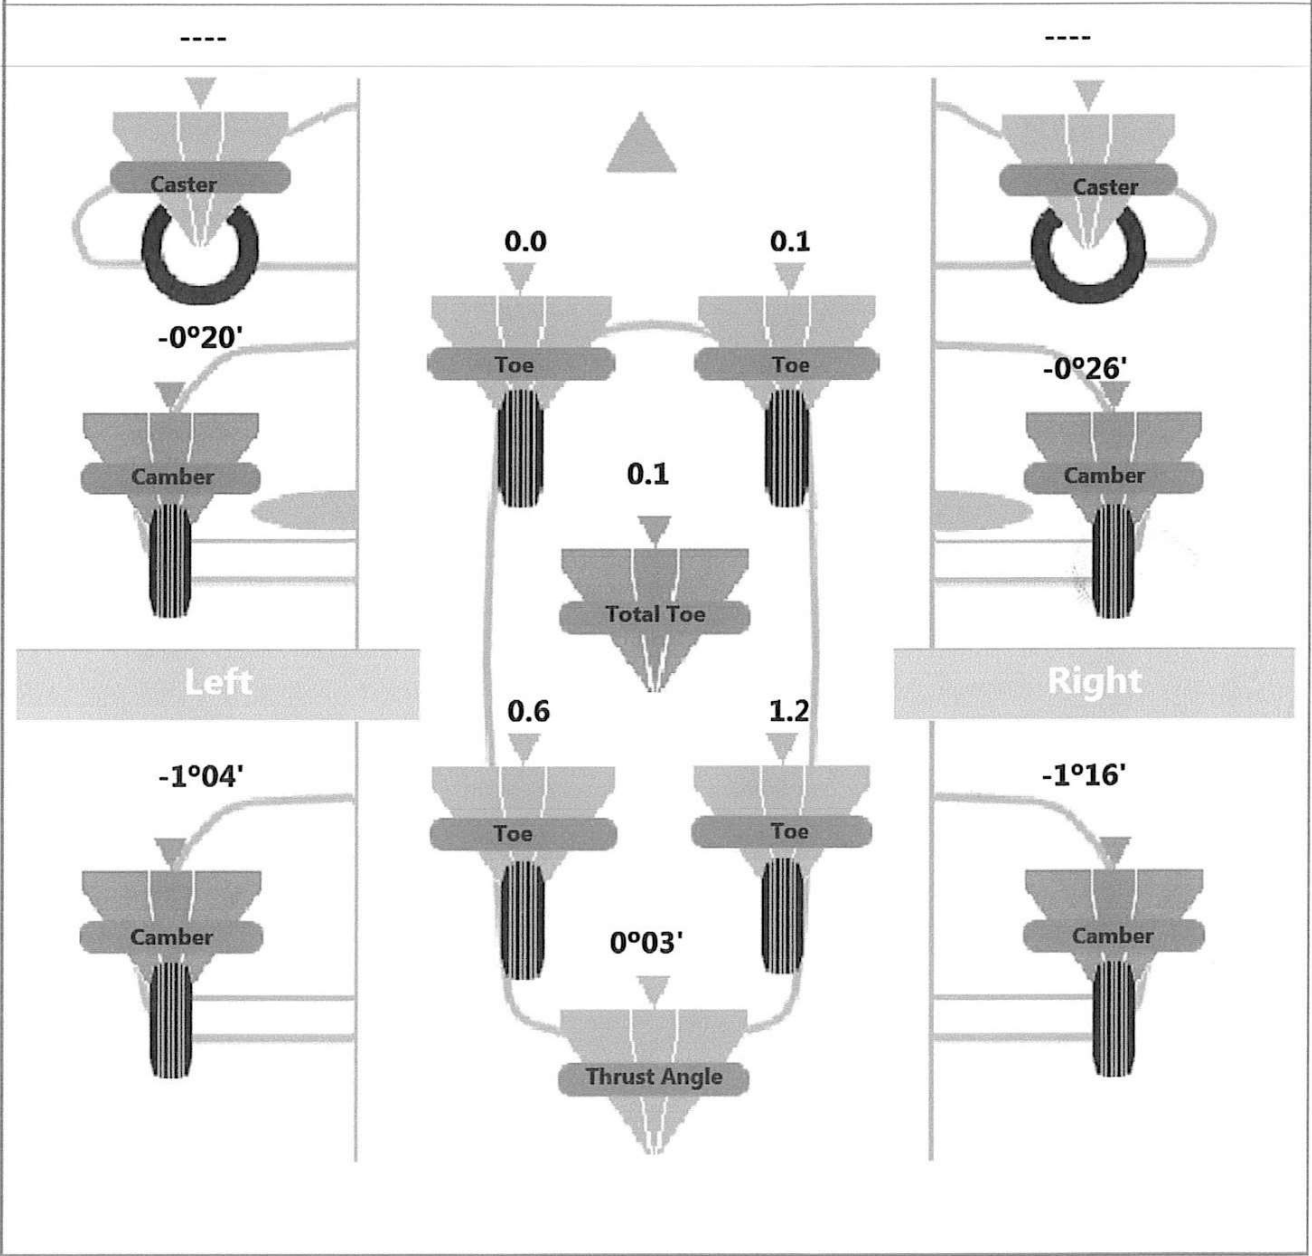
# Graphic Alignment Report

Customer:		Date:	13-Oct-21 3:07 PM
Company:		VIN	
License No:	SMV6744C	Technician:	
Odometer:		Order No.:

HYUNDAI, 2018, AVANTE(Custom)
