# GARAGE 13 PTE LTD

## NOTIFICATION OF ACCIDENT

Please be informed that an accident involving my/our vehicle no. SMV 6744 C and vehicle(s) no. G8A 5270 A had taken place at / along Sims Ave Twds Geylang on date 26/9/2021 at time 122500 hrs.

**RE: Road Traffic Accident on 26/9/2021  
Han Zhong Liang**

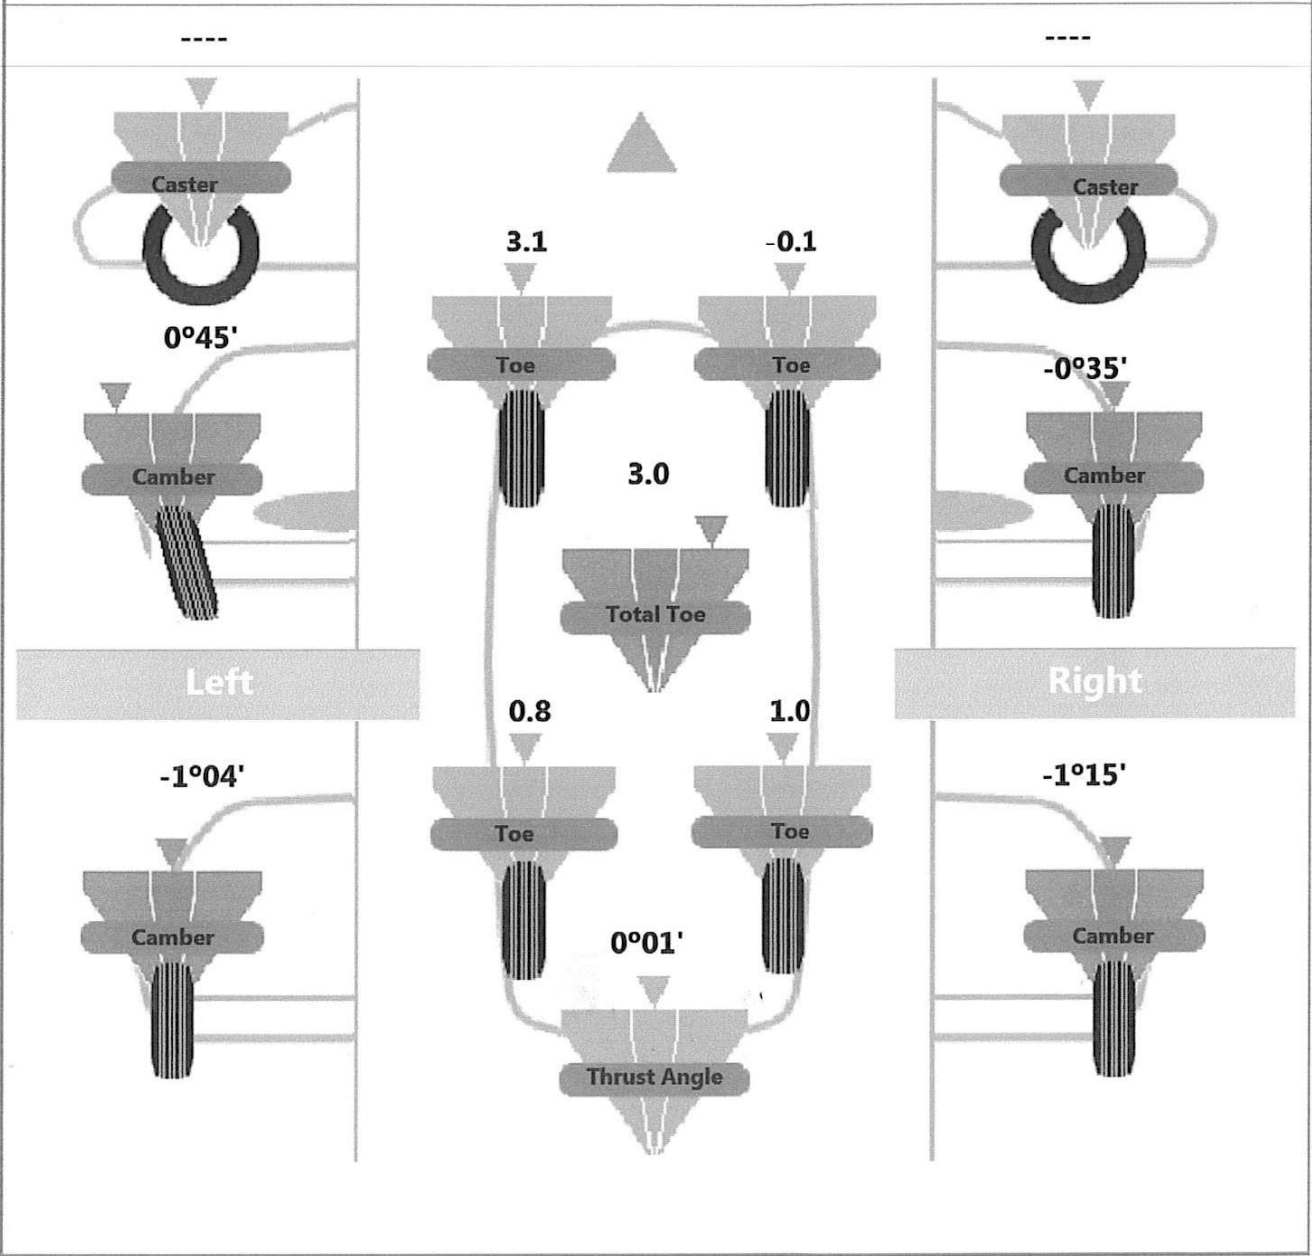
# Graphic Alignment Report

Customer:		Date:	11-Oct-21 12:23 PM
Company:		VIN	
License No:	SMV6744C	Technician:	
Odometer:		Order No.:

HYUNDAI, 2018, AVANTE(Custom)

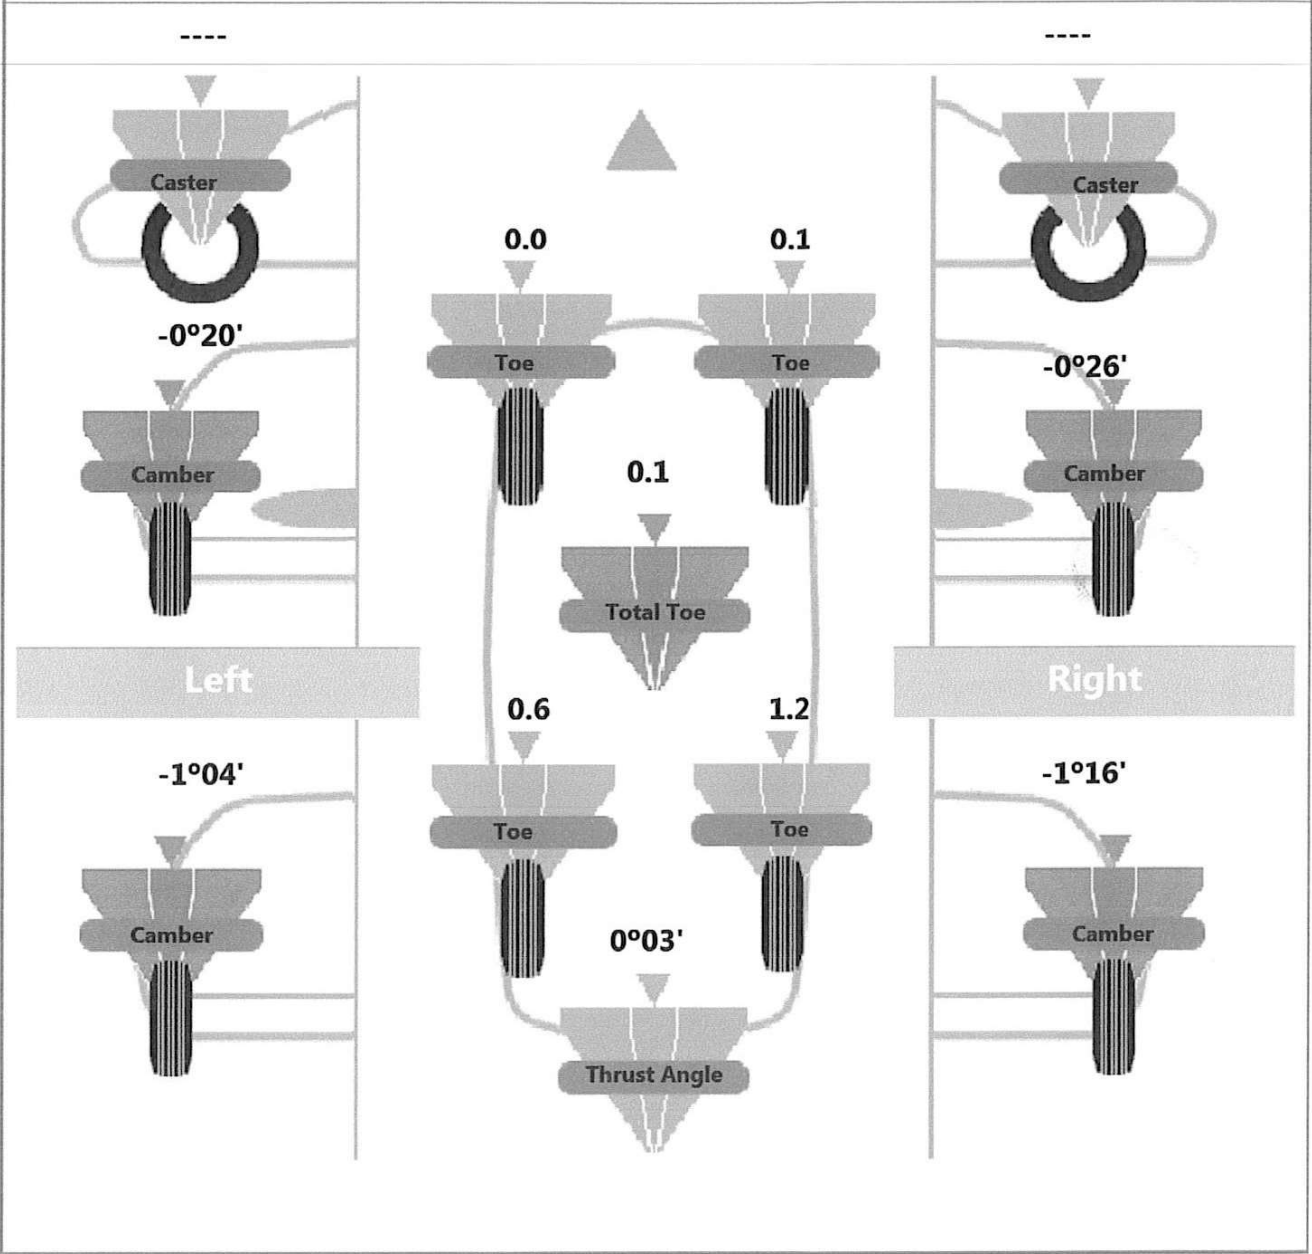
# Graphic Alignment Report

Customer:		Date:	13-Oct-21 3:07 PM
Company:		VIN	
License No:	SMV6744C	Technician:	
Odometer:		Order No.:

HYUNDAI, 2018, AVANTE(Custom)
