Our Reference : KAAS/TA/6388/1865/TP/04.21  
Date : 05 June 2022

## VEHICLE APPRAISAL REPORT

| Registration No. | : XD 1865J | Chassis Frame No. | : GKB4CLB00171 |
| Make / Model | : Nissan GKB45CLBHN | Engine No. ( Logcard ) | : GE13334157B |

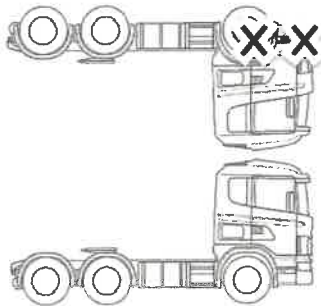
Damages sustained were consistent with the subject vehicle being involved in a collision with another vehicle and the impact was delivered **Diagonally to the LH Side from rear to front; left to right;** portion of the vehicle.

The general area of damages is at the **LH Side portion**  
( Please refer to the parts list and photographs as attached for more information )
