Your Ref: 202222006096  
Our Ref : CS4/AIS22007758/N

18 August 2022

**Allianz Insurance Singapore Pte. Ltd.**  
79 Robinson Road #09-01  
Singapore 068897  
(Claims Division)

## **TECHNICAL INVESTIGATION REPORT OF FIRE INCIDENT INVOLVING THE INSURED VEHICLE SKT 6298H ON 11 AUGUST 2022**

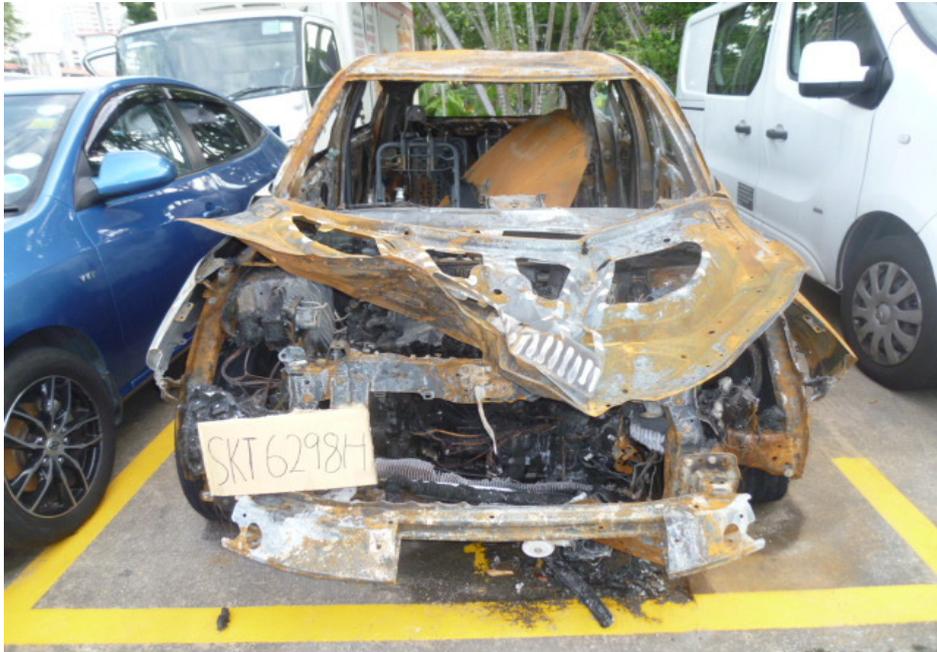
**Photo 1** shows a general view of the frontal portion of the Insured Vehicle at the time of our inspection. The Insured Vehicle was observed to have sustained extensive fire damage. The body panels at the front body and the undercarriage components at the front underside were all found to have been burnt to char.

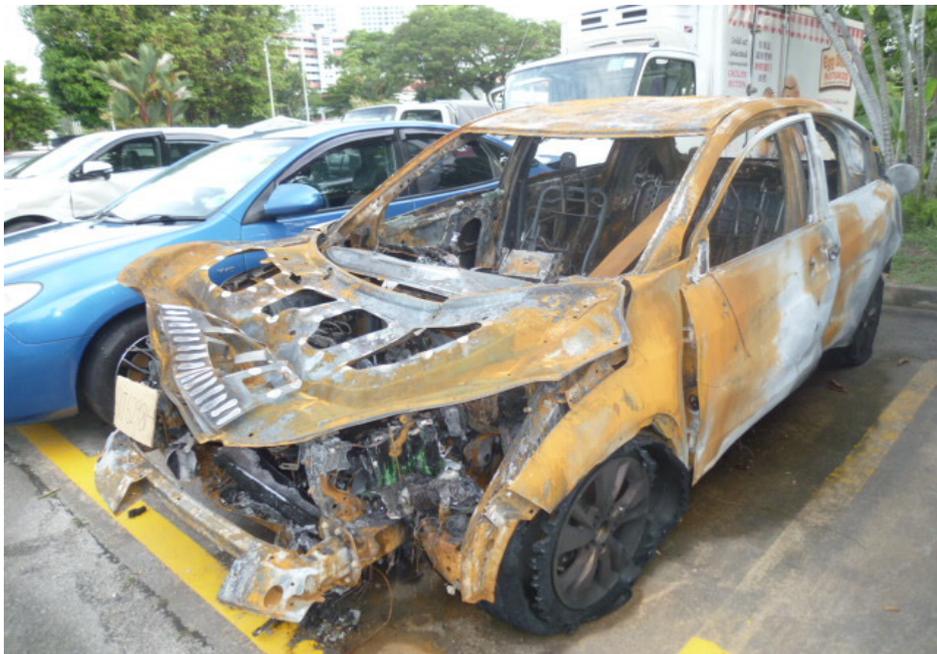
**Photo 2** shows a general view of the front left body of the Insured Vehicle at the time of our inspection. The Insured Vehicle was observed to have sustained extensive fire damage. The body panels at the front body like the front bonnet, front fenders, front door amongst others were all burnt to bare metal state.

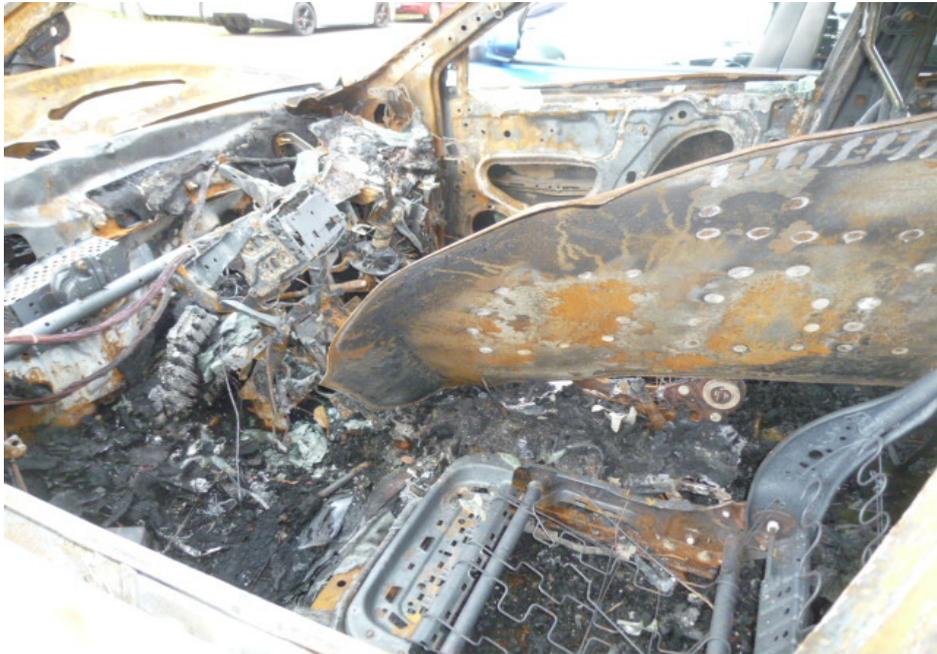
**Photo 3** shows the interior compartment of the Insured Vehicle. All the parts inside the interior compartment were found to be extensively burnt. Its front seats, rear seats, roof upholstery, carpet and various trims were all burnt and/or melted, leaving charred skeletal remains.

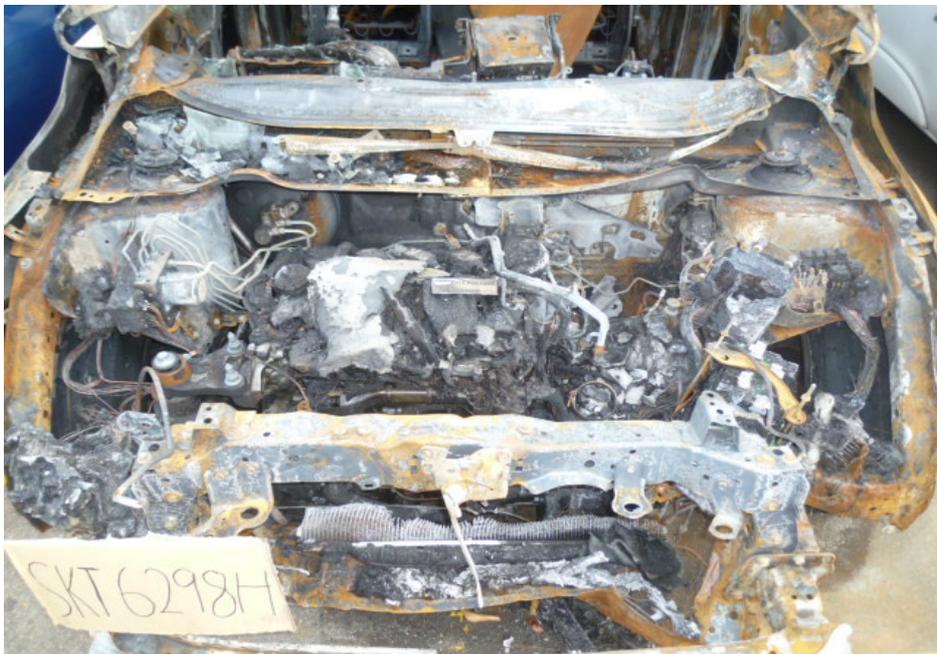
**Photo 4** shows the engine compartment of the Insured Vehicle. The various parts and components within the engine compartment of the Insured Vehicle were all extensively affected by the fire. This had included the engine and transmission of the Insured Vehicle.

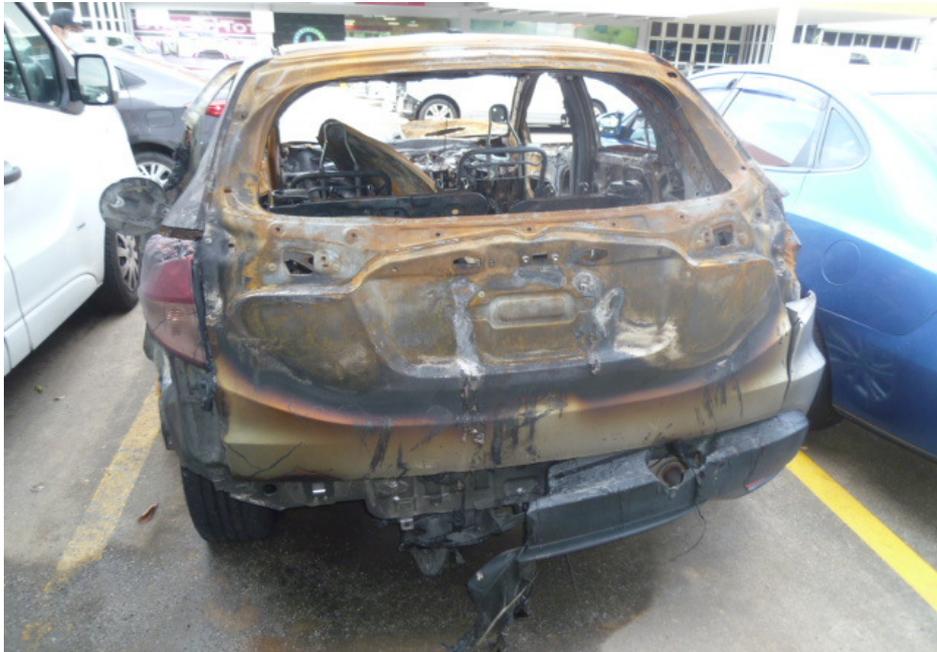
**Photo 5** shows the rear portion of the Insured Vehicle. Comparing the overall extent of fire damage like the rear tyres vs the front tyres, condition of rear body panels vs front body panels etc, it would appear that the frontal portion of the Insured Vehicle was more severely affected than its rear portion.

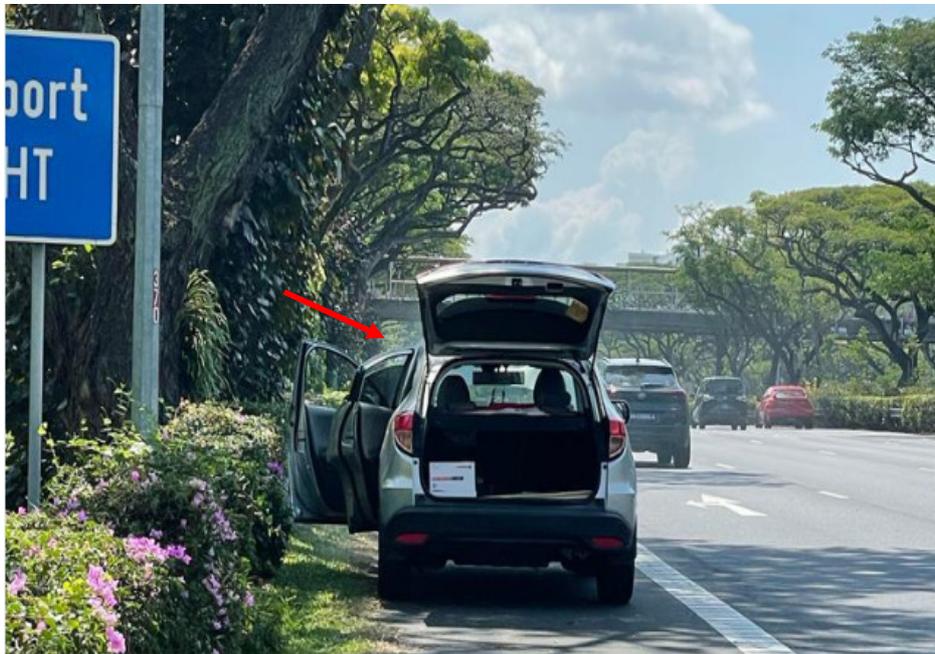
**Photo 7 shows** the Insured Vehicle stopped along PIE (Changi Airport) with smoke emitting from the left passenger side (arrowed).

15. For this case, Mr Chia first saw smoke coming out from the aircon vents. Taking Mr Chia's observations into consideration, the fire to the Insured Vehicle had originated around the left side of the dashboard, at or near the glove compartment area; with the cause of fire related to a defective originally fitted component. The following paragraphs discuss this aspect.
16. The Insured Vehicle was involved in a manufacturer recall campaign in year 2016. The recall was for an issue relating to a capacitor used in the engine idling stop system of the Insured Vehicle, which may be insufficient to protect against an overcurrent. Notably, the records had indicated that rectification to address the issue has been carried out to the Insured Vehicle prior to this incident. See search result below obtained from LTA.

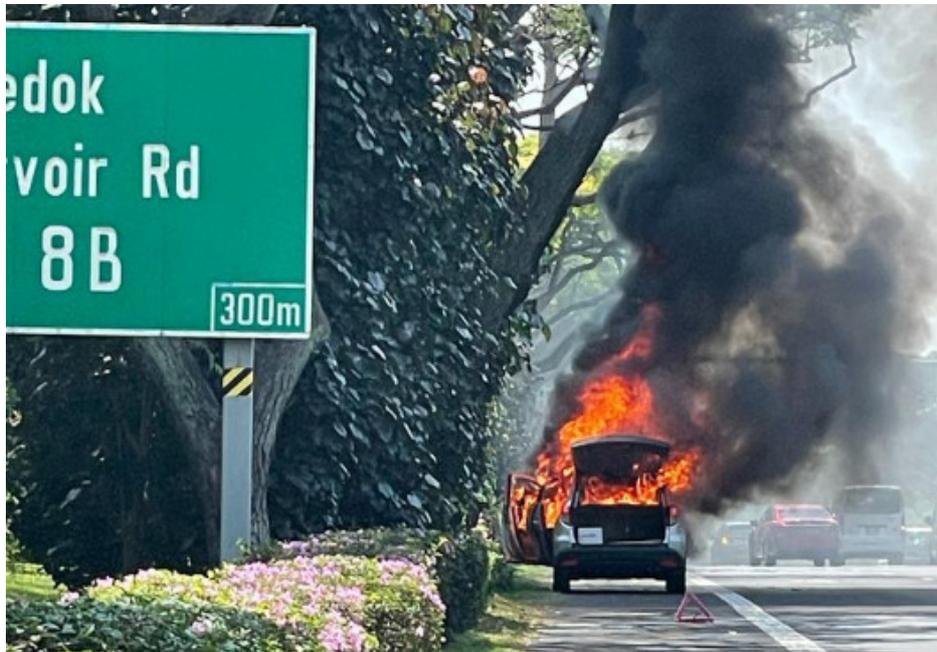
**Photo 8** shows the Insured Vehicle on fire. Comparing the overall extent of fire damage like the rear tyres vs the front tyres, condition of rear body panels vs front body panels etc, it would appear that the front body of the Insured Vehicle was more severely affected than its rear portion.

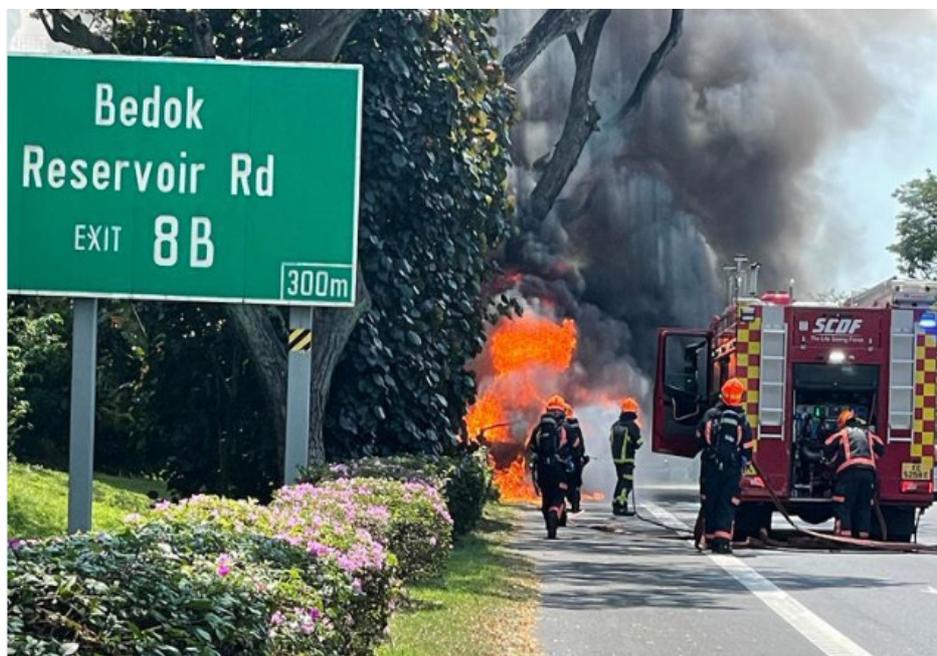
**Photo 9** shows firefighters passing by the Insured Vehicle who attended to the incident.

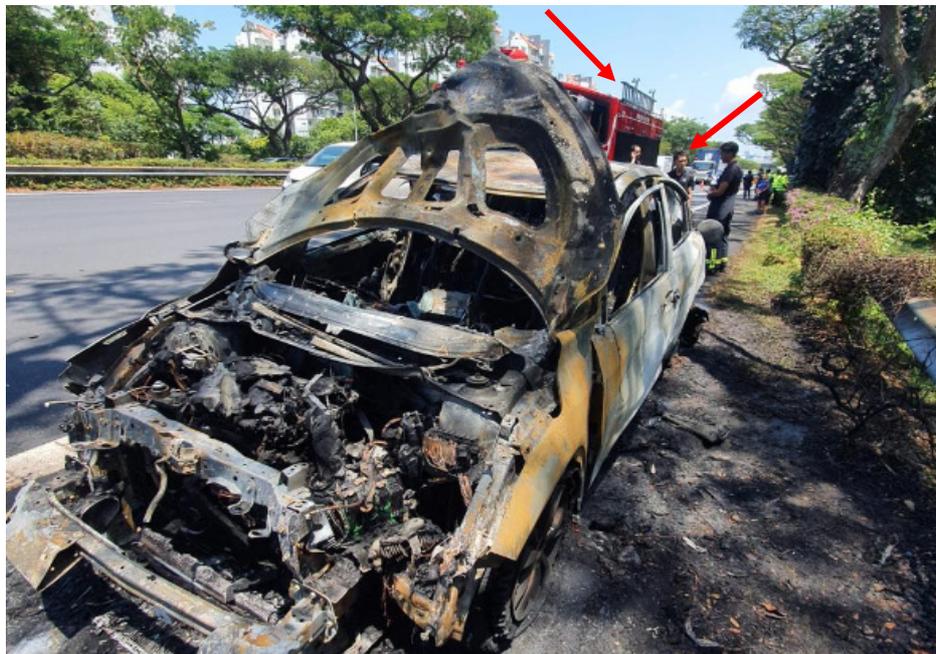
**Photo 10** shows the Insured Vehicle after the fire was extinguished. Generally, the information that we were able to gather from the photographs provided by Mr Chia had corresponded to the information that he had related to us which is the SCDF and police had responded to the incident (arrowed).

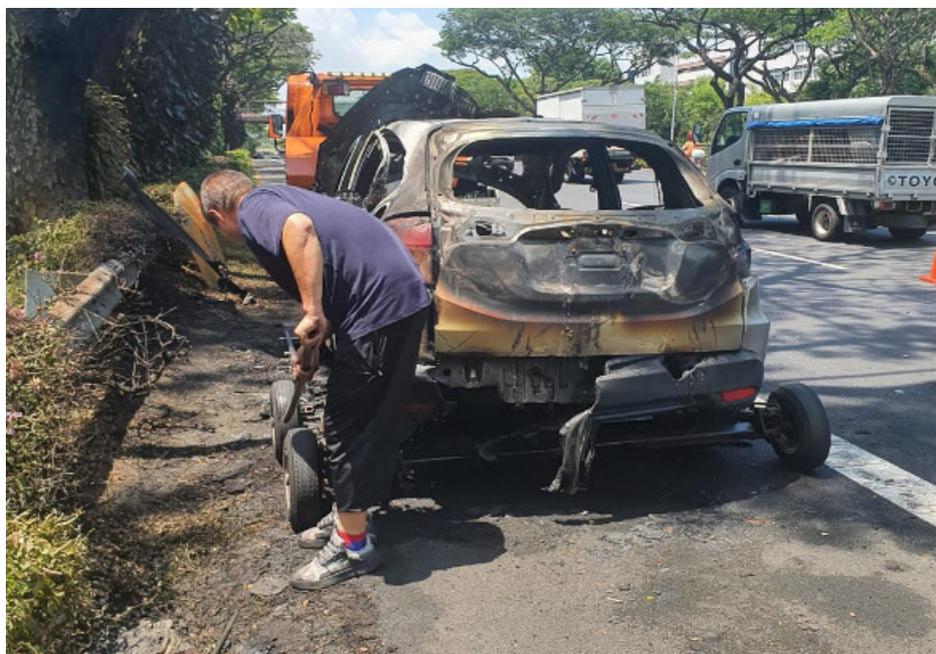
**Photo 11** shows the Insured Vehicle being prepped to be towed away post-incident.

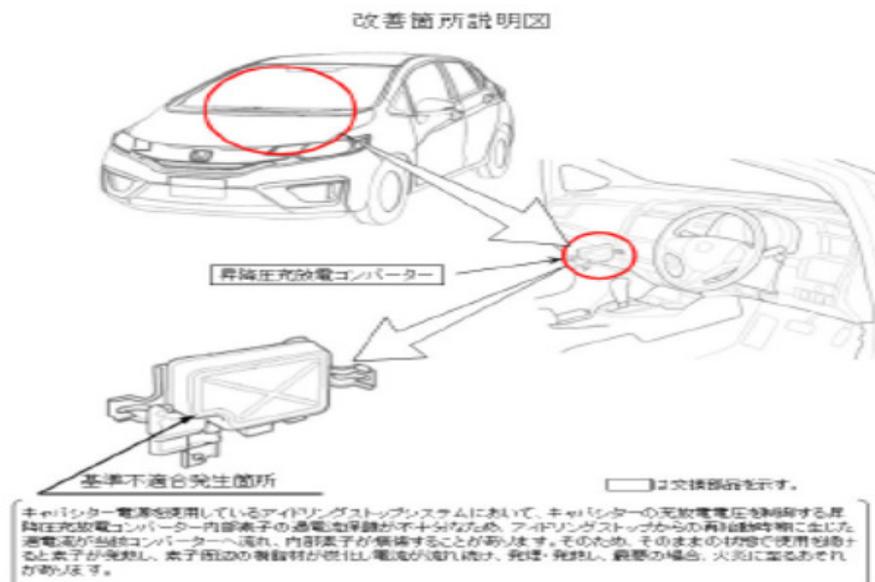
Honda recalled 160,000 Fit subcompact and Vezel sport-utility vehicles in Japan because of defective power steering and a part that controls the electric current in the vehicles. The recall does not affect any Honda models sold abroad.

There have been no injuries related to the problems. Six fires were reported related to the faulty part that controls electricity for capacitors, and two minor accidents were reported to the defect in the steering, according to Honda Motor Co.

**Screenshot 1** shows the write up that we were able to gather pertaining to the manufacturer recall campaign of similar make and model vehicles as the Insured Vehicle.

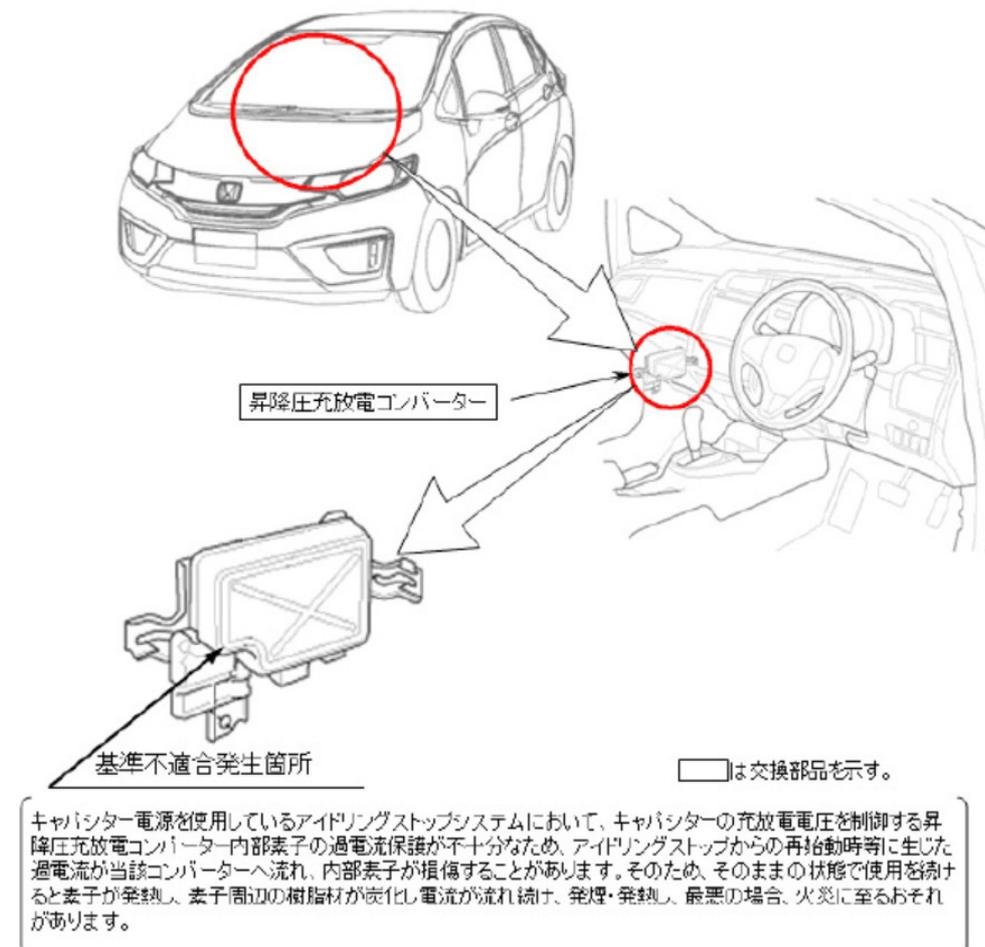
17. Our further research and checks on the capacitor that was mentioned in the recall details of the LTA search result revealed that this capacitor is a component that is fitted onto the inner side of the Insured Vehicle's front left "A" pillar, towards the left and below the glove compartment of the Insured Vehicle. We note that this location is at or near the location where Mr Chia had seen the most smoke. Basing on the information gathered pertaining to the capacitor; it can be determined that the fire to the Insured Vehicle is related to the purpose of the manufacturer recall campaign that involved the Insured Vehicle. See screenshots 1 & 2 showing the search result below gathered from our further research and checks.

**Screenshot 2** shows a zoom in view of the schematic diagram pertaining to the manufacturer recall campaign of similar make and model vehicles as the Insured Vehicle. The component, circled in the schematic diagram, is the capacitor that was mentioned in the recall details of the LTA search result. The location where this component was fitted was also at or near the location where Mr Chia had seen smoke.

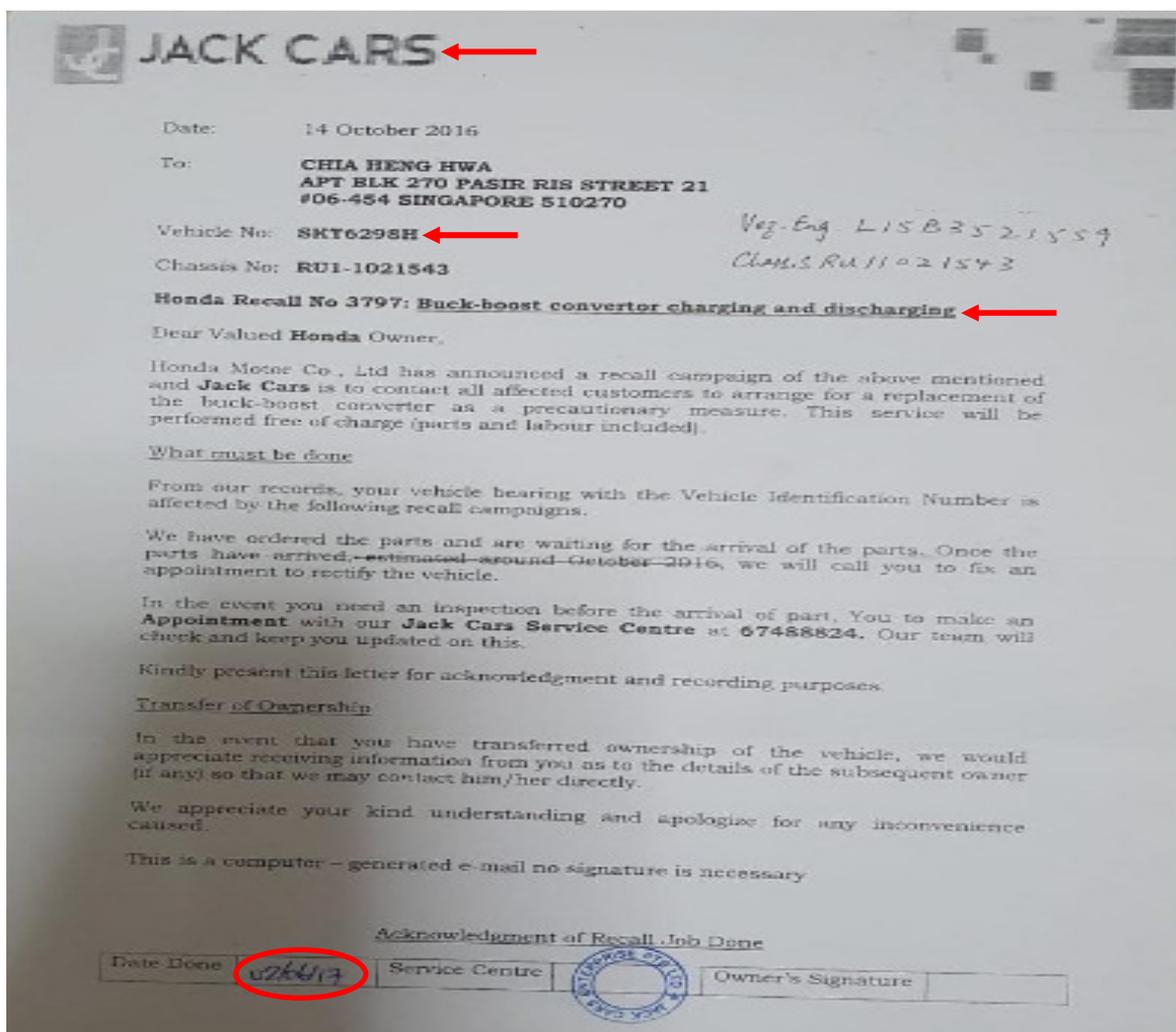
Screenshot 3 shows the contents of the letter from his dealer, Jack Cars stating that the rectification work on the Insured Vehicle had been carried out by Jack Cars (arrowed) on 2 June 2017 (circled).

19. We subsequently managed to acquire from Mr Chia, a letter from his dealer, Jack Cars stating that the rectification work had been carried out by Jack Cars on 2 June 2017. See screenshot 3 below.
