INVESTIGATION REPORT:

Our Ref : CS4/CTI22007763/N
Policy No : DMPCSNW00202242101
Insured : SJQ 26T
Date of Incident : 11 August 2022
Location : Yio Chu Kang Road towards SLE (TPE)

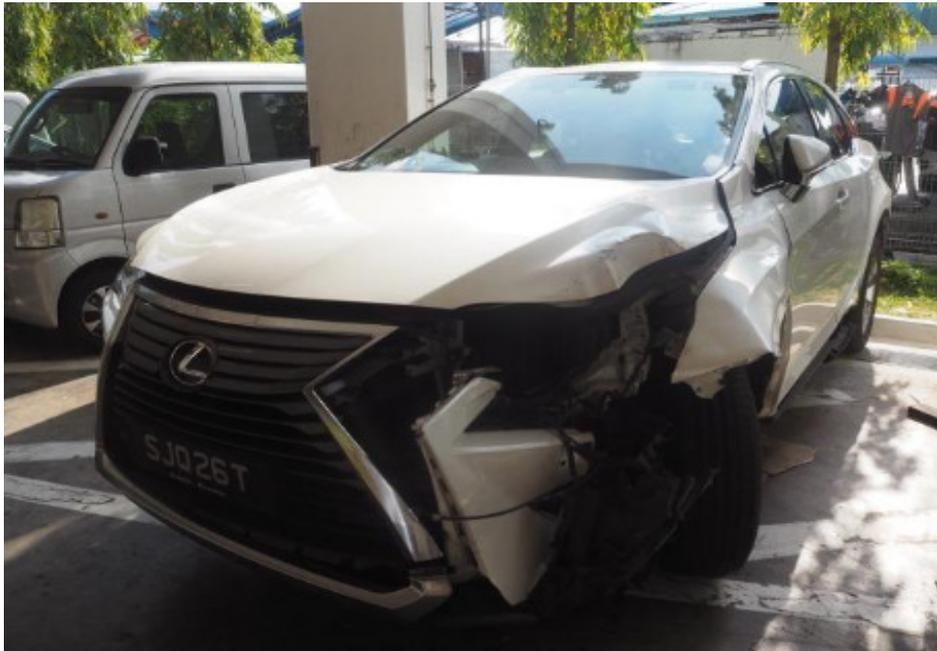
Photo 2 shows the general frontal view of the Insured Vehicle during the physical inspection at N51. The Insured Vehicle had sustained significant damages to its frontal portion and left body.

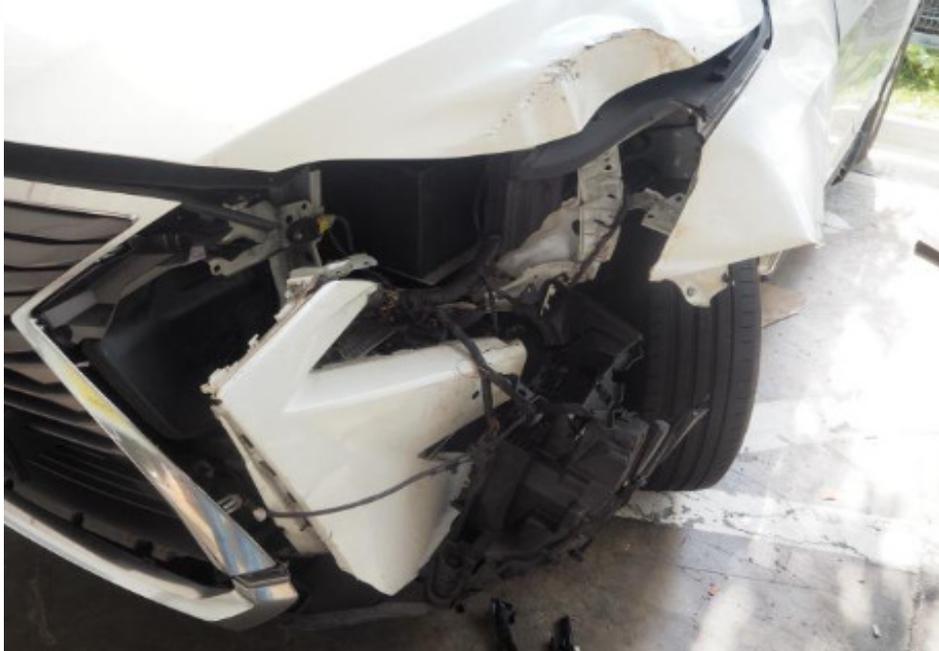
Photo 3 shows the left front portion of the Insured during the physical inspection at N51. The Insured Vehicle had sustained significant damages to its frontal portion and left body, particularly to front bonnet, front bumper, front left fender and left headlamp, left front and rear wheel rims as a result of the incident.

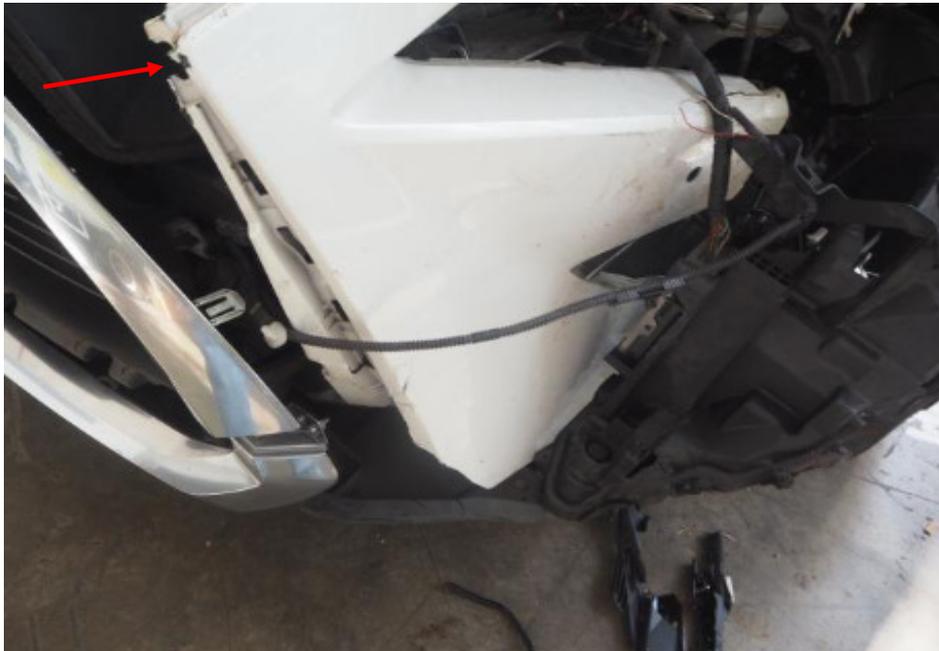
Photo 4 shows upon closer inspection, the deformed and cracked front bumper of the Insured Vehicle (arrowed) which corroborated with Mr Lim's statement that he had observed the damages to the front bumper post- incident.

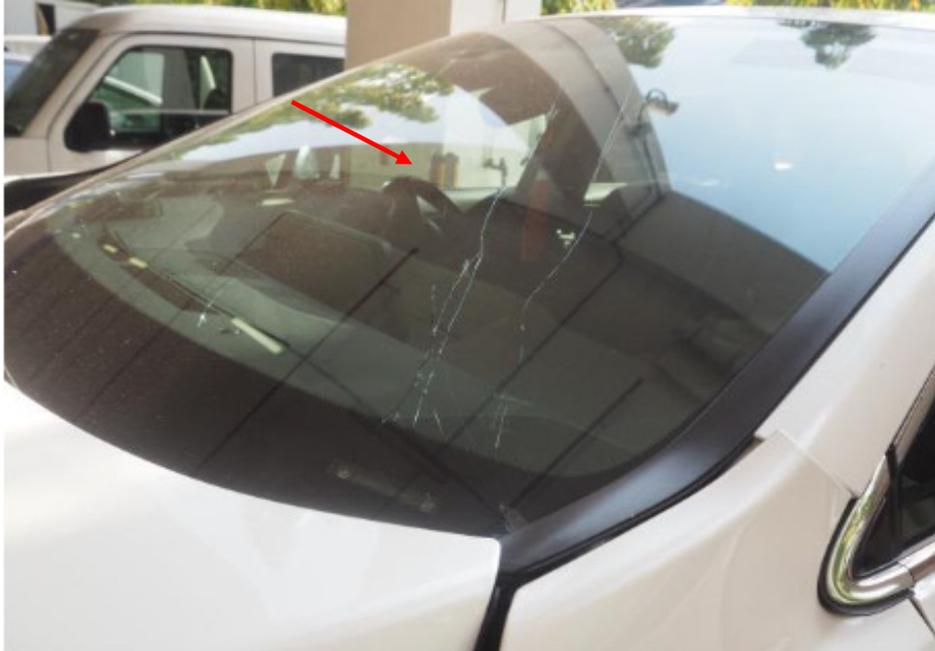
Photo 5 shows the relatively unaffected interior compartment of the Insured Vehicle (arrowed) which corroborates with Mr Lim's statement that the airbags were not deployed post- incident.

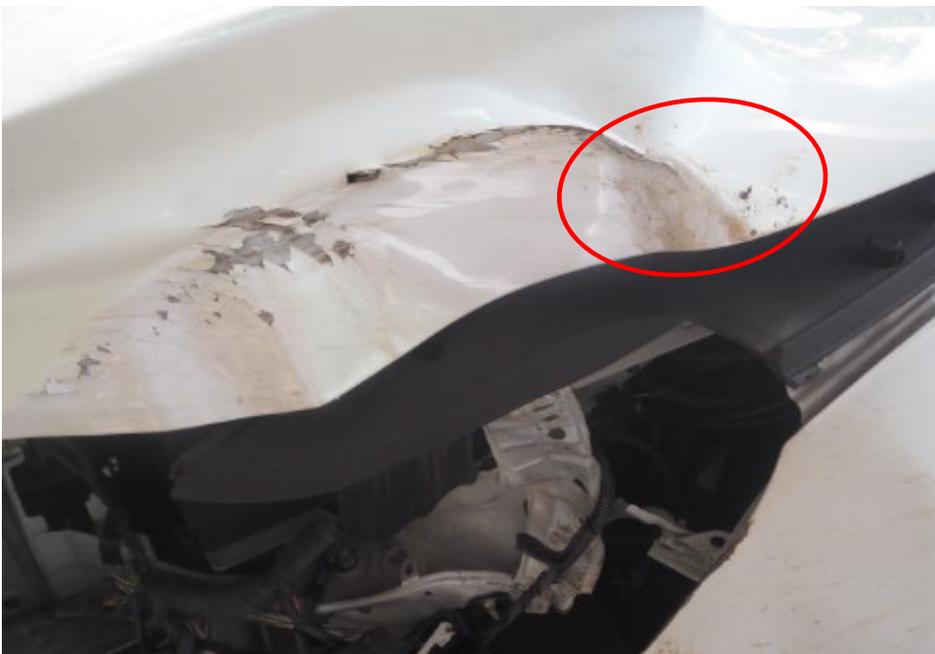
Photo 6 shows the broken pieces of tree bark (circled) that were found stuck to the front left portion of the Insured Vehicle, (circled) corresponding to the Insured Vehicle mounting the kerb and colliding into a small tree before coming to a stop.

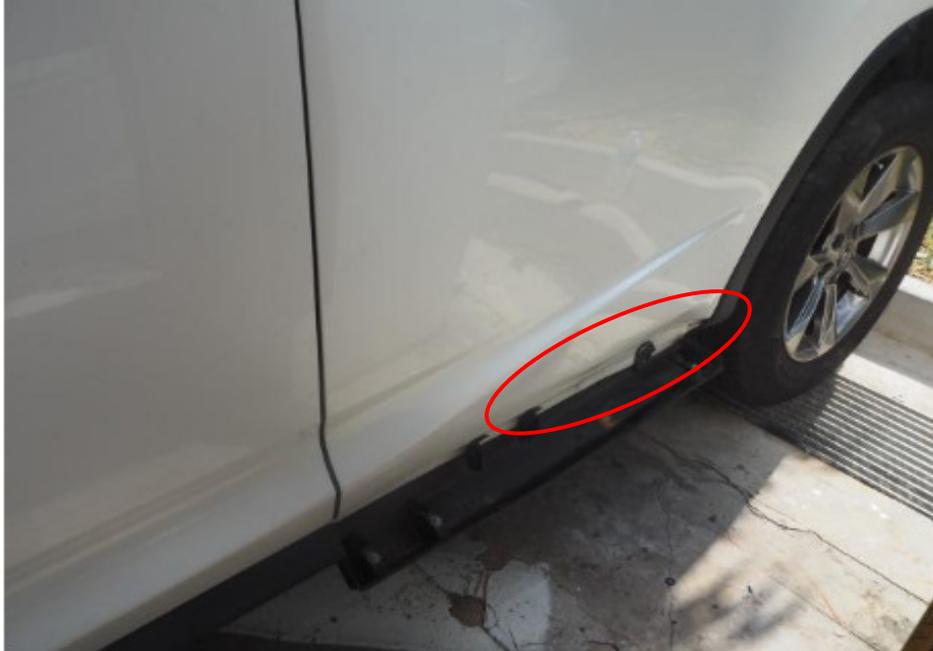
Photo 7 shows a closer view of the deformed left rear door of the Insured Vehicle (circled) post- incident.

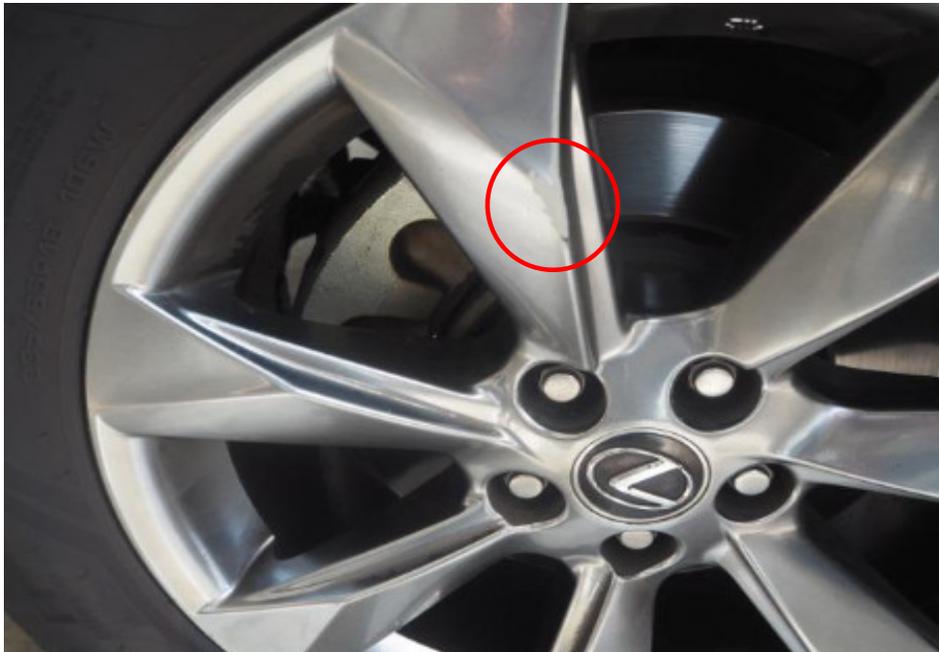
Photo 8 shows a close up view of the damages on the left front wheel rim (circled) as a result of Mr Lim running over an object and mounting the kerb.

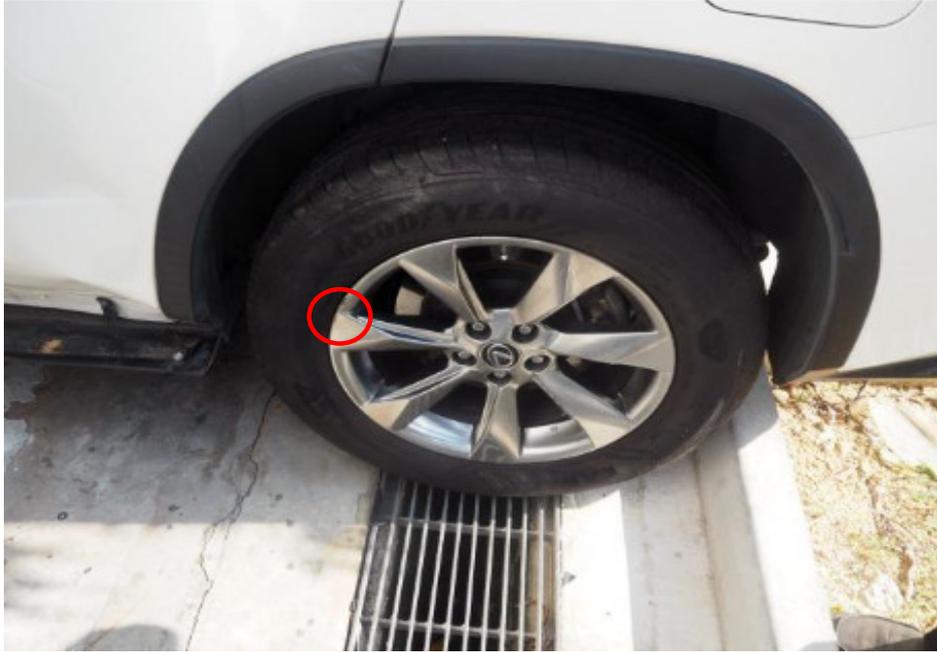
Photo 9 shows the relatively minor marks of grazing nature observed around the edges of the left rear wheel rim (circled) as a result of Mr Lim running over an object and mounting the kerb.

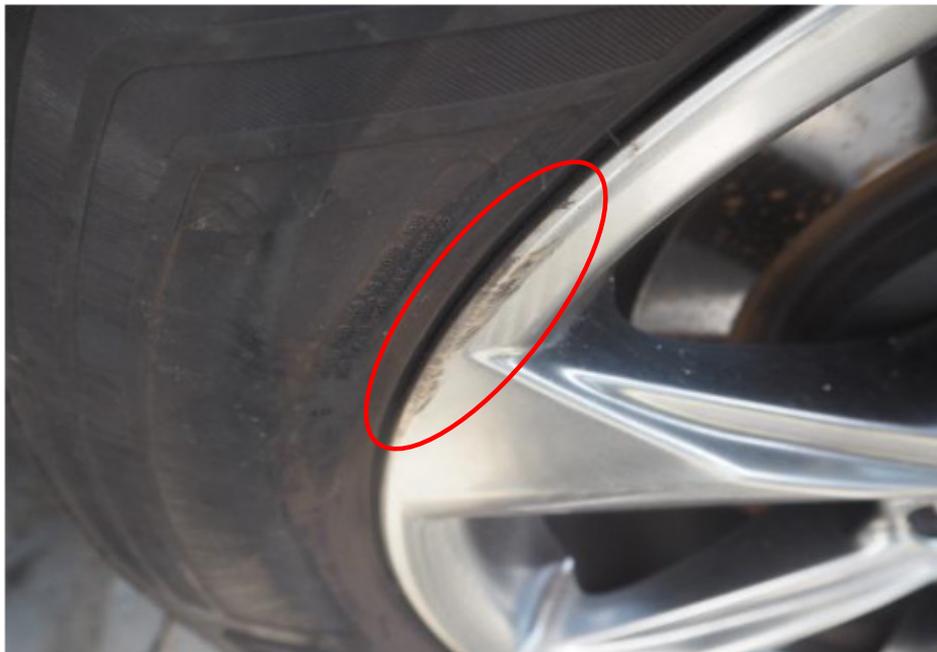
Photo 10 shows a close up view of the relatively minor marks of grazing nature observed around the edges of the left rear wheel rim (circled) as a result of Mr Lim running over an object and mounting the kerb.
