# LKK Auto Consultants Pte Ltd

### ADJUSTMENT ON REPAIR COST FOR VEHICLE NO. SKX 9729R

PHOTOGRAPHS FOR VEHICLE NO. SKX 9729R

INSPECTION

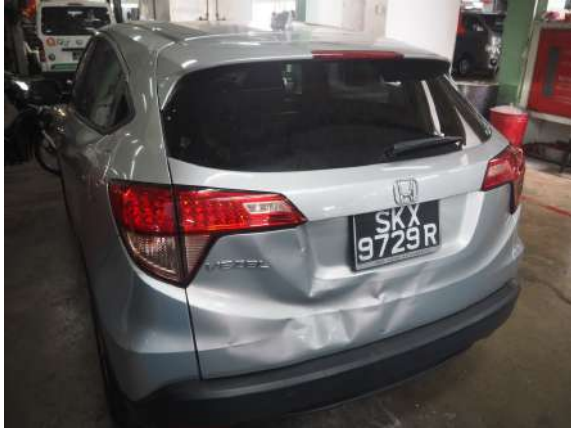
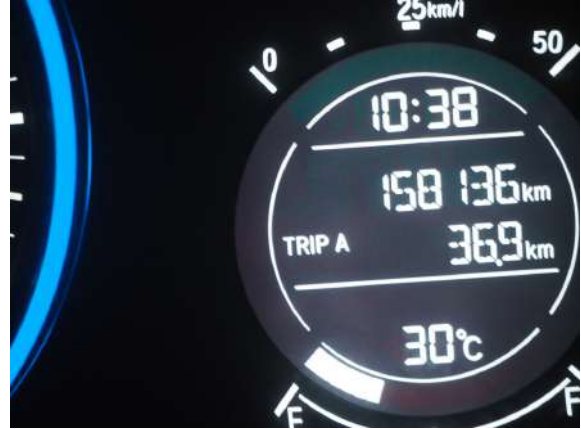
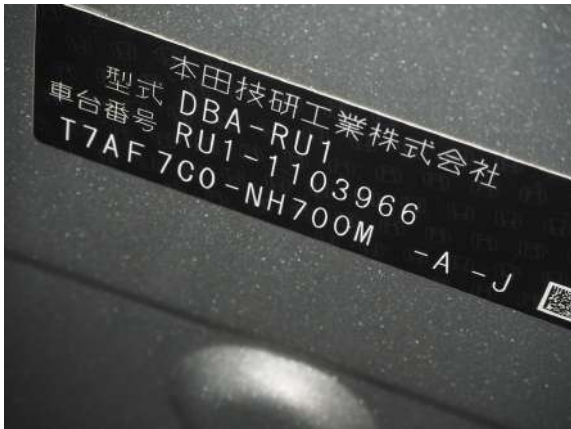
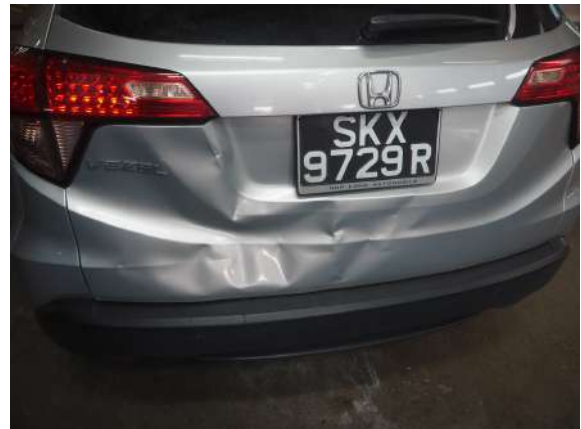
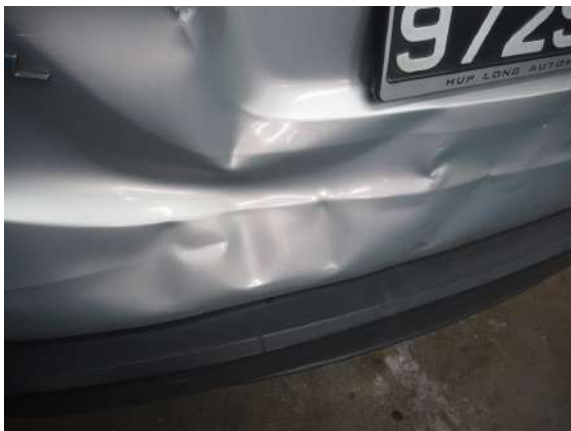
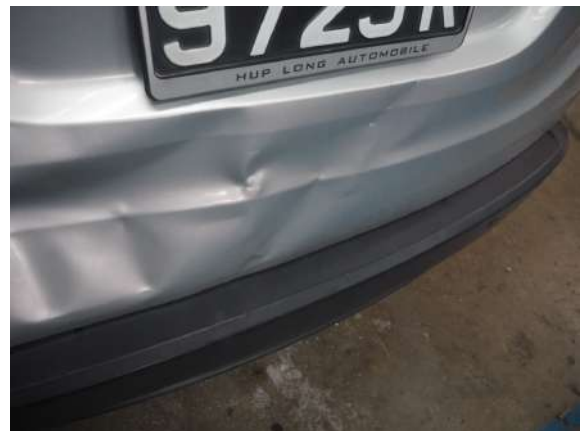
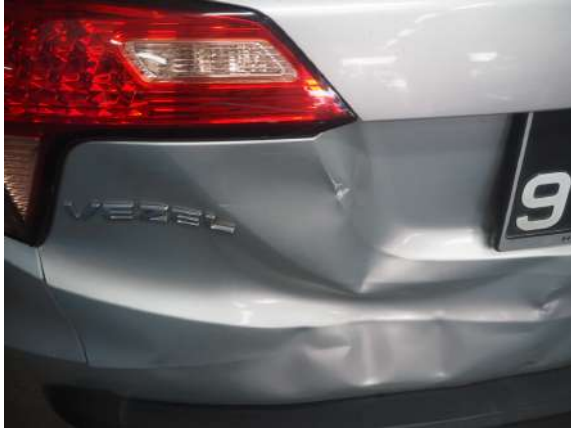
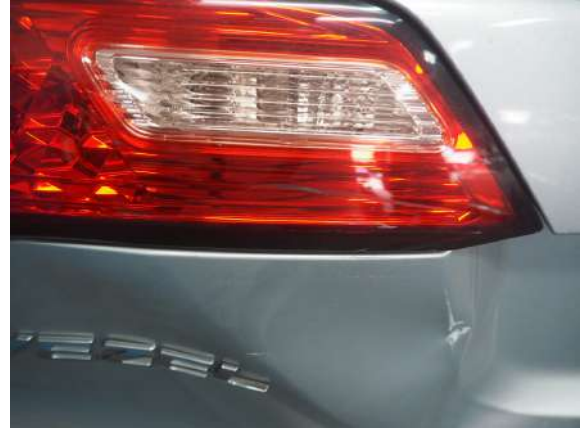
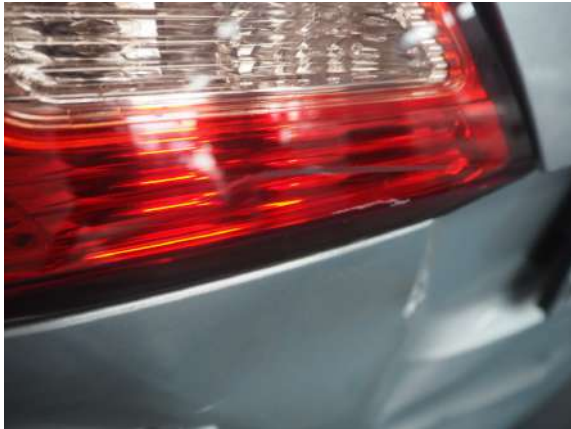
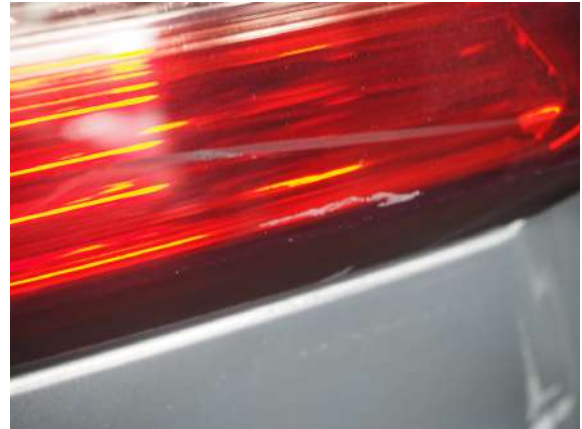
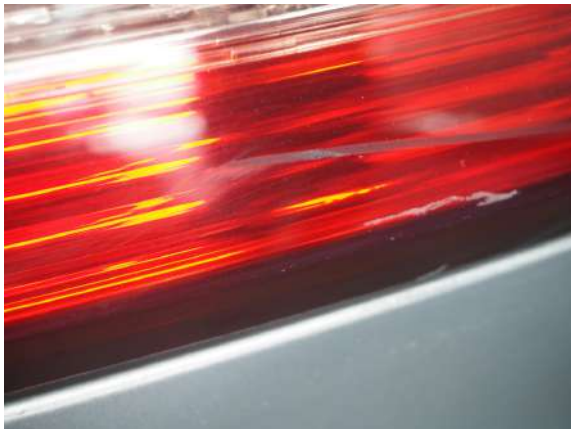
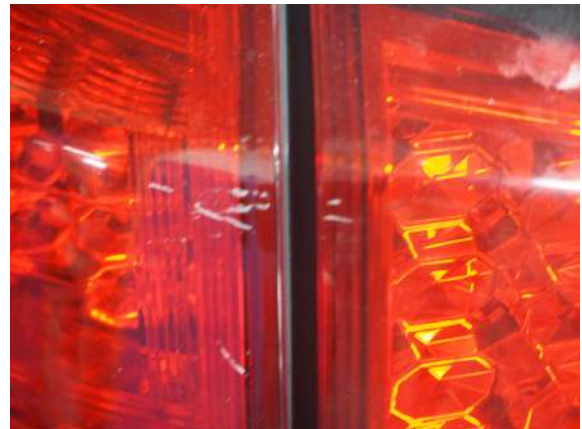
| Affiliated to Federation Internationale Des Experts En Automobile | | | | |
|---|---|---|---|---|
| THE VEHICLE SUSTAINED DAMAGES AT THE REAR PORTION. | | | | |
