Our Ref : CI/TP22008145/N

17 August 2022

Ethoz Protect Pte. Ltd.22 Tampines Street 92
Singapore 528876
(Claims Division)**TECHNICAL INVESTIGATION REPORT OF FIRE INCIDENT INVOLVING THE
INSURED VEHICLE GBH 7701Z ON 19 JULY 2022**

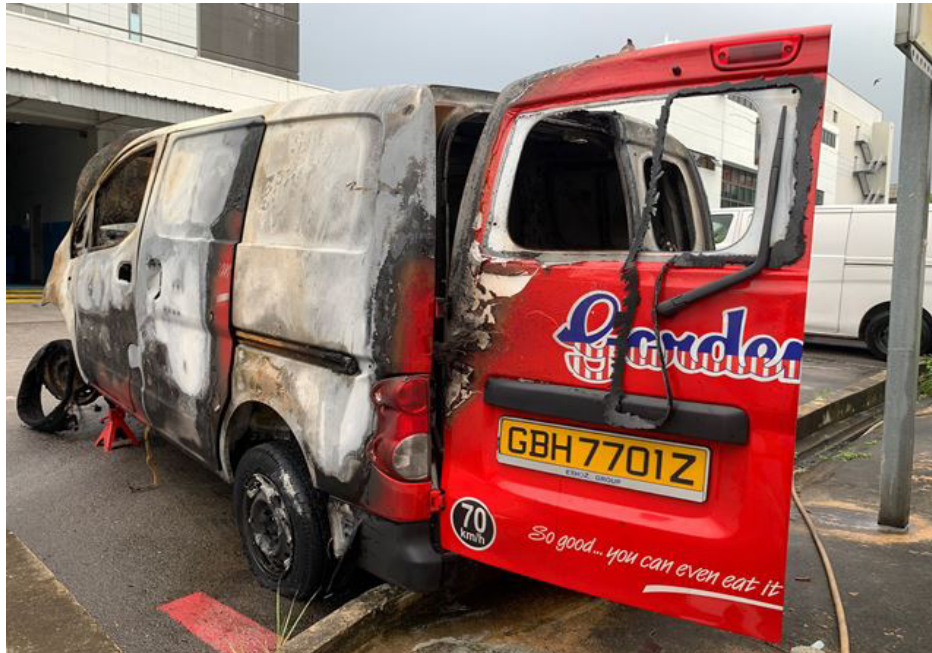
Photo 1 shows the general view of the left rear portion of the Insured Vehicle at the time of our inspection. The Insured Vehicle was observed to have sustained extensive fire damage all around. Rust had accumulated all over the Insured Vehicle as a result of exposure to environmental condition for a period of time.

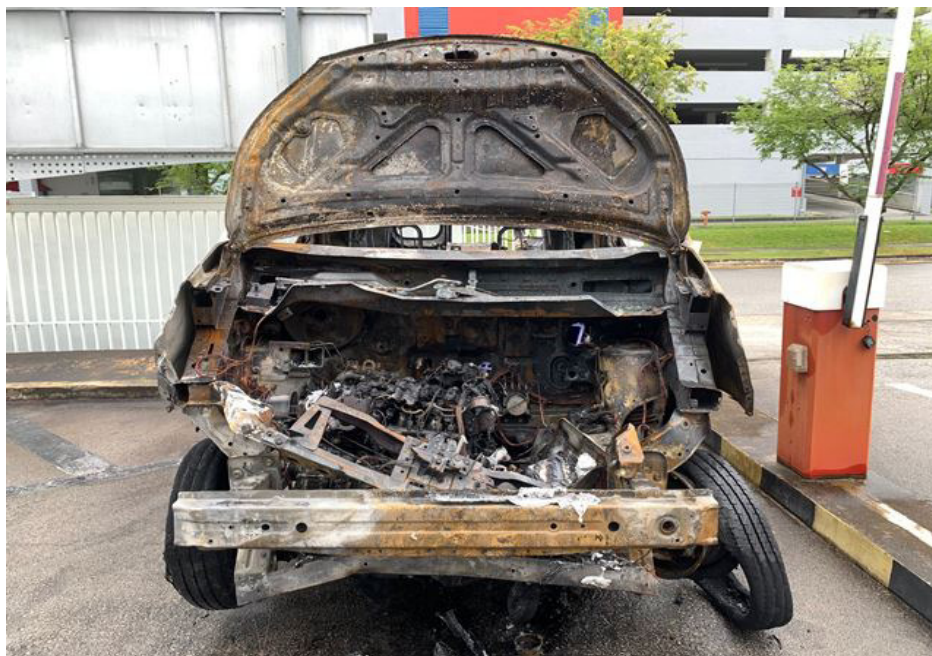
Photo 2 shows the general view of the frontal portion of the Insured Vehicle at the time of our inspection. The Insured Vehicle was observed to have sustained extensive fire damage all around. Its engine compartment and interior compartment were completely burnt. Rust had accumulated all over the Insured Vehicle as a result of exposure to environmental condition for a period of time.

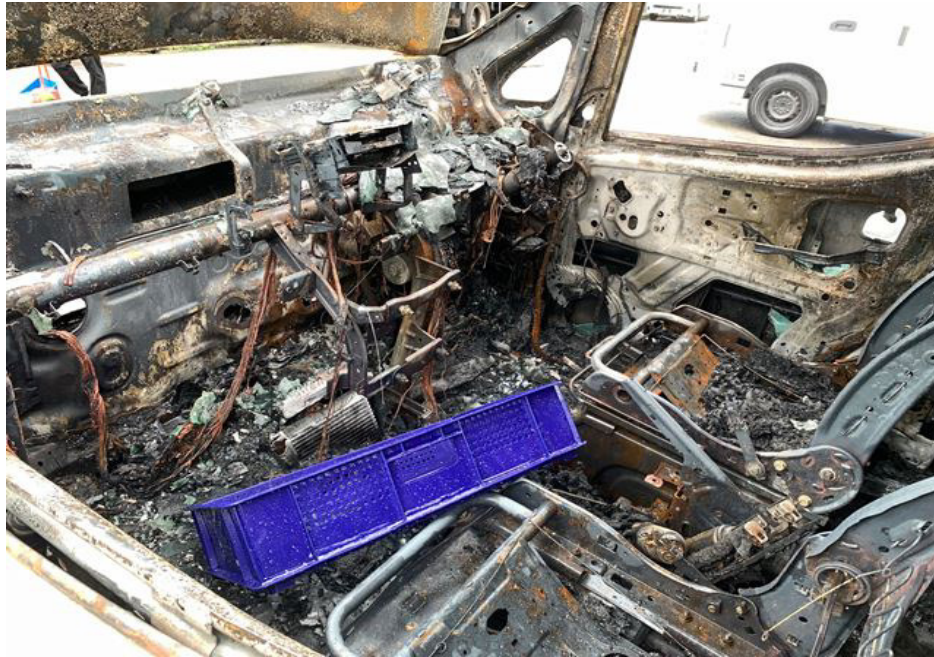
Photo 3 shows the general view of the interior compartment of the Insured Vehicle at the time of our inspection. Its interior compartment was completely burnt.

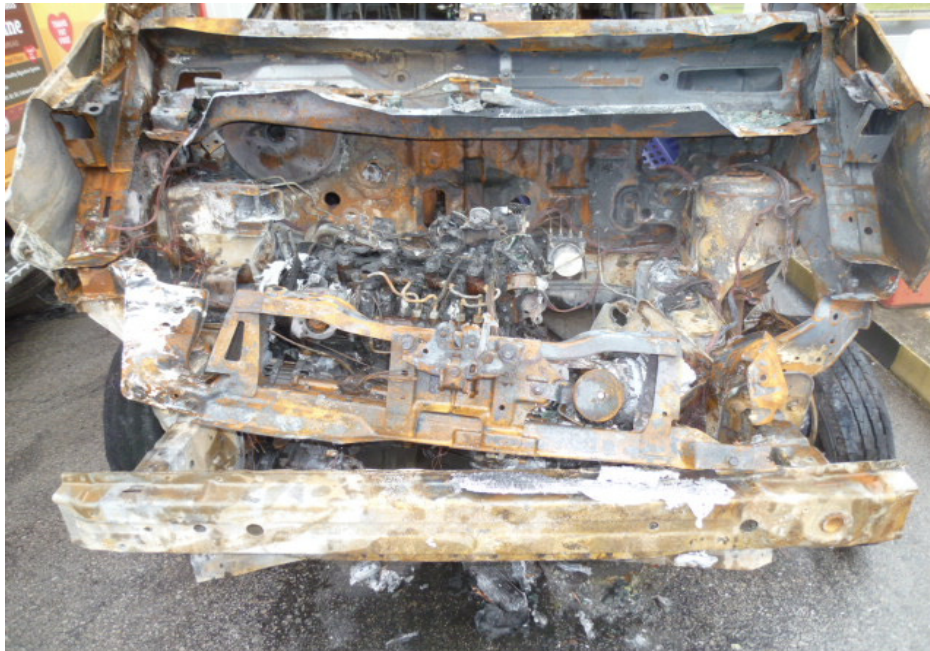
Photo 4 shows the engine compartment of the Insured Vehicle at the time of our inspection. The entire engine compartment of the Insured Vehicle was observed to be severely burnt. Most of the parts inside the engine compartment were found to be burnt and/or melted as a result of the fire.

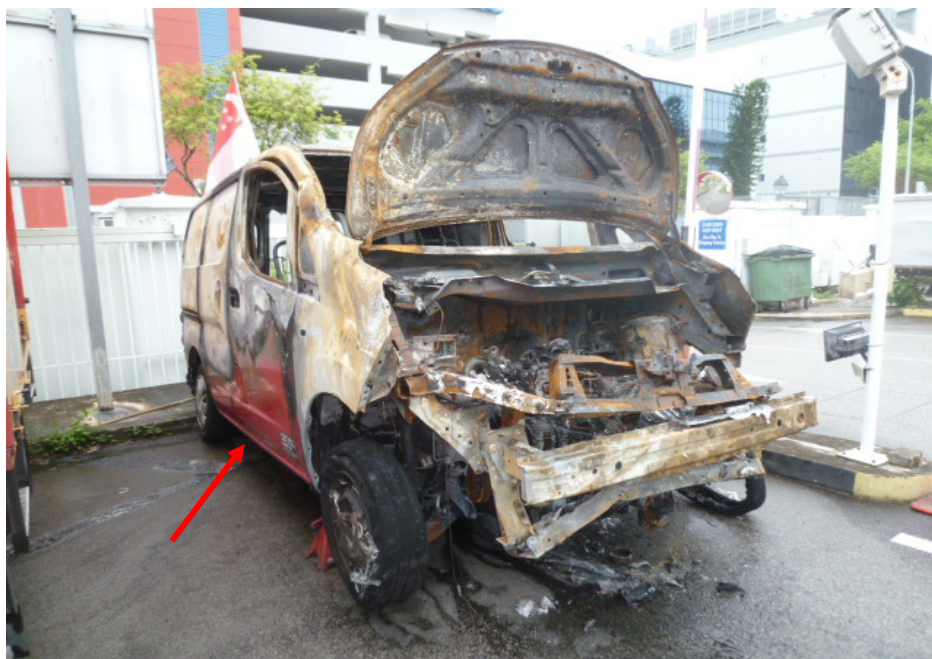
6. For this particular case, the fire appears to have originated within the engine compartment of the Insured Vehicle, somewhere around the left portion of the engine compartment due to the nature of the fire damage which was more extensive at the left portion. This can also be determined from the burn pattern and the high heat intensity burn marks (whitish burn marks) found on the left portion of the bonnet of the Insured Vehicle. The whitish burn marks are a result of exposure to prolonged heat intensity. See photos 5 & 6 below.

Photo 5 shows the right body of the Insured Vehicle. The nature of the fire damage was less extensive at the right portion (arrowed).

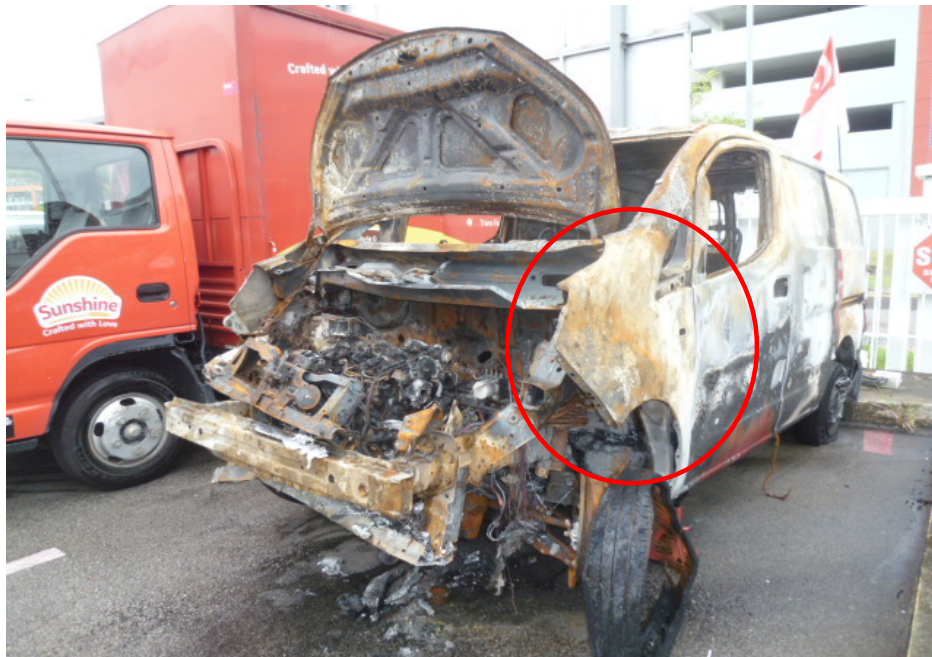
Photo 6 shows the burn pattern and whitish burn marks that were found on the left front fender of the Insured Vehicle (circled). Such whitish burn marks are a result of exposure to prolonged heat intensity, which may indicate where the fire had started.

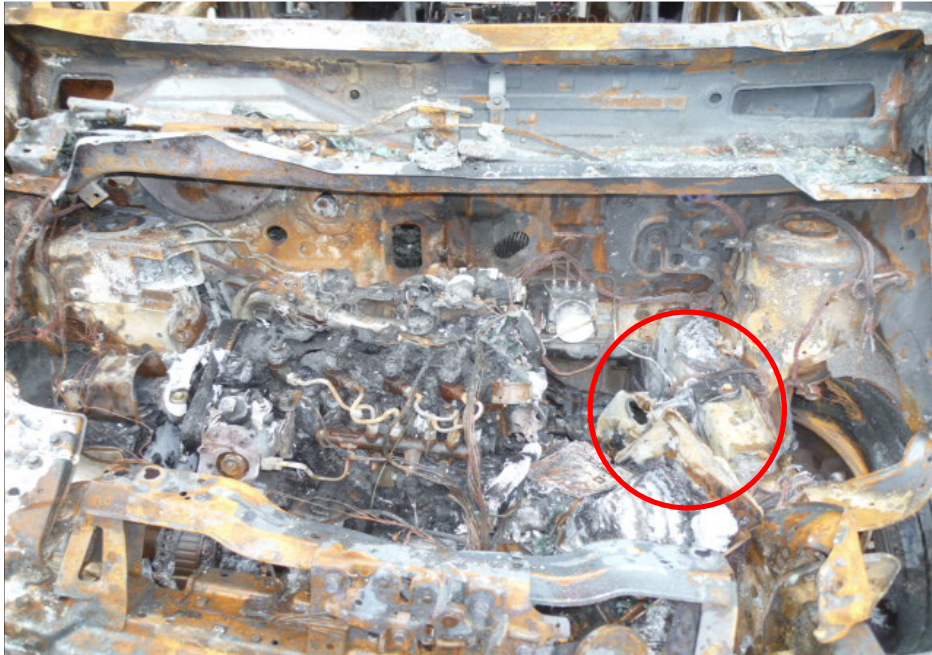
7. Upon closer examination of the left portion of the engine compartment, which was where the fire to the Insured Vehicle had likely started, we had found traces of greenish residue on several stretches of burnt wirings leading from the Engine Control Module (ECM). The presence of greenish residue indicates internal heating of copper wires, a sign of an electrical short circuit occurring. The greenish residue is normally left behind from oxidation as a result of chemical reaction involving the copper wires. This physical evidence would then appear to suggest that the cause of fire to the Insured Vehicle could have possibly been due to electrical in nature. See photos 7 - 10 below.

Photo 7 shows the burnt wirings leading from the ECM around the left portion of the engine compartment (circled), which is in the immediate vicinity where the fire to the Insured Vehicle had likely started.

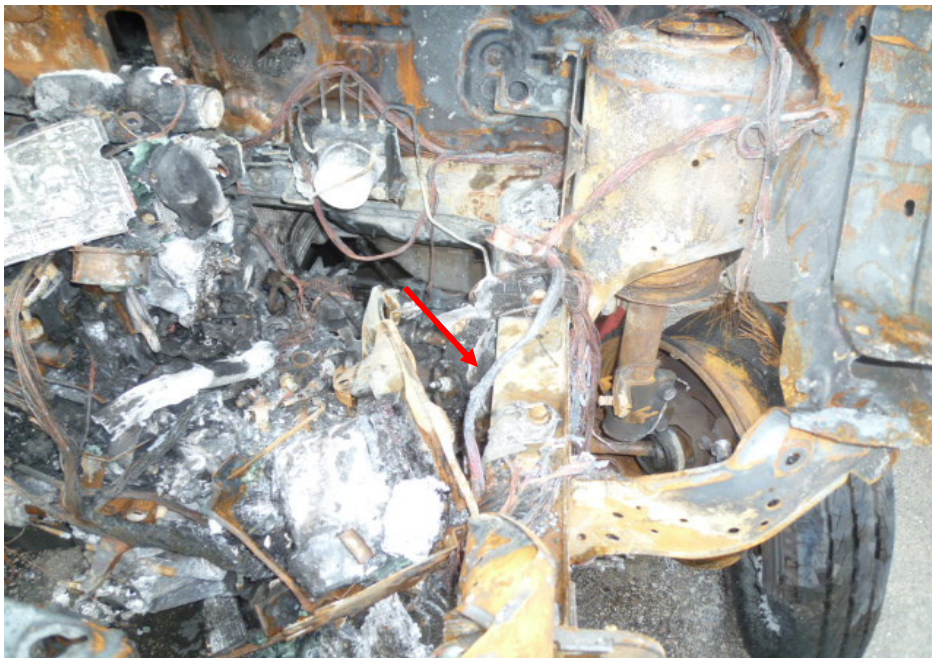
Photo 8 shows a closer view of the burnt wirings leading from the ECM around the left portion of the engine compartment, which is in the immediate vicinity where the fire to the Insured Vehicle had likely started. We noticed greenish residue on several stretches of burnt wirings (arrowed). The presence of greenish residue indicates internal heating of copper wires, a sign of an electrical short circuit occurring. The greenish residue is normally left behind from oxidation as a result of chemical reaction involving the copper wires.

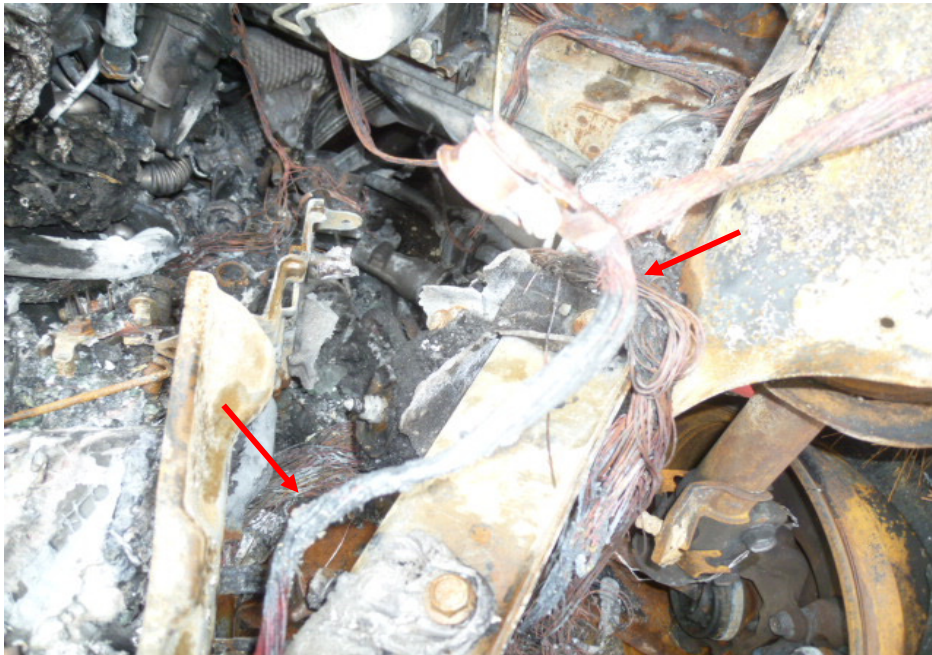
Photo 9 shows a closer view of the greenish residue found on several stretches of burnt wirings leading from the ECM (red arrows). The presence of such greenish residue suggests occurrence of an electrical short circuit.

21. Having investigated and technically analysed the damages to the Insured Vehicle, we are of the view that the cause of fire to the Insured Vehicle was of electrical in nature. For this particular case, the fire had originated along the wirings inside the engine compartment, leading from the ECM. The wirings were original factory wirings of the Insured Vehicle.
22. We did not find any evidence which had suggested that the cause of fire to the Insured Vehicle was due to poor maintenance and/or recurring electrical problem.
23. There were no modification(s) or additional electronic and/or electrical component(s) fitted on the Insured Vehicle at the time of our inspection of the Insured Vehicle.

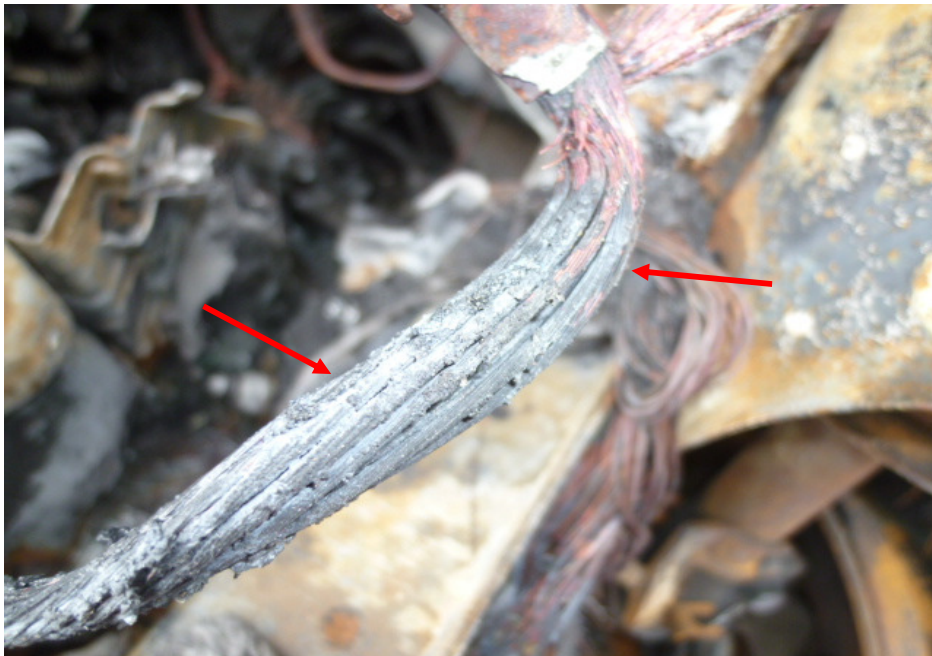
Photo 10 shows a close up view of the greenish residue found on several stretches of burnt wirings leading from the ECM (red arrows). The presence of such greenish residue suggests occurrence of an electrical short circuit.

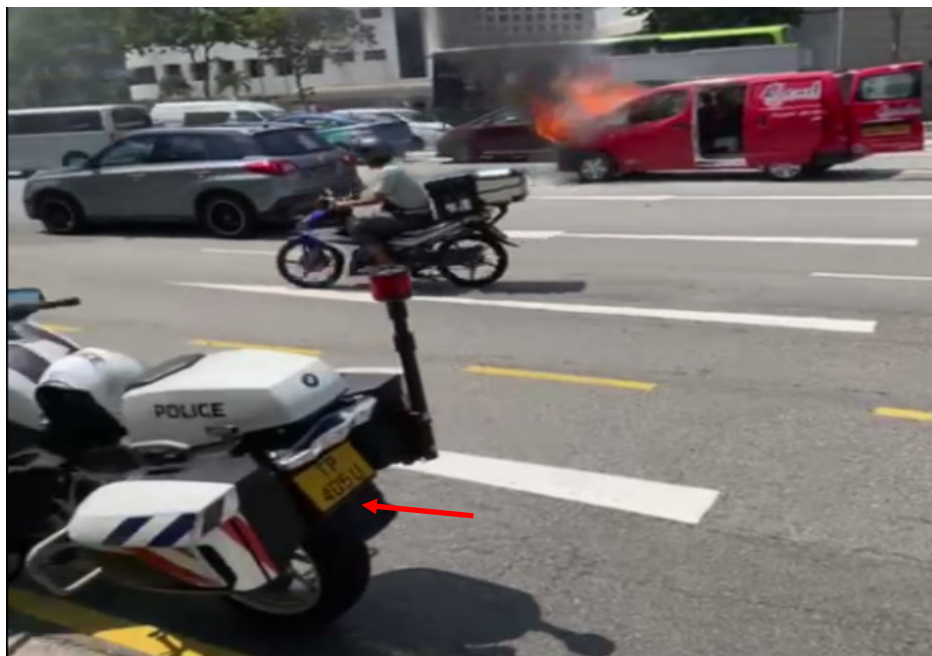
Photo 11 shows the Insured Vehicle on fire before the arrival of the SCDF. In general, the information that could be gathered from this photograph had corresponded to the events that were related to us by Mr Chua which is a Traffic Police officer had attended to the incident (arrowed).

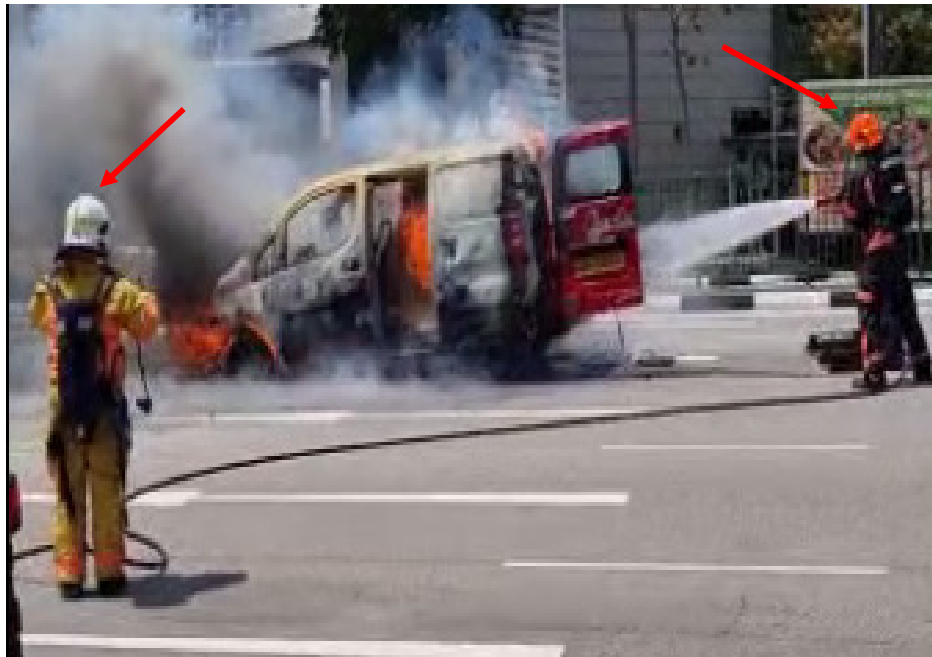
Photo 12 shows the SCDF attempting to put out the fire on the Insured Vehicle (arrowed).

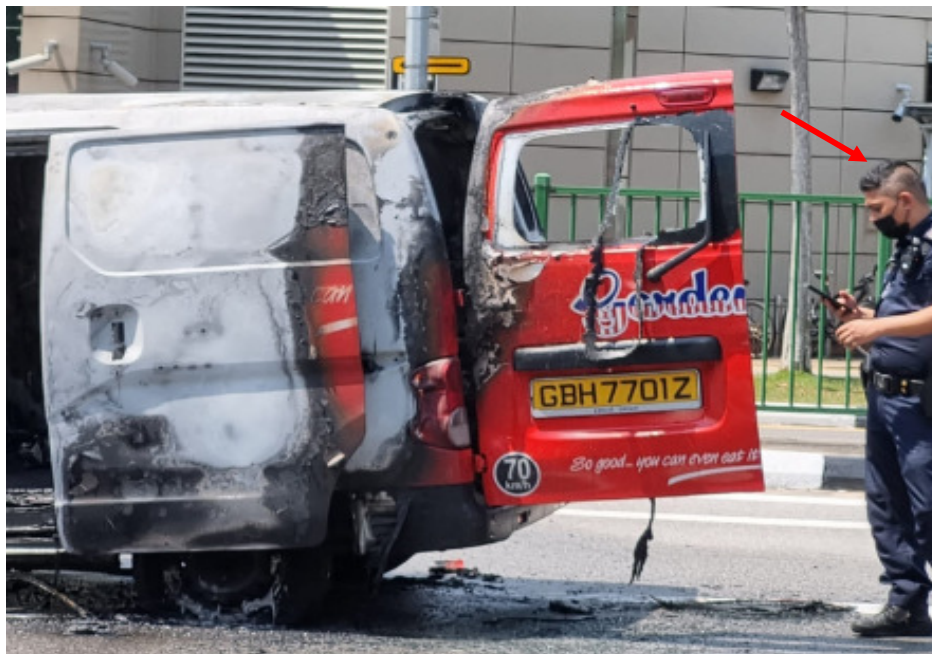
Photo 13 shows the Insured Vehicle post- incident. In general, the information that could be gathered from this photograph had corresponded to the events that were related to us by Mr Chua which is the police were present at the incident location (arrowed).

18. The possibility of the fire being due to external factors (foreign material(s) stuck on hot surfaces, arson and sabotage amongst others) would also seem unlikely given that our examination of the available incident scene photographs did not reveal any unusual material(s)/object(s) found on the ground where the Insured Vehicle was positioned. The location of where the Insured Vehicle was positioned was also observed to be not at a secluded location.
