Your Ref: TP/IP/12980/2022
Our Ref: CI/TPD22008161/P

8th September 2022

MECHANICAL INSPECTION REPORT OF MOTOR VAN PA 9648C

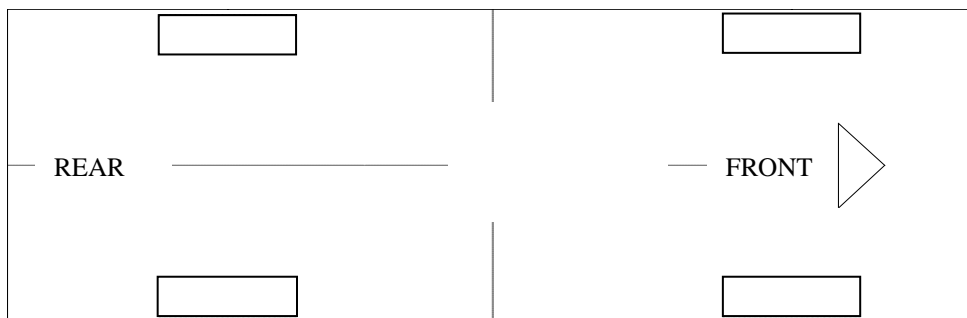
6. The 4 tyres of the Motor Van were observed to be in serviceable condition and sufficiently inflated for vehicular operation. I did not find any tear, cut or burst mark(s) on the outer and the inner sidewalls as well as across the tread of the 4 tyres. The tyre brand, tyre size and remaining tread depth of the 4 tyres of the Motor Van were recorded as follows:-

Yokohama 195/R15 (2mm)

Bridgestone 195/R15 (7.4mm)

Yokohama 195/R15 (2.5mm)

Bridgestone 195/R15 (7.7mm)

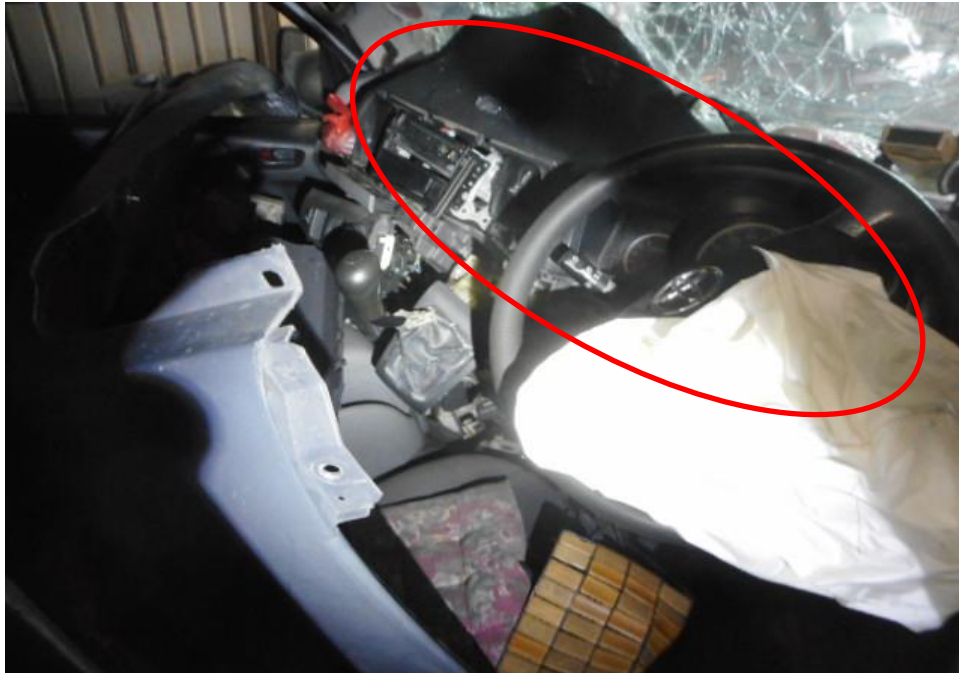
Photo 1 shows the close up view of the front portion of the Motor Van at the time of our inspection. The Motor Van was observed to have sustained major damages to its dashboard (circled) that was crushed due to the accident's impact.

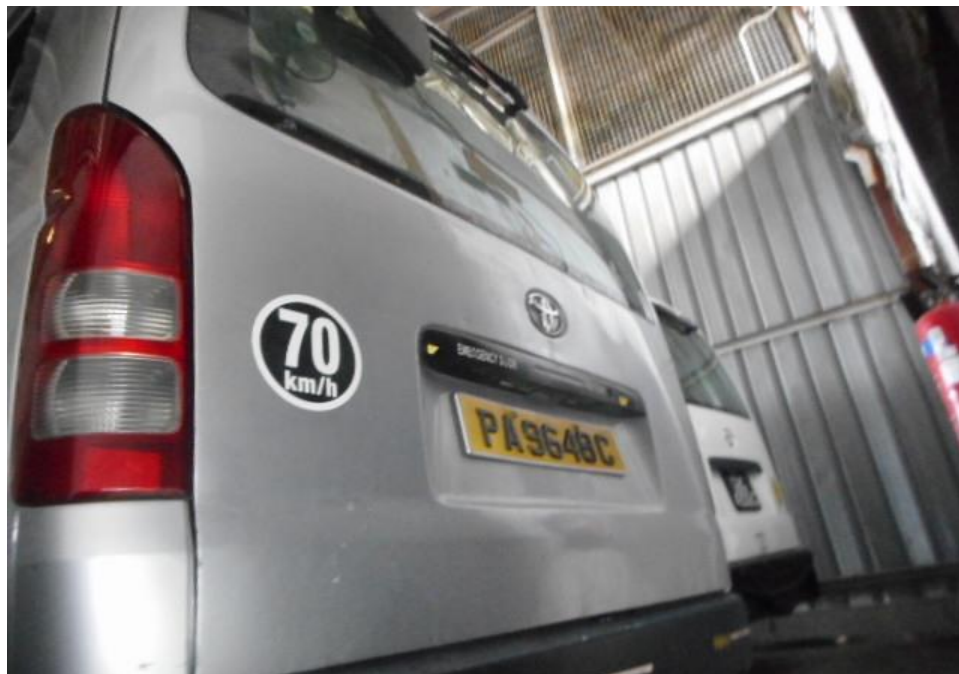
Photo 2 shows the general view of the Motor Van's rear body at the time of my inspection. The Motor Van rear was observed to be unaffected by the accident.

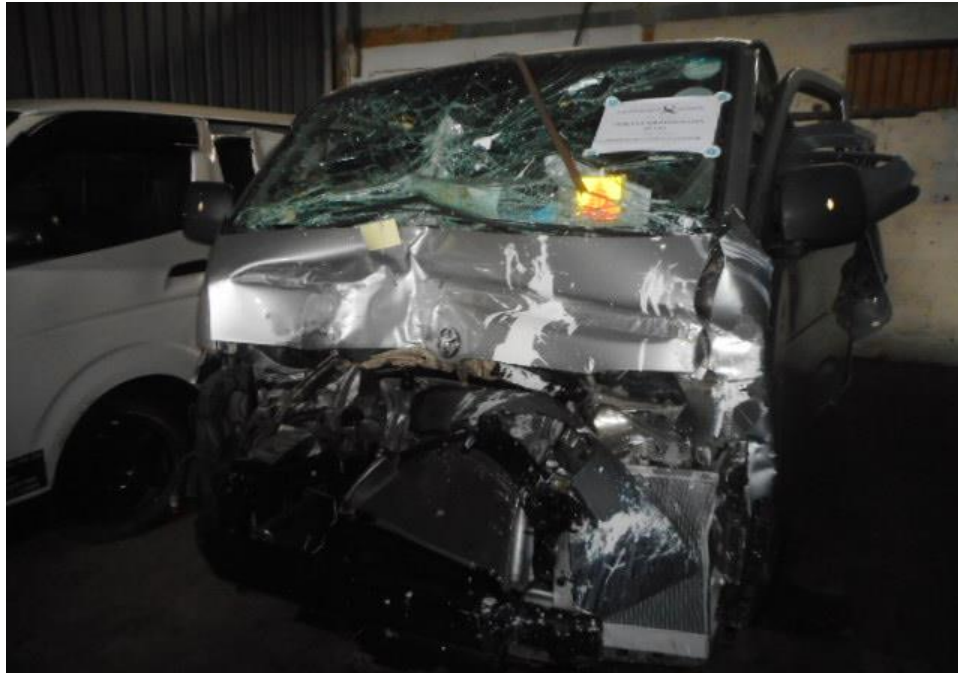
4. The mileage of the Motor Van at the time of my inspection was not recorded as the dashboard of the Motor Van was damaged as a result of the accident.
5. The Motor Van was observed to have sustained damages at its front, right and left portion. Its front windscreen, front body panel, front grille, front bumper, right and left doors was the body parts that were damaged and various engine components was also damaged as a result of the accident. The Supplemental Restraint System (SRS) was activated as a result of the accident.

Photo 3 shows a general view of the front portion of the Motor Van at the time of our inspection. The Motor Van was observed sustained major damages to its front, right and left portion. Its front windscreen, front body panel, front grille, front bumper, right and left doors was the body parts that were damaged and various engine components was also damaged as a result of the accident. The Supplemental Restraint System (SRS) was activated as a result of the accident.

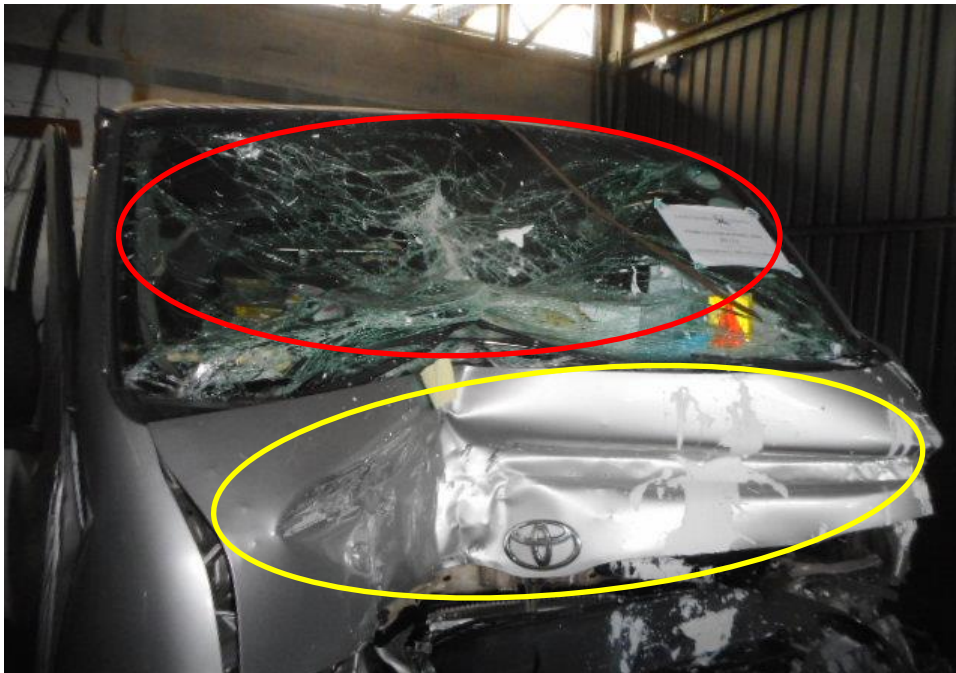
Photo 4 shows the close up view of the front portion of the Motor Van at the time of our inspection. The Motor Van was observed to have sustained major damages to its front windscreen (red circle) and front body panel (yellow circle) as a result of the accident.

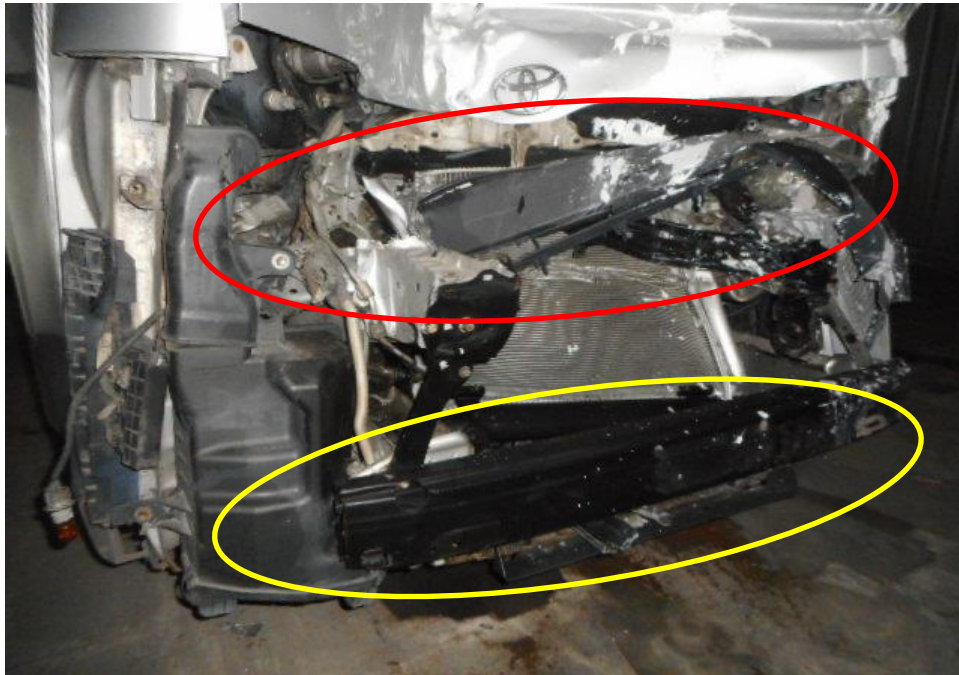
Photo 5 shows the close up view of the front portion of the Motor Van at the time of our inspection. The Motor Van was observed to have sustained major damages to its front grille (red circle) and front bumper (yellow circle) that was damaged as a result of the accident's impact.

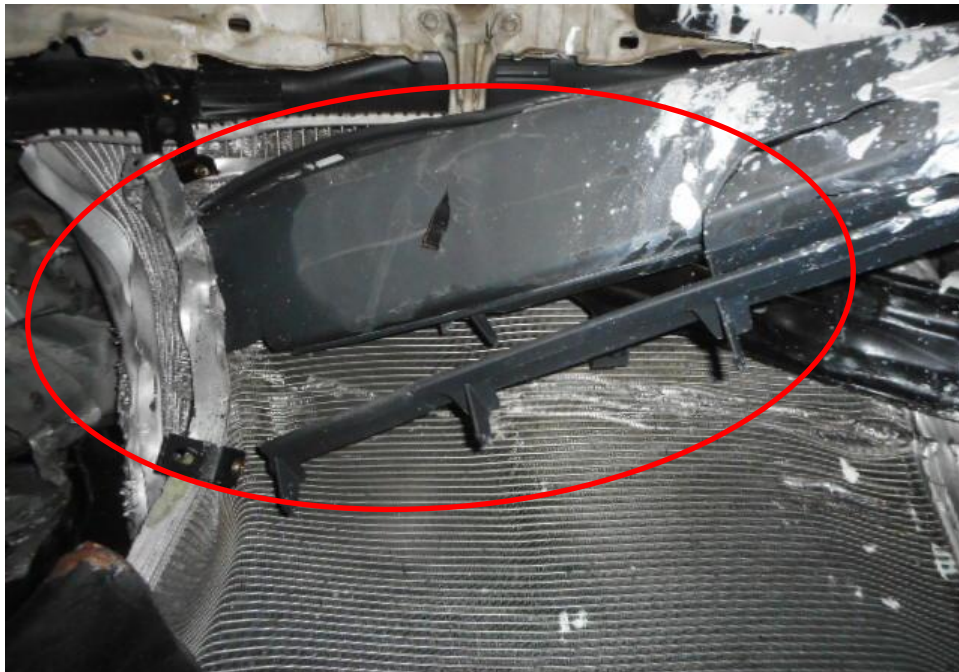
Photo 6 shows the close up view of the front portion of the Motor Van at the time of our inspection. The Motor Van was observed to have sustained major damages to its front engine coolant radiator (circled) was damaged as a result of the accident's impact.

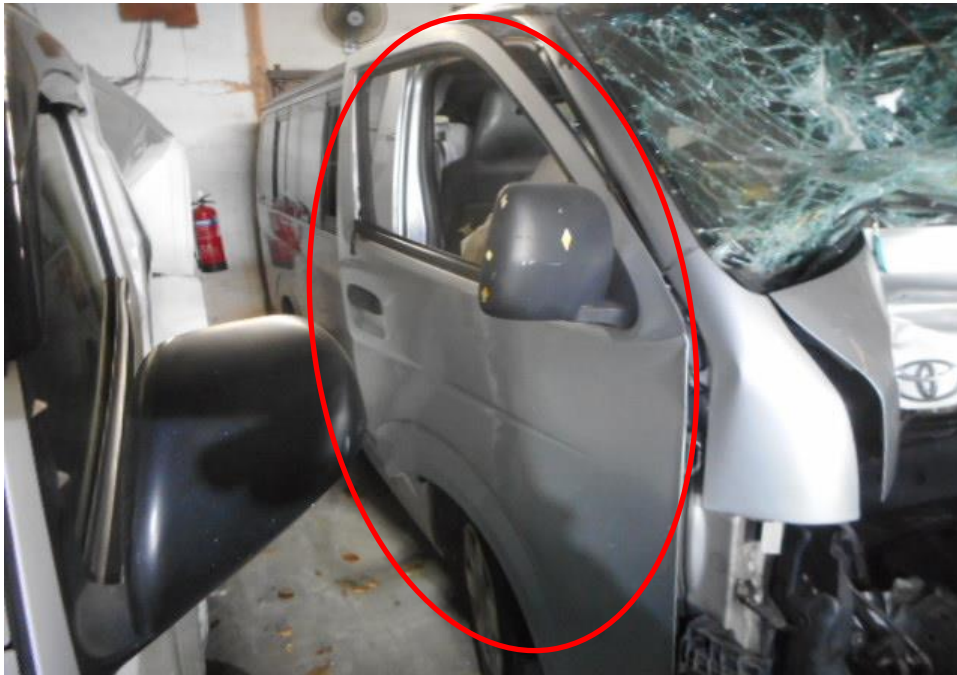
Photo 7 shows the close up view of the right door of the Motor Van at the time of our inspection. The Motor Van was observed to have sustained damages to its right door (circled) as a result of the accident.

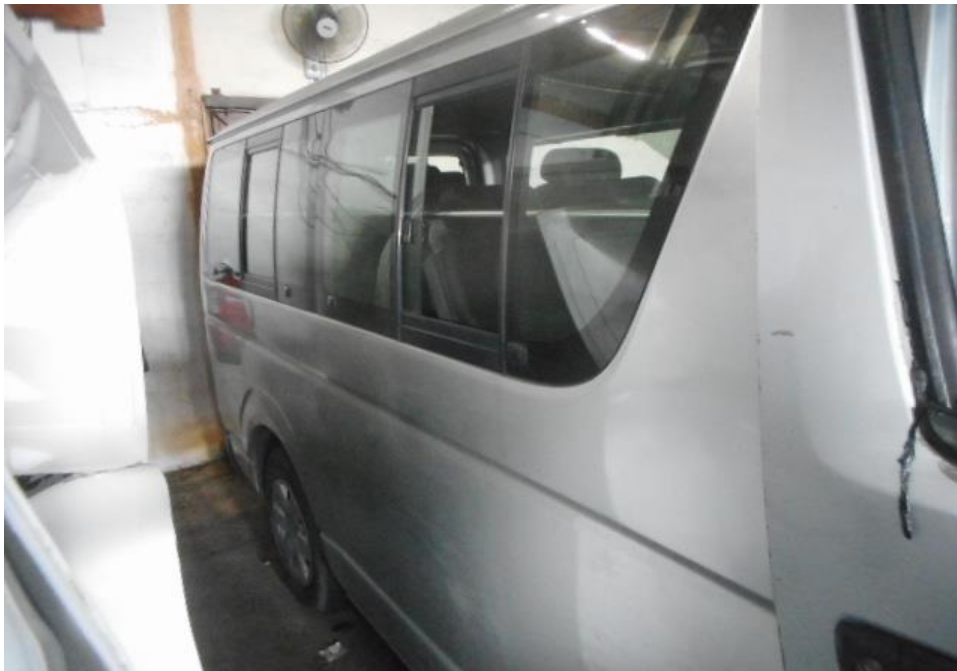
Photo 8 shows a general view of the Motor Van's right body at the time of my inspection. The right portion of the Motor Van was observed to have been unaffected by the accident.

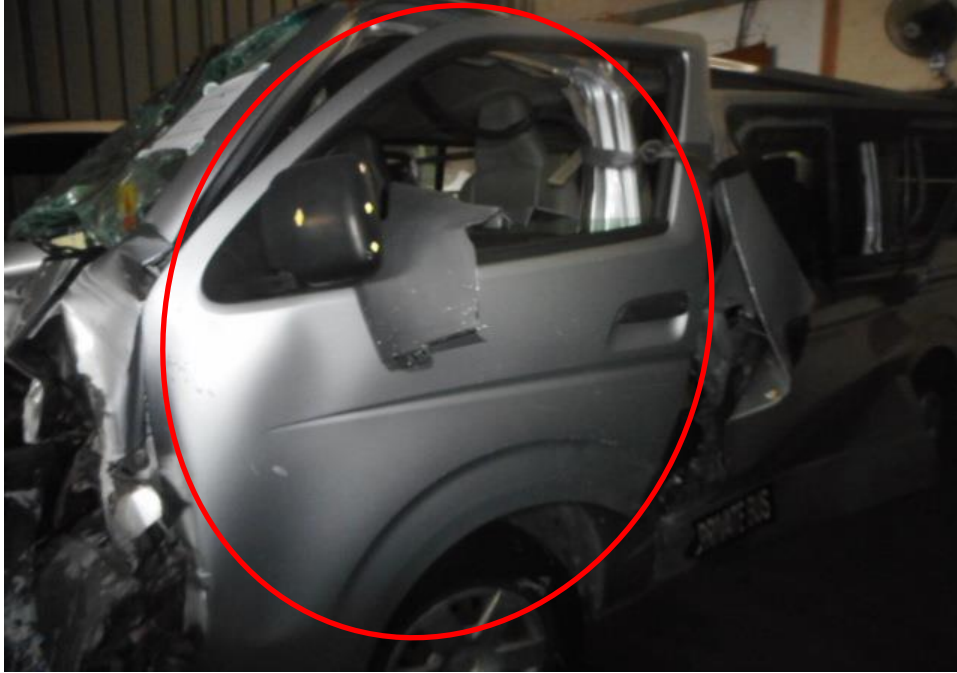
Photo 9 shows the close up view of the left door of the Motor Van at the time of our inspection. The Motor Van was observed to have sustained damages to its right door (circled) as a result of the accident.

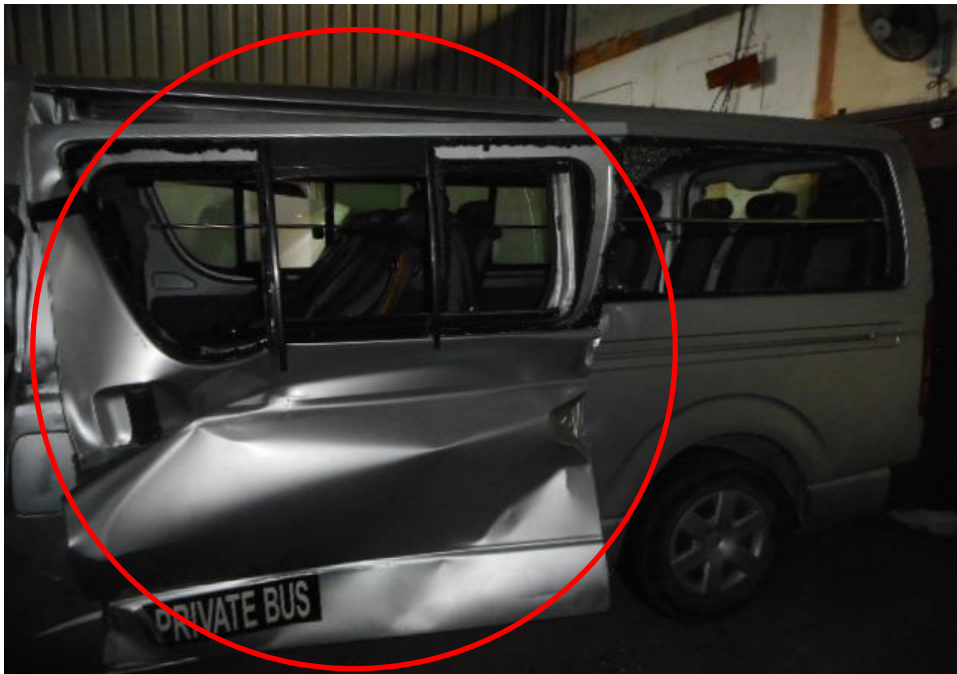
Photo 10 shows a general view of the Motor Van's left body at the time of my inspection. The Motor Van was observed to have sustained damages to its left rear door and windscreen (circled) as a result of the accident.

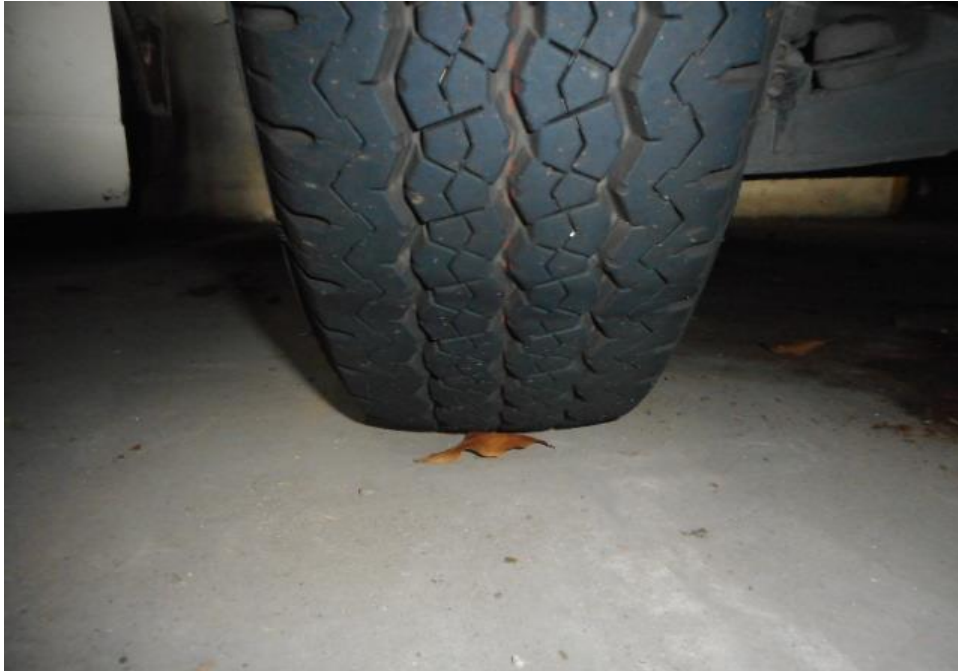
Photo 11 shows the condition of the front right tyre of the Motor Van, which were observed to be in serviceable condition with remaining, tread depth of approximately 7.7mm. The tyre, which was wrapped around standard steel wheel rim, it was observed to be sufficiently inflated for vehicular operation.

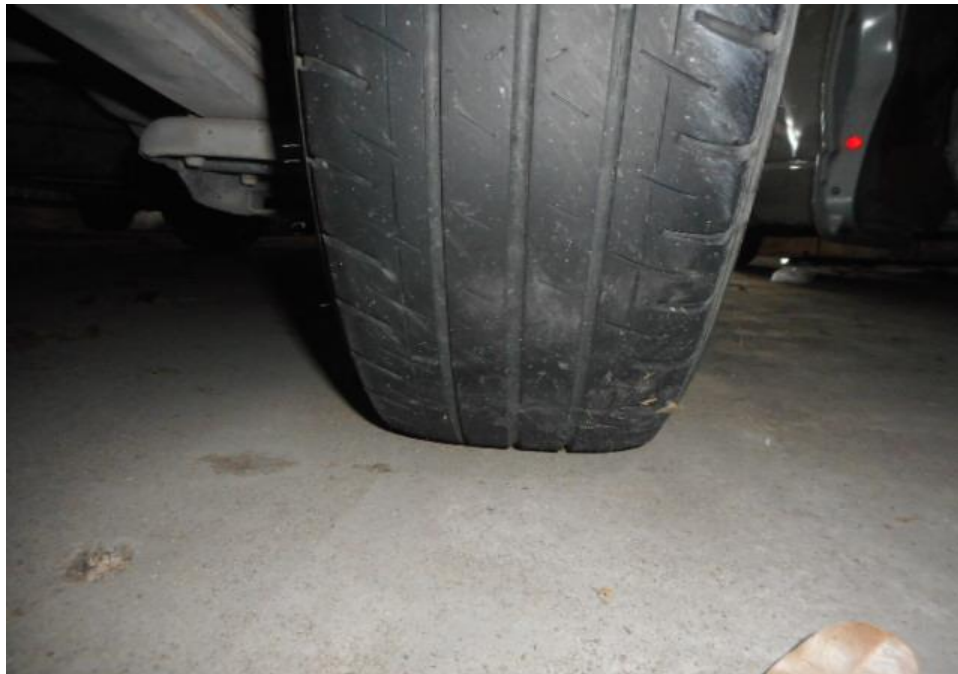
Photo 12 shows the condition of the rear right tyres of the Motor Van, which were observed to be in serviceable condition with remaining, tread depth of approximately 2.5mm. The tyre, which was wrapped around standard steel wheel rim, it was observed to be sufficiently inflated for vehicular operation.

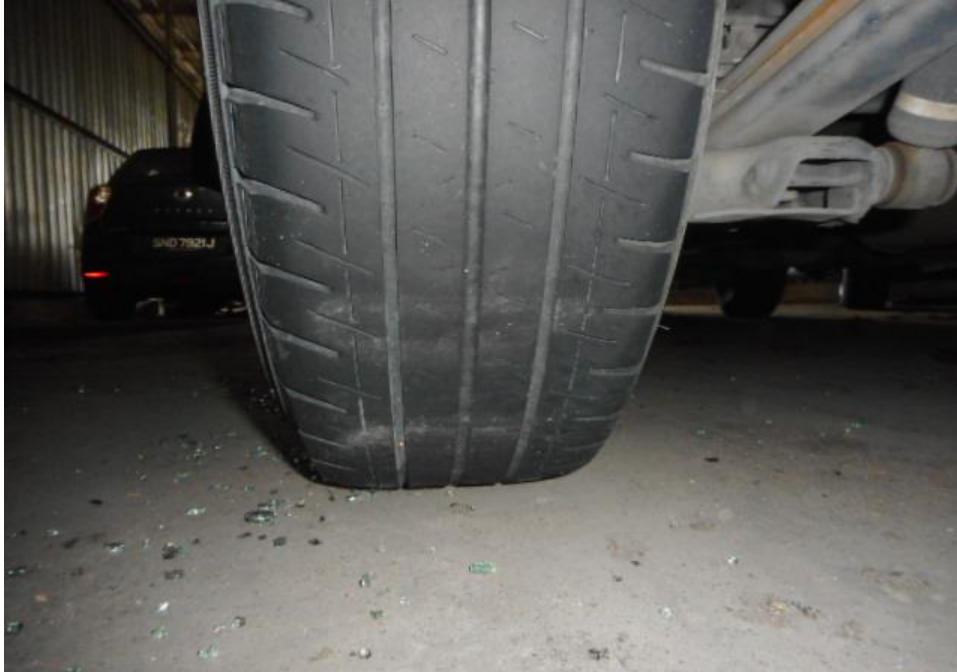
Photo 13 shows the condition of the rear left tyres of the Motor Van, which were observed to be in serviceable condition with remaining, tread depth of approximately 2mm.

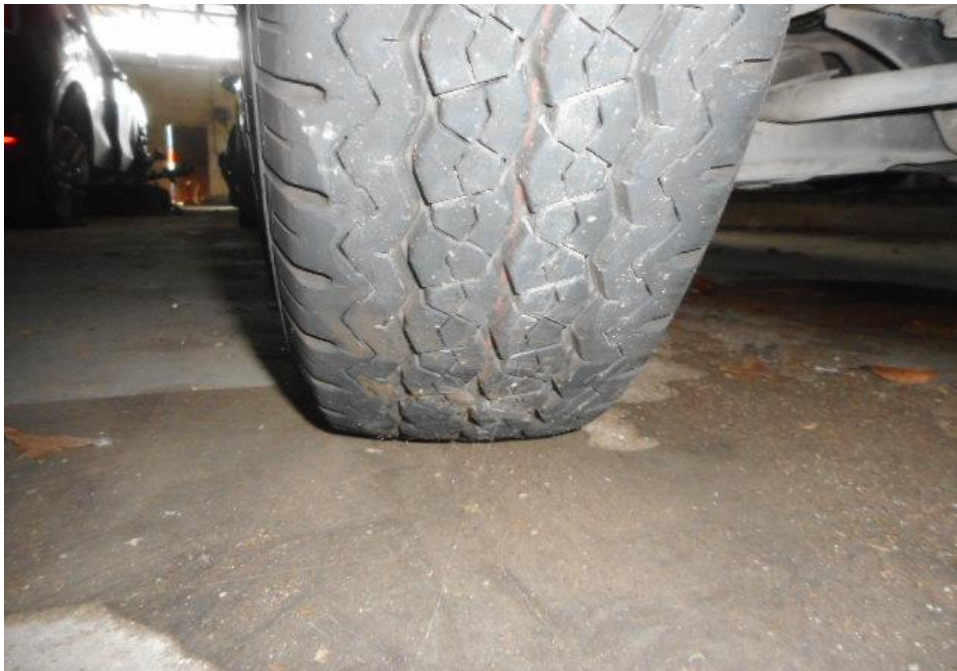
Photo 14 shows the condition of the front left tyre of the Motor Van, which were observed to be in serviceable condition with remaining, tread depth of approximately 7.4mm. There was also no tear, cut or burst mark(s) on the outer and the inner sidewalls as well as across the tread of the 4 tyres that were fitted on the Motor Van.

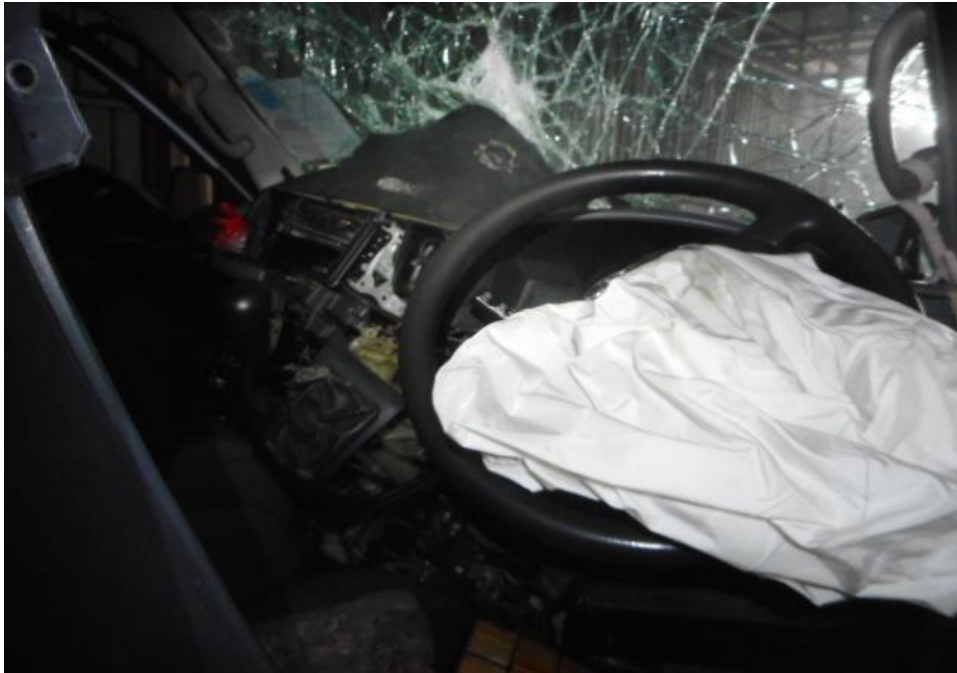
Photo 15 shows the deployment of the Supplemental Restraint System (SRS) airbag in the Motor Car as a result of the accident.

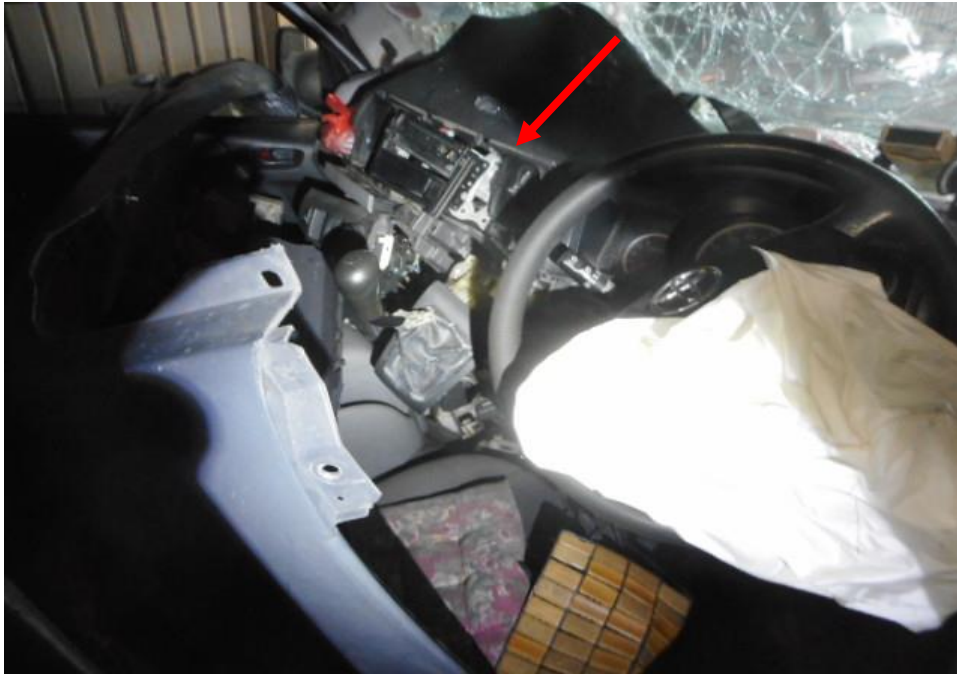
7. Upon examination of the Motor Van's engine compartment, we had observed that all the parts, components and fluids could not be inspected as due to the damage induced has crushed and deformed the dashboard and the cabin of the Motor Van which immobilized its opening and viewing.
8. Our subsequent checks on the underside of the Motor Van visually, the various undercarriage components of the Motor Van were observed to be intact and without any visible damage. See photos 16 and 17 below.

Photo 16 shows the induced damage to the dashboard of the front cabin (arrowed) of the Motor Van's which had immobilised the opening and viewing of the various parts and components inside the engine compartment a result of the accident.

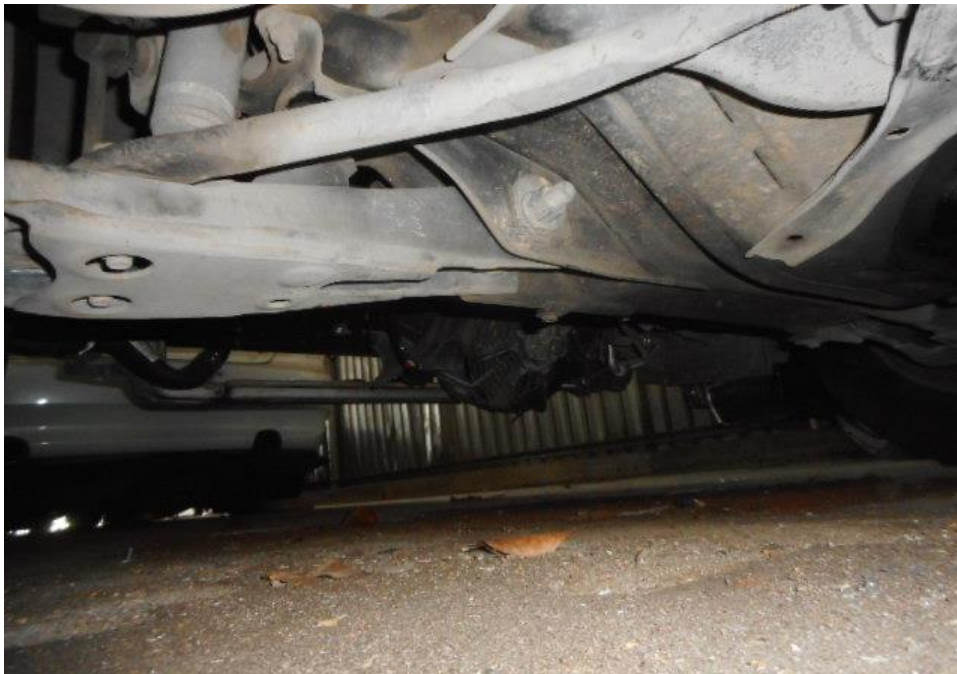
Photo 17 shows the undercarriage of the Motor Van, at the area where the engine housing and transmission housing are located. I did not find any sign(s) or indication(s) of fluid leak and/or fluid stain(s) on the underside of the Motor Van.

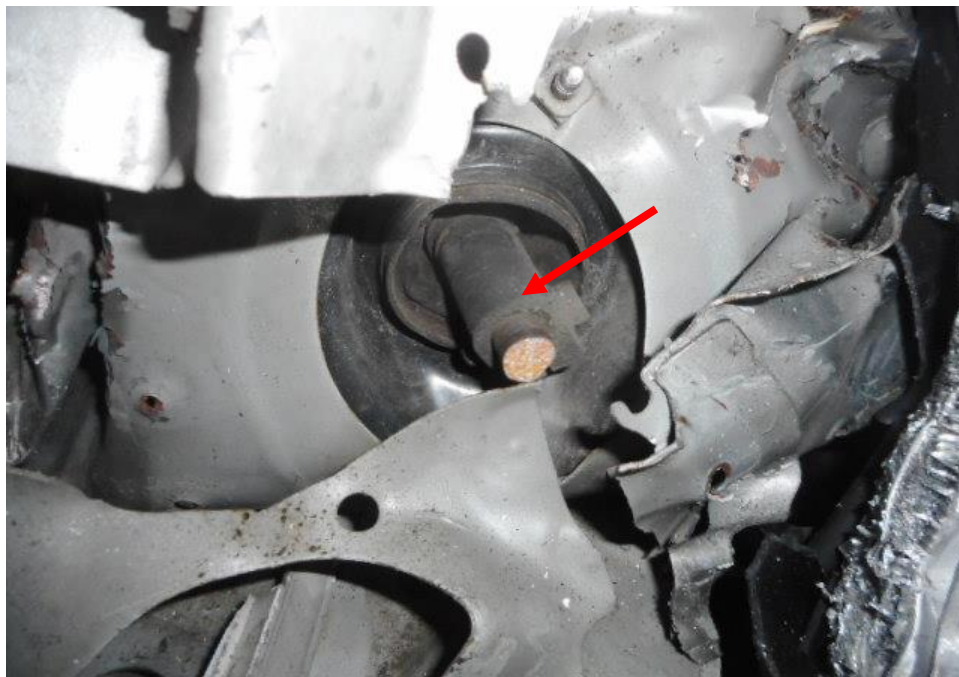
Photo 18 shows the steering box shaft (arrowed) of the Motor Van's steering system. The steering box was observed to sustained damages a result of the accident.

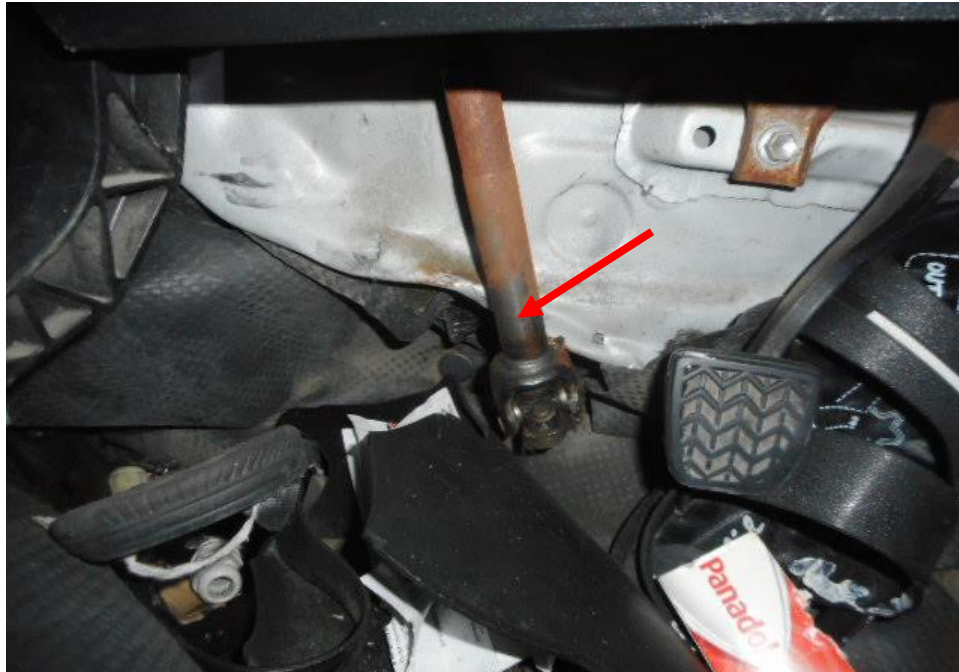
Photo 19 shows the steering box shaft (arrowed) of the Motor Van's steering system. The steering box was observed to sustained damages a result of the accident.

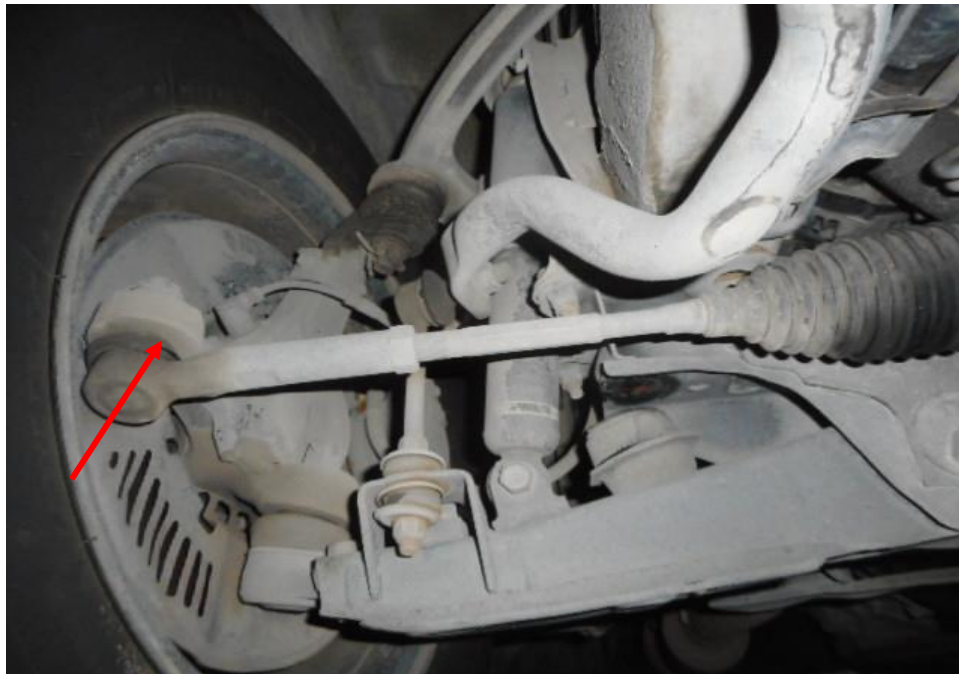
Photo 20 shows the various undercarriage components at the front right wheel of the Motor Van, in particular the steering tie rod end (arrowed). The various steering components were all found to be intact, suggesting that the steering system of the Motor Van was likely to be in serviceable condition at the material time of accident. There was also no sign of fluid stain(s) observed on the various undercarriage components.

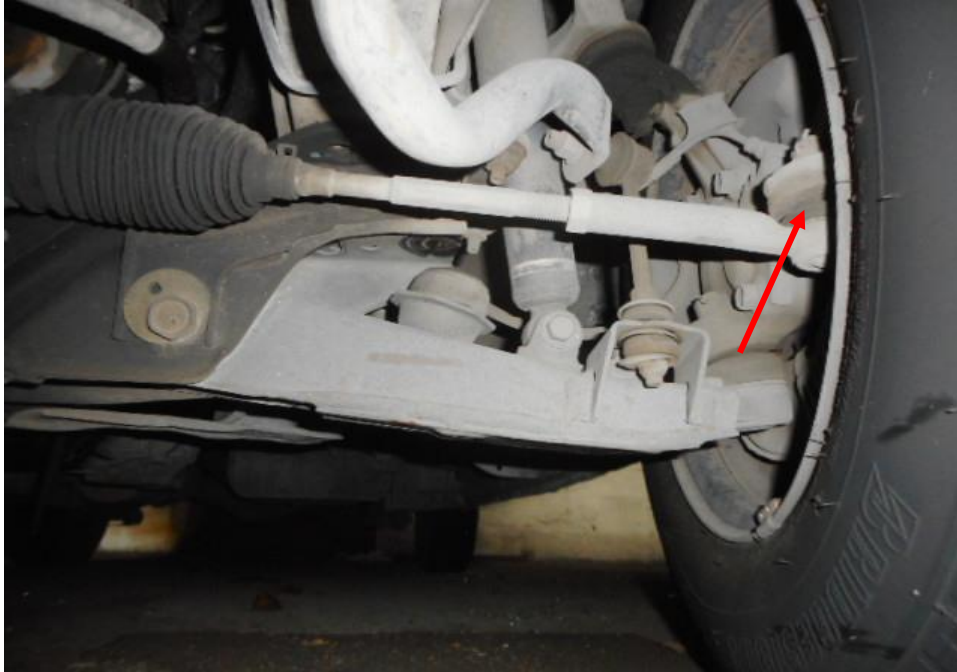
Photo 21 shows the various undercarriage components at the front left wheel of the Motor Van, in particular the steering tie rod end (arrowed). The various undercarriage components of the Motor Van were all found to be intact without any visible damage. There was also no sign of fluid stain(s) observed on the various undercarriage components.

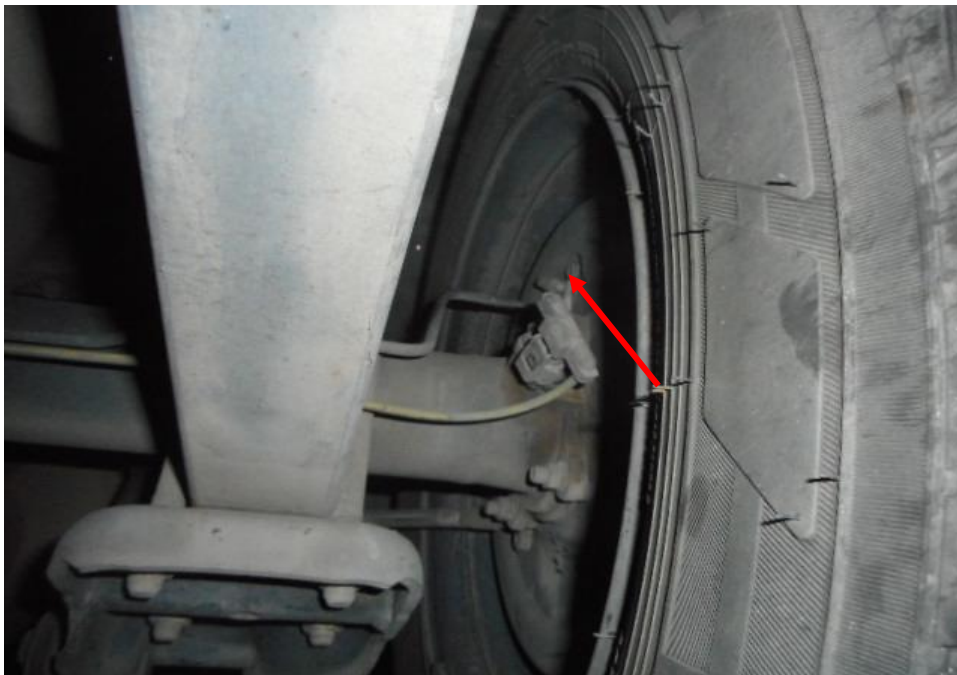
Photo 22 shows the brake pipe (arrowed) at the rear right wheel of the Motor Van. I did not observe any leakage of brake fluid at the time of my inspection of the Motor Van. My static tests of the Motor Van's braking system, along with my visual examination of the various mechanical components in the braking system, had indicated that there was no internal leakage of pressure/vacuum.

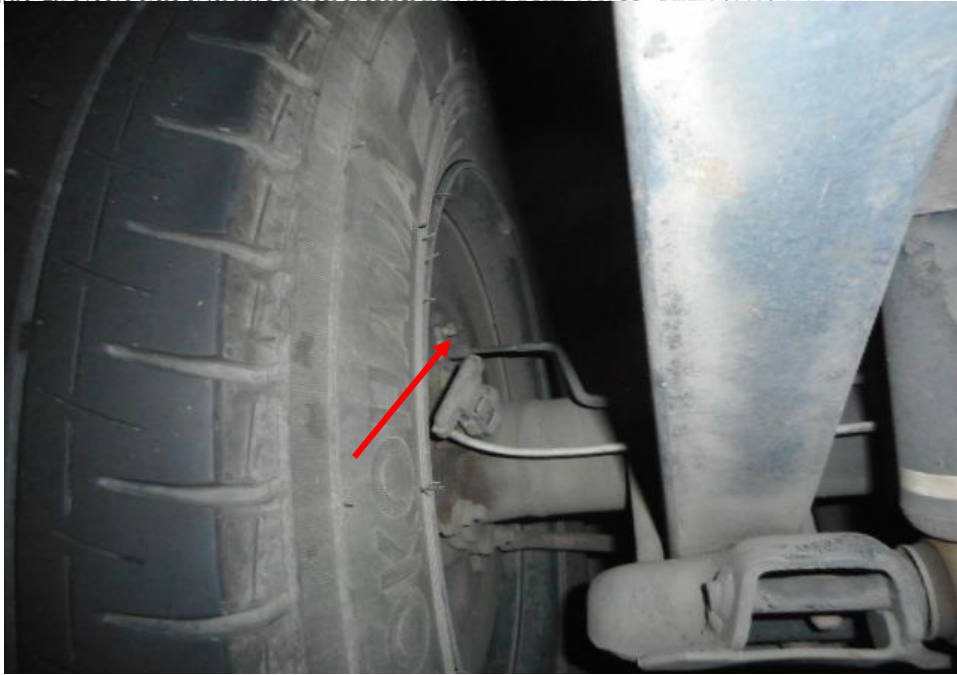
Photo 23 shows the brake pipe (arrowed) at the rear left wheel of the Motor Van. I did not observe any leakage of brake fluid at the time of my inspection of the Motor Van. My static tests of the Motor Van's braking system, along with my visual examination of the various mechanical components in the braking system had indicated that there was no internal leakage of pressure/vacuum. Hence the braking system of the Motor Van was likely to be in serviceable condition at the material time of accident.

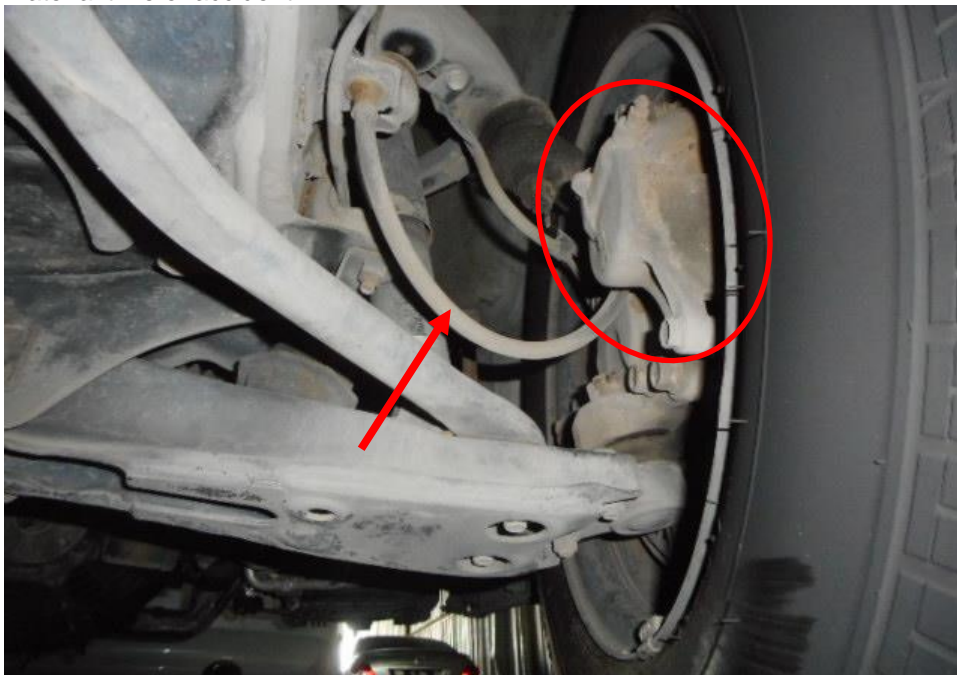
Photo 24 shows the brake hose/pipe (arrowed) at the front right wheel of the Motor Van. No leakage of brake fluid was observed. Visual examination of the various components of the braking system like the brake caliper (circled), brake booster, brake pedal etc had revealed all to be intact and without visible damage at the time of accident. There was also no sign of fluid stain(s) observed on the various undercarriage components.

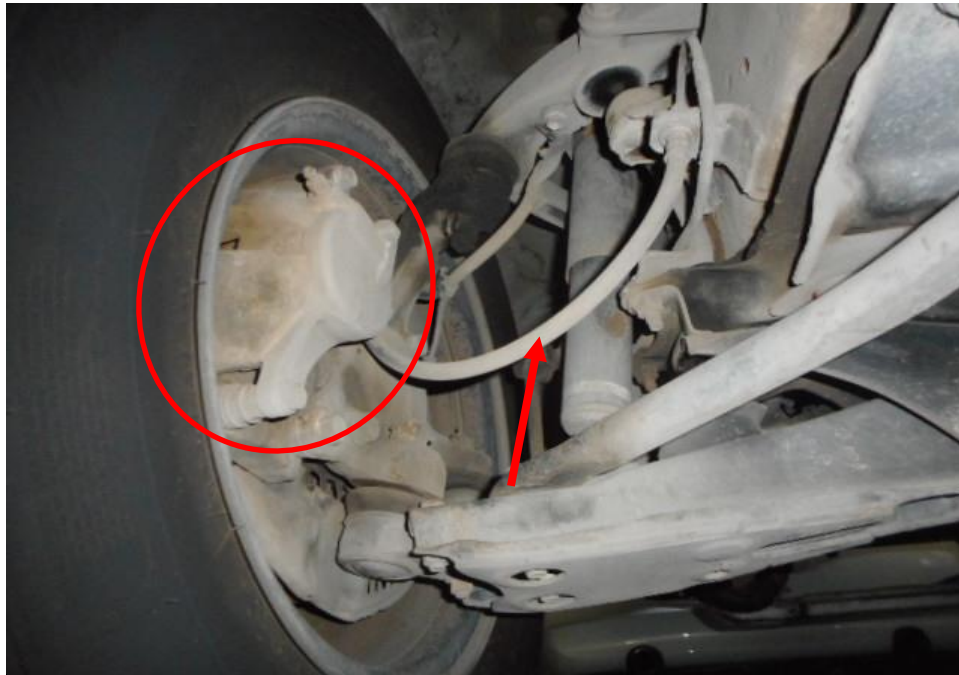
Photo 25 shows the brake hose/pipe (arrowed) at the front left wheel of the Motor Van. No leakage of brake fluid was observed. Visual examination of the various components of the braking system like the brake caliper (circled), brake booster, brake pedal etc had revealed all to be intact and without visible damage at the time of accident. There was also no sign of fluid stain(s) observed on the various undercarriage components.

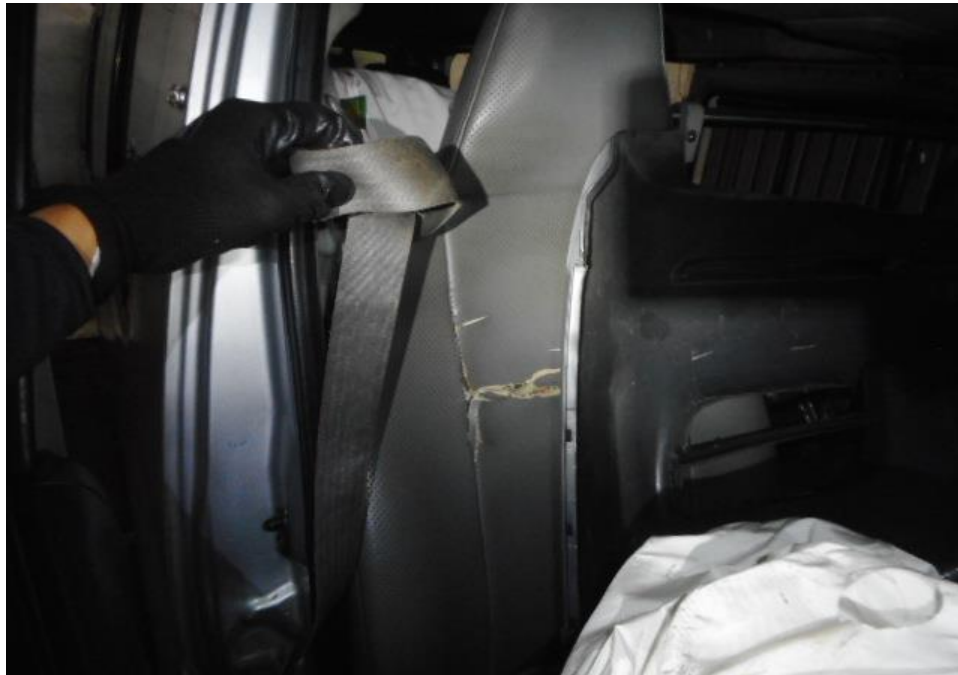
12. The front right seat belt of the "Motor Van" was worn at the material time of accident as the respective pre-tensioners that were fitted at the side of each seat was activated upon the material time. See photo 27 below.

Photo 27 shows that the seat belt on the right seat was worn at the material time of accident as the safety pre-tensioners was activated at the moment of impact and caused the seat belt to be locked into the last position.
