Your Ref: TP/IP/08485/2022
Our Ref : CI/TPD22008162/P

8th September 2022

MECHANICAL INSPECTION REPORT OF MOTOR CAR SLT 1332M

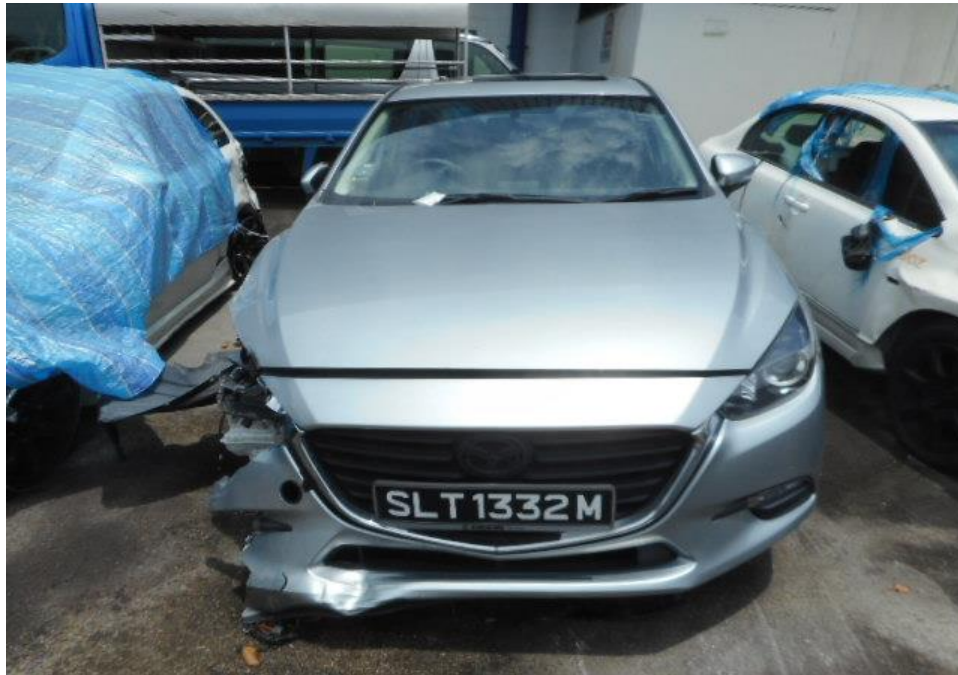
4. The mileage of the Motor Car at the time of my inspection was not recorded as the engine of the Motor Car was unable to be jumpstarted up despite multiple attempts in jumpstarting.
5. The Motor car was observed to have sustained damage at its front portion. Its front bonnet, front bumper, front right fender, front right headlamp was the body parts that were damaged as a result of the accident.

Photo 1 shows a general view of the Motor Car's front body at the time of my inspection. The Motor car was observed to have sustained damage at its front portion. Its front bonnet, front bumper, front right fender, front right headlamp was the body parts that were damaged as a result of the accident.

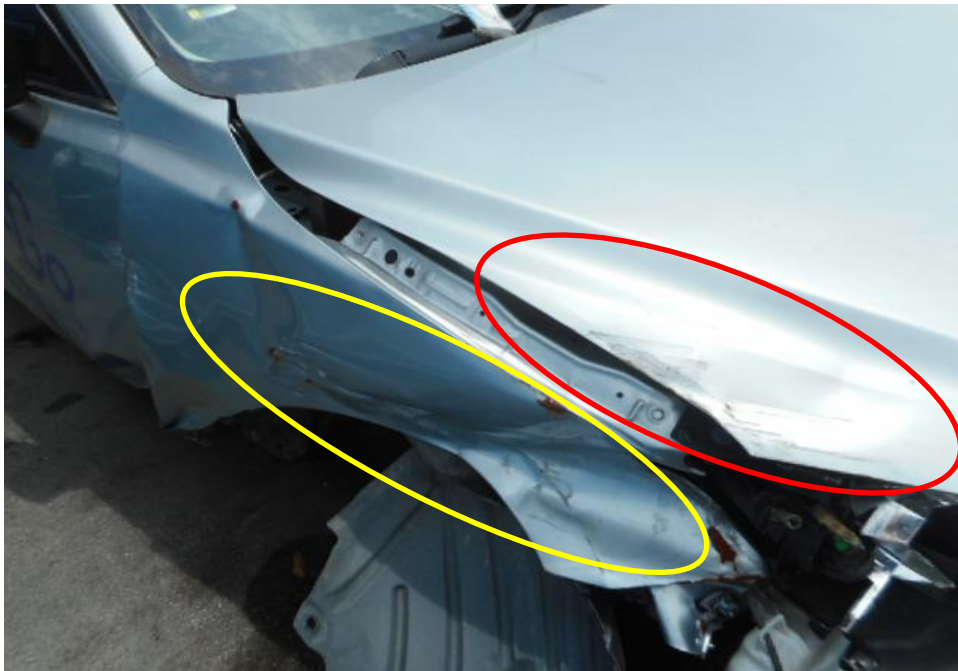
Photo 2 shows the close up view of the Motor Car's front body at the time of my inspection. The Motor car was observed to have sustained damage at its front portion. Its front bonnet (red circle) and its front right fender (yellow circle) was damaged as a result of the accident.

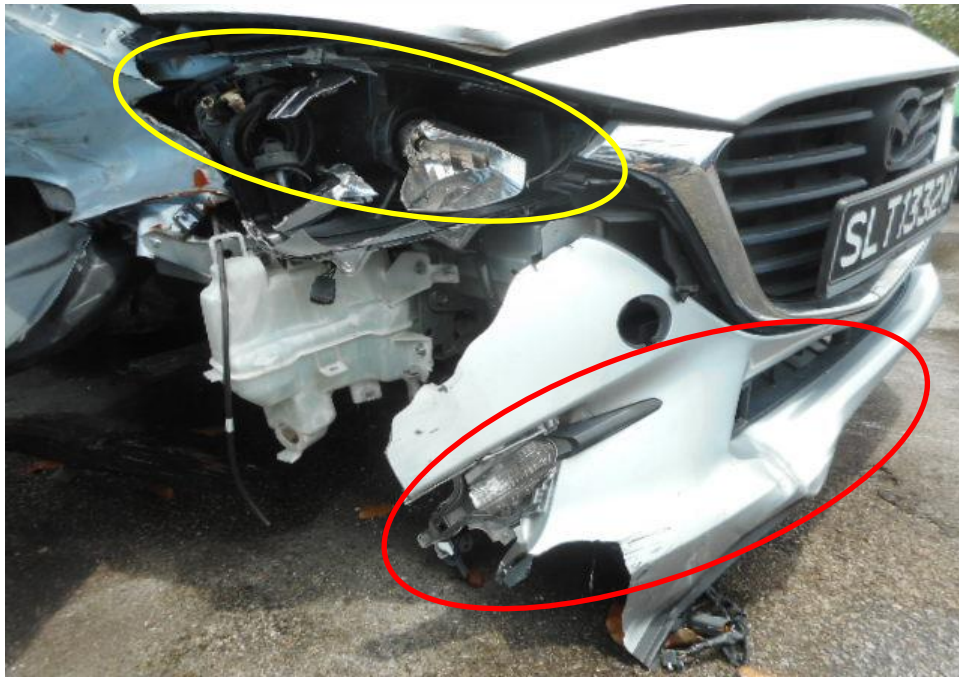
Photo 3 shows the close up view of the Motor Car's front body at the time of my inspection. The Motor car was observed to have sustained damage at its front portion. Its front bumper (red circle) and its front right headlamp (yellow circle) was damaged as a result of the accident.

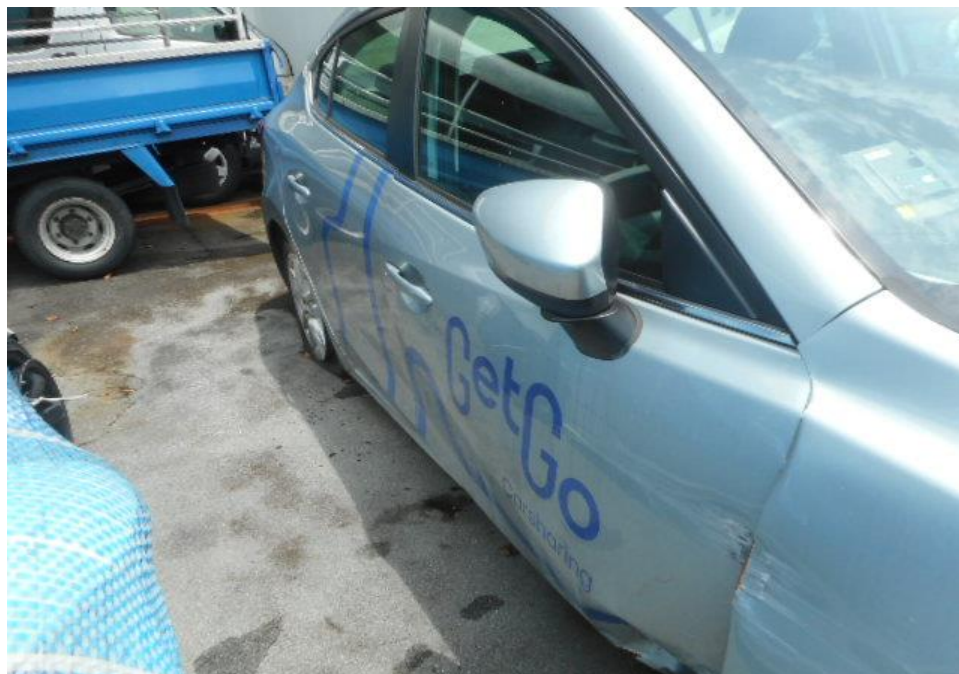
Photo 4 shows a general view of the Motor Car's right body at the time of my inspection. The right portion of the Motor Car was observed to have been undamaged by the accident.

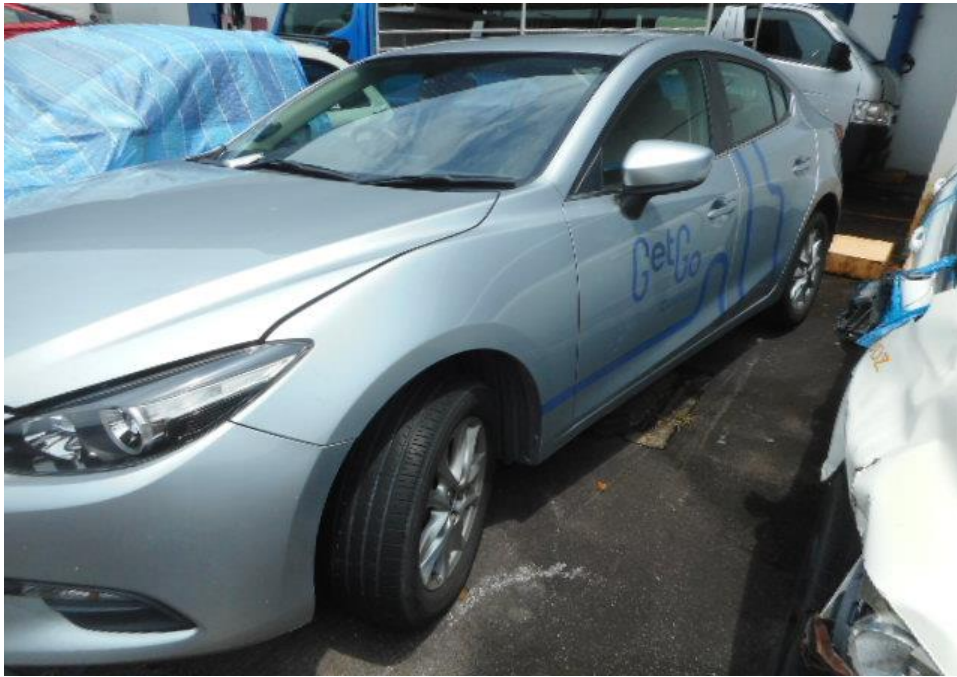
Photo 5 shows a general view of the Motor Car's left body at the time of my inspection. The left portion of the Motor Car was observed to have been undamaged by the accident.

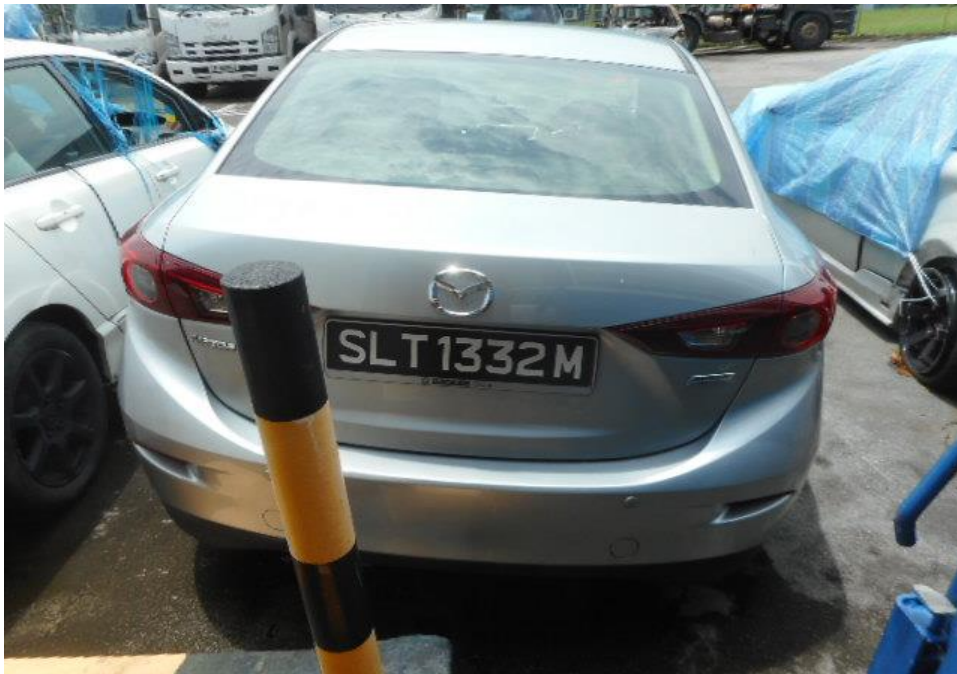
Photo 6 shows a general view of the Motor Car's rear body at the time of my inspection. The rear portion of the Motor Car was observed to have been undamaged by the accident.

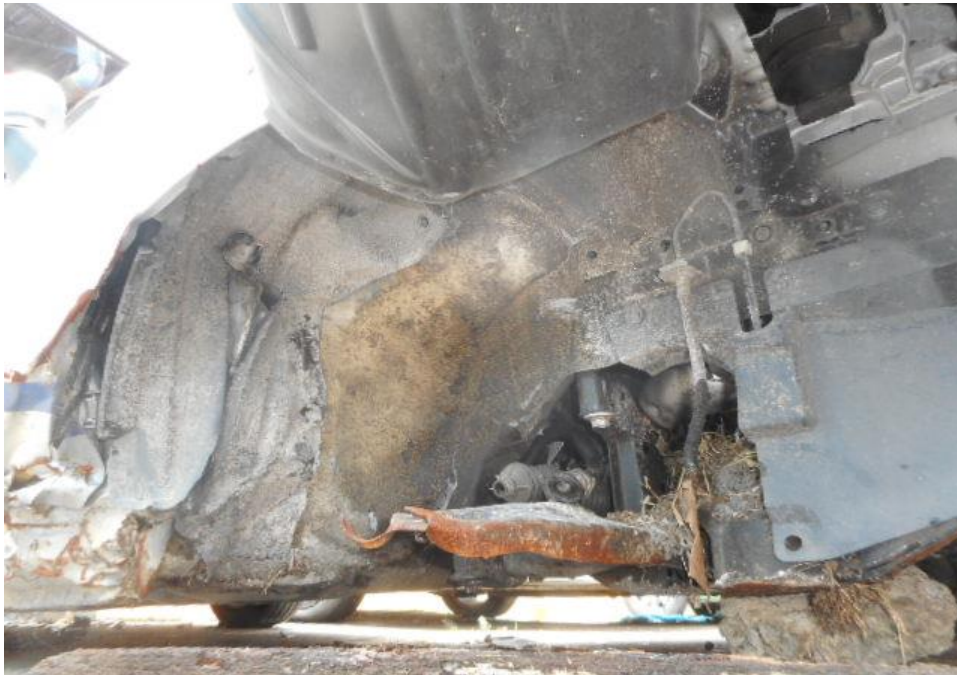
Photo 7 shows the location of where the front right tyre and wheel rim of the Motor Car should be, however observed that the whole tyre and wheel rim was missing as a result of the accident.

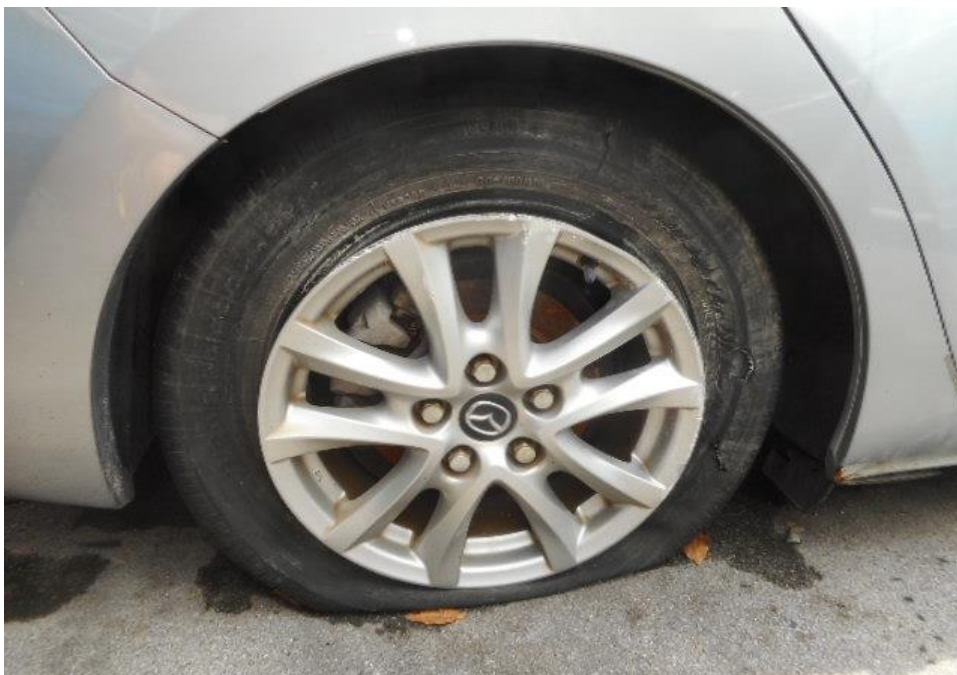
Photo 8 shows the general condition of the rear right tyre and wheel rim of the Motor Car, which was observed to be cut and deflated as a result of the accident with remaining tread depth of approximately 3.8mm.

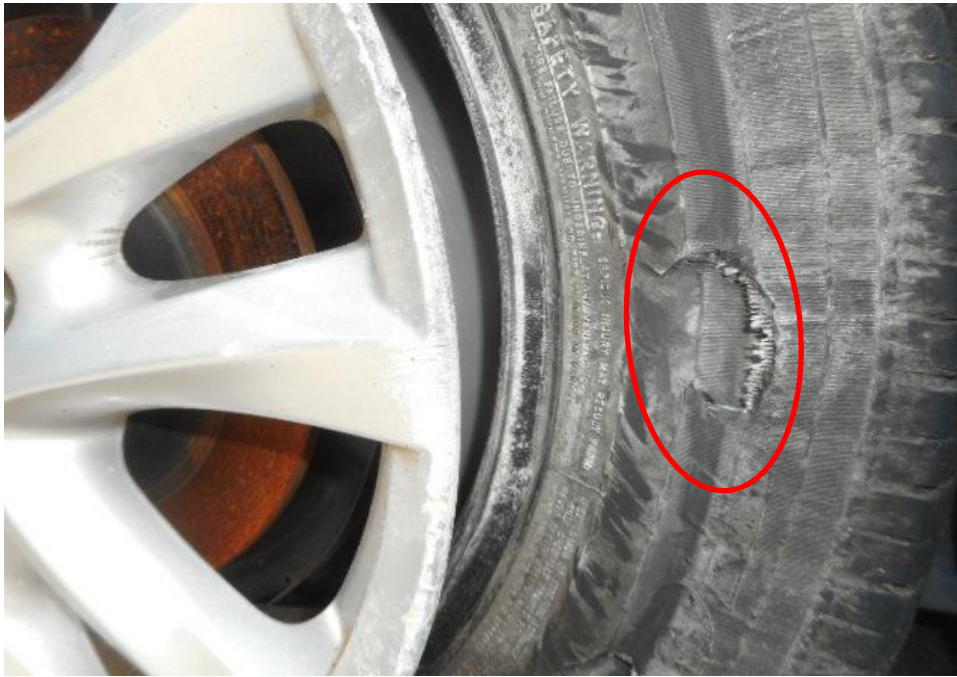
Photo 9 shows the close up condition of the rear right tyre and wheel rim of the Motor Car, which was observed to be cut and deflated (circled) as a result of the accident with remaining tread depth of approximately 3.8mm.

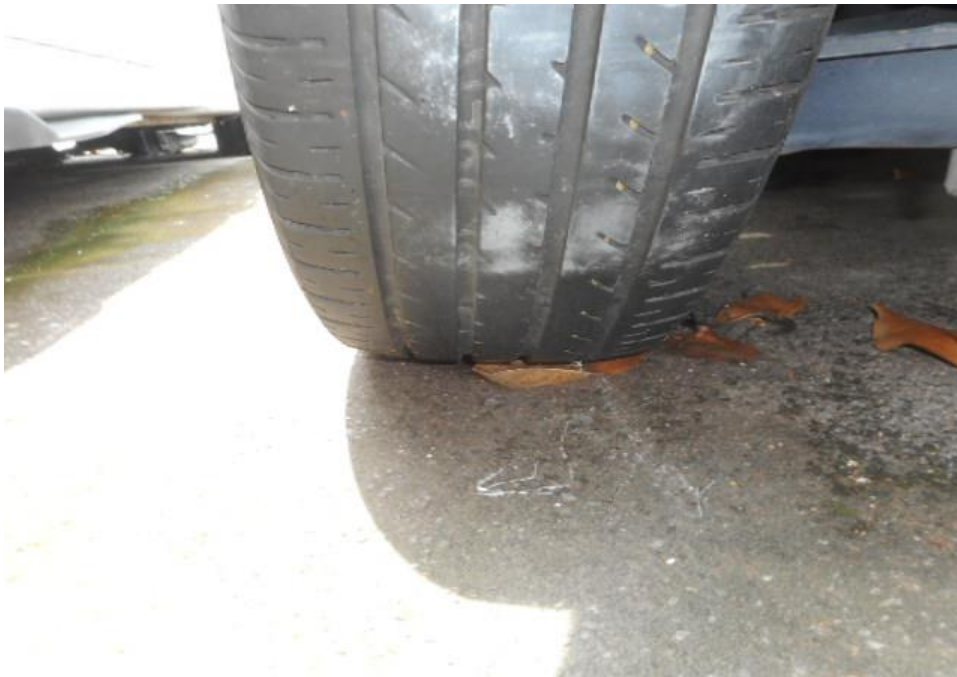
Photo 10 shows the condition of the rear left tyre of the Motor Car, which was observed to be in serviceable condition with remaining tread depth of approximately 3.8mm. The tyre was also observed to be sufficiently inflated for vehicular operation with no tear, cut or burst mark(s).

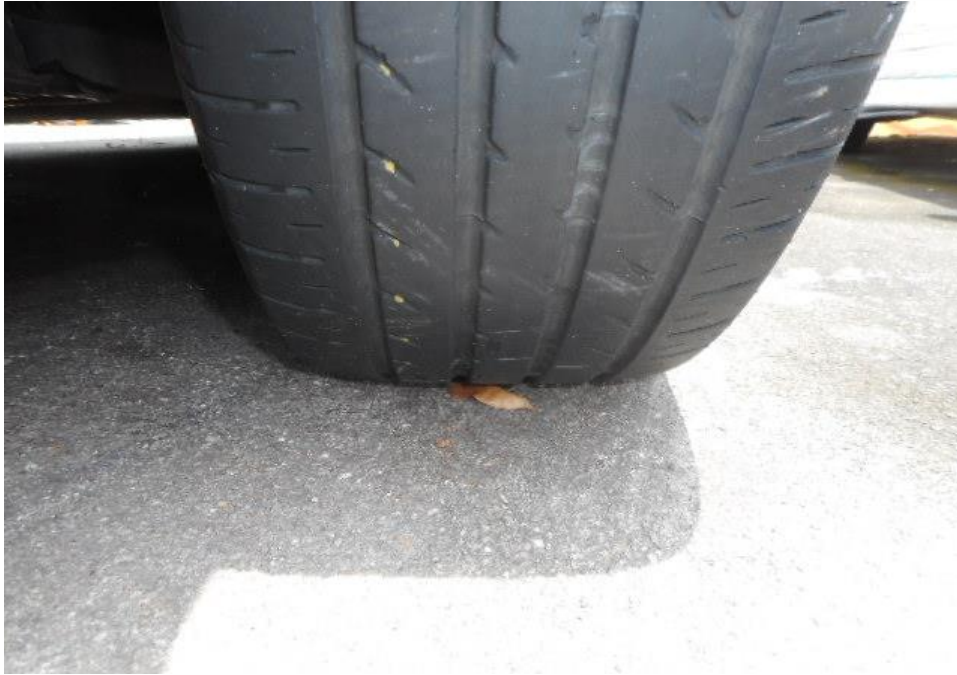
Photo 11 shows the condition of the front left tyre of the Motor Car, which was observed to be in serviceable condition with remaining tread depth of approximately 4mm. The tyre was also observed to be sufficiently inflated for vehicular operation with no tear, cut or burst mark(s).

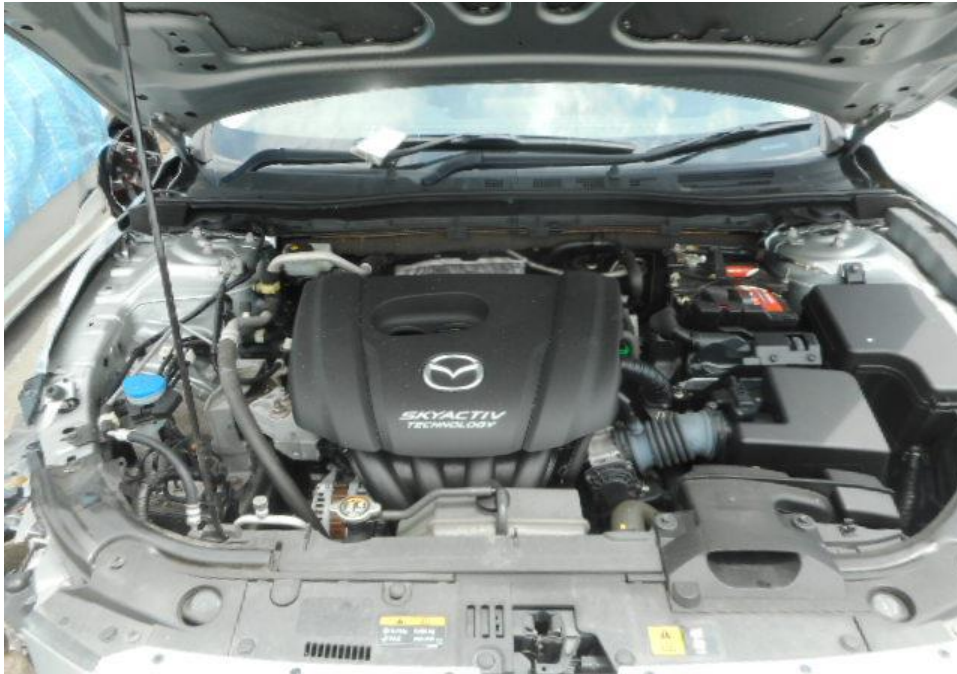
Photo 12 shows a general view of the Motor Car's engine compartment. Only the brake fluid in the reservoir was observed to be insufficient due to the missing brake caplier at the front right wheel as a result of the accident. The other various parts and components inside the engine compartment were unaffected by the accident. There was also no sign(s) or indication(s) of fluid leakage and/or fluid stain within the engine compartment.

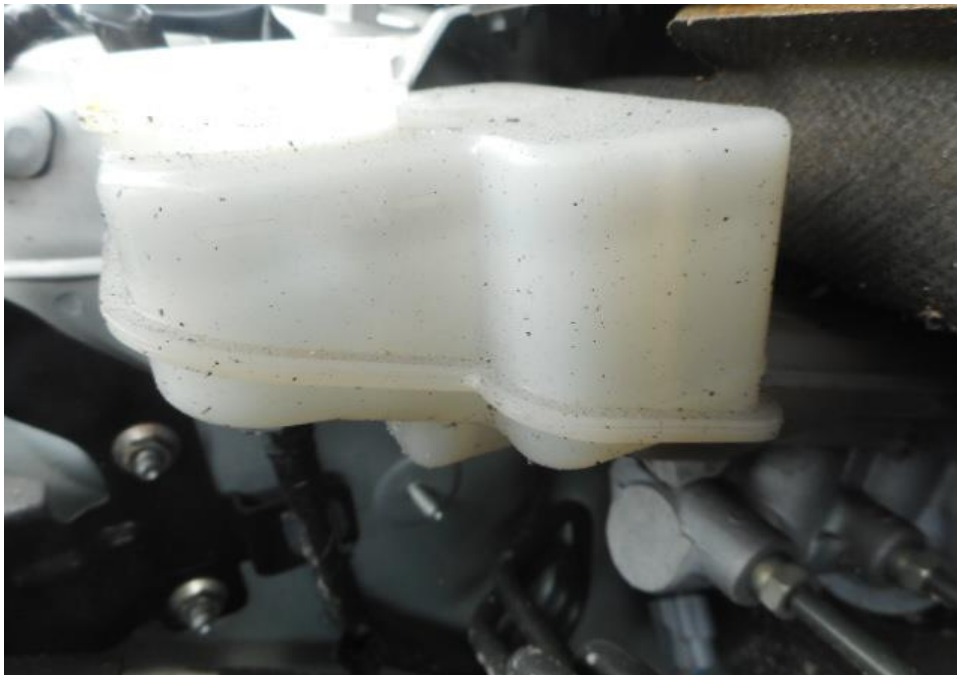
Photo 13 shows checks being carried out to the brake fluid reservoir of the Motor Car at the time of my inspection. The brake fluid was observed to be of insufficient due to the missing brake caplier at the front right wheel as a result of the accident.

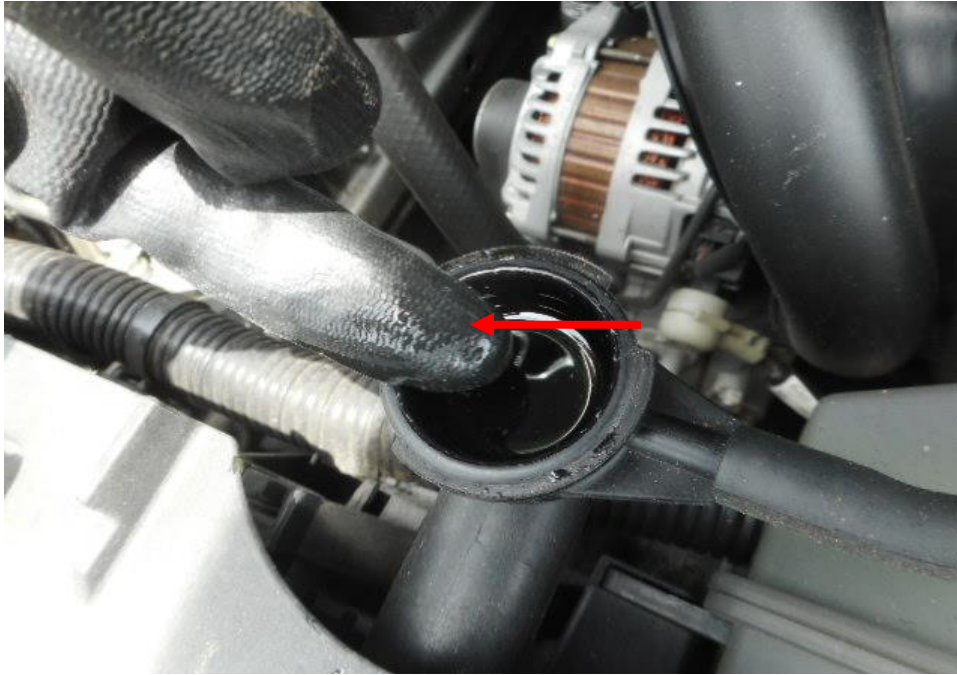
Photo 14 shows the engine coolant reservoir of the Motor Car at the time of my inspection. The coolant was observed to be of sufficient level (arrowed) and without any visible contamination.

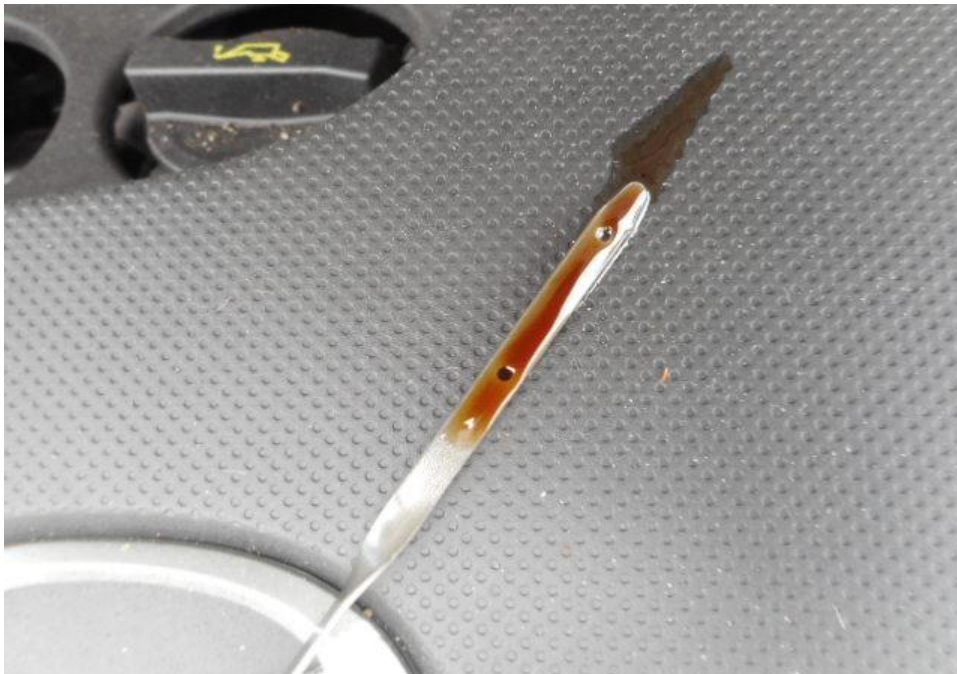
Photo 15 shows the engine oil level dipstick of the Motor Car at the time of my inspection. The engine oil was observed to be of sufficient level and without any visible contamination.

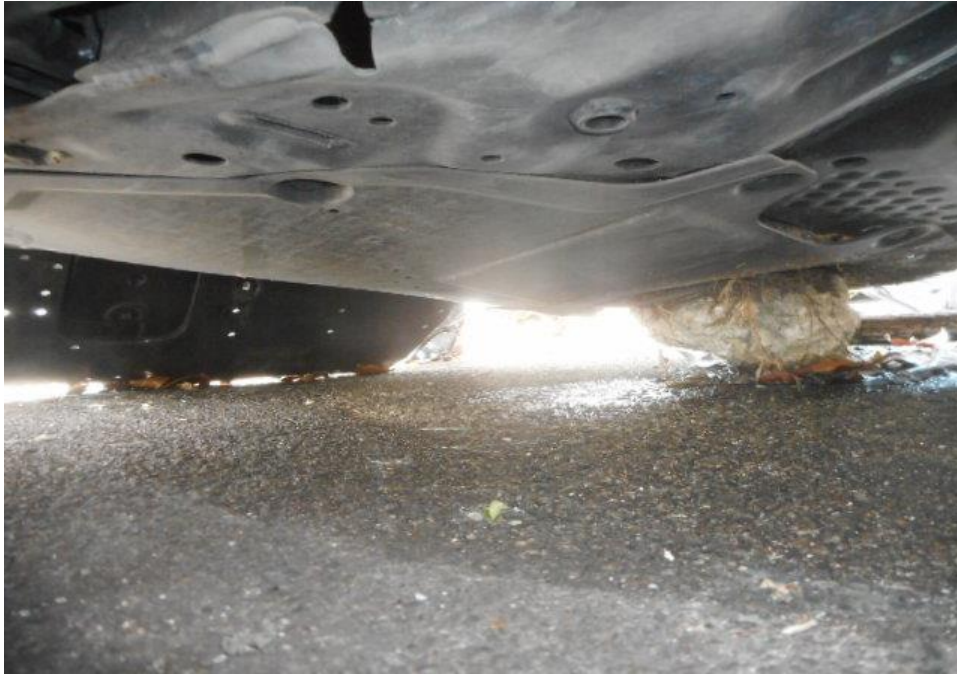
Photo 16 shows the undercarriage of the Motor Car, at the area where the engine housing and transmission housing are located. I did not find any sign(s) or indication(s) of fluid leak and/or fluid stain(s) on the underside of the Motor Car.

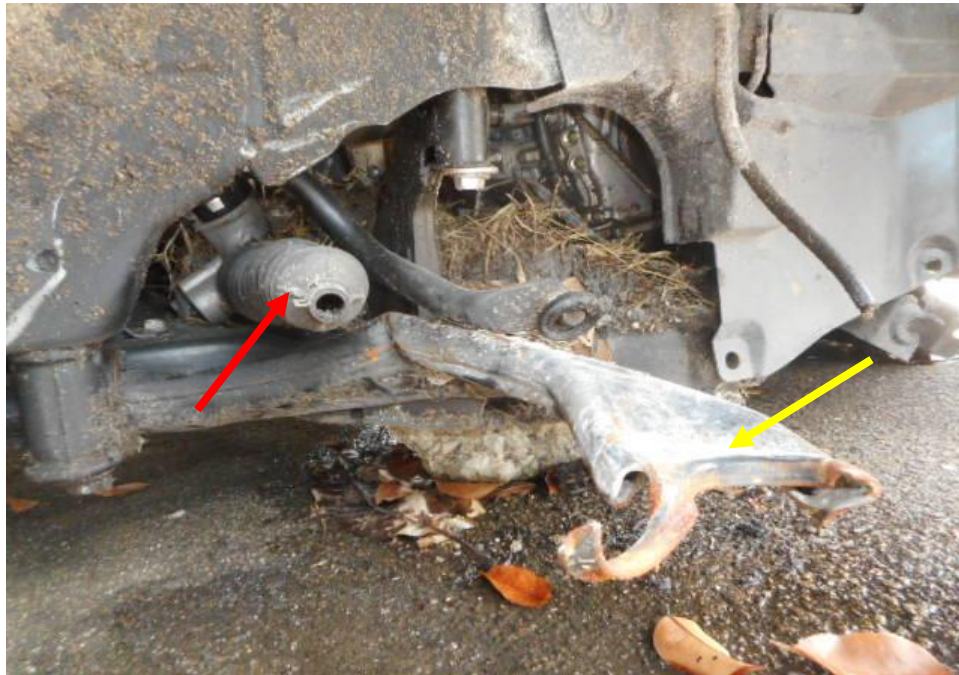
Photo 17 shows the various undercarriage components at the front right wheel of the Motor Car, in particular the steering tie rod (red arrow) and the lower control arm (yellow arrow) was observed to be missing and broken off as a result of the accident.

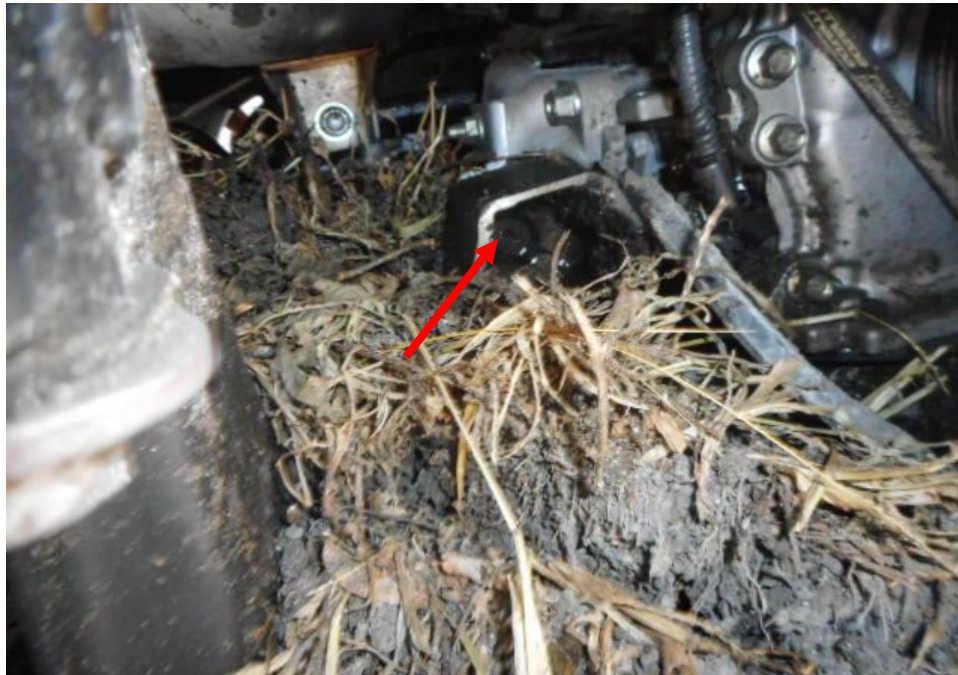
Photo 18 shows the various undercarriage components at the front right wheel of the Motor Car, in particular the driveshaft (arrowed) was observed to be missing as a result of the accident.

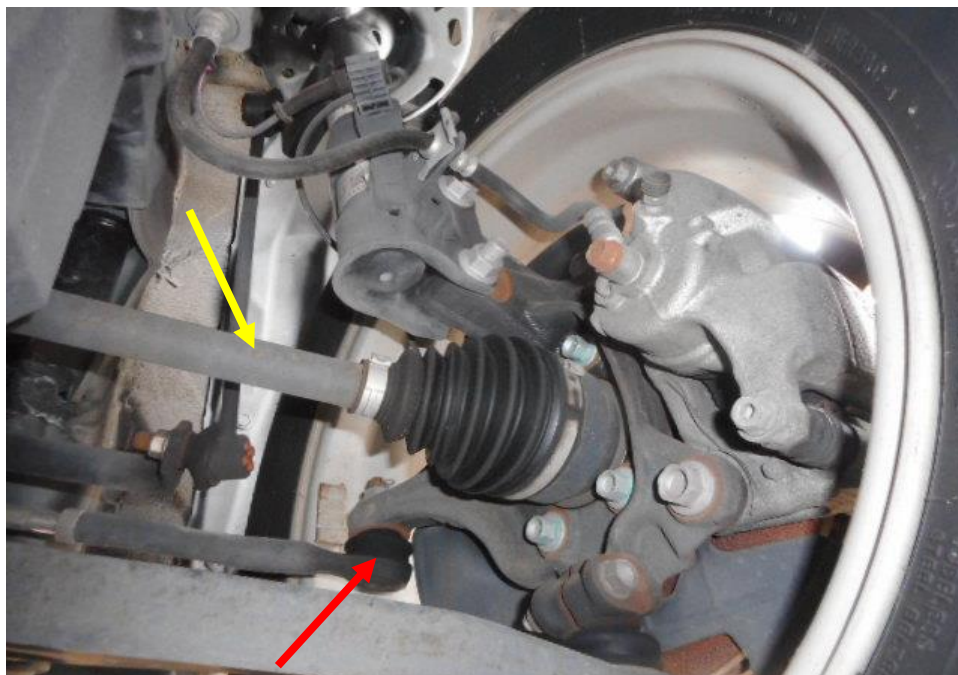
Photo 19 shows the various undercarriage components at the front left wheel of the Motor Car, in particular the steering tie rod (red arrow) and the driveshaft (yellow arrow) was observed to be intact.

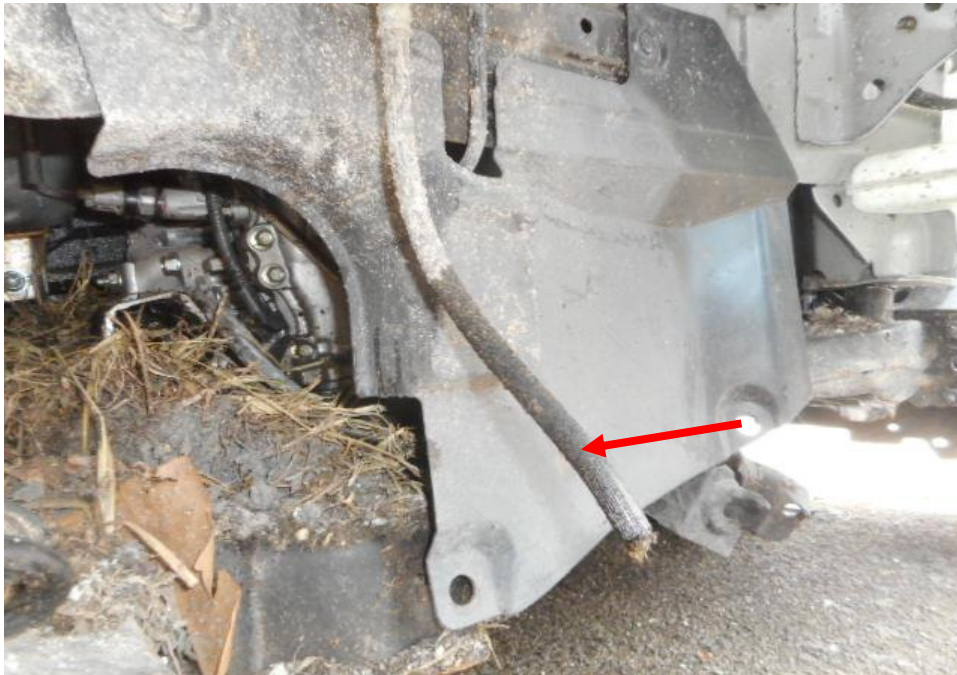
13. My visually examination of the various steering components had revealed that the front right brake caplier was missing as a result of the accident. However, the other the other braking components of the other wheels were all generally intact. The brake fluid in the reservoir was of insufficient level, as the missing brake caplier had caused a brake fluid leakage. See photo 17 - 23 below.

Photo 20 shows the brake hose/pipe (arrowed) at the front right wheel of the Motor Car. I did observed leakage of brake fluid from the broken brake hose due to the missing brake caplier which was caused by the result of the accident at the time of my inspection of the Motor Car.

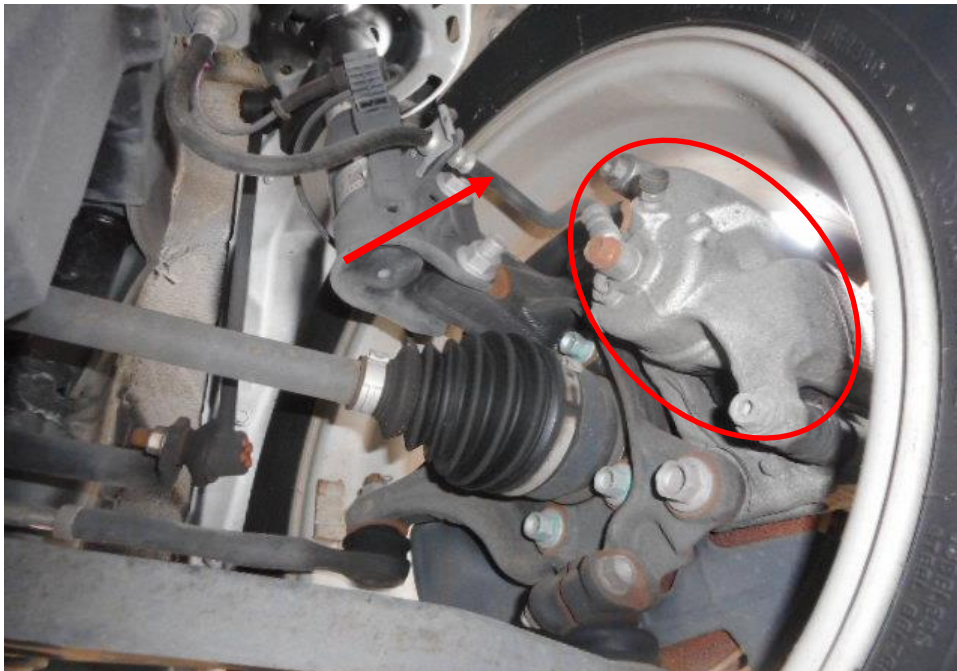
Photo 21 shows the brake hose/pipe (arrowed) at the front left wheel of the Motor Car. No leakage of brake fluid was observed. Visual examination of the various components of the braking system like the brake caliper (circled), brake booster, brake pedal etc had revealed all to be intact and without visible damage.

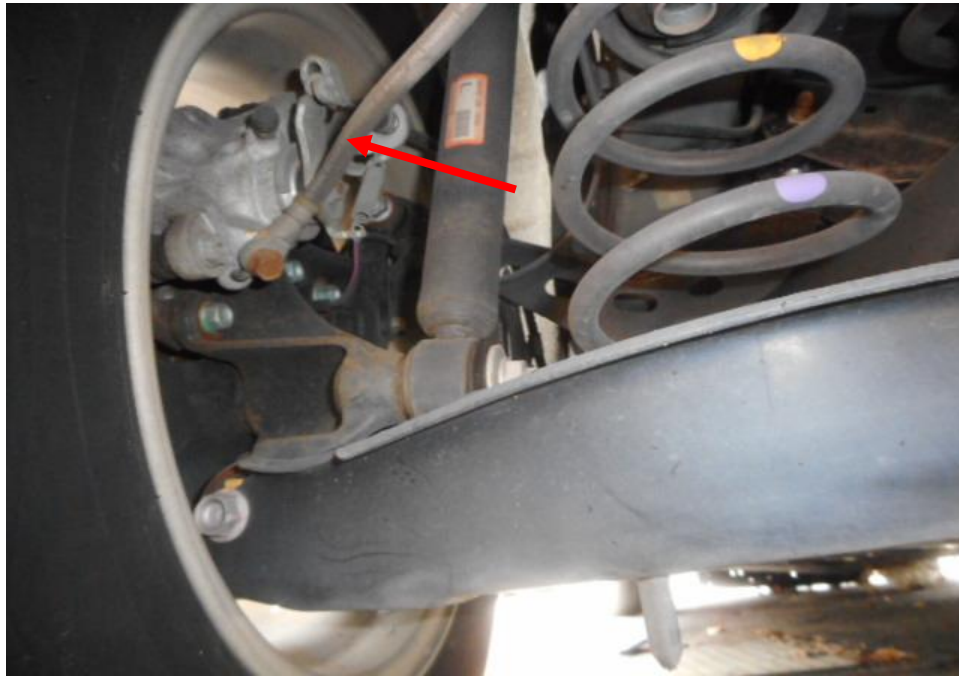
Photo 22 shows the brake hose/pipe (arrowed) at the rear left wheel of the Motor Car. No leakage of brake fluid was observed. Visual examination of the various components of the braking system like the drum brake, brake booster, brake pedal etc. had revealed all to be intact and without visible damage.

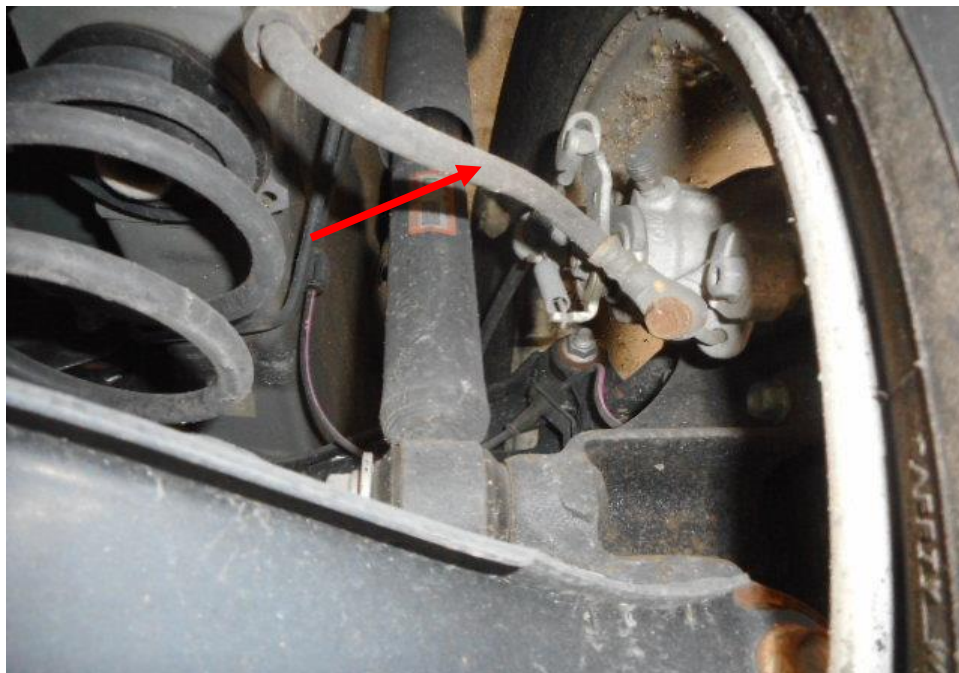
Photo 23 shows the brake hose/pipe (arrowed) at the rear right wheel of the Motor Car. No leakage of brake fluid was observed. Visual examination of the various components of the braking system like the drum brake, brake booster, brake pedal etc. had revealed all to be intact and without visible damage.

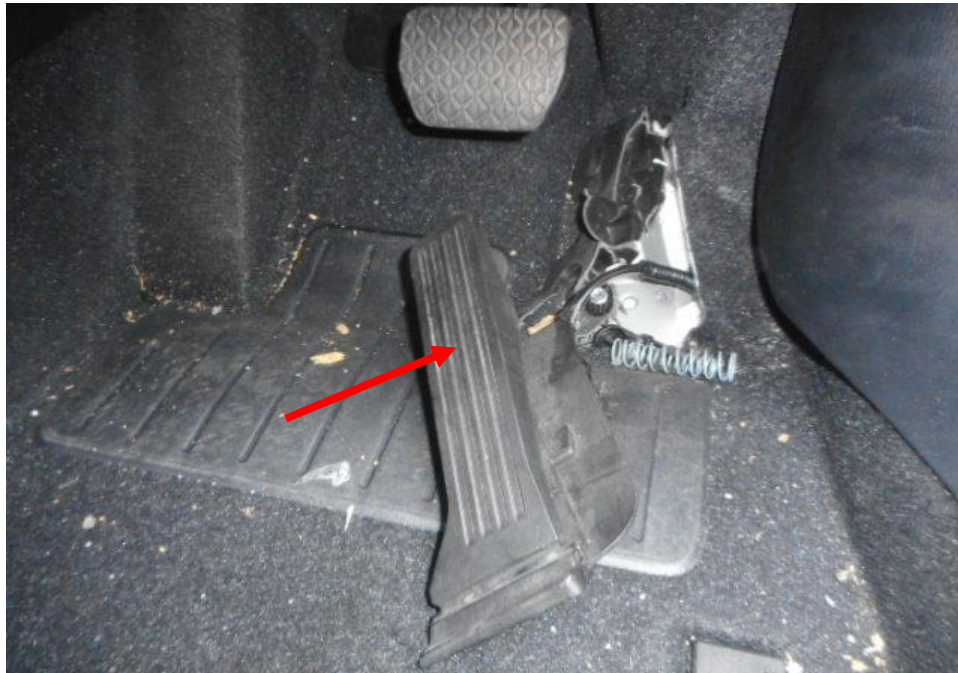
16. The driver's accelerator pedal was also observed to be damaged as a result of the induced impact from the accident that caused the body of the Motor Car to foot well area to bent inwards and damaged the accelerator pedal. See photo 24 and 25 below.

Photo 24 shows the general view of the accelerator pedal (arrowed) at the driver's foot well of the Motor Car. I observed that the accelerator pedal was broken due to the induced impact from the accident which had caused the body of the Motor Car to bent inwards and damage the accelerator at the time of my inspection of the Motor Car.

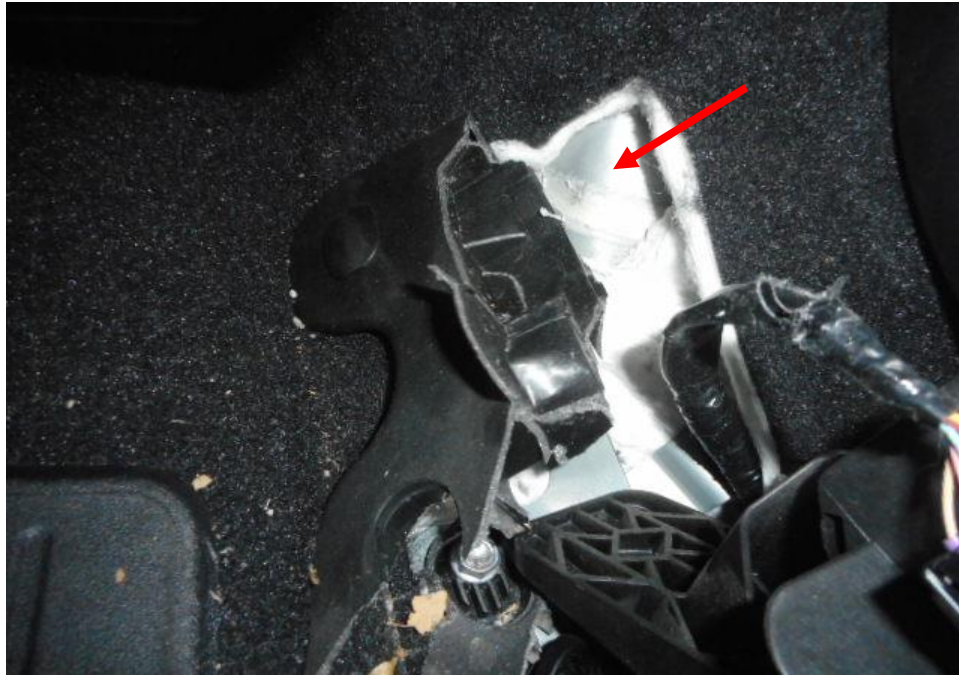
Photo 25 shows the close up view of the Motor Car's body that was bent inwards and damaged the accelerator pedal (arrowed) at the driver's foot well of the Motor Car also a result of the accident.
