Your Ref: TP/IP/17963/2022  
Our Ref : CI/TPD22008163/P

**Fatal Accident Investigation Team**

**MECHANICAL INSPECTION REPORT OF MOTOR LORRY GBF 4358L**

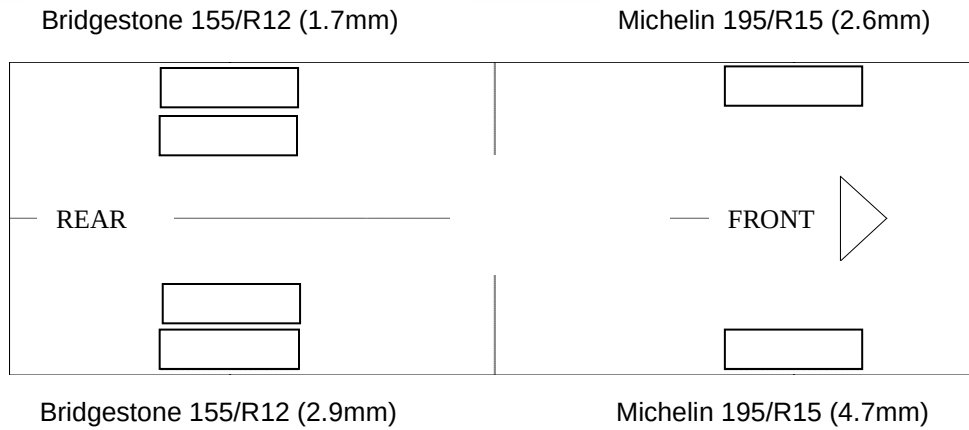
6. The 6 tyres of the Motor Lorry were observed to be in serviceable condition and sufficiently inflated for vehicular operation. I did not find any tear, cut or burst mark(s) on the outer and the inner sidewalls as well as across the tread of the 6 tyres. The tyre brand, tyre size and remaining tread depth of the 6 tyres of the Motor Lorry were recorded as follows:-

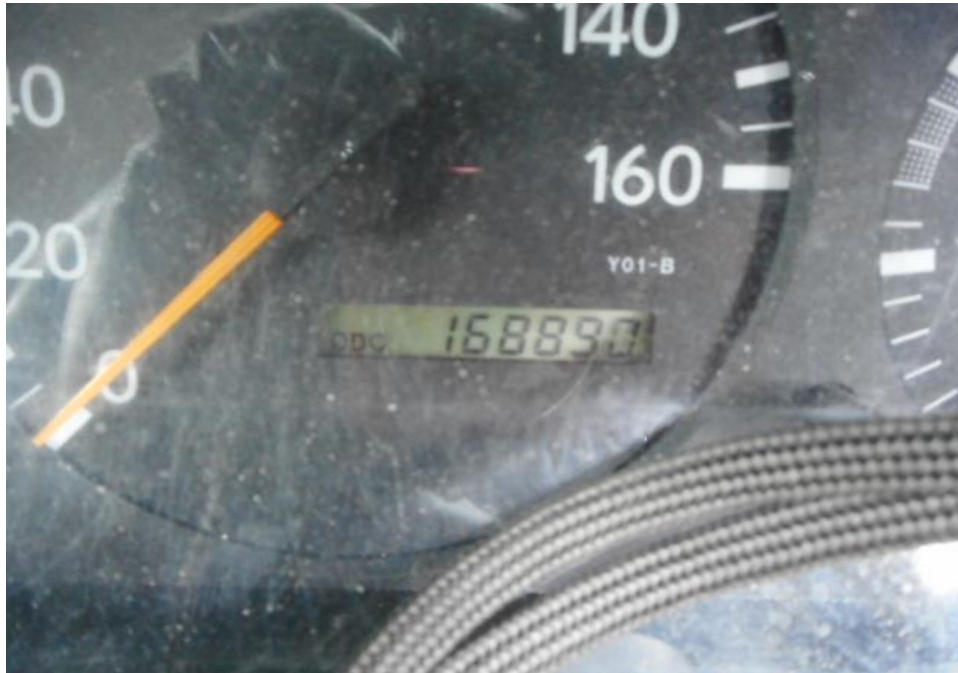
**Photo 1** shows a general view of the instrument cluster of the Motor Lorry at the time of my inspection. The mileage of the Motor Lorry was 168,890km

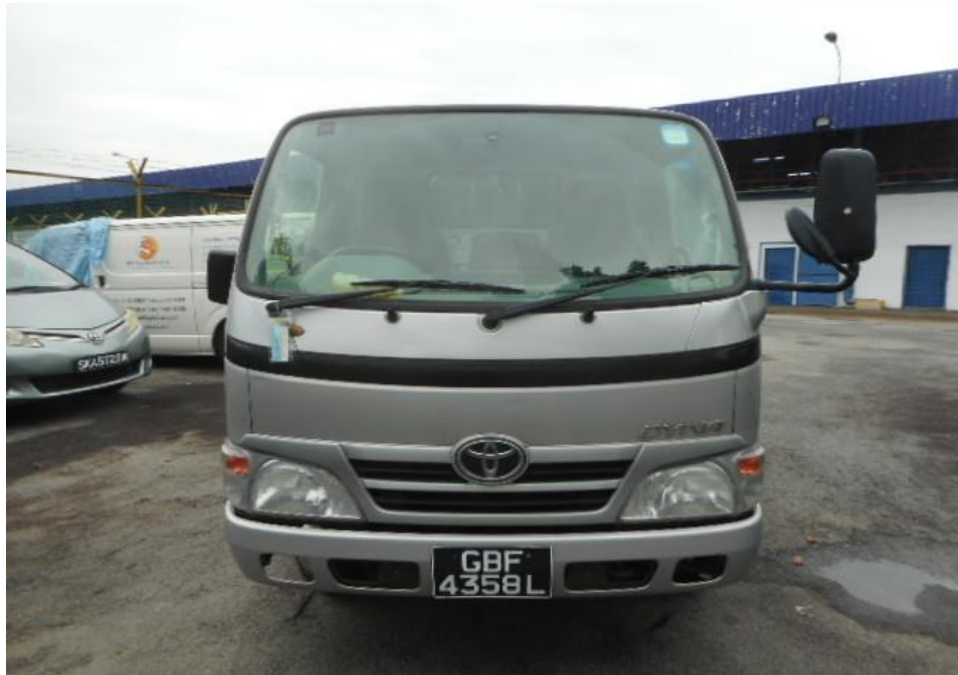
**Photo 2** shows a general view of the Motor Lorry's frontal portion at the time of my inspection. The Motor Lorry was observed to be intact and unaffected by the accident.

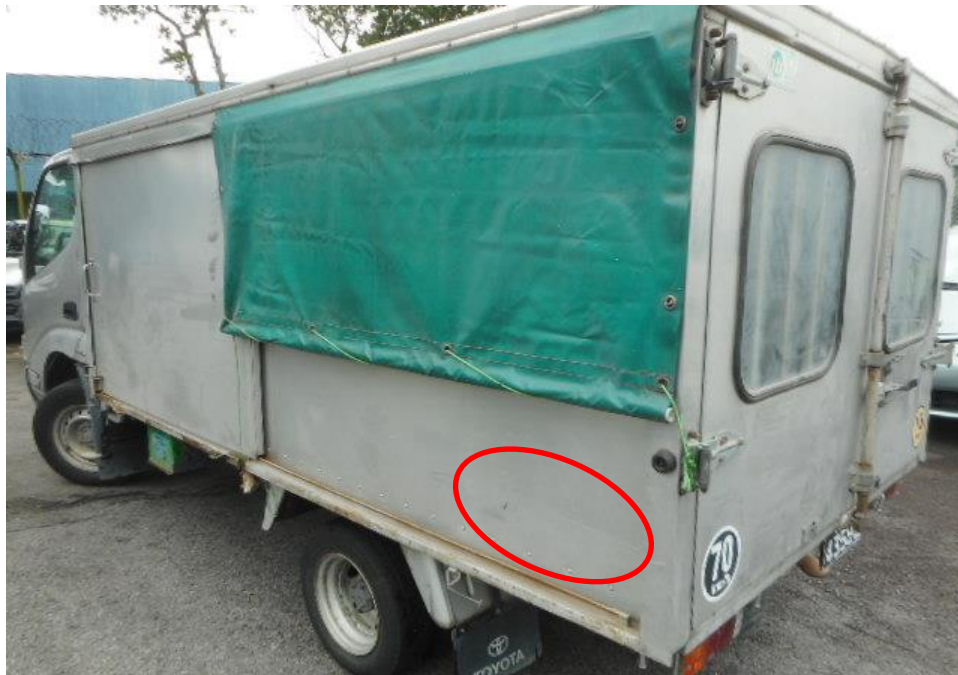
**Photo 3** shows a general view of the left body of the Motor Lorry at the time of my inspection. The Motor Lorry was observed to sustained damage at its left portion. Its rear left door panel (circled) was damage at the time of my inspection as a result of the accident.

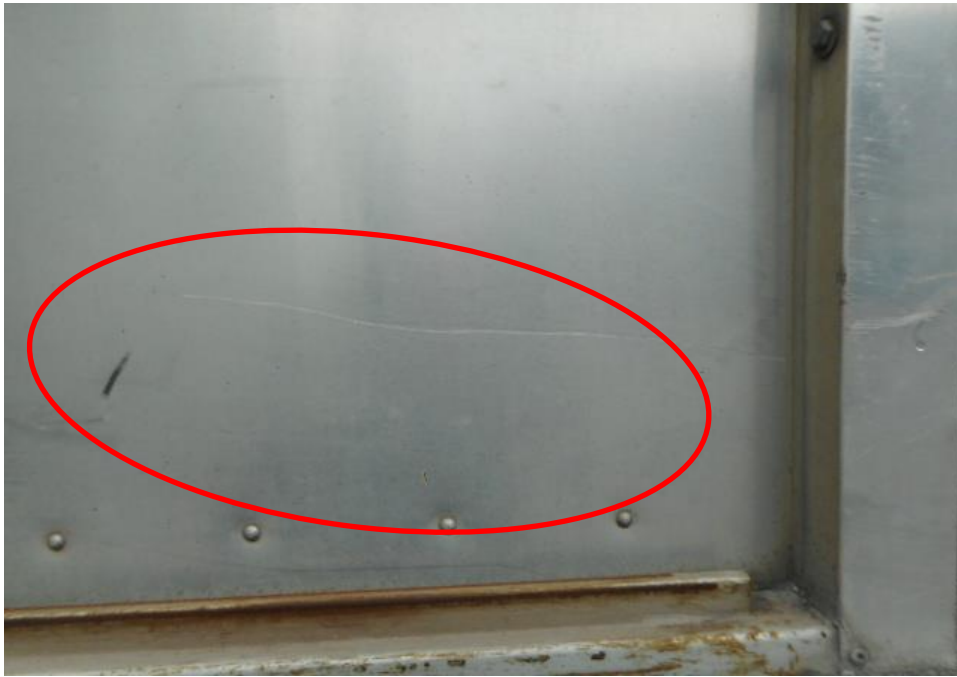
**Photo 4** shows a close up view of the left body of the Motor Lorry at the time of my inspection. The Motor Lorry was observed to sustained damage at its left portion. Its rear left door panel (circled) was damage at the time of my inspection as a result of the accident.

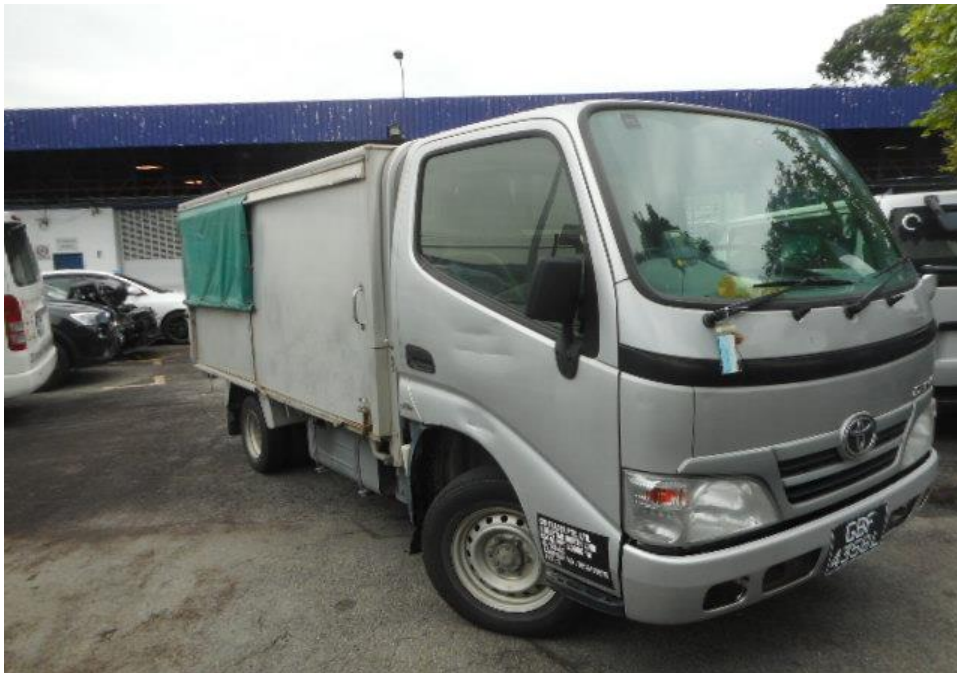
**Photo 5** shows a general view of the Motor Lorry's right portion at the time of my inspection. The Motor Lorry was observed to be intact and unaffected by the accident.

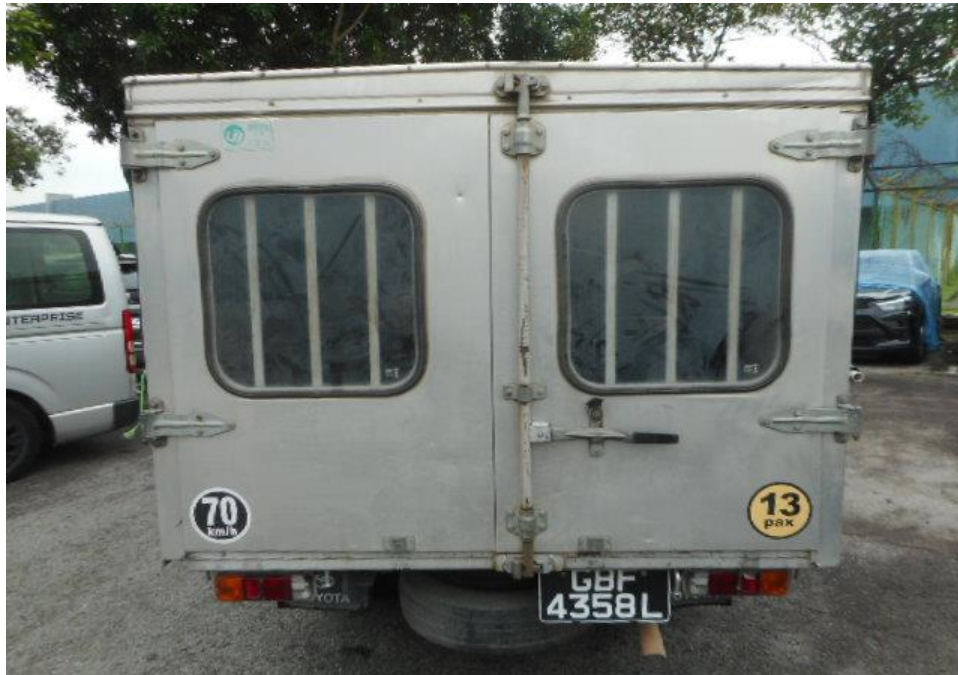
**Photo 6** shows a general view of the Motor Lorry's rear portion at the time of my inspection. The Motor Lorry was observed to be intact and unaffected by the accident.

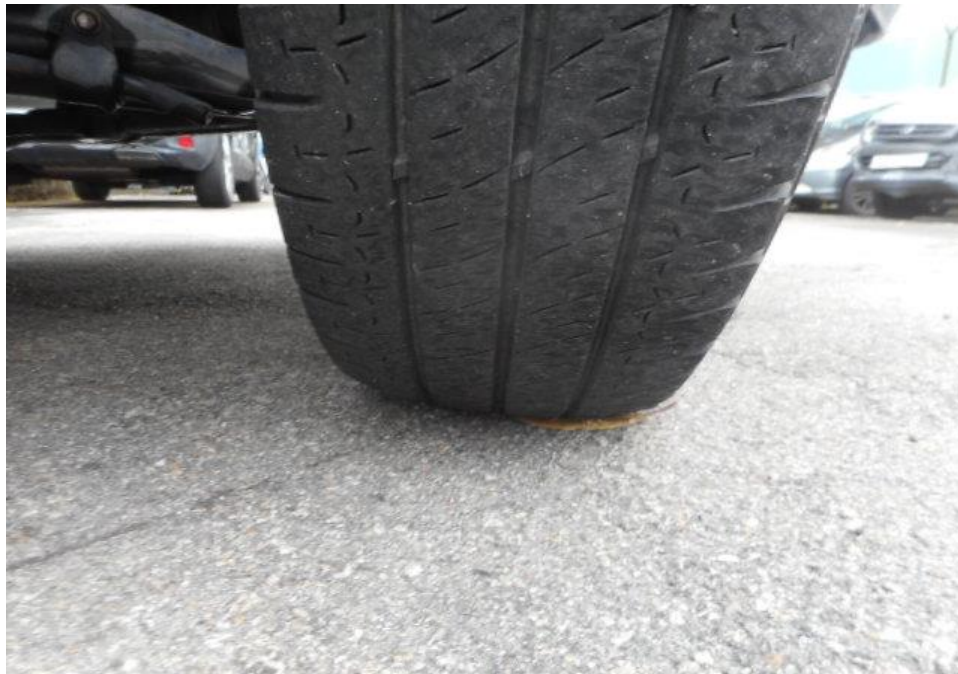
**Photo 7** shows the condition of the front right tyre of the Motor Lorry, which was observed to be in serviceable condition with remaining tread depth of approximately 4.7mm. The tyre, which was wrapped around standard steel wheel rim, it was observed to be sufficiently inflated for vehicular operation.

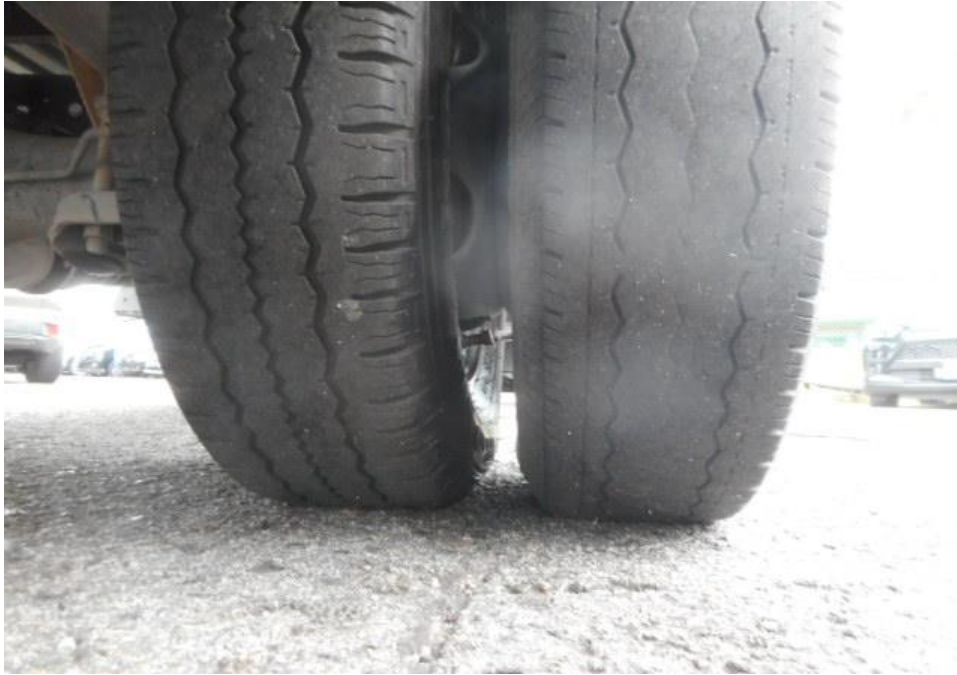
**Photo 8** shows the condition of the rear right tyre of the Motor Lorry, which was observed to be in serviceable condition with remaining tread depth of approximately 2.9mm. The tyre, which was wrapped around standard steel wheel rim, it was observed to be sufficiently inflated for vehicular operation.

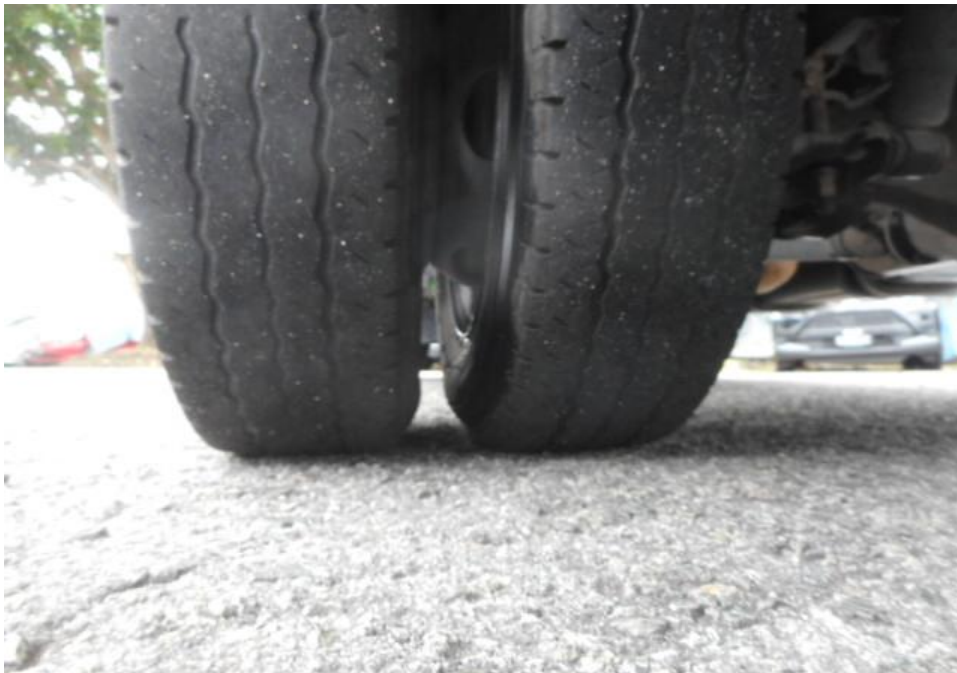
**Photo 9** shows the condition of the rear left tyres of the Motor Lorry, which was observed to be in serviceable condition with remaining tread depth of approximately 1.7mm. The tyres, which were wrapped around standard steel wheel rim, were also observed to be sufficiently inflated for vehicular operation.

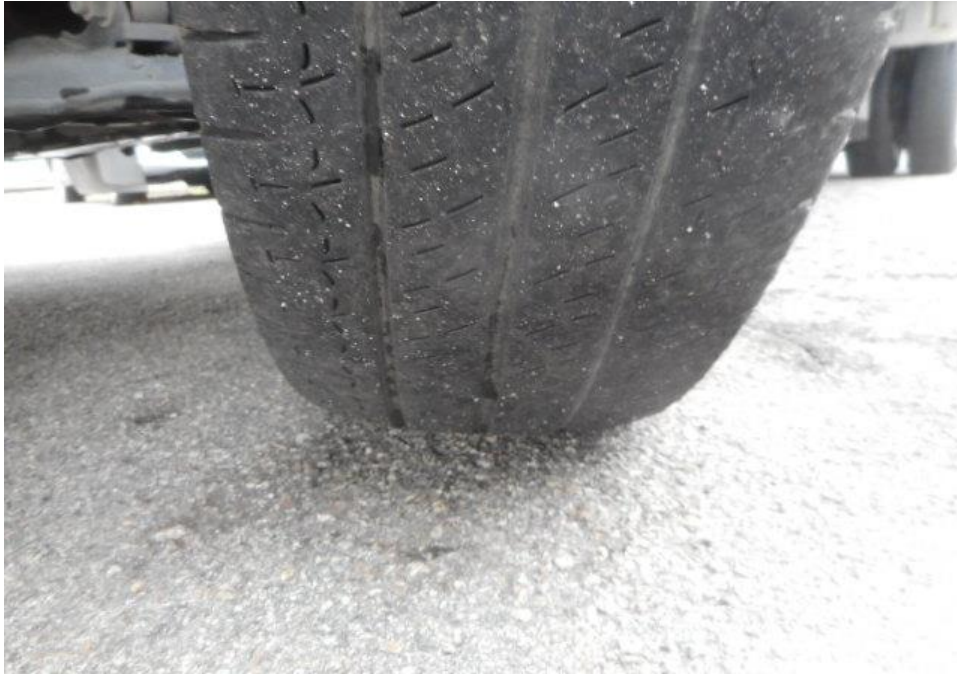
**Photo 10** shows the condition of the front right tyre of the Motor Lorry, which was observed to be in serviceable condition with remaining tread depth of approximately 2.6mm. The tyres, which were wrapped around standard steel wheel rim, were also observed to be sufficiently inflated for vehicular operation.

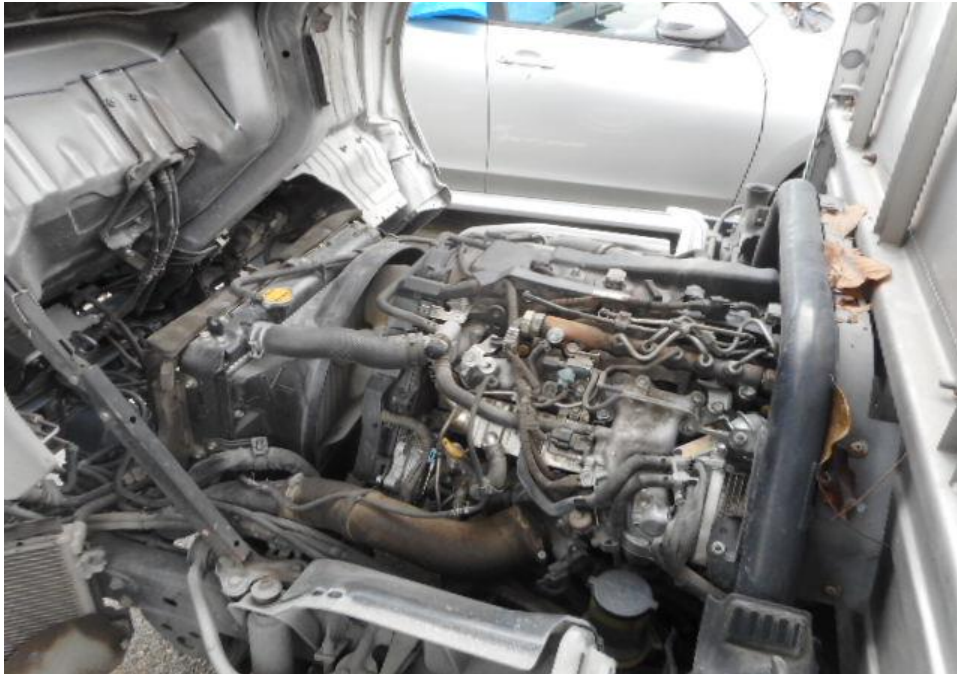
**Photo 11** shows a general view of the Motor Lorry's engine compartment, which was accessed by lifting the front cabin of the Motor Lorry. The various parts and components inside the engine compartment were unaffected by the accident. There was also no sign(s) or indication(s) of fresh fluid leakage and/or fluid stain within the engine compartment

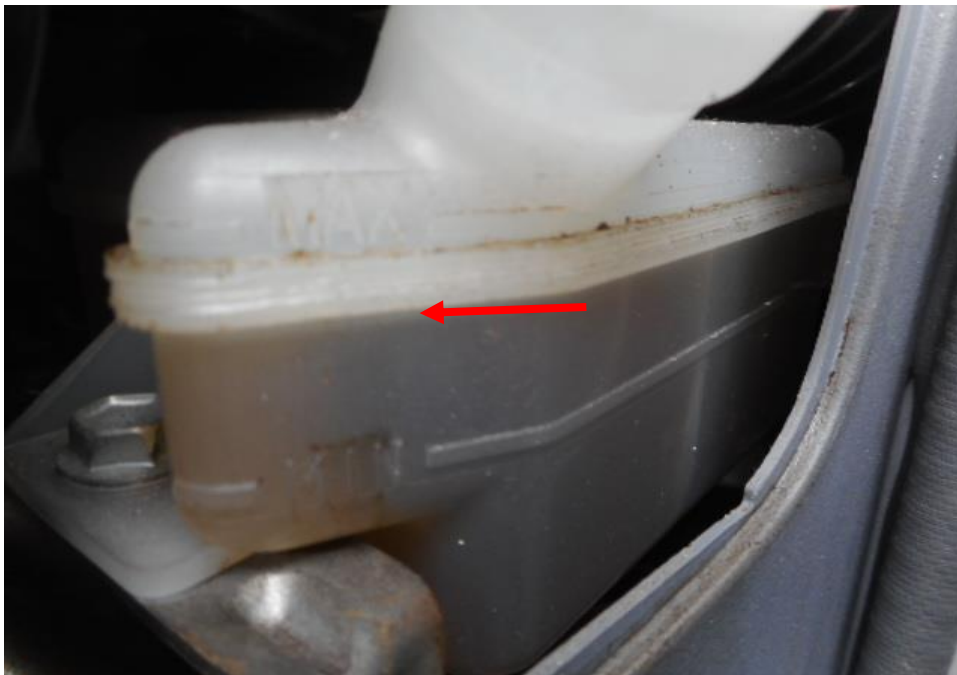
**Photo 12** shows the brake fluid reservoir of the Motor Lorry at the time of my inspection. The brake fluid was observed to be of sufficient level (arrowed) and without any visible contamination.

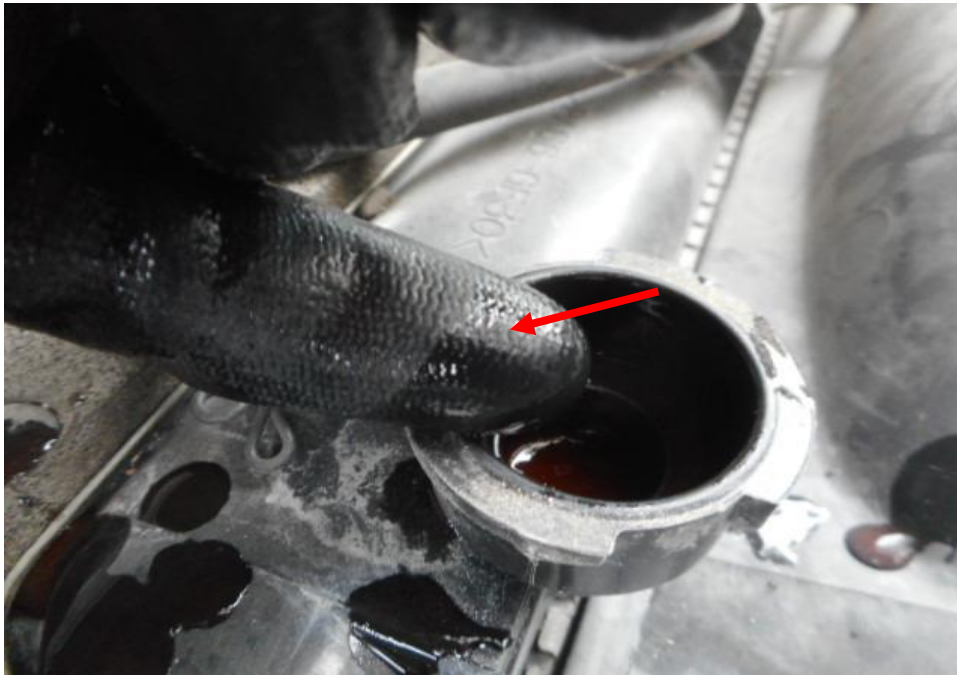
**Photo 13** shows the engine coolant reservoir of the Motor Lorry at the time of my inspection. The engine coolant was observed to be of sufficient level (arrowed) and without any visible contamination.

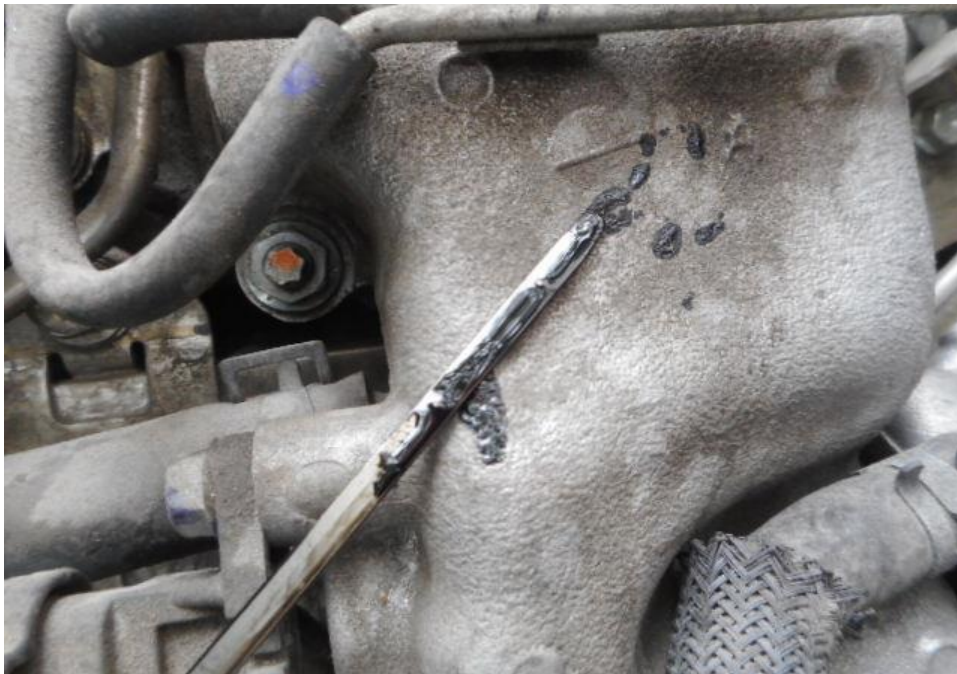
**Photo 14** shows the engine oil dip stick of the Motor Lorry at the time of my inspection. The engine oil was observed to be of sufficient level and without any visible contamination.

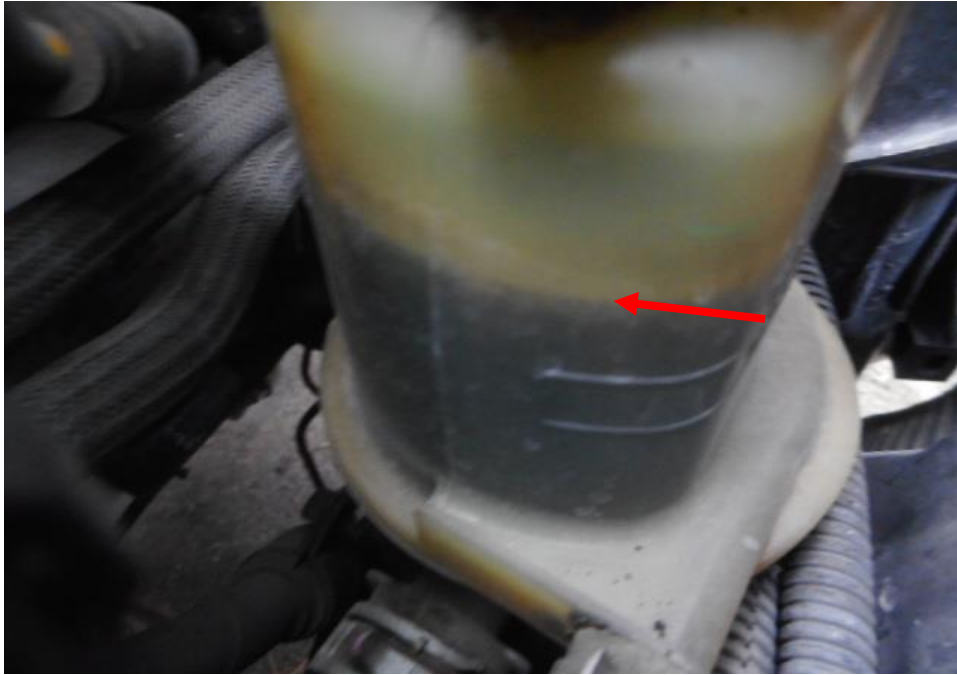
**Photo 15** shows the power steering fluid reservoir of the Motor Lorry at the time of my inspection. The power steering fluid (arrowed) was observed to be of sufficient level and without any visible contamination.

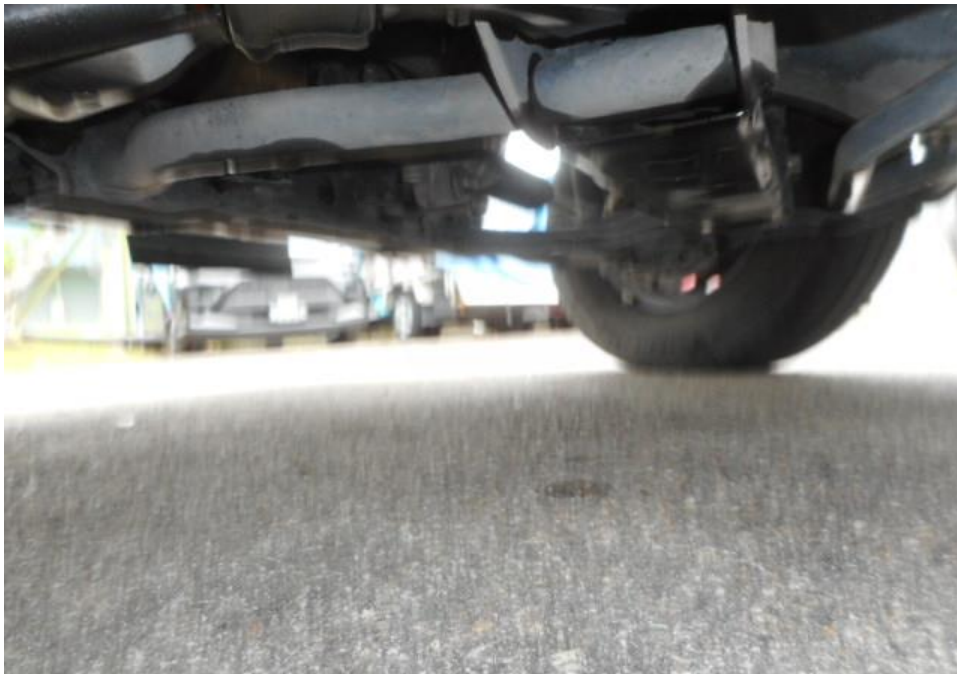
**Photo 16** shows the undercarriage of the Motor Lorry, at the area where the engine housing and transmission housing are located. I did not find any sign(s) or indication(s) of fluid leak and/or fluid stain(s) on the underside of the Motor Lorry.

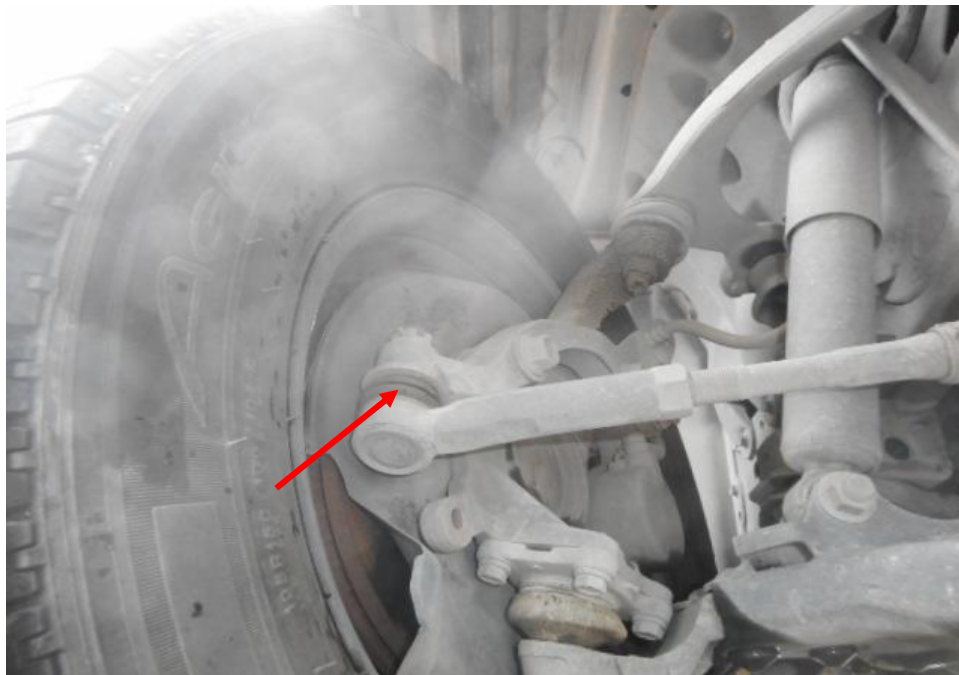
**Photo 17** shows the various undercarriage components at the front right wheel of the Motor Lorry, in particular the steering tie rod end (arrowed). The various steering components were all found to be intact, suggesting that the steering system of the Motor Lorry was likely to be in serviceable condition at the material time of accident. There was also no sign of fluid stain(s) observed on the various undercarriage components.

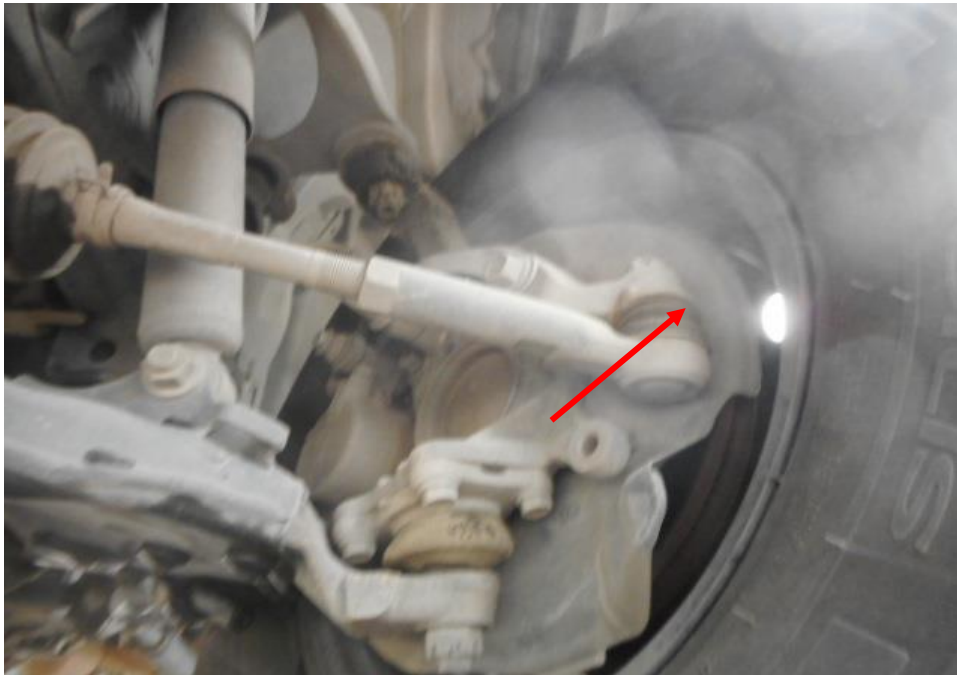
**Photo 18** shows the various undercarriage components at the front left wheel of the Motor Lorry, in particular the steering tie rod end (arrowed). The various undercarriage components of the Motor Lorry were all found to be intact without any visible damage. There was also no sign of fluid stain(s) observed on the various undercarriage components.

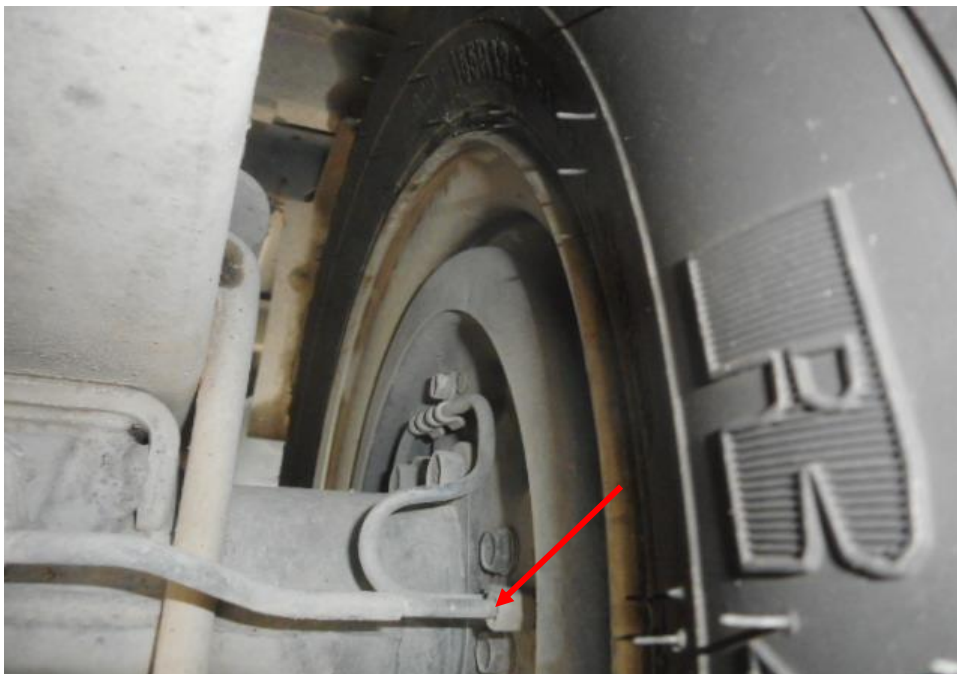
**Photo 19** shows the brake pipe (arrowed) at the rear right wheel of the Motor Lorry. I did not observe any leakage of brake fluid at the time of my inspection of the Motor Lorry. My static tests of the Motor Lorry's braking system, along with my visual examination of the various mechanical components in the braking system, had indicated that there was no internal leakage of pressure/vacuum. Hence the braking system of the Motor Lorry was likely to be in serviceable condition at the material time of accident.

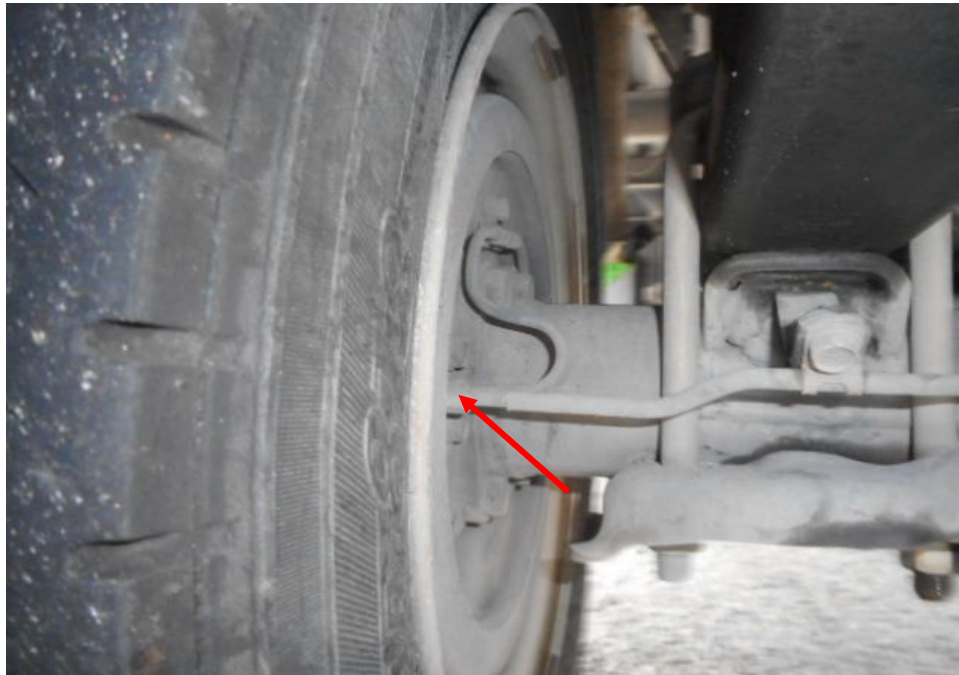
**Photo 20** shows the brake pipe (arrowed) at the rear left wheel of the Motor Lorry. I did not observe any leakage of brake fluid at the time of my inspection of the Motor Lorry. My static tests of the Motor Lorry's braking system, along with my visual examination of the various mechanical components in the braking system had indicated that there was no internal leakage of pressure/vacuum. Hence the braking system of the Motor Lorry was likely to be in serviceable condition at the material time of accident.

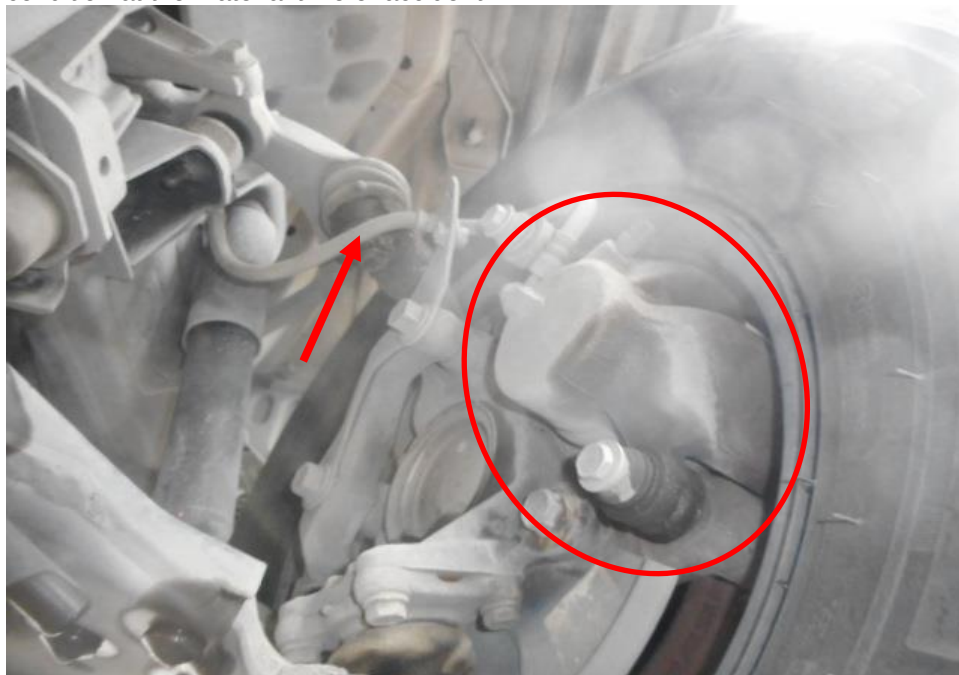
**Photo 21** shows the brake hose/pipe (arrowed) at the front right wheel of the Motor Lorry. No leakage of brake fluid was observed. Visual examination of the various components of the braking system like the brake caliper (circled), brake booster, brake pedal etc had revealed all to be intact and without visible damage at the time of accident. There was also no sign of fluid stain(s) observed on the various undercarriage components.

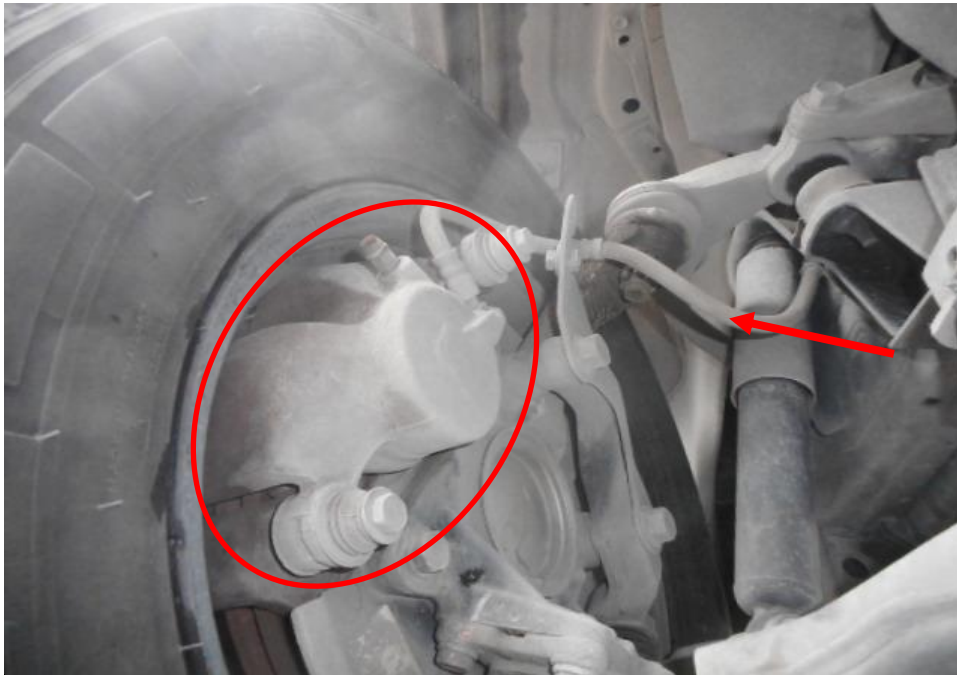
**Photo 22** shows the brake hose/pipe (arrowed) at the front left wheel of the Motor Lorry. No leakage of brake fluid was observed. Visual examination of the various components of the braking system like the brake caliper (circled), brake booster, brake pedal etc had revealed all to be intact and without visible damage at the time of accident. There was also no sign of fluid stain(s) observed on the various undercarriage components.

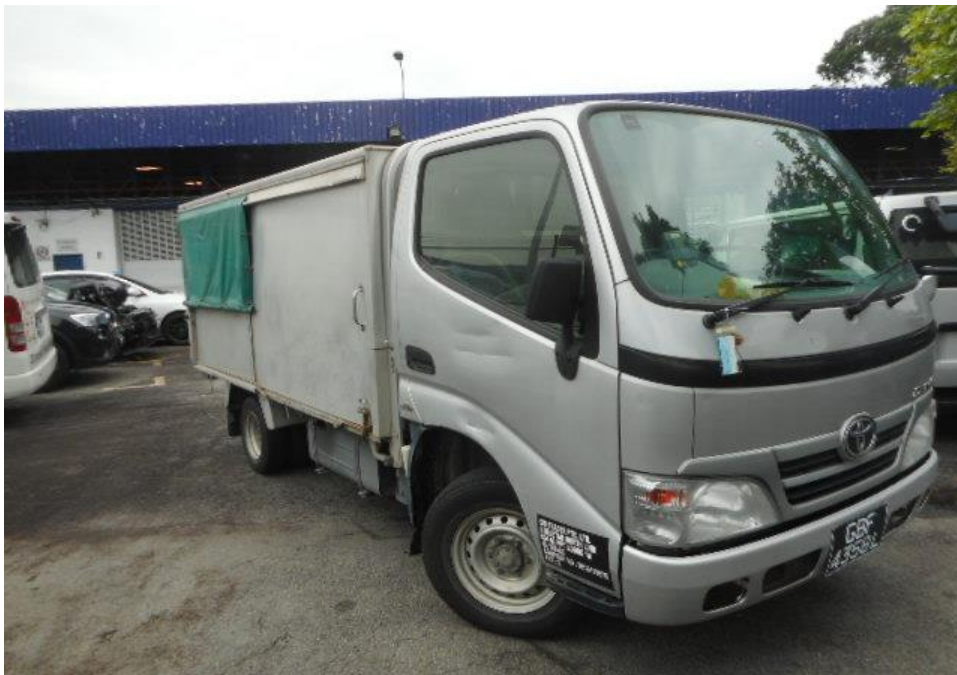
**Photo 23** shows the front right wheel of the Motor Lorry turned to its full left. During my steering system test, I did not experience any abnormal free play and/or resistance when I had turned the steering wheel towards the left and right. This would suggest that the steering system of the Motor Lorry was likely to be in serviceable condition at the material time of accident.
