Your Ref: TP/IP/18686/2022
Our Ref : CI/TPD22008167/P

8th September 2022

**MECHANICAL INSPECTION REPORT OF MOTOR TRAILER WC 4929P
(TBB7313)**

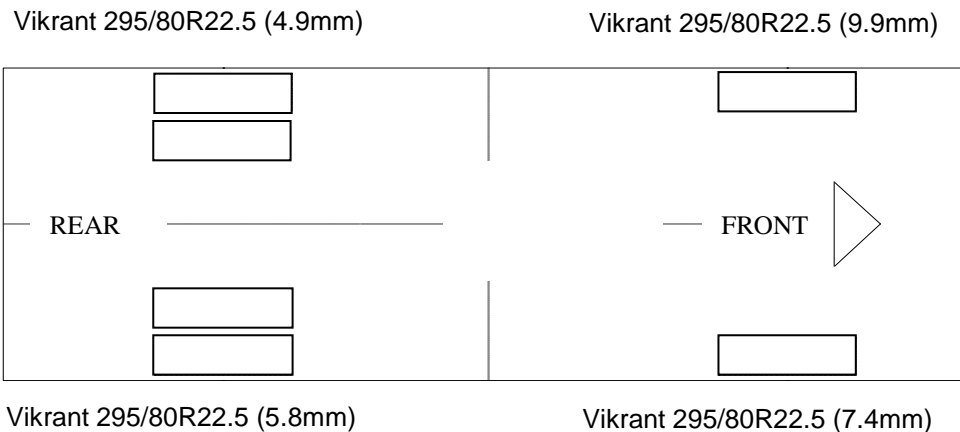
6. The 2 front tyres and 4 rear tyres of the Motor Trailer and 8 tyres of the trailer were observed to be in serviceable condition and sufficiently inflated for vehicular operation. I did not find any tear, cut or burst mark(s) on the outer and the inner sidewalls as well as across the tread of the 6 tyres of the Motor Trailer and the 8 tyres of the trailer. The tyre brand, tyre size and remaining tread depth of the 6 tyres of the Motor Trailer and 8 tyres of the trailer were recorded as follows:-

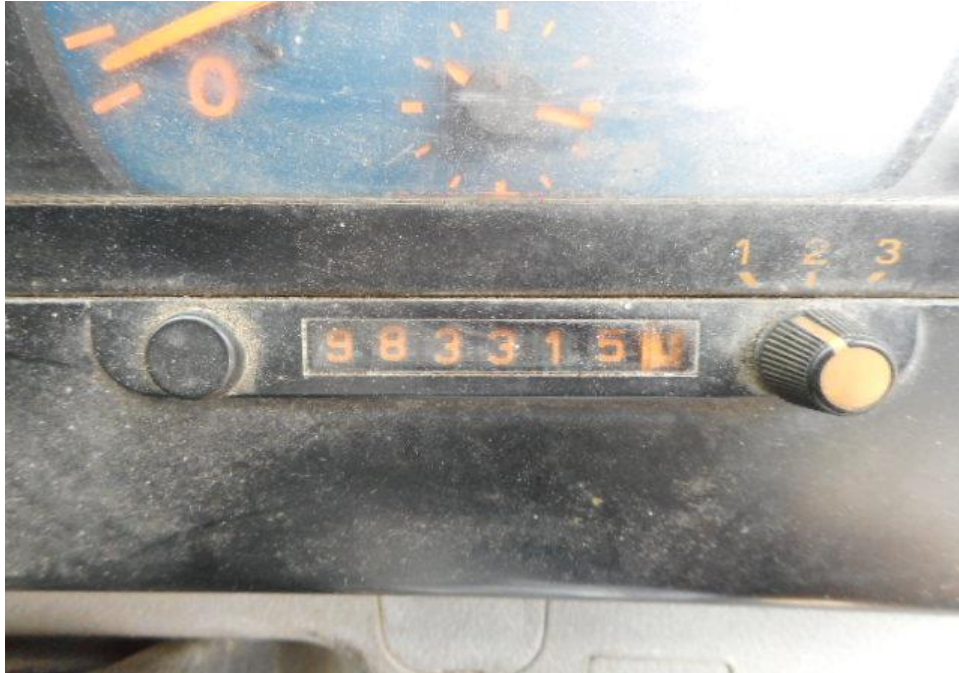
Photo 1 shows a general view of the instrument cluster of the Motor Trailer at the time of my inspection. The mileage of the Motor Trailer was 983,315km

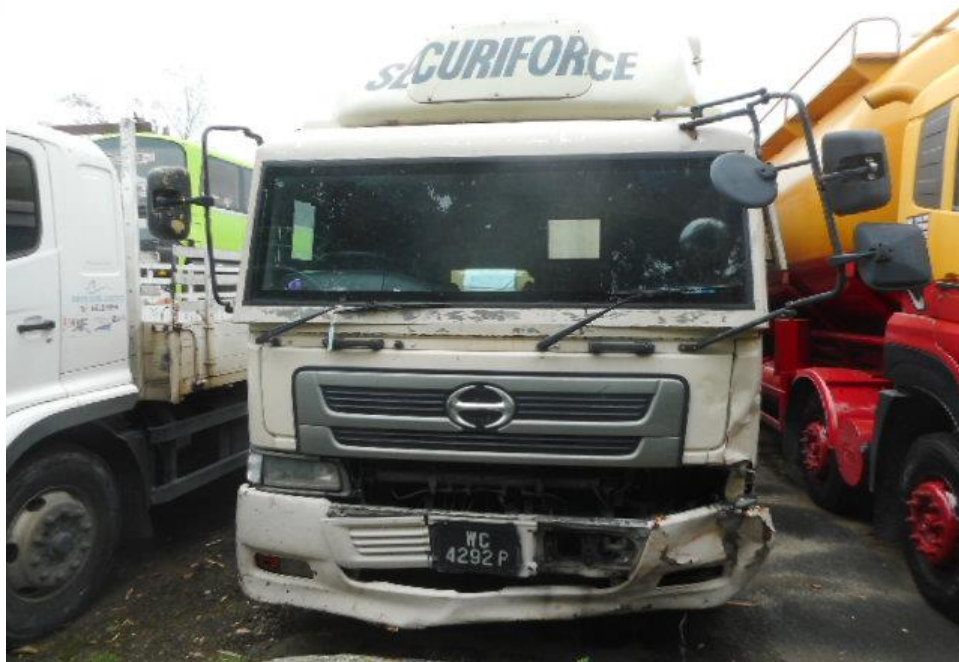
4. The mileage of the Motor Trailer at the time of my inspection was 983,315km.
5. The Motor Trailer was observed to sustain damaged on its Motor Trailer's front portion. Its front bumper, front left headlamp and front left body panel was damaged at the time of my inspection.

Photo 2 shows a general view of the front body of the Motor Trailer at the time of my inspection. The Motor Trailer was observed to sustain damaged on its Trailer's front portion. Its front bumper, front right headlamp and front left body panel was damaged at the time of my inspection.

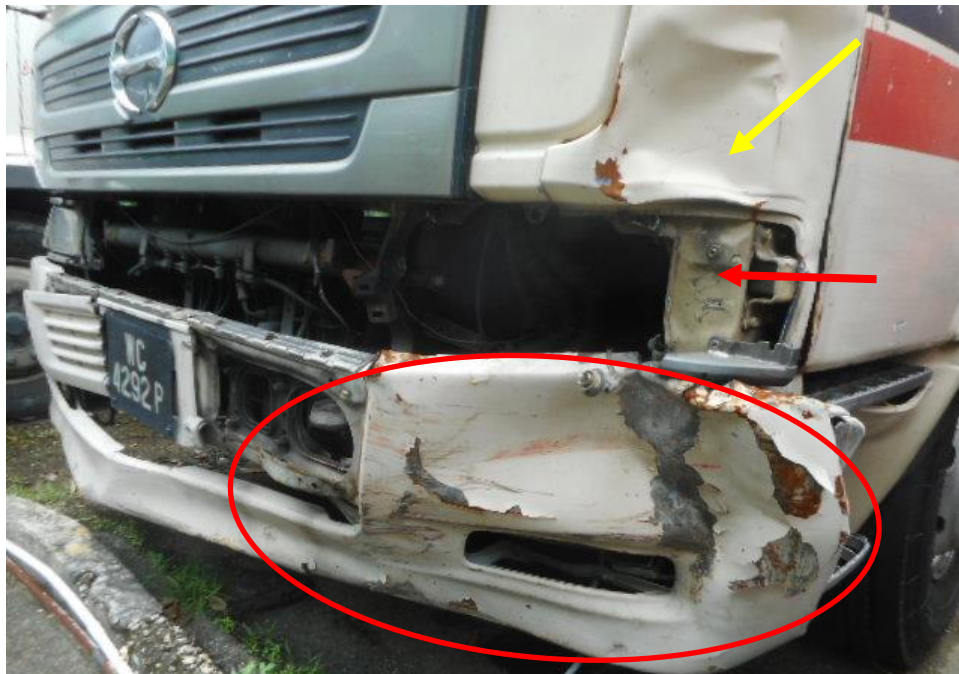
Photo 3 shows a general view of the front body of the Motor Trailer at the time of my inspection. The Motor Trailer was observed to sustain damaged on its Trailer's front portion. Its front bumper (circled), front right headlamp (red arrow) and its front left body panel (yellow arrow) was damaged at the time of my inspection.

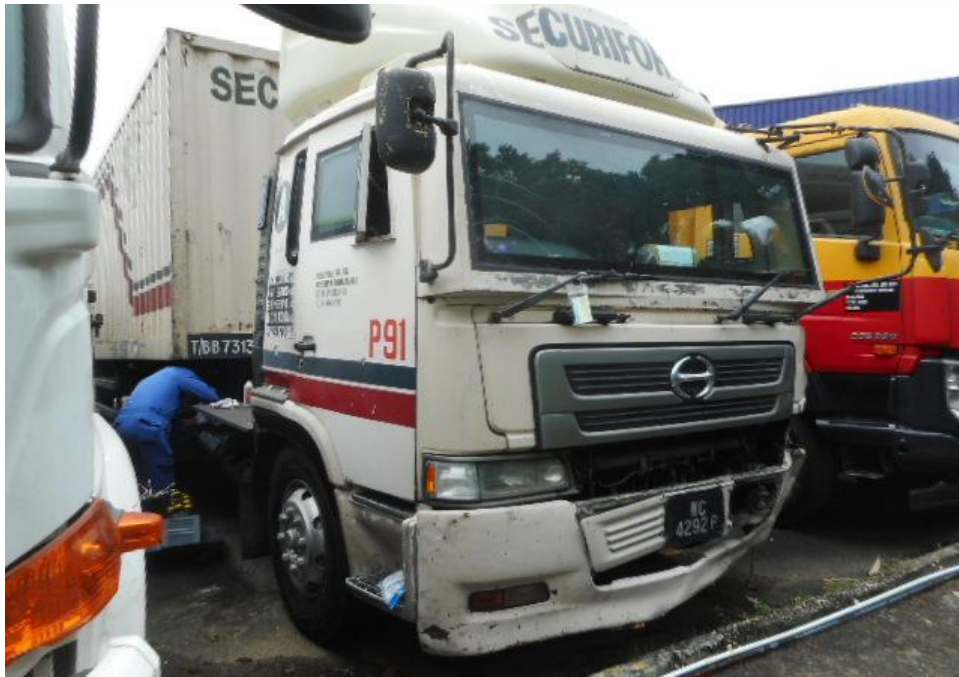
Photo 4 shows a general view of the front right body of the Motor Trailer at the time of my inspection. The Motor Trailer was observed to be intact and unaffected by the accident.

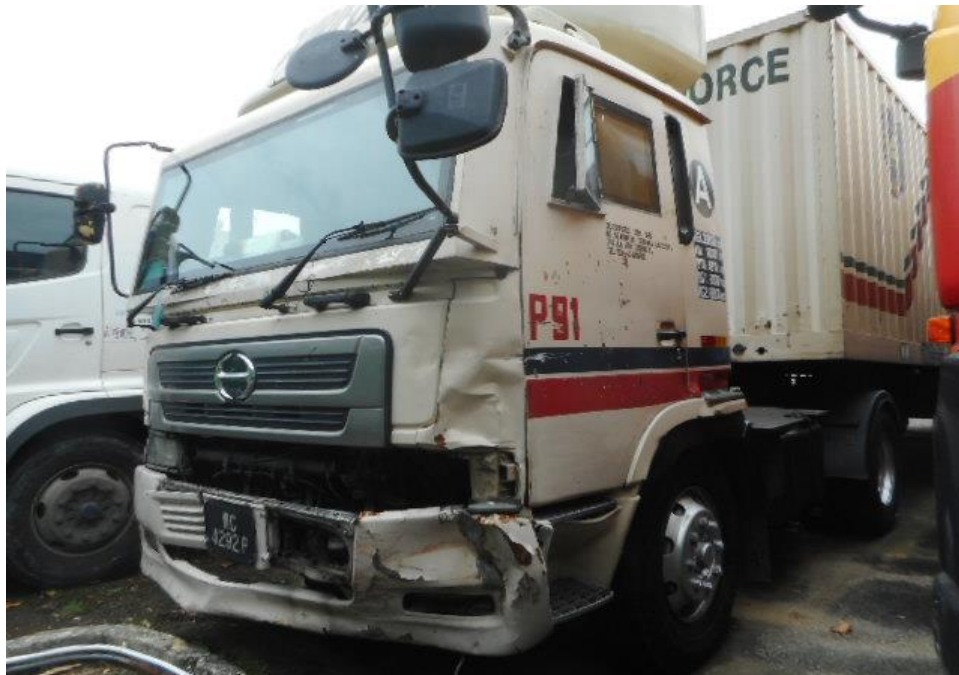
Photo 5 shows a general view of the front left body of the Motor Trailer at the time of my inspection. The Motor Trailer was observed to be intact and unaffected by the accident.

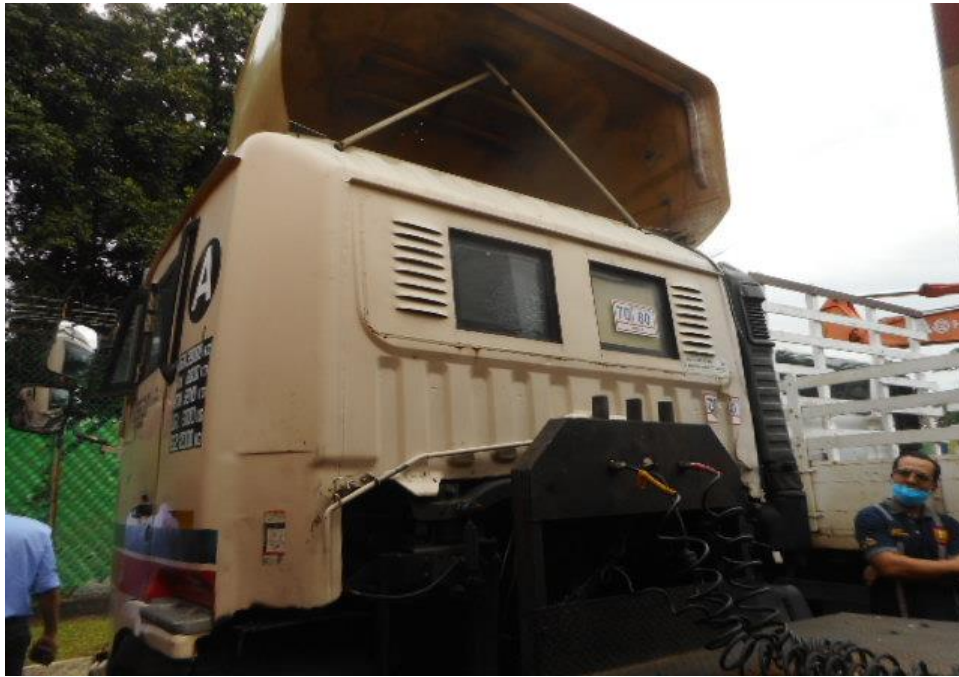
Photo 6 shows a general view of the Motor Trailer's rear body at the time of my inspection. The Motor Trailer was observed to be intact and unaffected by the accident.

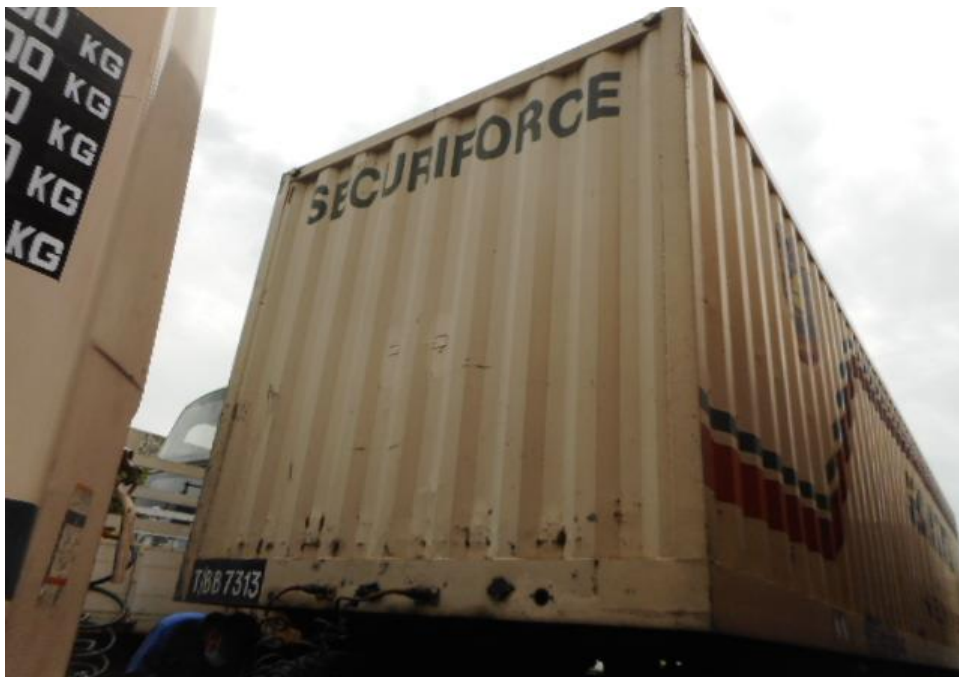
Photo 7 shows a general view of the front body of the trailer at the time of my inspection. The Motor Trailer was observed to be intact and unaffected by the accident.

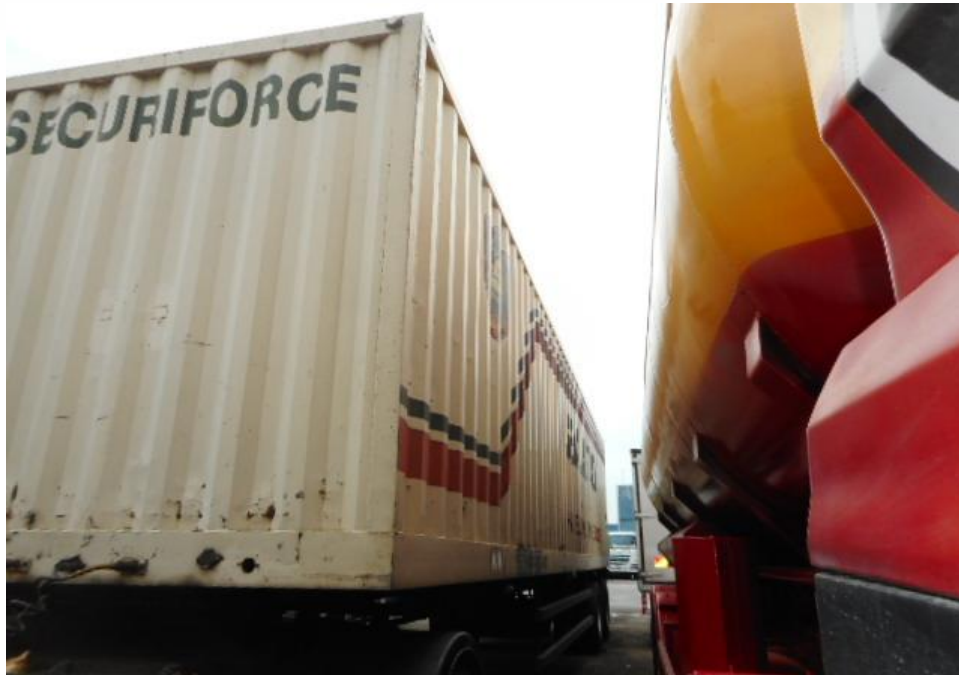
Photo 8 shows a general view of the trailer's left body at the time of my inspection. The Motor Trailer was observed to be intact and unaffected by the accident.

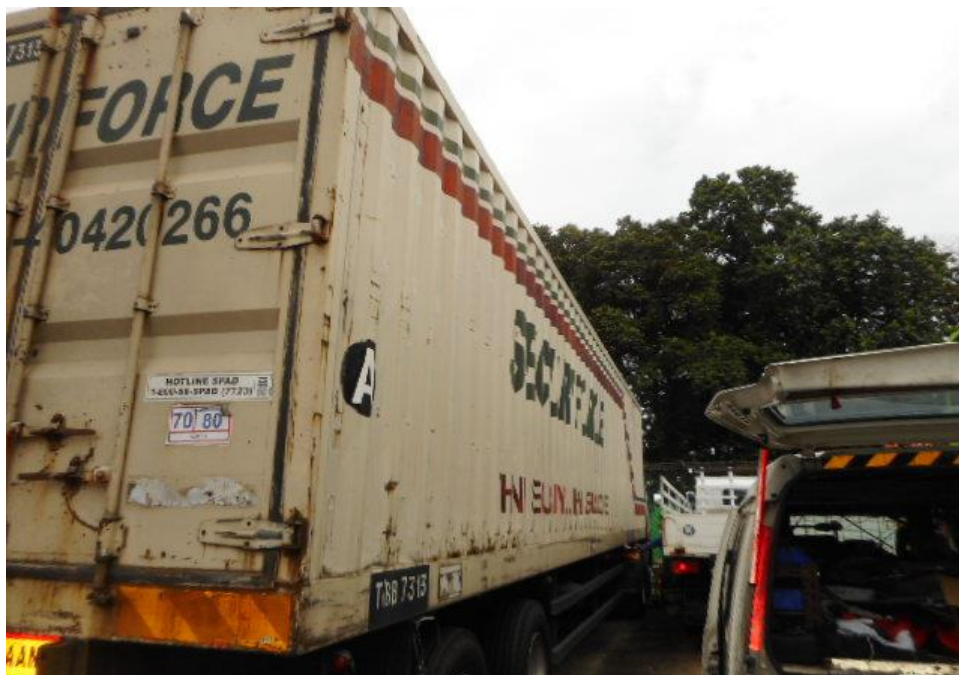
Photo 9 shows a general view of the trailer's right body at the time of my inspection. The Motor Trailer was observed to be intact and unaffected by the accident.

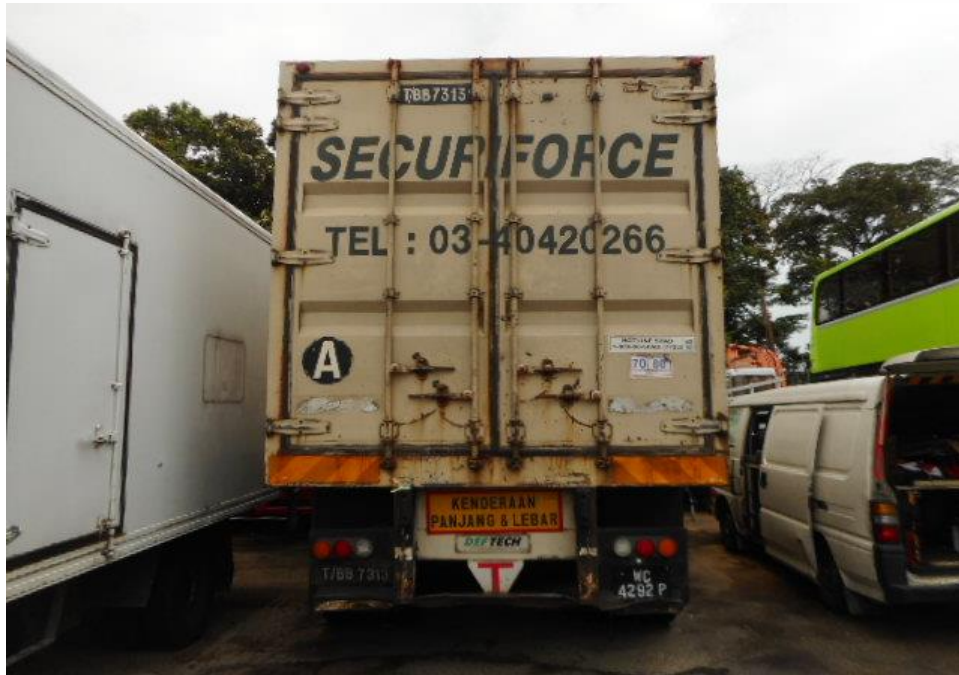
Photo 10 shows a general view of the trailer's rear body at the time of my inspection. The Motor Trailer was observed to be intact.

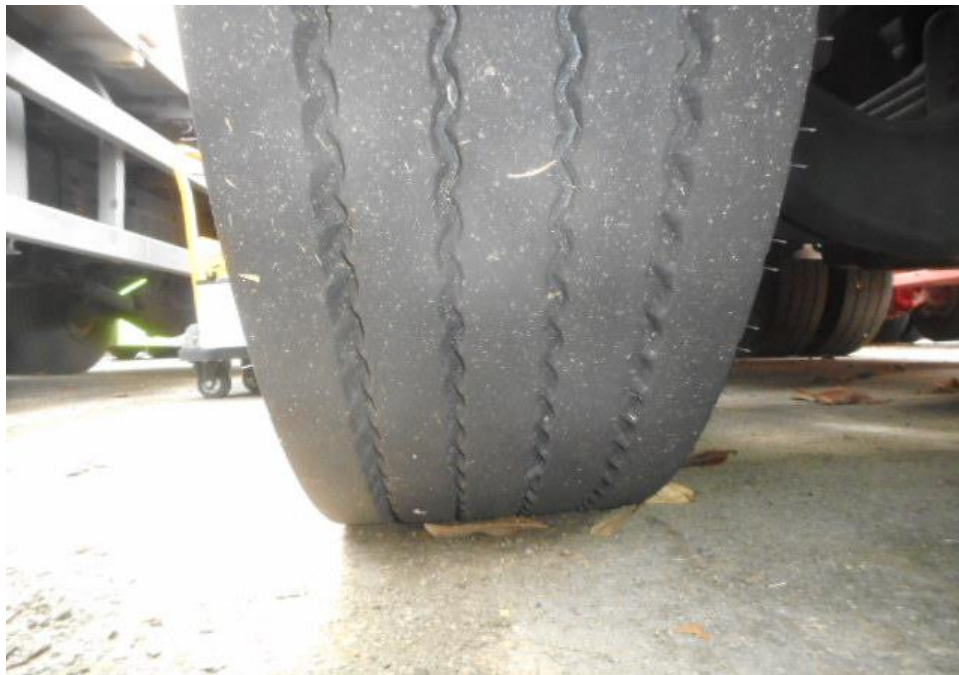
Photo 11 shows the condition of the front right tyre of the Motor Trailer, which was observed to be in serviceable condition with remaining tread depth of approximately 7.4mm. The tyre, which was wrapped around standard steel wheel rim, was also observed to be sufficiently inflated for vehicular operation. There was no tear, cut or burst mark(s) on the outer and the inner sidewalls as well as across the tread of the 6 tyres that were fitted on the Motor Trailer.

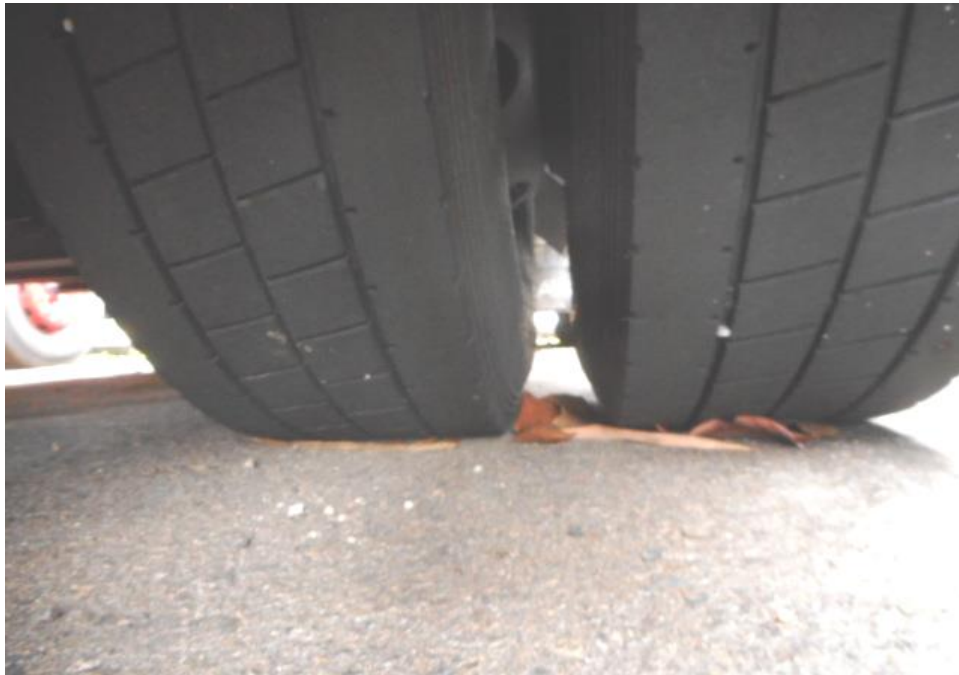
Photo 12 shows the condition of the rear right tyre of the Motor Trailer, which was observed to be in serviceable condition with remaining tread depth of approximately 5.8mm. The tyre, which was wrapped around standard steel wheel rim, was also observed to be sufficiently inflated for vehicular operation.

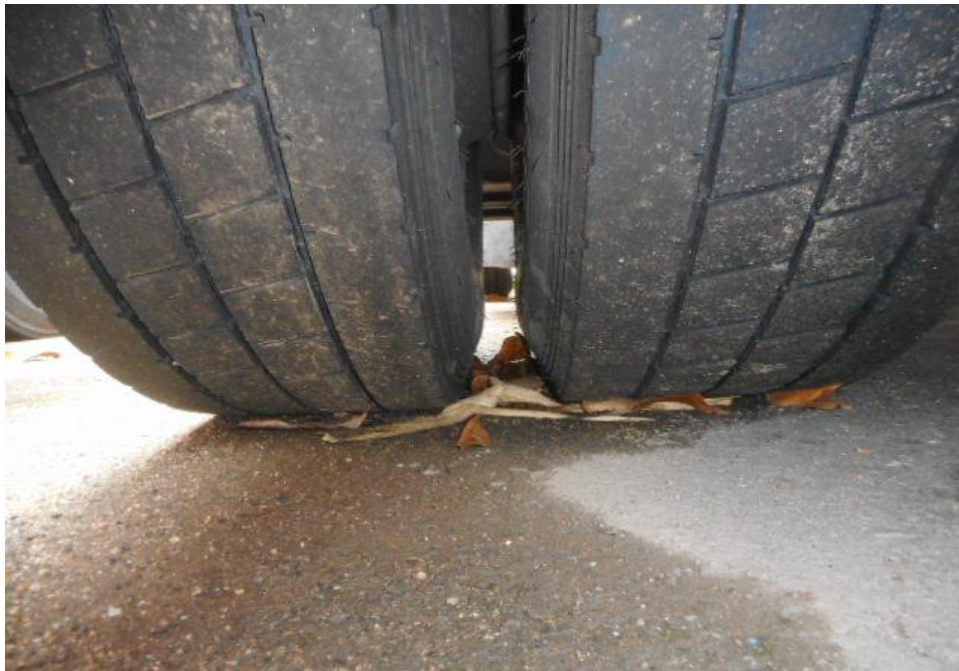
Photo 13 shows the condition of the rear left tyres of the Motor Trailer, which was observed to be in serviceable condition with remaining tread depth of approximately 4.9mm. The tyres, which were wrapped around standard steel wheel rim, were also observed to be sufficiently inflated for vehicular operation. There was also no damage found on all 6 steel wheel rims of the Motor Trailer.

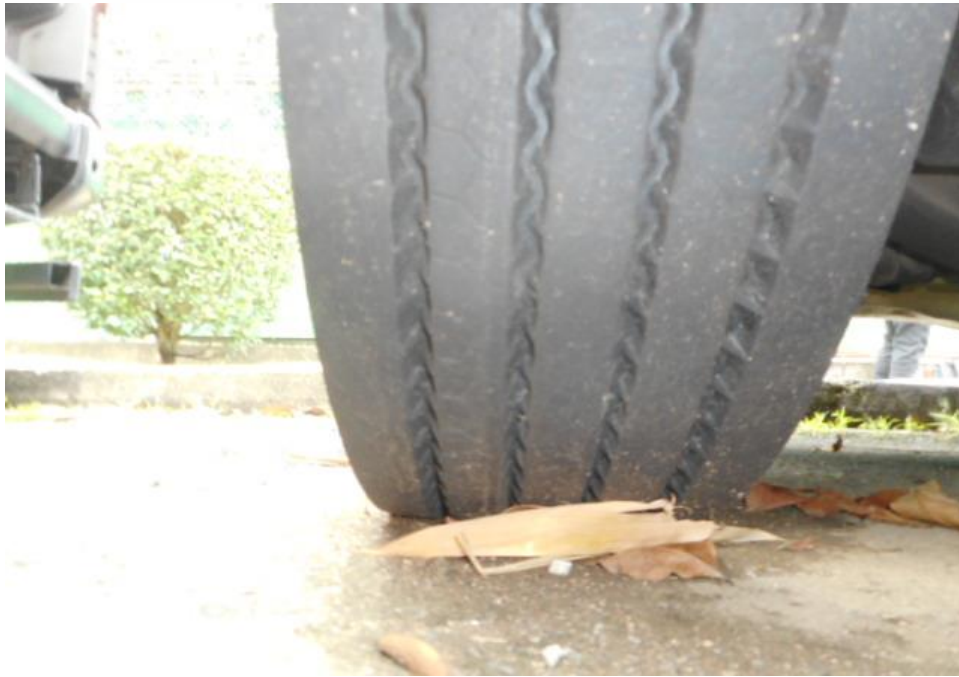
Photo 14 shows the condition of the front left tyres of the Motor Trailer, which were observed to be in serviceable condition with remaining tread depth of approximately 9.9mm. There was also no tear, cut or burst mark(s) on the outer and the inner sidewalls as well as across the tread of the 6 tyres that were fitted on the Motor Trailer.

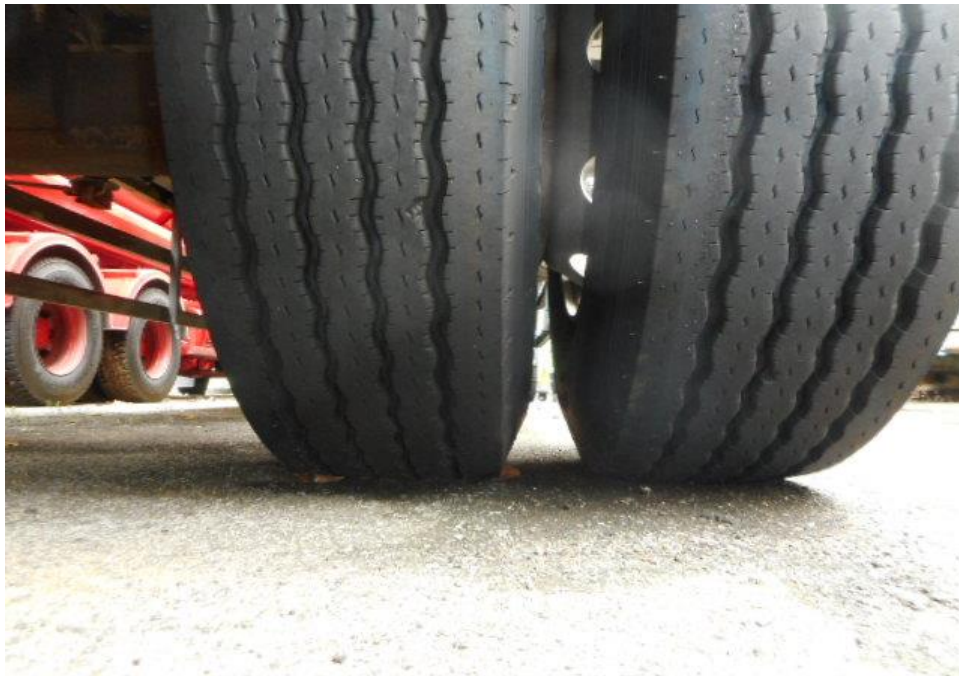
Photo 15 shows the condition of the right tyres of the trailer, which was observed to be in serviceable condition with remaining, tread depth of approximately 10.7mm. There was also no tear, cut or burst mark(s) on the outer and the inner sidewalls as well as across the tread of the 8 tyres that were fitted on the trailer.

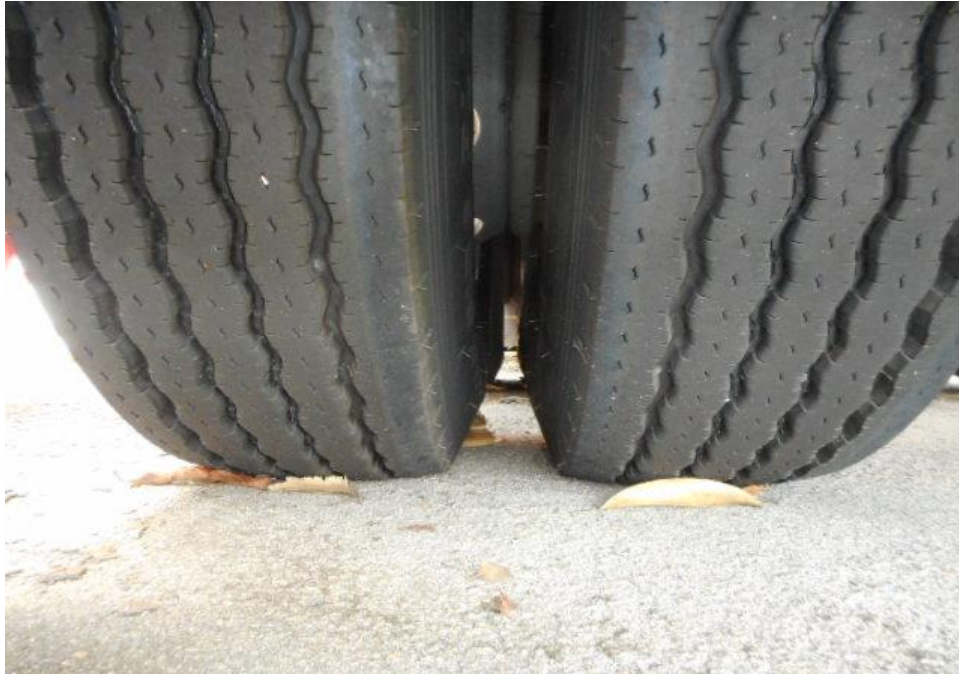
Photo 16 shows the condition of the left tyres of the trailer, which was observed to be in serviceable condition with remaining tread depth of approximately 9.8mm. There was also no tear, cut or burst mark(s) on the outer and the inner sidewalls as well as across the tread of the 8 tyres that were fitted on the trailer.

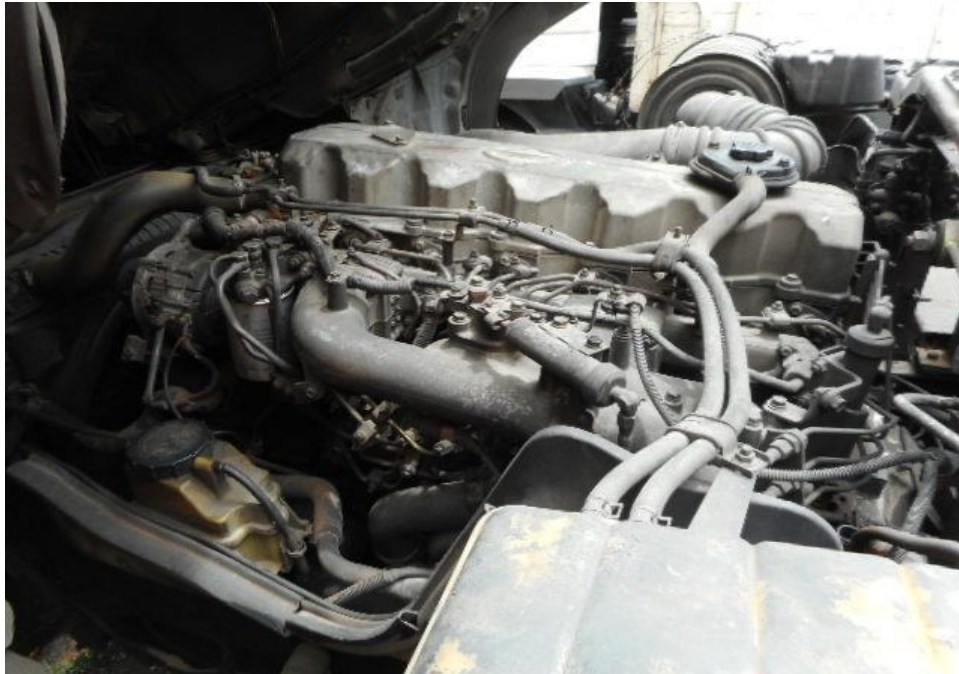
Photo 17 shows a general view of the Motor Trailer's engine compartment, which was accessed by lifting the front cabin of the Motor Trailer. The various parts and components inside the engine compartment were unaffected by the accident. There was also no sign(s) or indication(s) of fresh fluid leakage and/or fluid stain within the engine compartment

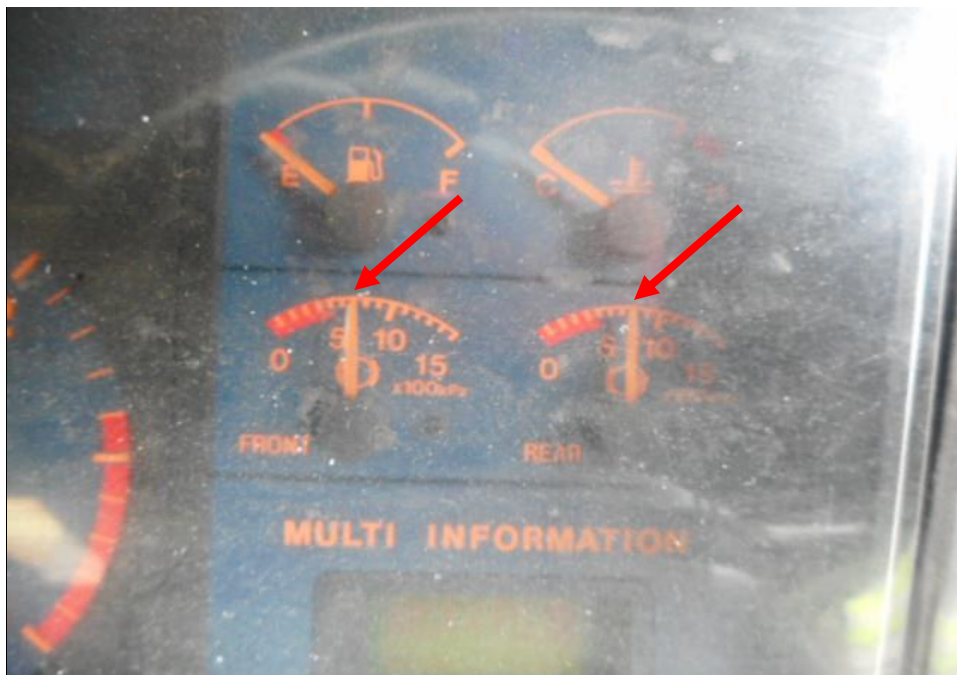
Photo 18 shows the air in the air brake cylinders of the Motor Trailer at the time of my inspection. The air in the cylinder was observed to be of sufficient level & serviceable at the time of the accident.

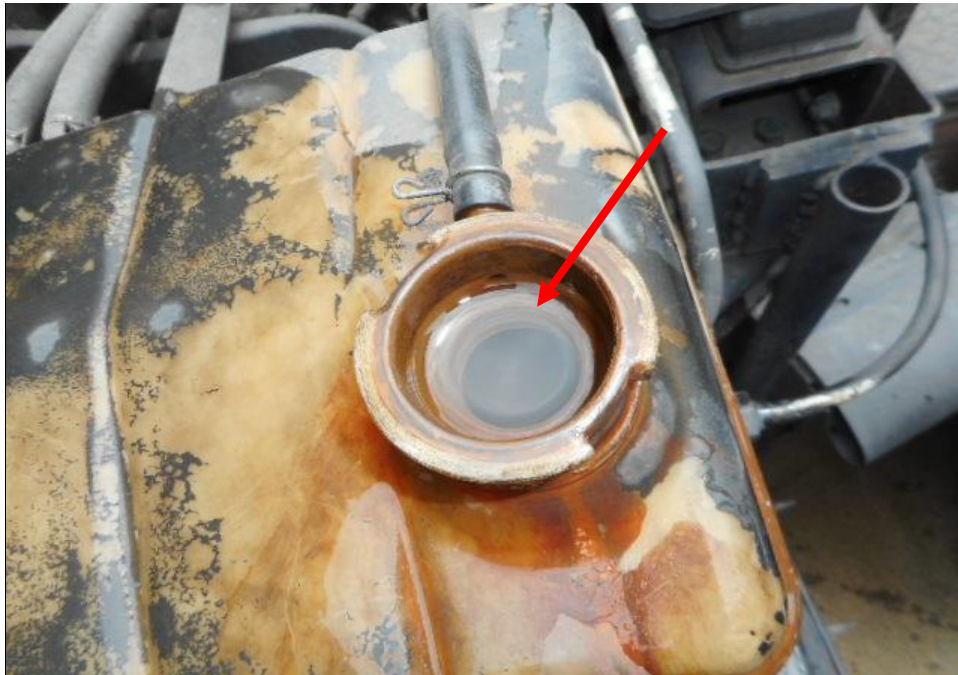
Photo 19 shows the engine coolant reservoir of the Motor Trailer at the time of my inspection. The engine coolant was observed to be of sufficient level (arrowed) and without any visible contamination.

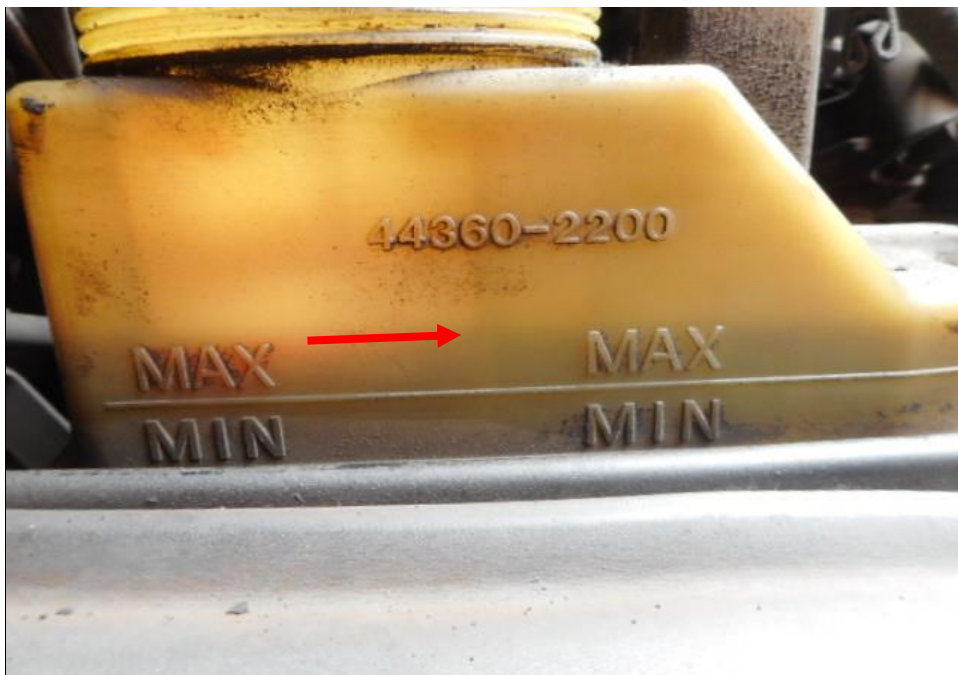
Photo 20 shows the power steering fluid reservoir of the Motor Trailer at the time of my inspection. The power steering fluid was observed to be of sufficient level (arrowed) and without any visible contamination.

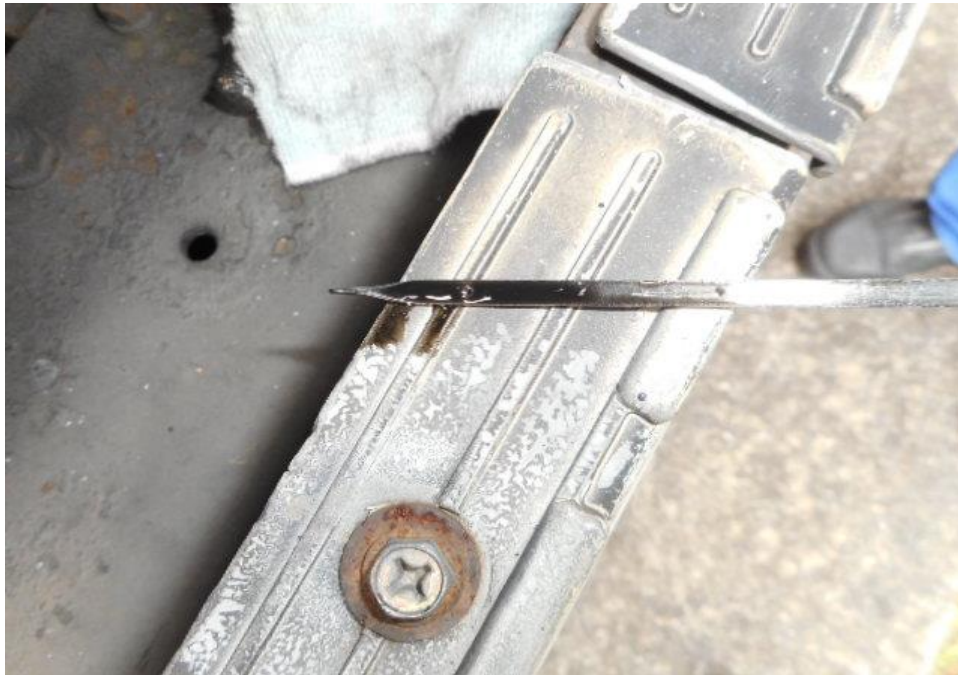
Photo 21 shows the engine oil dip stick of the Motor Trailer at the time of my inspection. The engine oil was observed to be of insufficient level at the time of our inspection.

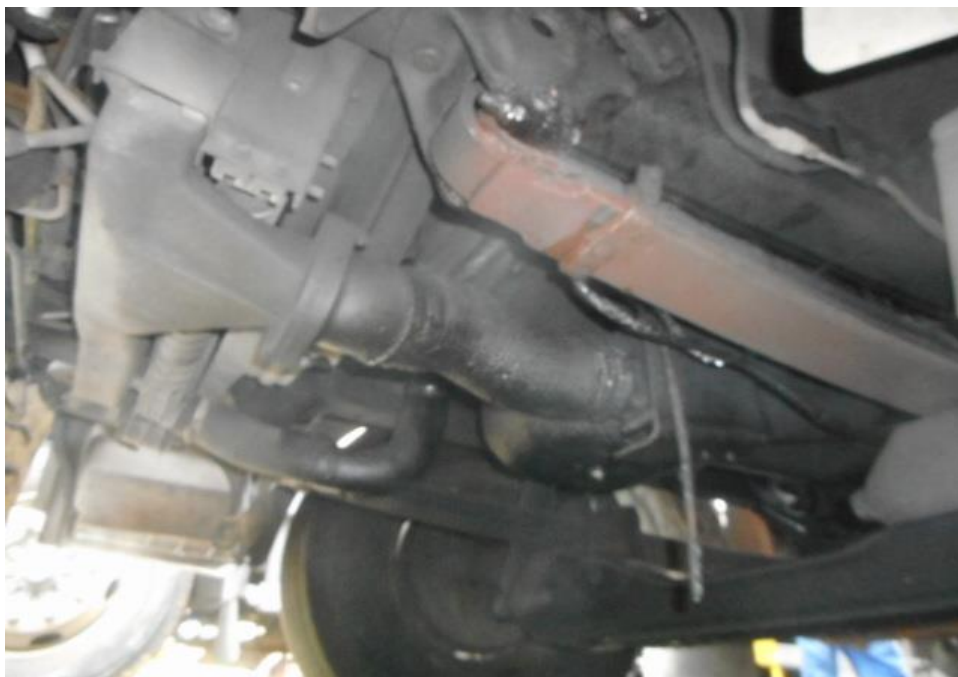
Photo 22 shows the undercarriage of the Motor Trailer, at the area where the engine housing located. I did not find any sign(s) or indication(s) of fluid leak, however old fluid stain(s) was observed on the underside of the Motor Trailer.

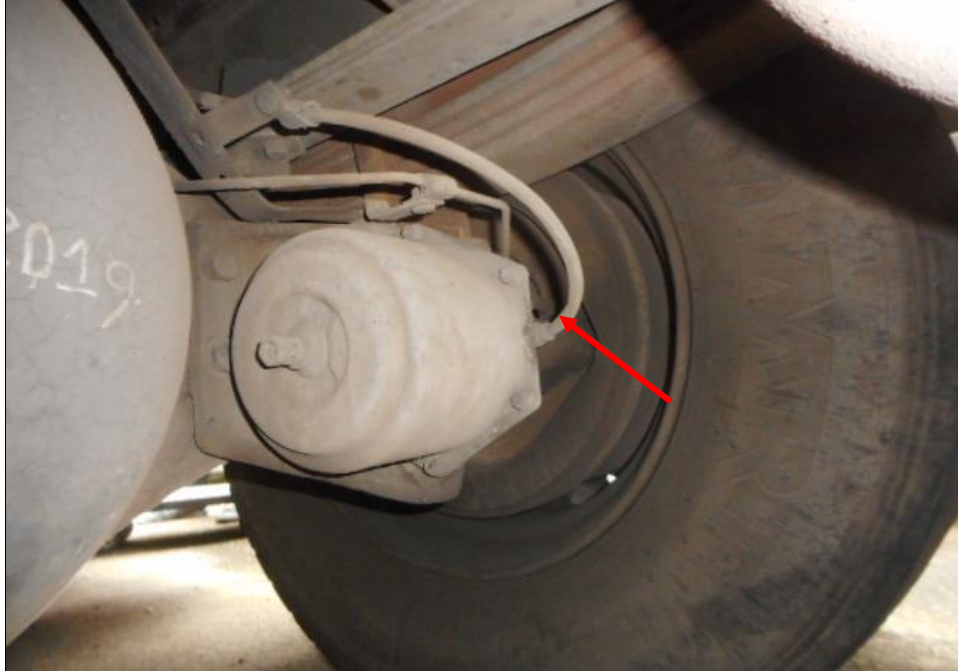
Photo 23 shows the brake pipe (arrowed) at the rear right wheel of the Motor Trailer. I did not observe any leakage of brake fluid at the time of my inspection of the Motor Trailer. My static tests of the Motor Trailer's braking system, along with my visual examination of the various mechanical components in the braking system, had indicated that there was no internal leakage of pressure/vacuum. Hence the braking system of the Motor Trailer was likely to be in serviceable condition at the material time of accident.

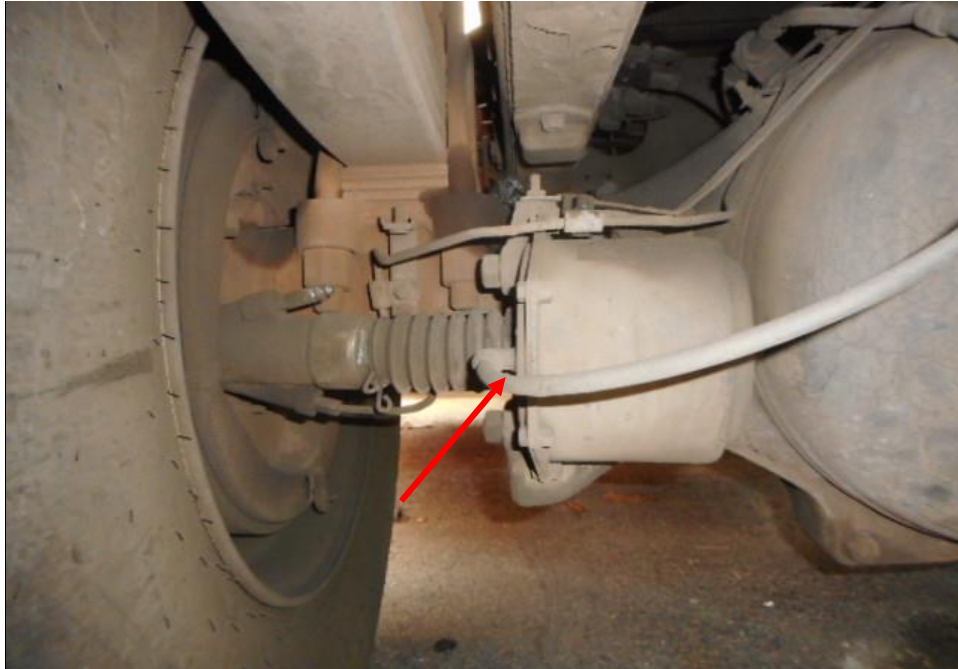
Photo 24 shows the brake pipe (arrowed) at the rear left wheel of the Motor Trailer. I did not observe any leakage of brake fluid at the time of my inspection of the Motor Trailer. My static tests of the Motor Trailer's braking system, along with my visual examination of the various mechanical components in the braking system, had indicated that there was no internal leakage of pressure/vacuum. Hence the braking system of the Motor Trailer was likely to be in serviceable condition at the material time of accident.

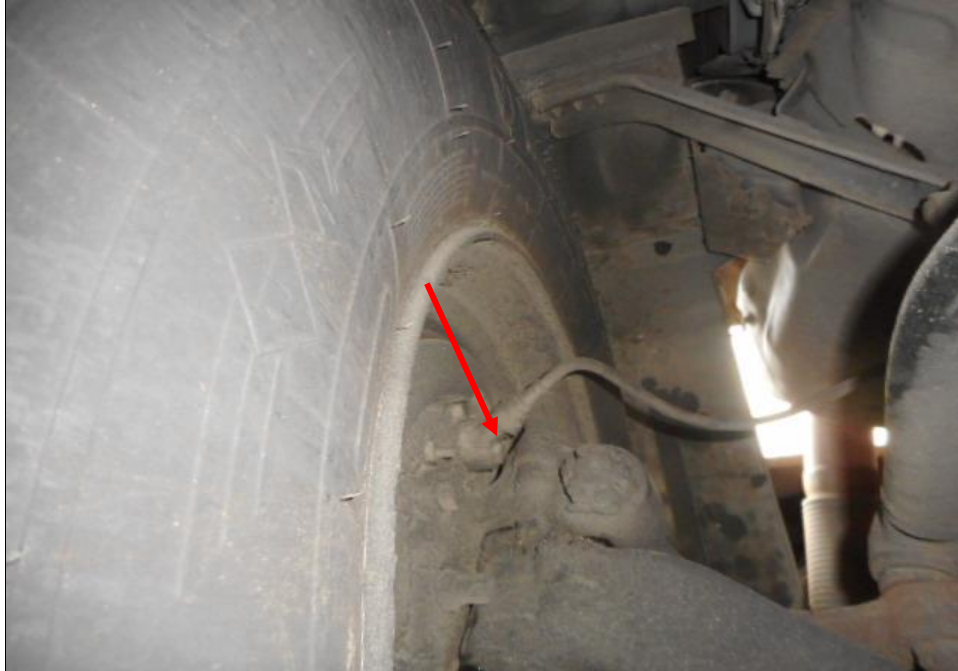
Photo 25 shows the brake pipe (arrowed) at the front right wheel of the Motor Trailer. I did not observe any leakage of brake fluid at the time of my inspection of the Motor Trailer. My static tests of the Motor Trailer's braking system, along with my visual examination of the various mechanical components in the braking system, had indicated that there was no internal leakage of pressure/vacuum. Hence the braking system of the Motor Trailer was likely to be in serviceable condition at the material time of accident.

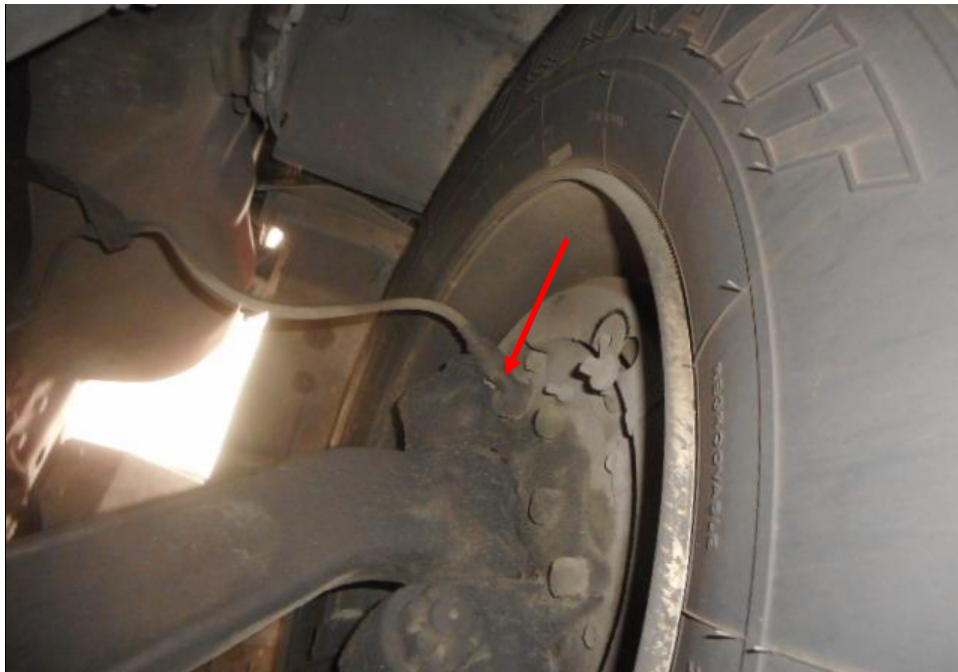
Photo 26 shows the brake pipe (arrowed) at the front left wheel of the Motor Trailer. I did not observe any leakage of brake fluid at the time of my inspection of the Motor Trailer. My static tests of the Motor Trailer's braking system, along with my visual examination of the various mechanical components in the braking system had indicated that there was no internal leakage of pressure/vacuum. Hence the braking system of the Motor Trailer was likely to be in serviceable condition at the material time of accident.

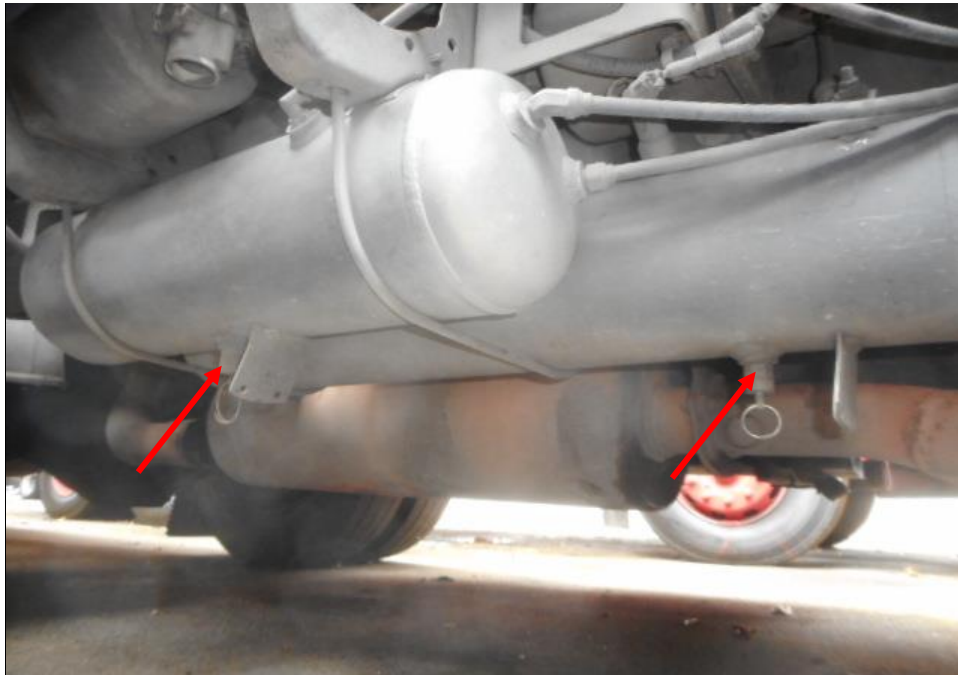
Photo 27 shows the air brake cylinders (arrowed) at the undercarriage of the Motor Trailer. I did not observe any leakage of air brake fluid at the time of my inspection of the Motor Trailer. My static tests of the Motor Trailer's braking system, along with my visual examination of the various mechanical components in the braking system had indicated that there was no internal leakage of pressure/vacuum. Hence the braking system of the Motor Trailer was likely to be in serviceable condition at the material time of accident.

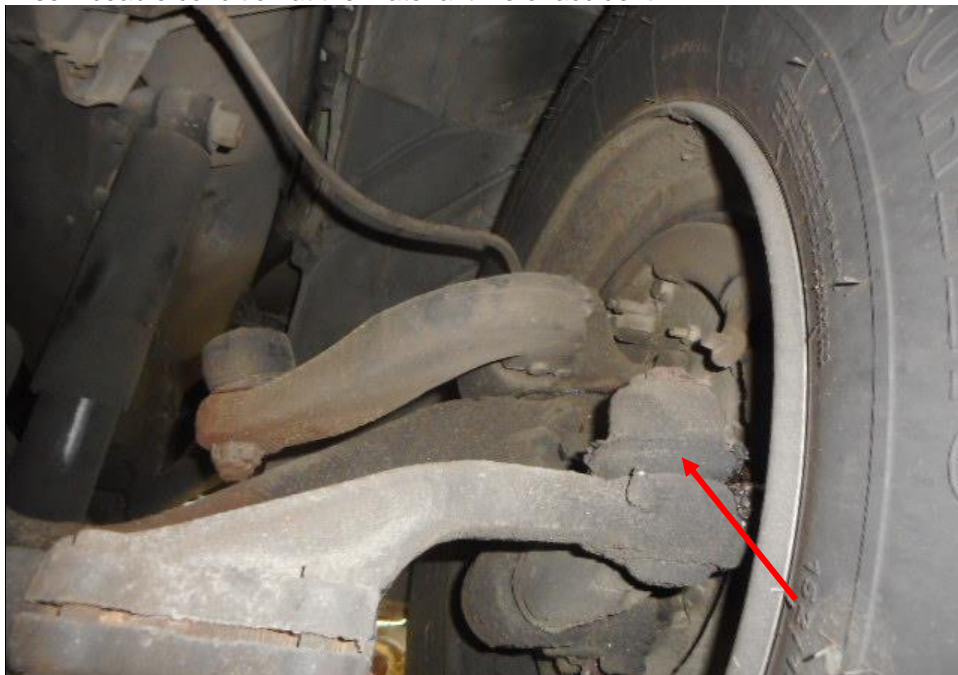
Photo 28 shows the various undercarriage components at the front right wheel of the Motor Trailer, in particular the steering tie rod end (arrowed). The various steering components were all found to be intact, suggesting that the steering system of the Motor Trailer was likely to be in serviceable condition at the material time of accident. There was also no sign of fluid stain(s) observed on the various undercarriage components.

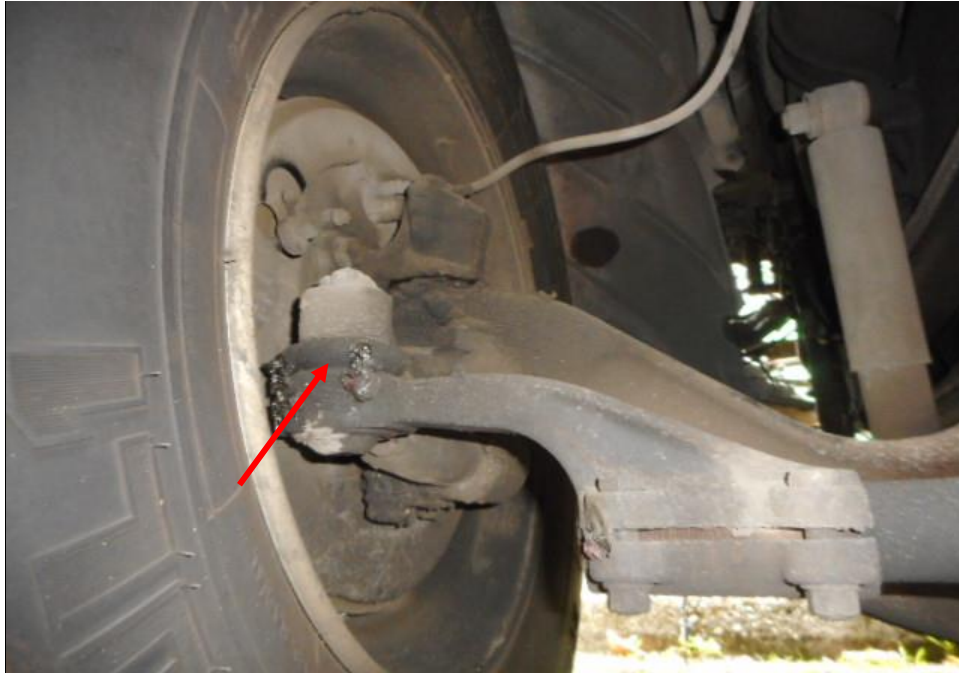
Photo 29 shows the various undercarriage components at the front left wheel of the Motor Trailer, in particular the steering tie rod end (arrowed). The various undercarriage components of the Motor Trailer were all found to be intact without any visible damage. There was also no sign of fluid stain(s) observed on the various undercarriage components.

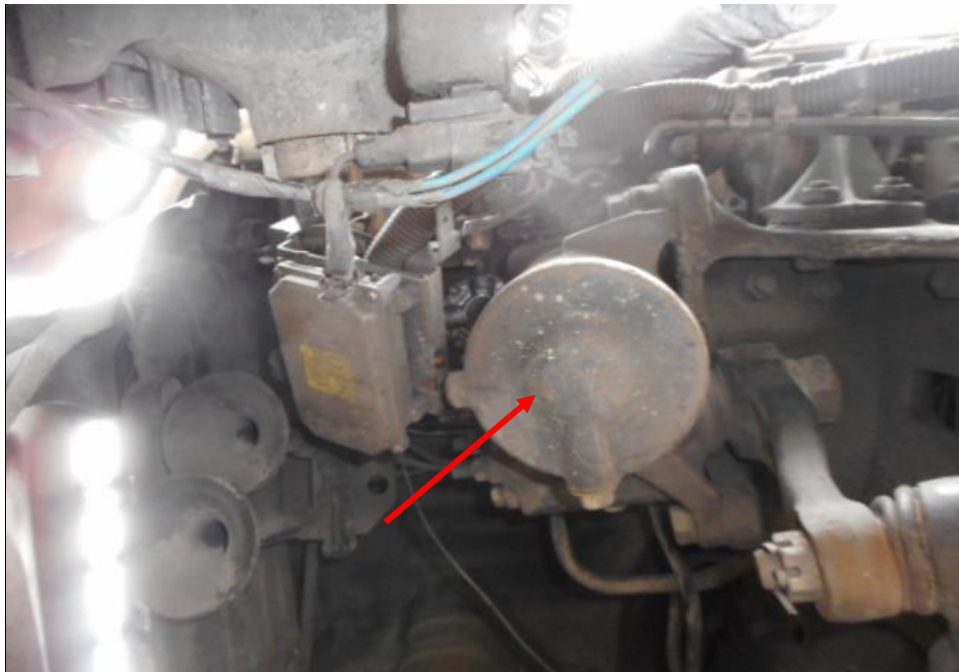
Photo 30 shows the steering box component (arrowed) at the undercarriage of the Motor Trailer was found to be intact without any visible damage. There was also no sign of fluid stain(s) observed on the various undercarriage components.
