Your Ref: TP/IP/18686/2022
Our Ref : CI/TPD22008167/P

8th September 2022

**MECHANICAL INSPECTION REPORT OF MOTOR TRAILER WC 4929P
(TBB7313)**

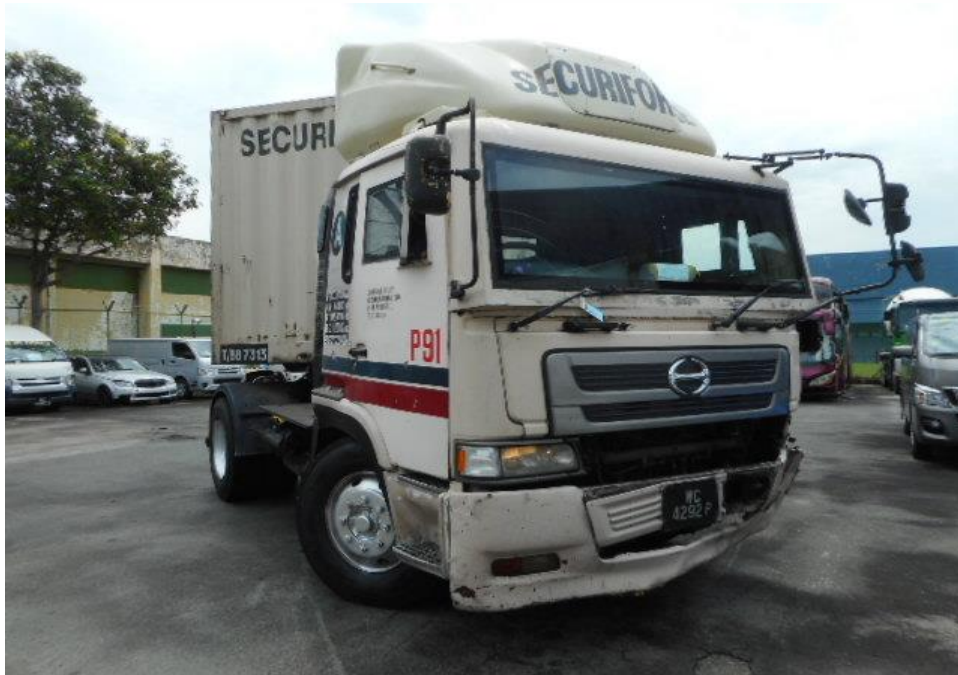
Photo 31 shows the front left wheel of the Motor Trailer turned to its full left. During my steering system test, I did not experience any abnormal free play and/or resistance when I had turned the steering wheel towards full left and full right. This would suggest that the steering system of the Motor Trailer was likely to be in serviceable condition at the material time of accident.
