Your Ref: TP/IP/20083/2022  
Our Ref : CI/TPD22008168/P

7<sup>th</sup> October 2022

**MECHANICAL INSPECTION REPORT OF MOTOR LORRY YP 3006J**

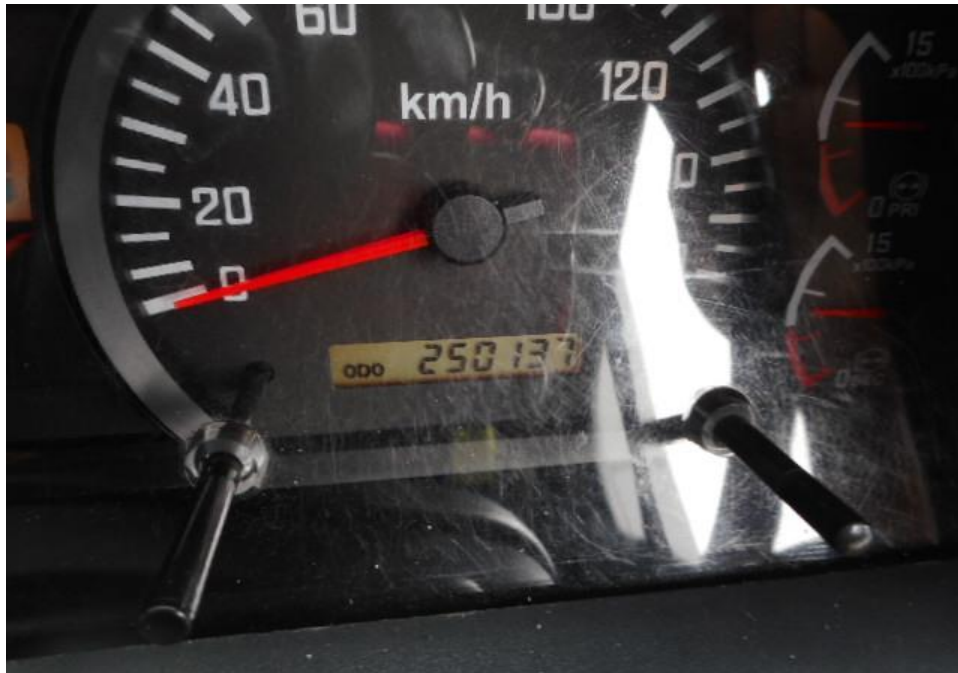
**Photo 1** shows a general view of the instrument cluster of the Motor Lorry at the time of my inspection. The mileage of the Motor Lorry was 250,137km

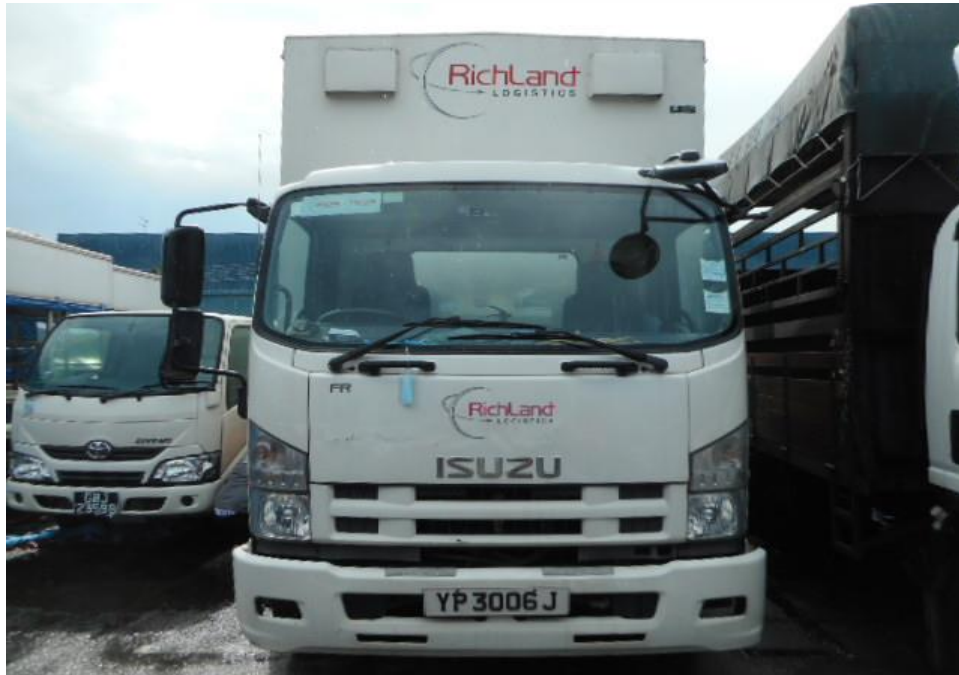
**Photo 2** shows a general view of the front body of the Motor Lorry at the time of my inspection. The Motor Lorry was observed to be intact and unaffected by the accident.

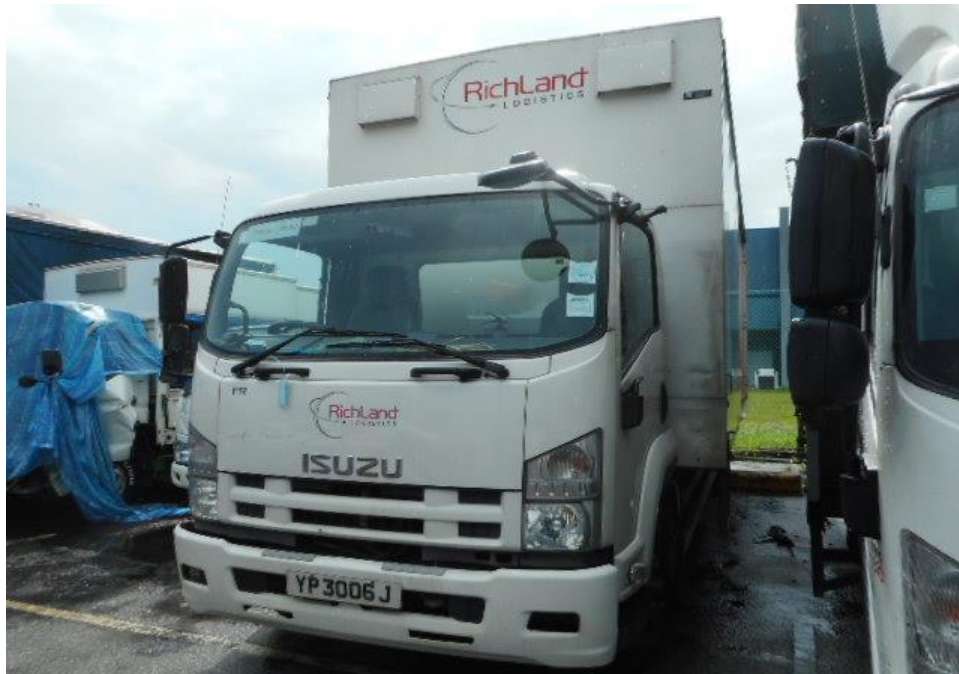
**Photo 3** shows a general view of the Motor Lorry's left portion at the time of my inspection. It appeared to have sustained damage at its left portion. Its left rear view mirror were damage at the time of my inspection as a result of the accident.

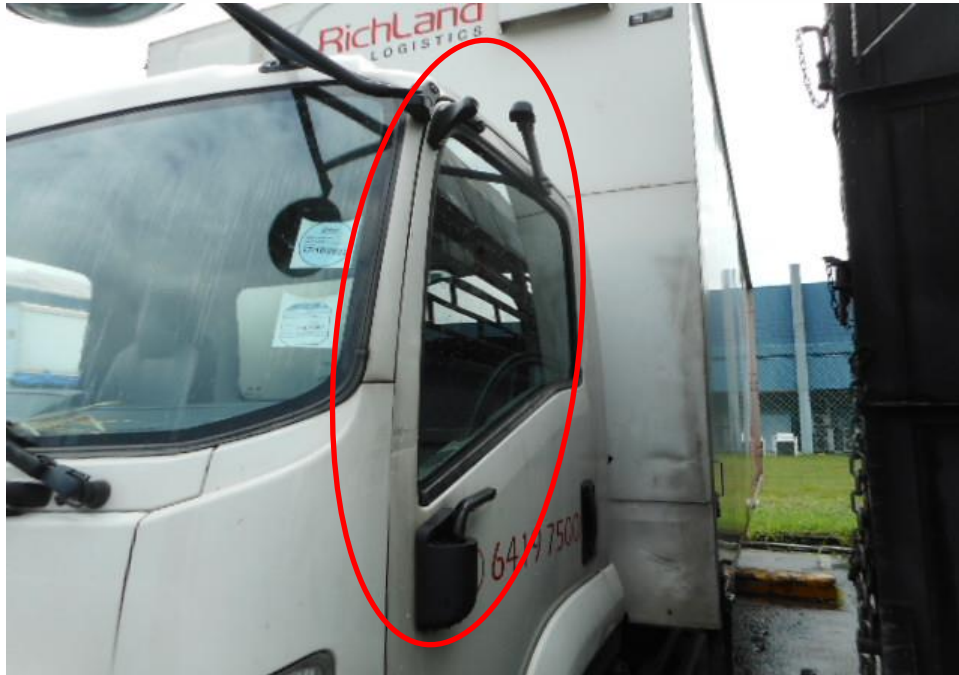
**Photo 4** shows a close up view of the Motor Lorry's left portion at the time of my inspection. Its left rear view mirror (circled) was damage at the time of my inspection as a result of the accident.

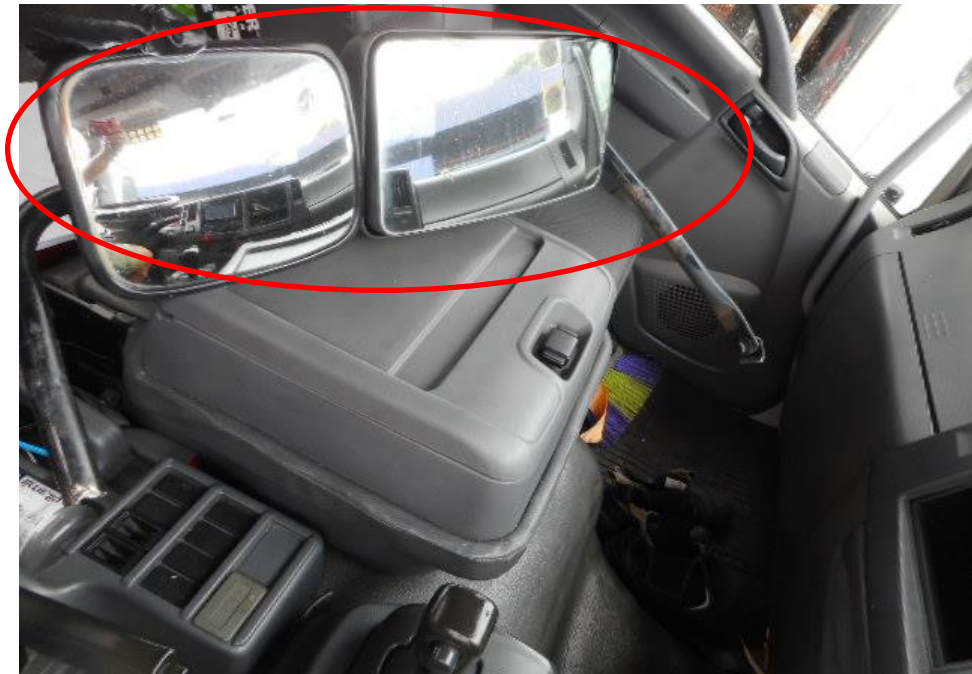
**Photo 5** shows a close up view of the Motor Lorry's left rear view mirror at the time of my inspection. Its left rear view mirror (circled) was damage at the time of my inspection as a result of the accident.

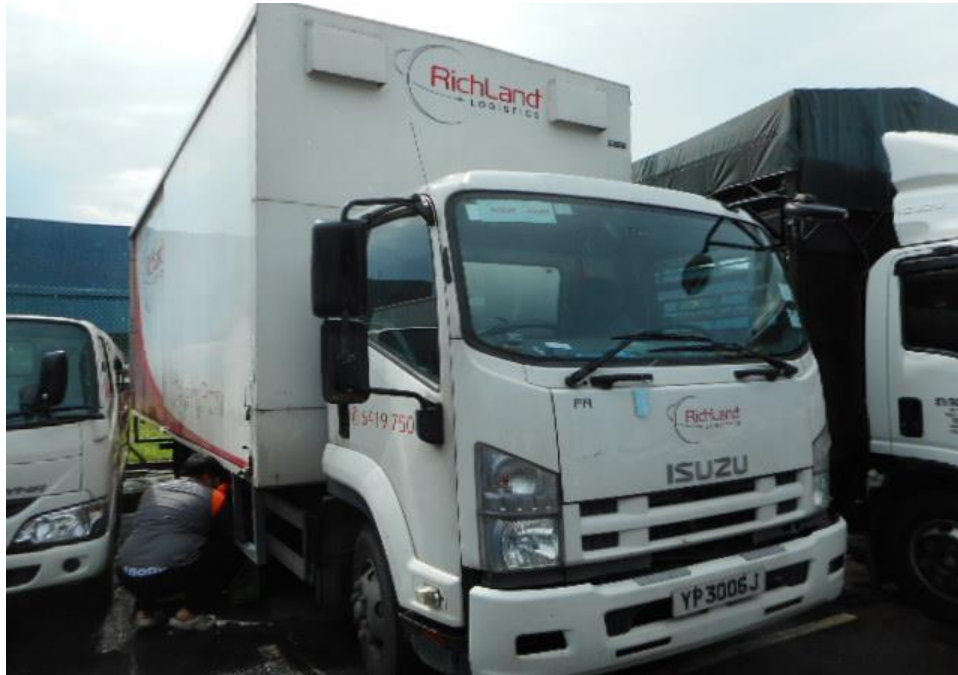
**Photo 6** shows a general view of the right body of the Motor Lorry at the time of my inspection. The Motor Lorry was observed to be intact and unaffected by the accident.

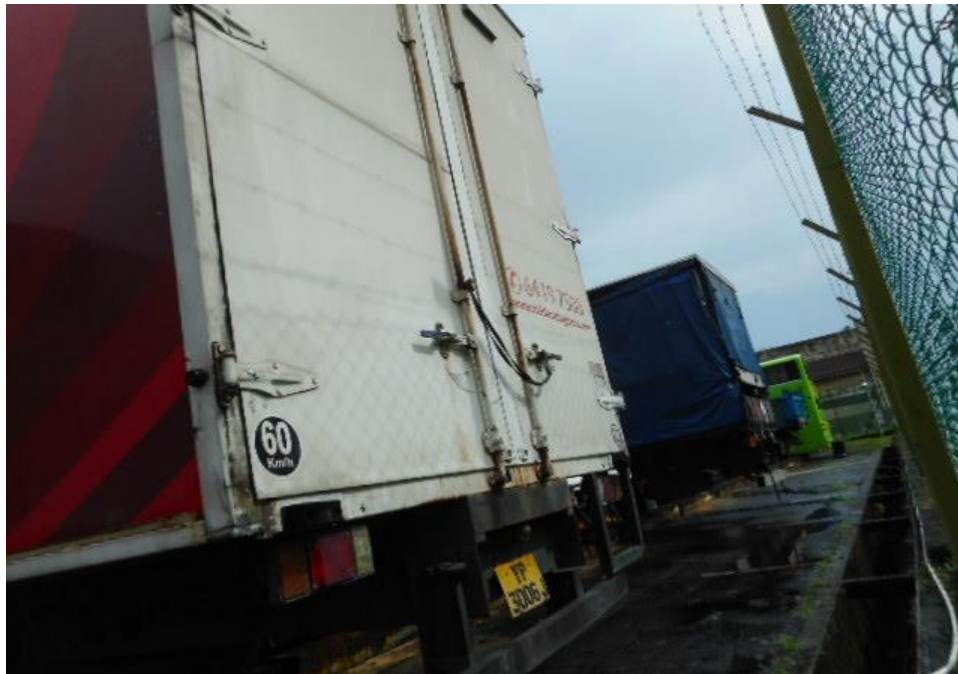
**Photo 7** shows a general view of the left body of the Motor Lorry at the time of my inspection. The Motor Lorry was observed to be intact and unaffected by the accident.

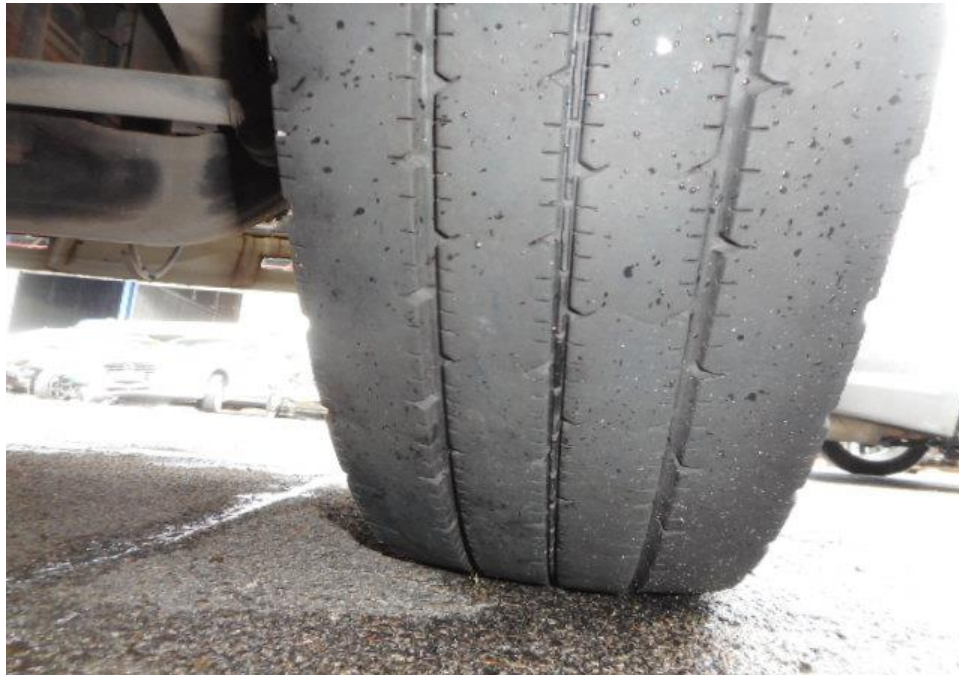
**Photo 8** shows the condition of the front right tyre of the Motor Lorry, which was observed to be in serviceable condition with remaining tread depth of approximately 6.5mm. The tyre, which was wrapped around standard steel wheel rim, was also observed to be sufficiently inflated for vehicular operation. There was no tear, cut or burst mark(s) on the outer and the inner sidewalls as well as across the tread of the 6 tyres that were fitted on the Motor Lorry.

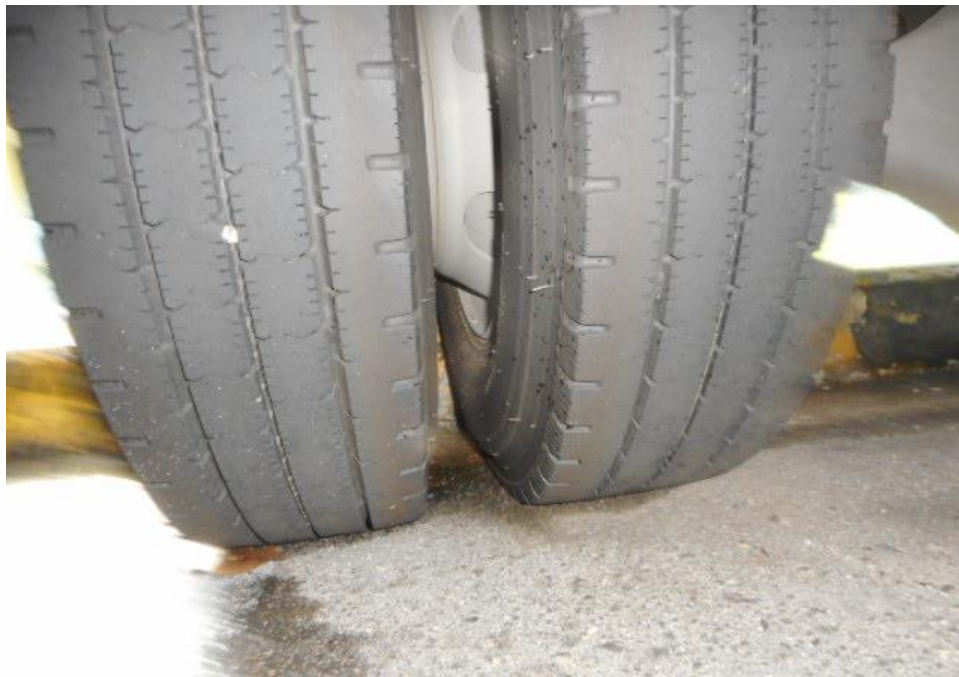
**Photo 9** shows the condition of the rear right tyres of the Motor Lorry, which was observed to be in serviceable condition with remaining tread depth of approximately 6mm. The tyre, which was wrapped around standard steel wheel rim, it was observed to be sufficiently inflated for vehicular operation.

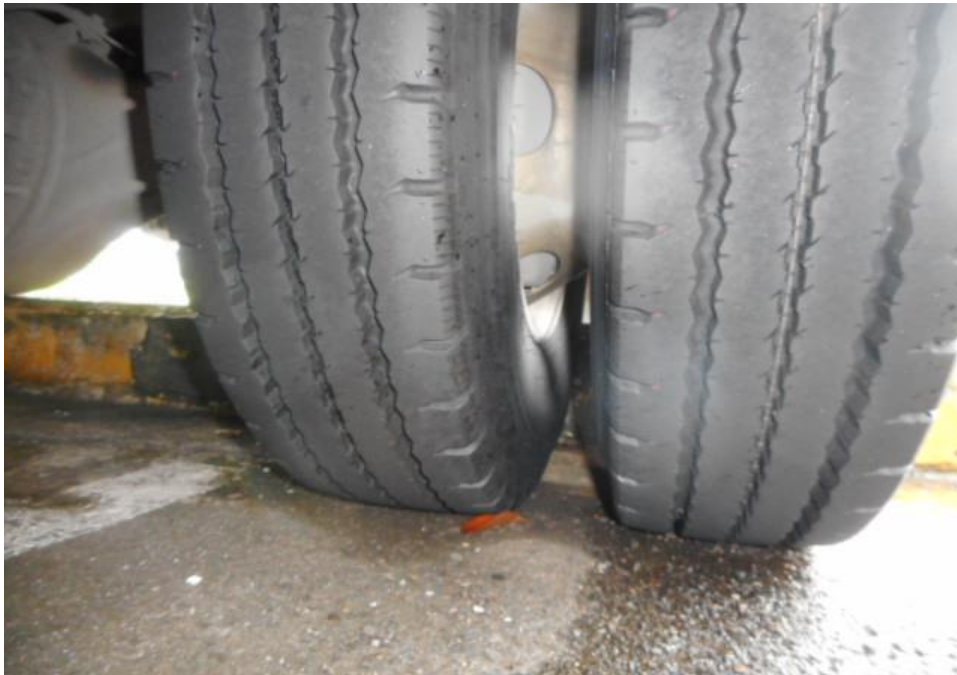
**Photo 10** shows the condition of the rear left tyres of the Motor Lorry, which was observed to be in serviceable condition with remaining tread depth of approximately 12.4mm. The tyres, which were wrapped around standard steel wheel rim, were also observed to be sufficiently inflated for vehicular operation.

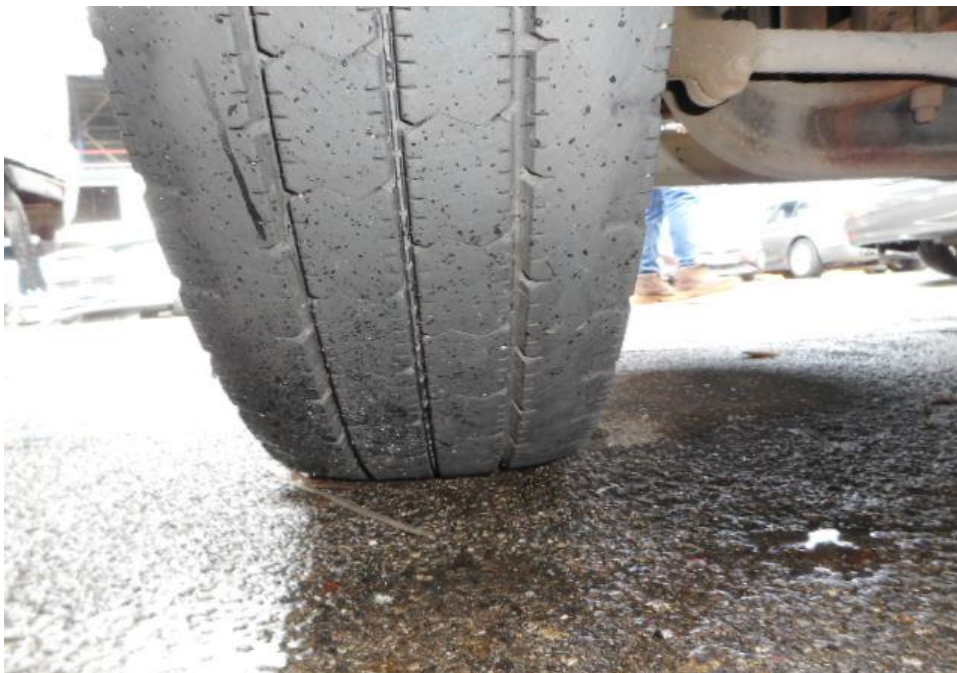
**Photo 11** shows the condition of the front left tyre of the Motor Lorry, which were observed to be in serviceable condition with remaining, tread depth of approximately 4.2mm. There was also no tear, cut or burst mark(s) on the outer and the inner sidewalls as well as across the tread of the 6 tyres that were fitted on the Motor Lorry.

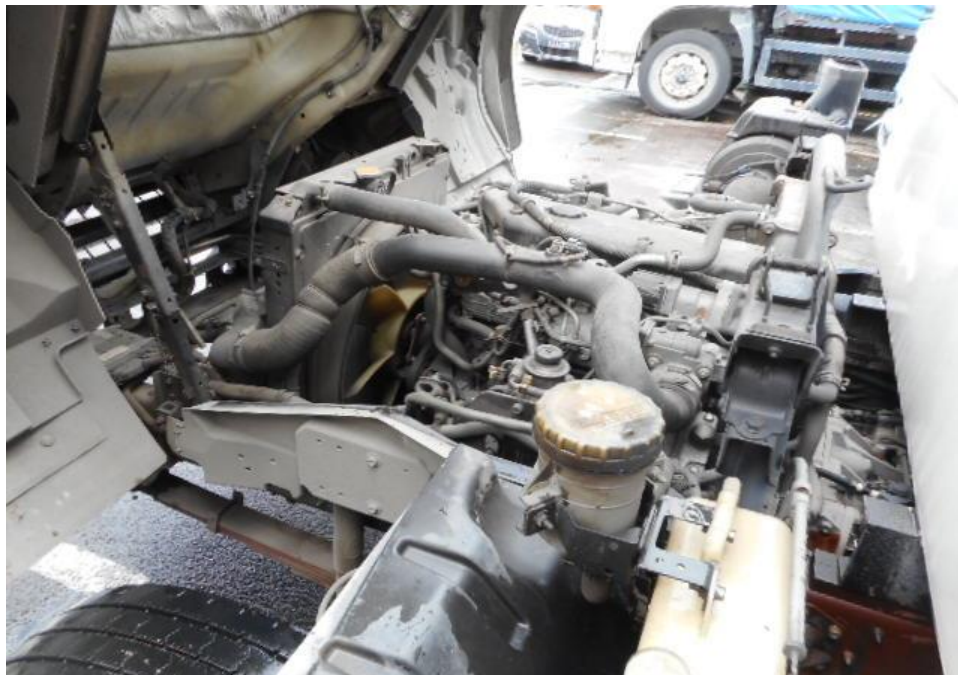
**Photo 12** shows a general view of the Motor Lorry's engine compartment, which was accessed by lifting the front cabin of the Motor Lorry. The various parts and components inside the engine compartment were unaffected by the accident. There was also no sign(s) or indication(s) of fresh fluid leakage and/or fluid stain within the engine compartment

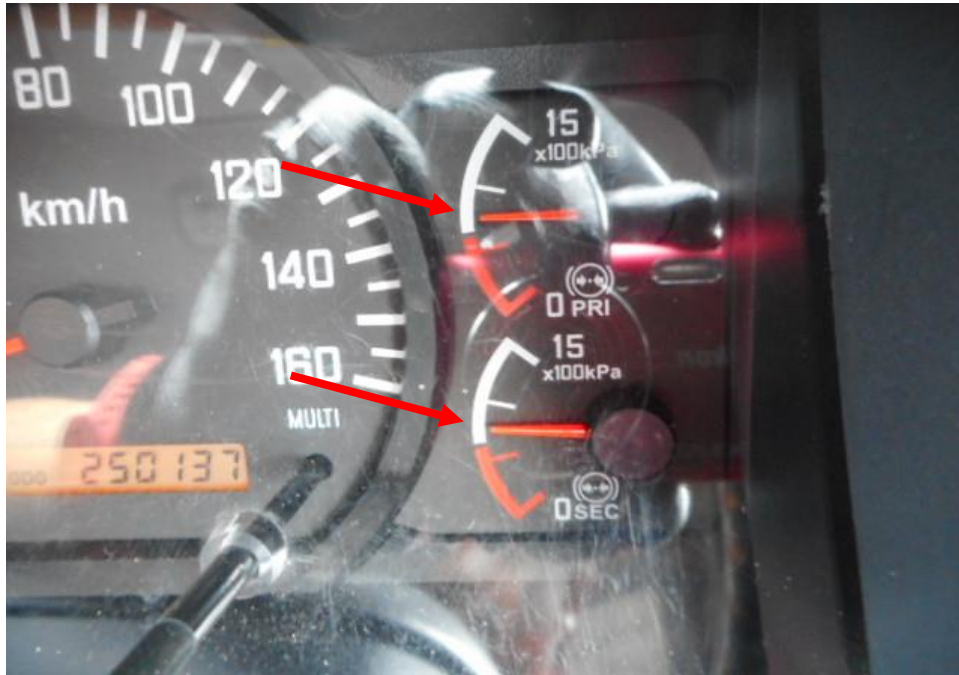
**Photo 13** shows the air in the air brake cylinders of the Motor Lorry at the time of my inspection. The air in the cylinder was observed to be of sufficient level & serviceable at the time of the accident.

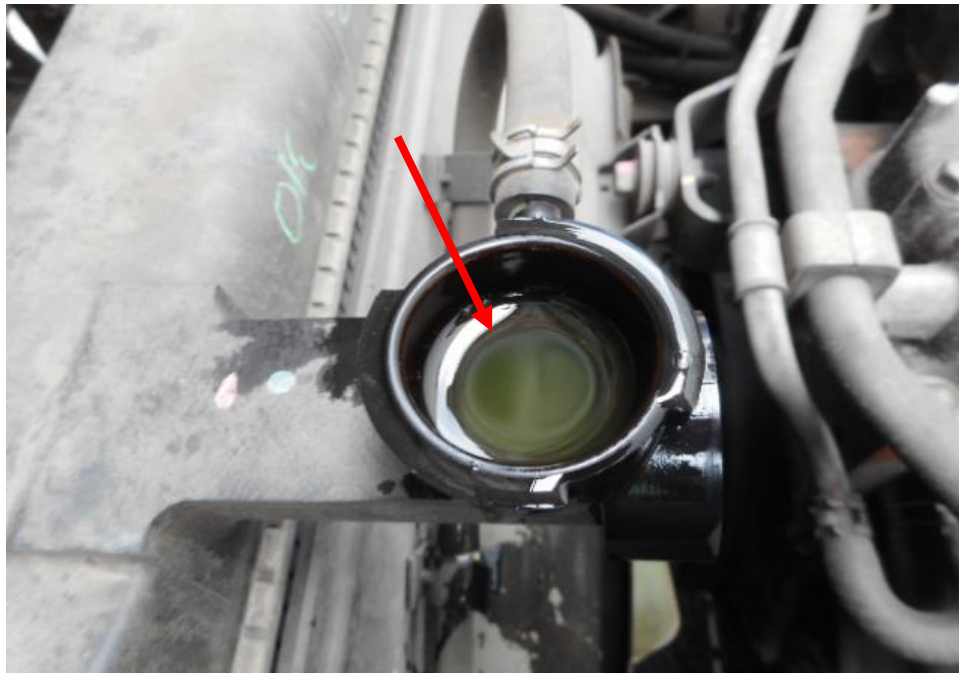
**Photo 14** shows the engine coolant reservoir of the Motor Lorry at the time of my inspection. The engine coolant was observed to be of sufficient level (arrowed) and without any visible contamination.

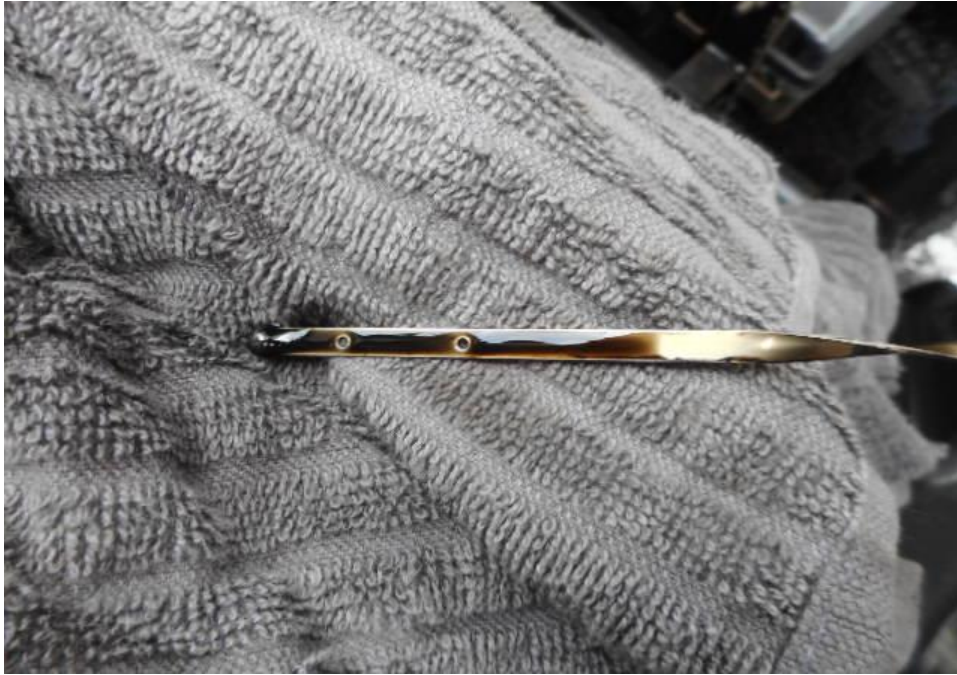
**Photo 15** shows the engine oil dip stick of the Motor Lorry at the time of my inspection. The engine oil was observed to be of sufficient level and without any visible contamination.

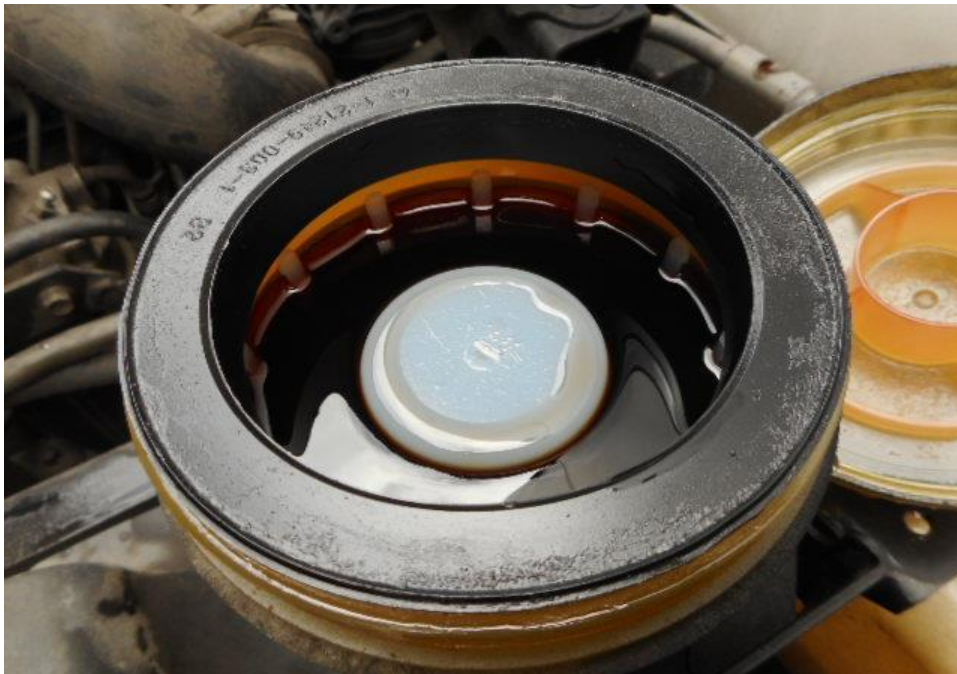
**Photo 16** shows the power steering fluid reservoir of the Motor Lorry at the time of my inspection. The power steering fluid was observed to be of sufficient level and without any visible contamination.

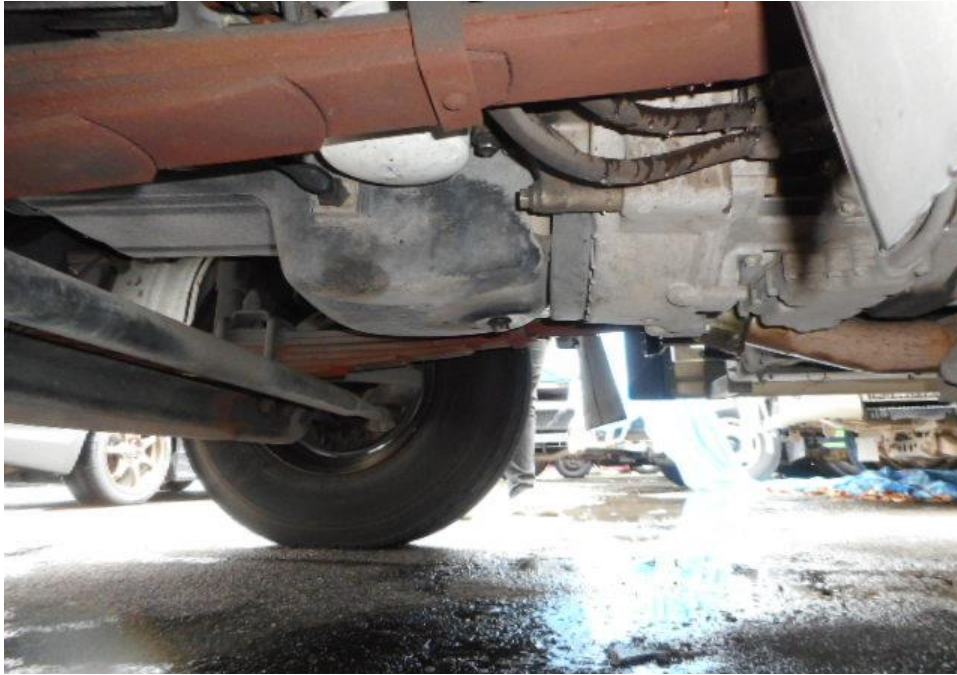
**Photo 17** shows the undercarriage of the Motor Lorry, at the area where the engine housing and transmission housing are located. I did not find any sign(s) or indication(s) of fluid leak and/or fluid stain(s) on the underside of the Motor Lorry.

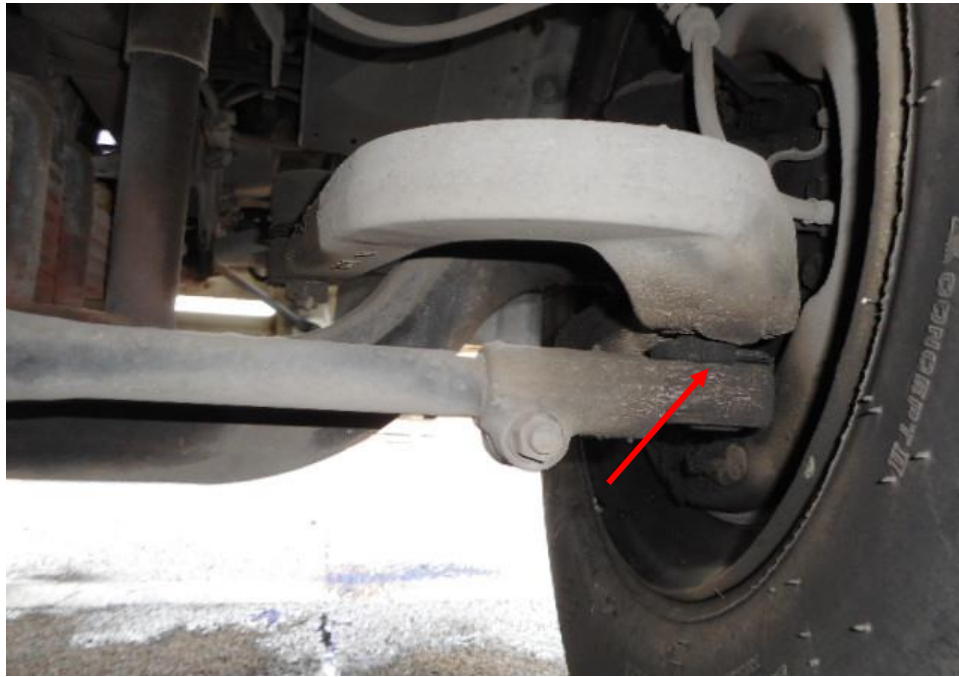
**Photo 18** shows the various undercarriage components at the front right wheel of the Motor Lorry, in particular the steering tie rod end (arrowed). The various steering components were all found to be intact, suggesting that the steering system of the Motor Lorry was likely to be in serviceable condition at the material time of accident. There was also no sign of fluid stain(s) observed on the various undercarriage components.

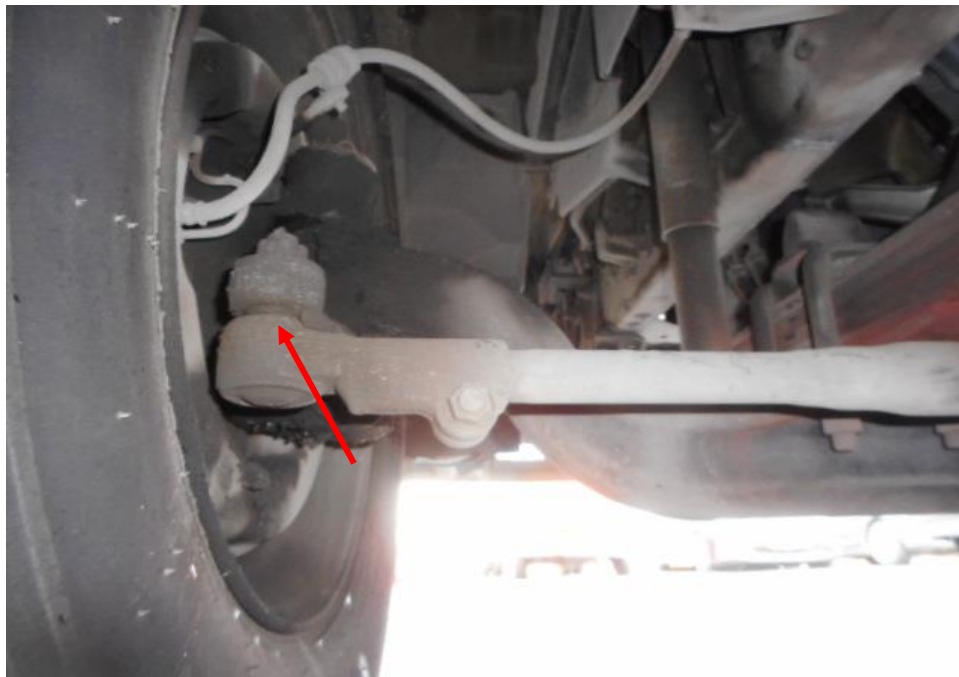
**Photo 19** shows the various undercarriage components at the front left wheel of the Motor Lorry, in particular the steering tie rod end (arrowed). The various undercarriage components of the Motor Lorry were all found to be intact without any visible damage. There was also no sign of fluid stain(s) observed on the various undercarriage components.

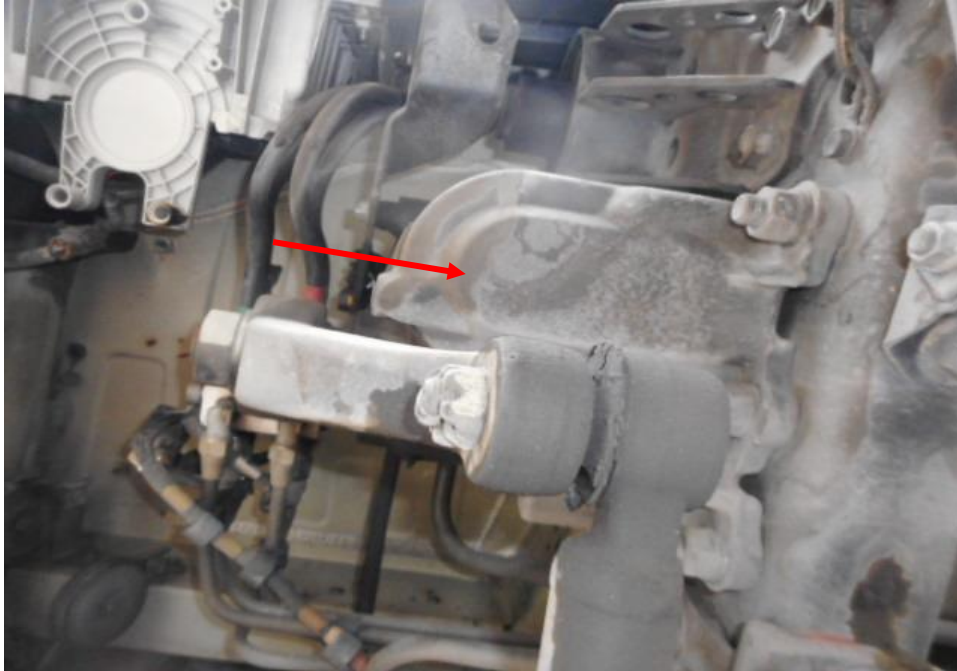
**Photo 20** shows the various undercarriage components at the front right wheel of the Motor Lorry, in particular the steering box (arrowed). The various undercarriage components of the Motor Lorry were all found to be intact without any visible damage. There was also no sign of fluid stain(s) observed on the various undercarriage components.

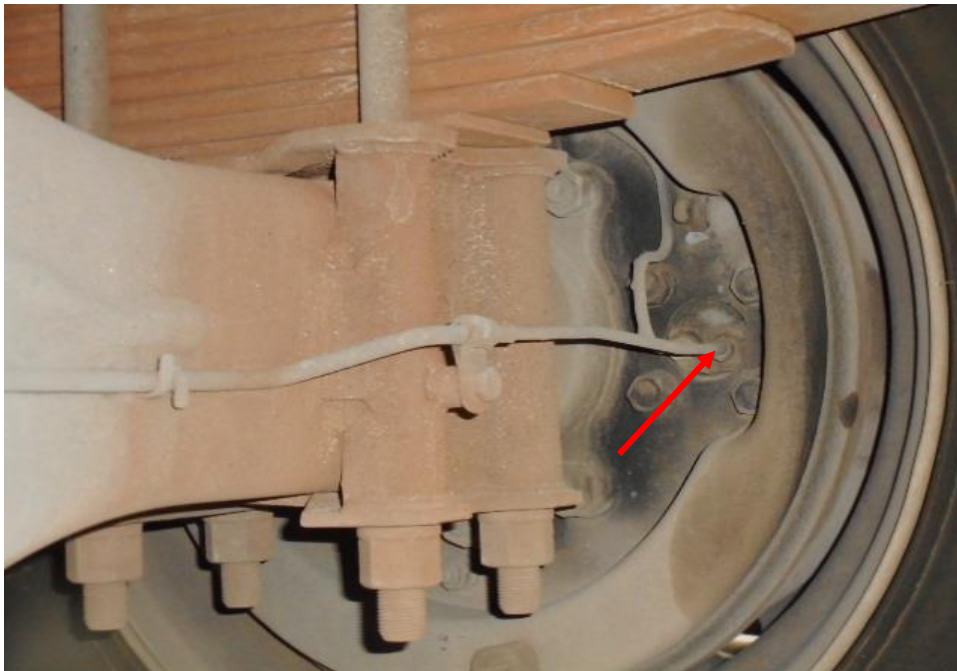
**Photo 21** shows the brake pipe (arrowed) at the rear right wheel of the Motor Lorry. I did not observe any leakage of air brake at the time of my inspection of the Motor Lorry. My static tests of the Motor Lorry's braking system, along with my visual examination of the various mechanical components in the braking system, had indicated that there was no internal leakage of pressure/vacuum. Hence the braking system of the Motor Lorry was likely to be in serviceable condition at the material time of accident.

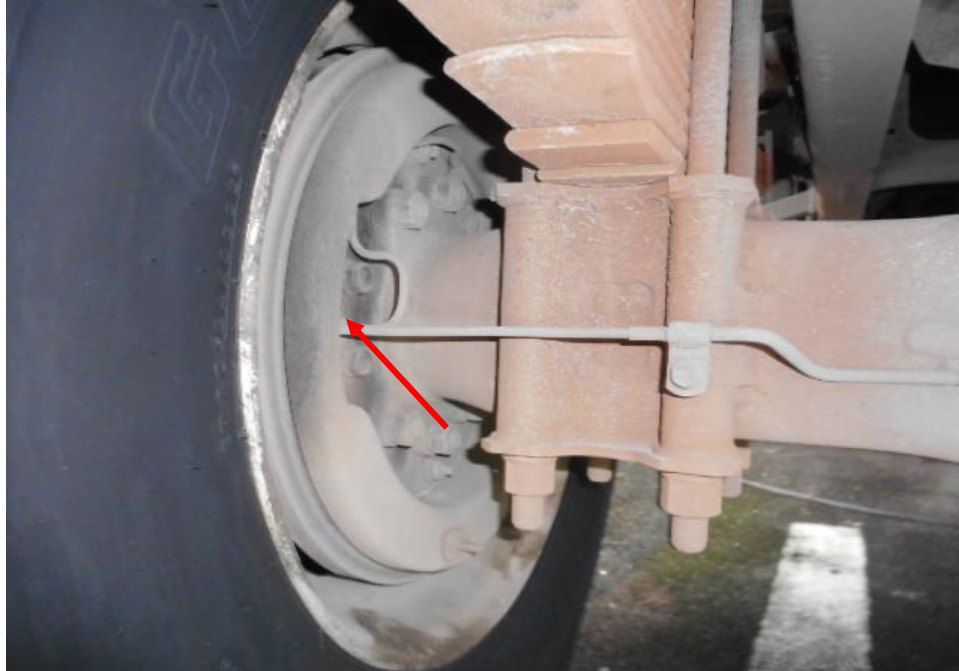
**Photo 22** shows the brake pipe (arrowed) at the rear left wheel of the Motor Lorry. I did not observe any leakage of air brake at the time of my inspection of the Motor Lorry. My static tests of the Motor Lorry's braking system, along with my visual examination of the various mechanical components in the braking system, had indicated that there was no internal leakage of pressure/vacuum. Hence the braking system of the Motor Lorry was likely to be in serviceable condition at the material time of accident.

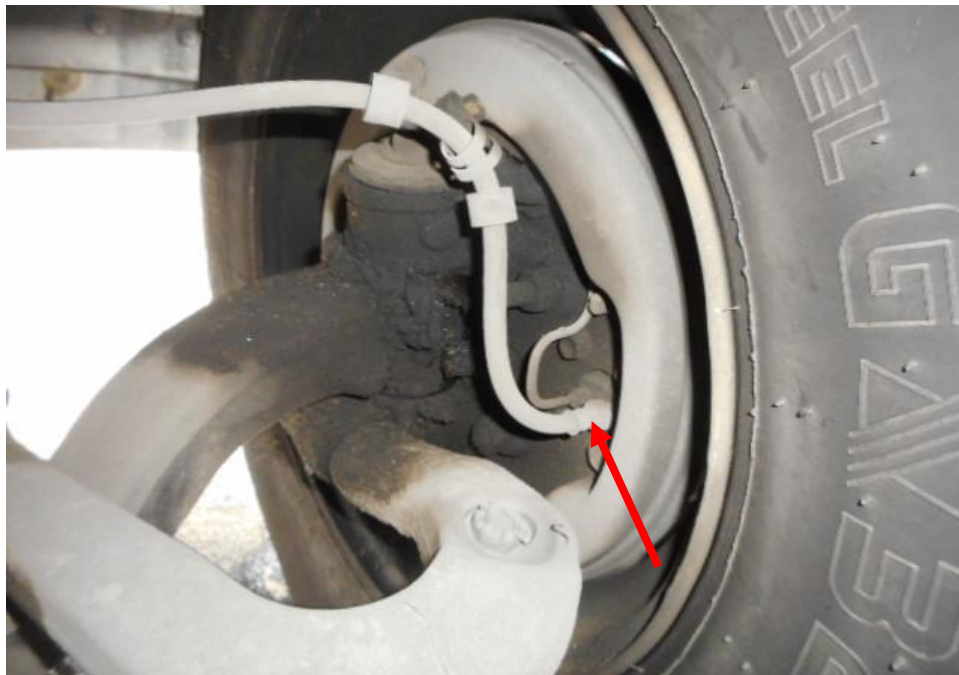
**Photo 23** shows the brake hose/pipe (arrowed) at the front right wheel of the Motor Lorry. No leakage of air brake was observed. Visual examination of the various components of the braking system like the brake drum, brake booster, brake pedal etc had revealed all to be intact and without visible damage at the time of accident. There was also no sign of fluid stain(s) observed on the various undercarriage components.

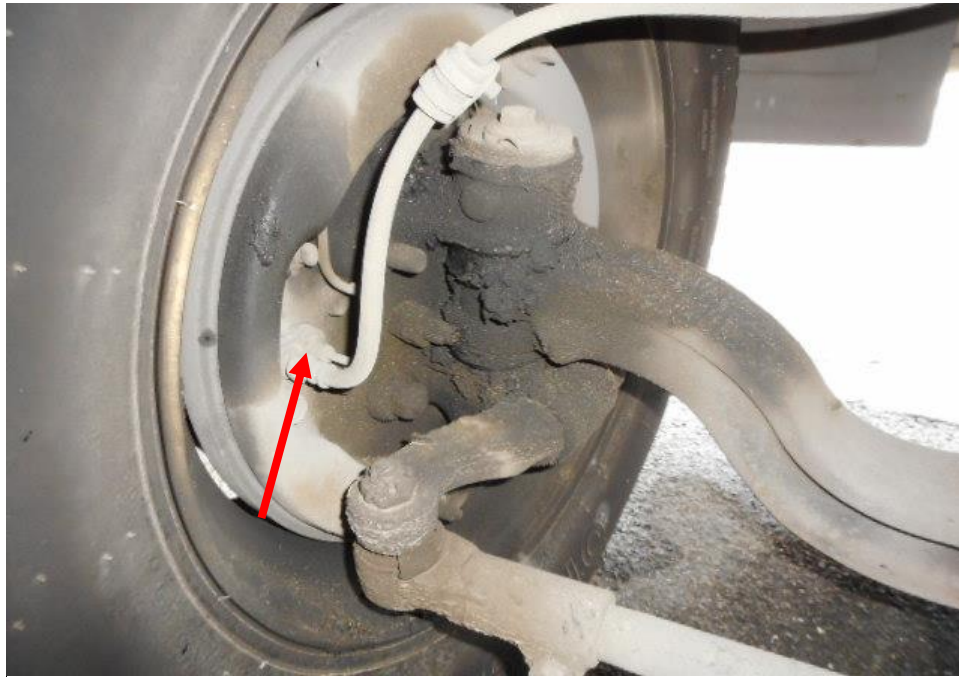
**Photo 24** shows the brake hose/pipe (arrowed) at the front left wheel of the Motor Lorry. No leakage of air brake was observed. Visual examination of the various components of the braking system like the brake drum, brake booster, brake pedal etc had revealed all to be intact and without visible damage at the time of accident. There was also no sign of fluid stain(s) observed on the various undercarriage components.

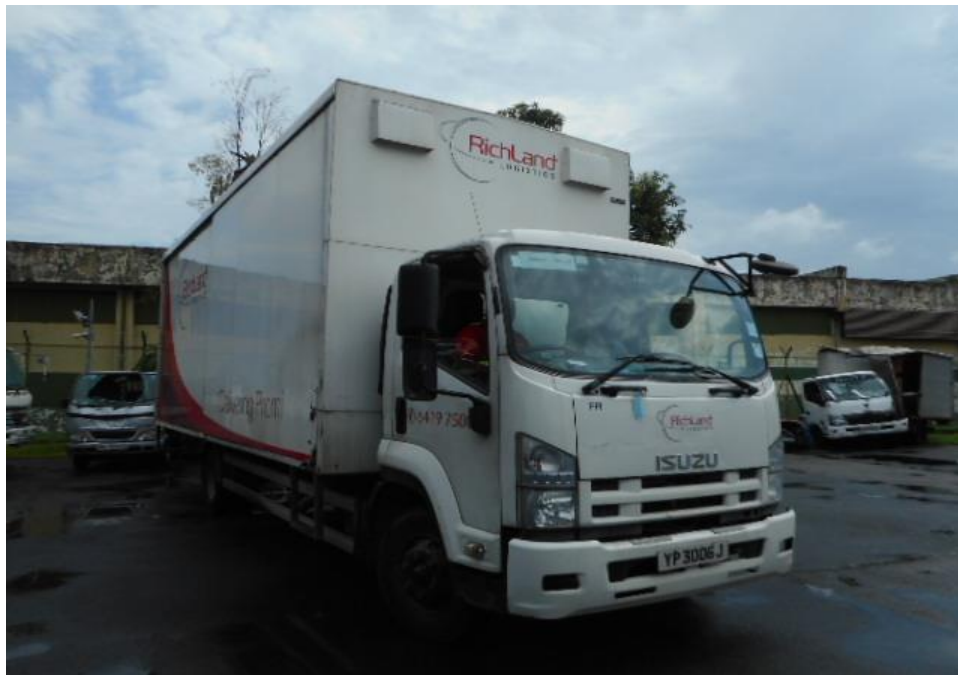
**Photo 25** shows the front right wheel of the Motor Lorry turned to its full left. During my steering system test, I did not experience any abnormal free play and/or resistance when I had turned the steering wheel towards full left and full right. This would suggest that the steering system of the Motor Lorry was likely to be in serviceable condition at the material time of accident.
