**MECHANICAL INSPECTION REPORT OF MOTOR CAR SJM 1477P**

1. I refer to your request on 16<sup>th</sup> August 2022 to conduct a physical inspection of a Motor car bearing registration number SJM 1477P (herein referred to as "**Motor Car**"), which was involved in a road traffic accident on 9<sup>th</sup> July 2022.
2. The objective of the inspection is to determine if there was any possible mechanical failure to the Motor car that may have contributed to the accident.
3. Following the request, I had carried out a physical inspection of the Motor Car on 29<sup>th</sup> November 2022 at the premises of Traffic Police vehicle pound, 517 Airport Road Singapore 539942. I now set out below my observations and comments with respect to this inspection.

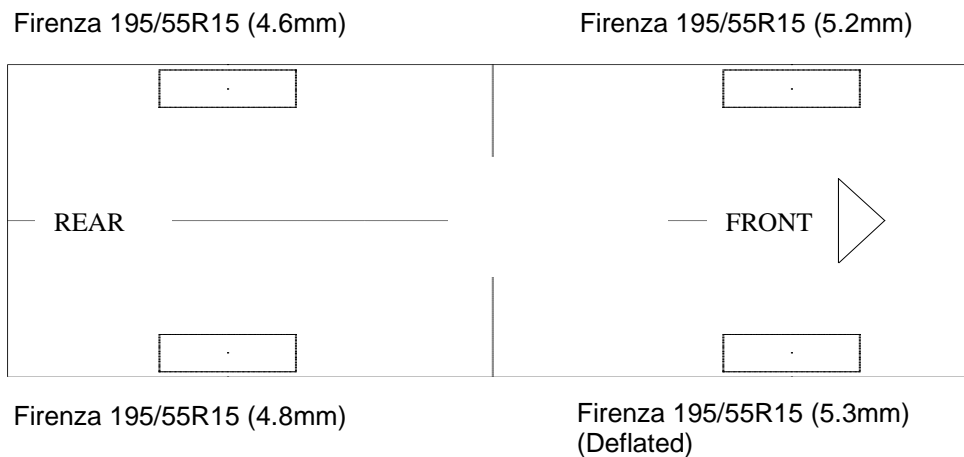
6. The front right tyre was observed to be deflated due to an induce impact sustained as a result of the accident. However, the condition of the Motor Car's 4 tyres was observed to be in serviceable condition. I did not find any tear, cut or burst mark(s) on the outer and the inner sidewalls as well as across the tread of the 4 tyres. The 3 tyres were also observed to be sufficiently inflated for vehicular operation. The tyre brand, tyre size and remaining tread depth of the 4 tyres were recorded as follows:-

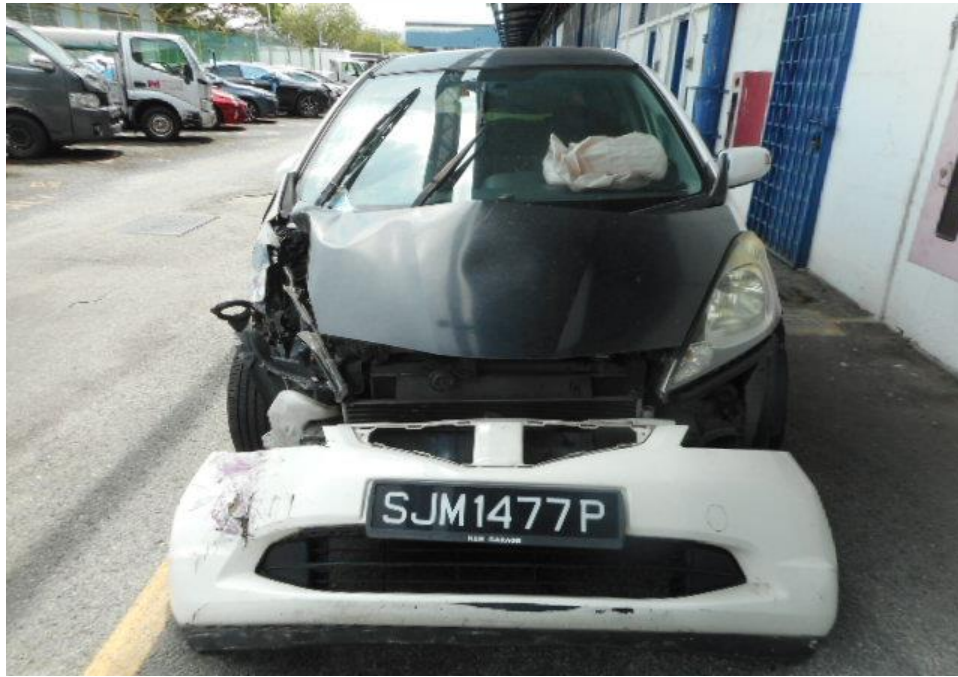
**Photo 1** shows a general view of the Motor Car's front body at the time of my inspection. The Motor car was observed to have sustained damage at its front portion. Its front bonnet, front bumper, front right fender and front right headlamp was amongst the body parts damaged as a result of the accident.

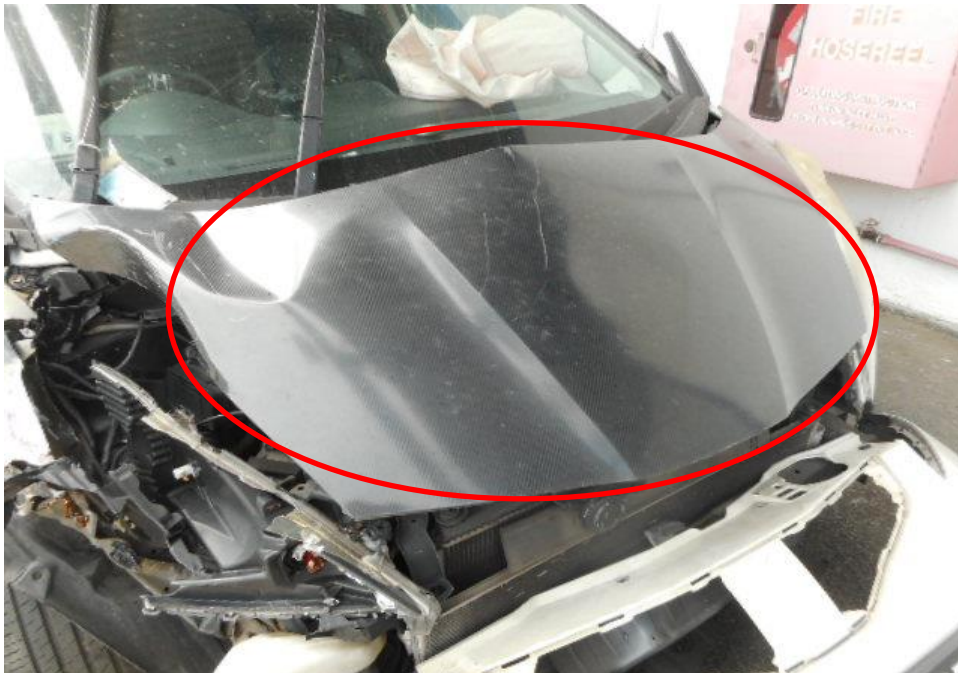
**Photo 2** shows the close up view of the Motor Car's front body at the time of my inspection. The Motor car was observed to have sustained damage at its front portion. Its front bonnet (circled) was damaged as a result of the accident.

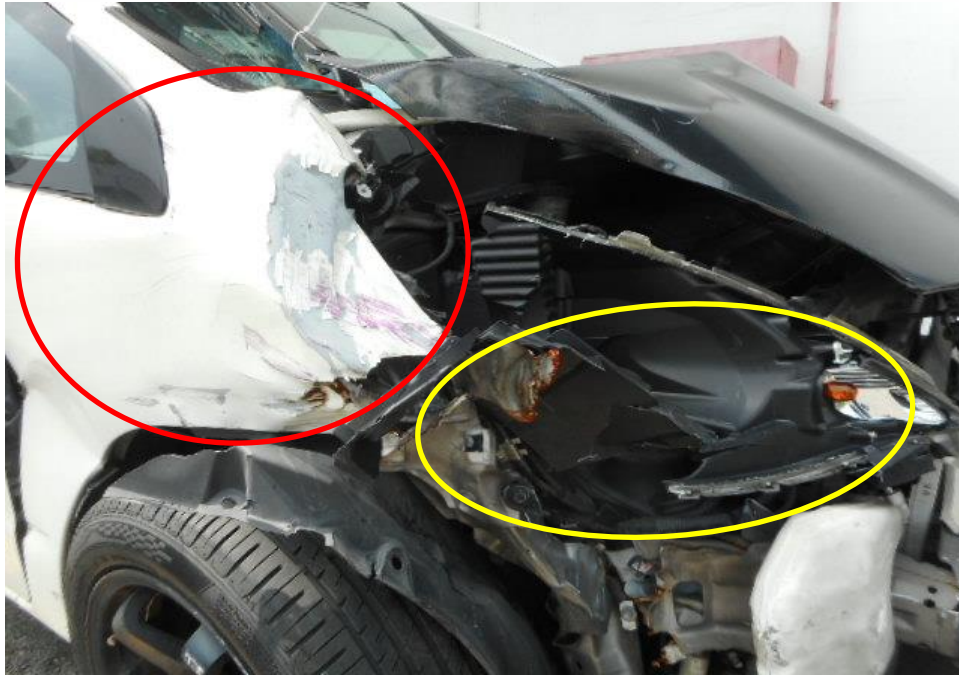
**Photo 3** shows the close up view of the Motor Car's front body at the time of my inspection. The Motor car was observed to have sustained damage at its front portion. Its front right fender (red circle) and front right headlamp (yellow circle) was damaged as a result of the accident.

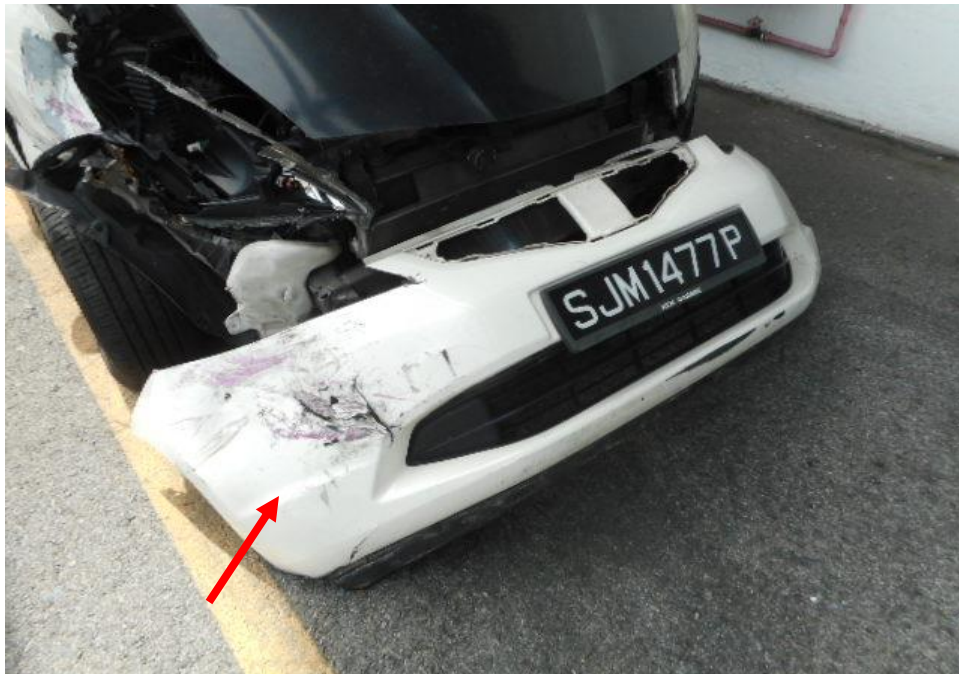
**Photo 4** shows the close up view of the Motor Car's front body at the time of my inspection. The Motor car was observed to have sustained damage at its front portion. Its front bumper (arrowed) was damaged as a result of the accident.

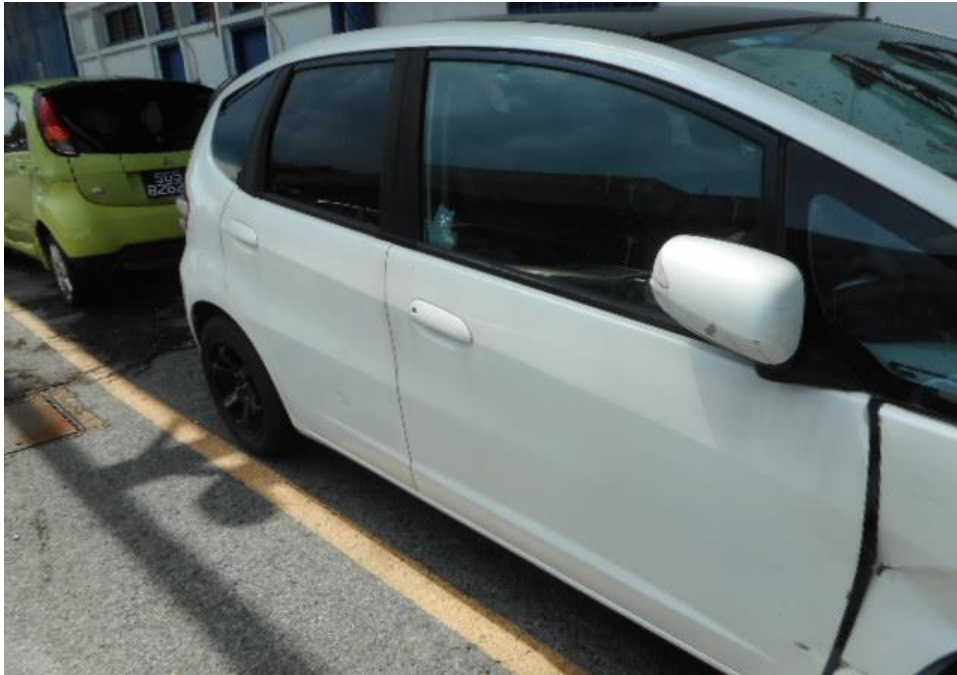
**Photo 5** shows a general view of the Motor Car's right body at the time of my inspection. The right portion of the Motor Car was observed to have been undamaged by the accident.

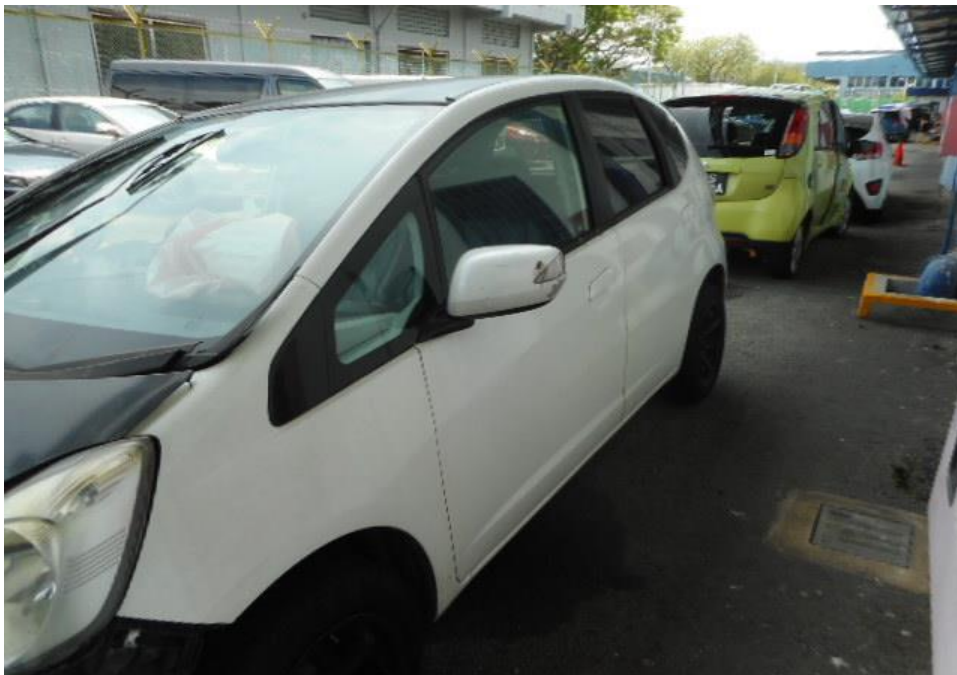
**Photo 6** shows a general view of the Motor Car's left body at the time of my inspection. The left portion of the Motor Car was observed to have been undamaged by the accident.

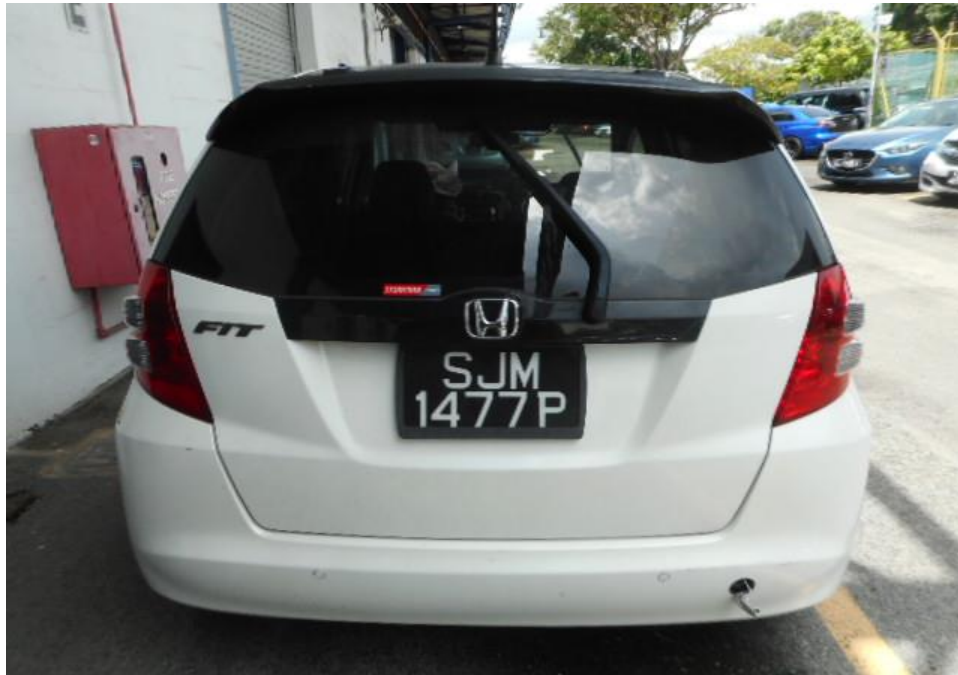
**Photo 7** shows a general view of the Motor Car's rear body at the time of my inspection. The rear portion of the Motor Car was observed to have been undamaged by the accident.

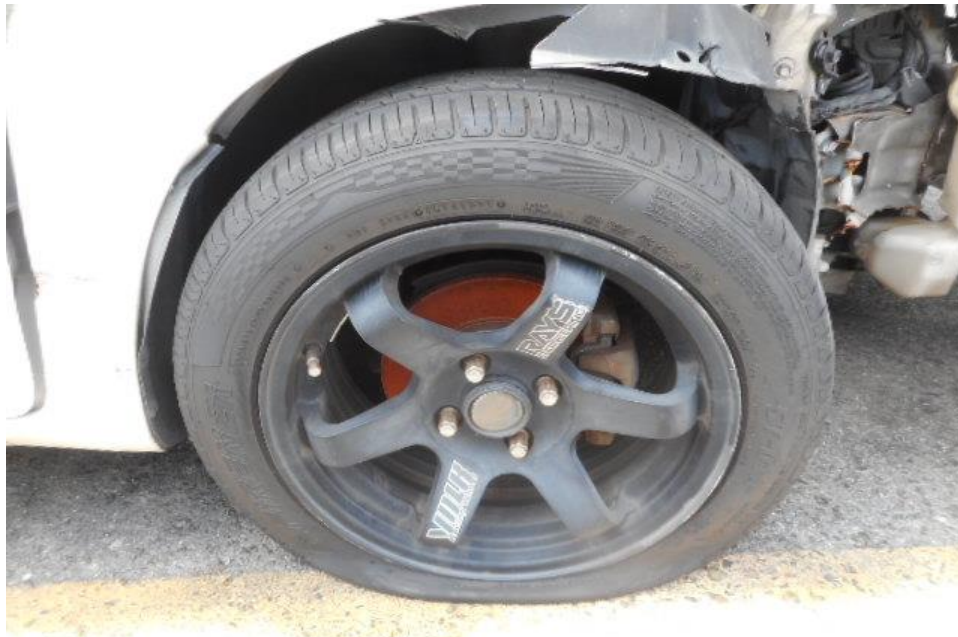
**Photo 8** shows the condition of the front right tyre of the Motor Car, which was observed to be deflated due to an induce impact sustained as a result of the accident. The remaining tread depth is approximately 5.3mm.

18. The front right tyre was observed to be deflated as a result of the accident, however the other 3 tyres of the Motor Car were found to be in serviceable condition. I did not find any tear, cut or burst mark(s) on the outer and the inner sidewalls as well as across the tread of the 4 tyres. The 3 tyres were also observed to be sufficiently inflated for vehicular operation with remaining tread depth of approximately 4.6mm to 5.3mm.

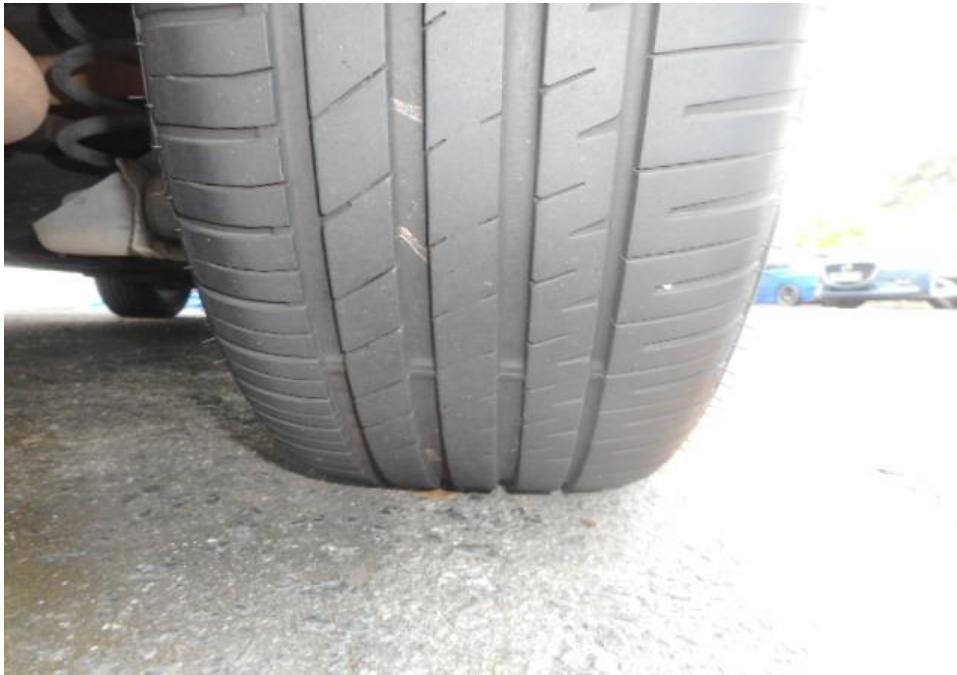
**Photo 9** shows the condition of the rear right tyre of the Motor Car, which was observed to be in serviceable condition with remaining tread depth of approximately 4.8mm. The tyre was also observed to be sufficiently inflated for vehicular operation with no tear, cut or burst mark(s).

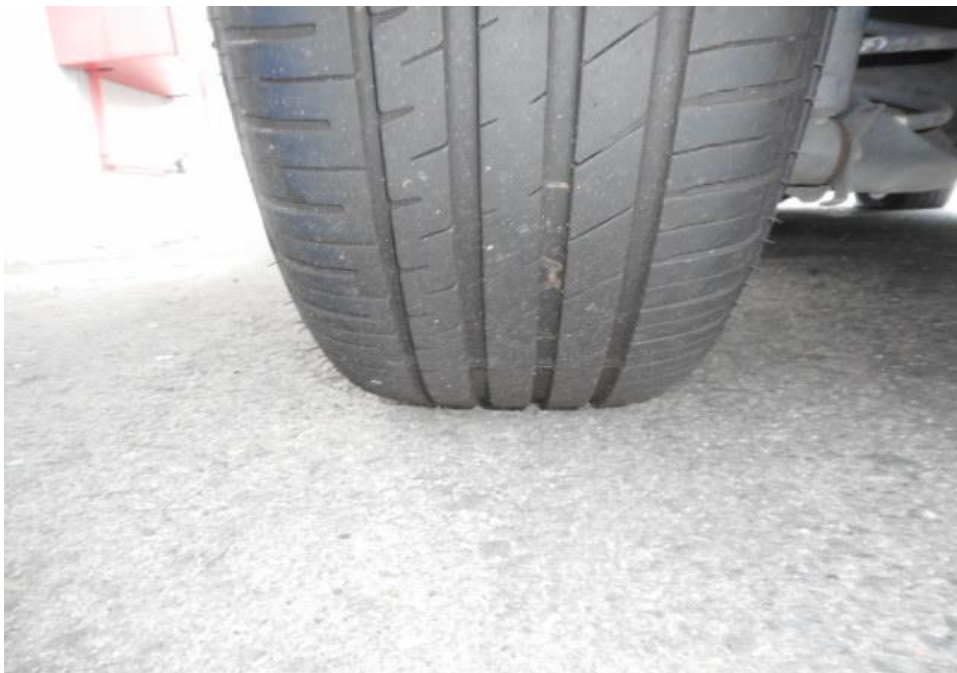
**Photo 10** shows the condition of the rear left tyre of the Motor Car, which was observed to be in serviceable condition with remaining tread depth of approximately 4.6mm. The tyre was also observed to be sufficiently inflated for vehicular operation with no tear, cut or burst mark(s).

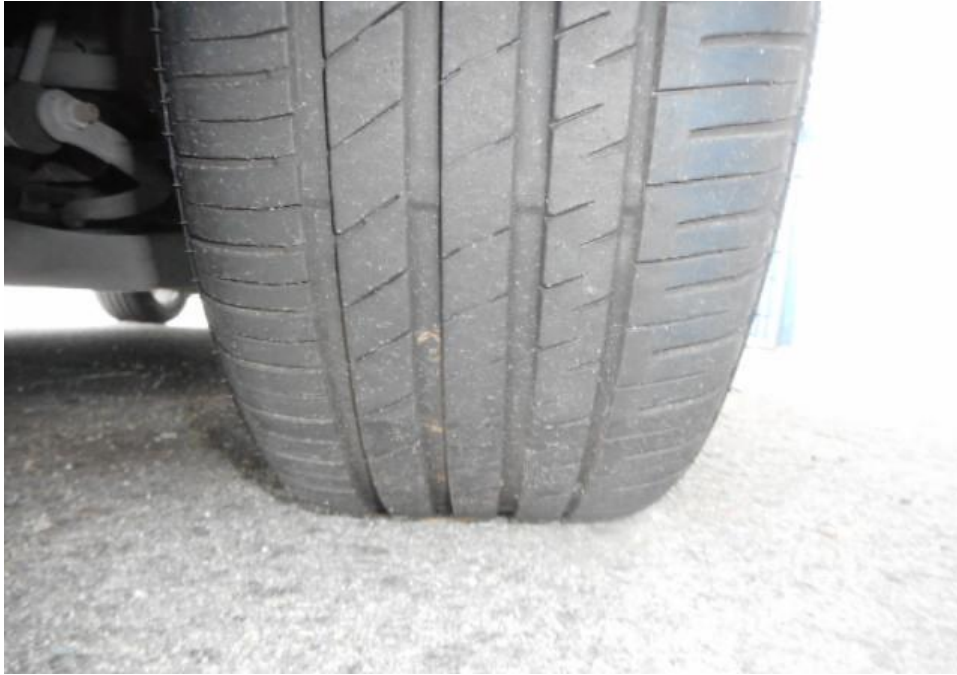
**Photo 11** shows the condition of the front left tyre of the Motor Car, which was observed to be in serviceable condition with remaining tread depth of approximately 5.2mm. The tyre was also observed to be sufficiently inflated for vehicular operation with no tear, cut or burst mark(s).

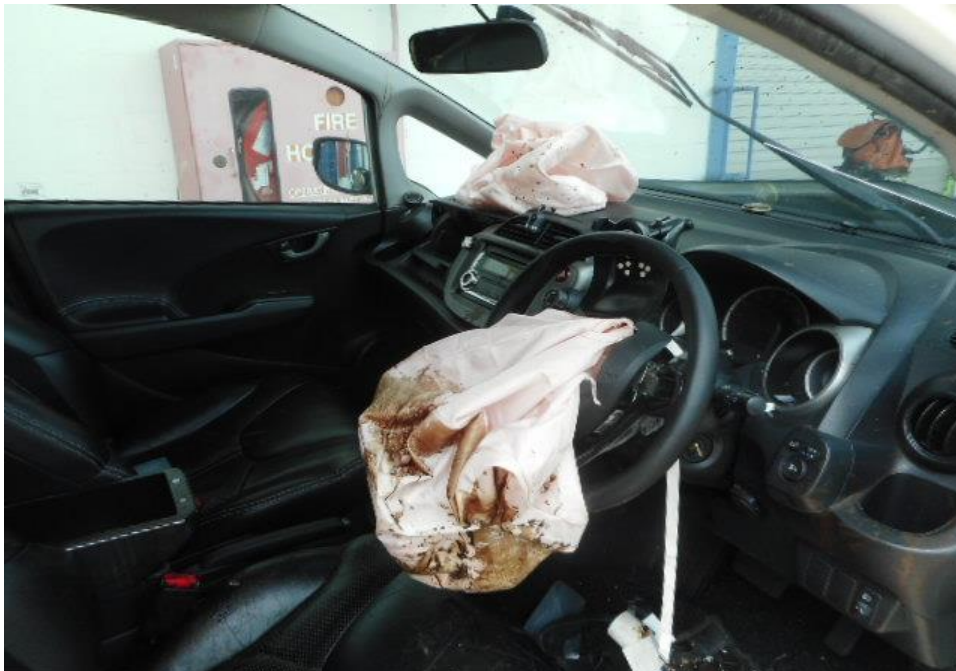
**Photo 12** shows the deployment of the Supplemental Restraint System (SRS) airbag in the Motor Car as a result of the accident.

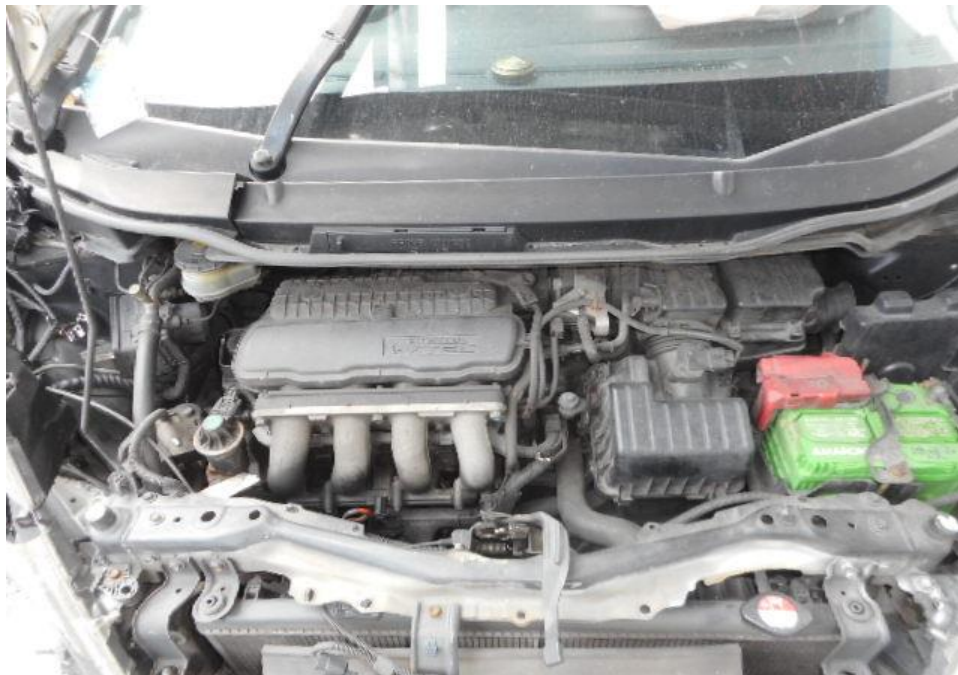
**Photo 13** shows a general view of the Motor Car's engine compartment. The various parts and components inside the engine compartment were unaffected by the accident. There was also no sign(s) or indication(s) of fluid leakage and/or fluid stain within the engine compartment.

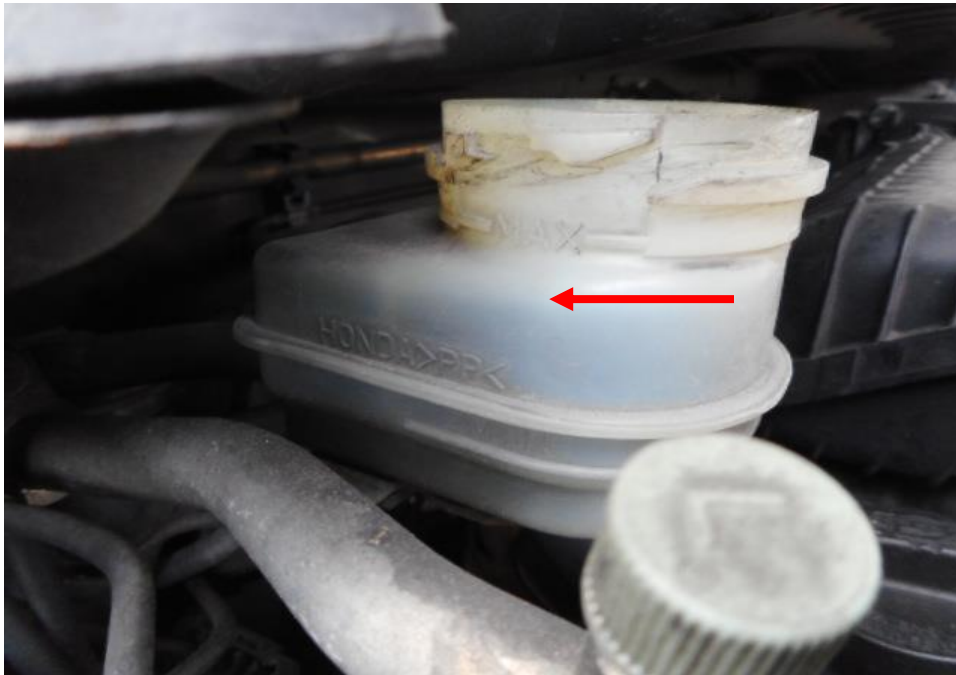
**Photo 14** shows the brake fluid reservoir of the Motor Car at the time of my inspection. The brake fluid was observed to be of sufficient level (arrowed) and without any visible contamination.

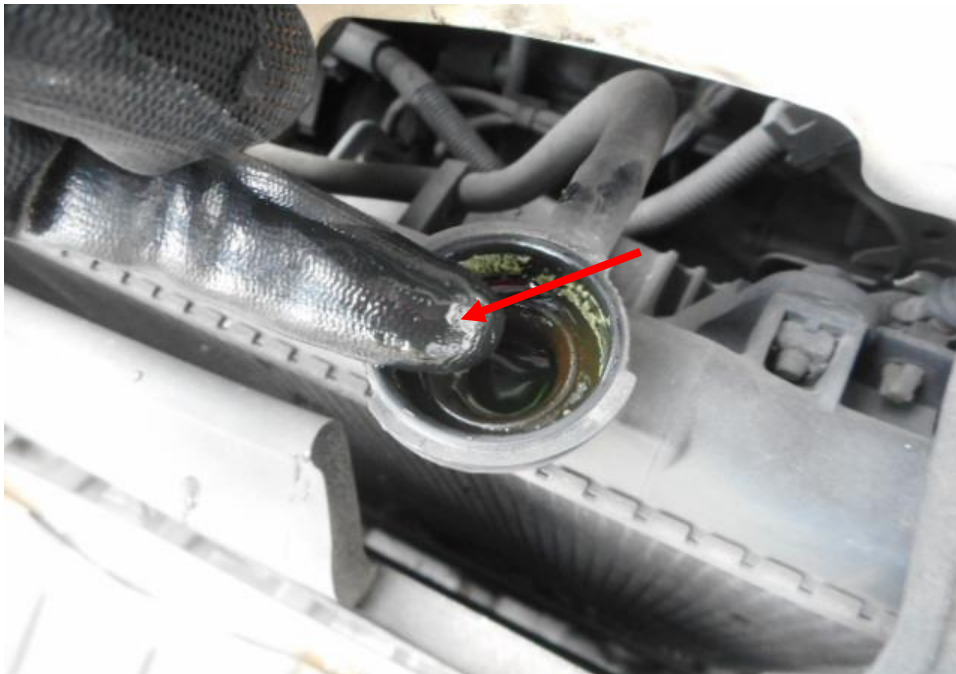
**Photo 15** shows checks being carried out to the engine coolant of the Motor Car at the time of my inspection. The engine coolant was observed to be of sufficient level (arrowed) and without any visible contamination.

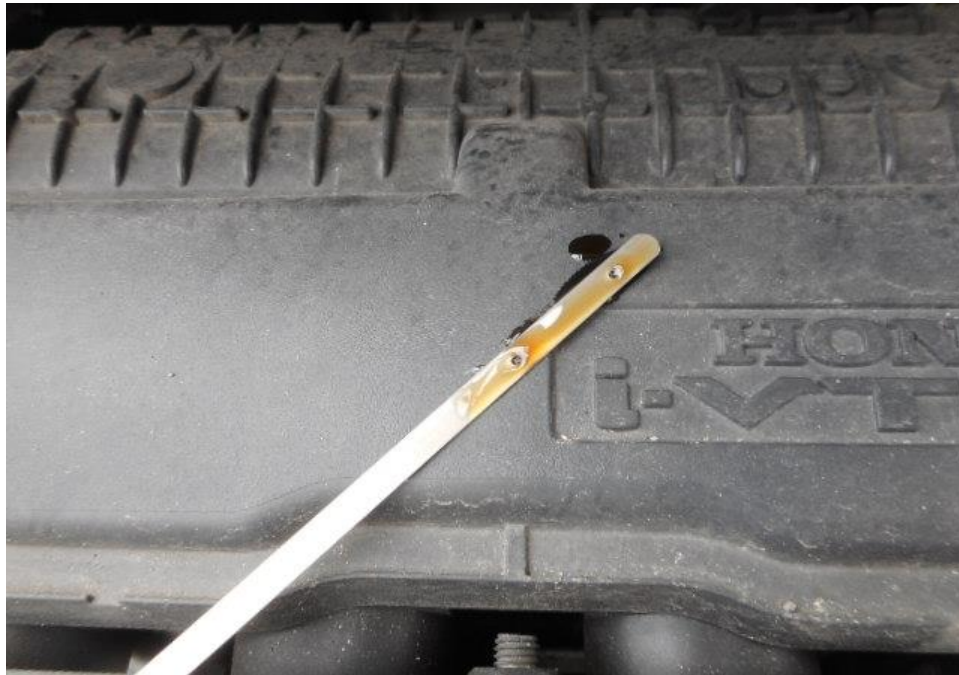
**Photo 16** shows the engine oil dip stick of the Motor Car at the time of my inspection. The engine oil was observed to be of sufficient level and without any visible contamination.

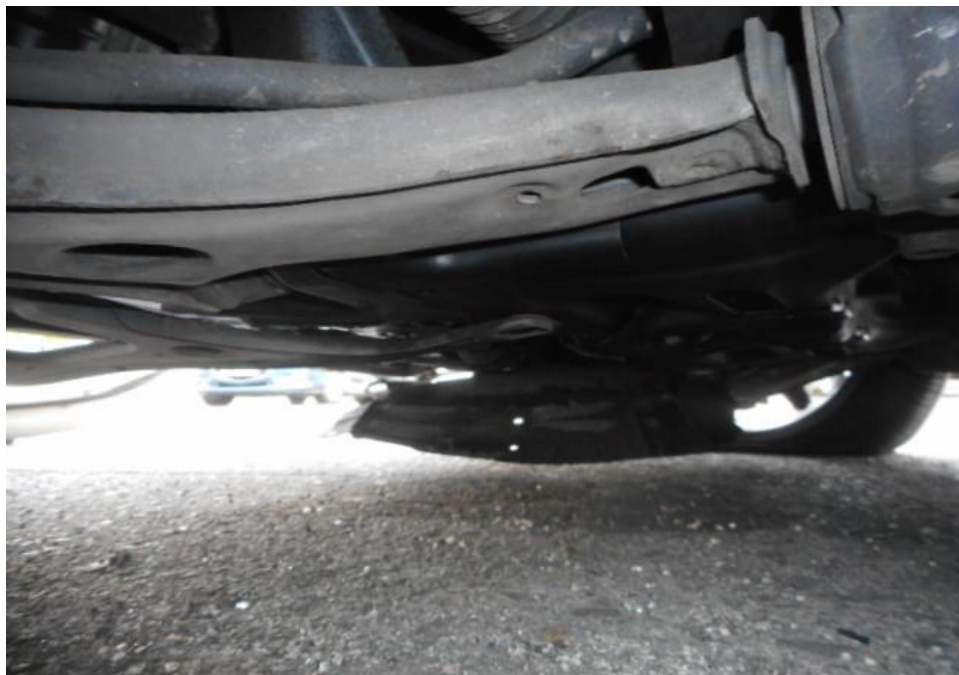
**Photo 17** shows the undercarriage of the Motor Car, at the area where the engine housing and transmission housing are located. I did not find any sign(s) or indication(s) of fluid leak and/or fluid stain(s) on the underside of the Motor Car.

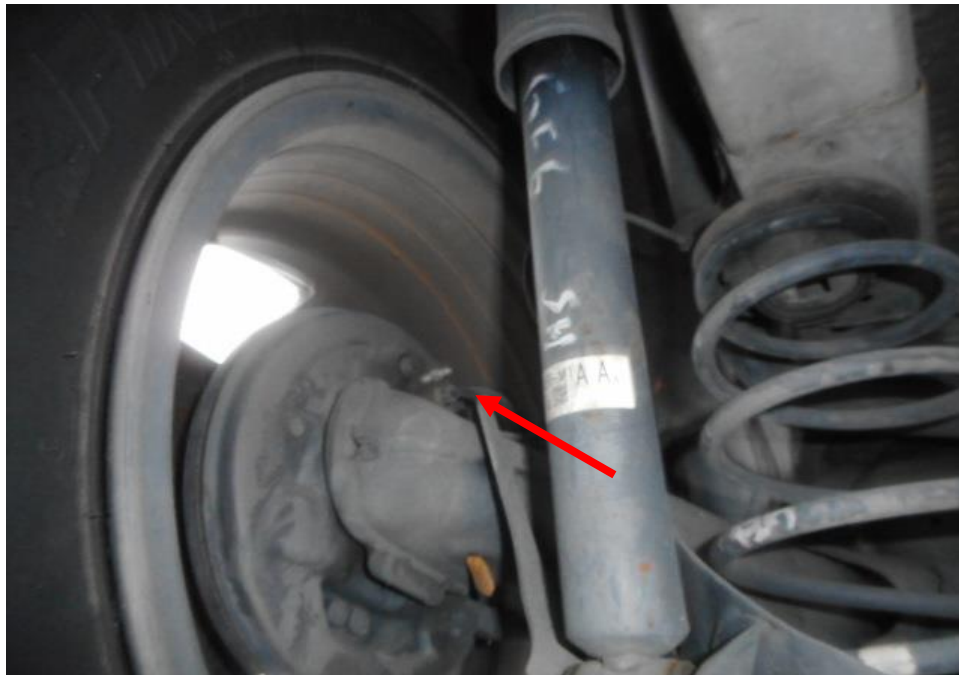
**Photo 18** shows the brake hose/pipe (arrowed) at the rear left wheel of the Motor Car. No leakage of brake fluid was observed. Visual examination of the various components of the braking system like the drum brake, brake booster, brake pedal etc. had revealed all to be intact and without visible damage.

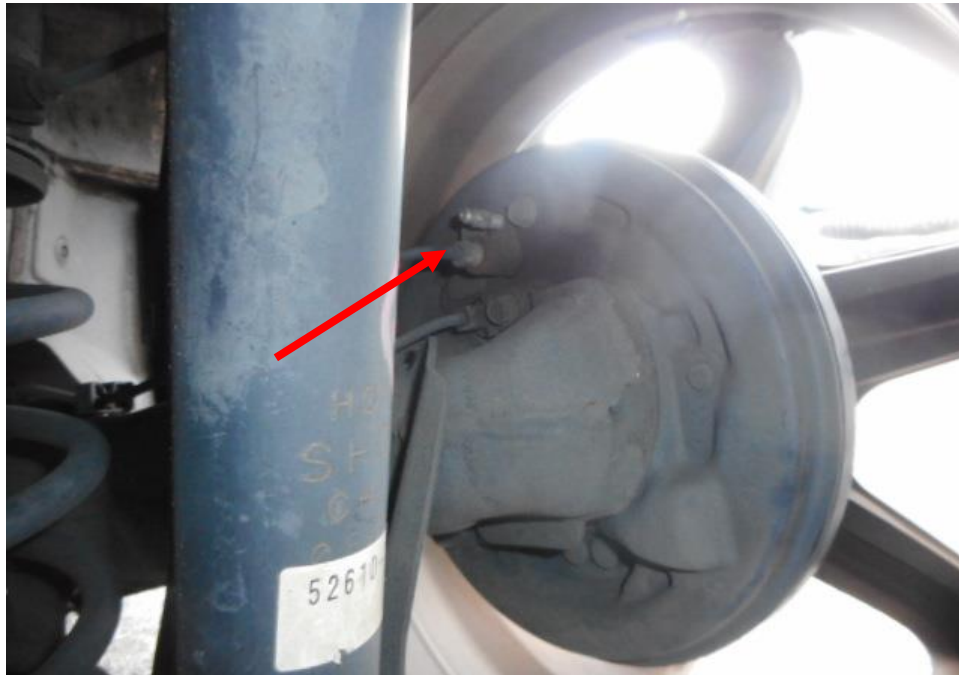
**Photo 19** shows the brake hose/pipe (arrowed) at the rear right wheel of the Motor Car. No leakage of brake fluid was observed. Visual examination of the various components of the braking system like the drum brake, brake booster, brake pedal etc. had revealed all to be intact and without visible damage.

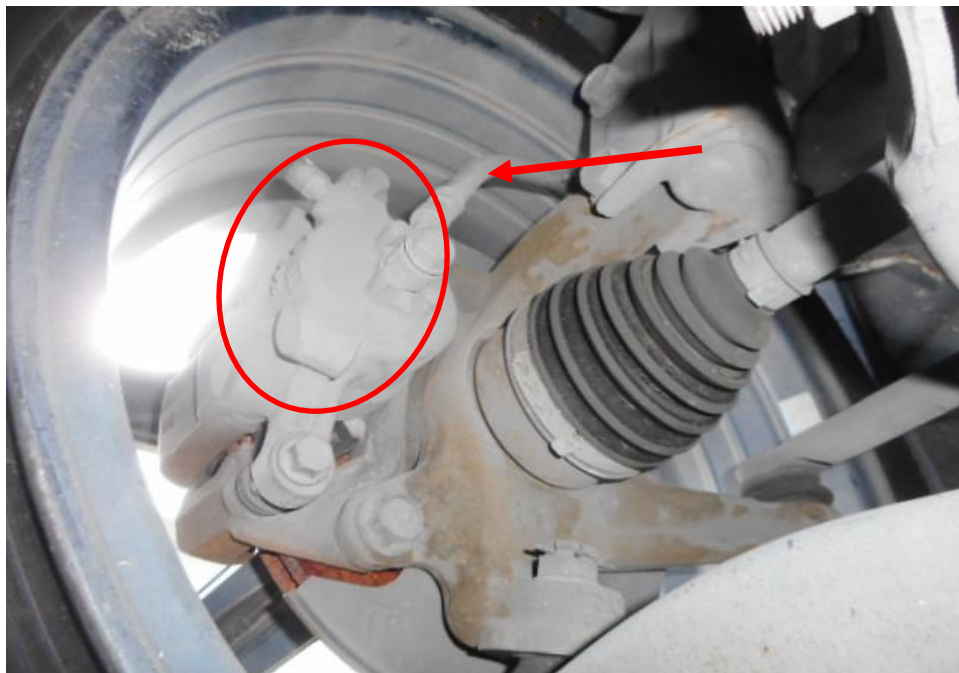
**Photo 20** shows the brake hose/pipe (arrowed) at the front right wheel of the Motor Car. I did not observe any leakage of brake fluid at the time of my inspection of the Motor Car. Static tests of the Motor Car's braking system had indicated that there was no internal leakage of pressure/vacuum.

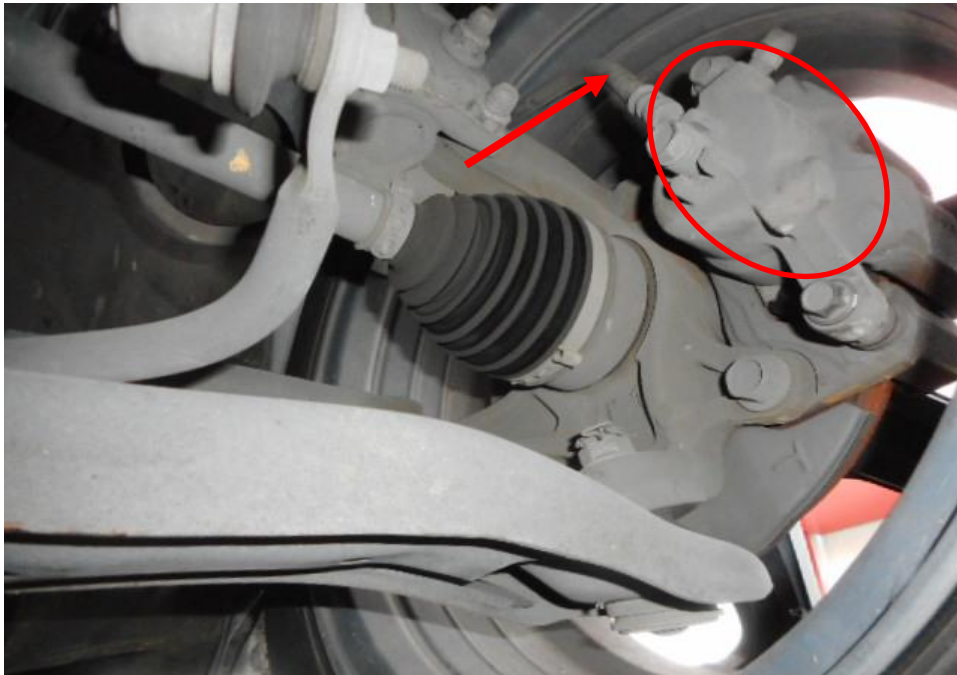
**Photo 21** shows the brake hose/pipe (arrowed) at the front left wheel of the Motor Car. No leakage of brake fluid was observed. Visual examination of the various components of the braking system like the brake caliper (circled), brake booster, brake pedal etc had revealed all to be intact and without visible damage.

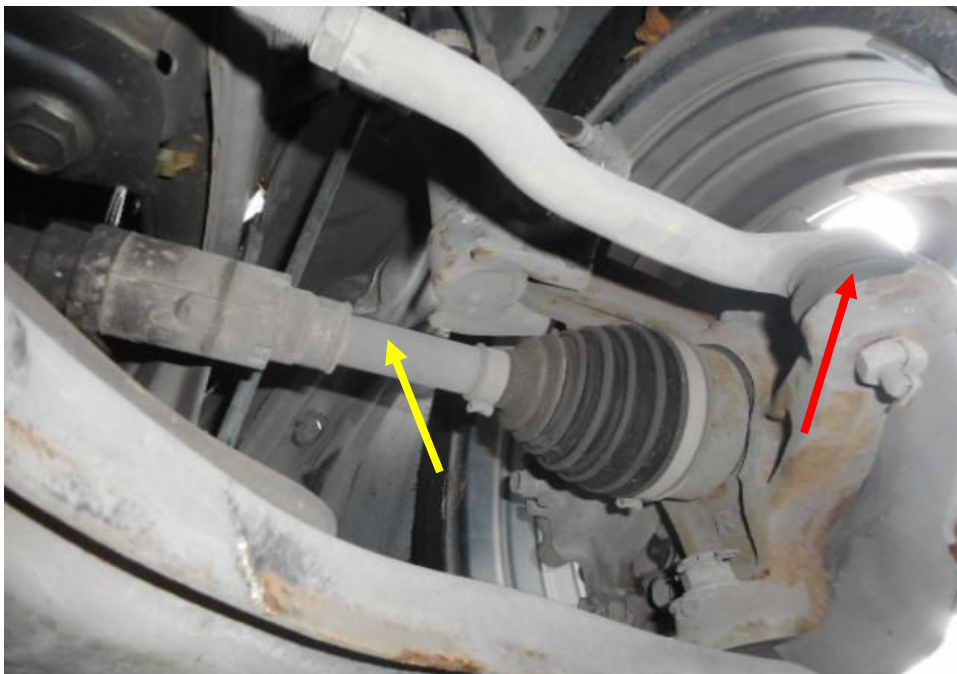
**Photo 22** shows the various undercarriage components at the front right wheel of the Motor Car, in particular the steering tie rod (red arrow) and the driveshaft (yellow arrow). The various steering components were all found to be intact, suggesting that the steering system of the Motor Car was likely to be in serviceable condition at the material time of accident. There was also no sign of fluid stain observed on the various undercarriage components at the front right wheel of the Motor Car.

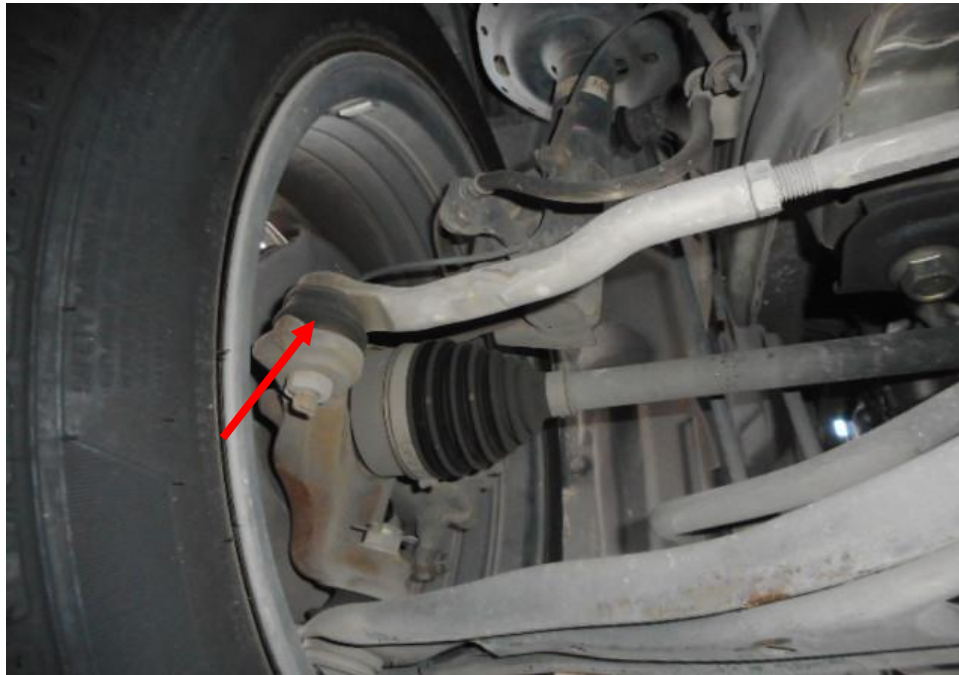
**Photo 23** shows the various undercarriage components at the front left wheel of the Motor Car, in particular the steering tie rod end (arrowed). The various undercarriage components of the Motor Car were all found to be intact without any visible damage. There was also no sign of fluid stain(s) observed on the various undercarriage components.

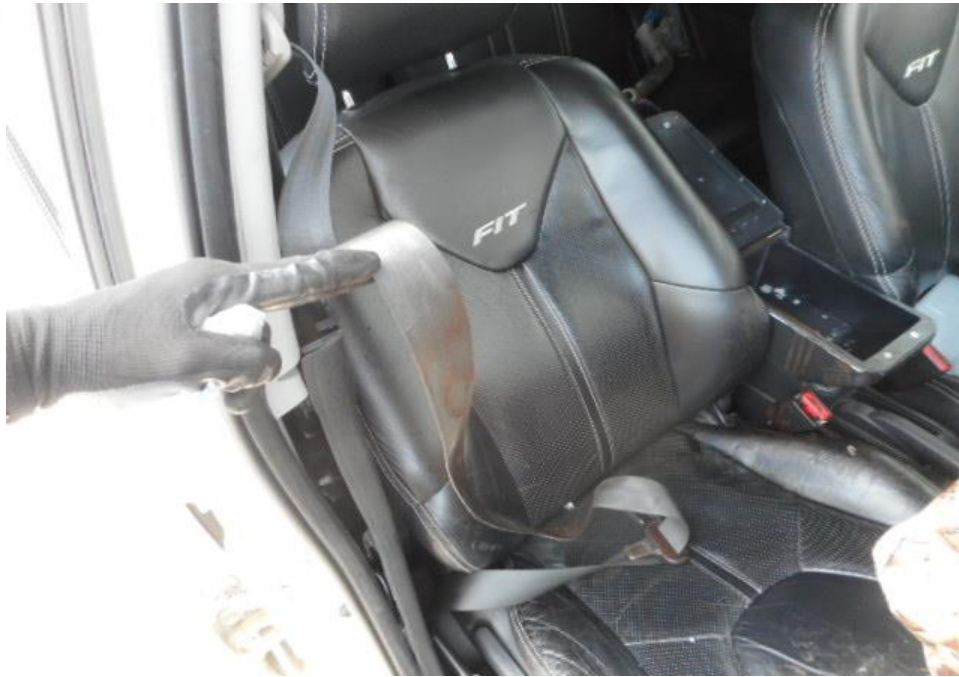
**Photo 24** shows that the seat belt on the right seat was worn at the material time of accident as the safety pre-tensioners was activated at the moment of impact and caused the seat belt to be locked into the last position.

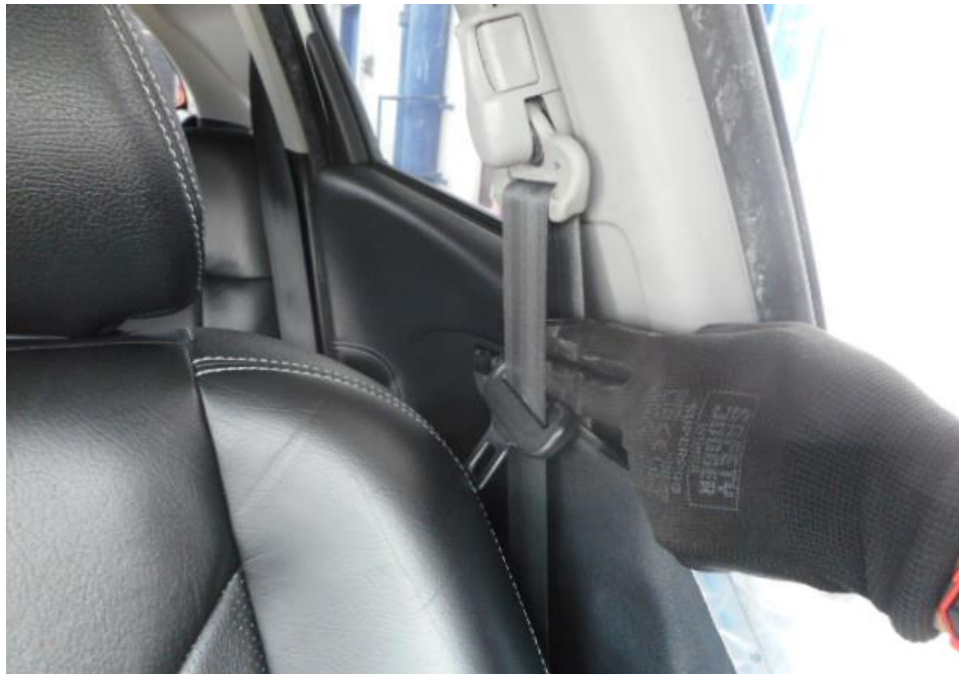
**Photo 25** shows that the seat belt on the left seat was not worn at the material time of accident as the safety pre-tensioners was activated at the moment of impact and caused the seat belt to be locked into the last position.
