Your Ref: TP/IP/20187/2022  
Our Ref : CI/TPD22008172/P

**General Investigation Team**

**MECHANICAL INSPECTION REPORT OF MOTOR CAR SND 5736R**

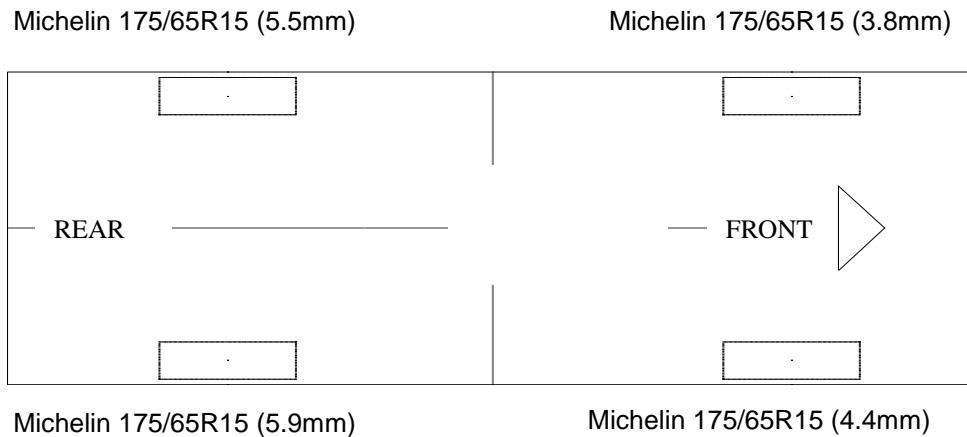
6. The condition of the Motor Car's 4 tyres was observed to be in serviceable condition. I did not find any tear, cut or burst mark(s) on the outer and the inner sidewalls as well as across the tread of the 4 tyres. The 4 tyres were also observed to be sufficiently inflated for vehicular operation. The tyre brand, tyre size and remaining tread depth of the 4 tyres were recorded as follows:-

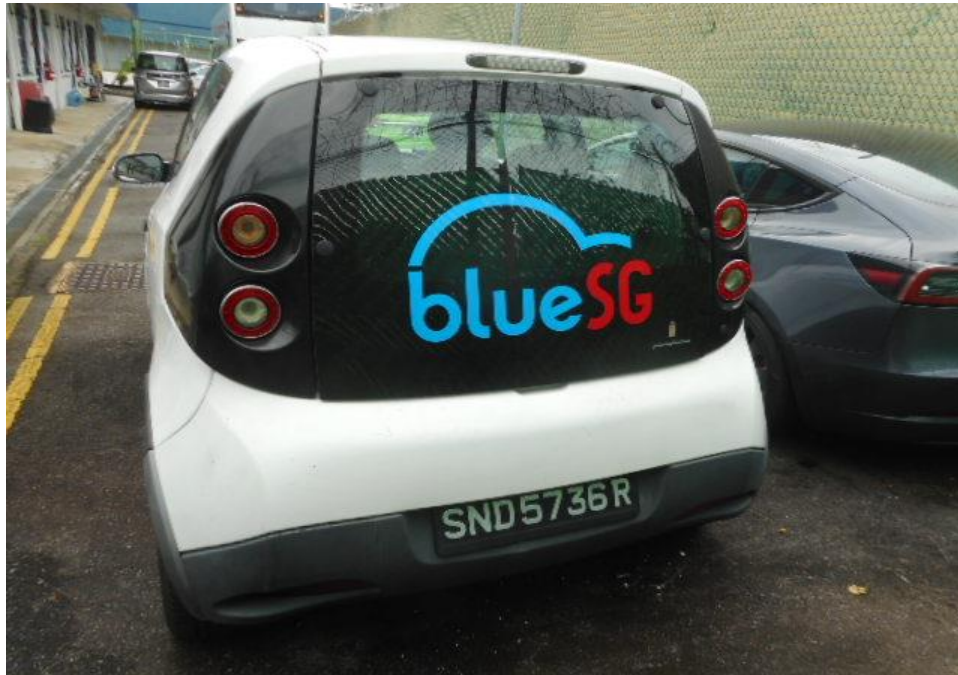
**Photo 1** shows the general view of the Motor Car's rear body at the time of my inspection. The Motor Car rear was observed to be unaffected by the accident.

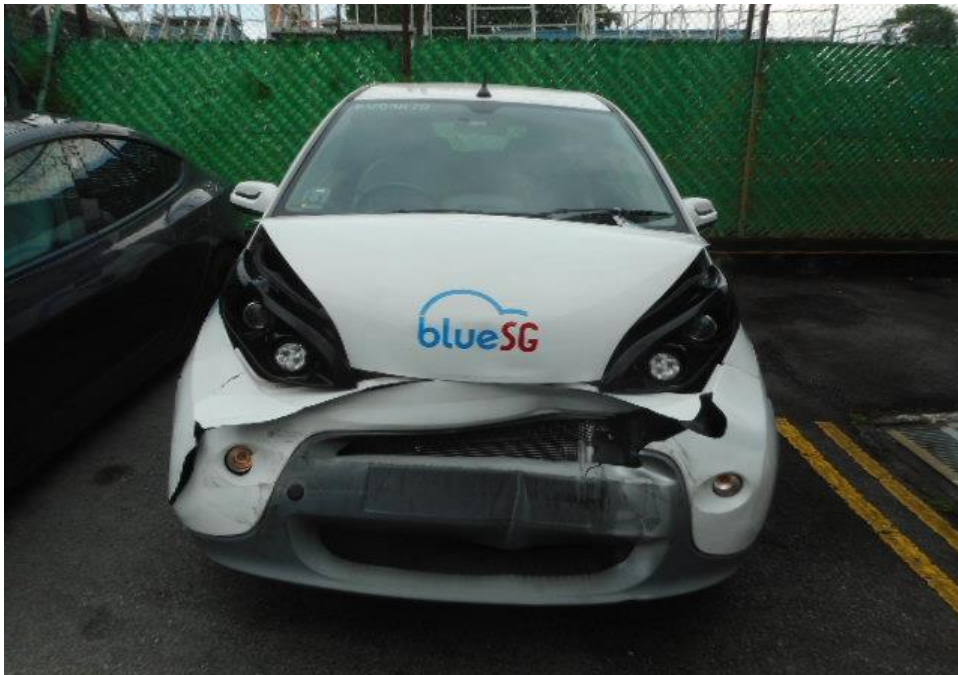
**Photo 2** shows a general view of the Motor Car's front body at the time of my inspection. The Motor Car was observed to have sustained damage at its front portion. Its front bonnet, front body panel and front bumper were amongst the body parts and various engine components were damaged as a result of the accident.

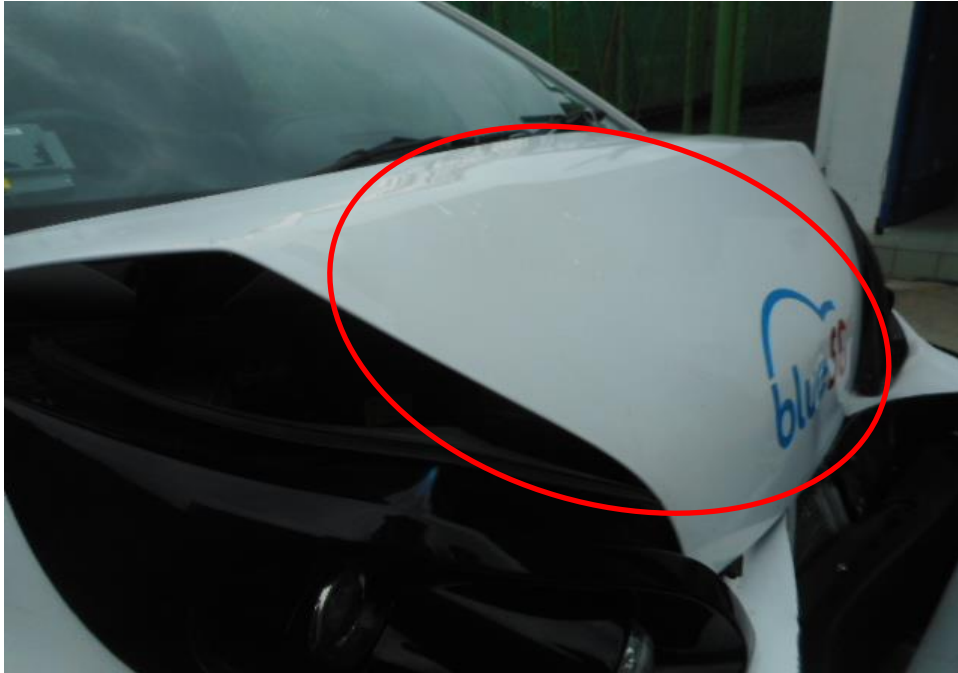
**Photo 3** shows the close up view of the Motor Car's front body at the time of my inspection. The Motor Car was observed to have sustained damage at its front portion. Its front bonnet (circled) were amongst the body parts that were damaged as a result of the accident.

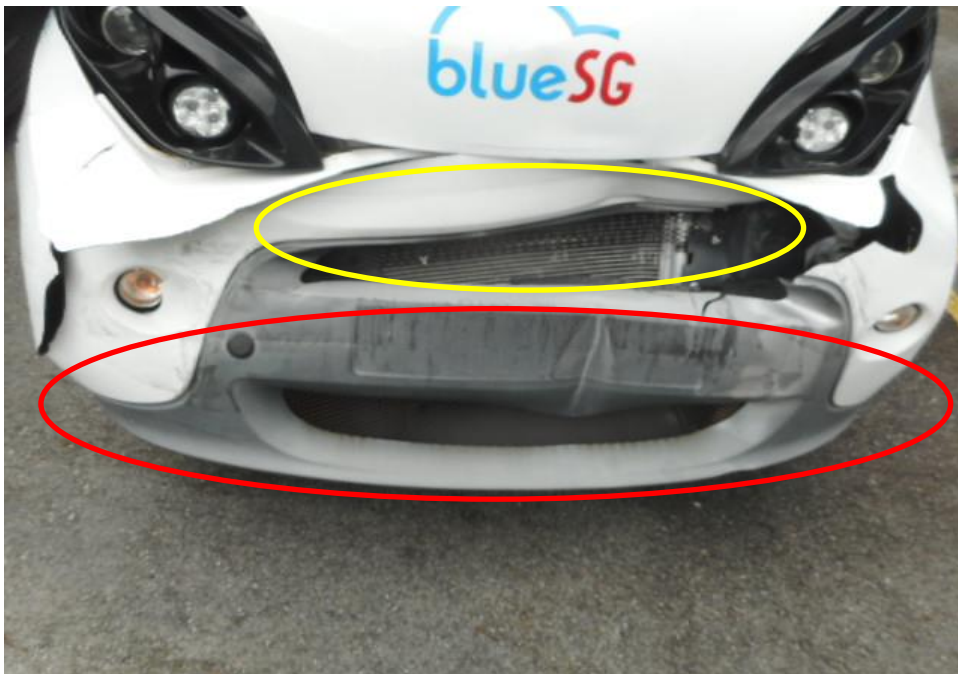
**Photo 4** shows the close up view of the Motor Car's front body at the time of my inspection. The Motor Car was observed to have sustained damage at its front portion. Its front bumper (red circle) and front body panel (yellow circle) were amongst the body parts that were damaged as a result of the accident.

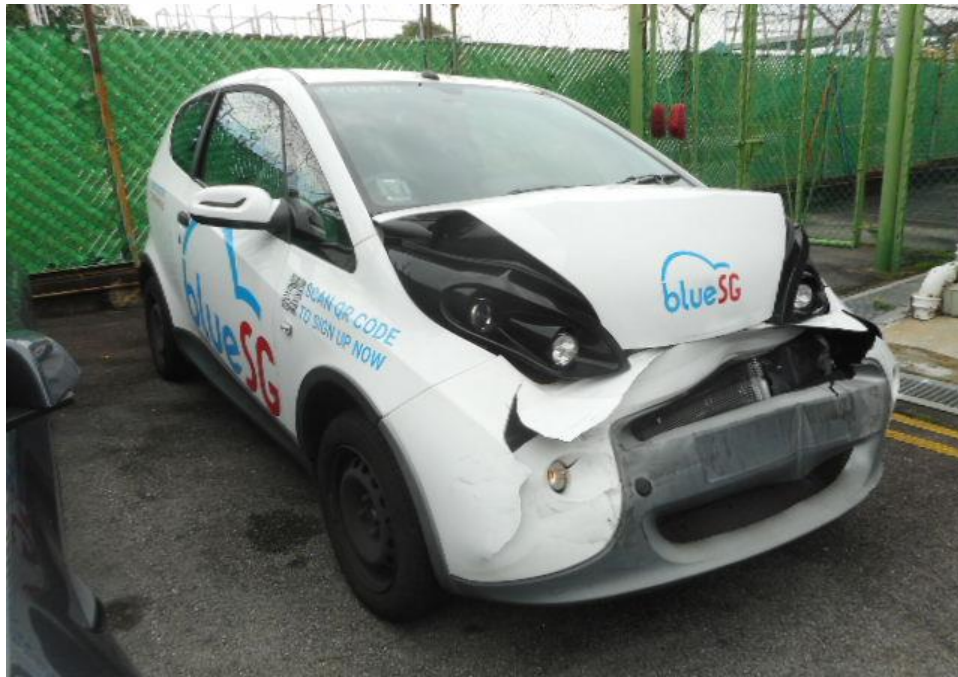
**Photo 5** shows a general view of the Motor Car's right body at the time of my inspection. The Motor Car left was observed to be unaffected by the accident.

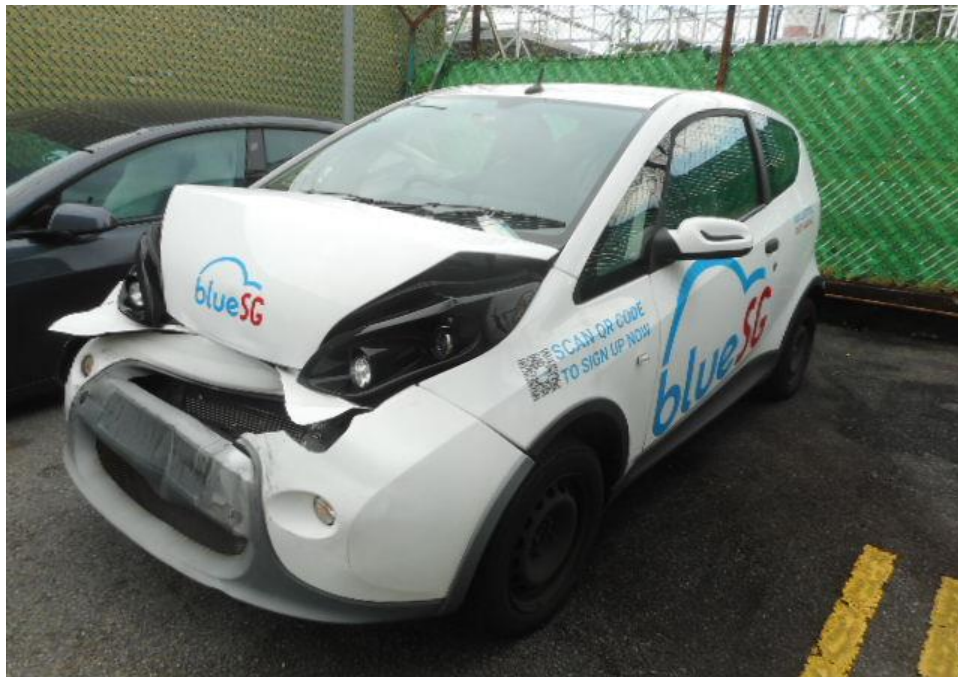
**Photo 6** shows a general view of the Motor Car's left body at the time of my inspection. The Motor Car left was observed to be unaffected by the accident.

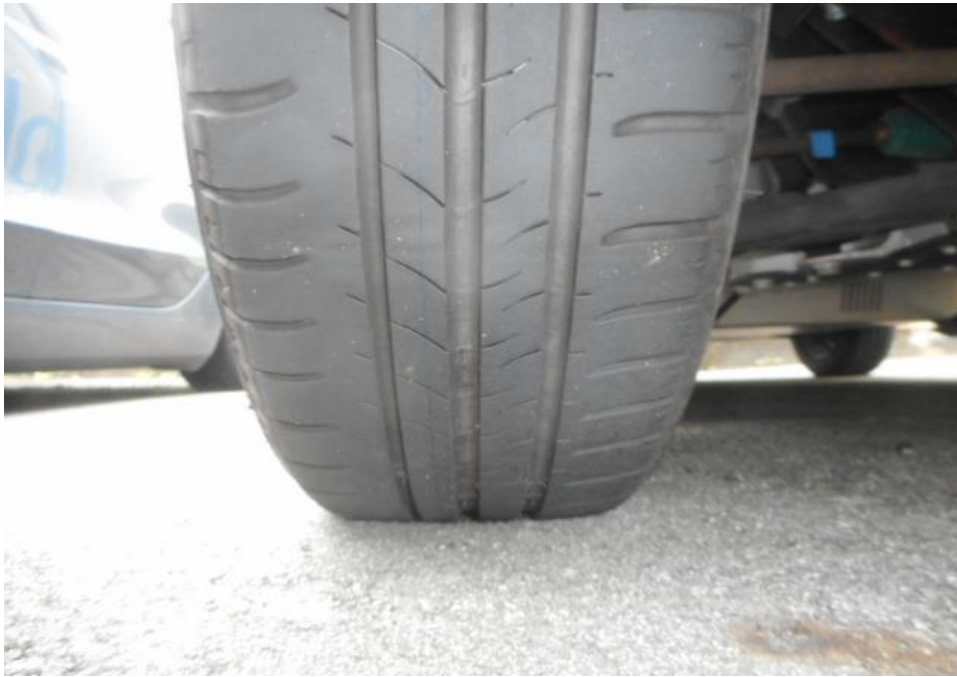
**Photo 7** shows the condition of the front right tyre of the Motor Car, which was observed to be in serviceable condition with remaining tread depth of approximately 4.4mm. The tyre, which was wrapped around alloy wheel rim, was also observed to be sufficiently inflated for vehicular operation.

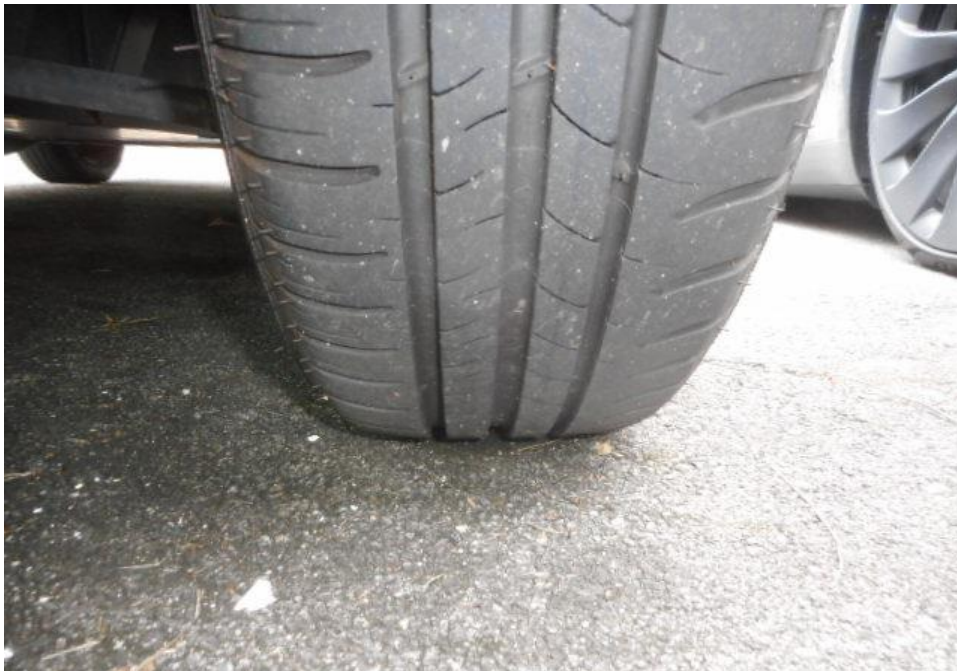
**Photo 8** shows the condition of the rear right tyre of the Motor Car, which was observed to be in serviceable condition with remaining tread depth of approximately 5.9mm. The tyre, which was wrapped around standard steel wheel rim, was also observed to be sufficiently inflated for vehicular operation.

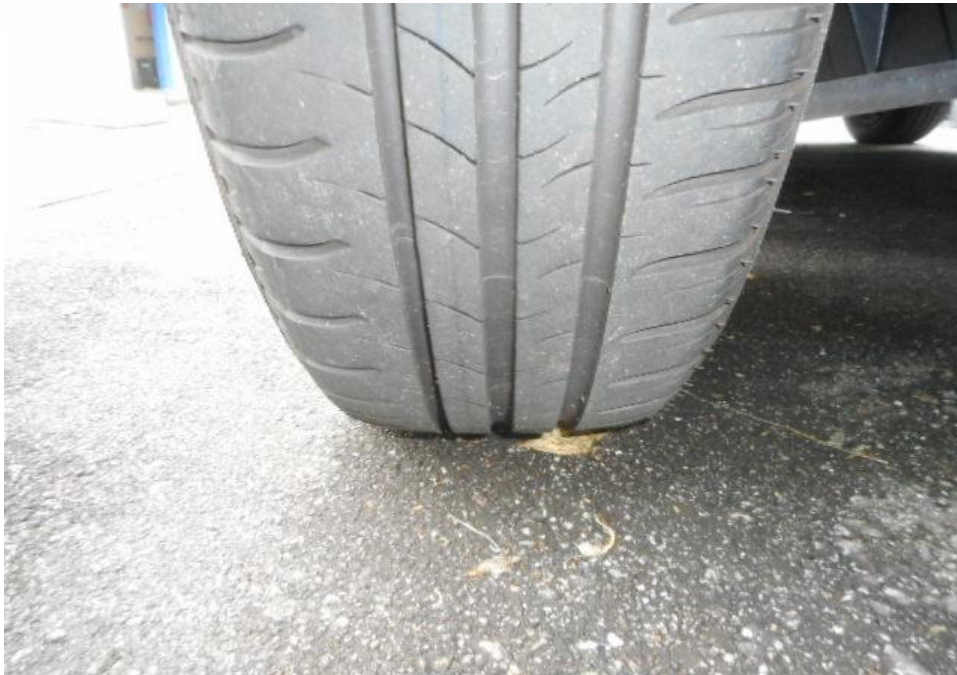
**Photo 9** shows the condition of the rear left tyre of the Motor Car, which was observed to be in serviceable condition with remaining tread depth of approximately 5.5mm. The tyre, which was wrapped around standard steel wheel rim, was also observed to be sufficiently inflated for vehicular operation.

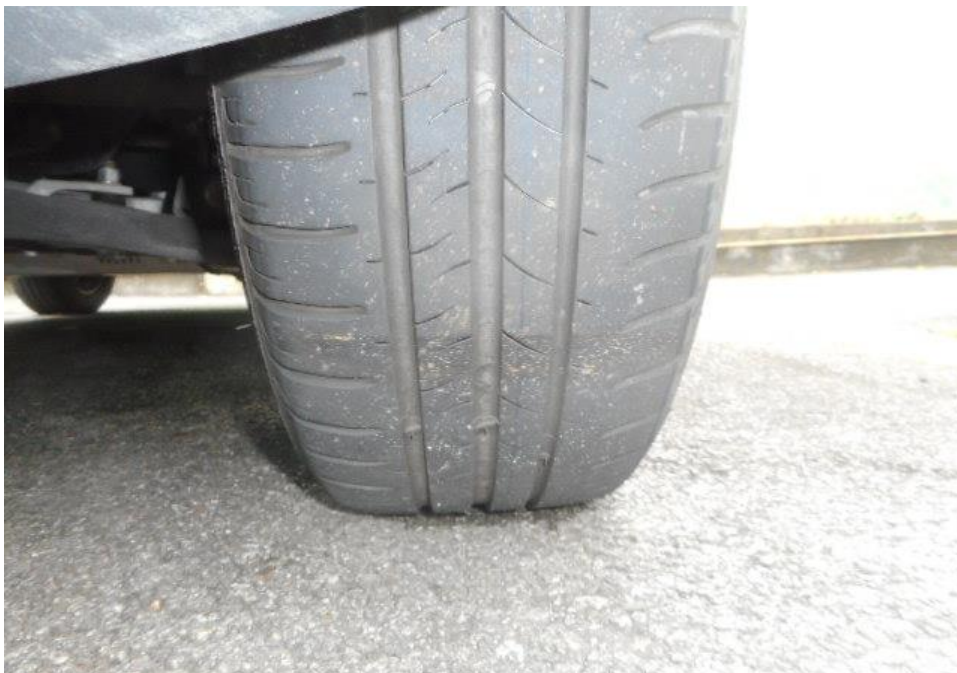
**Photo 10** shows the condition of the front left tyre of the Motor Car, which was observed to be in serviceable condition with remaining tread depth of approximately 3.8mm. The tyre, which was wrapped around standard steel wheel rim, was also observed to be sufficiently inflated for vehicular operation.

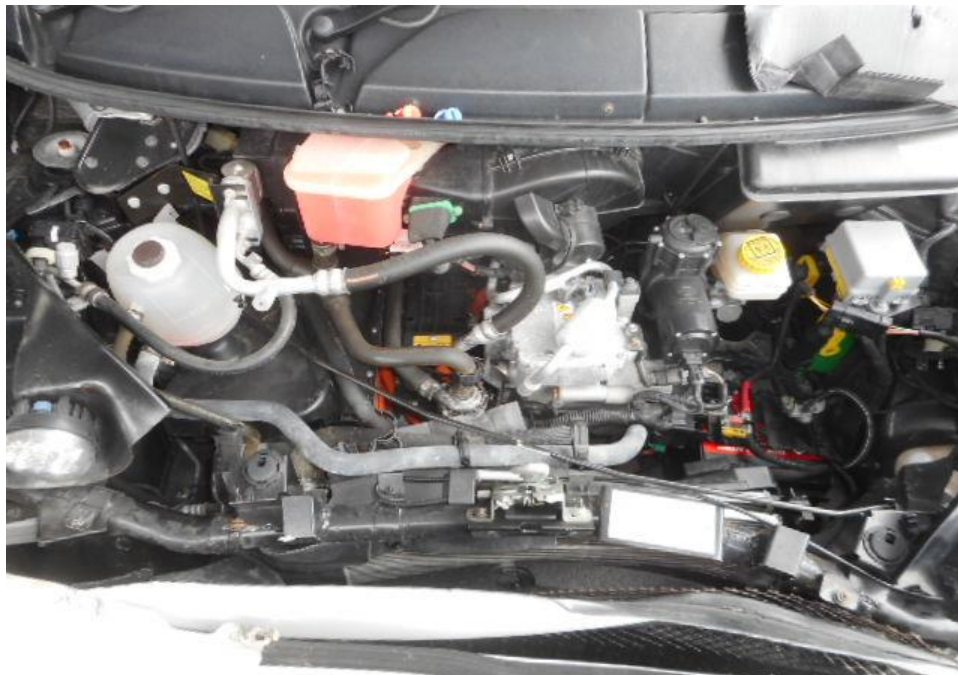
8. Upon examination of the electric motor compartment of the Motor Car, I had observed the coolant radiator, 12V battery and high voltage cables inside the electric motor compartment to be damaged as a result of the impact from the accident which had pushed the coolant radiator towards there components and resulting to the sustained damages. The electric motor coolant was observed to be insufficient as a result of the damage to the coolant radiator sustained from the accident. The brake fluid were found to be of sufficient level for operating purposes. Visually, there was also no contamination found to the fluid.

**Photo 11** shows a general view of the Motor Car's electric motor compartment. I had observed the coolant radiator, 12V battery and high voltage cables inside the electric motor compartment to be damaged as a result of the impact from the accident which had pushed the coolant radiator towards these components and resulting to the sustained damages. The electric motor coolant was observed to be insufficient as a result of the damage to the coolant radiator sustained from the accident. However, the brake fluid were found to be of sufficient level for operating purposes. Visually, there was also no contamination found to the fluid.

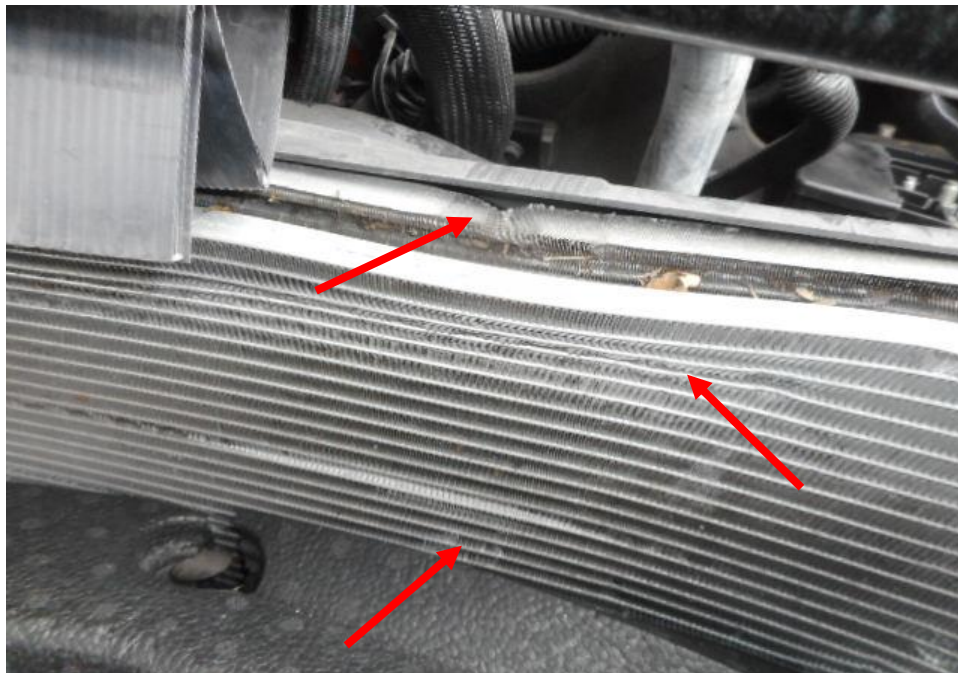
**Photo 12** shows the coolant radiator of the Motor Car at the time of my inspection. The coolant radiator (arrowed) was observed to be damaged as a result of the accident.

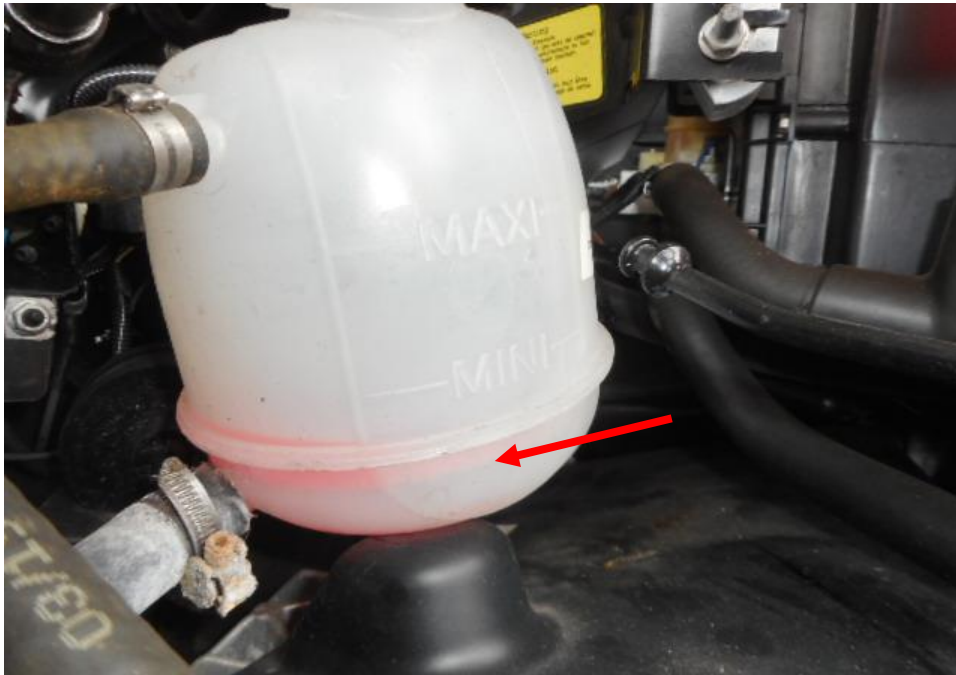
**Photo 13** shows the coolant reservoir of the Motor Car at the time of my inspection. The coolant fluid was observed to be of insufficient level (arrowed) due to the damaged radiator as a result of the accident.

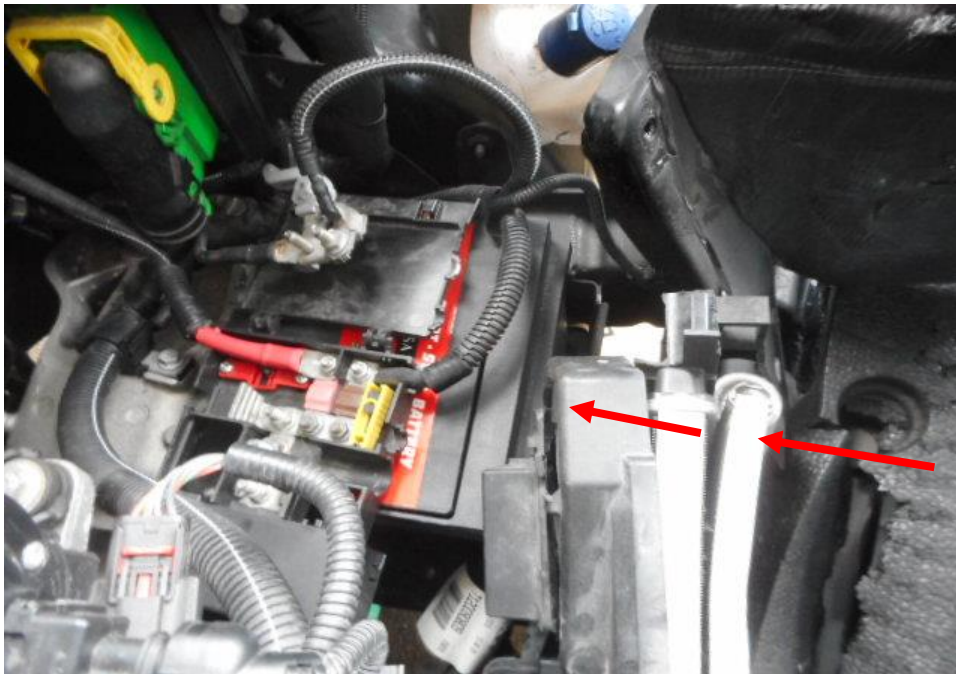
**Photo 14** shows checks being carried out to electric motor compartment on where the location of the 12V battery of the Motor Car is located at the time of my inspection. The coolant radiator was observed to bend inwards and pieced the 12V battery (arrowed) as result of the induced impact from the accident.

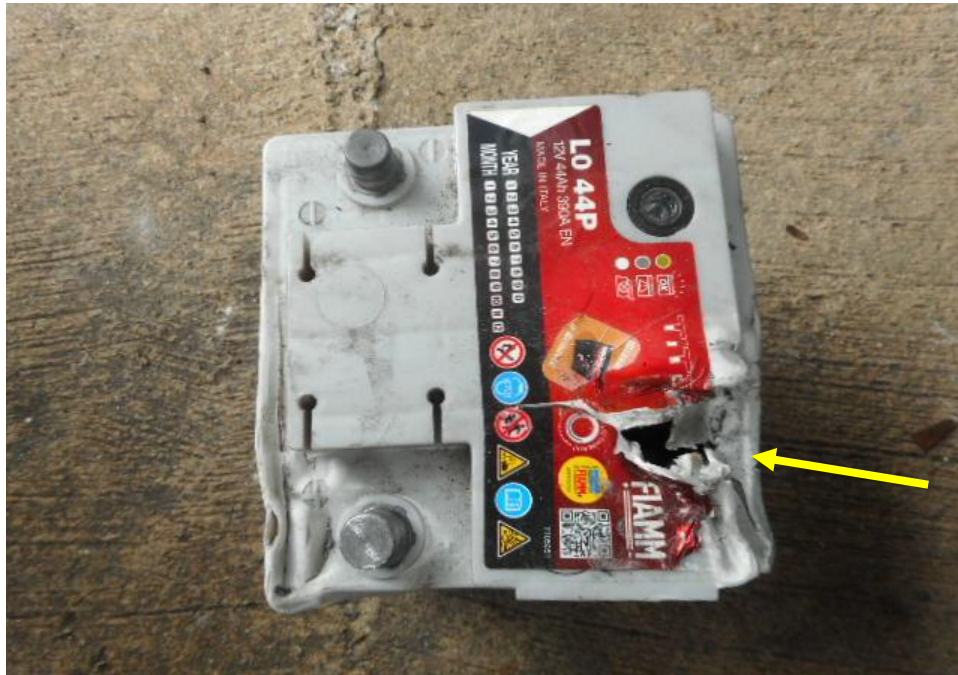
**Photo 15** shows checks being carried out to the original 12V battery of the Motor Car at the time of my inspection. The 12V battery was observed to be pieced by the bend coolant radiator as result of the induced impact from the accident (arrowed).

11. The original 12V battery taken out and replaced with a new 12V battery to facilitate our inspection. See photo 11 – 19 below.

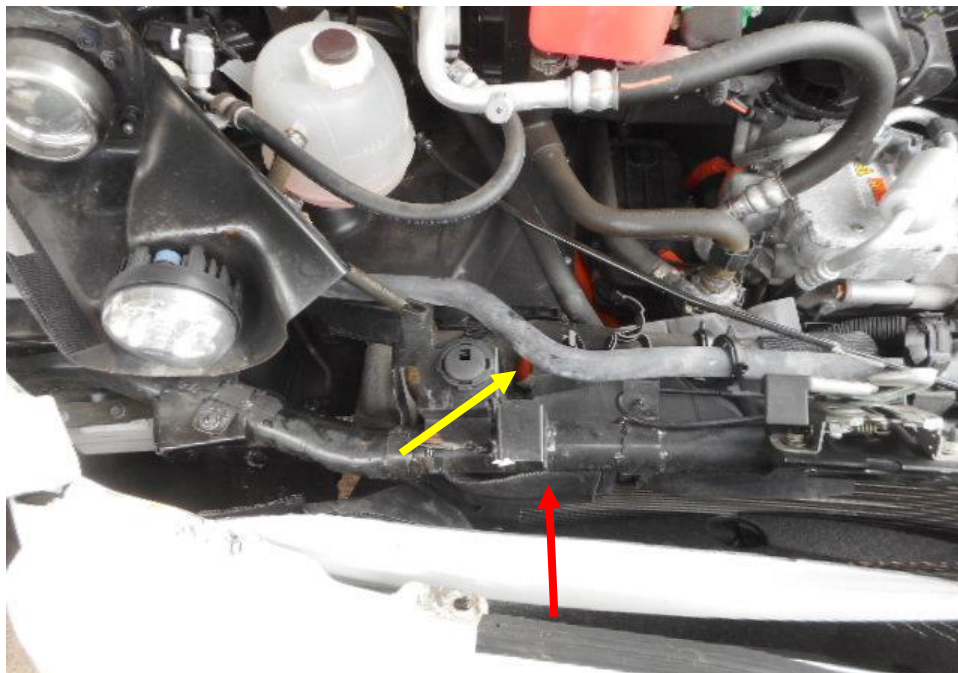
**Photo 16** shows checks being carried out to electric motor compartment on where the location of the high voltage cable of the Motor Car is located at the time of my inspection. The high voltage cables (yellow arrow) was observed to sustain damages as result of the induced impact on the coolant radiator (red arrow) from the accident.

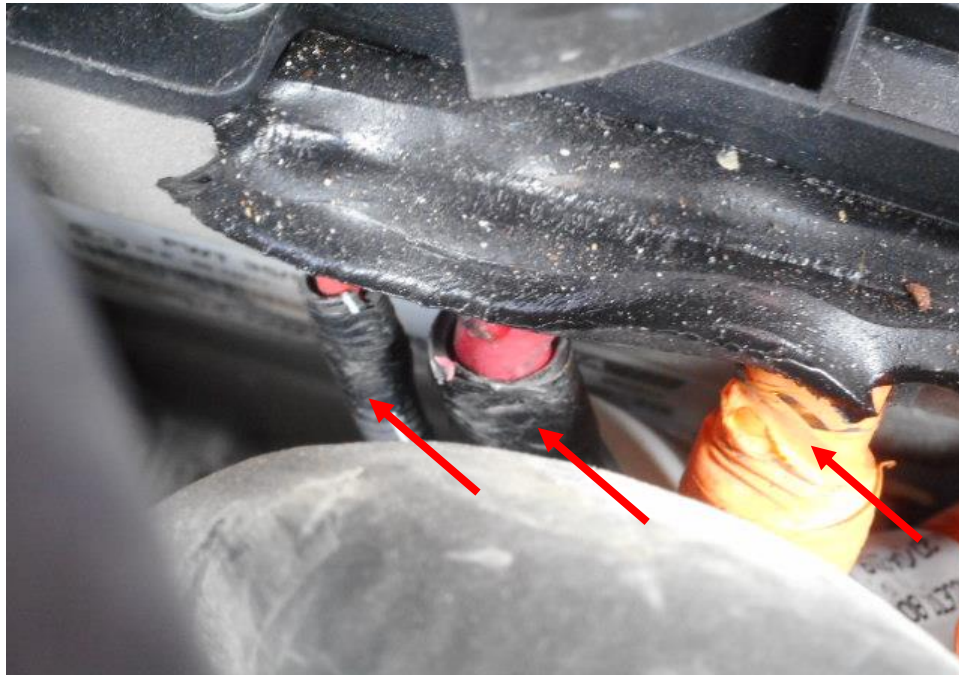
**Photo 17** shows the close up view on the electric motor compartment on where the location of the high voltage cable of the Motor Car is located at the time of my inspection. The high voltage cables (arrowed) was observed to sustain damages as result of the induced impact on the coolant radiator from the accident

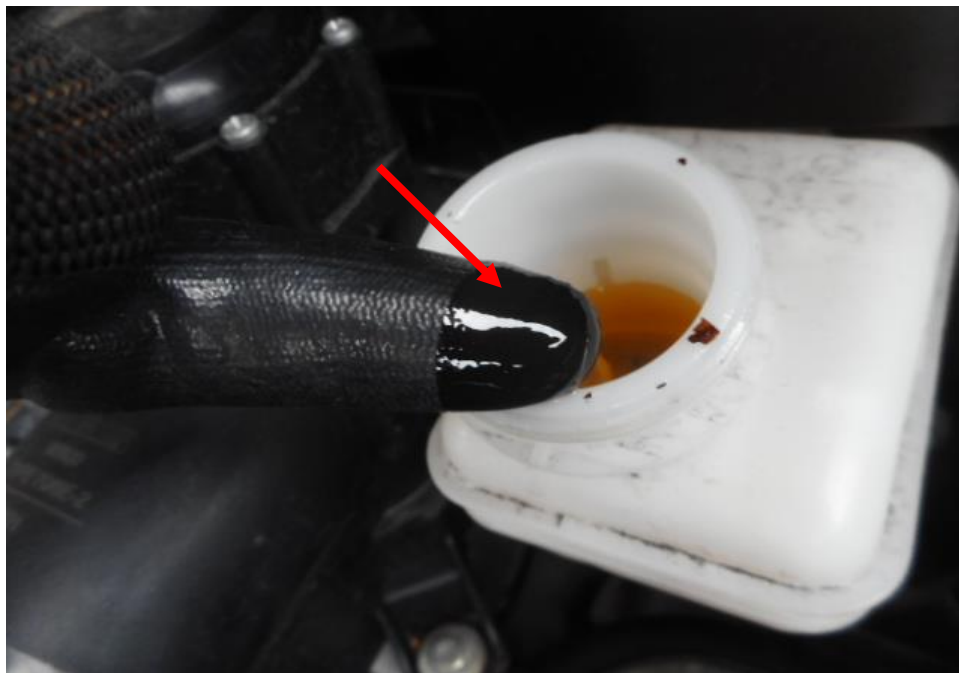
**Photo 18** shows the brake fluid reservoir of the Motor Car at the time of my inspection. The brake fluid was observed to be of sufficient level (arrowed) and without any visible contamination.

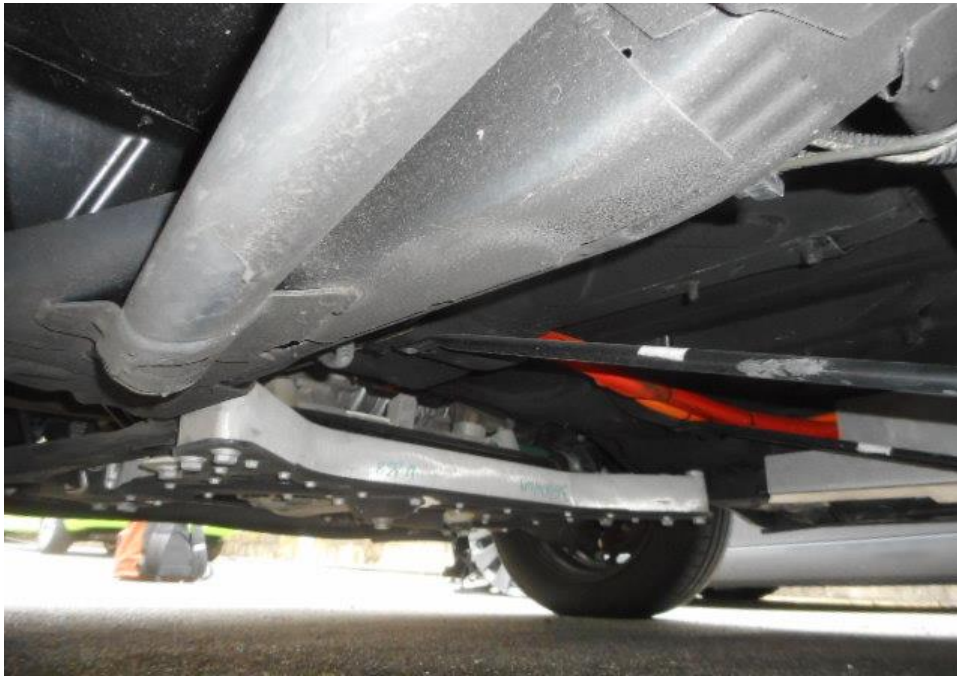
**Photo 19** shows the undercarriage of the Motor Car, at the area where the electric motor housing and transmission housing are located. I did not find any sign(s) or indication(s) of fluid leak and/or fluid stain(s) on the underside of the Motor Car.

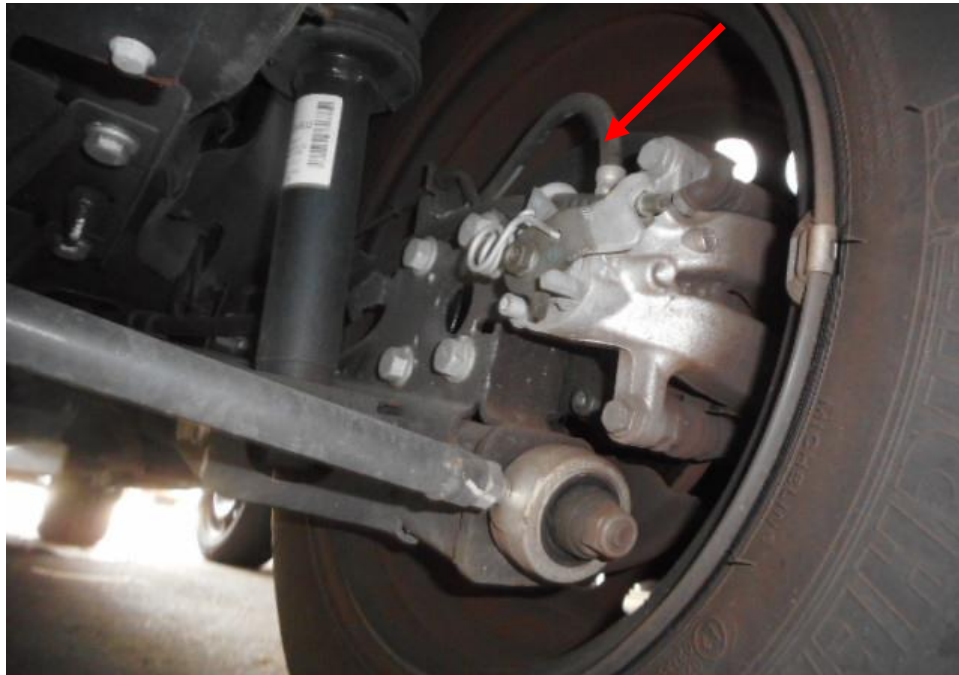
**Photo 20** shows the brake hose/pipe (arrowed) at the rear right wheel of the Motor Car. No leakage of brake fluid was observed. Visual examination of the various components of the braking system like the drum brake, brake booster, brake pedal etc. had revealed all to be intact and without visible damage.

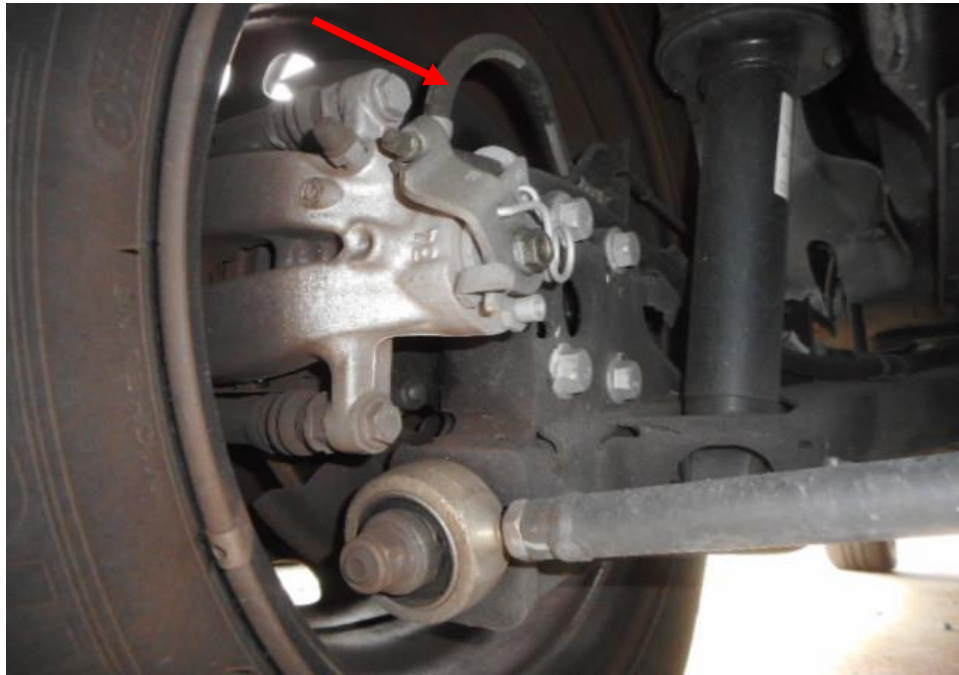
**Photo 21** shows the brake hose/pipe (arrowed) at the rear left wheel of the Motor Car. I did not observe any leakage of brake fluid at the time of my inspection of the Motor Car. The undercarriage components of the Motor Car were also all found to be intact and without any visible damage.

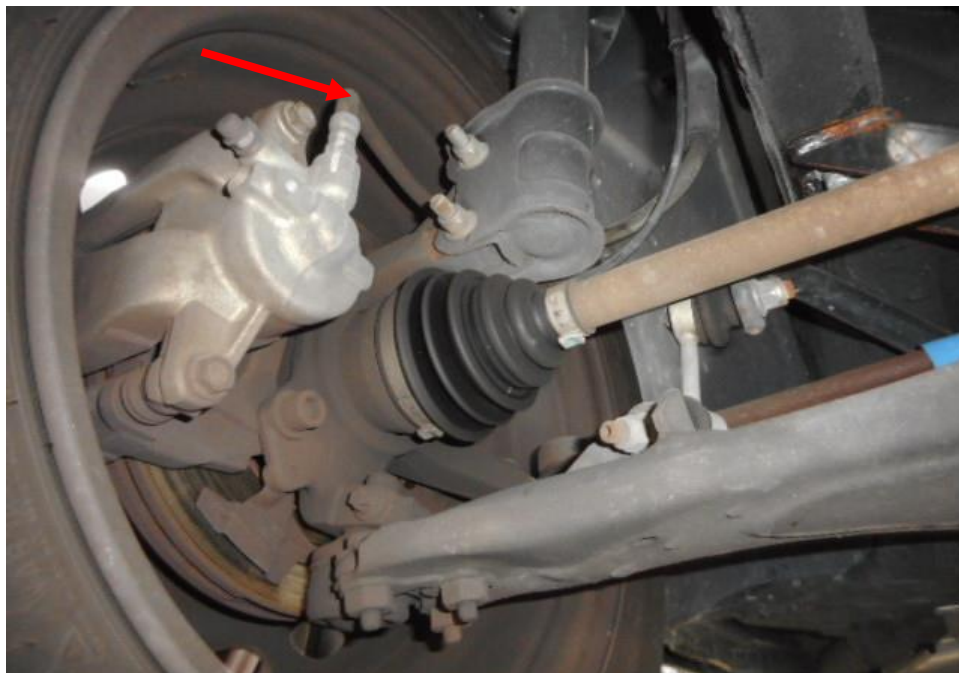
**Photo 22** shows the brake hose/pipe (arrowed) at the front right wheel of the Motor Car. I did not observe any leakage of brake fluid at the time of my inspection of the Motor Car. The undercarriage components of the Motor Car were also all found to be intact and without any visible damage.

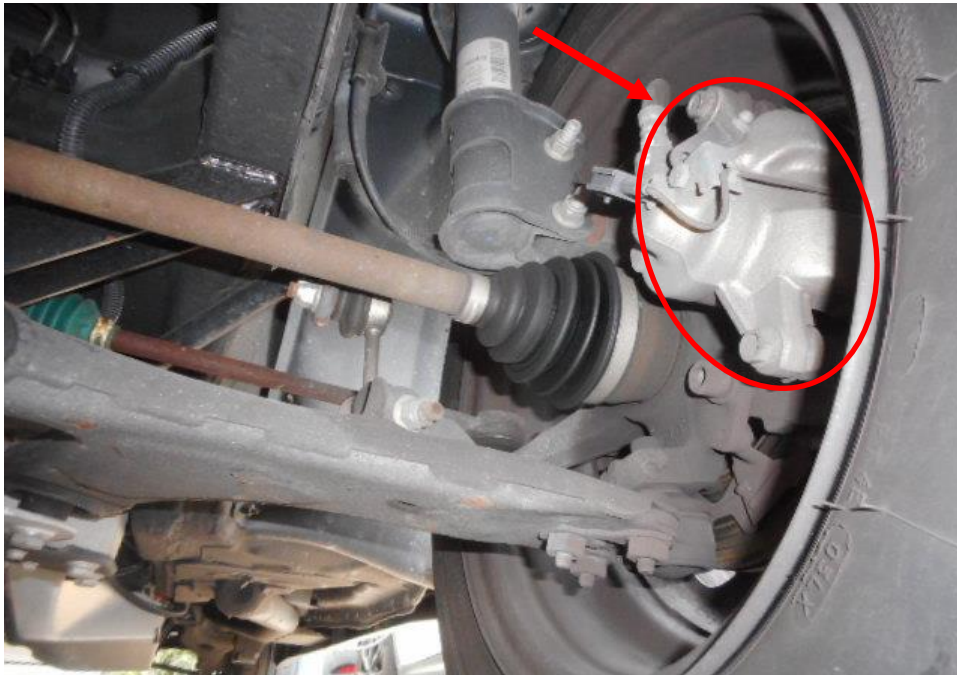
**Photo 23** shows the brake hose/pipe (arrowed) at the front left wheel of the Motor Car. No leakage of brake fluid was observed. Visual examination of the various components of the braking system like the brake caliper (circled), brake booster, brake pedal etc had revealed all to be intact and without visible damage.

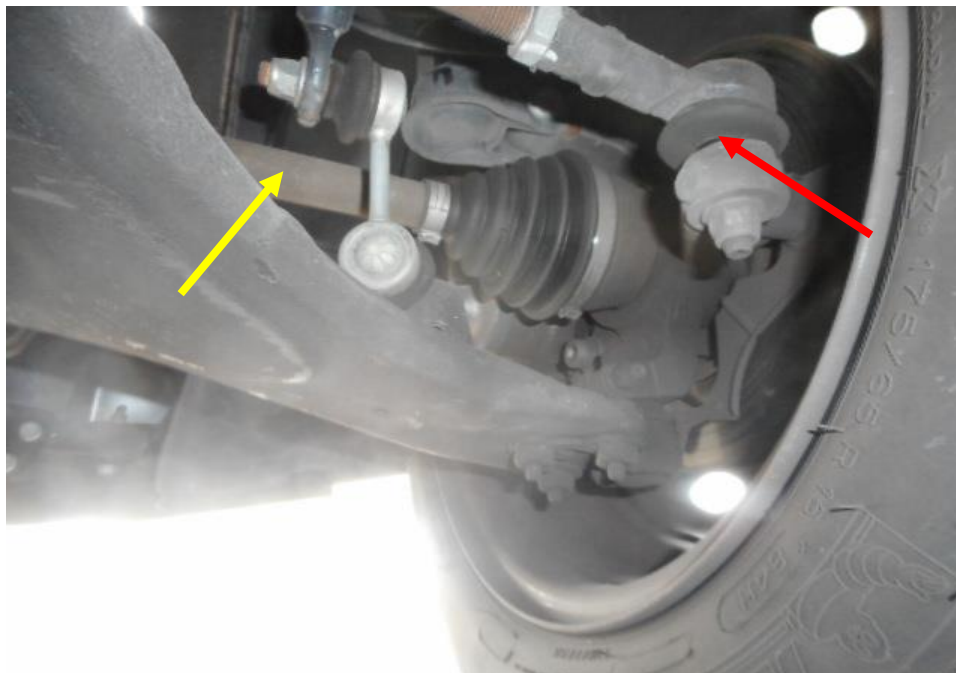
**Photo 24** shows the various undercarriage components at the front right wheel of the Motor Car, in particular the steering tie rod (red arrow) and its driveshaft (yellow arrow). The various steering components were all found to be intact. There was also no sign of fluid stain observed on the various undercarriage components at the front right wheel of the Motor Car.

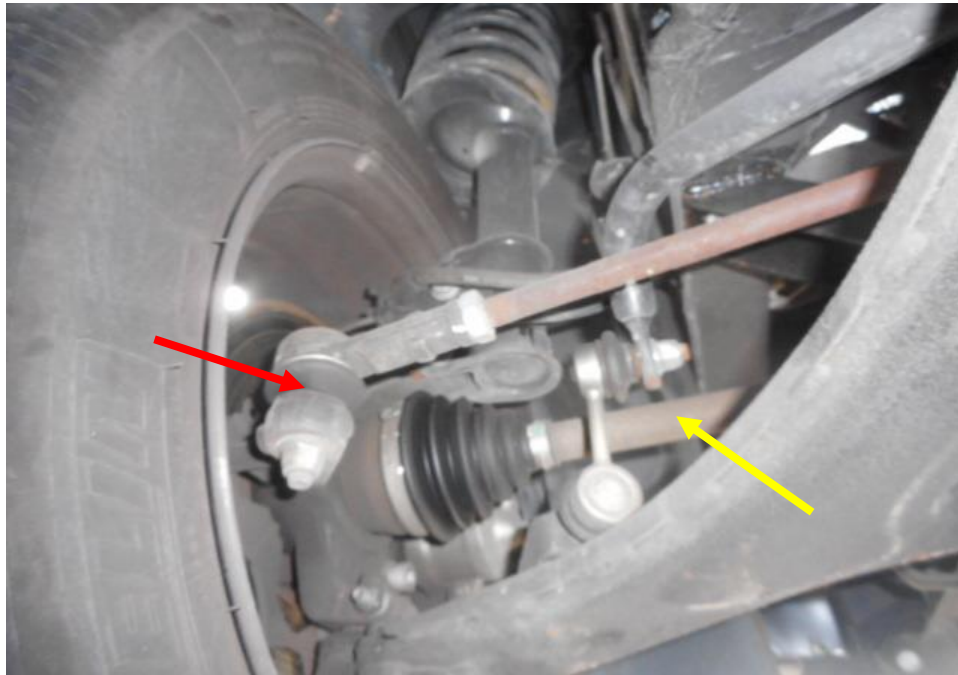
**Photo 25** shows the various undercarriage components at the front right wheel of the Motor Car, in particular the steering tie rod (red arrow) and its driveshaft (yellow arrow). The various steering components were all found to be intact. There was also no sign of fluid stain observed on the various undercarriage components at the front right wheel of the Motor Car.
