Your Ref: TP/IP/17223/2022  
Our Ref : CI/TPD22008174/P

**MECHANICAL INSPECTION REPORT OF MOTOR LORRY YP 6916M**

1. I refer to your request on 16<sup>th</sup> August 2022 to conduct a physical inspection of a Motor Lorry bearing registration number YP 6916M (herein referred to as "**Motor Lorry**"), which was involved in a road traffic accident on 2<sup>nd</sup> July 2022.
2. The objective of this inspection is to determine if there was any possible mechanical failure to the Motor Lorry that may have contributed to the accident.
3. Following the request, I had carried out a physical inspection of the Motor Lorry on 31<sup>st</sup> August 2022 at the premises of Traffic Police vehicle pound, 517 Airport Road Singapore 539942. I now set out below my observations and comments with respect to this inspection.

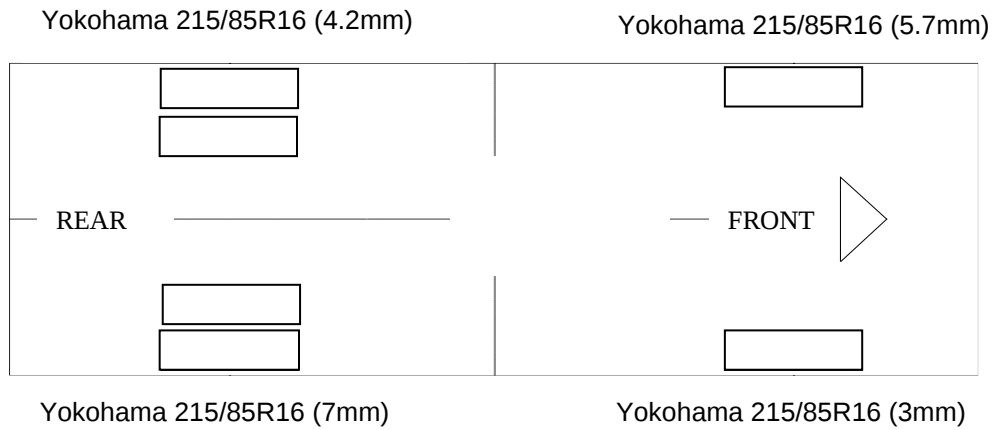
6. The 6 tyres of the Motor Lorry were observed to be in serviceable condition and sufficiently inflated for vehicular operation. I did not find any tear, cut or burst mark(s) on the outer and the inner sidewalls as well as across the tread of the 6 tyres. The tyre brand, tyre size and remaining tread depth of the 6 tyres of the Motor Lorry were recorded as follows:-

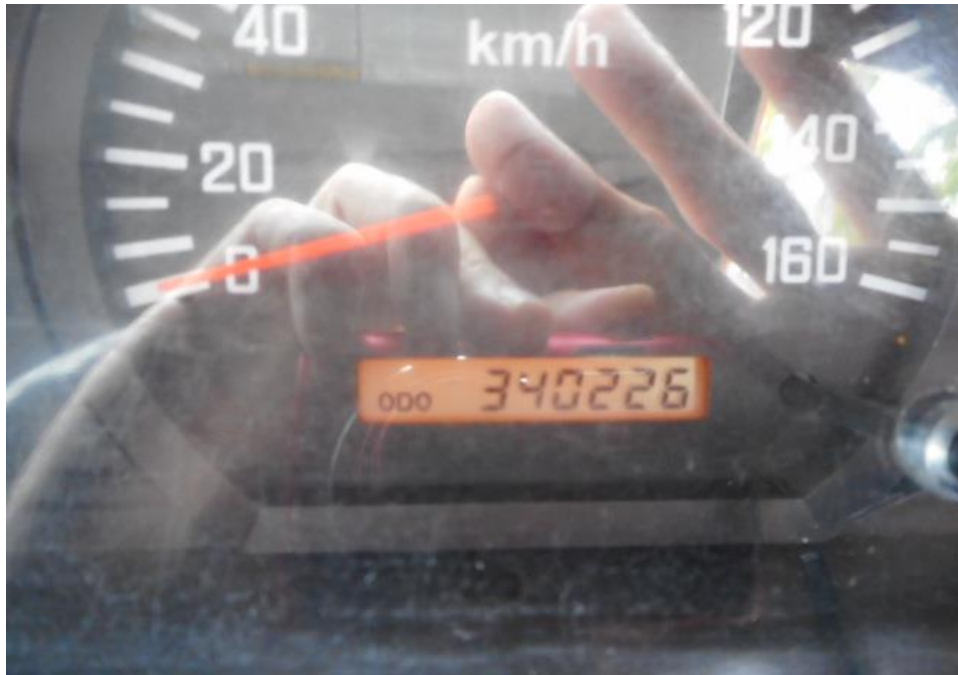
**Photo 1** shows a general view of the instrument cluster of the Motor Lorry at the time of my inspection. The mileage of the Motor Lorry was 340,226km

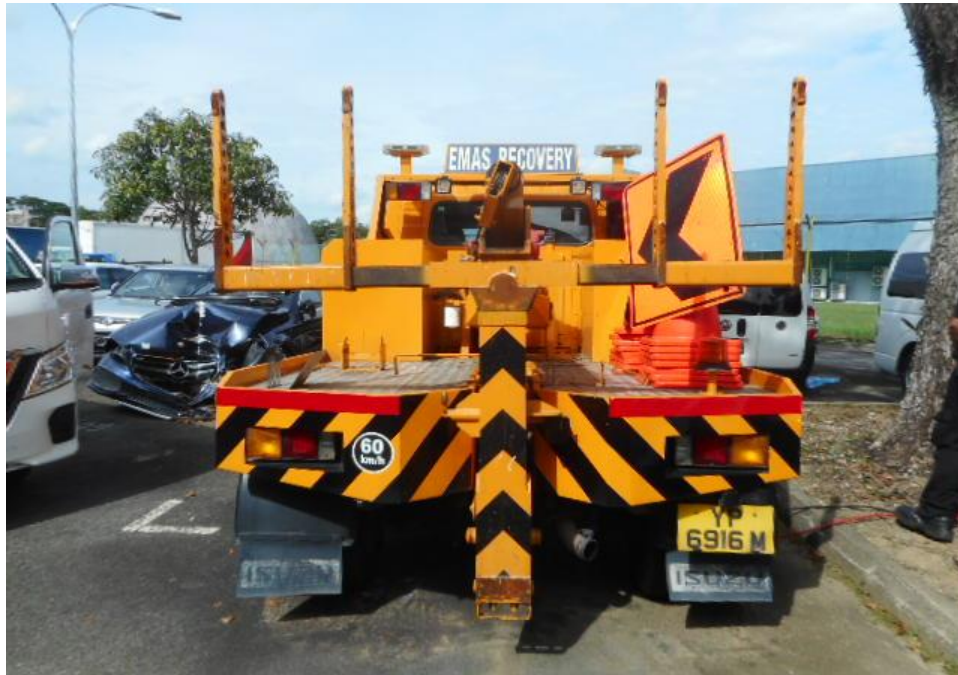
4. The mileage of the Motor Lorry at the time of my inspection was 340,226km.
5. The Motor Lorry was observed to sustained damage at its rear portion. Its rear towing fork was damage at the time of my inspection as a result of the accident.

**Photo 2** shows a general view of the Motor Lorry's rear portion at the time of my inspection. It appeared to have sustained damage at its rear portion. Its rear tow fork was damage at the time of my inspection as a result of the accident.

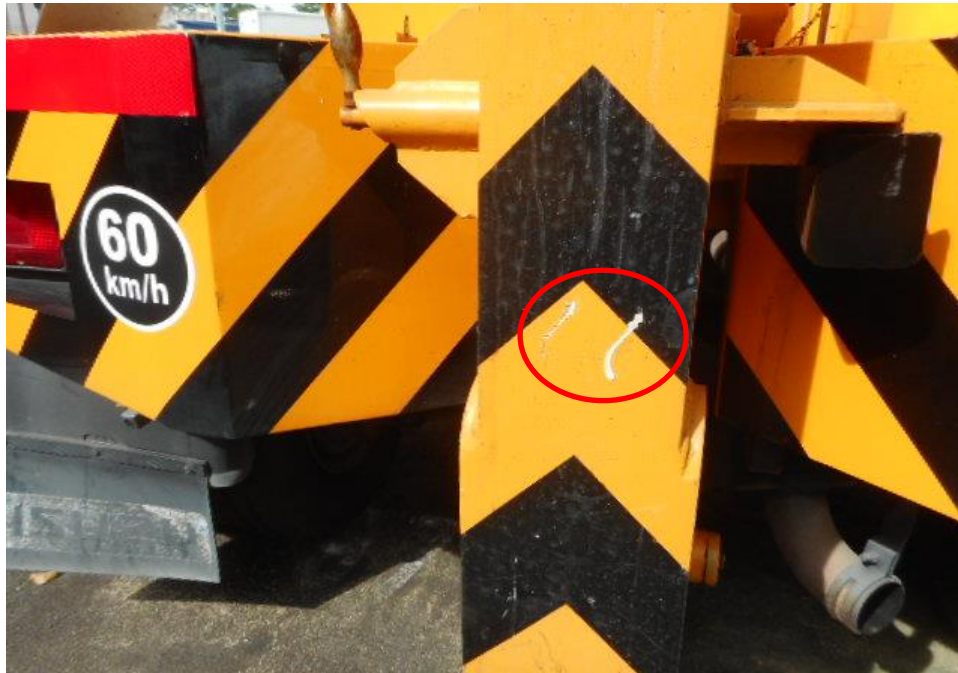
**Photo 3** shows a close up view of the Motor Lorry's rear portion at the time of my inspection. Its rear tow fork (circled) was damage at the time of my inspection as a result of the accident.

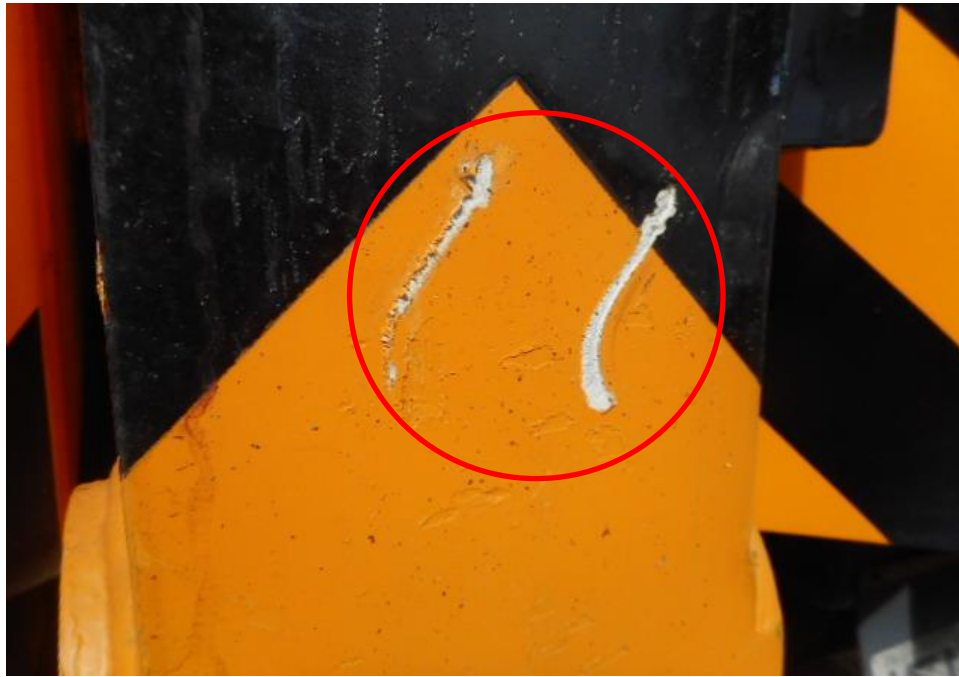
**Photo 4** shows a close up view of the Motor Lorry's rear portion at the time of my inspection. Its rear tow fork (circled) was damage at the time of my inspection as a result of the accident.

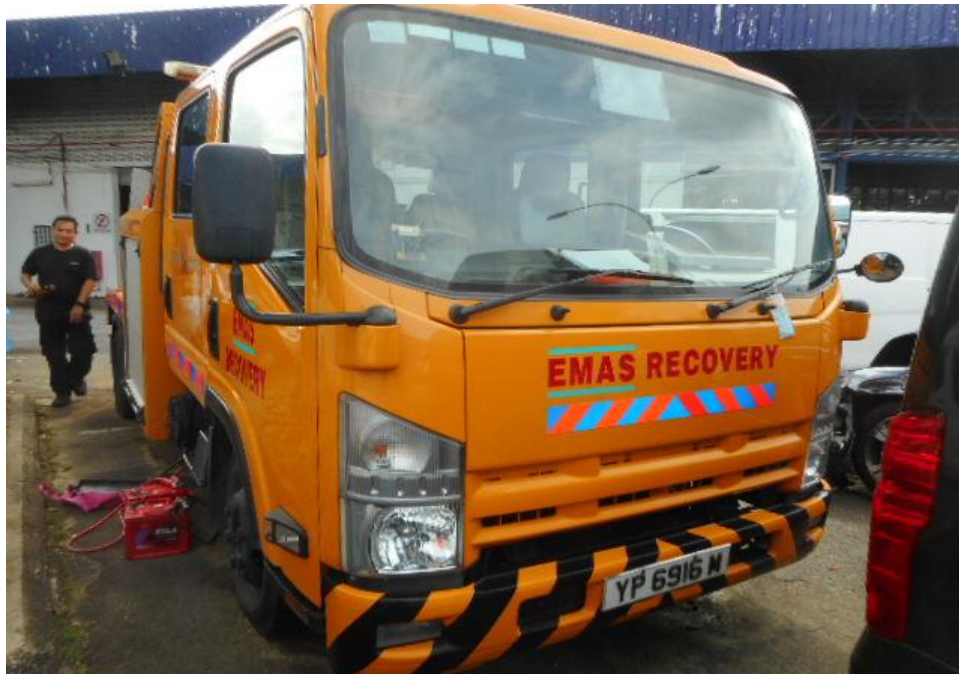
**Photo 5** shows a general view of the front body of the Motor Lorry at the time of my inspection. The Motor Lorry was observed to be intact and unaffected by the accident.

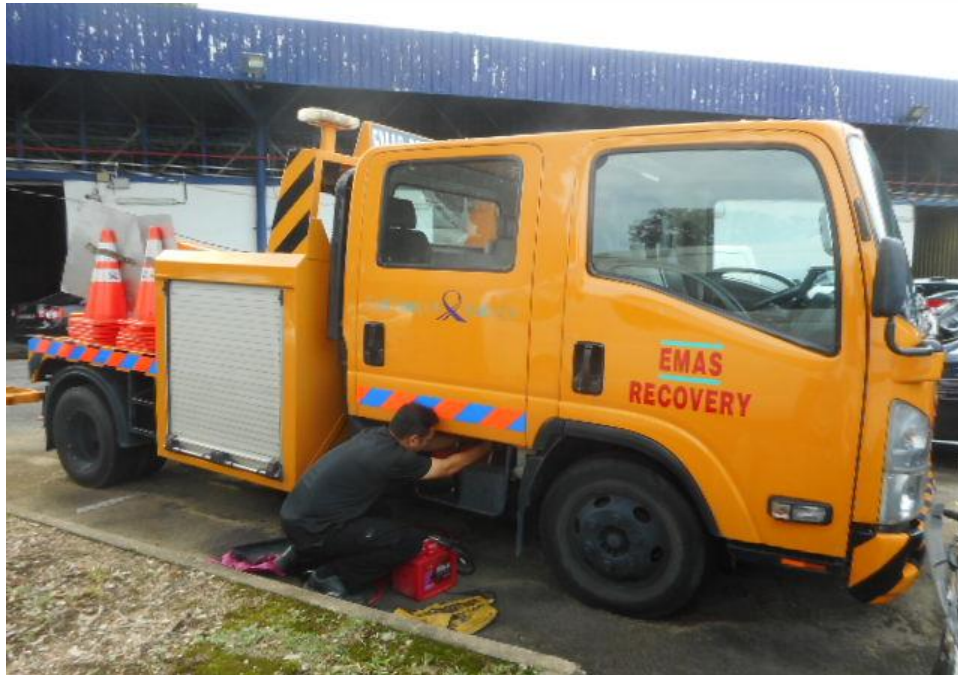
**Photo 6** shows a general view of the right body of the Motor Lorry at the time of my inspection. The Motor Lorry was observed to be intact and unaffected by the accident.

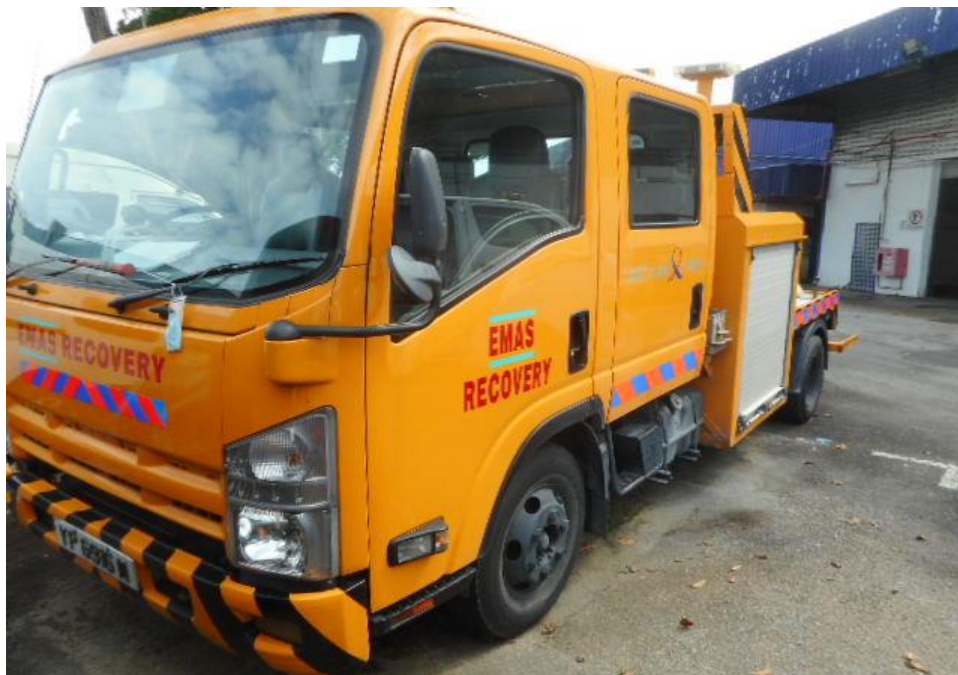
**Photo 7** shows a general view of the left body of the Motor Lorry at the time of my inspection. The Motor Lorry was observed to be intact and unaffected by the accident.

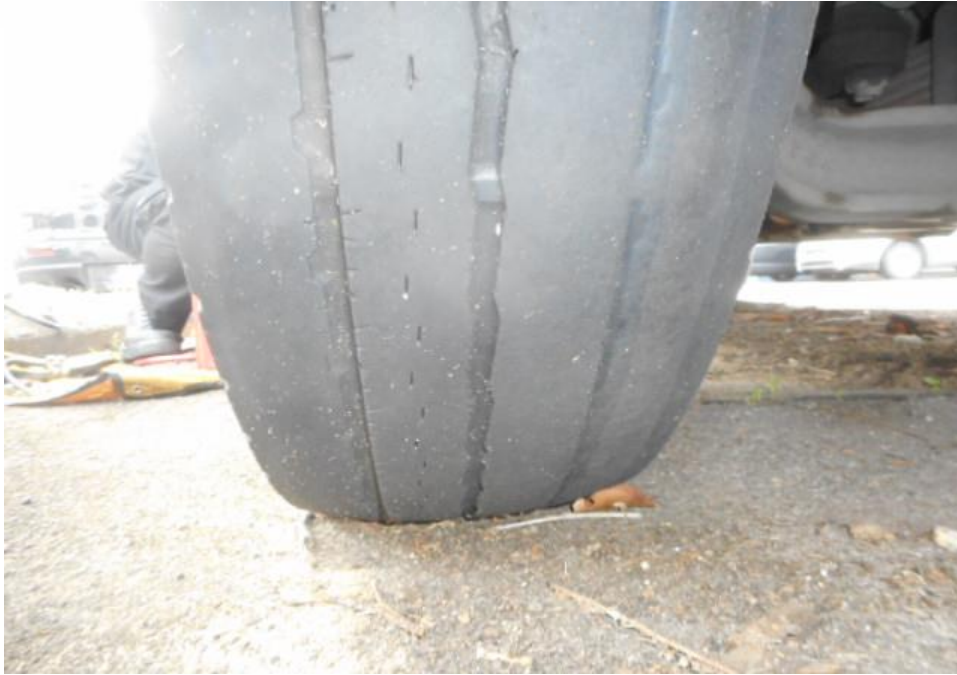
**Photo 8** shows the condition of the front right tyre of the Motor Lorry, which was observed to be in serviceable condition with remaining tread depth of approximately 3mm. The tyre, which was wrapped around standard steel wheel rim, was also observed to be sufficiently inflated for vehicular operation. There was no tear, cut or burst mark(s) on the outer and the inner sidewalls as well as across the tread of the 6 tyres that were fitted on the Motor Lorry.

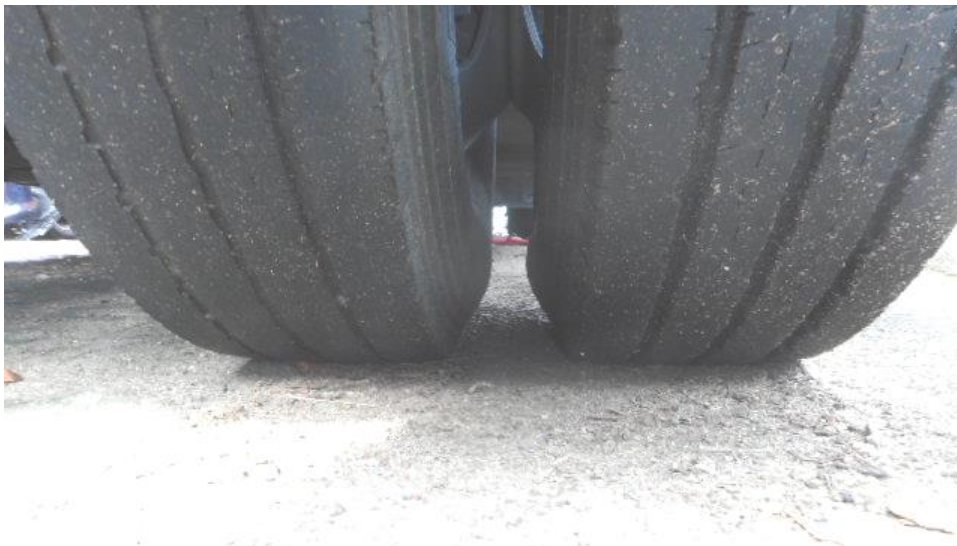
**Photo 9** shows the condition of the rear right tyre of the Motor Lorry, which was observed to be in serviceable condition with remaining tread depth of approximately 7mm. The tyre, which was wrapped around standard steel wheel rim, it was observed to be sufficiently inflated for vehicular operation.

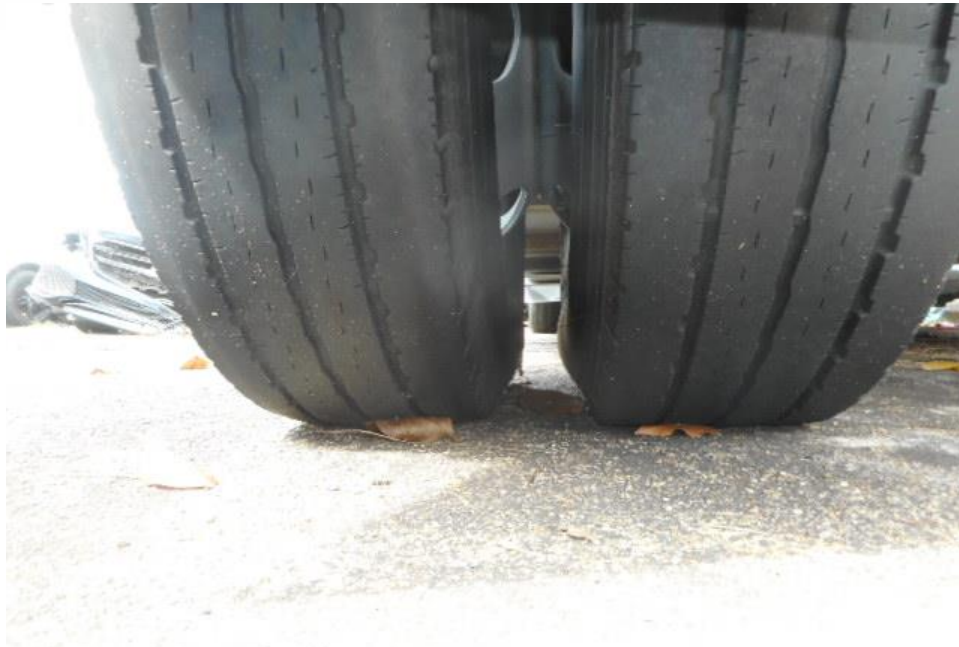
**Photo 10** shows the condition of the rear left tyres of the Motor Lorry, which was observed to be in serviceable condition with remaining tread depth of approximately 4.2mm. The tyres, which were wrapped around standard steel wheel rim, were also observed to be sufficiently inflated for vehicular operation.

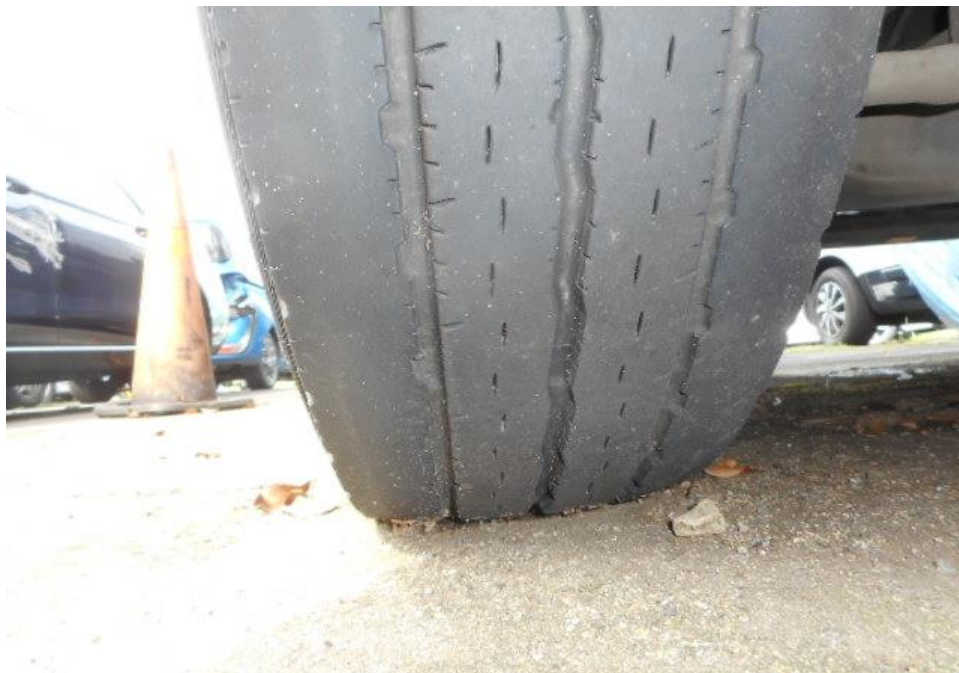
**Photo 11** shows the condition of the rear right tyres of the Motor Lorry, which were observed to be in serviceable condition with remaining tread depth of approximately 5.7mm. There was also no tear, cut or burst mark(s) on the outer and the inner sidewalls as well as across the tread of the 6 tyres that were fitted on the Motor Lorry.

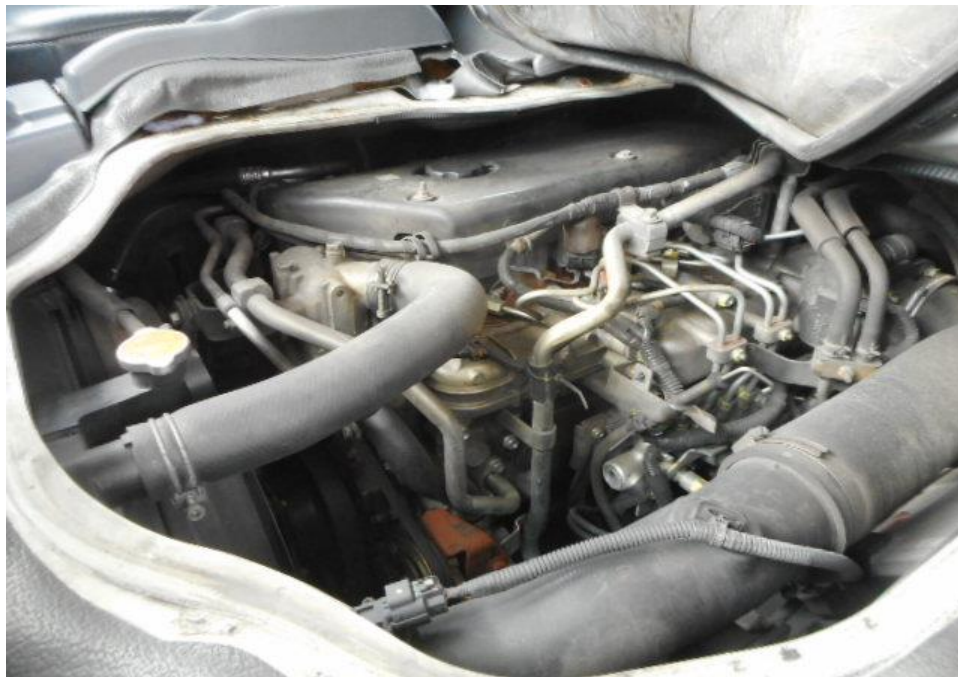
**Photo 12** shows a general view of the Motor Lorry's engine compartment, which was accessed by lifting the front cabin of the Motor Lorry. The various parts and components inside the engine compartment were unaffected by the accident. There was also no sign(s) or indication(s) of fresh fluid leakage and/or fluid stain within the engine compartment

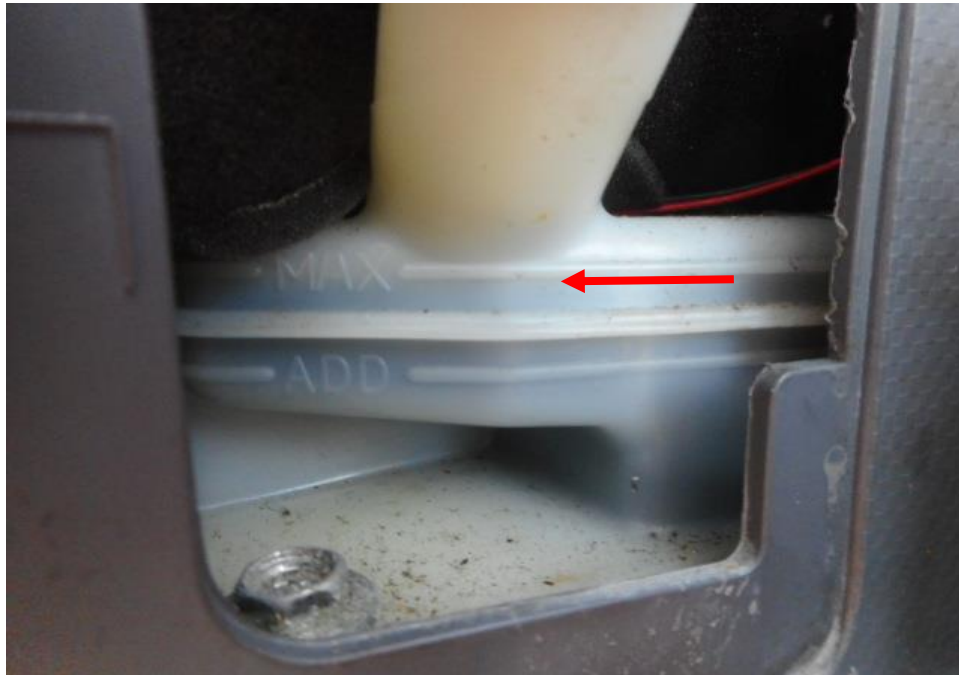
**Photo 13** shows the brake fluid reservoir of the Motor Lorry at the time of my inspection. The brake fluid was observed to be of sufficient level (arrowed) and without any visible contamination.

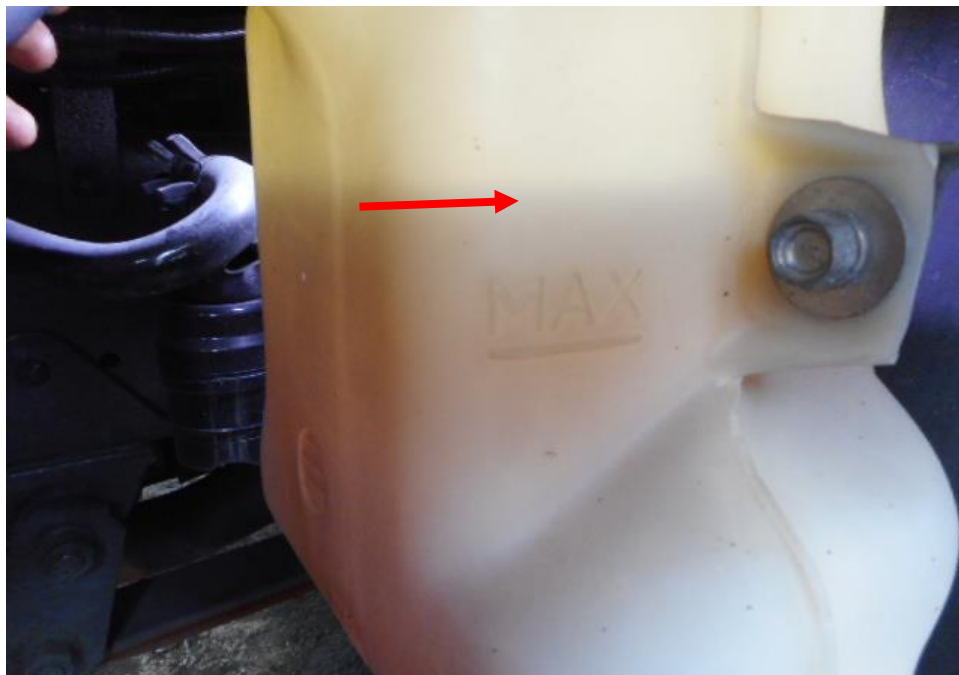
**Photo 14** shows the engine coolant reservoir of the Motor Lorry at the time of my inspection. The engine coolant was observed to be of sufficient level (arrowed) and without any visible contamination.

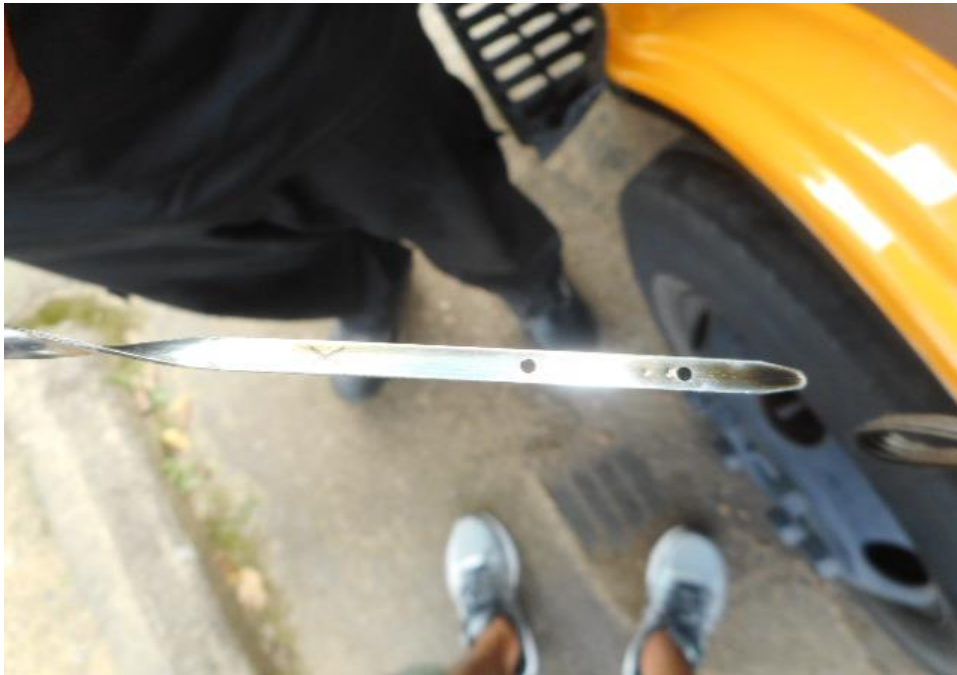
**Photo 15** shows the engine oil dip stick of the Motor Lorry at the time of my inspection. The engine oil was observed to be of sufficient level and without any visible contamination.

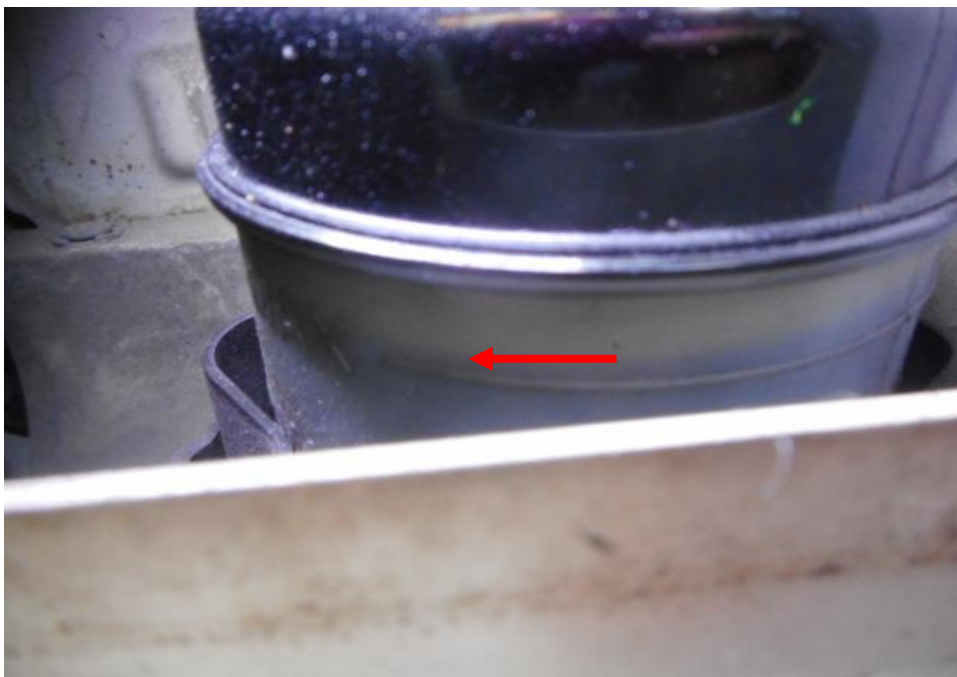
**Photo 16** shows the power steering fluid reservoir of the Motor Lorry at the time of my inspection. The power steering fluid was observed to be of sufficient level (arrowed) and without any visible contamination.

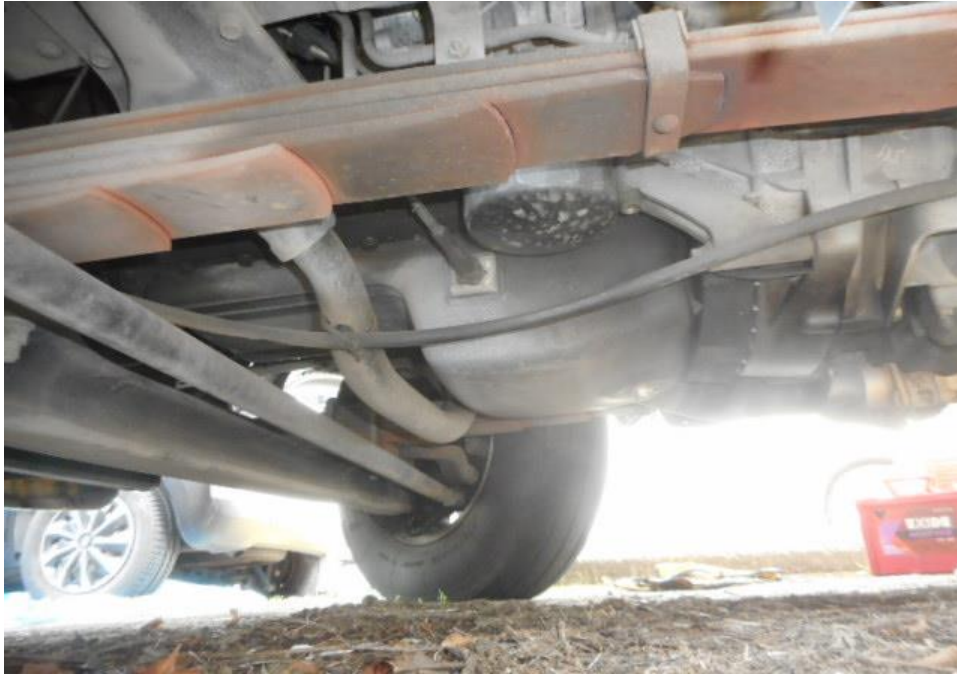
**Photo 17** shows the undercarriage of the Motor Lorry, at the area where the engine housing and transmission housing are located. I did not find any sign(s) or indication(s) of fluid leak and/or fluid stain(s) on the underside of the Motor Lorry.

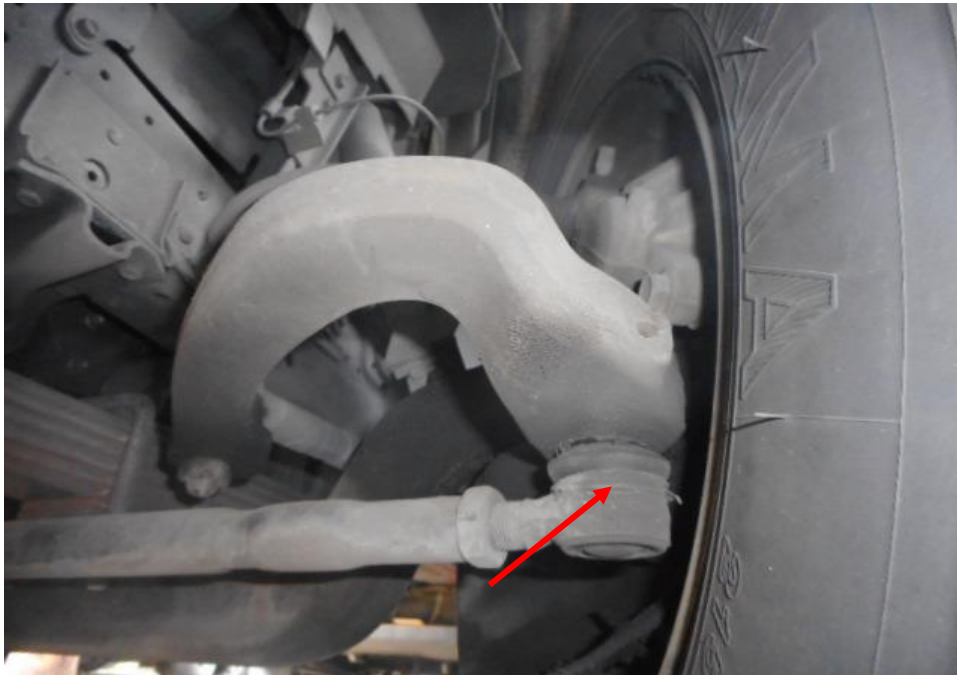
**Photo 18** shows the various undercarriage components at the front right wheel of the Motor Lorry, in particular the steering tie rod end (arrowed). The various steering components were all found to be intact, suggesting that the steering system of the Motor Lorry was likely to be in serviceable condition at the material time of accident. There was also no sign of fluid stain(s) observed on the various undercarriage components.

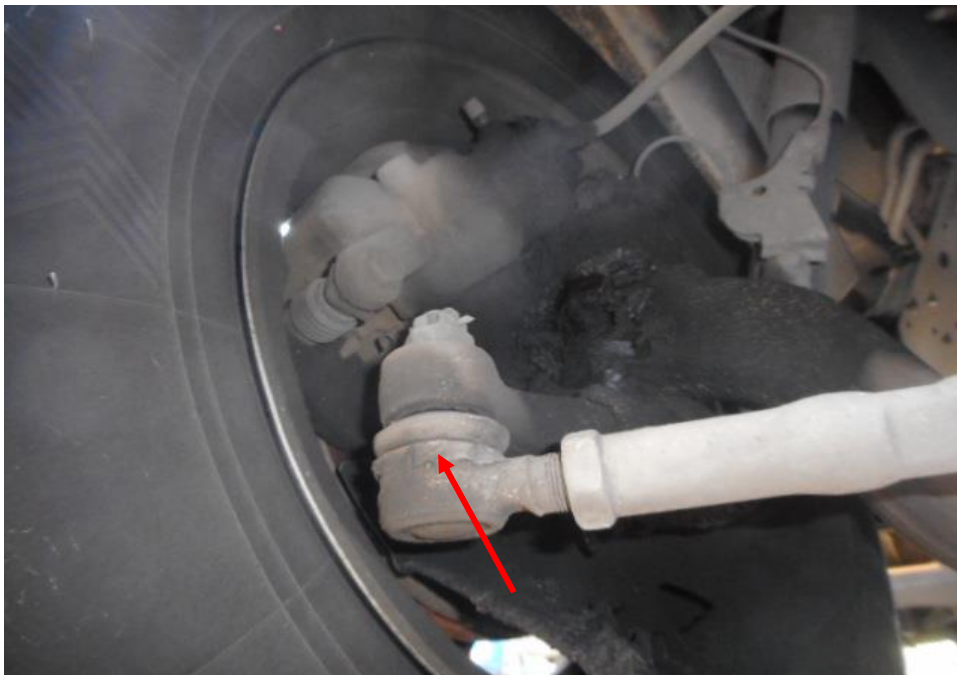
**Photo 19** shows the various undercarriage components at the front left wheel of the Motor Lorry, in particular the steering tie rod end (arrowed). The various undercarriage components of the Motor Lorry were all found to be intact without any visible damage. There was also no sign of fluid stain(s) observed on the various undercarriage components.

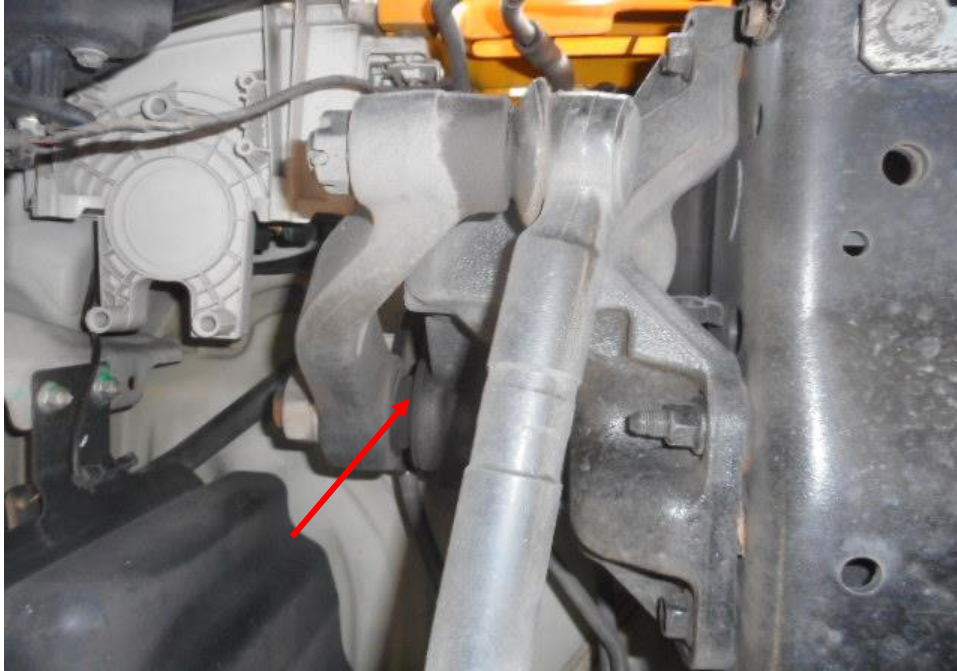
**Photo 20** shows the various undercarriage components at the front right wheel of the Motor Lorry, in particular the steering box (arrowed). The various undercarriage components of the Motor Lorry were all found to be intact without any visible damage. There was also no sign of fluid stain(s) observed on the various undercarriage components.

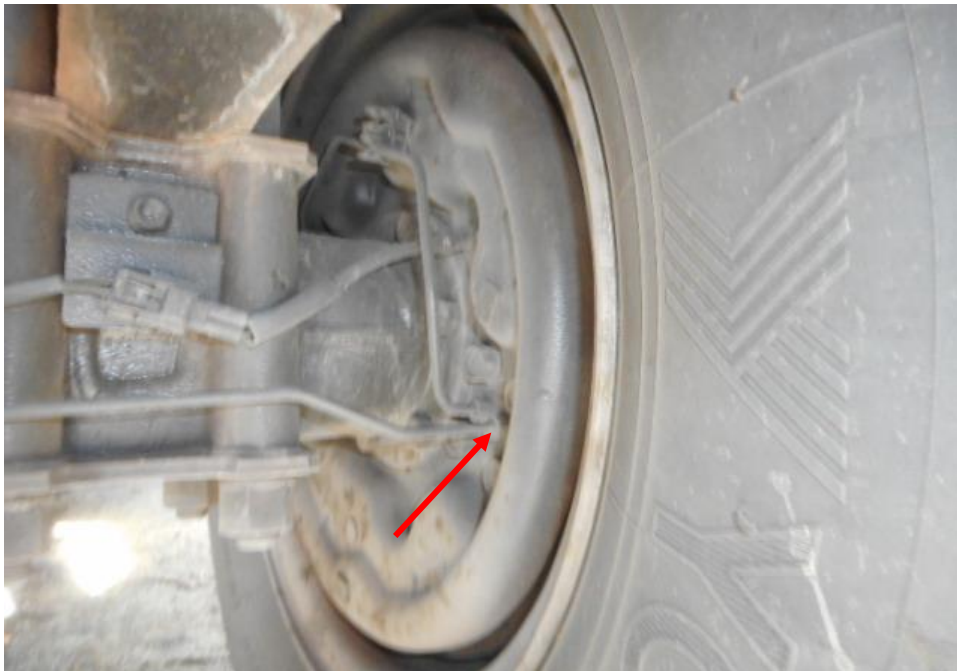
**Photo 21** shows the brake pipe (arrowed) at the rear right wheel of the Motor Lorry. I did not observe any leakage of brake fluid at the time of my inspection of the Motor Lorry. My static tests of the Motor Lorry's braking system, along with my visual examination of the various mechanical components in the braking system, had indicated that there was no internal leakage of pressure/vacuum. Hence the braking system of the Motor Lorry was likely to be in serviceable condition at the material time of accident.

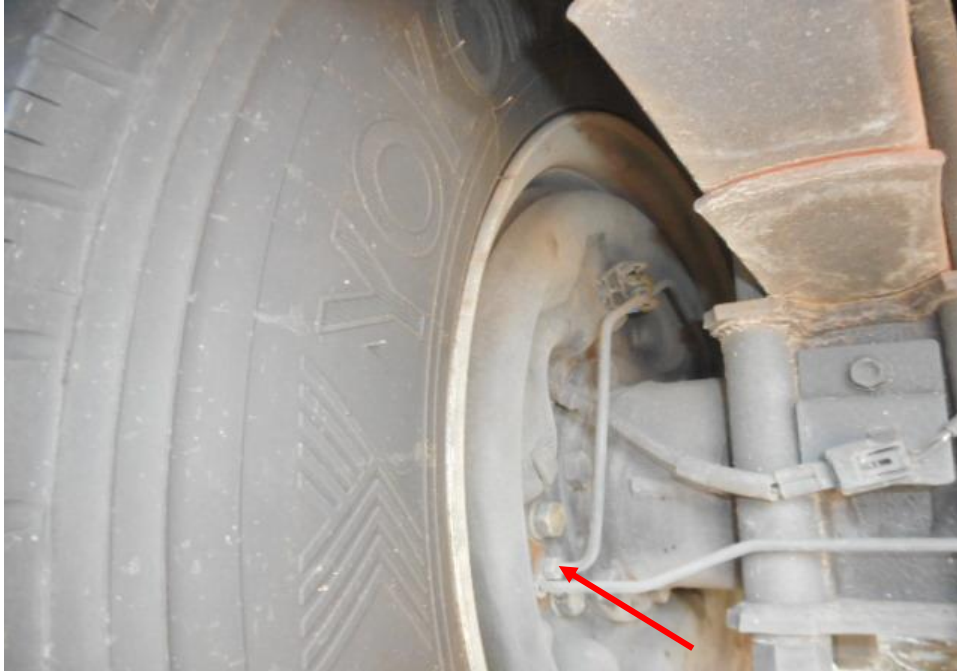
**Photo 22** shows the brake pipe (arrowed) at the rear left wheel of the Motor Lorry. I did not observe any leakage of brake fluid at the time of my inspection of the Motor Lorry. My static tests of the Motor Lorry's braking system, along with my visual examination of the various mechanical components in the braking system had indicated that there was no internal leakage of pressure/vacuum. Hence the braking system of the Motor Lorry was likely to be in serviceable condition at the material time of accident.

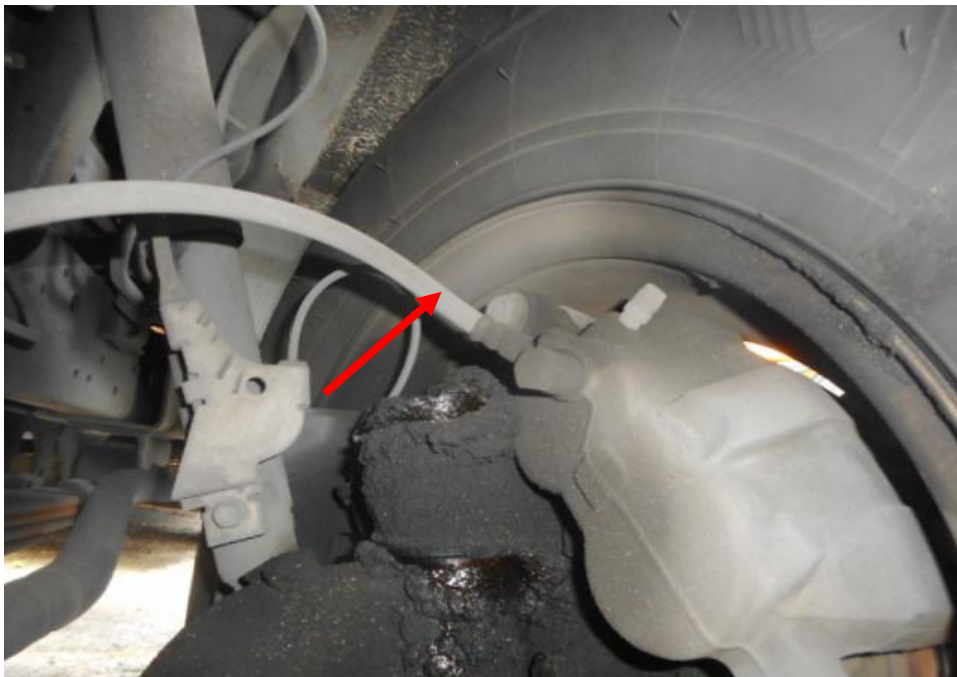
**Photo 23** shows the brake hose/pipe (arrowed) at the front right wheel of the Motor Lorry. No leakage of brake fluid was observed. Visual examination of the various components of the braking system like the brake caliper, brake booster, brake pedal etc had revealed all to be intact and without visible damage at the time of accident. There was also no sign of fluid stain(s) observed on the various undercarriage components.

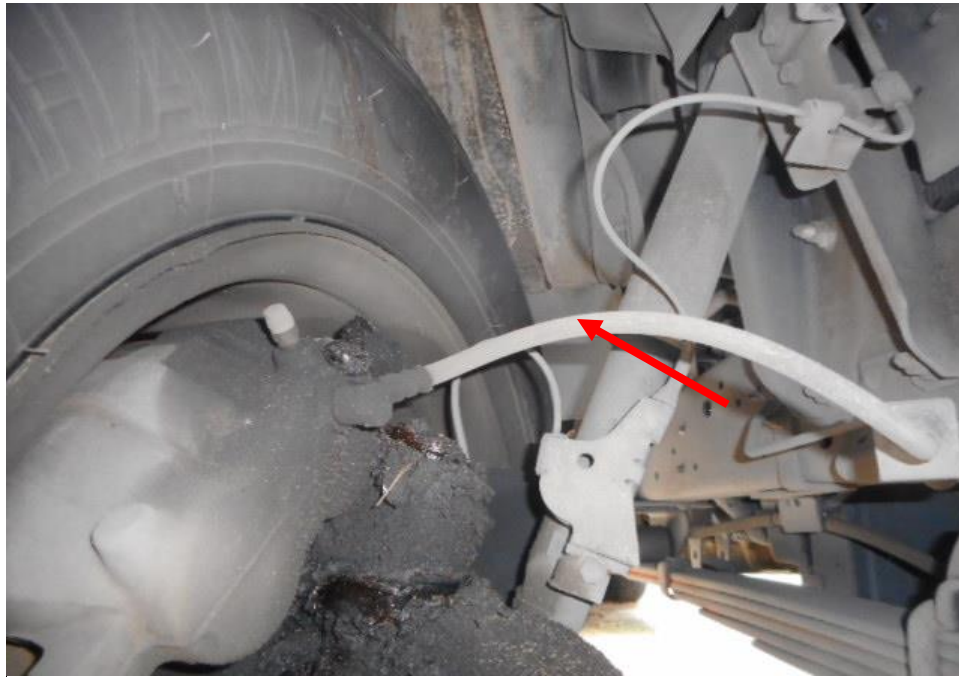
**Photo 24** shows the brake hose/pipe (arrowed) at the front left wheel of the Motor Lorry. No leakage of brake fluid was observed. Visual examination of the various components of the braking system like the brake caplier, brake booster, brake pedal etc had revealed all to be intact and without visible damage at the time of accident. There was sign of old fluid stain(s) observed on the various undercarriage components.

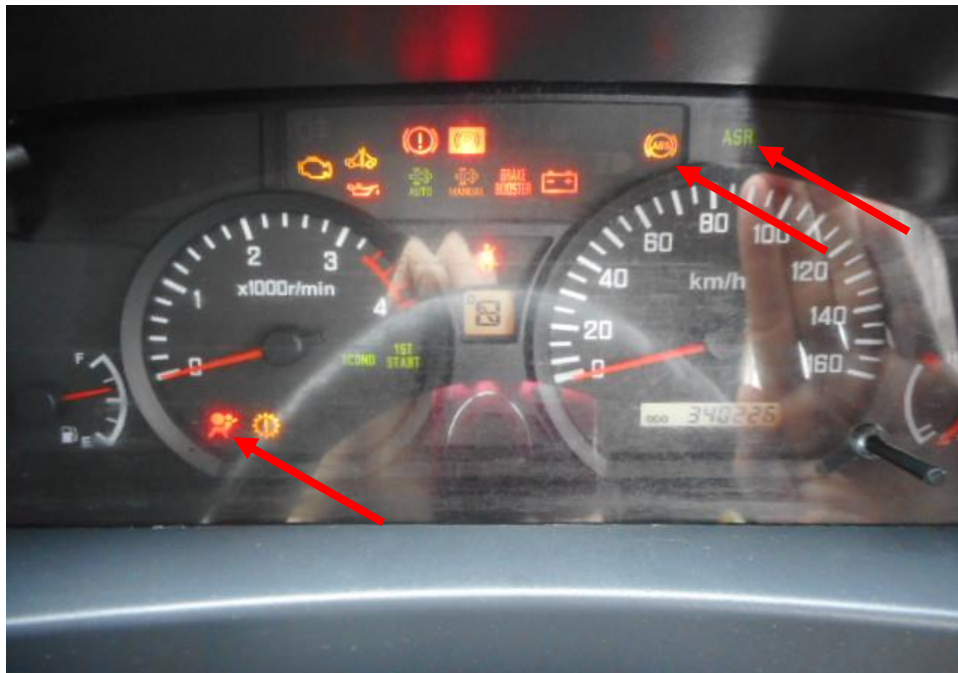
**Photo 26** shows the warning light for Anti-Lock Braking System (ABS) and Supplemental Restraint System (SRS) (arrowed) appearing on the instrument panel of the Motor Lorry during the self-test of its various electronic operating systems when its engine was cranked.

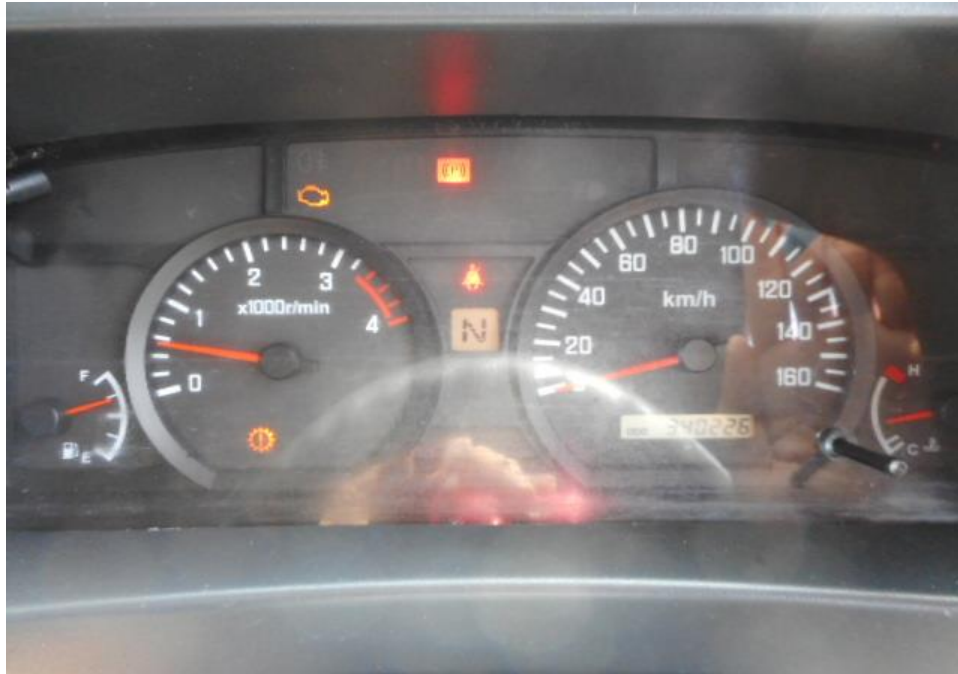
**Photo 27** shows no warning lights illuminated on the instrument panel of the Motor Lorry after the engine was cranked. This would suggest that there was no abnormality to the electronic operating system of the Motor Lorry, like the ABS, ASR, SRS etc.
