Your Ref: TP/IP/10687/2022
Our Ref : CI/TPD22008176/P

8th September 2022

MECHANICAL INSPECTION REPORT OF ELECTRIC TAXI SHB 1326Z

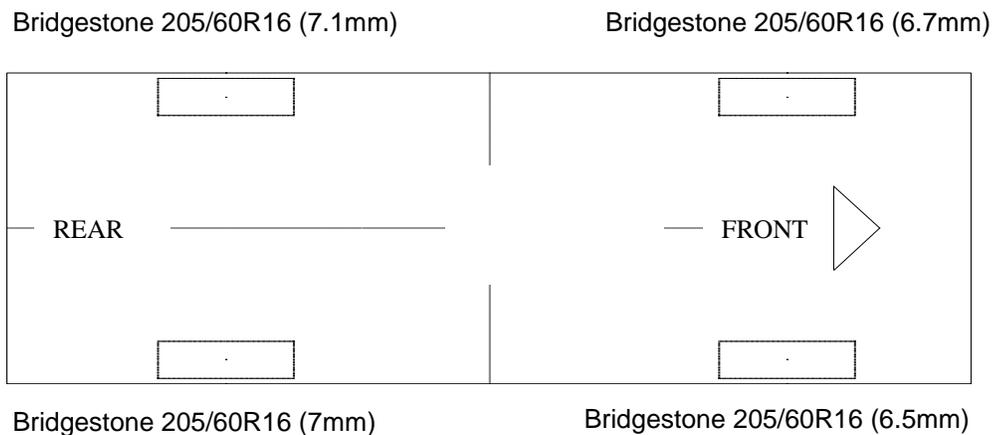
6. The condition of the Electric Taxi's 4 tyres was observed to be in serviceable condition. I did not find any tear, cut or burst mark(s) on the outer and the inner sidewalls as well as across the tread of the 4 tyres. The 4 tyres were also observed to be sufficiently inflated for vehicular operation. The tyre brand, tyre size and remaining tread depth of the 4 tyres were recorded as follows:-

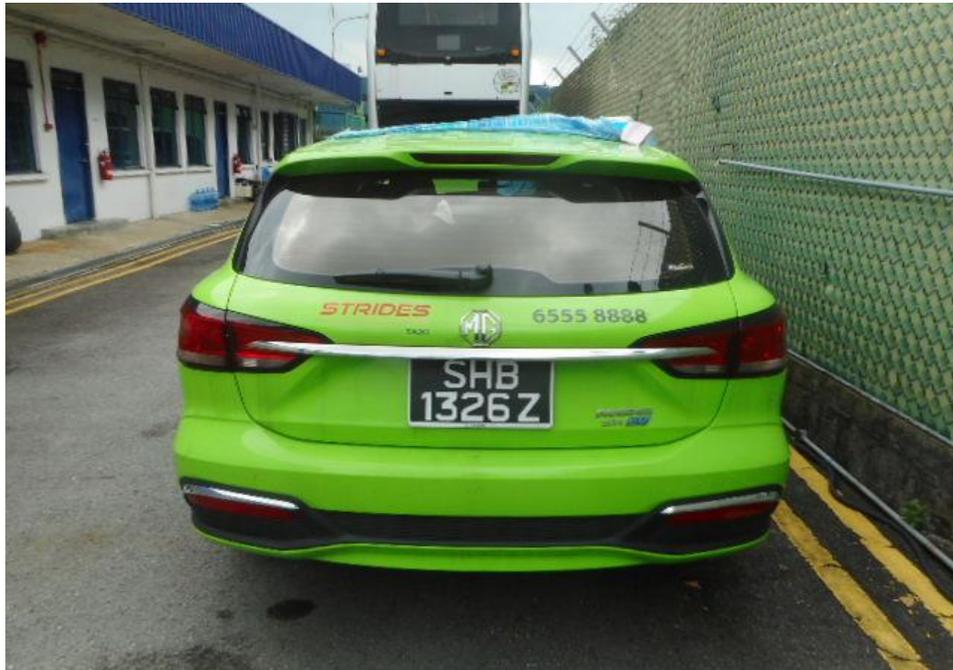
Photo 1 shows the general view of the Electric Taxi's rear body at the time of my inspection. The Electric Taxi rear was observed to be unaffected by the accident.

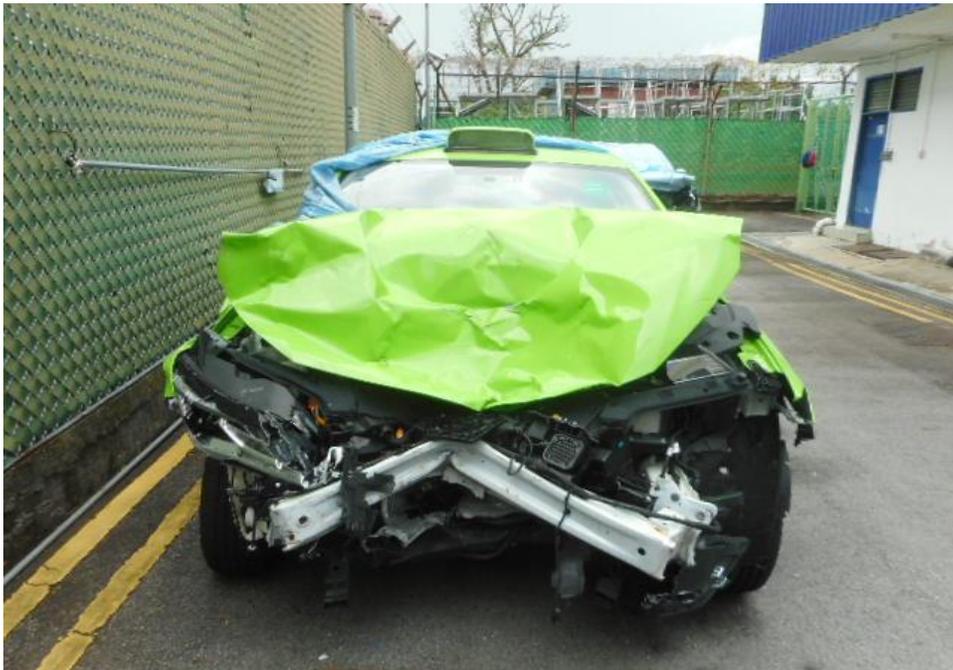
4. The mileage of the Electric Taxi was not recorded as the access to the high voltage batteries to jumpstart the Electric Taxi was blocked and the high voltage electrical wirings to the batteries was also damaged as a result of the accident.
5. The Electric Taxi was observed to have sustained damage at its front portion. Its front bonnet, front body panel and front bumper were amongst the body parts and various electric motor components were damaged as a result of the accident. The Supplemental Restraint System (SRS) was activated as a result of the accident.

Photo 2 shows a general view of the Electric Taxi's front body at the time of my inspection. The Electric Taxi was observed to have sustained damage at its front portion. Its front bonnet, front body panel and front bumper were amongst the body parts and various electric motor components were damaged as a result of the accident.

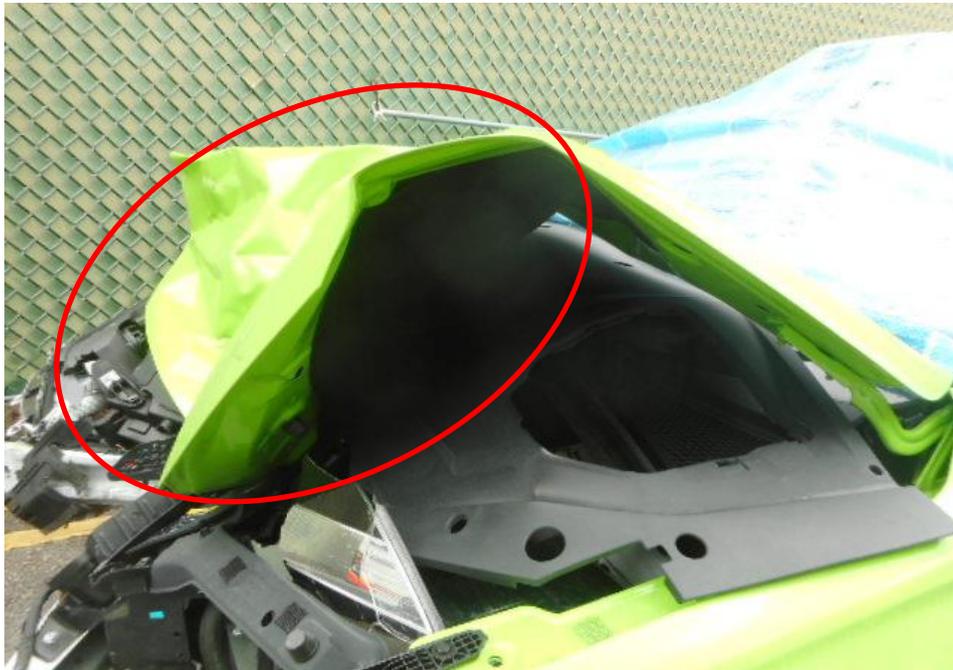
Photo 3 shows the close up view of the Electric Taxi's front body at the time of my inspection. The Electric Taxi was observed to have sustained damage at its front portion. Its front bonnet (circled) were amongst the body parts that were damaged as a result of the accident.

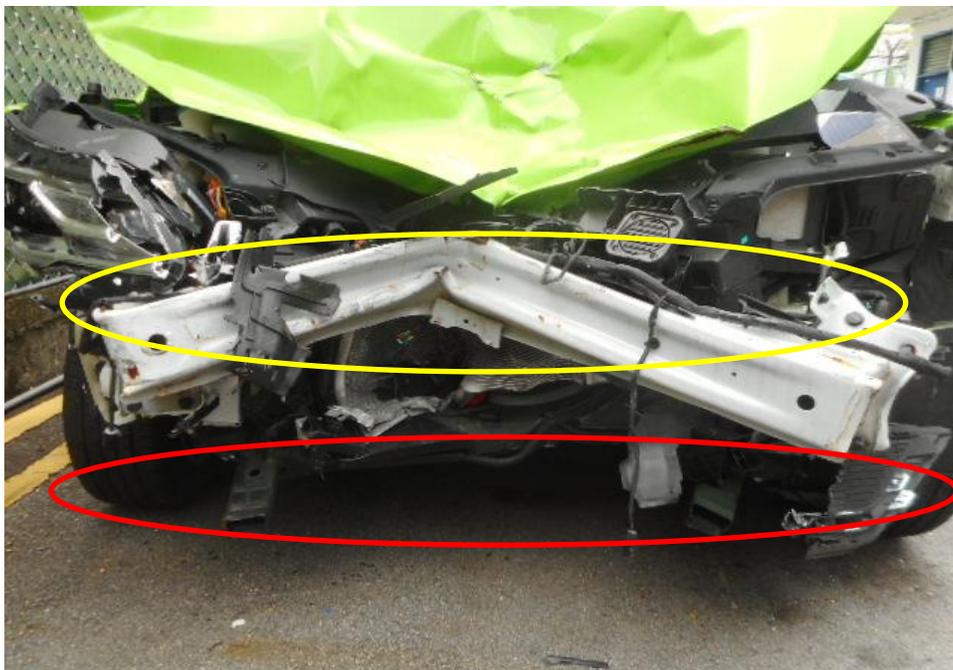
Photo 4 shows the close up view of the Electric Taxi's front body at the time of my inspection. The Electric Taxi was observed to have sustained damage at its front portion. Its front bumper (red circle) and front body panel (yellow circle) were amongst the body parts that were damaged as a result of the accident.

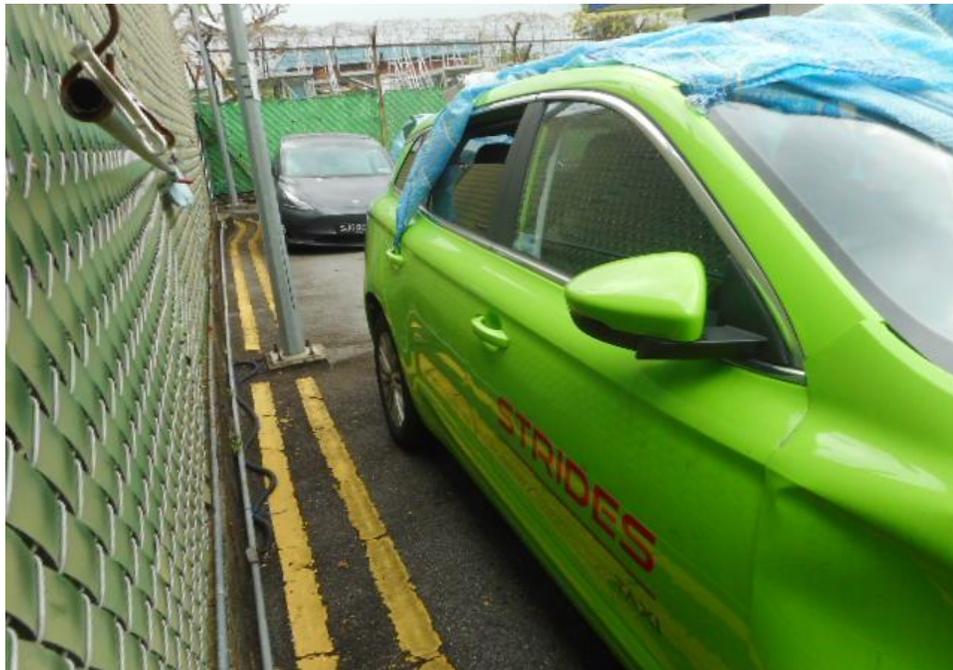
Photo 5 shows a general view of the Electric Taxi's right body at the time of my inspection. The Electric Taxi left was observed to be unaffected by the accident.

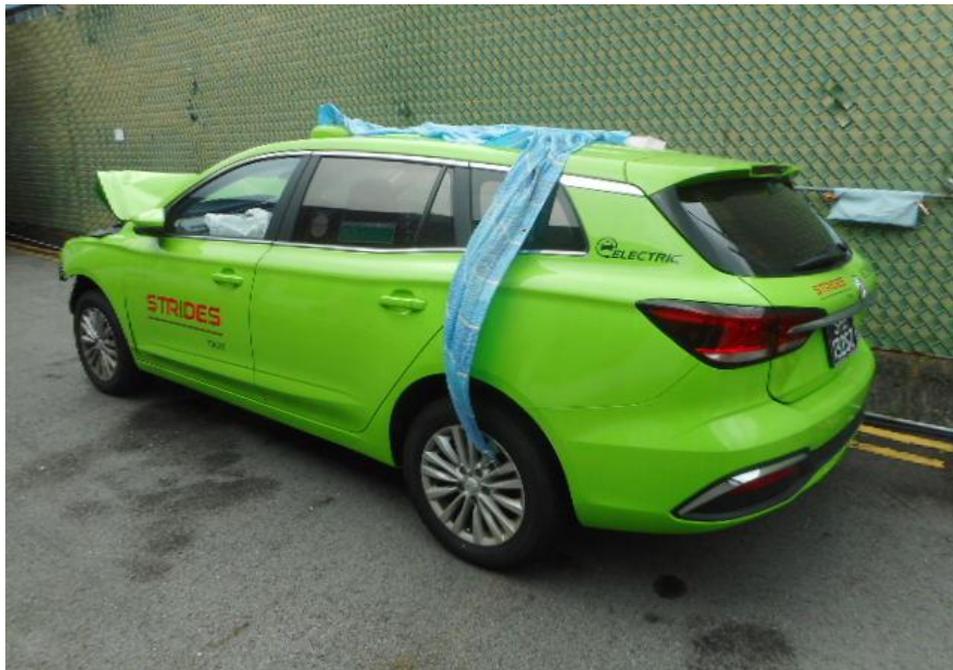
Photo 6 shows a general view of the Electric Taxi's left body at the time of my inspection. The Electric Taxi left was observed to be unaffected by the accident.

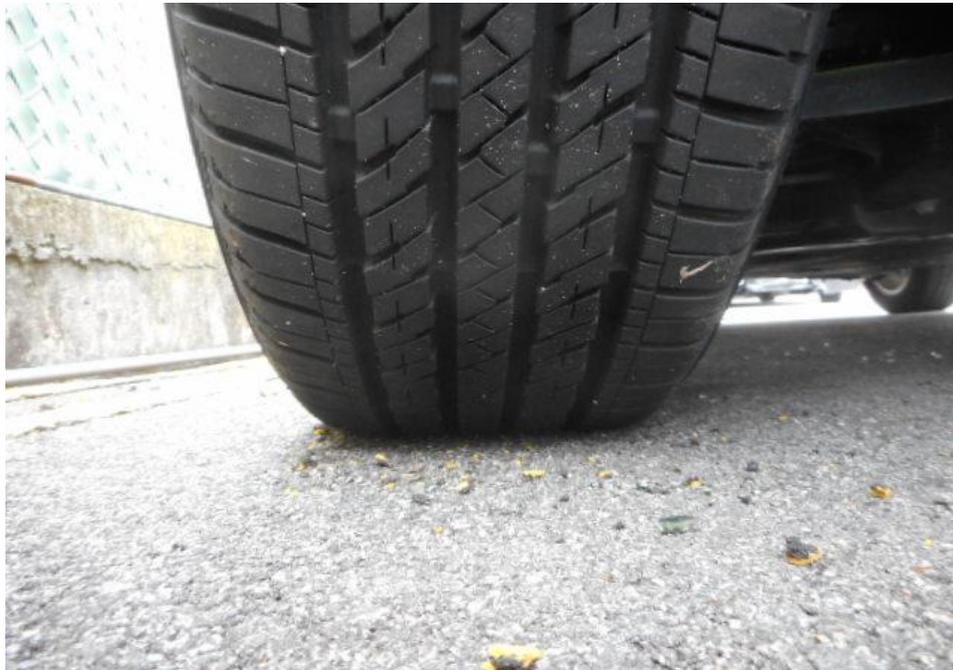
Photo 7 shows the condition of the front right tyre of the Electric Taxi, which was observed to be in serviceable condition with remaining tread depth of approximately 6.5mm. The tyre, which was wrapped around alloy wheel rim, was also observed to be sufficiently inflated for vehicular operation.

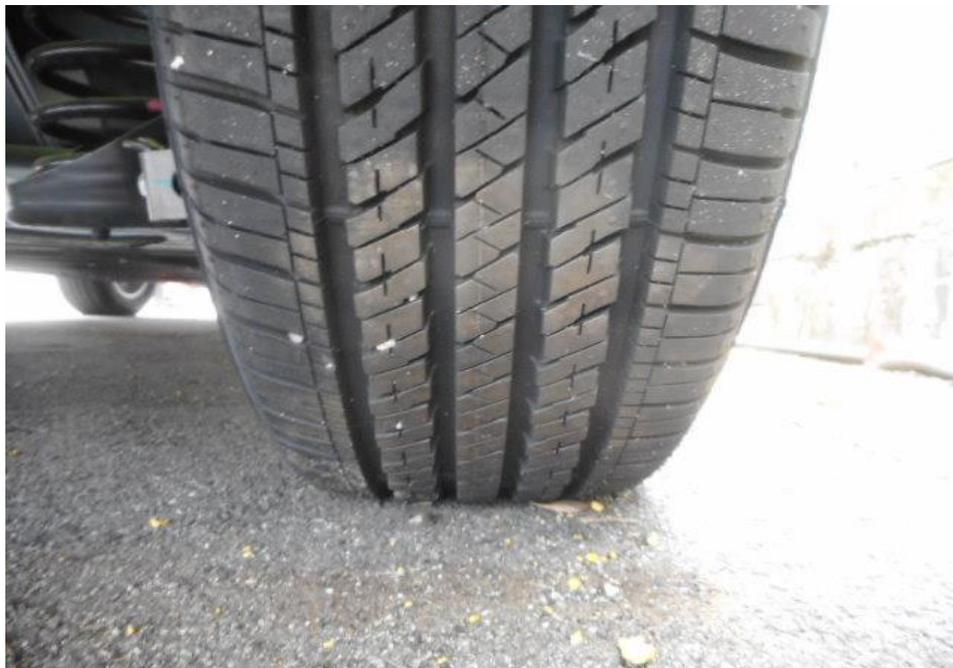
Photo 8 shows the condition of the rear right tyre of the Electric Taxi, which was observed to be in serviceable condition with remaining tread depth of approximately 7mm. The tyre, which was wrapped around standard alloy wheel rim, was also observed to be sufficiently inflated for vehicular operation.

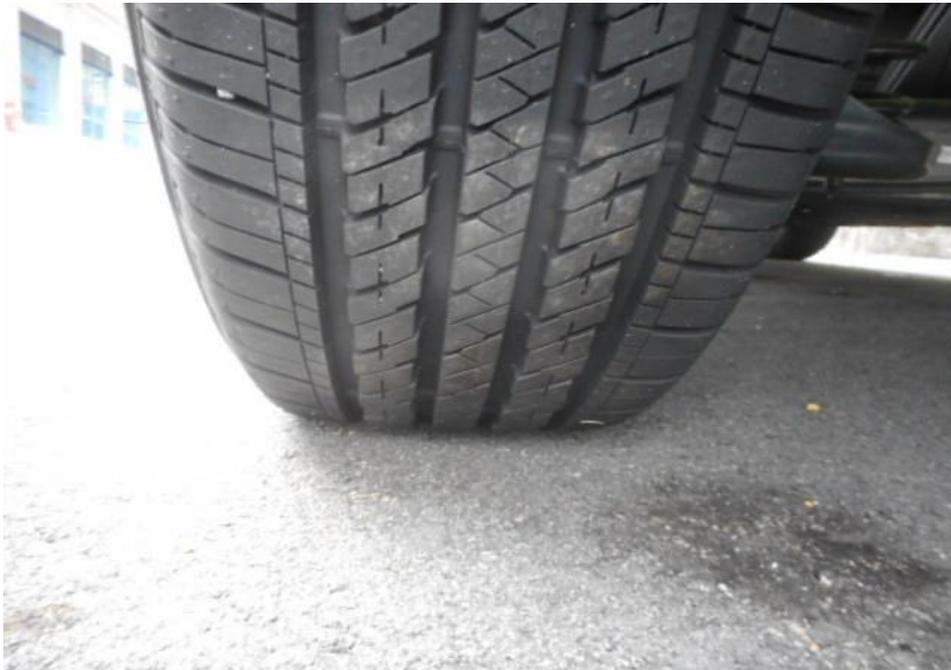
Photo 9 shows the condition of the rear left tyre of the Electric Taxi, which was observed to be in serviceable condition with remaining tread depth of approximately 7.1mm. The tyre, which was wrapped around standard alloy wheel rim, was also observed to be sufficiently inflated for vehicular operation.

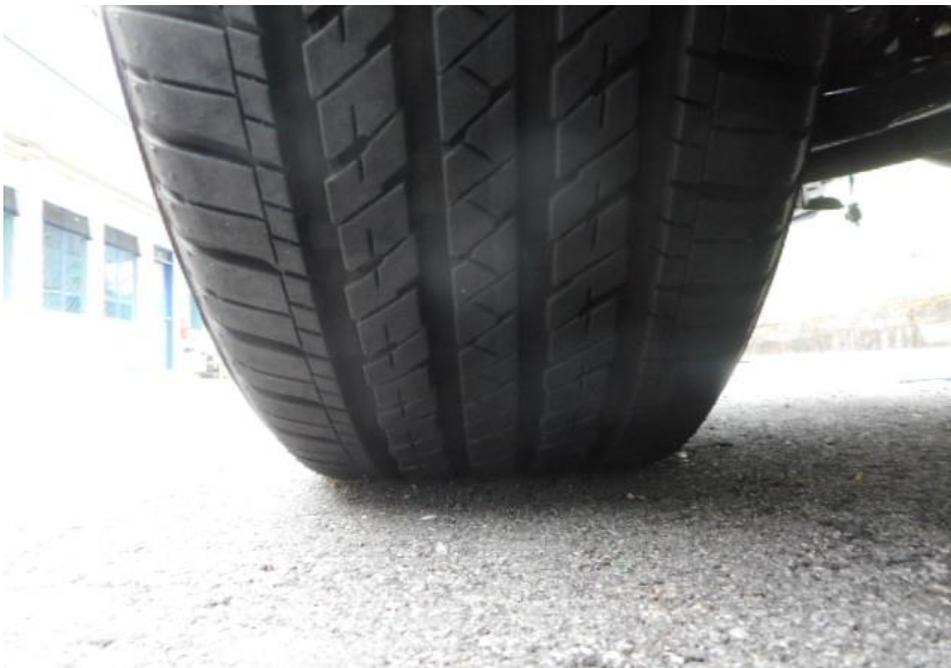
Photo 10 shows the condition of the front left tyre of the Electric Taxi, which was observed to be in serviceable condition with remaining tread depth of approximately 6.7mm. The tyre, which was wrapped around standard alloy wheel rim, was also observed to be sufficiently inflated for vehicular operation.

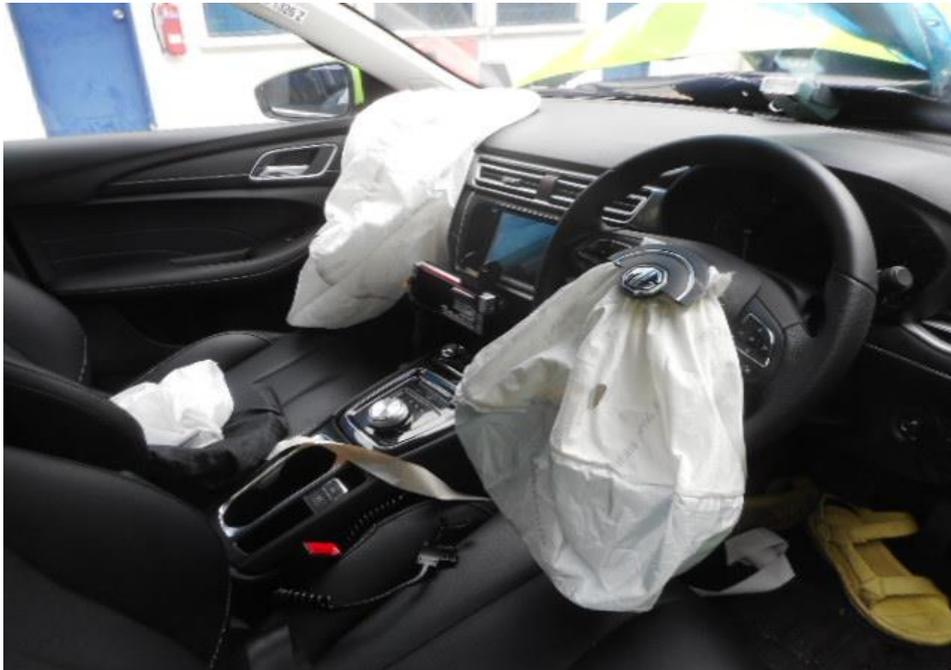
Photo 11 shows the deployment of the Supplemental Restraint System (SRS) airbag in the Motor Car as a result of the accident.

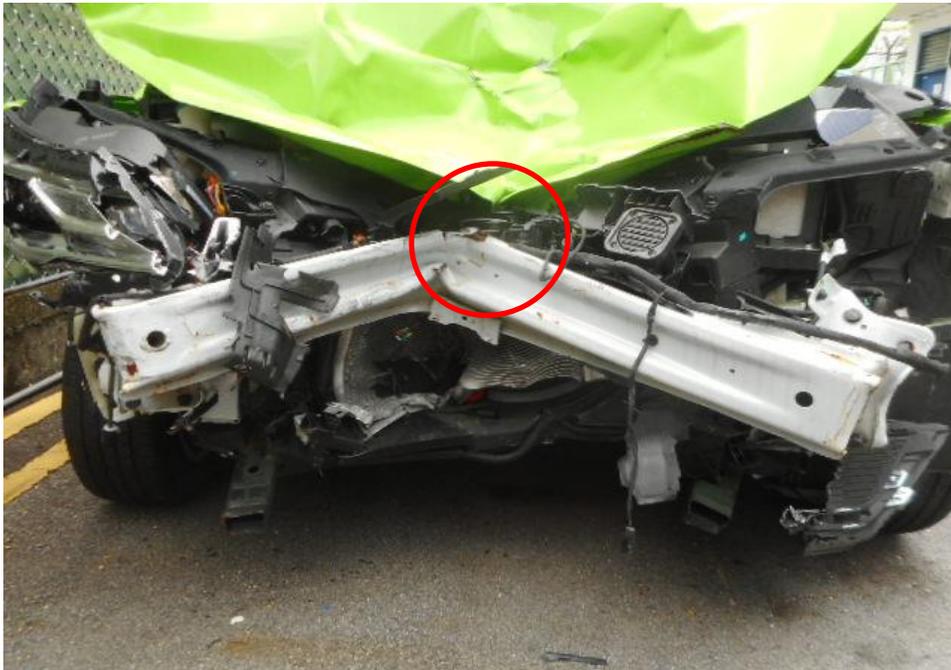
Photo 12 shows a general view of the Electric Taxi's front bonnet. The front bonnet was unable to be opened up as the lock mechanism of the front bonnet was observed to be damaged as a result of the accident.

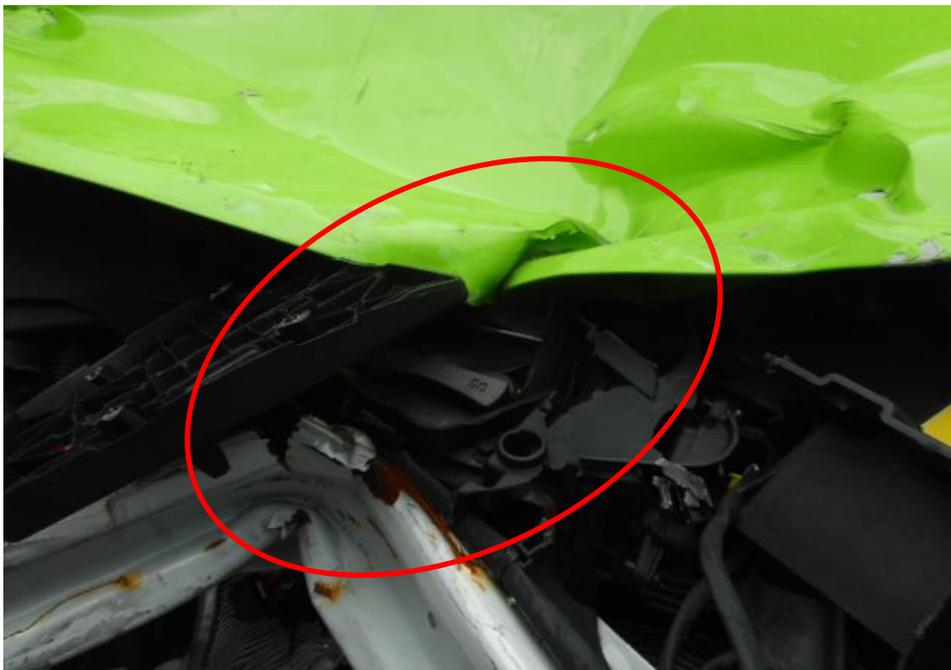
Photo 13 shows a close up view of the Electric Taxi's front bonnet. The front bonnet was unable to be opened up as the lock mechanism of the front bonnet was observed to be damaged as a result of the accident.

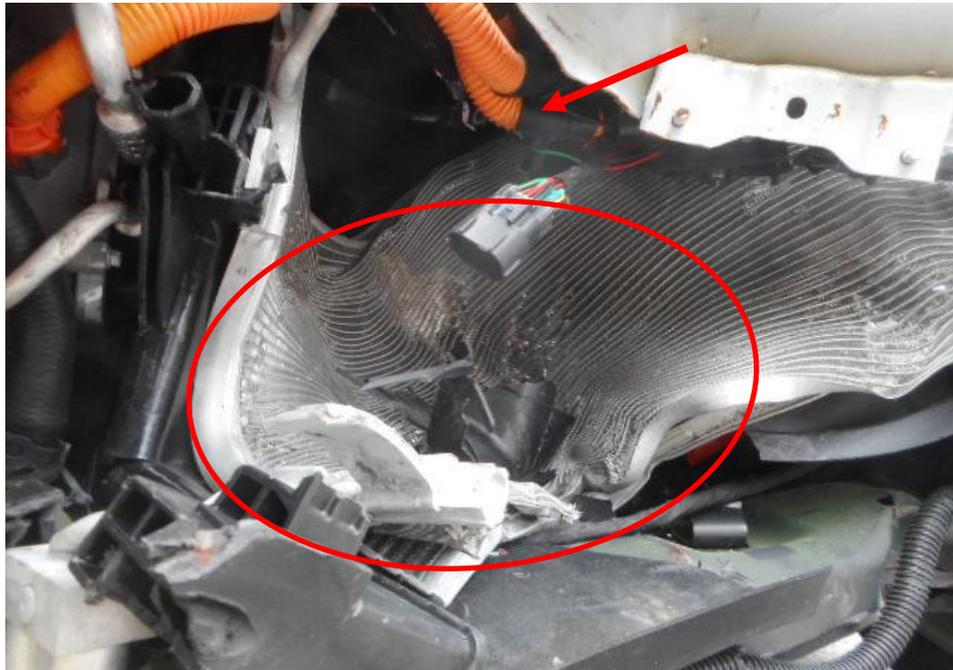
8. We are unable to open the bonnet of the electric taxi as the lock mechanism was damaged as a result of the accident. However, upon examination of the surroundings of the electric taxi motor compartment, I had observed the coolant radiator and high voltage cables inside the electric taxi compartment to be damaged as a result of the impact from the accident which had pushed the coolant radiator towards the high voltage cables and components in the electric motor compartment and resulting to the sustained damages. The electric motor coolant was observed to be insufficient as a result of the damage to the coolant radiator sustained from the accident. The brake fluid were found to be of sufficient level for operating purposes. Visually, there was also no contamination found to the fluid.

Photo 14 shows the close up view of the surroundings of the electric motor compartment at the time of my inspection. The coolant radiator (circled) and high voltage cables (arrowed) was observed to be damaged as a result of the accident.

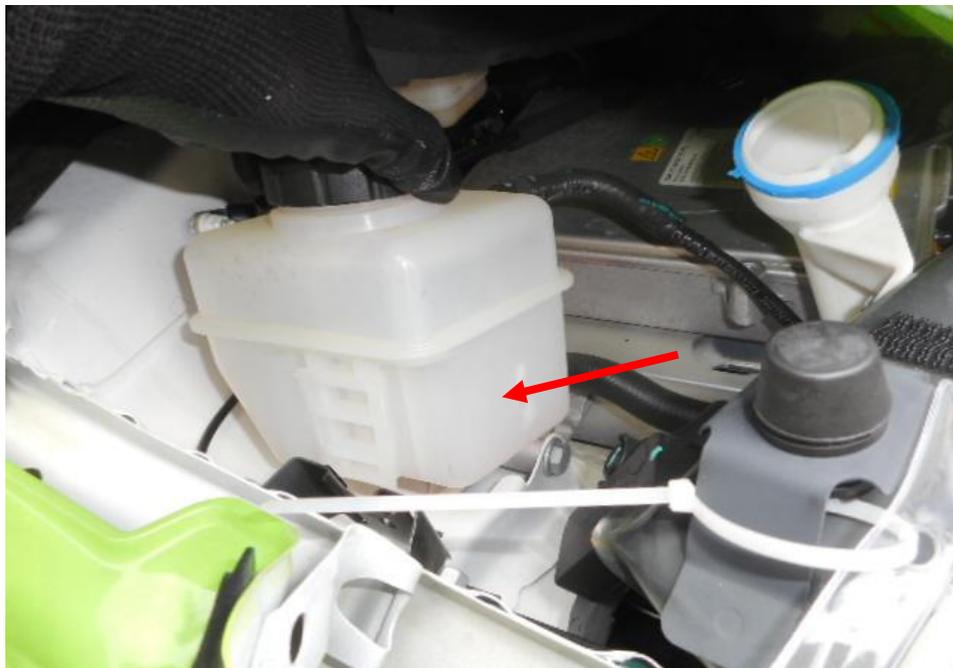
Photo 15 shows the coolant reservoir of the Electric Taxi motor at the time of my inspection. The coolant fluid was observed to be of insufficient level (arrowed) due to the damaged radiator as a result of the accident.

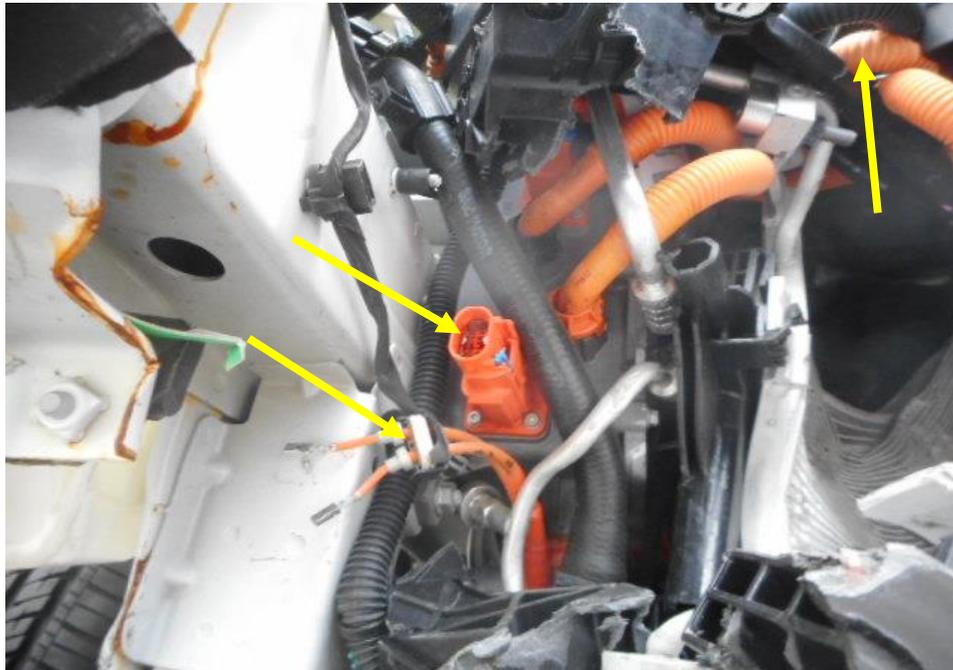
Photo 16 shows the close up view of the surroundings of the electric motor compartment at the time of my inspection. The high voltage cables (arrowed) was observed to be damaged as a result of the accident.

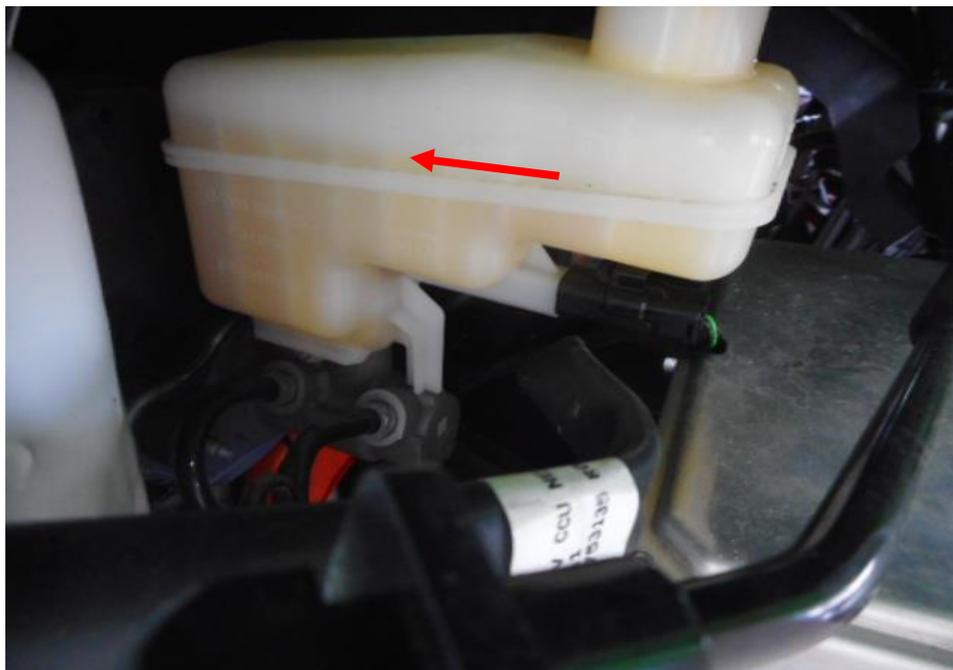
Photo 17 shows the brake fluid reservoir of the Electric Taxi at the time of my inspection. The brake fluid was observed to be of sufficient level (arrowed) and without any visible contamination.

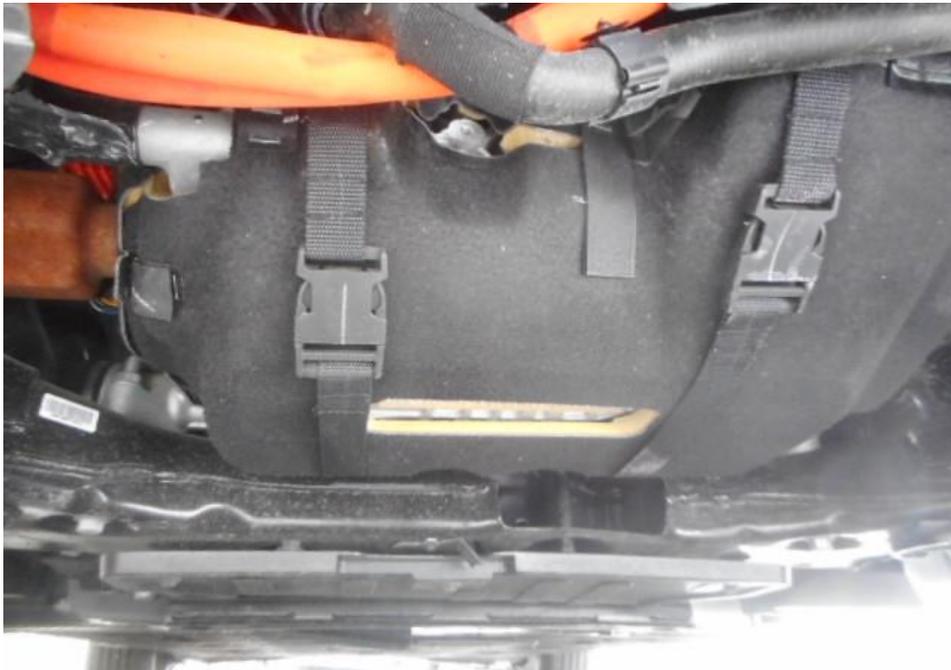
Photo 18 shows the undercarriage of the Electric Taxi, at the area where the electric motor housing and transmission housing are located. I did not find any sign(s) or indication(s) of fluid leak and/or fluid stain(s) on the underside of the Electric Taxi.

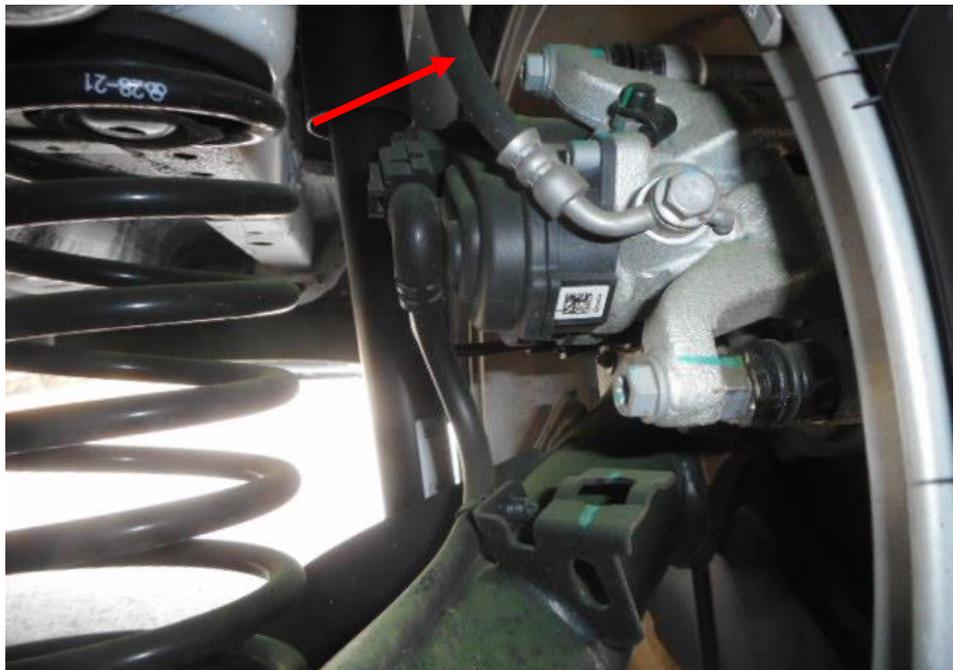
Photo 19 shows the brake hose/pipe (arrowed) at the rear right wheel of the Electric Taxi. No leakage of brake fluid was observed. Visual examination of the various components of the braking system like the drum brake, brake booster, brake pedal etc. had revealed all to be intact and without visible damage.

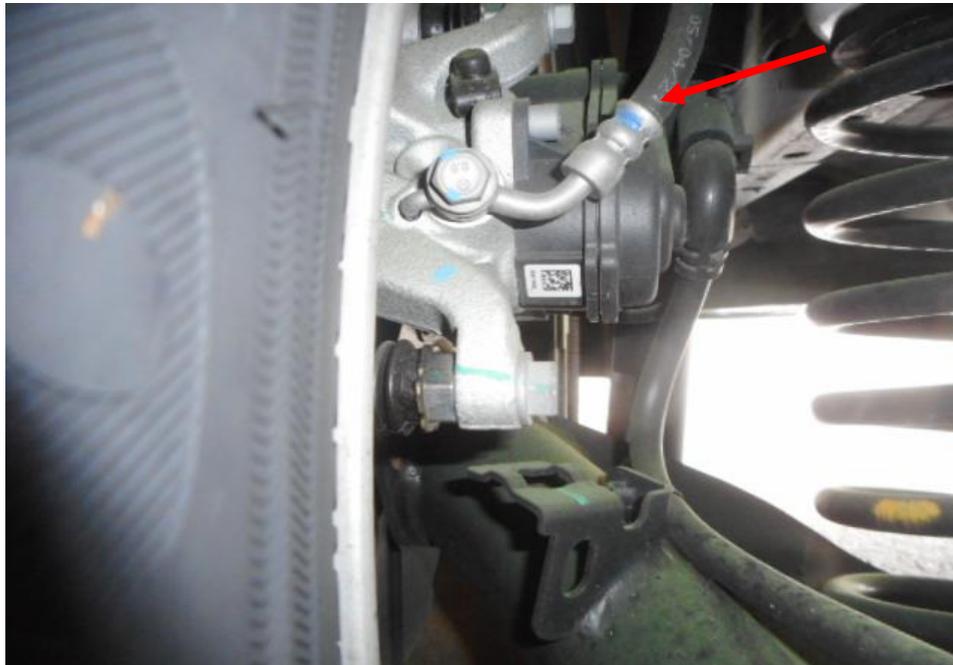
Photo 20 shows the brake hose/pipe (arrowed) at the rear left wheel of the Electric Taxi. I did not observe any leakage of brake fluid at the time of my inspection of the Electric Taxi. The undercarriage components of the Electric Taxi were also all found to be intact and without any visible damage.

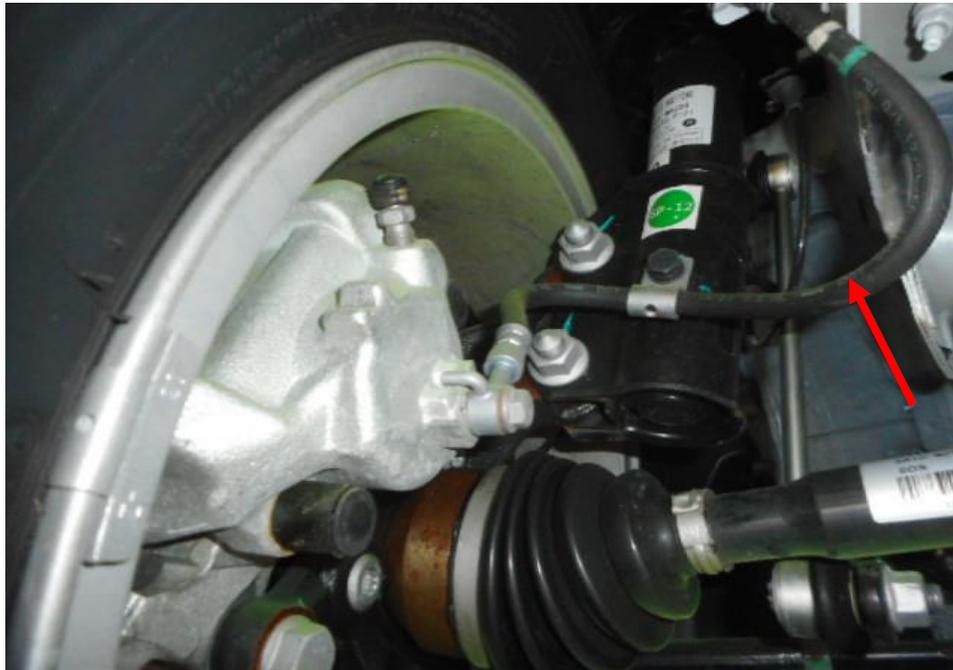
Photo 21 shows the brake hose/pipe (arrowed) at the front right wheel of the Electric Taxi. I did not observe any leakage of brake fluid at the time of my inspection of the Electric Taxi. The undercarriage components of the Electric Taxi were also all found to be intact and without any visible damage.

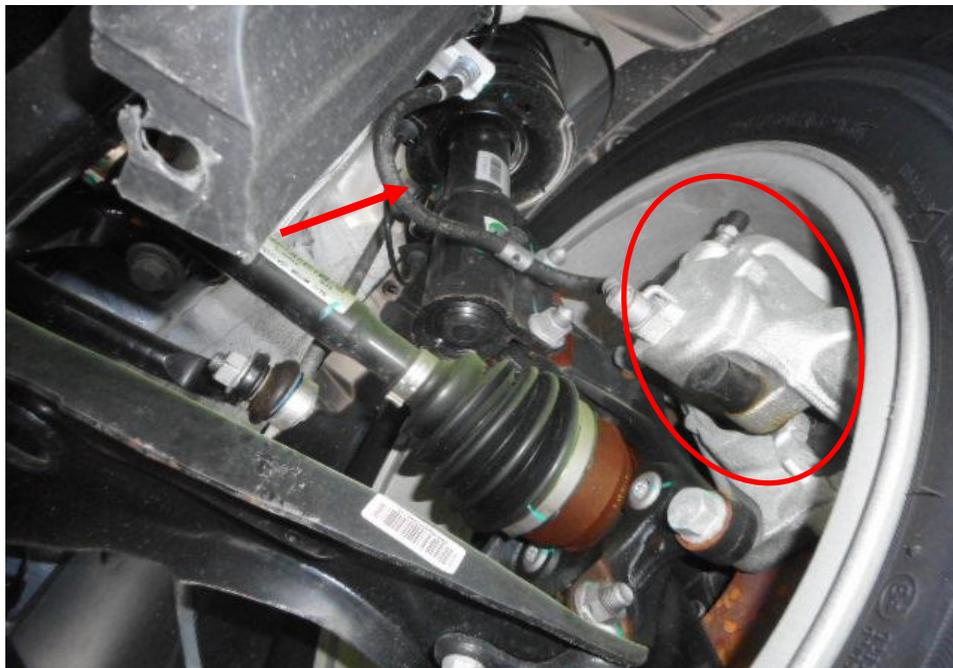
Photo 22 shows the brake hose/pipe (arrowed) at the front left wheel of the Electric Taxi. No leakage of brake fluid was observed. Visual examination of the various components of the braking system like the brake caliper (circled), brake booster, brake pedal etc had revealed all to be intact and without visible damage.

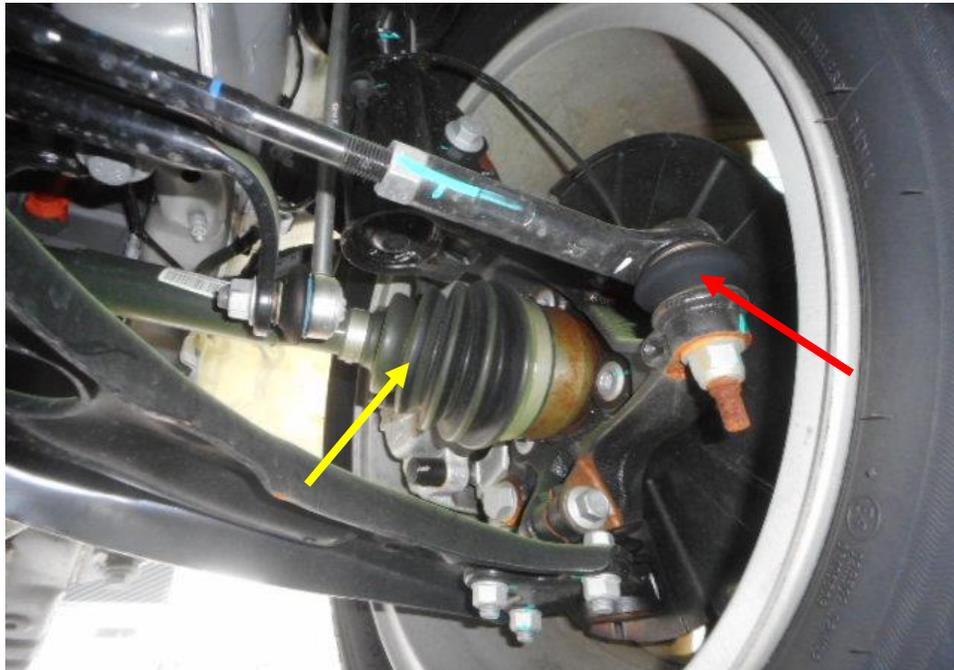
Photo 23 shows the various undercarriage components at the front right wheel of the Electric Taxi, in particular the steering tie rod (red arrow) and its driveshaft (yellow arrow). The various steering components were all found to be intact. There was also no sign of fluid stain observed on the various undercarriage components at the front right wheel of the Electric Taxi.

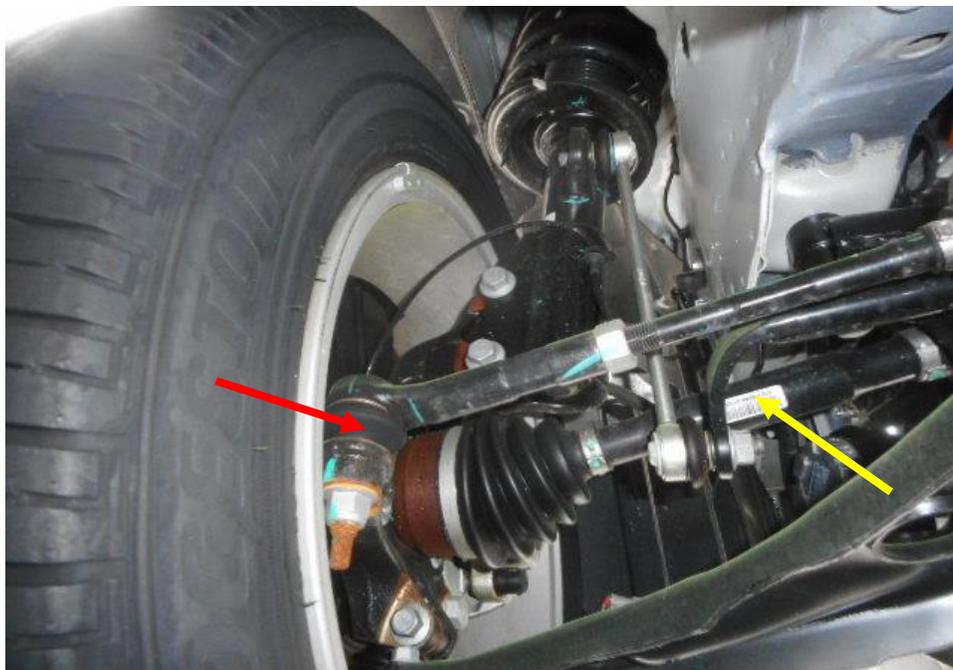
Photo 24 shows the various undercarriage components at the front left wheel of the Electric Taxi, in particular the steering tie rod (red arrow) and its driveshaft (yellow arrow). The various steering components were all found to be intact. There was also no sign of fluid stain observed on the various undercarriage components at the front left wheel of the Electric Taxi.

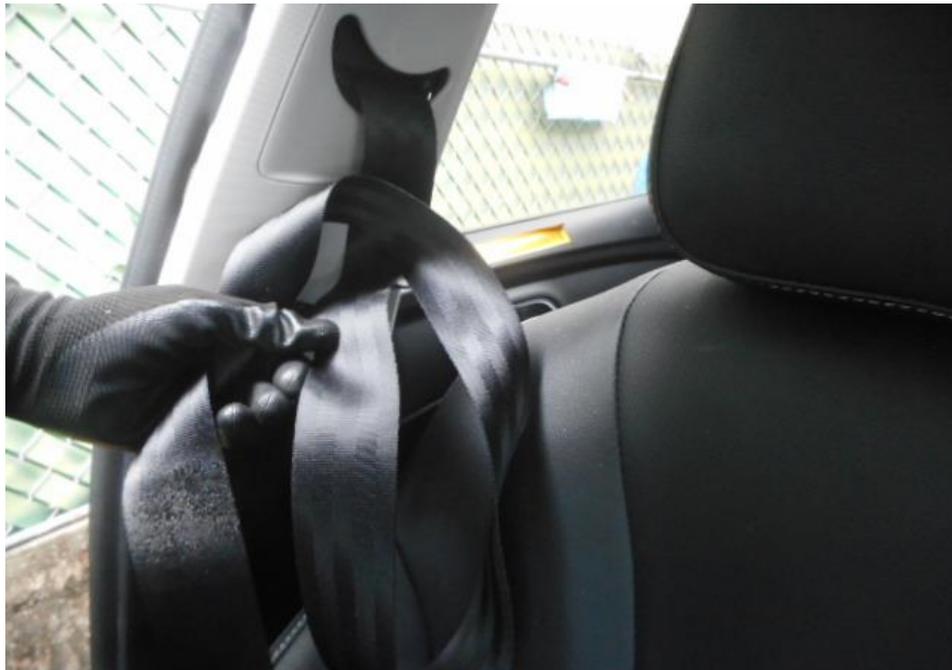
Photo 25 shows that the seat belt on the right seat was worn at the material time of accident as the safety pre-tensioners was activated at the moment of impact and caused the seat belt to be locked into the last position.

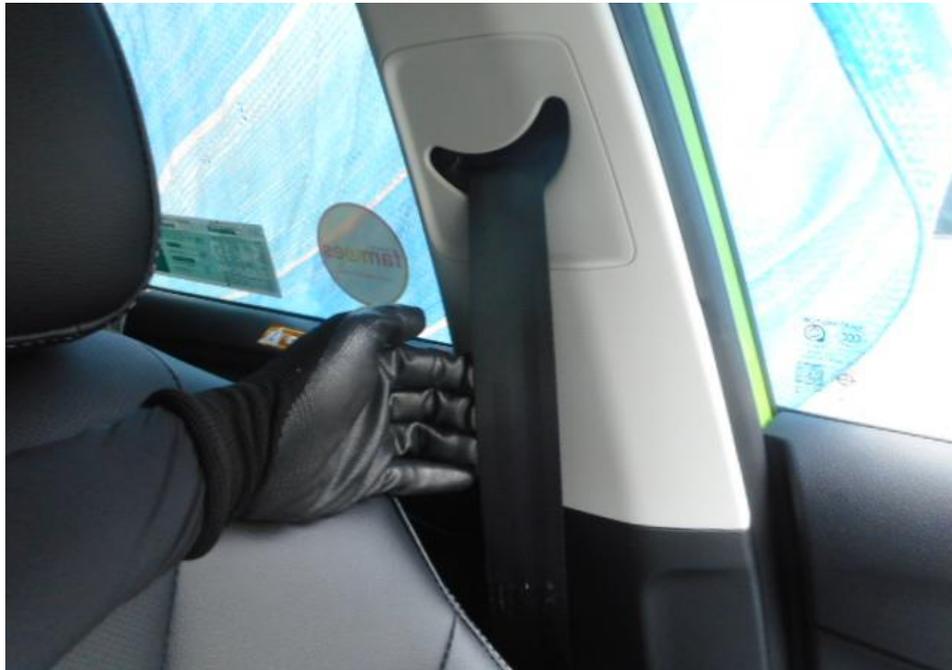
Photo 26 shows that the seat belt on the left seat was not worn at the material time of accident as the safety pre-tensioners was activated at the moment of impact and caused the seat belt to be locked into the last position.
