Your Ref: TP/IP/19473/2022  
Our Ref : CI/TPD22008177/P

**MECHANICAL INSPECTION REPORT OF POLICE VAN GBB 7823L**

1. I refer to your request on 16<sup>th</sup> August 2022 to conduct a physical inspection of a Police Van bearing registration number GBB 7823L (herein referred to as "**Police Van**"), which was involved in a road traffic accident on 25<sup>th</sup> July 2022.
2. The objective of this inspection is to determine if there was any possible mechanical failure to the Police Van that may have contributed to the accident.
3. Following the request, I had carried out a physical inspection of the Police Van on 7<sup>th</sup> September 2022 at the premises of Traffic Police vehicle pound, 517 Airport Road Singapore 539942. I now set out below my observations and comments with respect to this inspection.

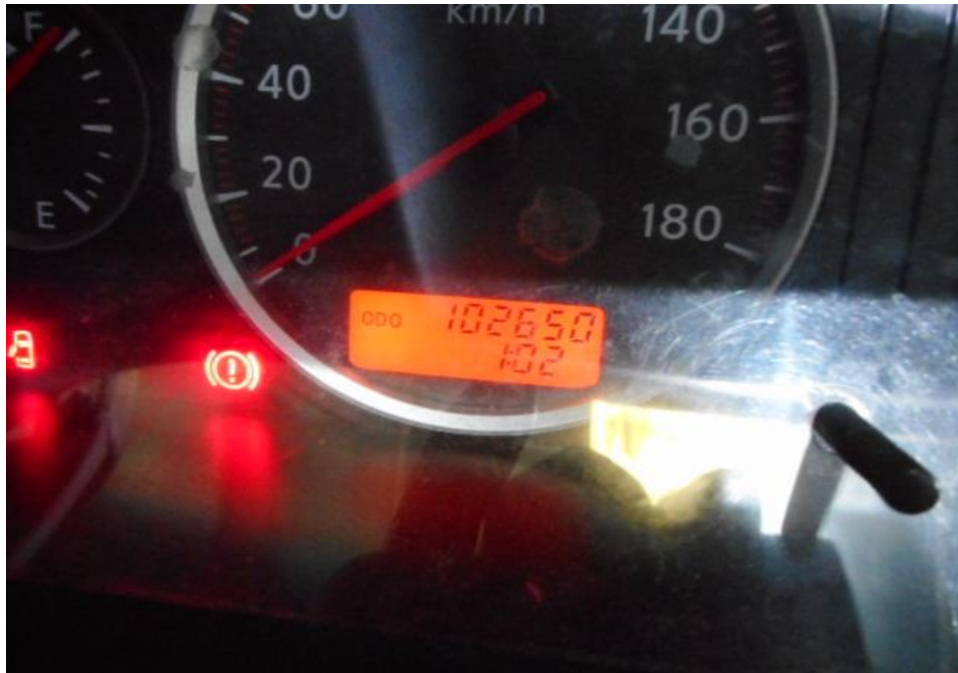
4. The mileage of the Police Van at the time of my inspection was 102,650km.
5. The Police Van appeared to have sustained damage at its frontal portion. Its front body panel, front grille, front bumper, both front left headlamp and its front right door were observed to be damaged at the time of my inspection.

**Photo 1** shows a general view of the instrument cluster of the Police Van at the time of my inspection. The mileage of the Police Van was 102,650km

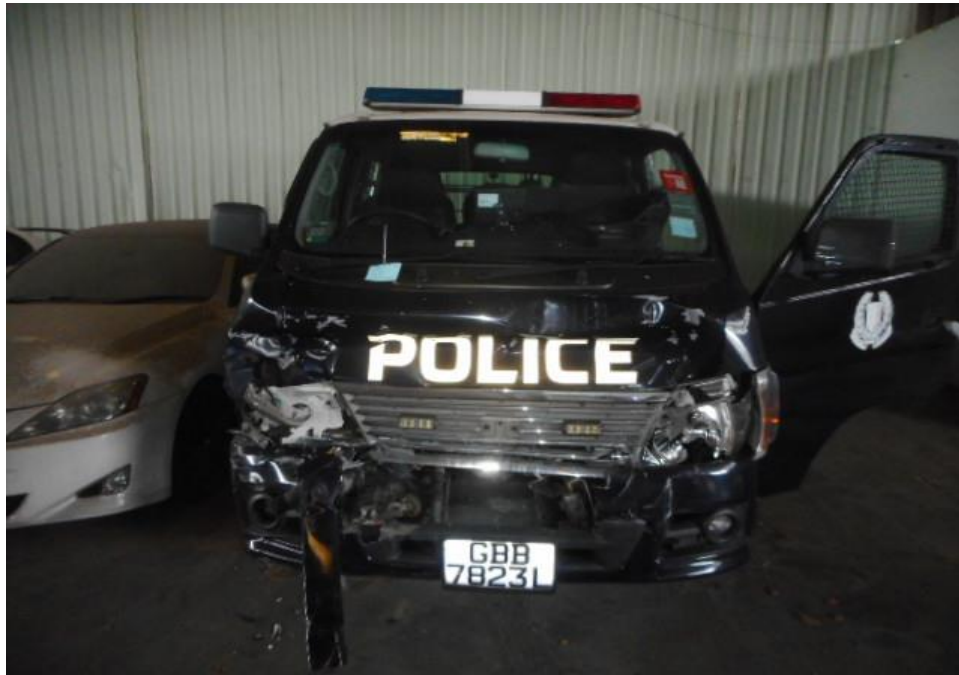
**Photo 2** shows a general view of the Police Van's frontal portion at the time of my inspection. It appeared to have sustained damage at its frontal portion. Its front body panel, front grille, front bumper, both front left headlamp and its front right door were observed to be damaged at the time of my inspection.

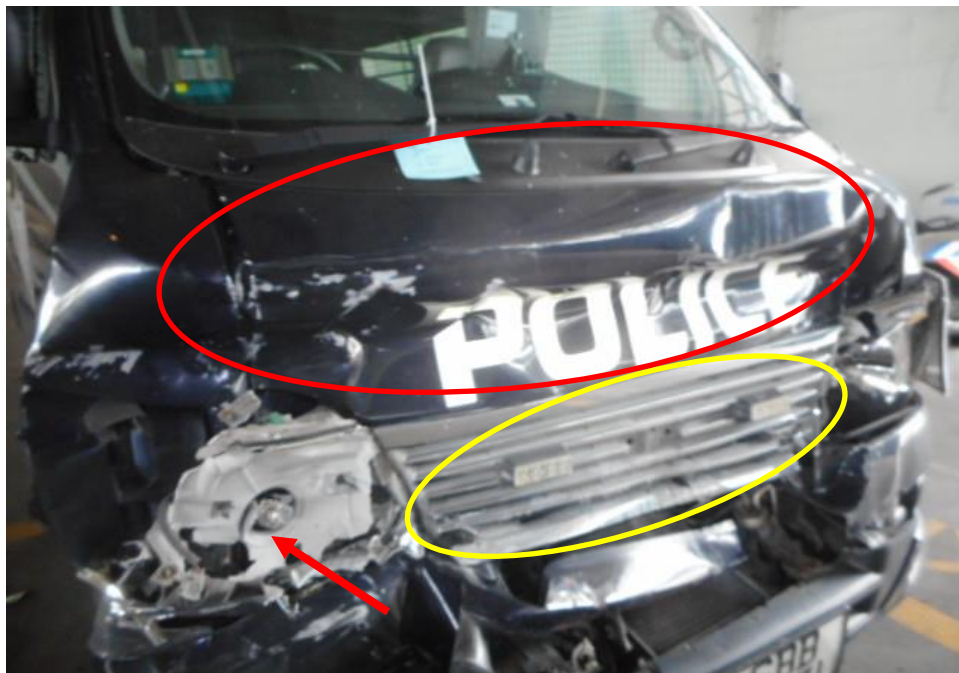
**Photo 3** shows a close up view of the Police Van's frontal portion at the time of my inspection. It appeared to have sustained damage at its frontal portion. Its front grille (yellow circle), its front body panel (red circle) and front right headlamp (arrowed) was damaged at the time of my inspection as a result of the accident.

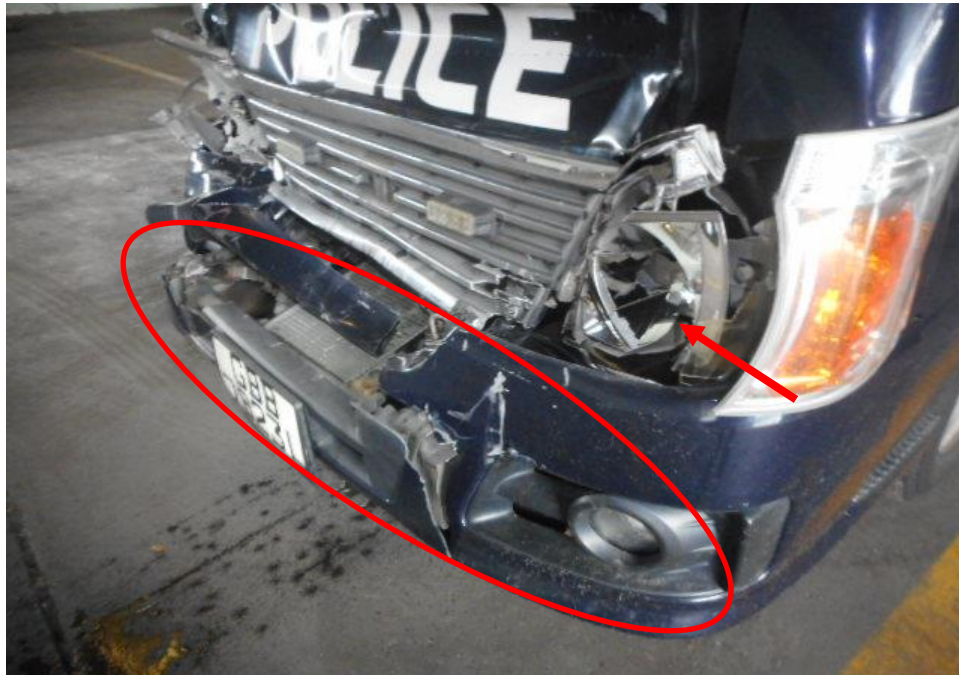
**Photo 4** shows a close up view of the Police Van's frontal portion at the time of my inspection. It appeared to have sustained damage at its frontal portion. Its front left headlamp (arrowed) and front bumper (circled) was damaged at the time of my inspection as a result of the accident.

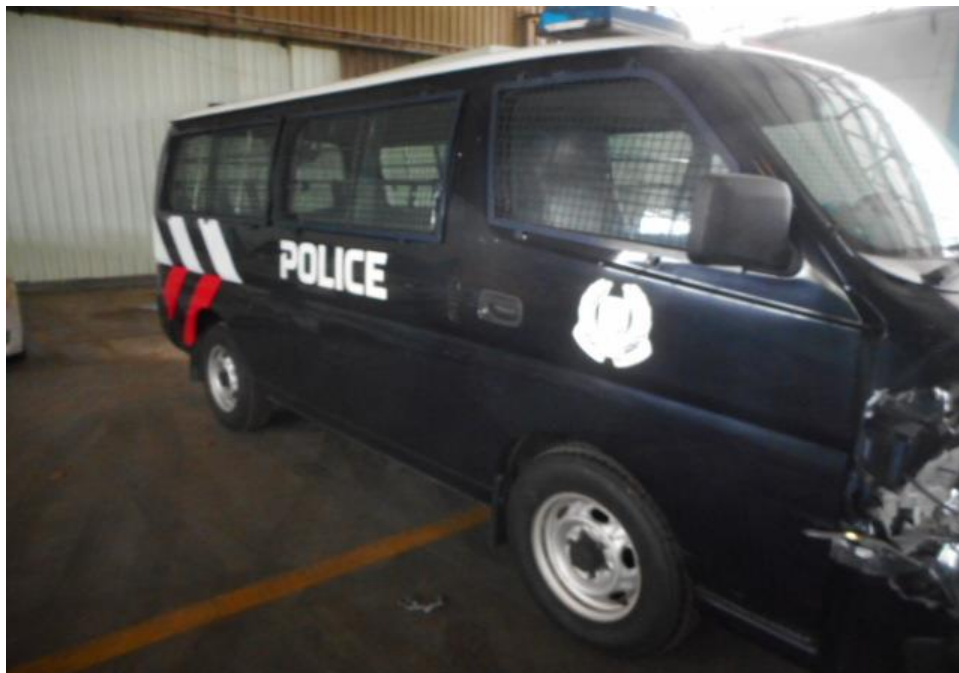
**Photo 5** shows a general view of the right body of the Police Van at the time of my inspection. The front right door of the Police Van was observed to be damaged as a result of the accident.

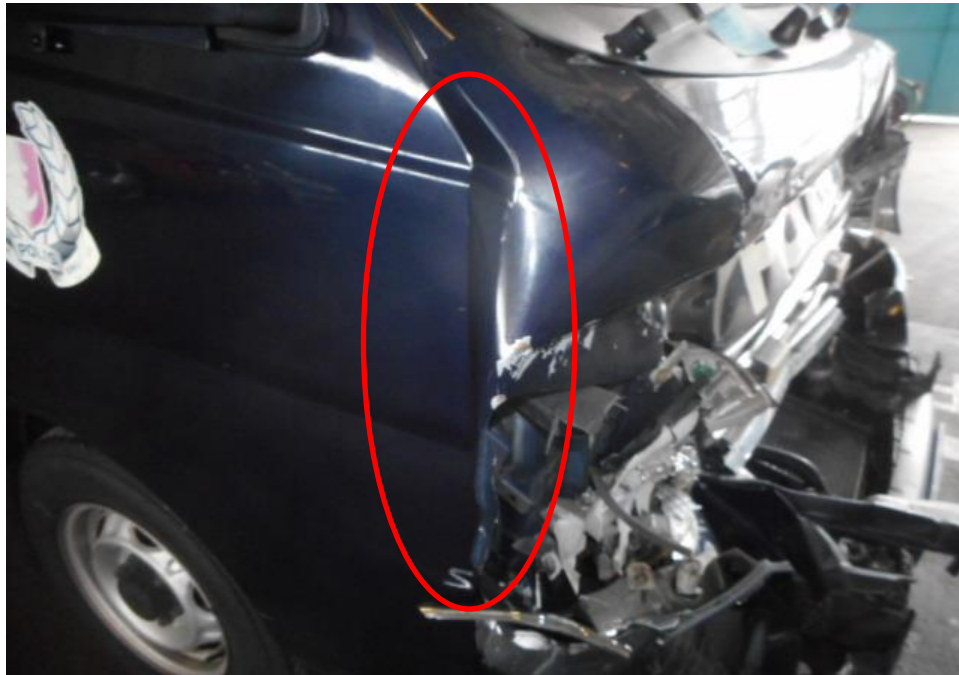
**Photo 6** shows a close up view of the right body of the Police Van at the time of my inspection. The front right door (circled) of the Police Van was observed to be damaged as a result of the accident.

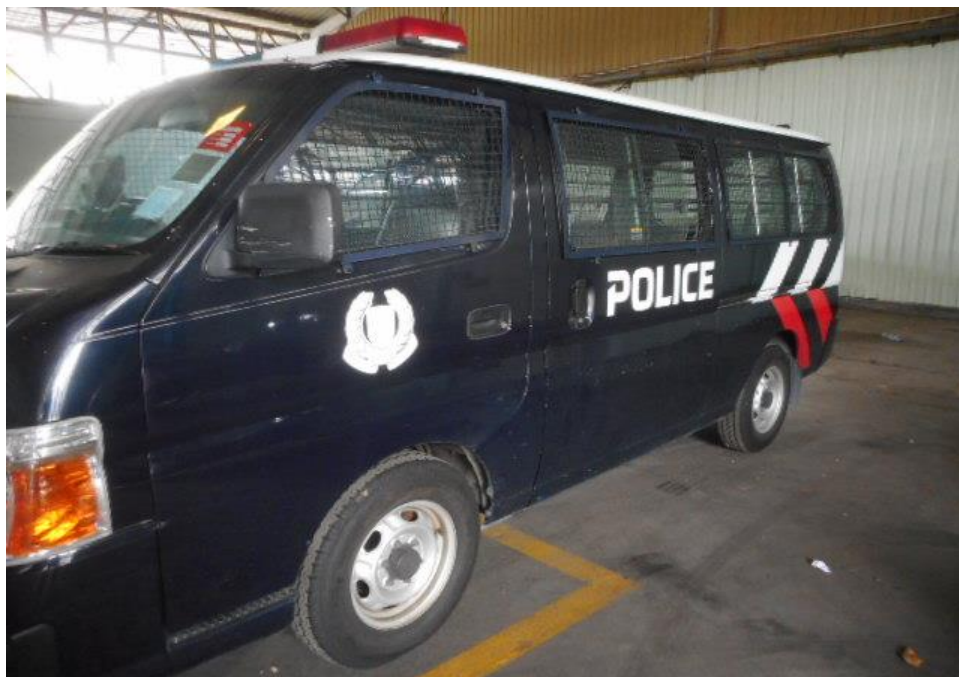
**Photo 7** shows a general view of the left body of the Police Van at the time of my inspection. The Police Van was observed to be intact and unaffected by the accident.

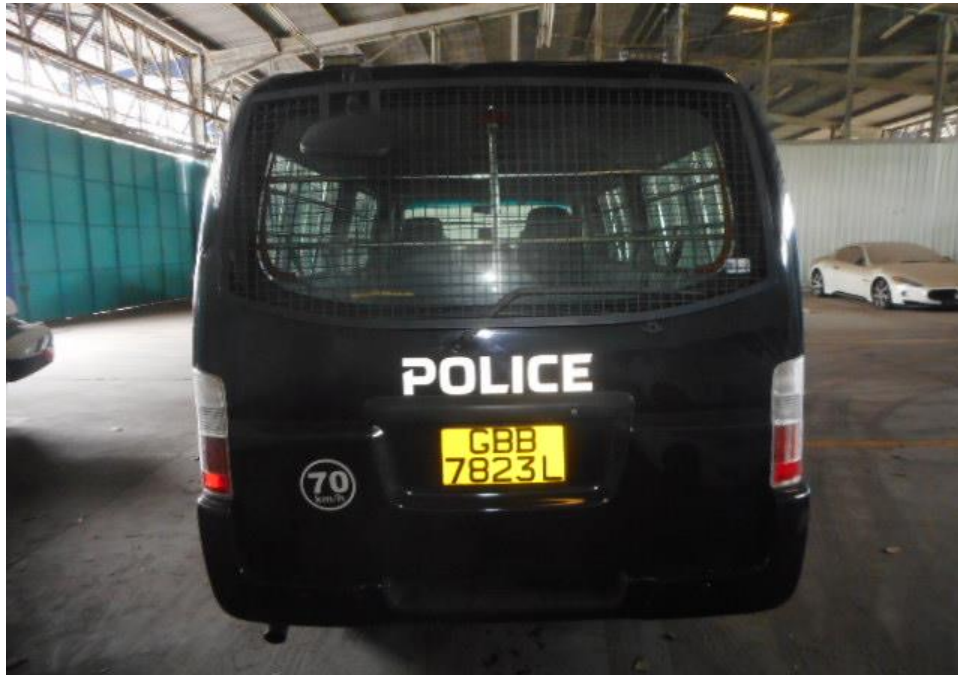
**Photo 8** shows a general view of the rear body of the Police Van at the time of my inspection. The Police Van was observed to be intact and unaffected by the accident.

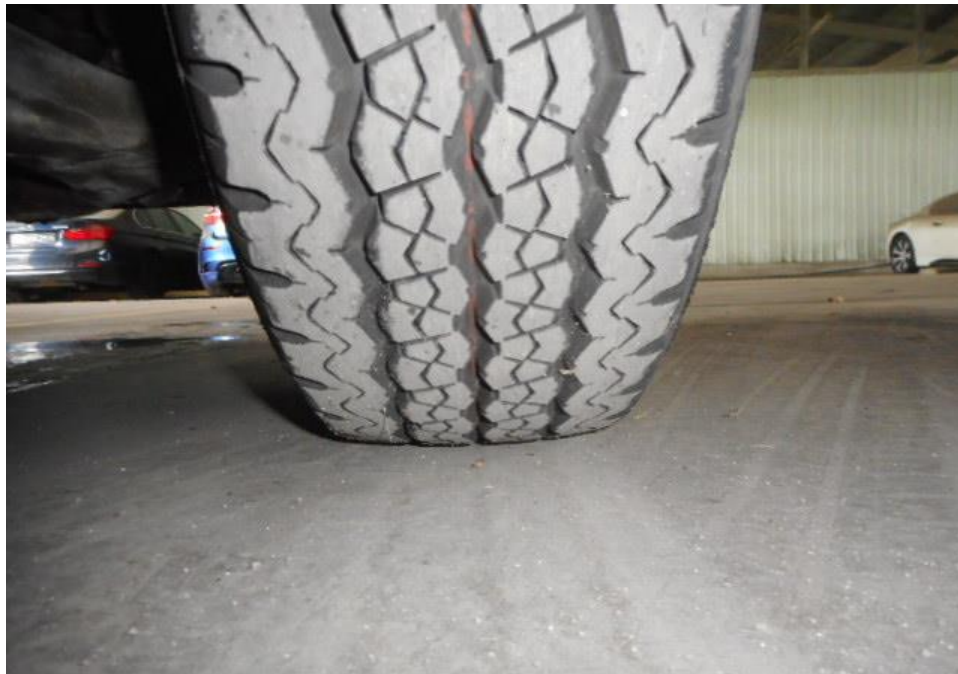
**Photo 9** shows the condition of the front right tyre of the Police Van, which was observed to be in serviceable condition with remaining tread depth of approximately 7.7mm. The tyre, which was wrapped around standard steel wheel rim, was also observed to be sufficiently inflated for vehicular operation. There was no tear, cut or burst mark(s) on the outer and the inner sidewalls as well as across the tread of the 4 tyres that were fitted on the Police Van.

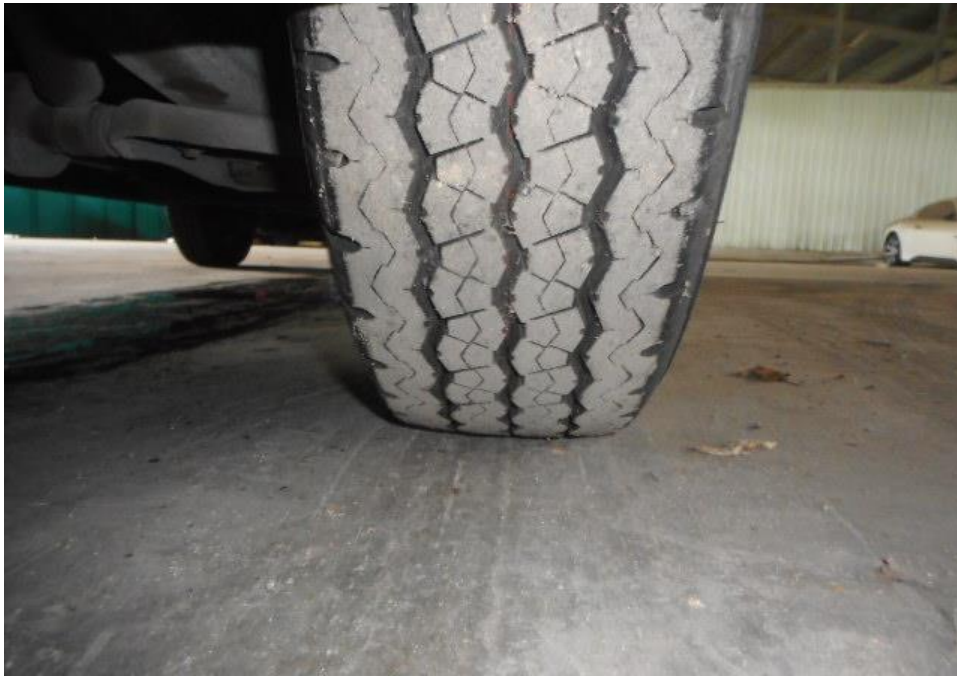
**Photo 10** shows the condition of the rear right tyre of the Police Van, which was observed to be in serviceable condition with remaining tread depth of approximately 7.3mm. The tyre, which was wrapped around standard steel wheel rim, it was observed to be sufficiently inflated for vehicular operation.

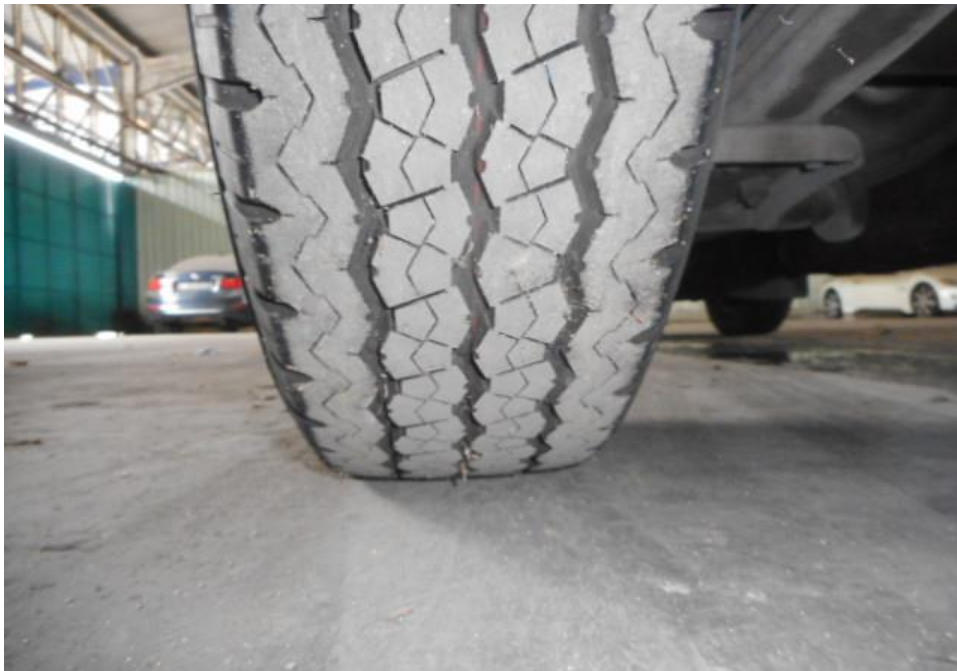
**Photo 11** shows the condition of the rear left tyres of the Police Van, which was observed to be in serviceable condition with remaining tread depth of approximately 7.7mm. The tyres, which were wrapped around standard steel wheel rim, were also observed to be sufficiently inflated for vehicular operation. There was also no damage found on all 4 steel wheel rims of the Police Van.

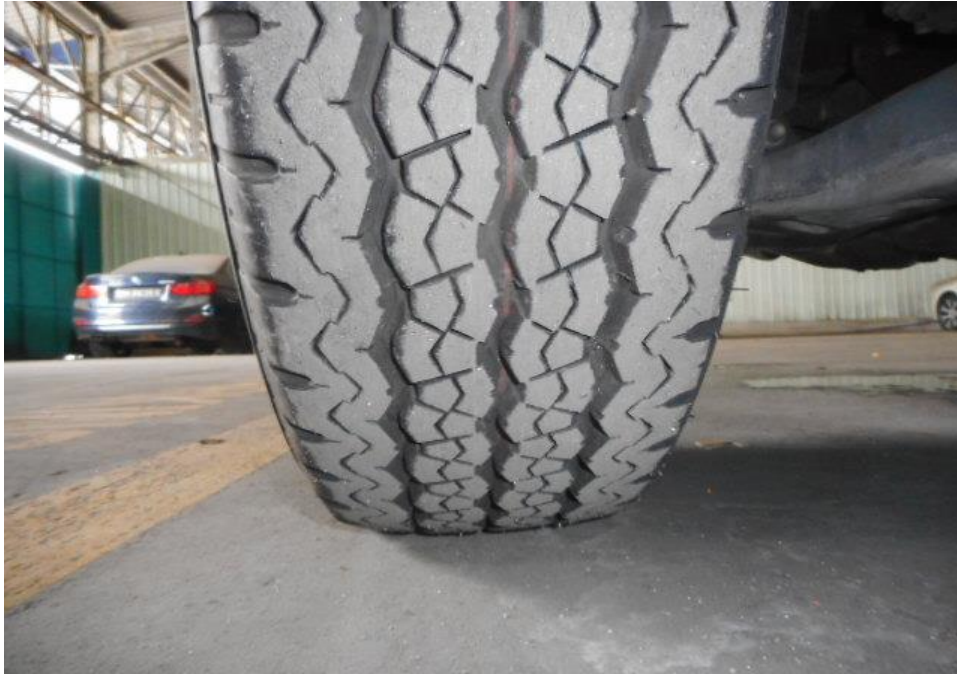
**Photo 12** shows the condition of the front left tyres of the Police Van, which was observed to be in serviceable condition with remaining tread depth of approximately 7.7mm. The tyres, which were wrapped around standard steel wheel rim, were also observed to be sufficiently inflated for vehicular operation. There was also no damage found on all 4 steel wheel rims of the Police Van.

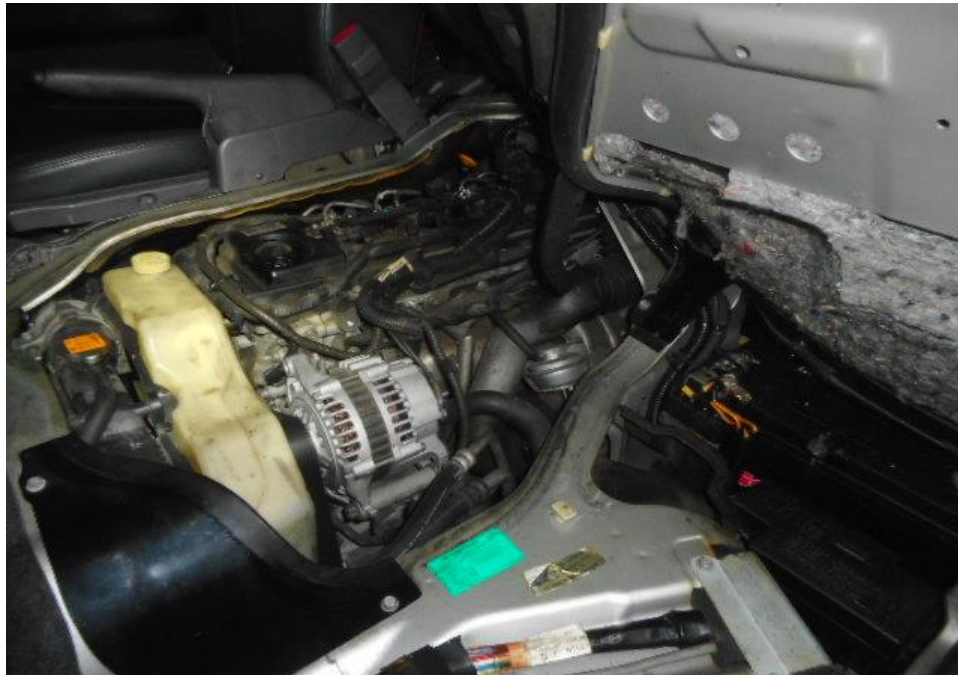
8. Upon examination of the Police Van's engine compartment, I had observed all the parts and components inside the engine compartment to be intact and unaffected by the accident. The engine coolant, and engine oil were all found to be of sufficient level for operating purposes. Visually, there was also no contamination found to these fluids. However, the brake fluid was unable to be checked as the brake fluid reservoir was block by the damaged front right door which was not able to be opened due to the induct impact sustained from the accident.

**Photo 13** shows a general view of the Police Van's engine compartment, which was accessed by lifting the front cabin of the Police Van. The various parts and components inside the engine compartment were unaffected by the accident. There was also no sign(s) or indication(s) of fresh fluid leakage and/or fluid stain within the engine compartment

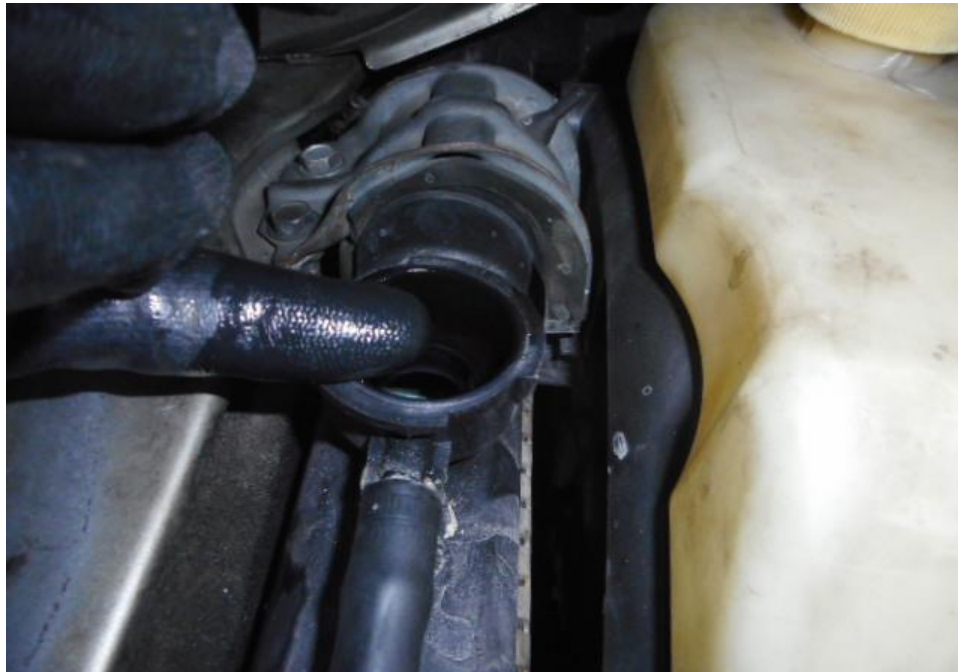
**Photo 14** shows the engine coolant of the Police Van at the time of my inspection. The engine coolant was observed to be of sufficient level and without any visible contamination.

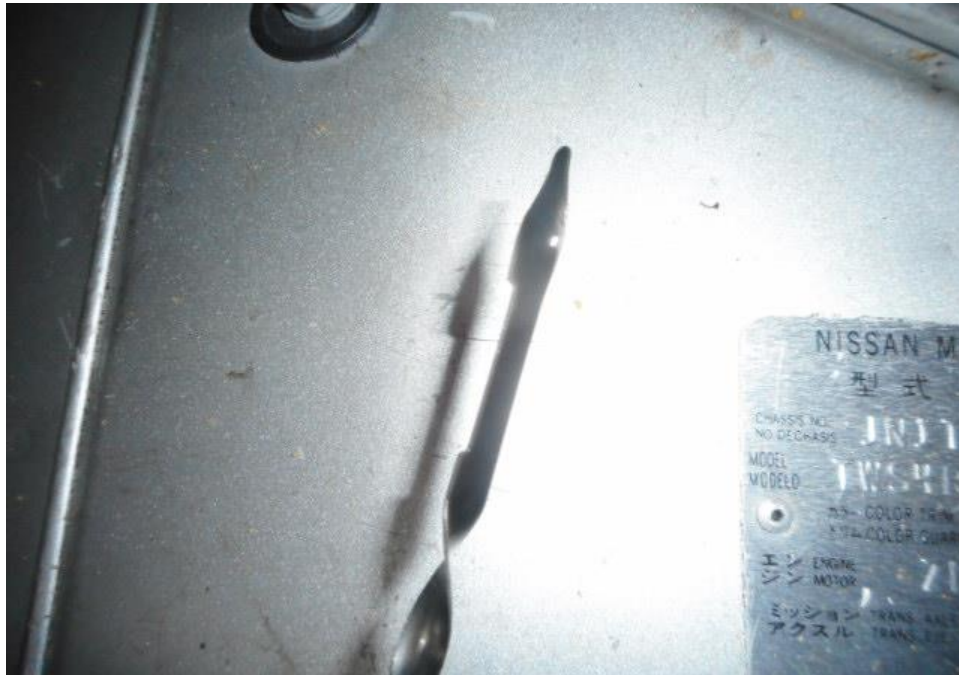
**Photo 15** shows the engine oil dip stick of the Police Van at the time of my inspection. The engine oil was observed to be of sufficient level and without any visible contamination.

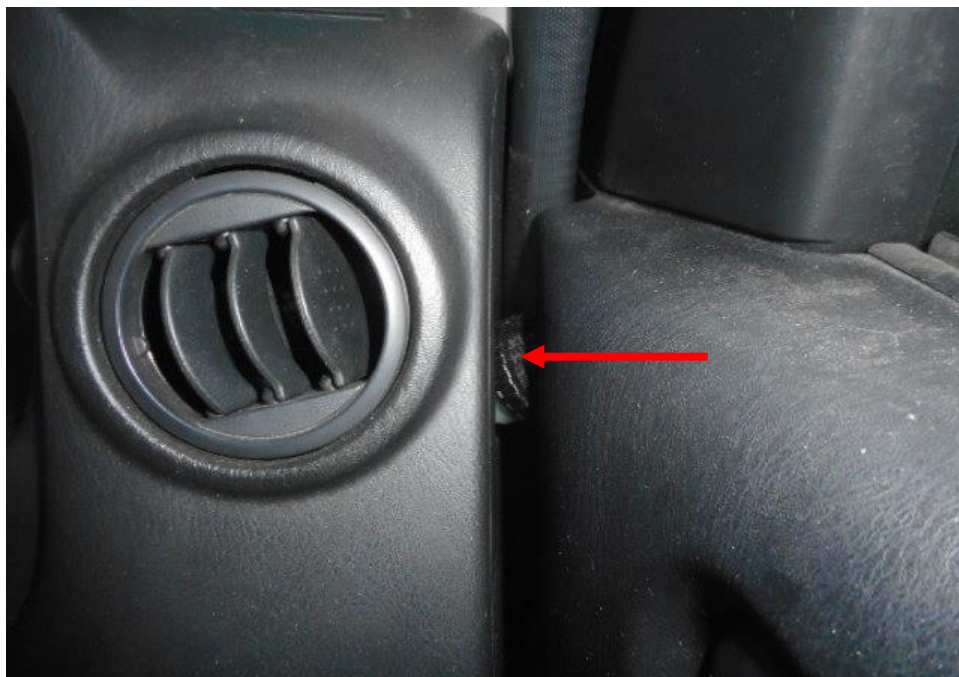
**Photo 16** shows the brake fluid reservoir of the Police Van at the time of my inspection. The brake fluid was unable to be observed as the front right door was damaged as a result of the accident and was unable to be opened, blocking the viewing of the brake fluid reservoir (arrowed).

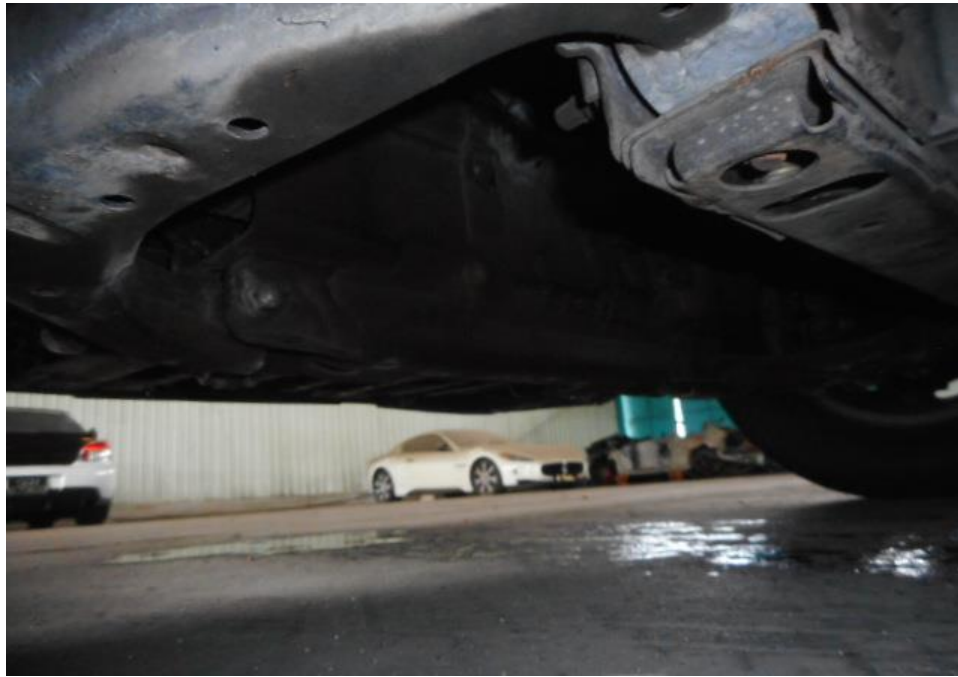
10. My subsequent checks on the underside of the Police Van also revealed no fluid stain. Visually, the various undercarriage components of the Police Van were all observed to be intact and without any visible damage. See photo 13 – 17 below.

**Photo 17** shows the undercarriage of the Police Van, at the area where the engine housing and transmission housing are located. . I did not find any sign(s) or indication(s) of fluid leak and/or fluid stain(s) on the underside of the Police Van.

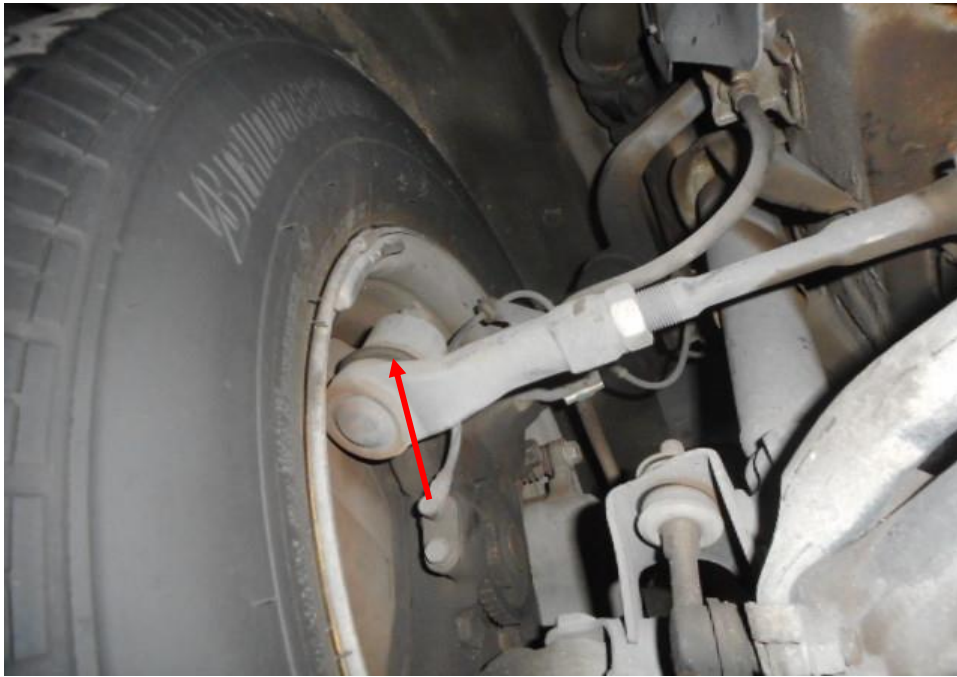
**Photo 18** shows the various undercarriage components at the front right wheel of the Police Van, in particular the steering tie rod end (red arrow). The various steering components were all found to be intact. There was also no sign of fluid stain(s) observed on the various undercarriage components.

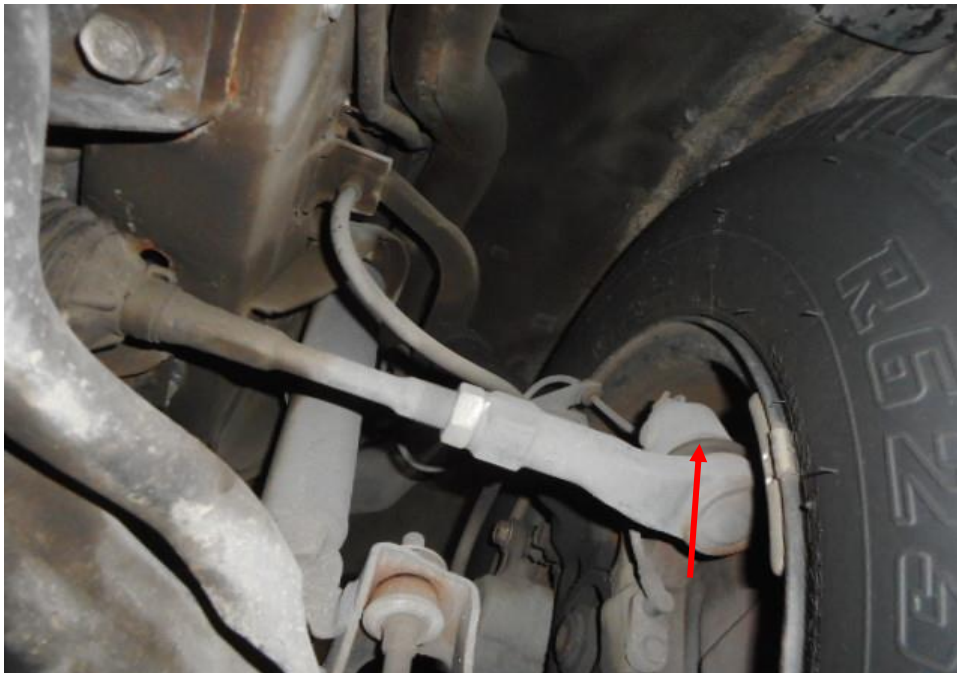
**Photo 19** shows the various undercarriage components at the front left wheel of the Police Van, in particular the steering tie rod end (red arrow). The various steering components were all found to be intact. There was also no sign of fluid stain(s) observed on the various undercarriage components.

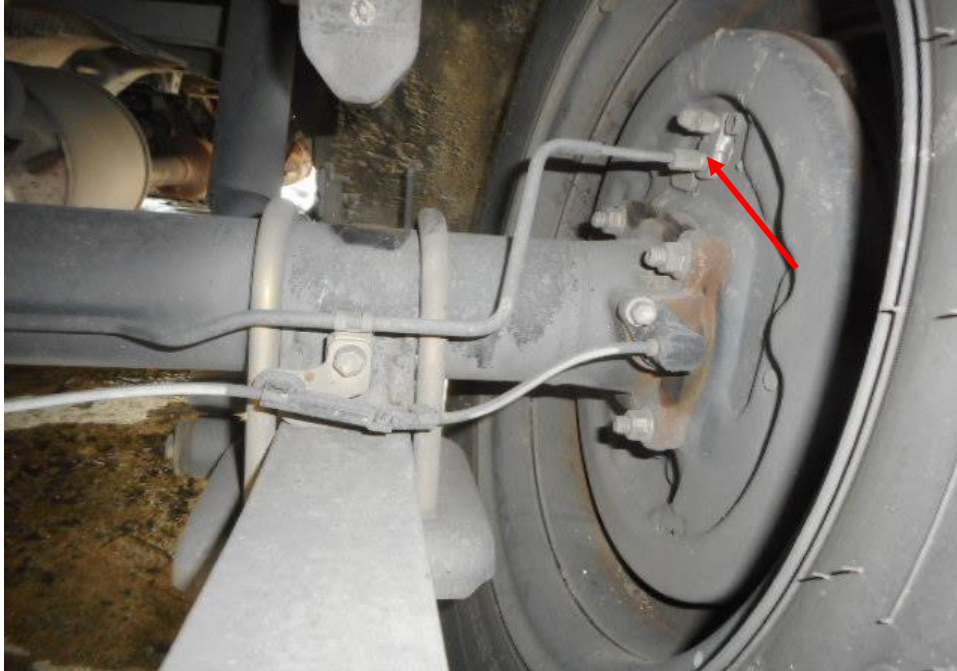
**Photo 20** shows the brake pipe (arrowed) at the rear right wheel of the Police Van. I did not observe any leakage of brake fluid at the time of my inspection of the Police Van. My static tests of the Police Van's braking system, along with my visual examination of the various mechanical components in the braking system, had indicated that there was no internal leakage of pressure/vacuum. Hence the braking system of the Police Van was likely to be in serviceable condition at the material time of accident.

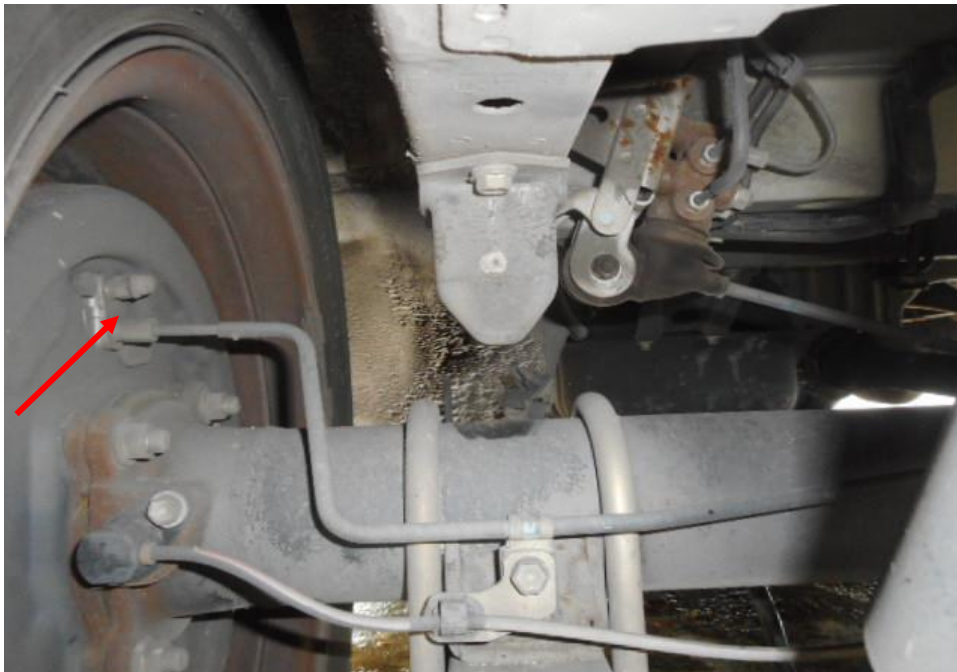
**Photo 21** shows the brake pipe (arrowed) at the rear left wheel of the Police Van. I did not observe any leakage of brake fluid at the time of my inspection of the Police Van. My static tests of the Police Van's braking system, along with my visual examination of the various mechanical components in the braking system had indicated that there was no internal leakage of pressure/vacuum. Hence the braking system of the Police Van was likely to be in serviceable condition at the material time of accident.

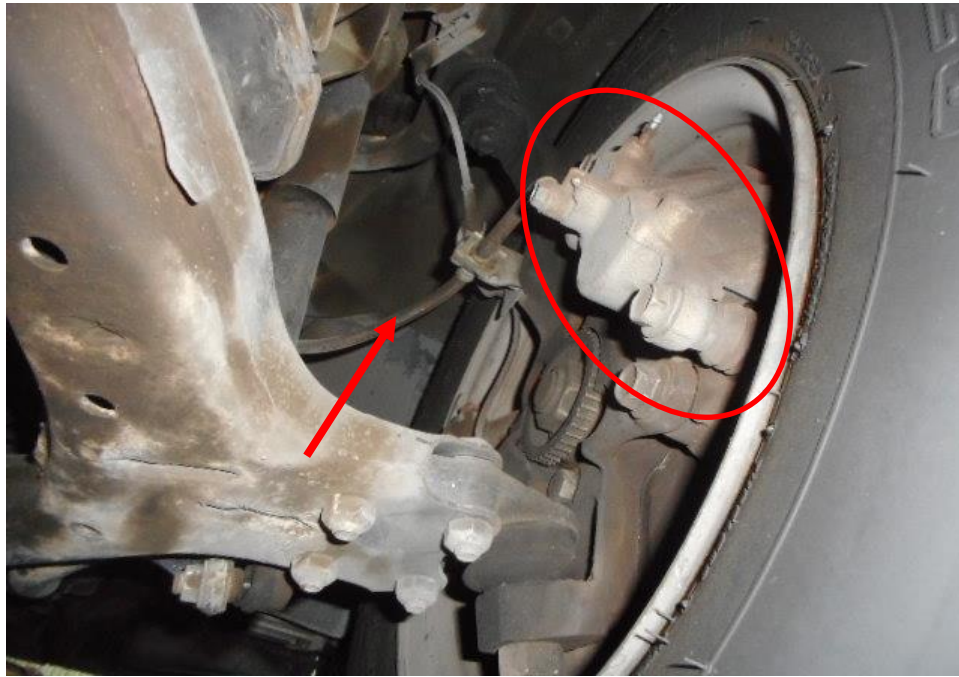
**Photo 22** shows the brake hose/pipe (arrowed) at the front right wheel of the Police Van. No leakage of brake fluid was observed. Visual examination of the various components of the braking system like the brake caliper (circled), brake booster, brake pedal etc had revealed all to be intact and without visible damage at the time of accident. There was also no sign of fluid stain(s) observed on the various undercarriage components.

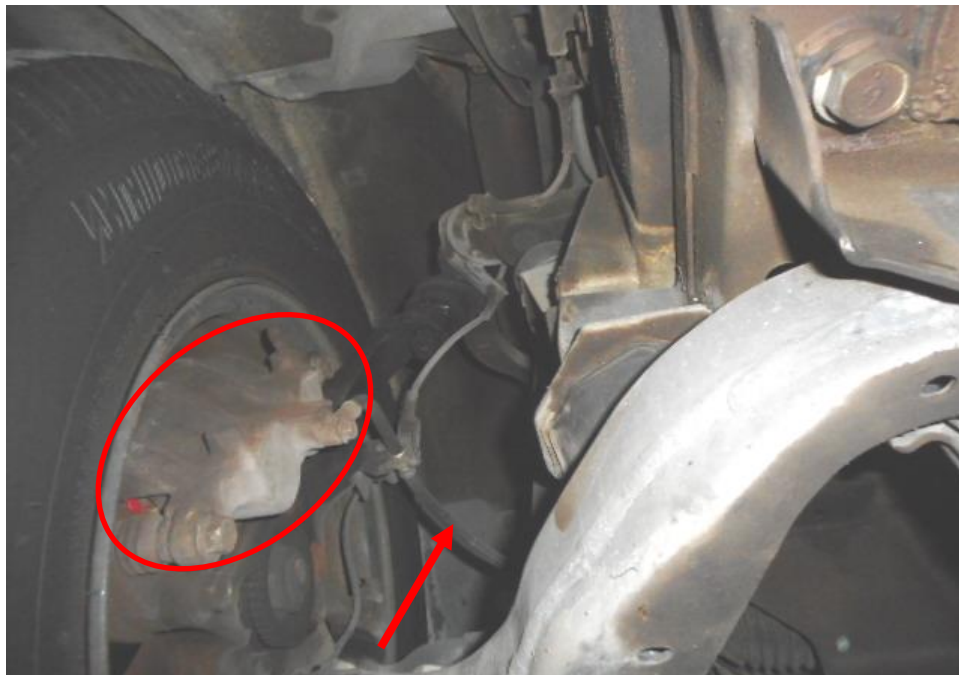
**Photo 23** shows the brake hose/pipe (arrowed) at the front left wheel of the Police Van. No leakage of brake fluid was observed. Visual examination of the various components of the braking system like the brake caliper (circled), brake booster, brake pedal etc had revealed all to be intact and without visible damage at the time of accident. There was also no sign of fluid stain(s) observed on the various undercarriage components.

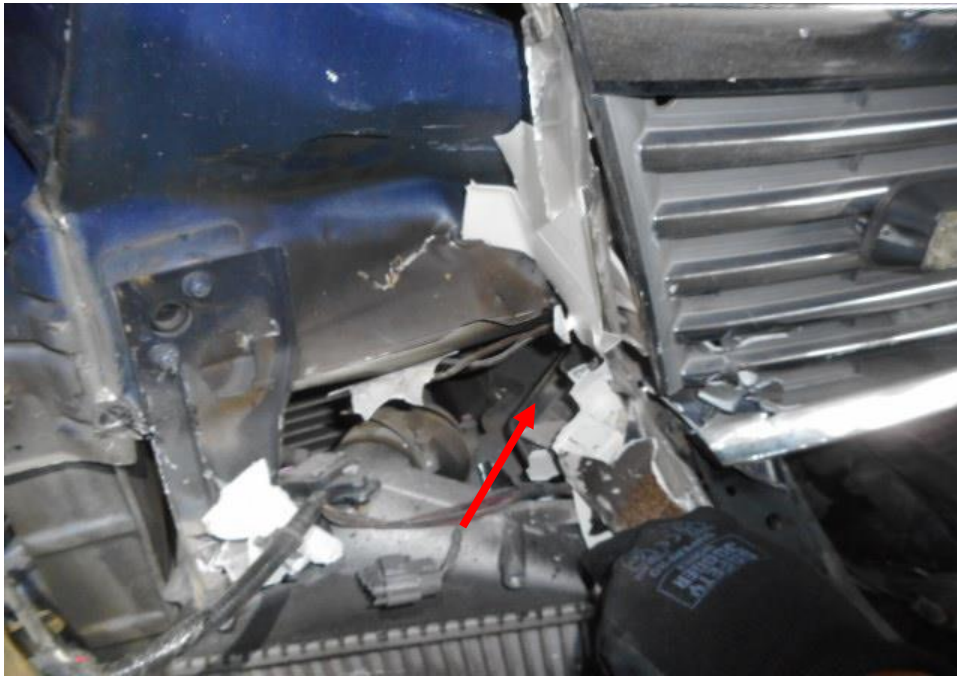
12. Static test on the steering system of the Police Van also revealed abnormality to the steering system. I have experienced abnormal resistance when turning the steering wheel left and right to full lock positions. My visual examination of the various steering components which had included the rack and pinion, tie rods, tie rod ends and ball joints had revealed that these components were all generally in good condition. However, the steering column box was observed to be damaged as a result of the impact sustained from the accident. See photo 18 - 26 below.

**Photo 24** shows the general view of the steering column box (arrowed) at the front portion of the Police Van, it was observed to be damaged as a result of the impact sustained from the accident.

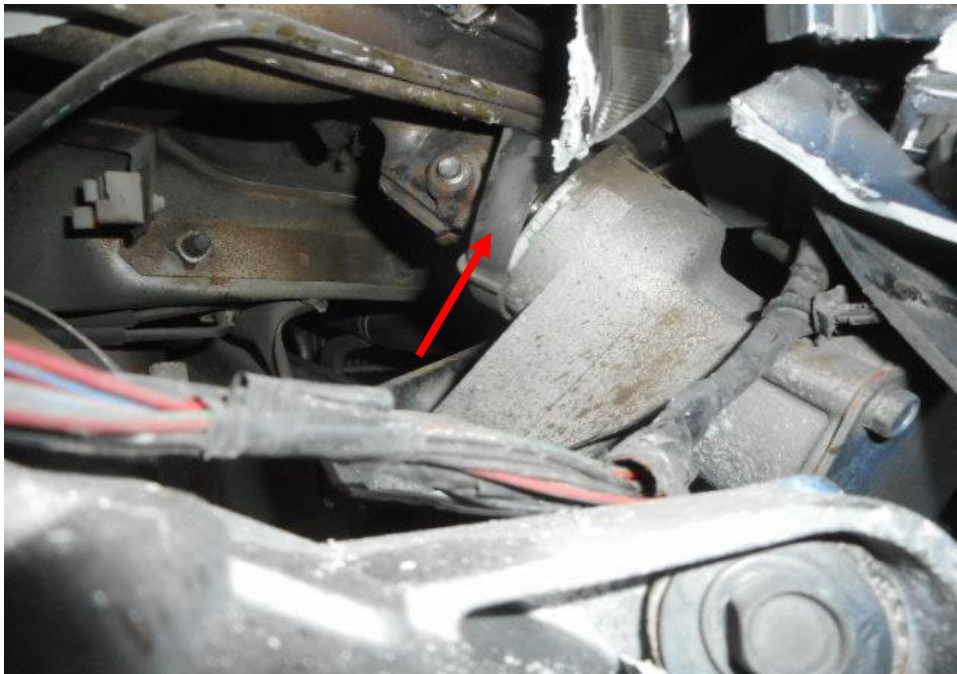
**Photo 25** shows the close up view of the steering column box (arrowed) at the front portion of the Police Van, it was observed to be damaged as a result of the impact sustained from the accident.

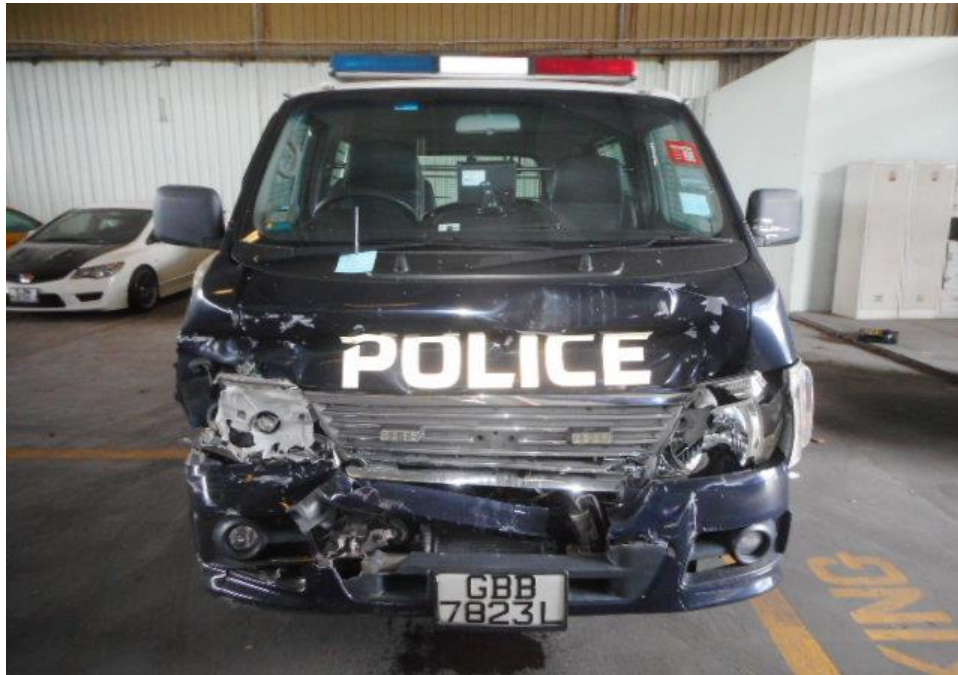
**Photo 26** shows the position of the Police Van that had moved forward. During my braking system test, the brake booster had responded well to the various tests conducted. There was also no abnormal movement of the brake pedal when it was depressed. In general, the static brake tests had suggested that there was no internal leakage of pressure/vacuum in the braking system of the Police Van. The braking system of the Police Van was likely to be in serviceable condition at the material time.

15. During the operational test, the various transmission gears of the Police Van were able to be engage without any difficulty and manually shifting the gear lever. There were no abnormal sounds heard and/or abnormal behaviour of the Police Van's engine system. It was able to move forward and backward normally. The braking system was also found to be in working condition as the Police Van was able to slow down and come to a complete stop upon depressing of the brake pedal. However, only the operational test to the steering system was unable to be conduct due to the damage it had sustained from the accident. Refer to photo 2 & 26

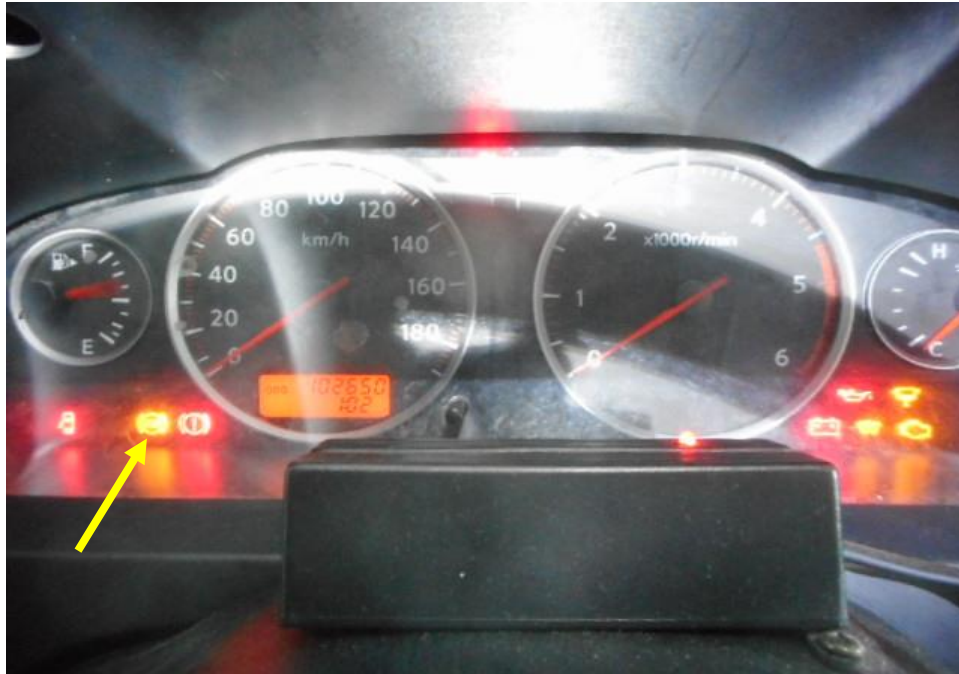
**Photo 27** shows the warning light for Anti-Lock Braking System (ABS) (arrowed) appearing on the instrument panel of the Police Van during the self-test of its various electronic operating systems when its engine was cranked.

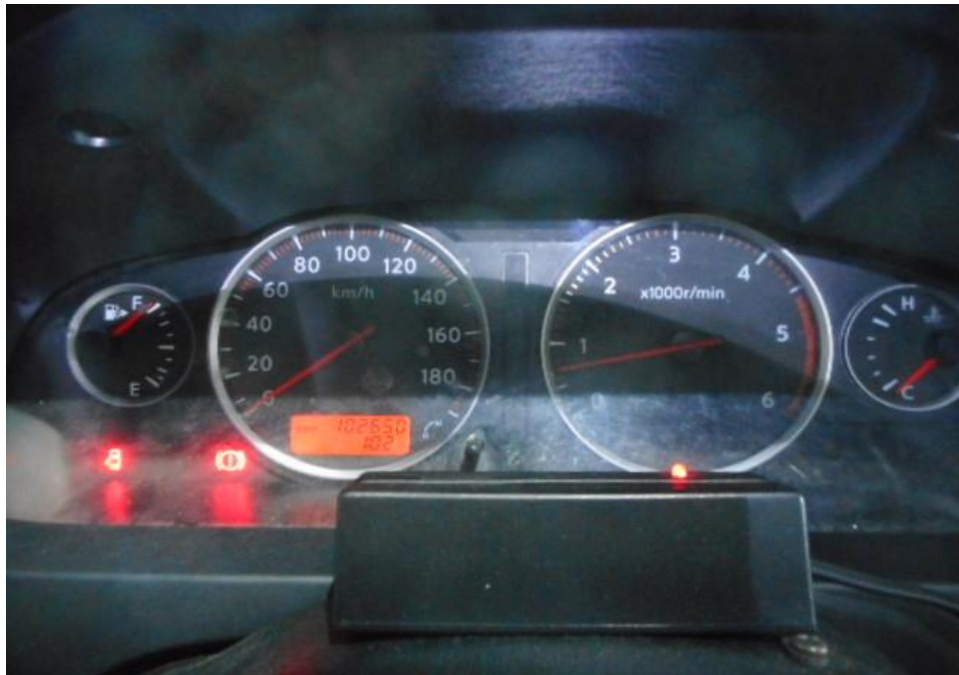
**Photo 28** shows no warning lights illuminated on the instrument panel of the Police Van after the engine was cranked. This would suggest that there was no abnormality to the electronic operating system of the Police Van, like the ABS, and etc.
