Your Ref: TP/IP/19824/2022  
Our Ref : CI/TPD22008178/P

20<sup>th</sup> December 2022

**MECHANICAL INSPECTION REPORT OF TIPPER TRUCK, XE 1993S**

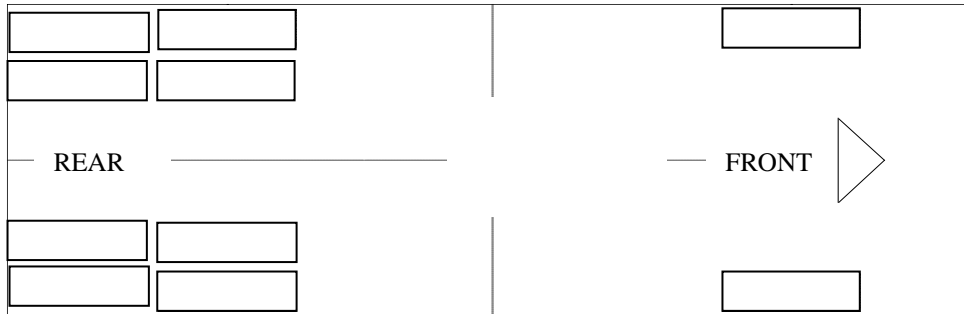
6. The 2 front tyres and 4 rear tyres of the Tipper Truck were observed to be in serviceable condition and sufficiently inflated for vehicular operation. I did not find any tear, cut or burst mark(s) on the outer and the inner sidewalls as well as across the tread of the 6 tyres of the Tipper Truck. The tyre brand, tyre size and remaining tread depth of the 6 tyres of the Tipper Truck were recorded as follows:-

Sailun 295/80 R22.5 (14.2mm)

Sailun 295/80 R22.5 (11.8mm)

Sailun 295/80 R22.5 (9.1mm)

Sailun 295/80 R22.5 (8.9mm)

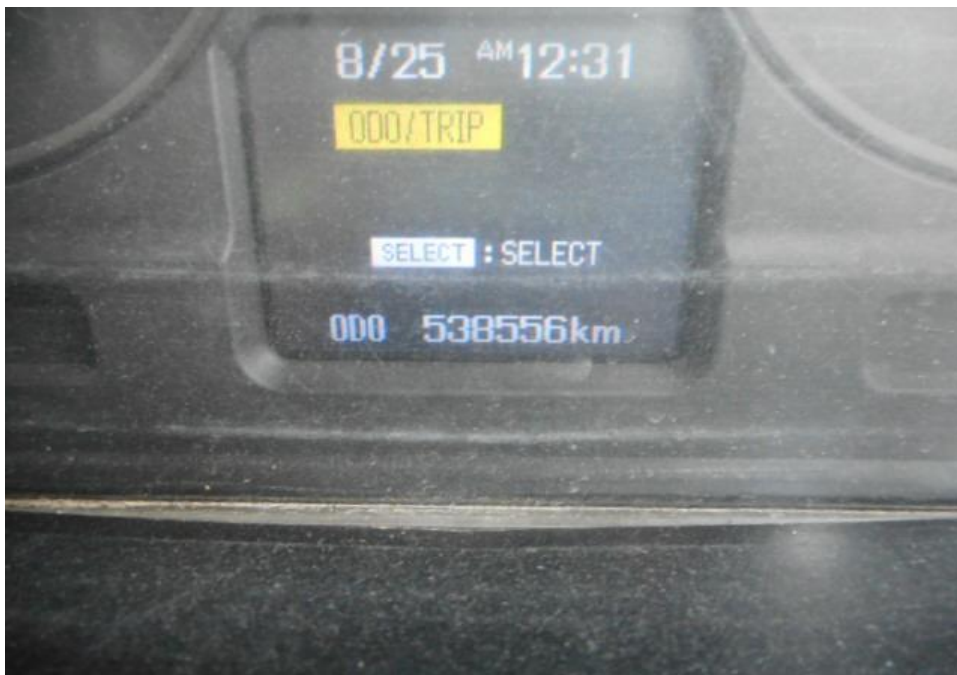
4. The mileage of the Tipper Truck at the time of my inspection was 538,556km.
5. There was no visible damage observed on Tipper Truck at the time of my inspection.

**Photo 1** shows a general view of the instrument cluster of the Tipper Truck at the time of my inspection. The mileage of the Tipper Truck was 538,556km

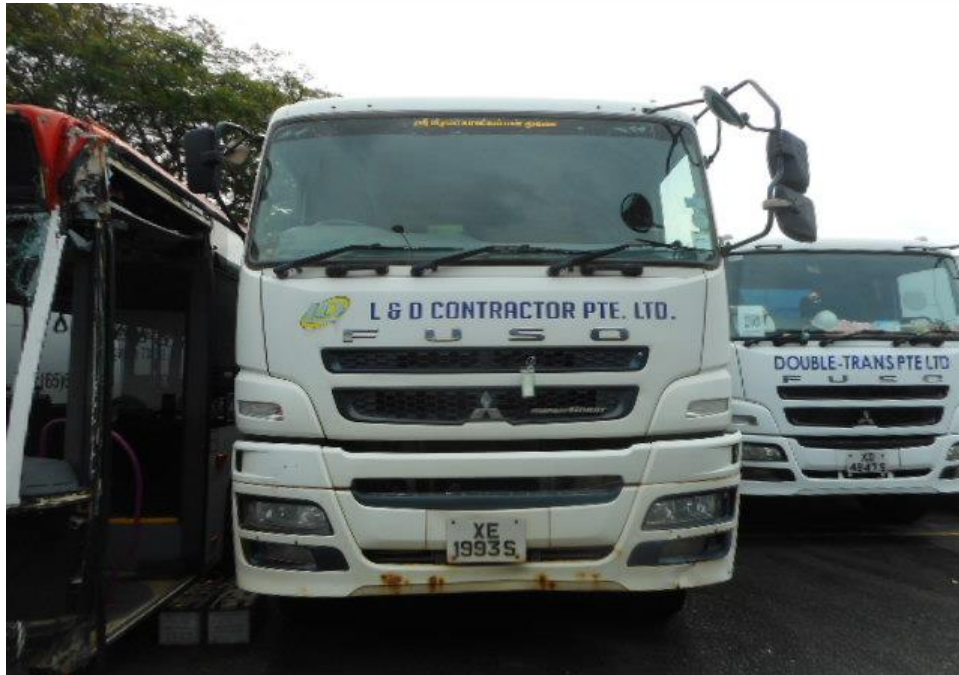
**Photo 2** shows a general view of the front body of the Tipper Truck at the time of my inspection. The Tipper Truck was observed to be intact and unaffected by the accident.

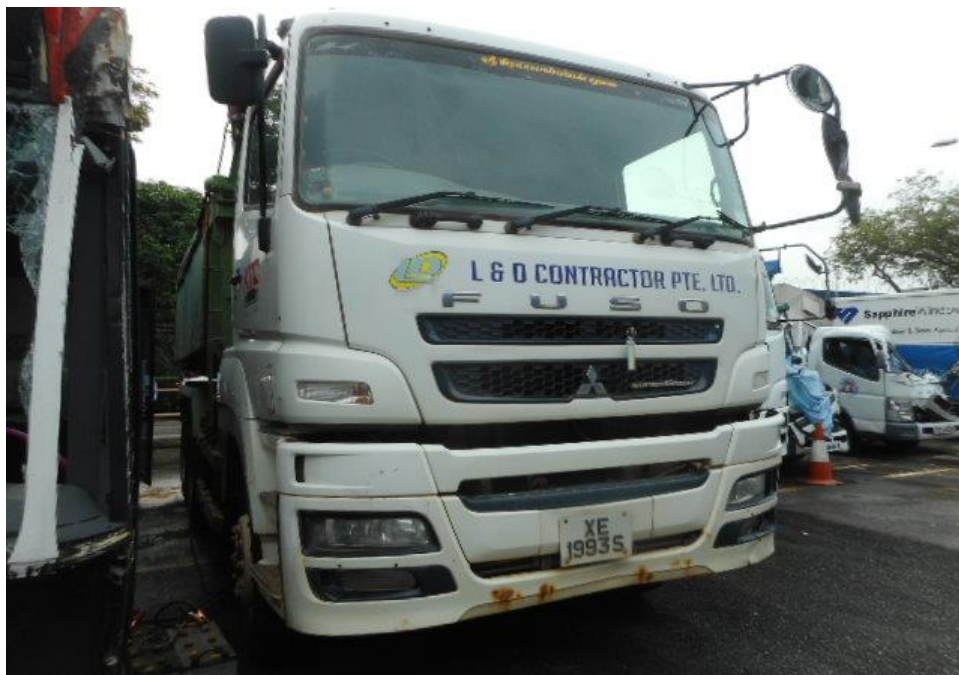
**Photo 3** shows a general view of the front right body of the Tipper Truck at the time of my inspection. The Tipper Truck was observed to be intact and unaffected by the accident.

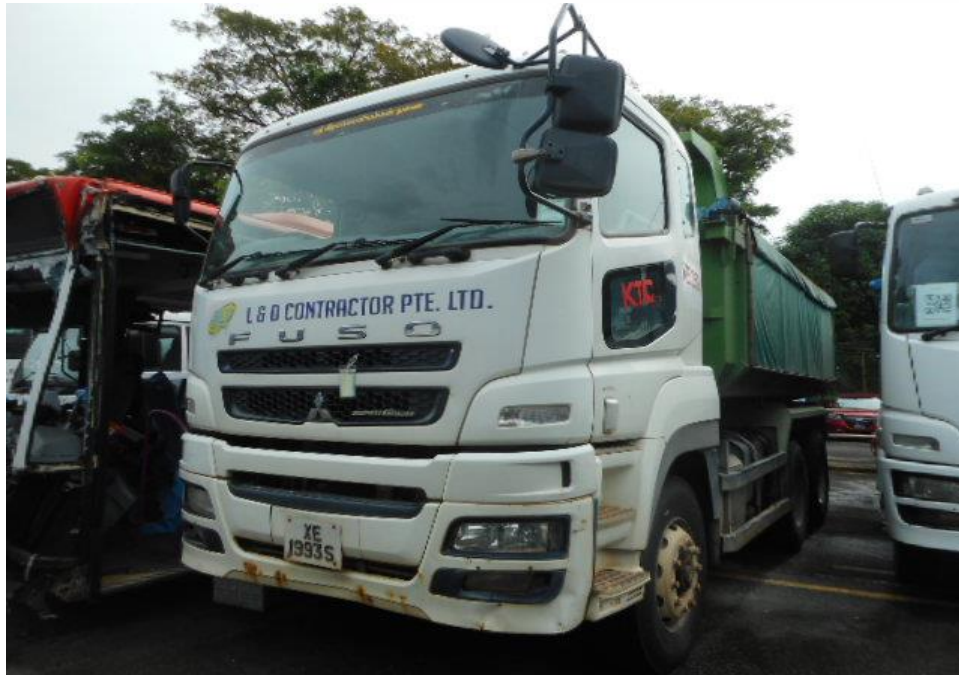
**Photo 4** shows a general view of the front left body of the Tipper Truck at the time of my inspection. The Tipper Truck was observed to be intact and unaffected by the accident.

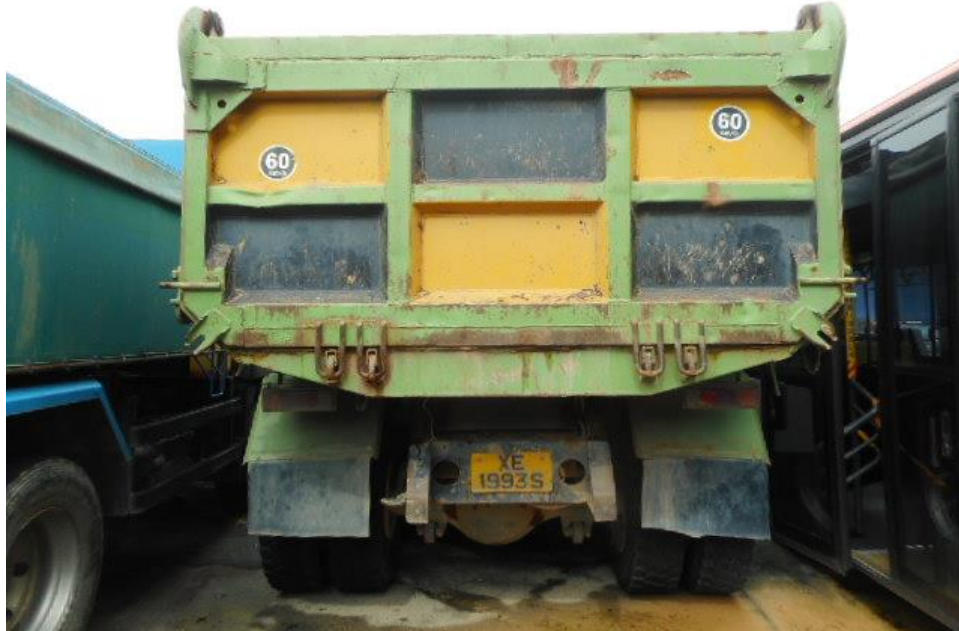
**Photo 5** shows a general view of the Tipper Truck's rear body at the time of my inspection. The Tipper Truck was observed to be intact and unaffected by the accident.

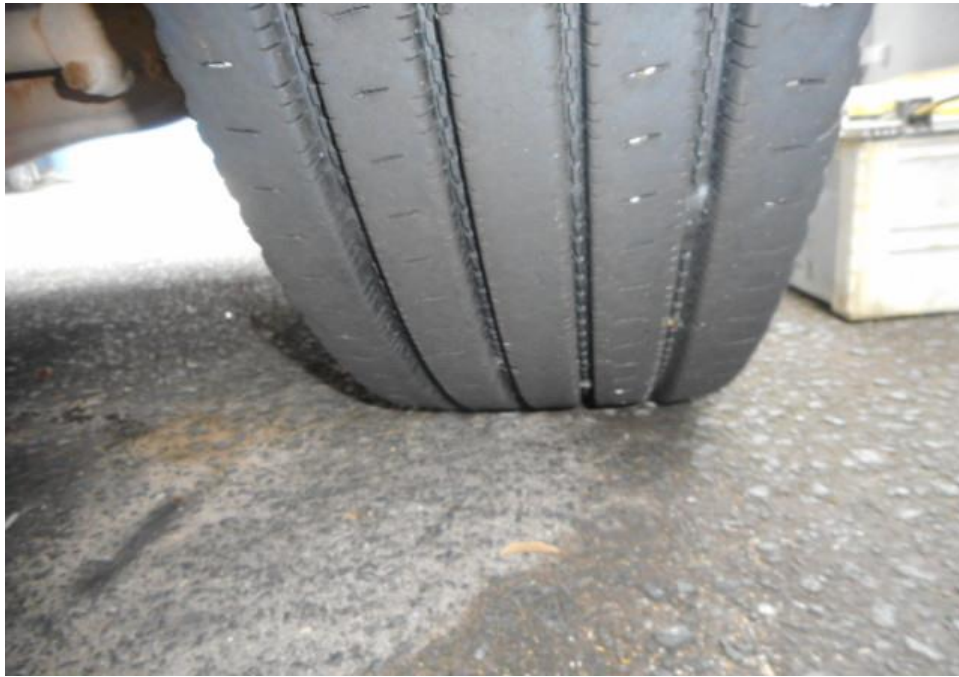
**Photo 6** shows the condition of the front right tyre of the Tipper Truck, which was observed to be in serviceable condition with remaining tread depth of approximately 8.9mm. The tyre, which was wrapped around standard steel wheel rim, was also observed to be sufficiently inflated for vehicular operation. There was no tear, cut or burst mark(s) on the outer and the inner sidewalls as well as across the tread of the 6 tyres that were fitted on the Tipper Truck.

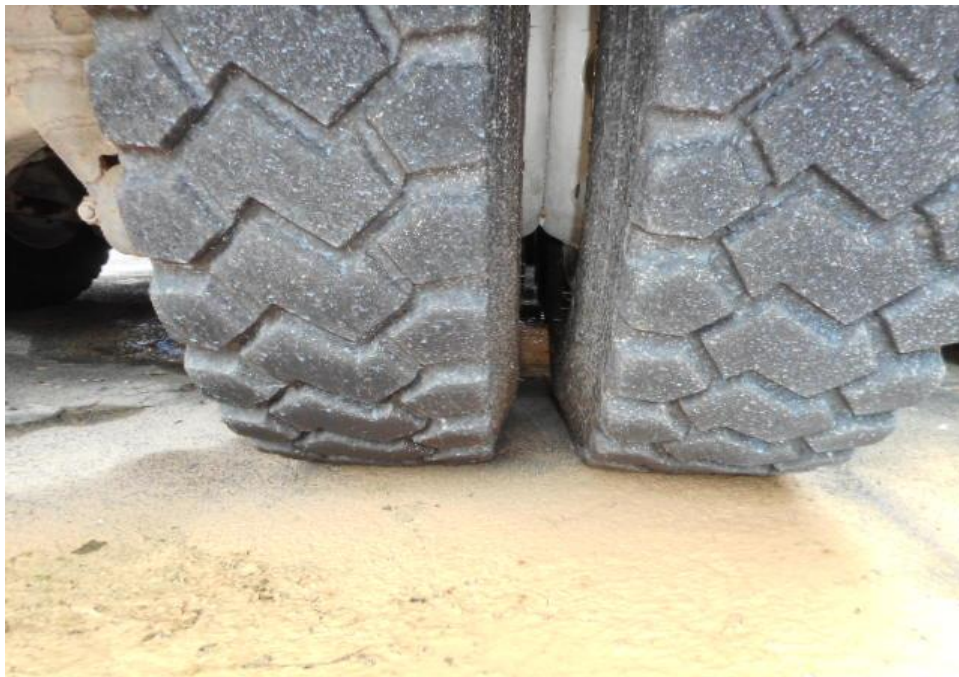
**Photo 7** shows the condition of the rear right tyre of the Tipper Truck, which was observed to be in serviceable condition with remaining tread depth of approximately 9.1mm. The tyre, which was wrapped around standard steel wheel rim, was also observed to be sufficiently inflated for vehicular operation.

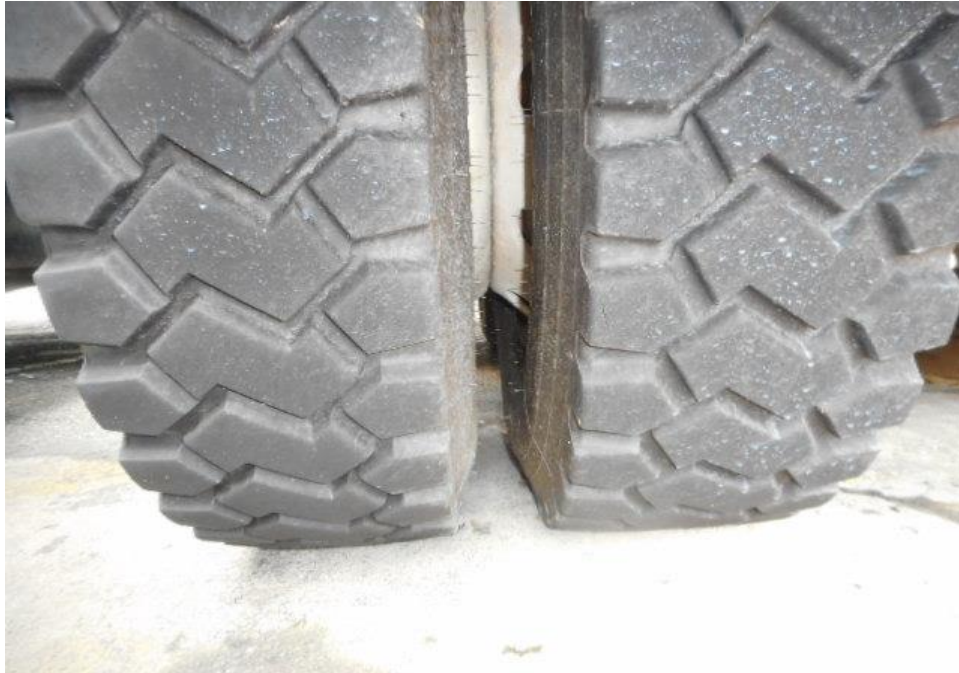
**Photo 8** shows the condition of the rear left tyres of the Tipper Truck, which was observed to be in serviceable condition with remaining tread depth of approximately 14.2mm. The tyres, which were wrapped around standard steel wheel rim, were also observed to be sufficiently inflated for vehicular operation. There was also no damage found on all 6 steel wheel rims of the Tipper Truck.

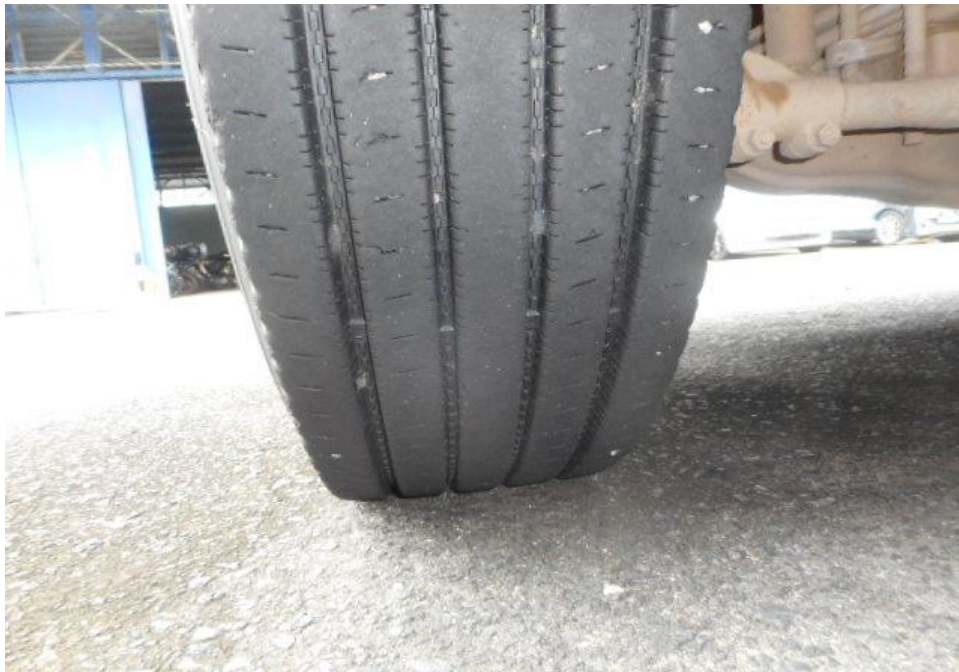
**Photo 9** shows the condition of the front left tyres of the Tipper Truck, which were observed to be in serviceable condition with remaining tread depth of approximately 11.8mm. There was also no tear, cut or burst mark(s) on the outer and the inner sidewalls as well as across the tread of the 6 tyres that were fitted on the Tipper Truck.

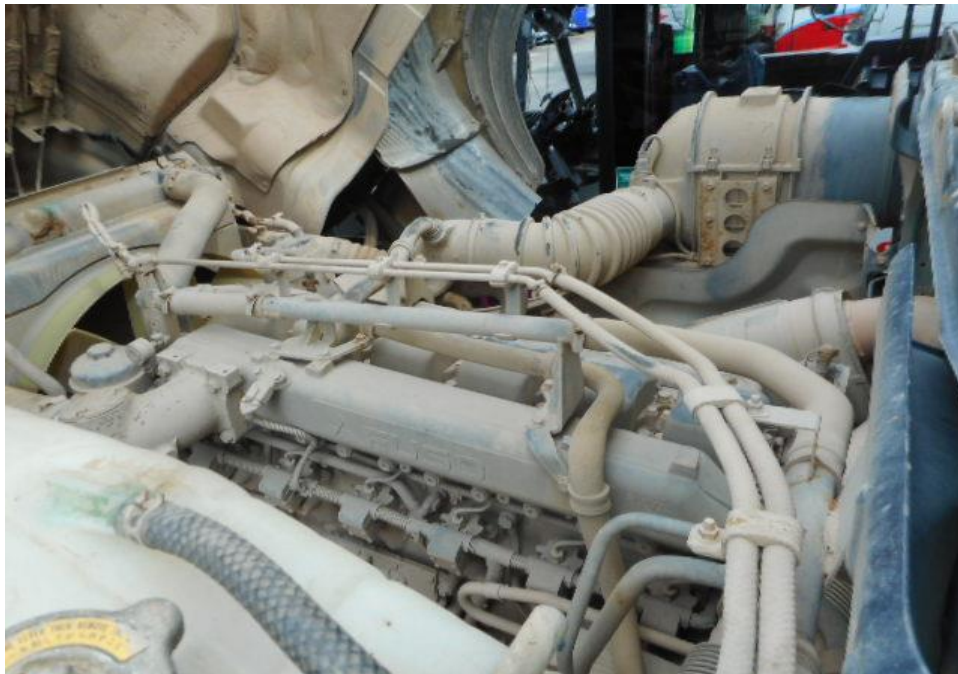
**Photo 10** shows a general view of the Tipper Truck's engine compartment, which was accessed by lifting the front cabin of the Tipper Truck. The various parts and components inside the engine compartment were unaffected by the accident. There was also no sign(s) or indication(s) of fresh fluid leakage and/or fluid stain within the engine compartment

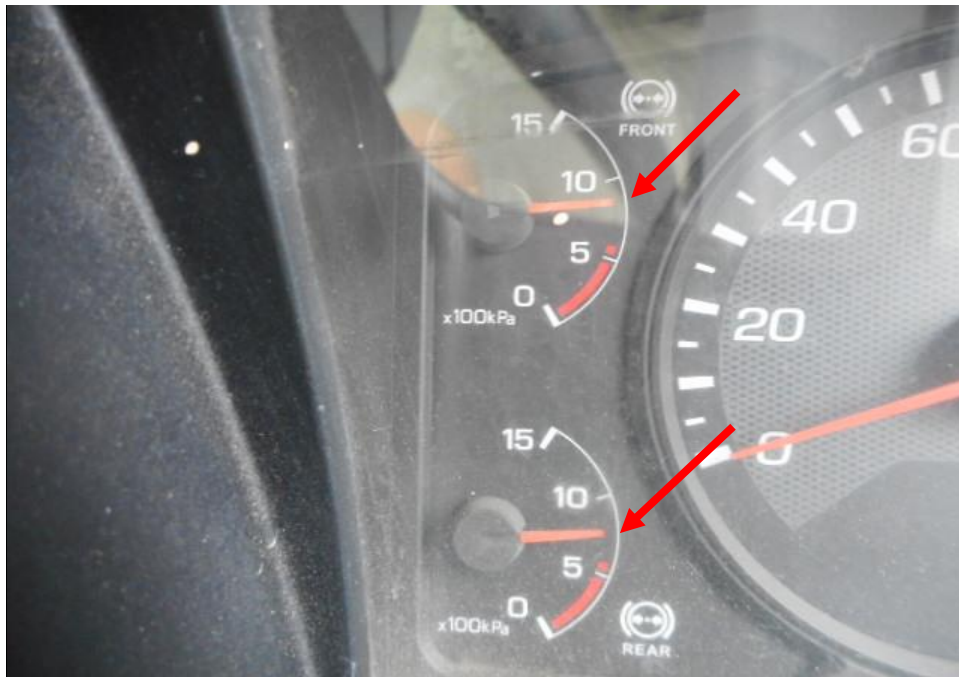
**Photo 11** shows the air in the air brake cylinders of the Tipper Truck at the time of my inspection. The air in the cylinder was observed to be of sufficient level & serviceable at the time of the accident.

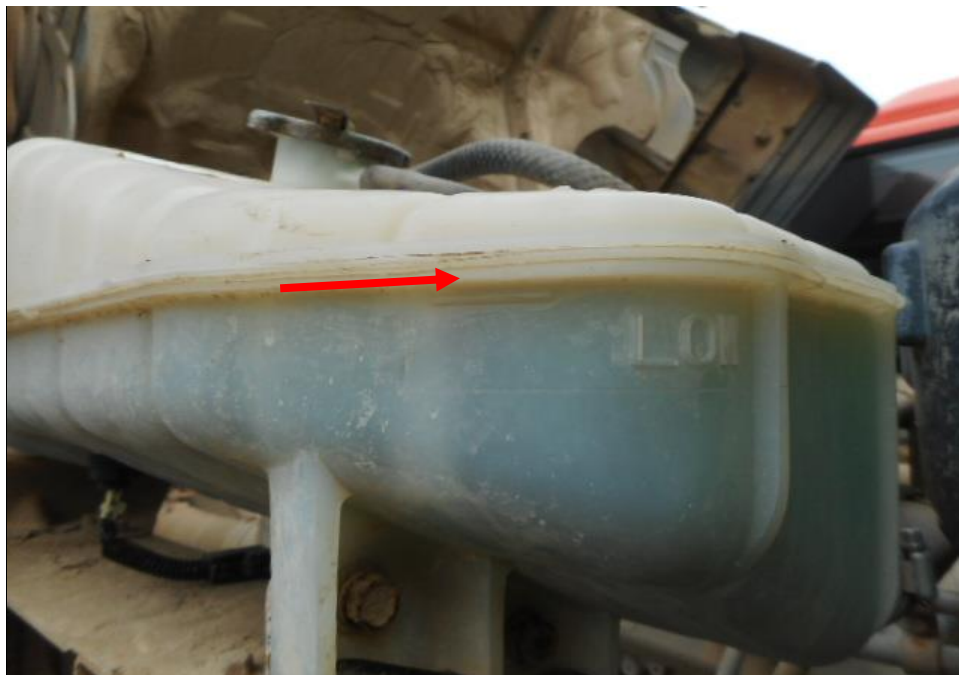
**Photo 12** shows the engine coolant reservoir of the Tipper Truck at the time of my inspection. The engine coolant was observed to be of sufficient level (arrowed) and without any visible contamination.

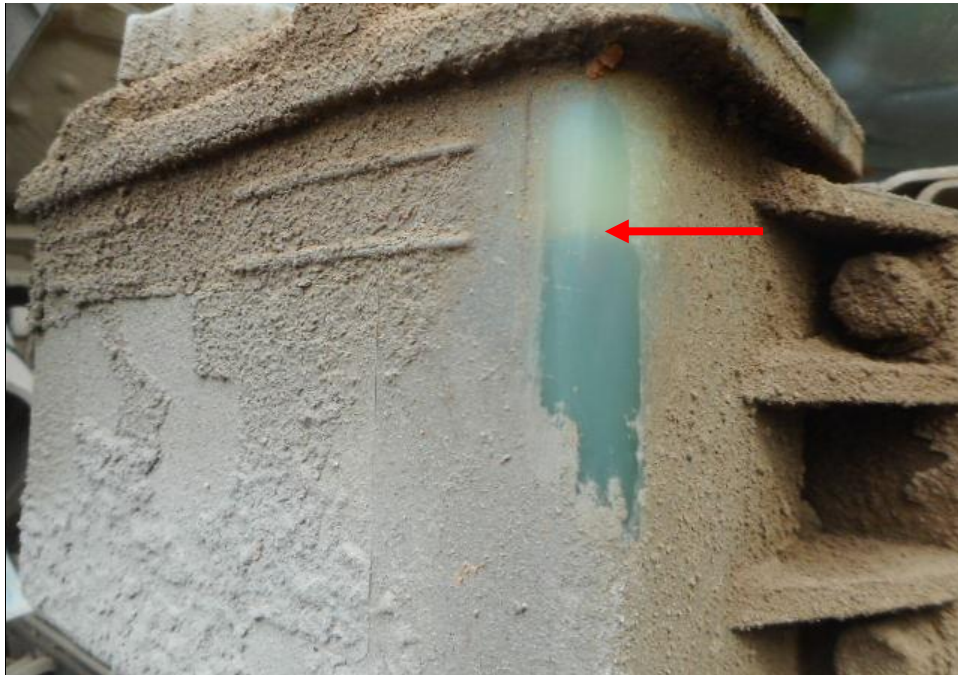
**Photo 13** shows the power steering fluid reservoir of the Tipper Truck at the time of my inspection. The power steering fluid was observed to be of sufficient level (arrowed) and without any visible contamination.

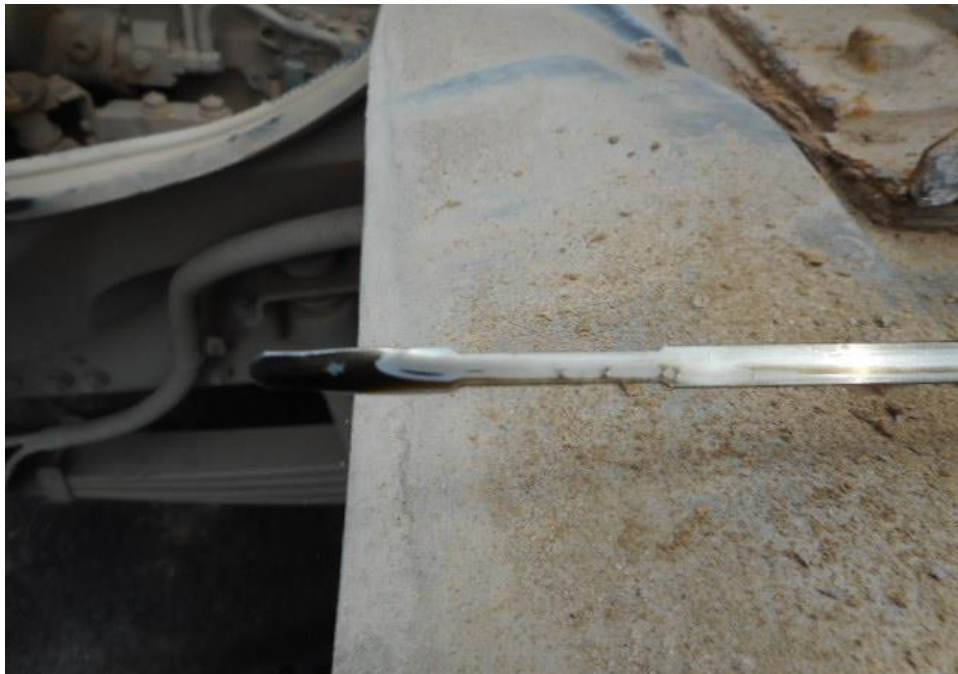
**Photo 14** shows the engine oil dip stick of the Tipper Truck at the time of my inspection. The engine oil was observed to be of insufficient level at the time of our inspection.

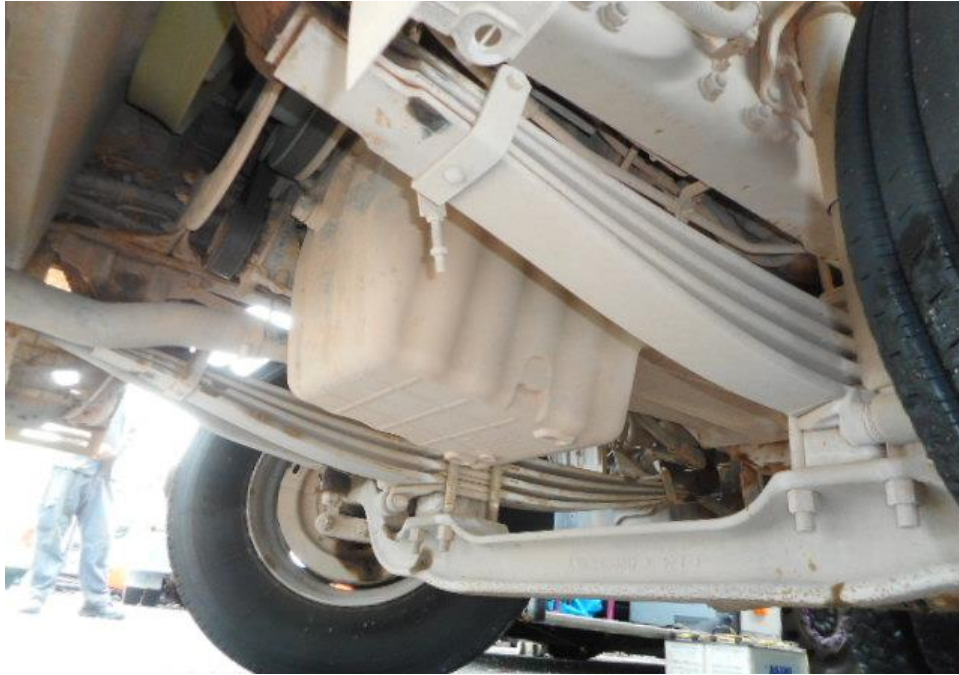
**Photo 15** shows the undercarriage of the Tipper Truck, at the area where the engine housing located. I did not find any sign(s) or indication(s) of fluid leak, however old fluid stain(s) was observed on the underside of the Tipper Truck.

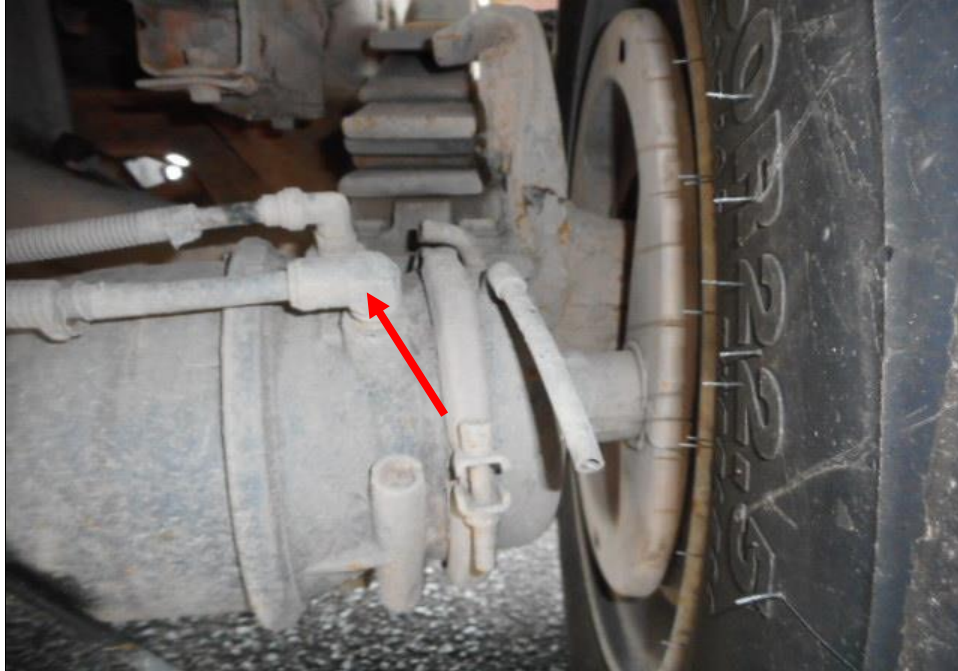
**Photo 16** shows the brake pipe (arrowed) at the rear right wheel of the Tipper Truck. I did not observe any leakage of brake fluid at the time of my inspection of the Tipper Truck. My static tests of the Tipper Truck's braking system, along with my visual examination of the various mechanical components in the braking system, had indicated that there was no internal leakage of pressure/vacuum. Hence the braking system of the Tipper Truck was likely to be in serviceable condition at the material time of accident.

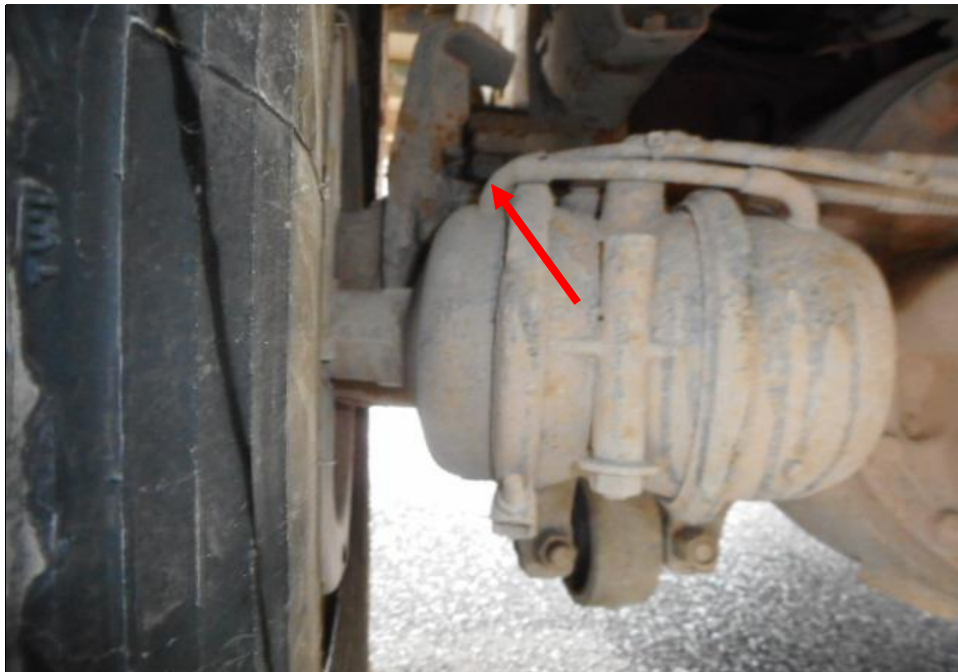
**Photo 17** shows the brake pipe (arrowed) at the rear left wheel of the Tipper Truck. I did not observe any leakage of brake fluid at the time of my inspection of the Tipper Truck. My static tests of the Tipper Truck's braking system, along with my visual examination of the various mechanical components in the braking system, had indicated that there was no internal leakage of pressure/vacuum. Hence the braking system of the Tipper Truck was likely to be in serviceable condition at the material time of accident.

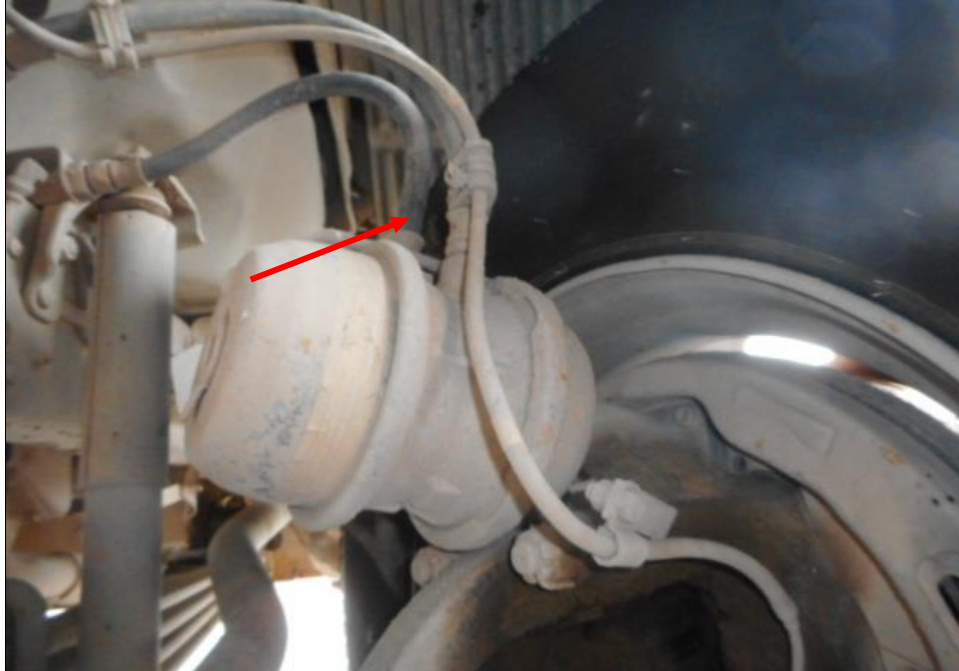
**Photo 18** shows the brake pipe (arrowed) at the front right wheel of the Tipper Truck. I did not observe any leakage of brake fluid at the time of my inspection of the Tipper Truck. My static tests of the Tipper Truck's braking system, along with my visual examination of the various mechanical components in the braking system, had indicated that there was no internal leakage of pressure/vacuum. Hence the braking system of the Tipper Truck was likely to be in serviceable condition at the material time of accident.

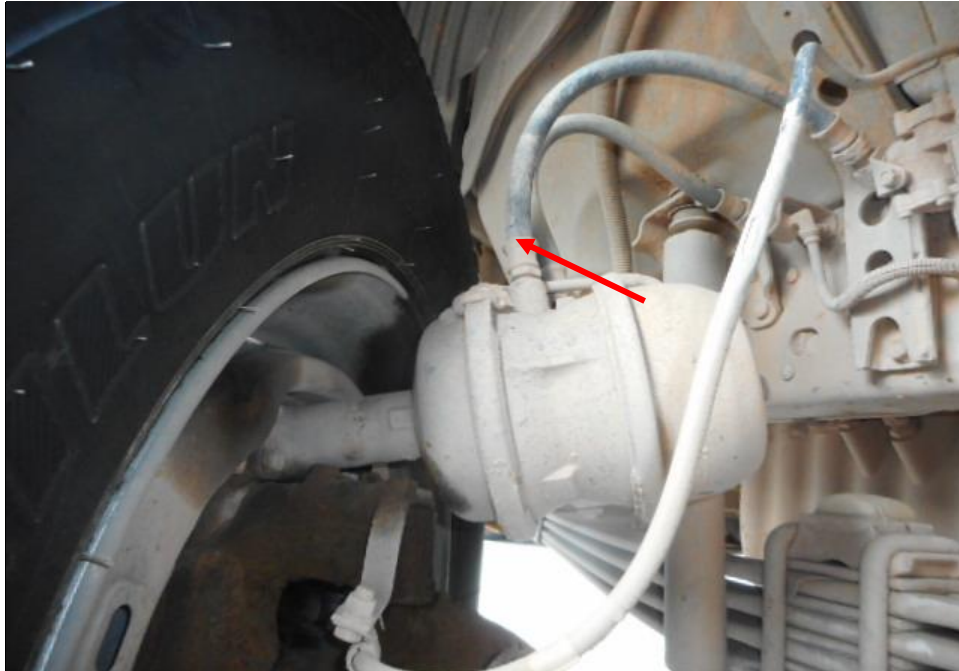
**Photo 19** shows the brake pipe (arrowed) at the front left wheel of the Tipper Truck. I did not observe any leakage of brake fluid at the time of my inspection of the Tipper Truck. My static tests of the Tipper Truck's braking system, along with my visual examination of the various mechanical components in the braking system had indicated that there was no internal leakage of pressure/vacuum. Hence the braking system of the Tipper Truck was likely to be in serviceable condition at the material time of accident.

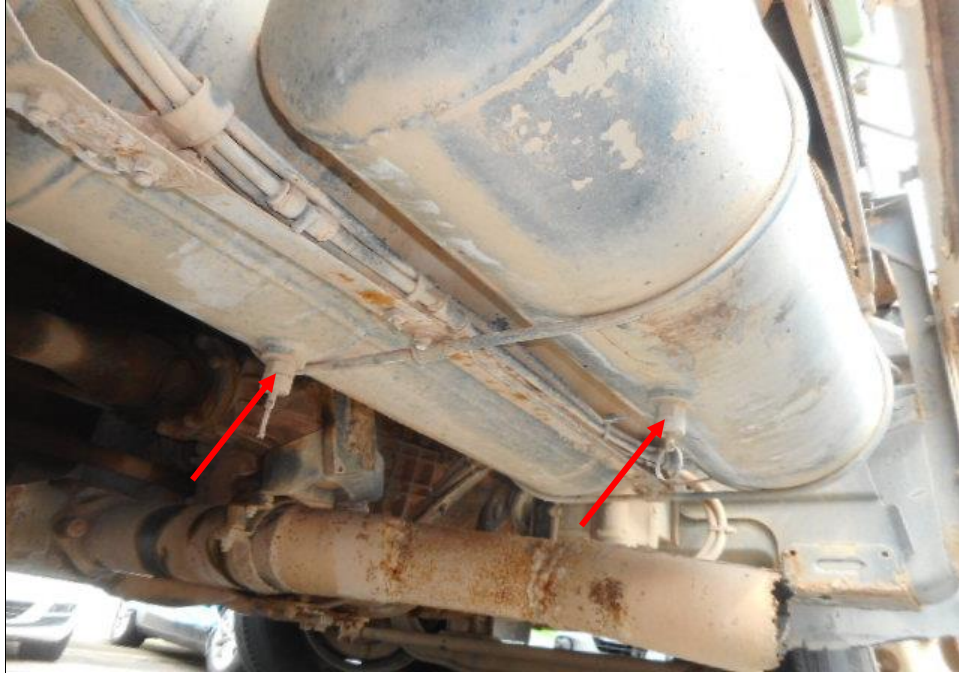
**Photo 20** shows the air brake cylinders (arrowed) at the undercarriage of the Tipper Truck. I did not observe any leakage of air brake fluid at the time of my inspection of the Tipper Truck. My static tests of the Tipper Truck's braking system, along with my visual examination of the various mechanical components in the braking system had indicated that there was no internal leakage of pressure/vacuum. Hence the braking system of the Tipper Truck was likely to be in serviceable condition at the material time of accident.

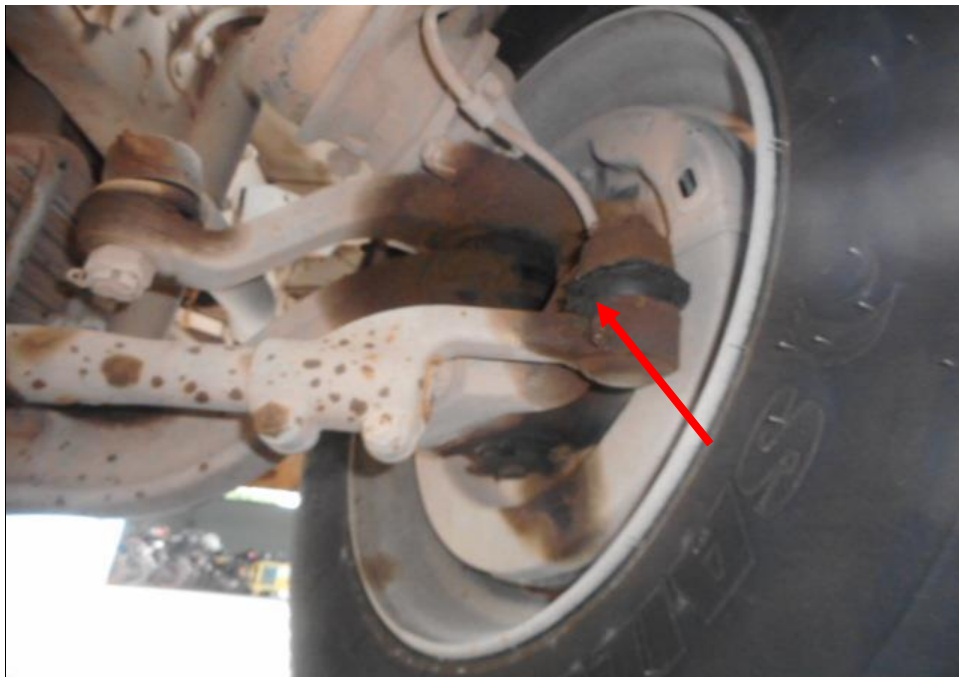
**Photo 21** shows the various undercarriage components at the front right wheel of the Tipper Truck, in particular the steering tie rod end (arrowed). The various steering components were all found to be intact, suggesting that the steering system of the Tipper Truck was likely to be in serviceable condition at the material time of accident. There was also no sign of fluid stain(s) observed on the various undercarriage components.

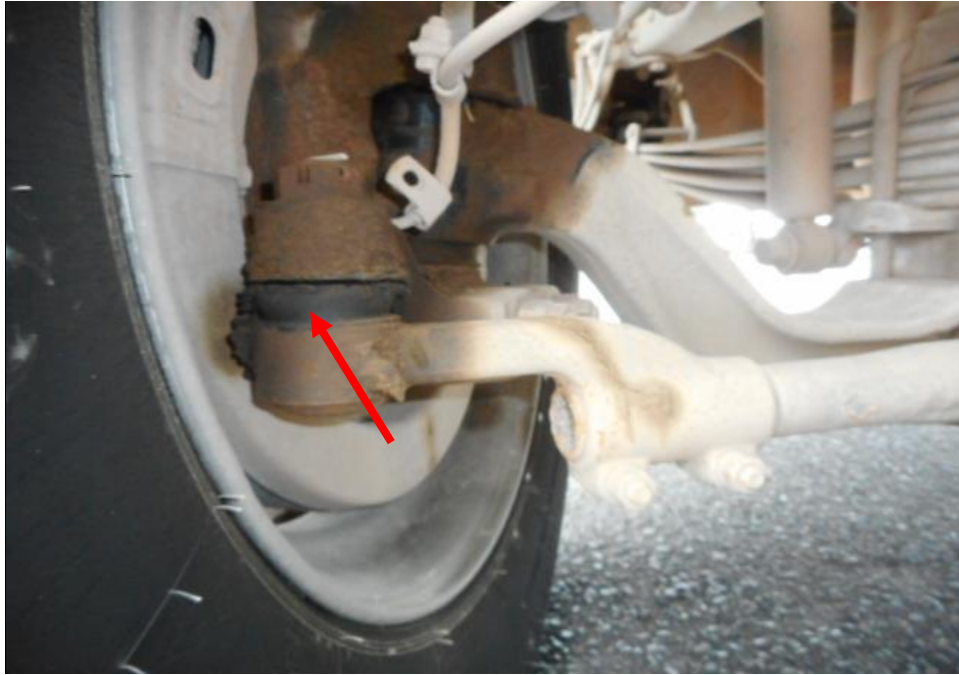
**Photo 22** shows the various undercarriage components at the front left wheel of the Tipper Truck, in particular the steering tie rod end (arrowed). The various undercarriage components of the Tipper Truck were all found to be intact without any visible damage. There was also no sign of fluid stain(s) observed on the various undercarriage components.

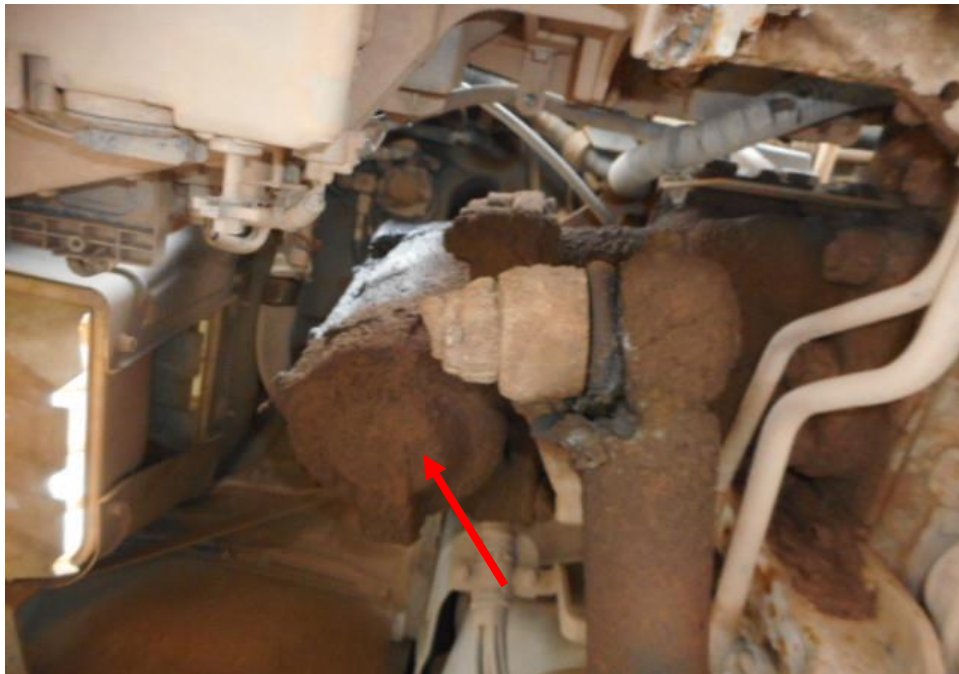
**Photo 23** shows the steering box component (arrowed) at the undercarriage of the Tipper Truck was found to be intact without any visible damage. There was also no sign of fluid stain(s) observed on the various undercarriage components.

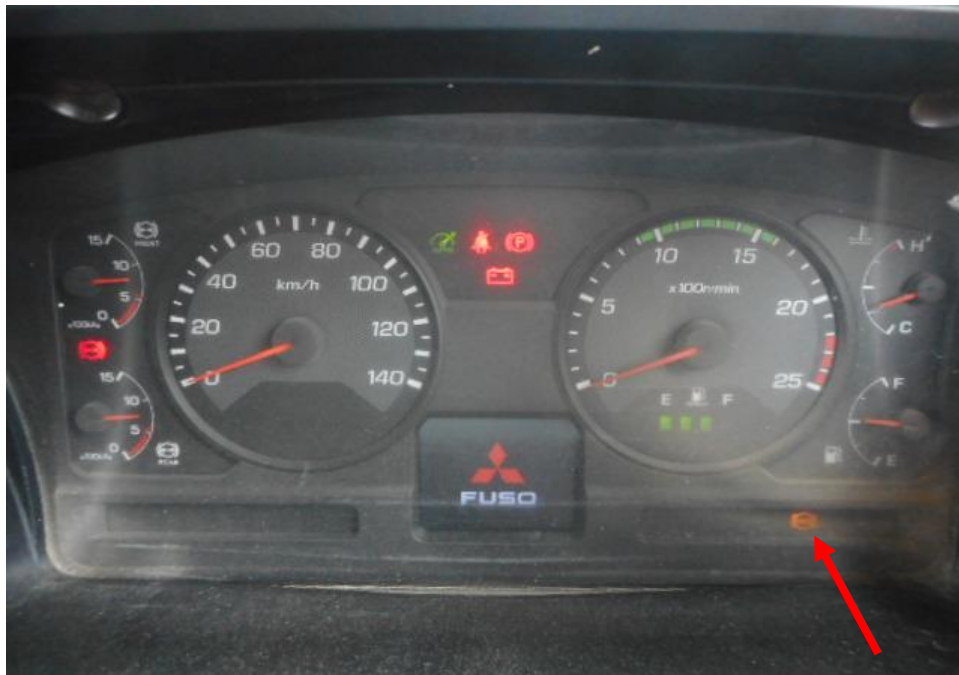
**Photo 25** shows the warning light for Anti-Lock Braking System (ABS) (arrowed) appearing on the instrument panel of the Prime Mover during the self-test of its various electronic operating systems when its engine was cranked.

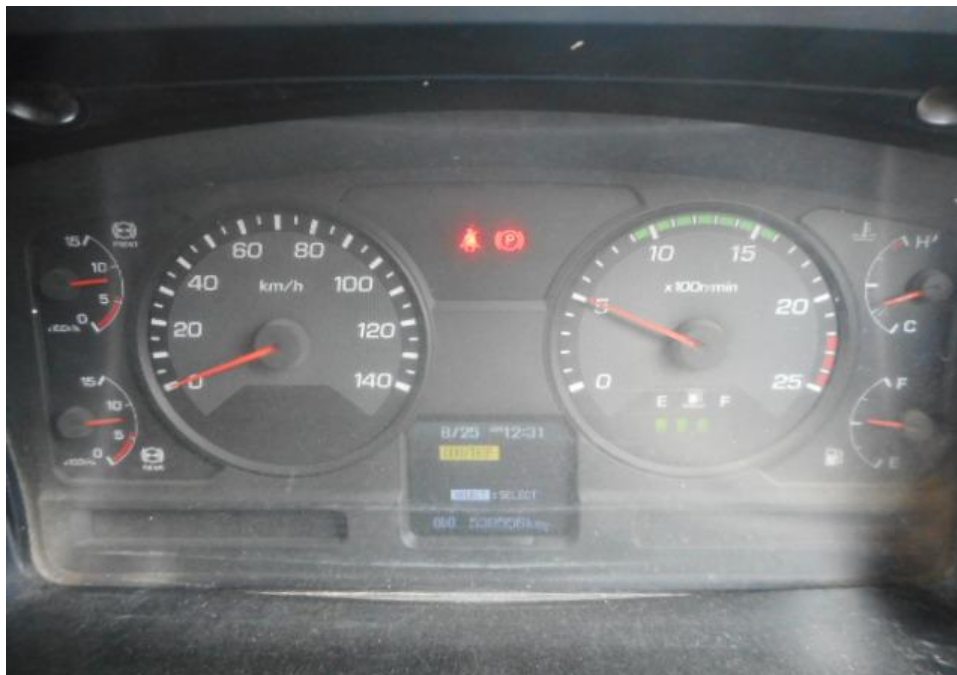
**Photo 26** shows the Anti-Lock Braking System (ABS) warning lights had went off on the instrument panel of the Prime Mover after the engine was cranked. This would suggest that there was no abnormality to the electronic operating system of the Prime Mover, like the ABS, and etc.
