Your Ref: TP/IP/18025/2022
Our Ref : CI/TPD22008179/P

Fatal Accident Investigation Team

MECHANICAL INSPECTION REPORT OF MOTOR CAR SJS 3974B

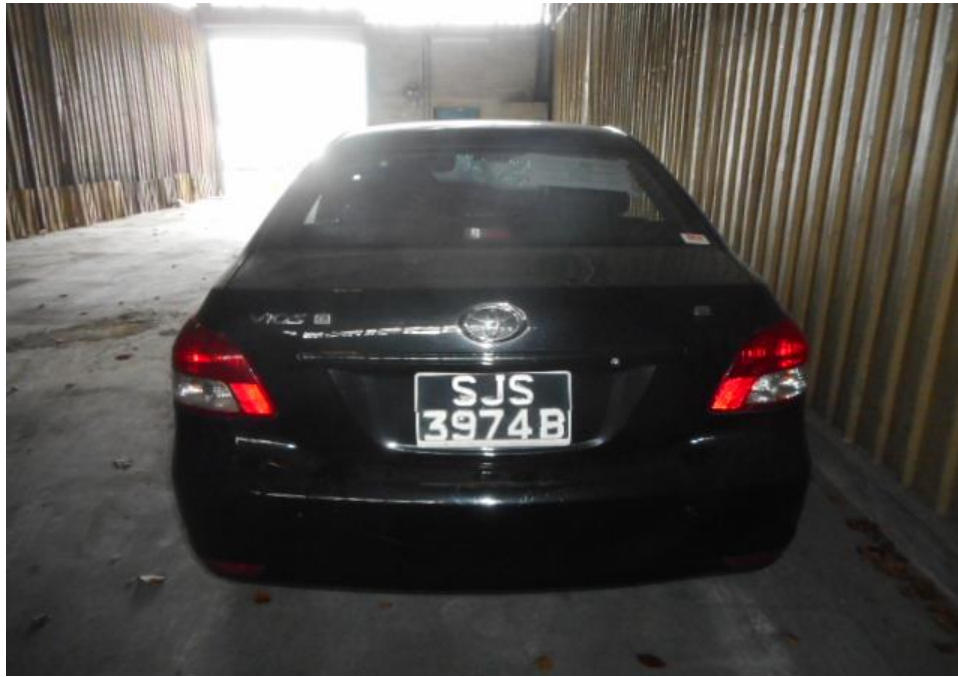
Photo 1 shows a general view of the Motor Car's rear body at the time of my inspection. The rear portion of the Motor Car was observed to have been undamaged by the accident.

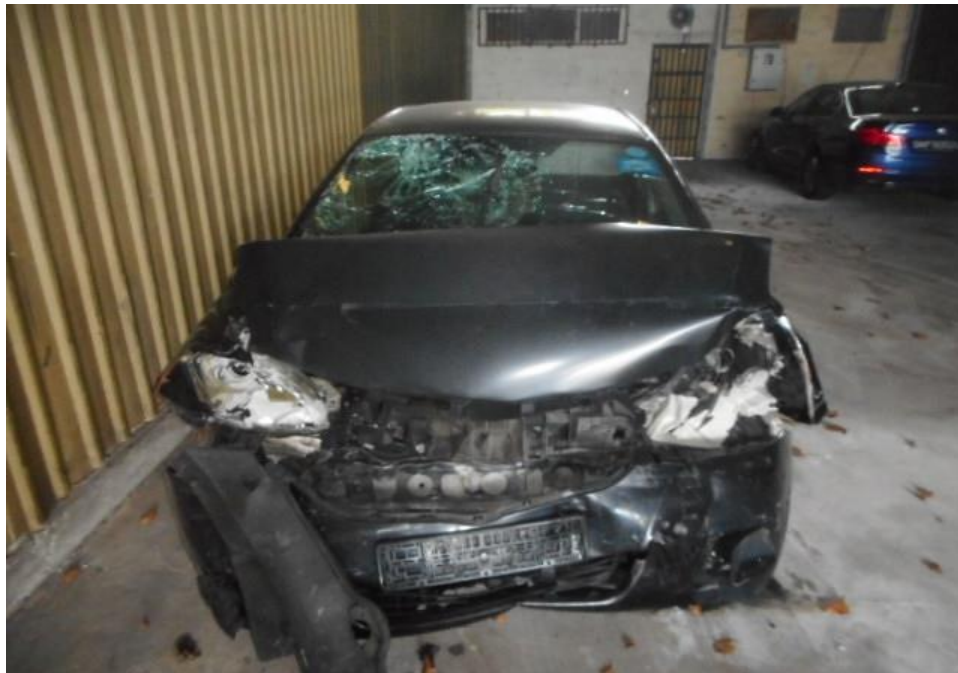
Photo 2 shows a general view of the Motor Car's front body at the time of my inspection. The Motor car was observed to have sustained damage at its front portion. Its front windscreen, front bonnet, front bumper, front left and right fender, front left and right headlamp was amongst the body parts and various engine components were also damaged as a result of the accident. The Supplemental Restraint System (SRS) was activated as a result of the accident.

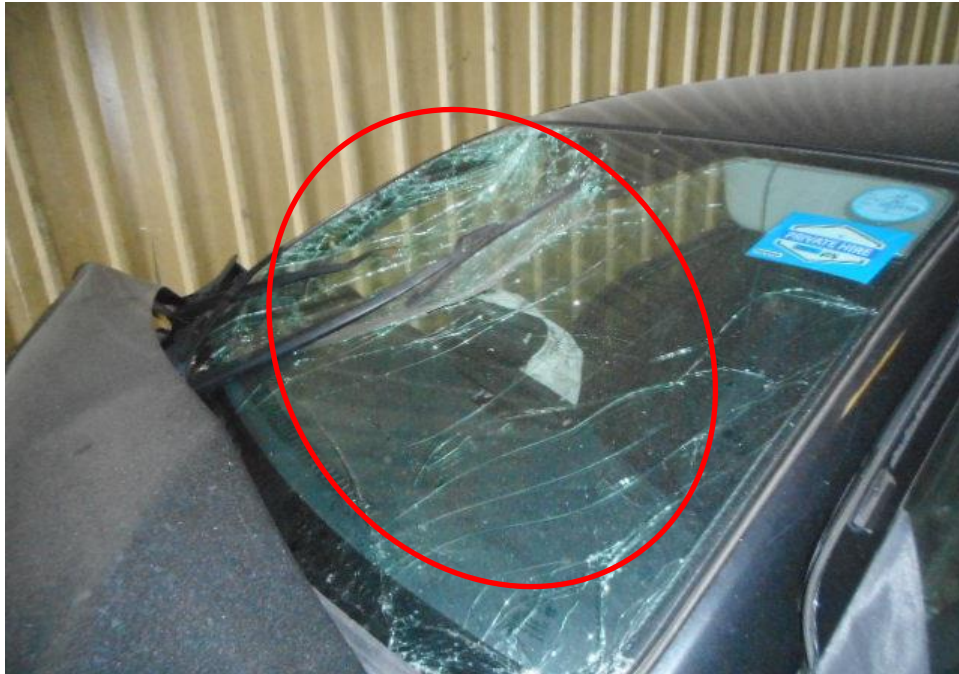
Photo 3 shows the close up view of the Motor Car's front body at the time of my inspection. The Motor car was observed to have sustained damage at its front portion. Its front windscreen (circled) was damaged as a result of the accident.

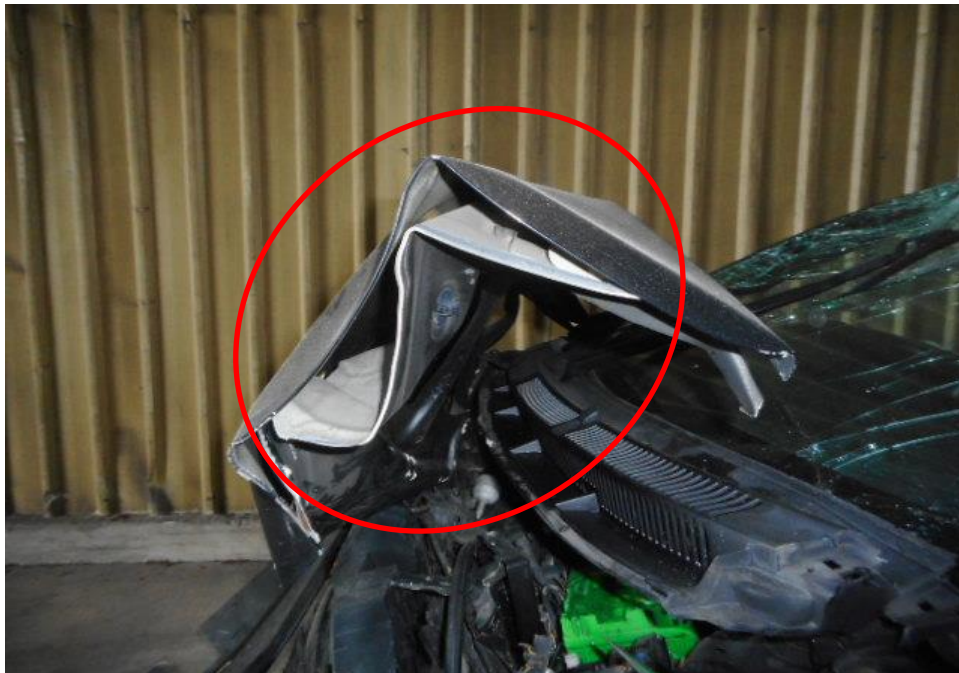
Photo 4 shows the close up view of the Motor Car's front body at the time of my inspection. The Motor car was observed to have sustained damage at its front portion. Its front bonnet (circled) was damaged as a result of the accident.

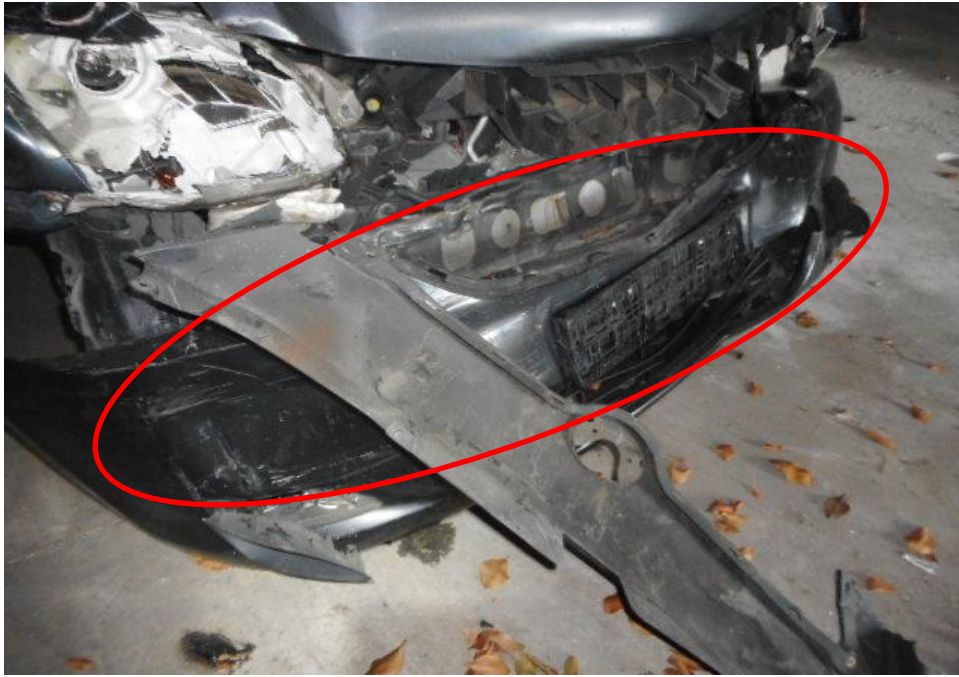
Photo 5 shows the close up view of the Motor Car's front body at the time of my inspection. The Motor car was observed to have sustained damage at its front portion. Its front bumper (circled) was damaged as a result of the accident.

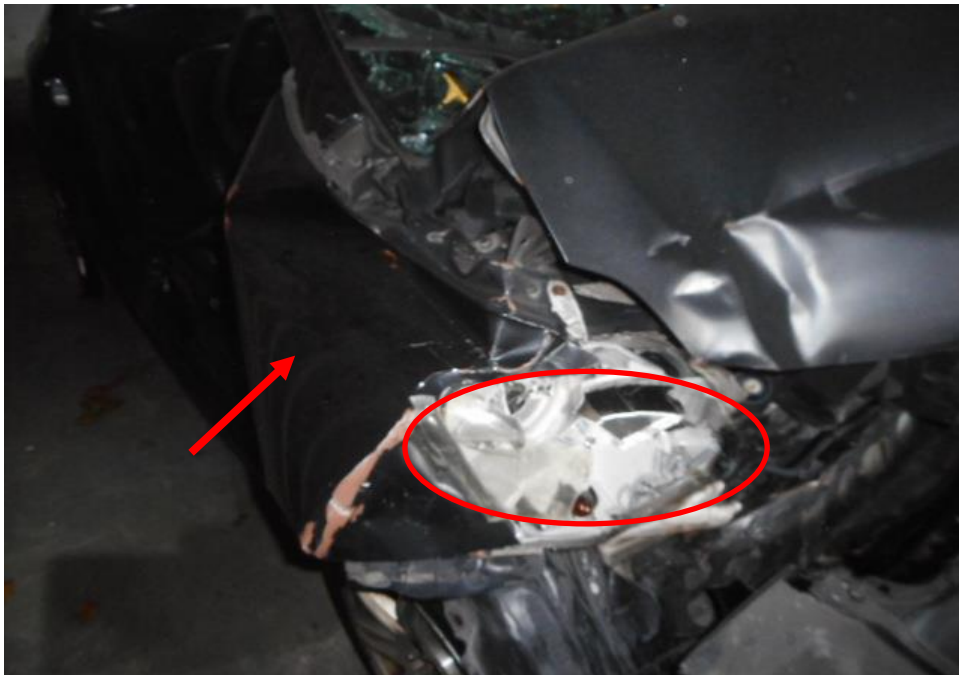
Photo 6 shows the close up view of the Motor Car's front body at the time of my inspection. The Motor car was observed to have sustained damage at its front portion. Its front right headlamp (circled) and front right fender (arrowed) was amongst the body parts and various components in the engine compartments were also damaged as a result of the accident.

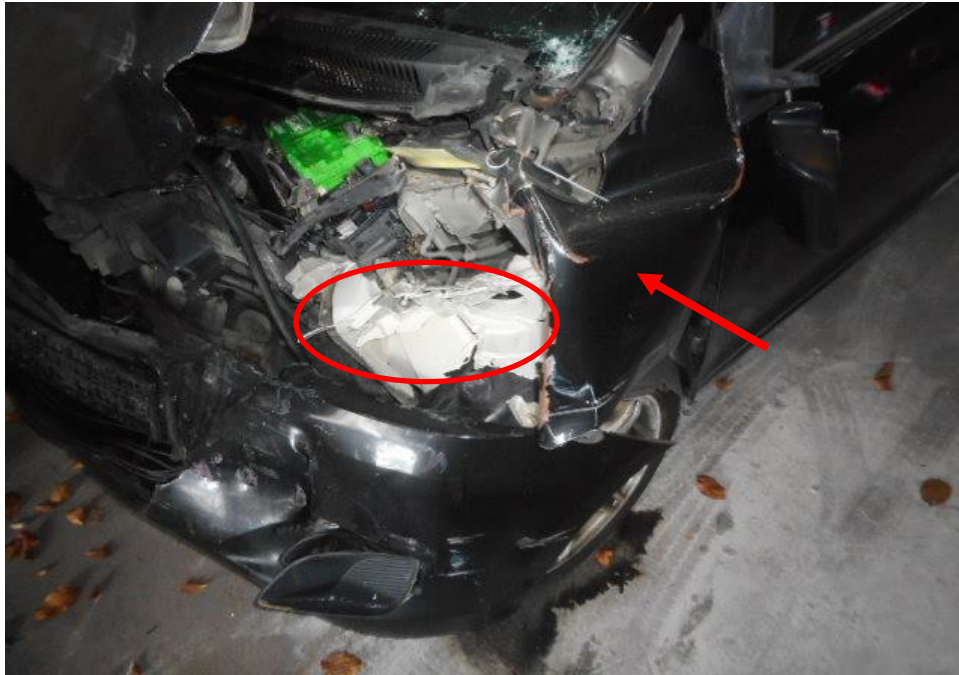
Photo 7 shows the close up view of the Motor Car's front body at the time of my inspection. The Motor car was observed to have sustained damage at its front portion. Its front left headlamp (circled) and front left fender (arrowed) was amongst the body parts and various components in the engine compartments were also damaged as a result of the accident.

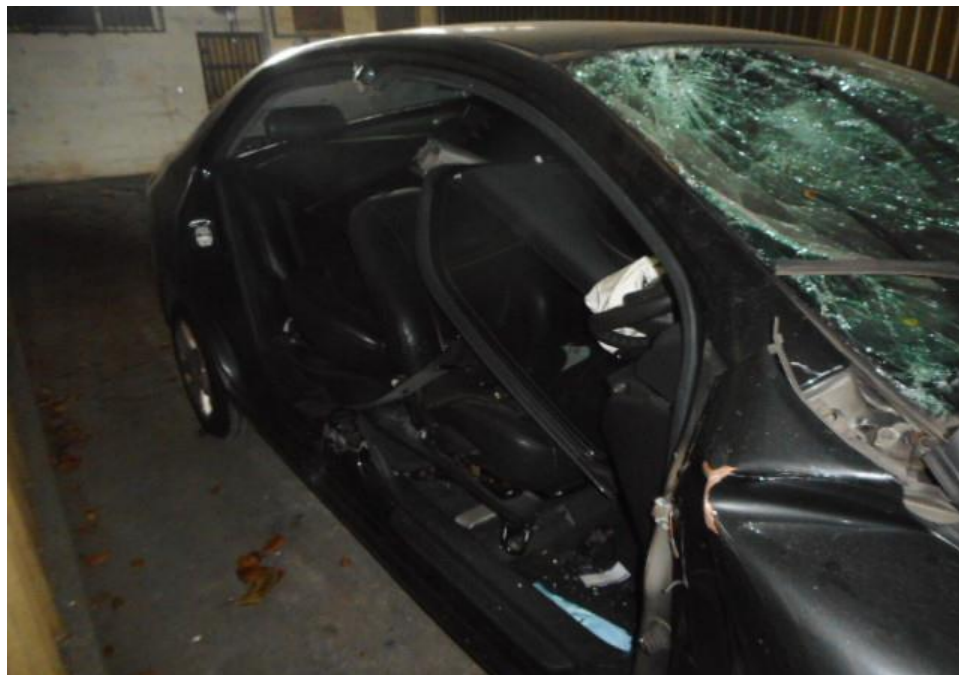
Photo 8 shows a general view of the Motor Car's right body at the time of my inspection. The right portion of the Motor Car was observed to have been removed due to the accident.

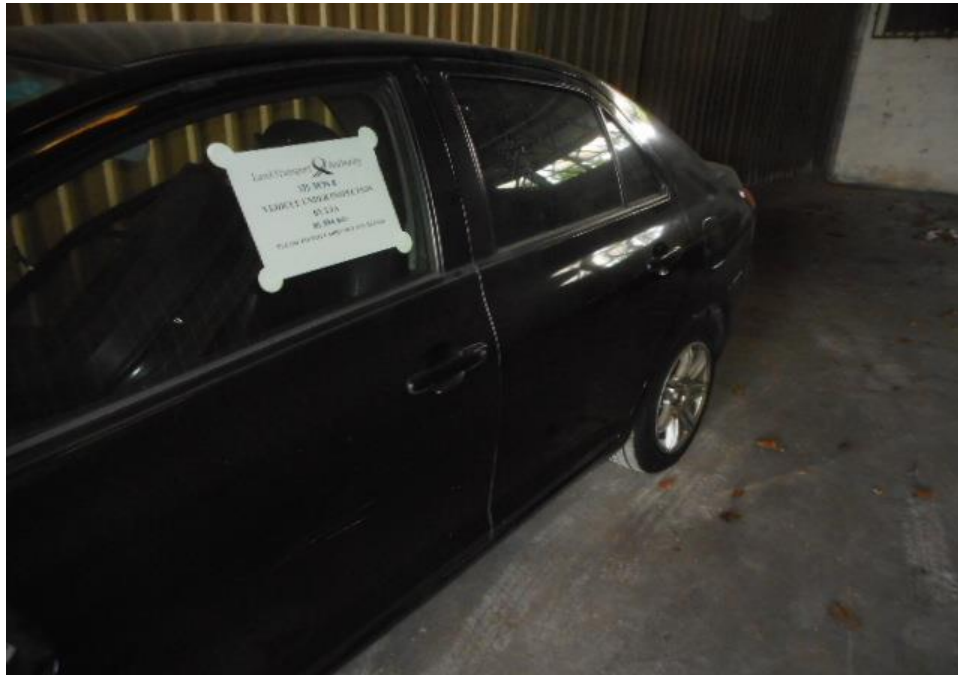
Photo 9 shows a general view of the Motor Car's left body at the time of my inspection. The left portion of the Motor Car was observed to have been undamaged by the accident.

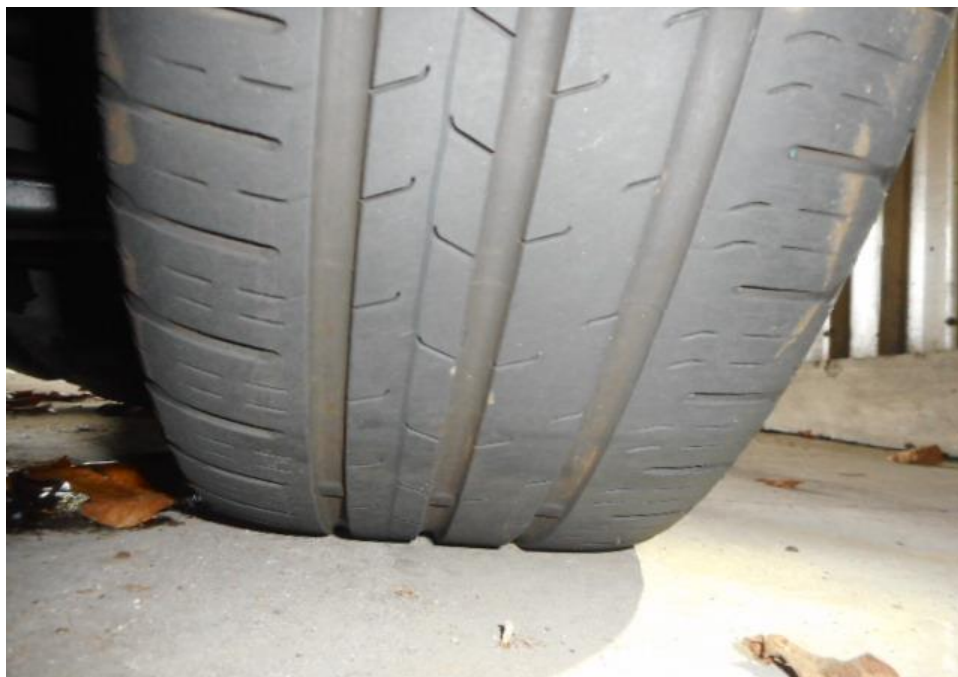
Photo 10 shows the condition of the front right tyre of the Motor Car, which was observed to be in serviceable condition with remaining tread depth of approximately 4.5mm. The tyre, which was wrapped around alloy wheel rim, was also observed to be sufficiently inflated for vehicular operation.

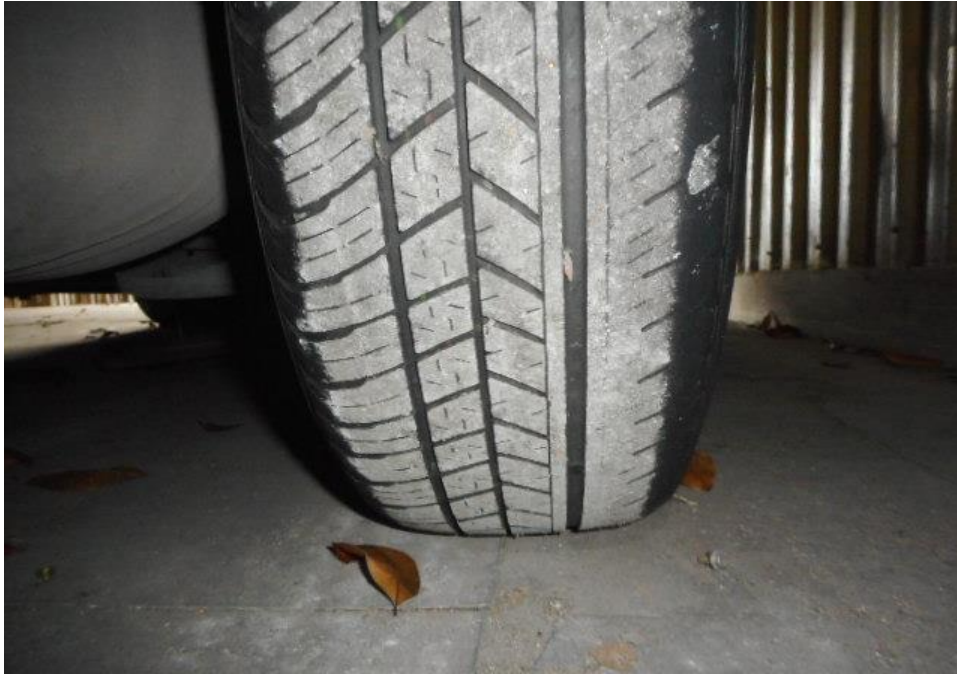
Photo 11 shows the condition of the rear right tyre of the Motor Car, which was observed to be in serviceable condition with remaining tread depth of approximately 3.3mm. The tyre was also observed to be sufficiently inflated for vehicular operation with no tear, cut or burst mark(s).

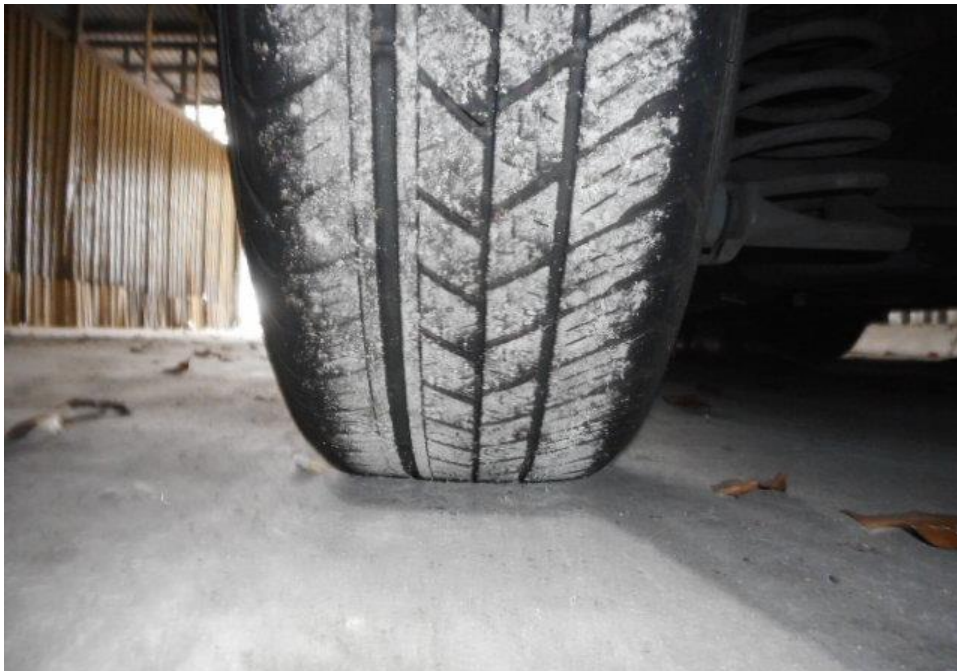
Photo 12 shows the condition of the rear left tyre of the Motor Car, which was observed to be in serviceable condition with remaining tread depth of approximately 4.2mm. The tyre was also observed to be sufficiently inflated for vehicular operation with no tear, cut or burst mark(s).

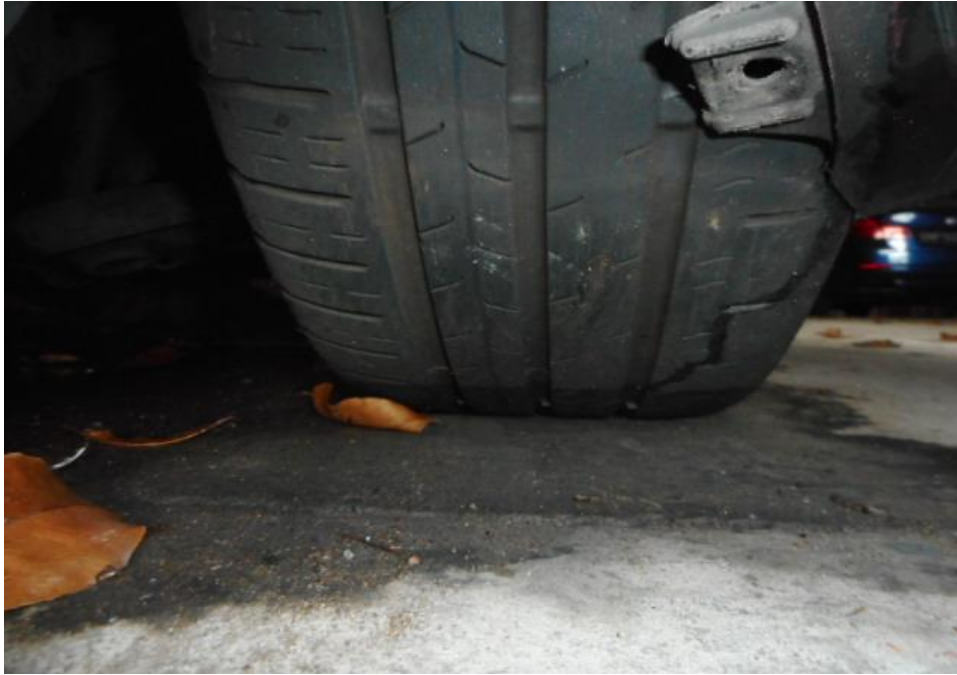
Photo 13 shows the condition of the front left tyre of the Motor Car, which was observed to be in serviceable condition with remaining tread depth of approximately 3.1mm. The tyre was also observed to be sufficiently inflated for vehicular operation with no tear, cut or burst mark(s).

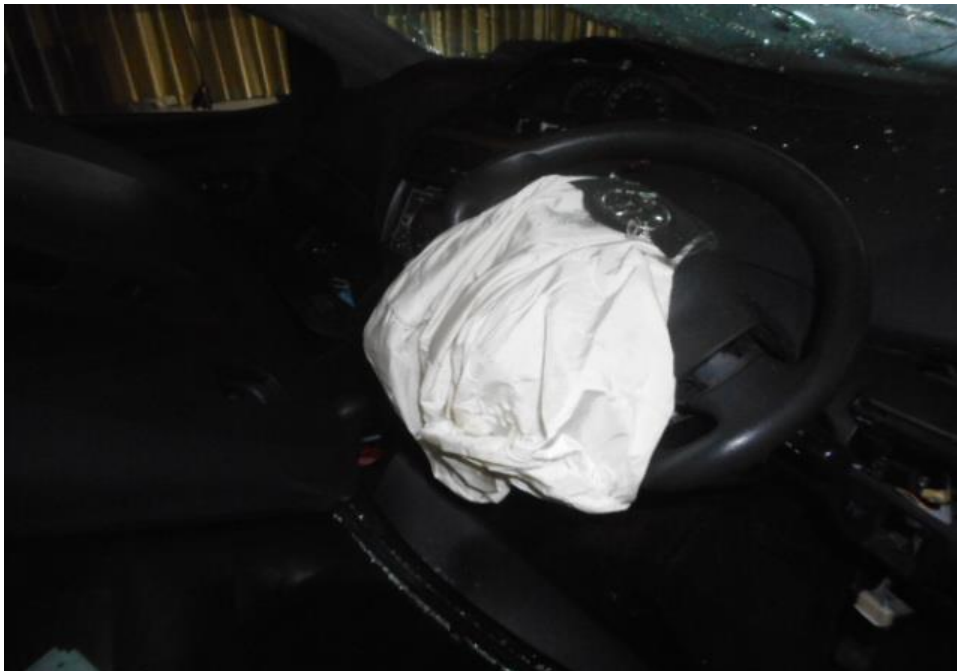
Photo 14 shows the deployment of the Supplemental Restraint System (SRS) airbag in the Motor Car as a result of the accident.

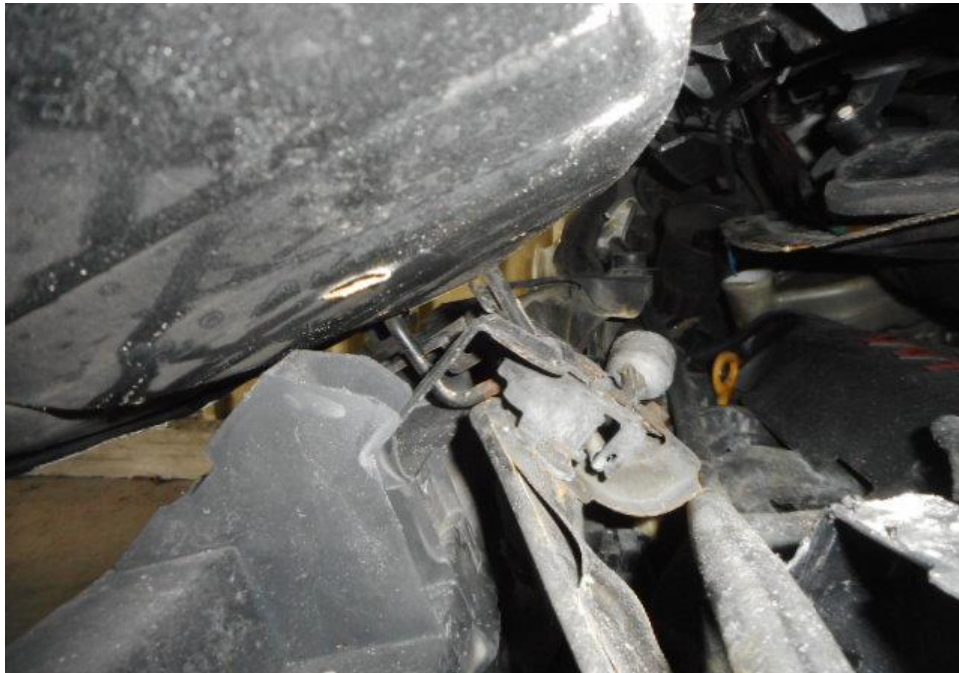
8. We were unable to raise the front bonnet of the Motor car to conduct the examination of the Motor Car's engine compartment because the damage caused by the accident had resulted in the damages to the lock mechanism of the bonnet and the structure of the engine compartment. (Unable to open).
9. During our inspection, we observed that the engine and ignition system was damaged as a result of the induced impact from the accident.
10. My subsequent checks on the underside of the Motor Car revealed sign(s) or indication(s) of fluid leak and/or fluid stain(s) from the damaged engine as a result of the accident. See photo 15 -17 below.

Photo 15 shows the close up view of the Motor Car's engine compartment at the time of my inspection. Its engine and components were crushed and damaged as a result of the accident.

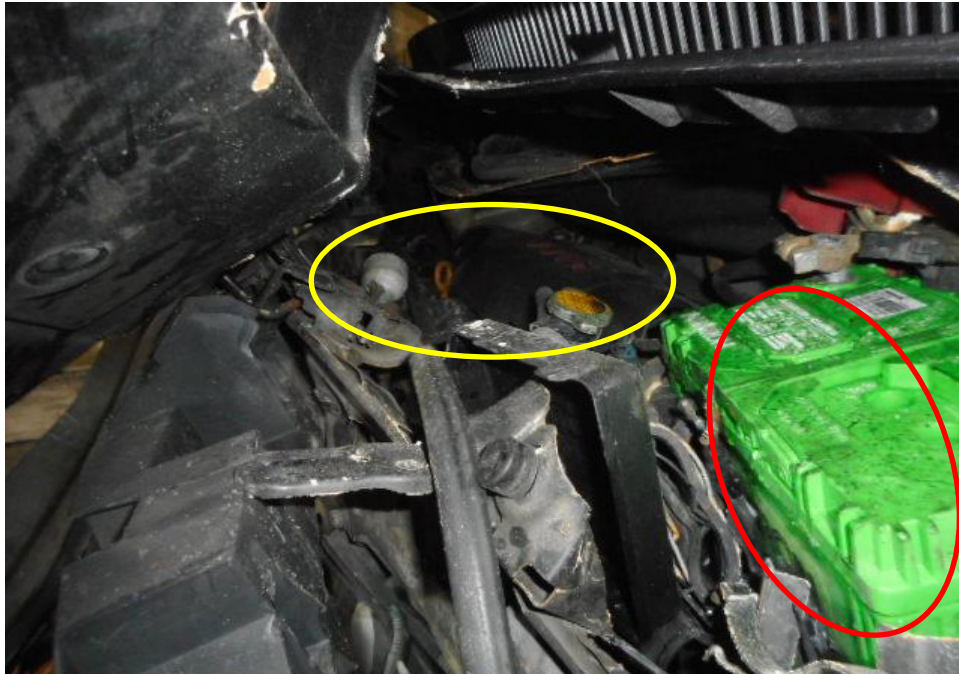
Photo 16 shows the close up view of the Motor Car's front body at the time of my inspection. The Motor car was observed to have sustained damage at its front portion. Its ignition system battery (red circle) and engine (yellow circle) was amongst the various components in the engine compartments were also damaged as a result of the accident.

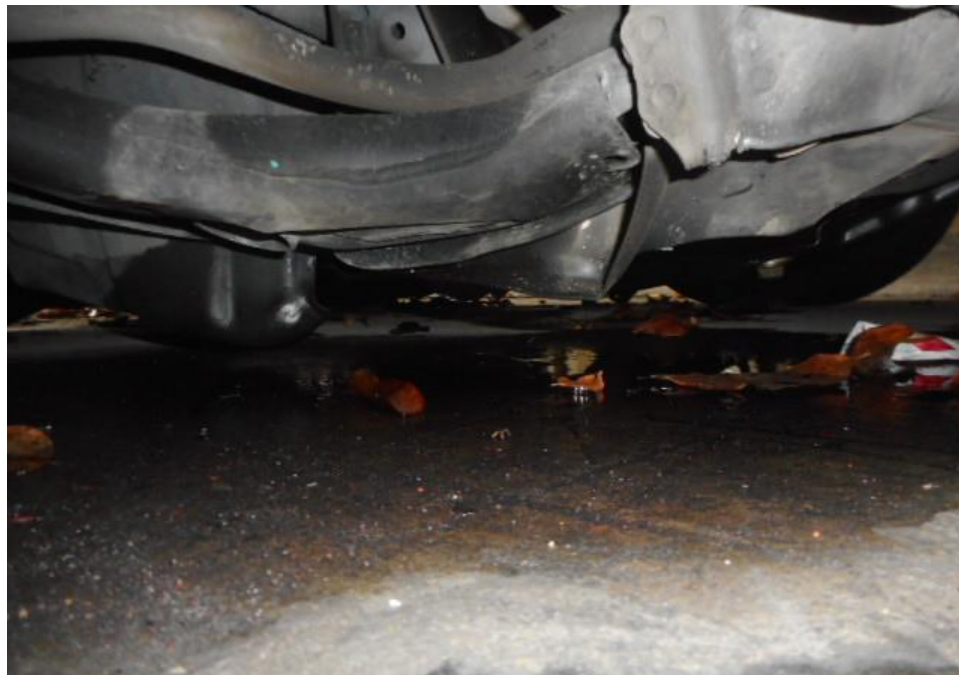
Photo 17 shows the undercarriage of the Motor Car, at the area where the engine housing and transmission housing are located. I found sign(s) or indication(s) of fluid leak and/or fluid stain(s) on the underside of the Motor Car due to the damaged engine as a result of the accident.

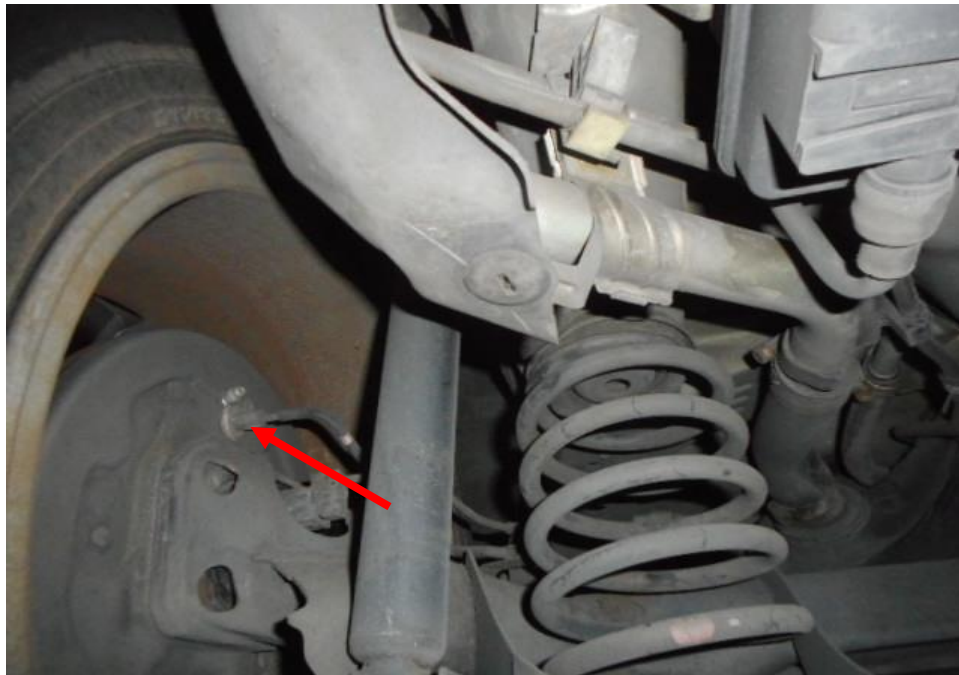
Photo 18 shows the brake hose/pipe (arrowed) at the rear left wheel of the Motor Car. No leakage of brake fluid was observed. Visual examination of the various components of the braking system like the drum brake, brake booster, brake pedal etc. had revealed all to be intact and without visible damage.

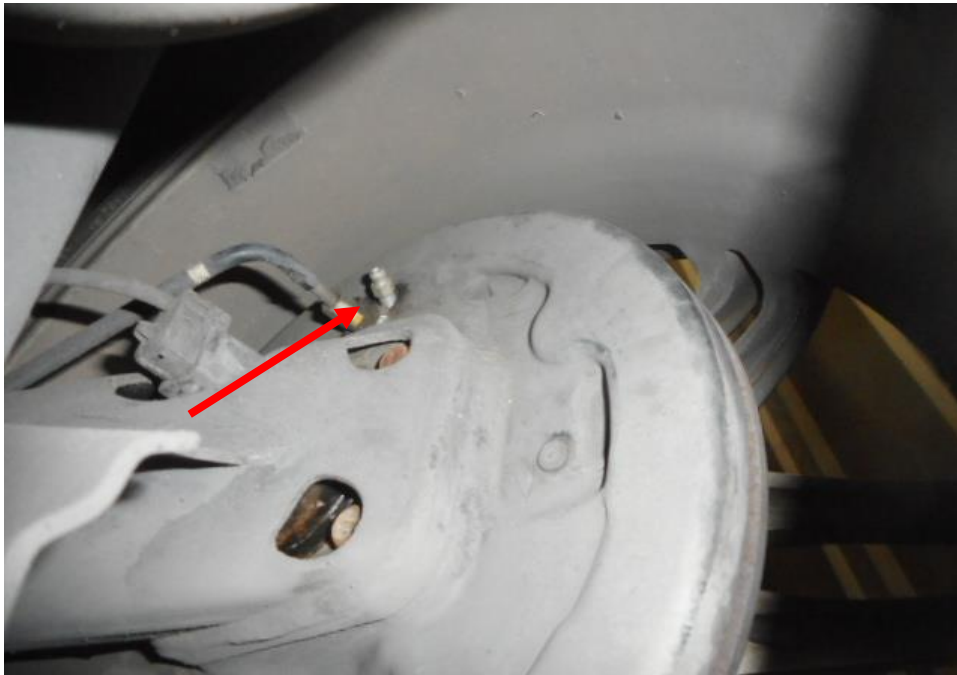
Photo 19 shows the brake hose/pipe (arrowed) at the rear right wheel of the Motor Car. No leakage of brake fluid was observed. Visual examination of the various components of the braking system like the drum brake, brake booster, brake pedal etc. had revealed all to be intact and without visible damage.

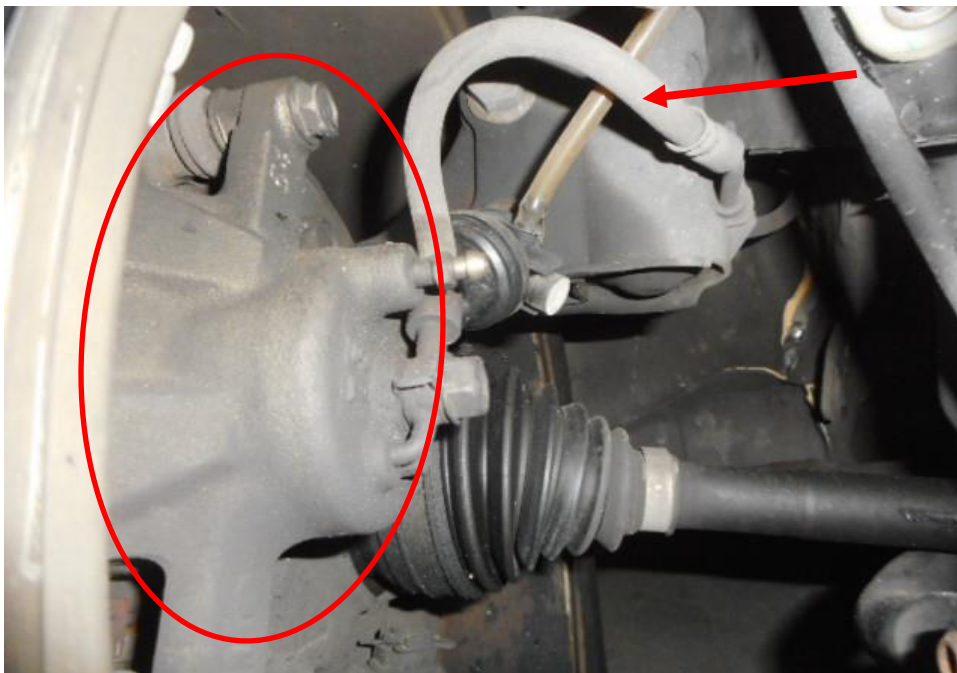
Photo 20 shows the brake hose/pipe (arrowed) at the front right wheel of the Motor Car. I did not observe any leakage of brake fluid at the time of my inspection of the Motor Car. Static tests of the Motor Car's braking system had indicated that there was no internal leakage of pressure/vacuum.

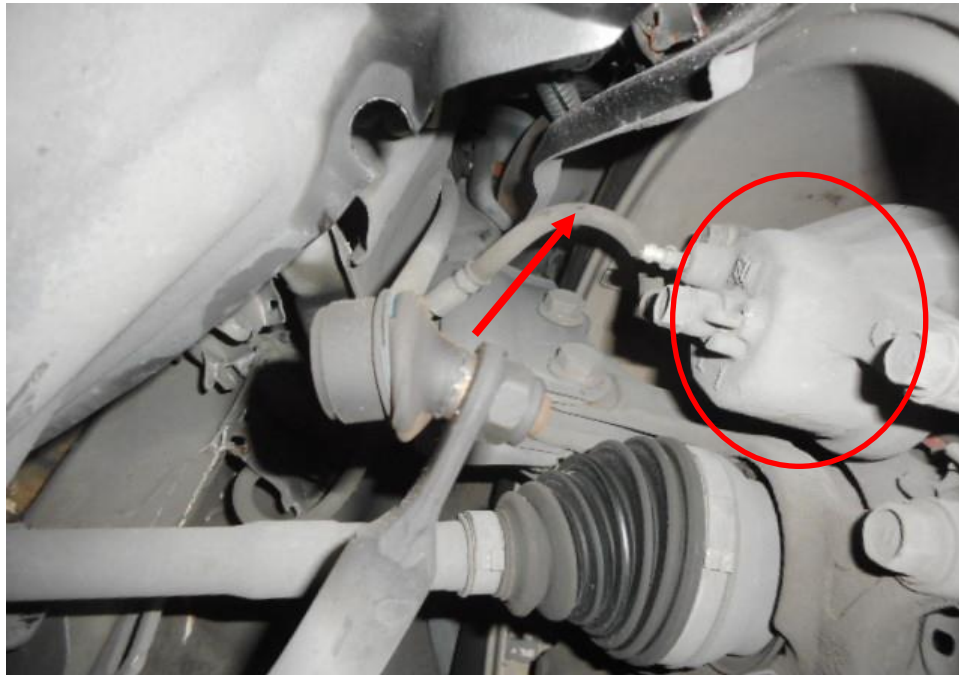
Photo 21 shows the brake hose/pipe (arrowed) at the front left wheel of the Motor Car. No leakage of brake fluid was observed. Visual examination of the various components of the braking system like the brake caliper (circled), brake booster, brake pedal etc had revealed all to be intact and without visible damage.

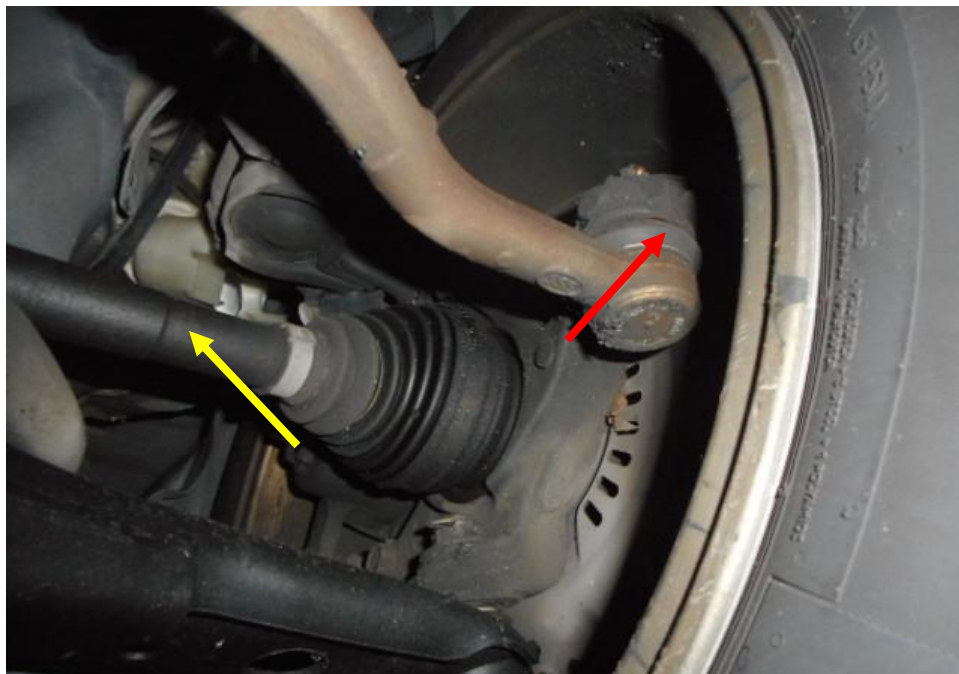
Photo 22 shows the various undercarriage components at the front right wheel of the Motor Car, in particular the steering tie rod (red arrow) and the driveshaft (yellow arrow). The various steering components were all found to be intact, suggesting that the steering system of the Motor Car was likely to be in serviceable condition at the material time of accident. There was also no sign of fluid stain observed on the various undercarriage components at the front right wheel of the Motor Car.

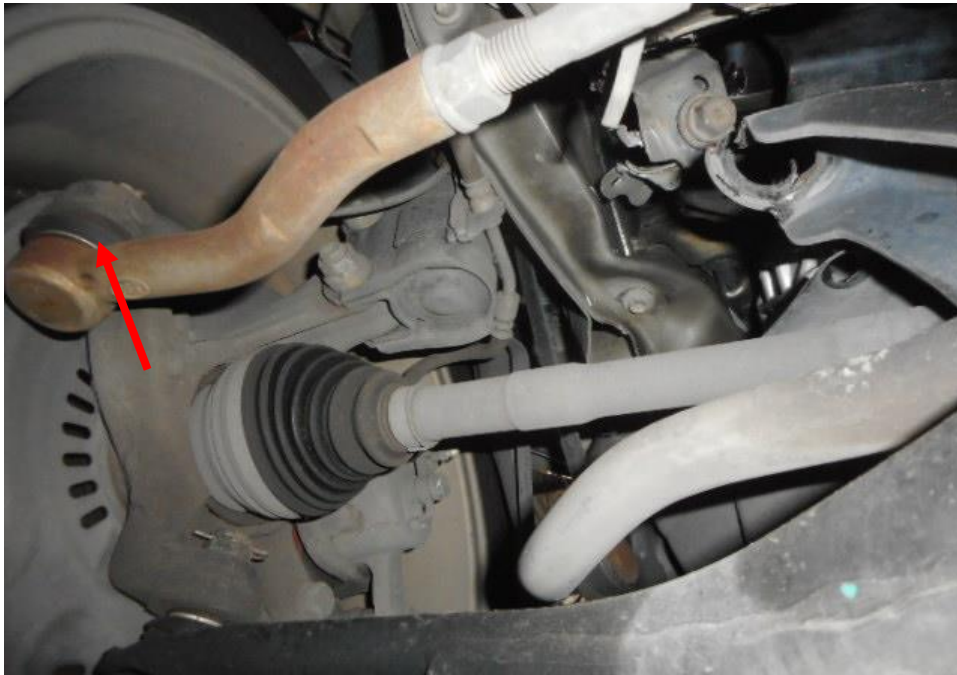
Photo 23 shows the various undercarriage components at the front left wheel of the Motor Car, in particular the steering tie rod end (arrowed). The various undercarriage components of the Motor Car were all found to be intact without any visible damage. There was also no sign of fluid stain(s) observed on the various undercarriage components.

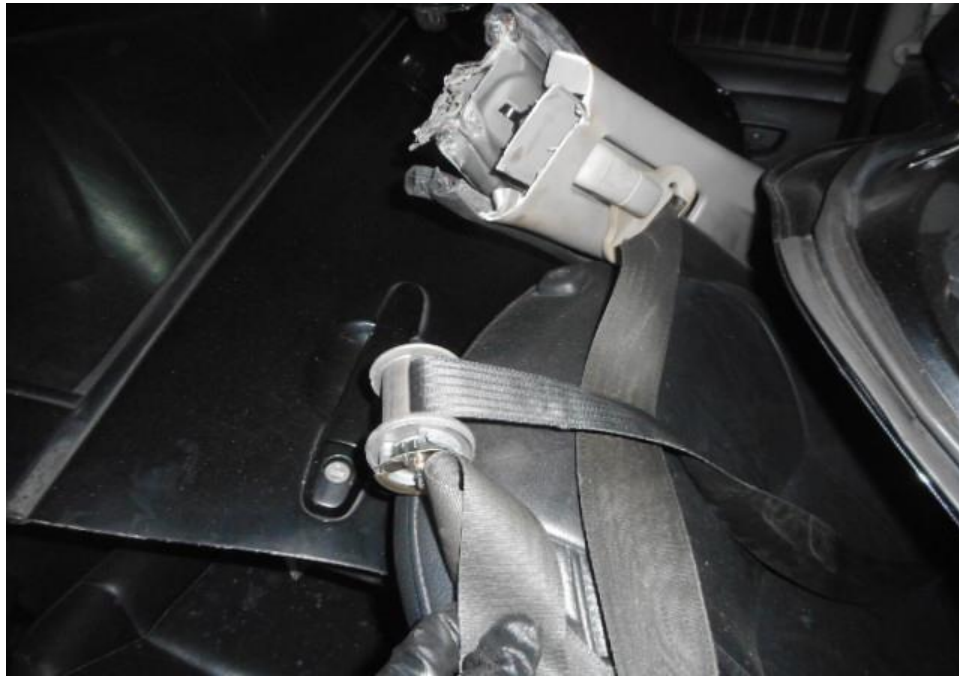
14. The front right seat belt of the "Motor Car" was unable to be checked as the respective pre-tensioners that were fitted at the side of the seat was observed to be removed at the time of our inspection. See photo 24 below.

Photo 24 shows that the seat belt on the right seat was removed at the time of our inspection.
