Your Ref: TP/IP/19901/2022
Our Ref : CI/TPD22008181/P

Fatal Accident Investigation Team

MECHANICAL INSPECTION REPORT OF MOTOR BUS PC 7763E

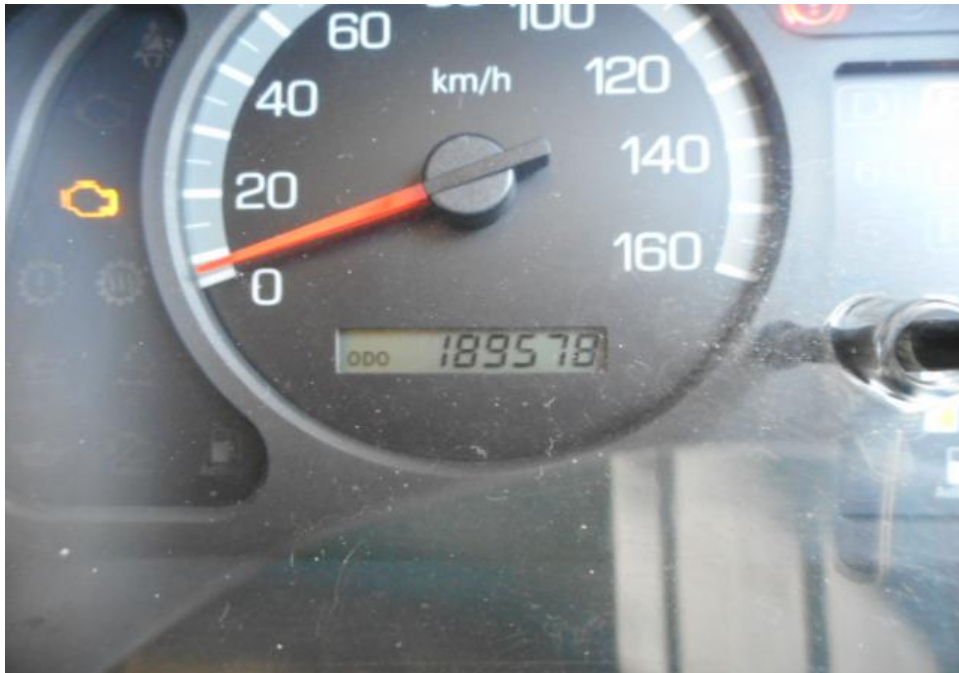
Photo 1 shows a general view of the instrument cluster of the Motor Bus at the time of my inspection. The mileage of the Motor Bus was 189,578km

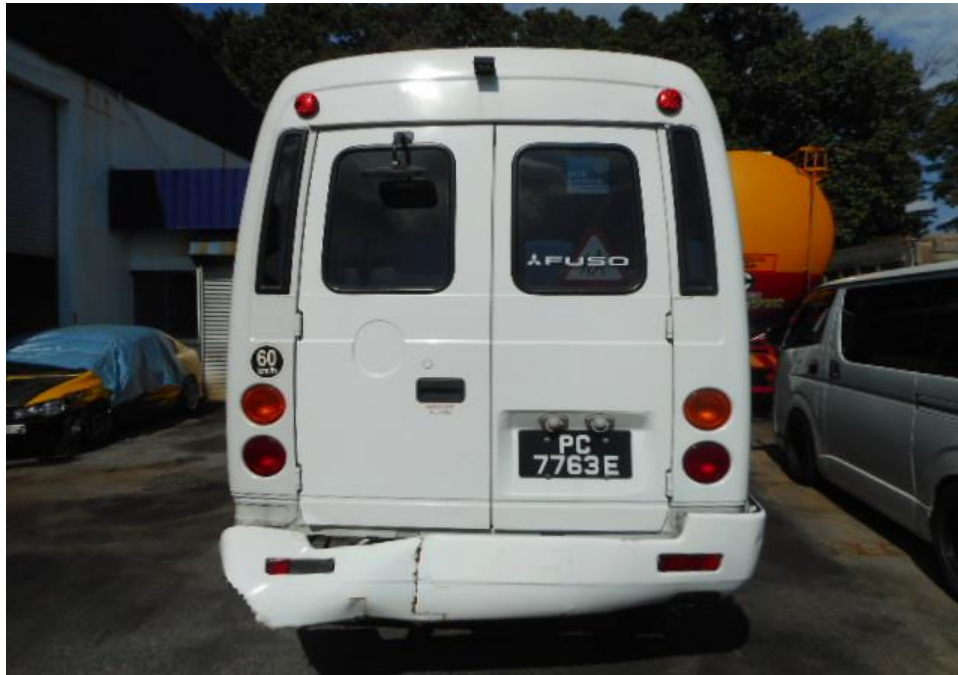
4. The mileage of the Motor Bus at the time of my inspection was 189,578km.
5. The Motor Bus was observed to have sustained damage at its rear and left portion. Its rear bumper and left rear body panel was the body parts that were damaged at the time of inspection.

Photo 2 shows a general view of the rear body of the Motor Bus at the time of my inspection. The Motor Bus was observed to have sustained damages at its rear bumper was observed to be damaged at time of our inspection.

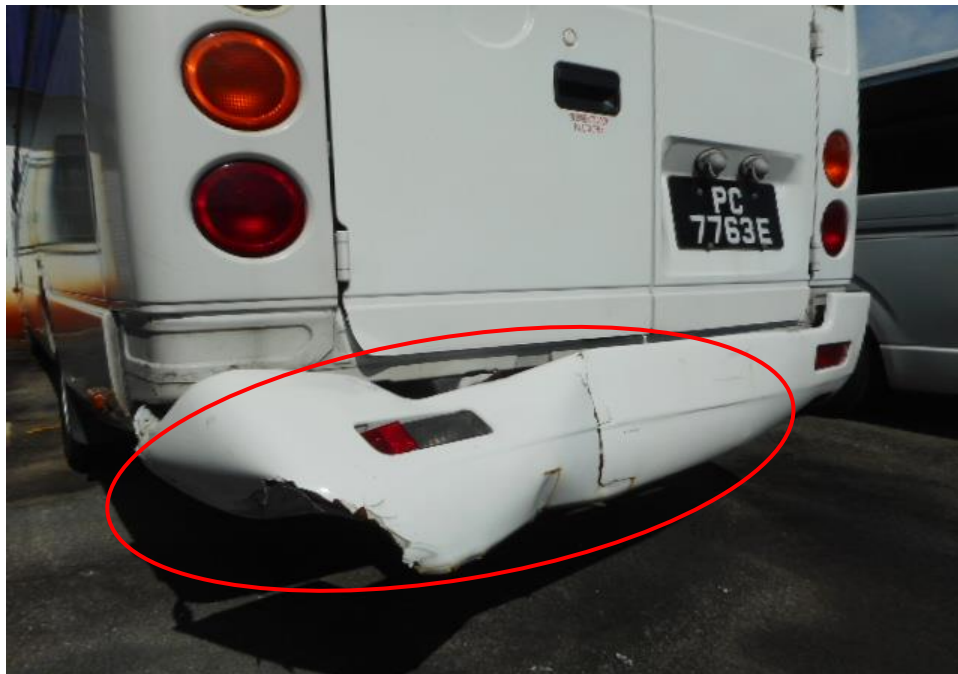
Photo 3 shows a close up view of the rear body of the Motor Bus at the time of our inspection. The Motor Bus was observed to have sustained damages at its rear bumper (circled) as a result of the accident.

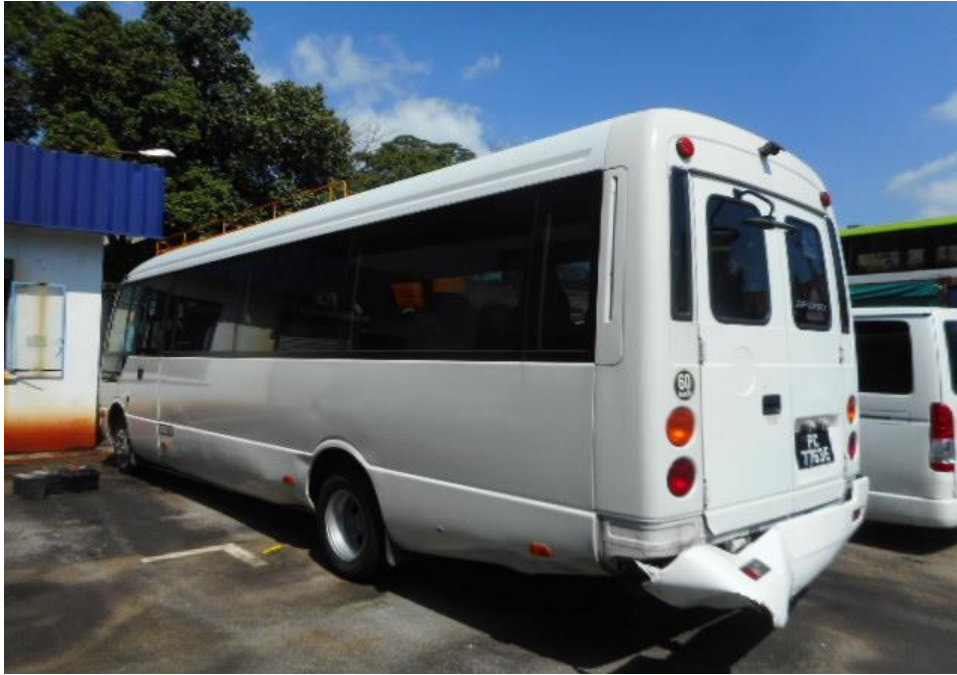
Photo 4 shows a general view of the left body of the Motor Bus at the time of my inspection. The Motor Bus was observed to have sustained damages at its left rear body panel was observed to be damaged at time of our inspection.

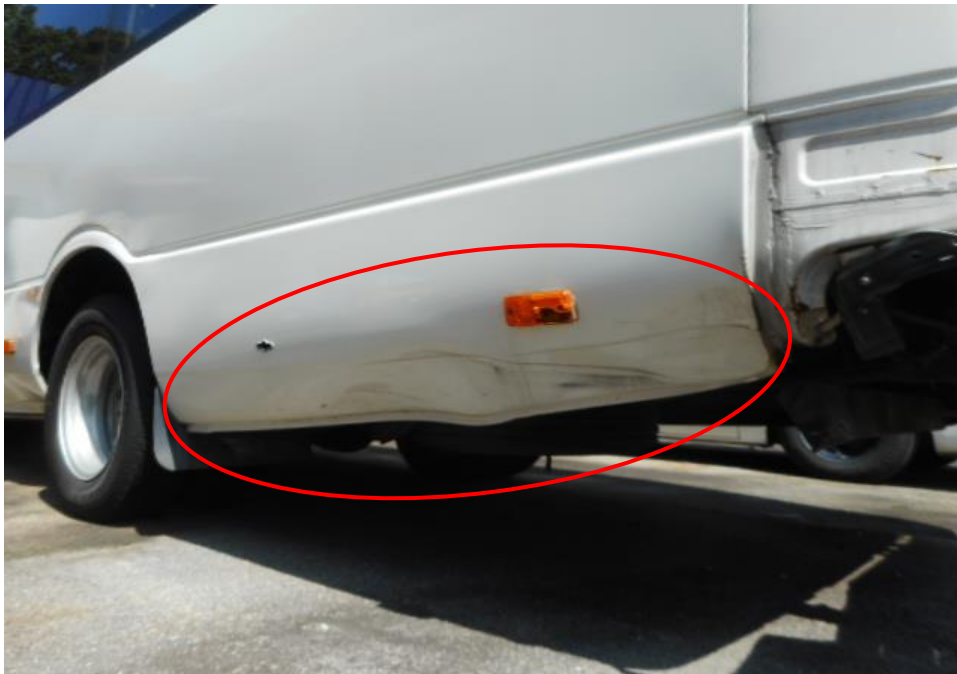
Photo 5 shows a close up view of the left body of the Motor Bus at the time of our inspection. The Motor Bus was observed to have sustained damages at its left rear body panel (circled) as a result of the accident.

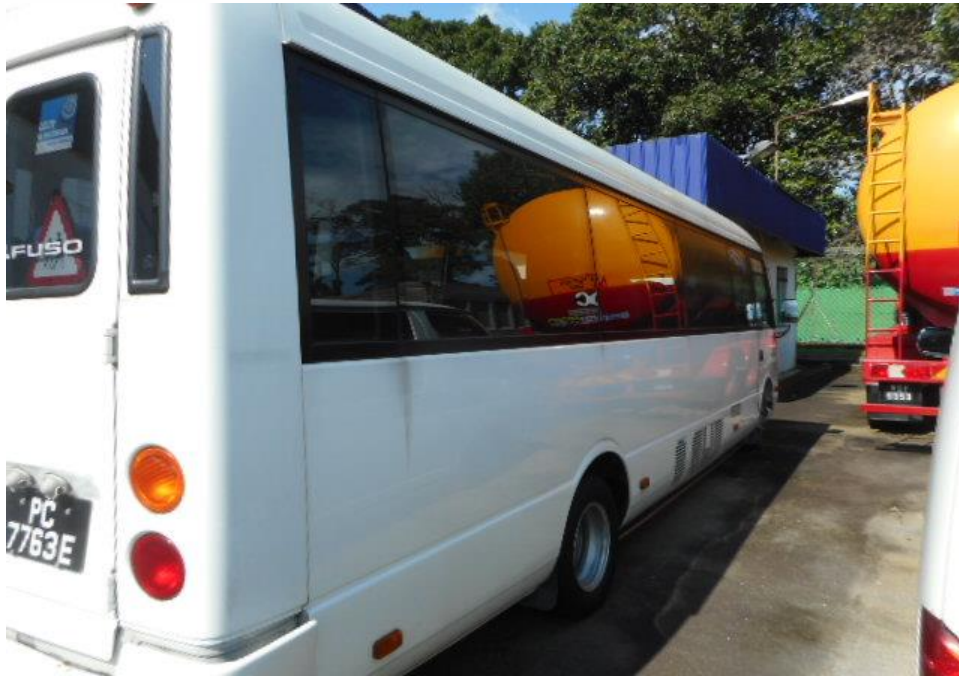
Photo 6 shows a general view of the right body of the Motor Bus at the time of my inspection. The Motor Bus was observed to be intact and unaffected by the accident.

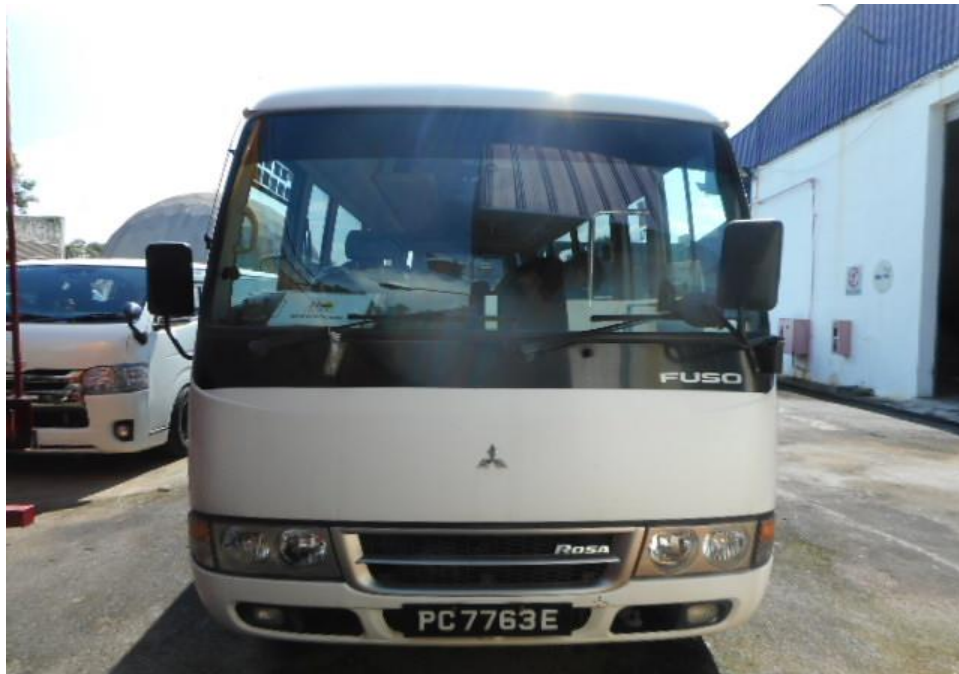
Photo 7 shows a general view of the front body of the Motor Bus at the time of my inspection. The Motor Bus was observed to be intact and unaffected by the accident.

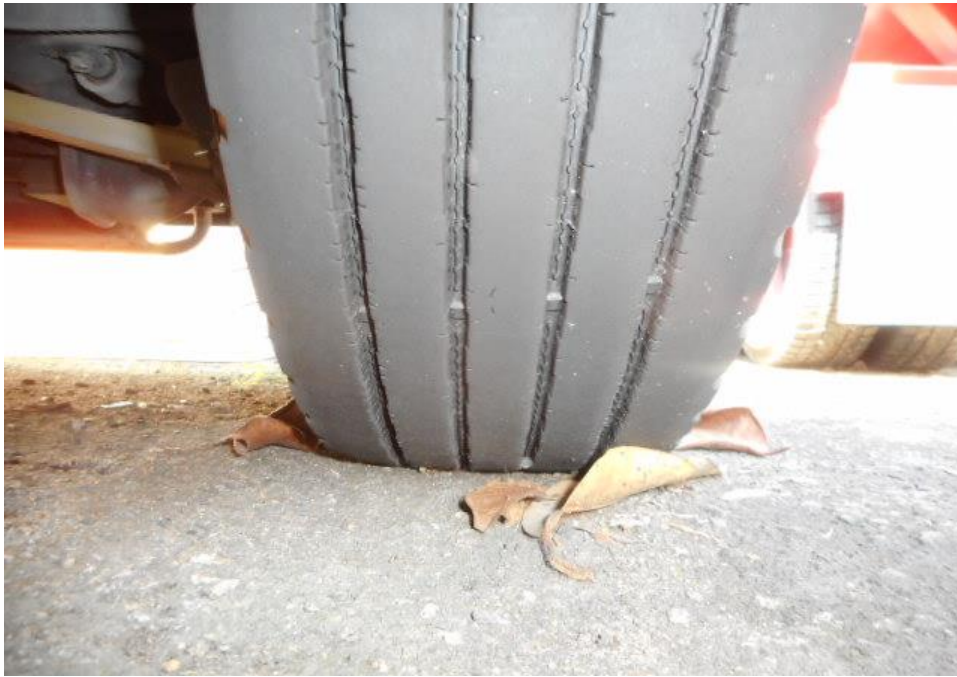
Photo 8 shows the condition of the front right tyre of the Motor Bus, which was observed to be in serviceable condition with remaining tread depth of approximately 4mm. The tyre, which was wrapped around standard steel wheel rim, was also observed to be sufficiently inflated for vehicular operation. There was no tear, cut or burst mark(s) on the outer and the inner sidewalls as well as across the tread of the 6 tyres that were fitted on the Motor Bus.

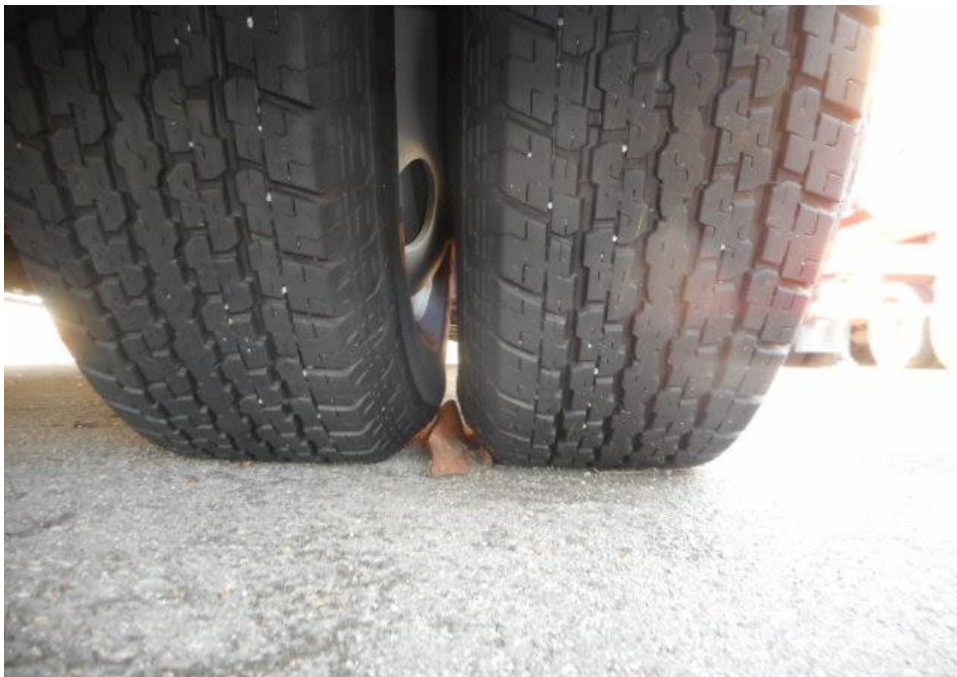
Photo 9 shows the condition of the rear right tyre of the Motor Bus, which was observed to be in serviceable condition with remaining tread depth of approximately 4.6mm. The tyre, which was wrapped around standard steel wheel rim, was also observed to be sufficiently inflated for vehicular operation.

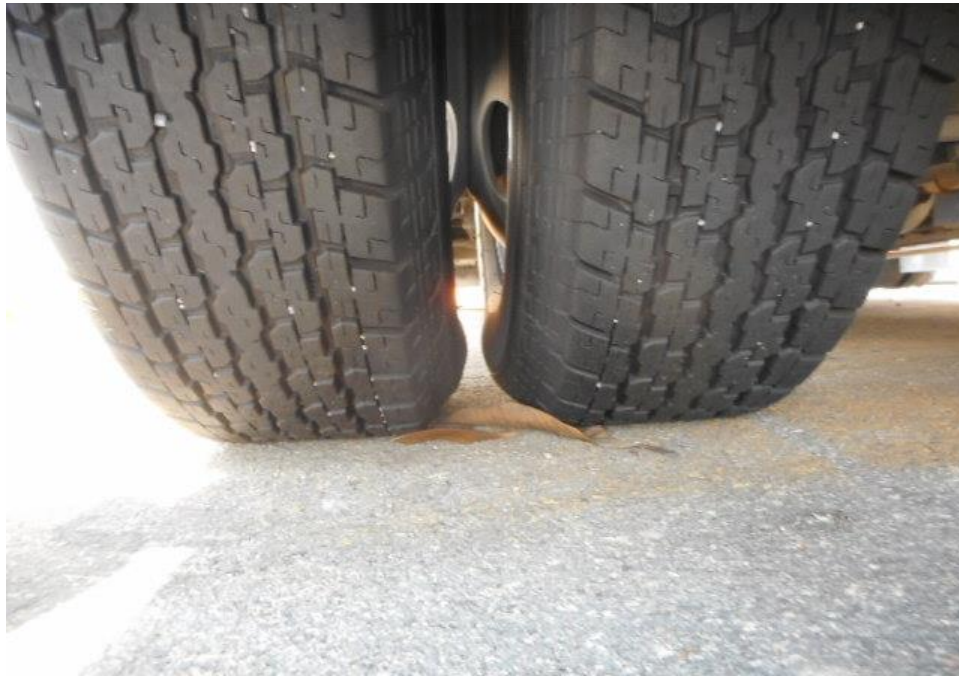
Photo 10 shows the condition of the rear left tyres of the Motor Bus, which was observed to be in serviceable condition with remaining tread depth of approximately 4.4mm. The tyres, which were wrapped around standard steel wheel rim, were also observed to be sufficiently inflated for vehicular operation. There was also no damage found on all 6 steel wheel rims of the Motor Bus.

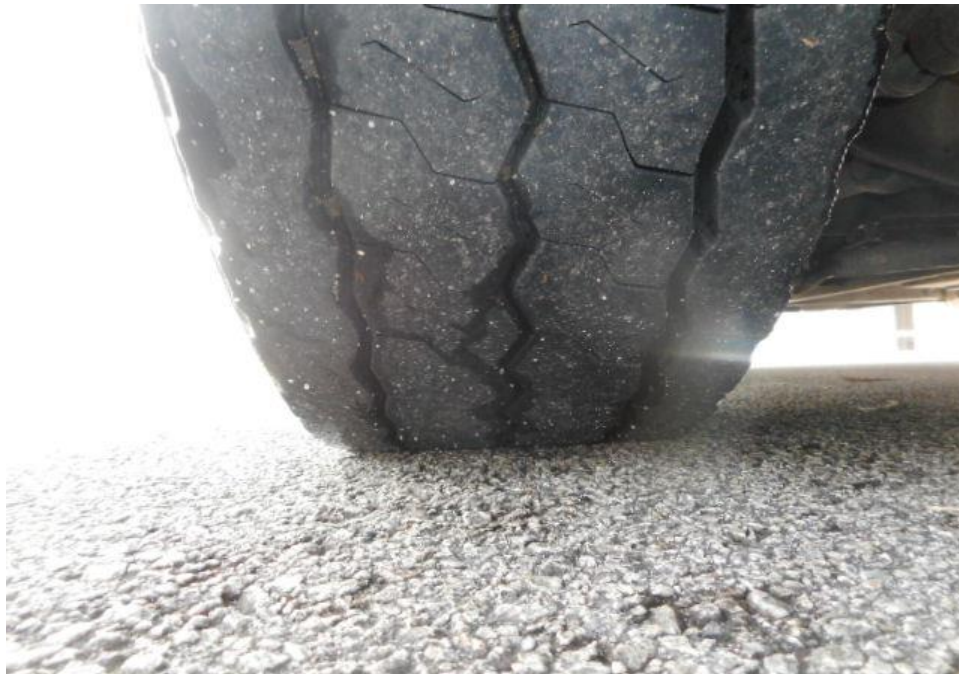
Photo 11 shows the condition of the front left tyres of the Motor Bus, which were observed to be in serviceable condition with remaining tread depth of approximately 3.6mm. There was also no tear, cut or burst mark(s) on the outer and the inner sidewalls as well as across the tread of the 6 tyres that were fitted on the Motor Bus.

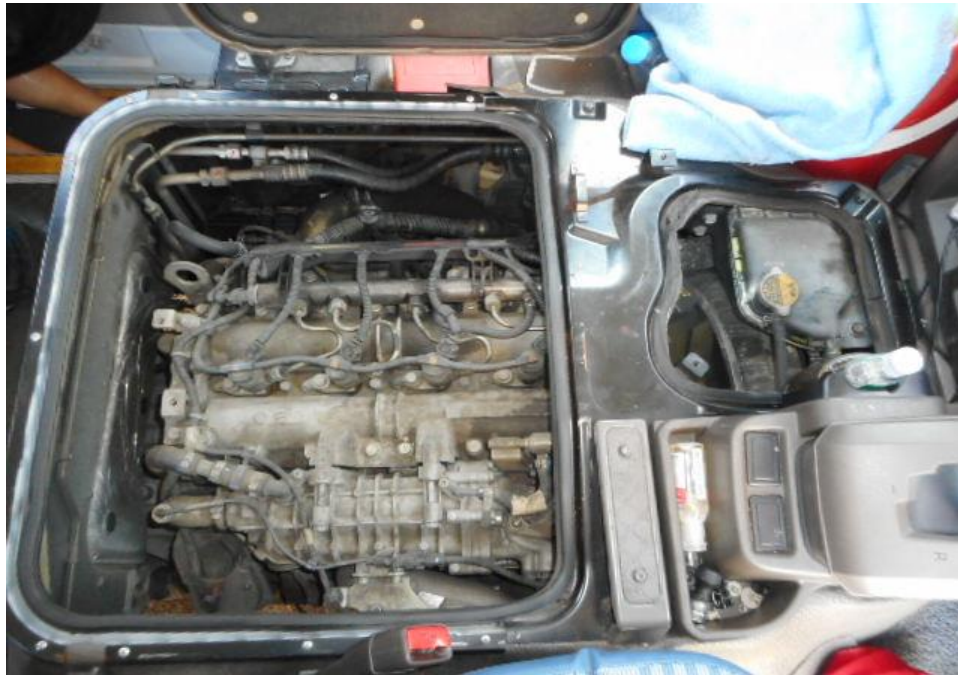
Photo 12 shows a general view of the Motor Bus's engine compartment, which was accessed by lifting the rear of the Motor Bus. The various parts and components inside the engine compartment were unaffected by the accident. There was also no sign(s) or indication(s) of fresh fluid leakage and/or fluid stain within the engine compartment

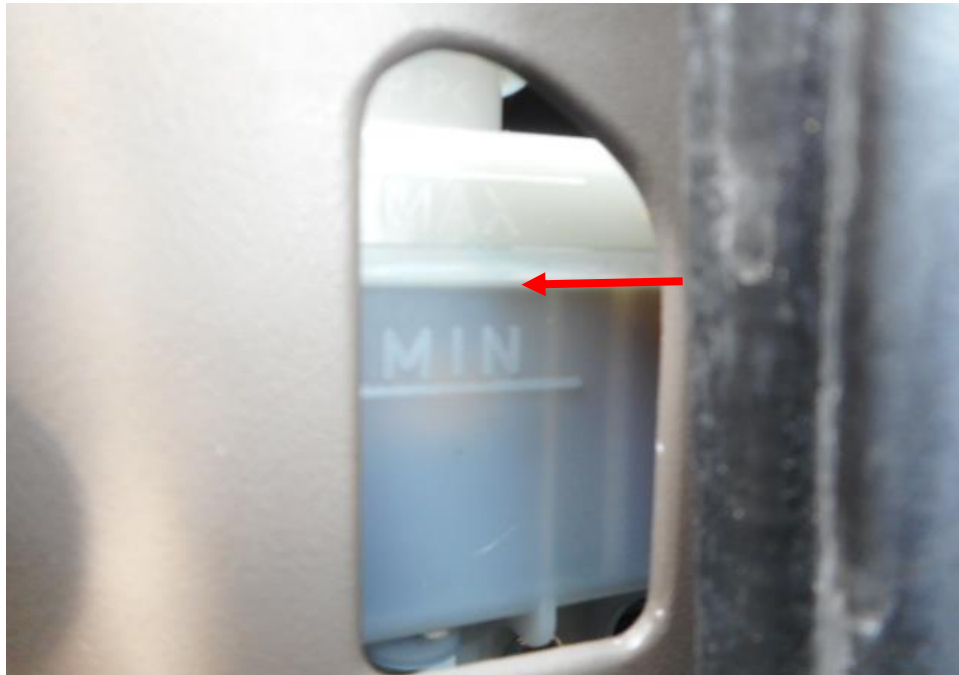
Photo 13 shows the brake fluid reservoir of the Motor Bus at the time of my inspection. The brake fluid was observed to be of sufficient level (arrowed) and without any visible contamination.

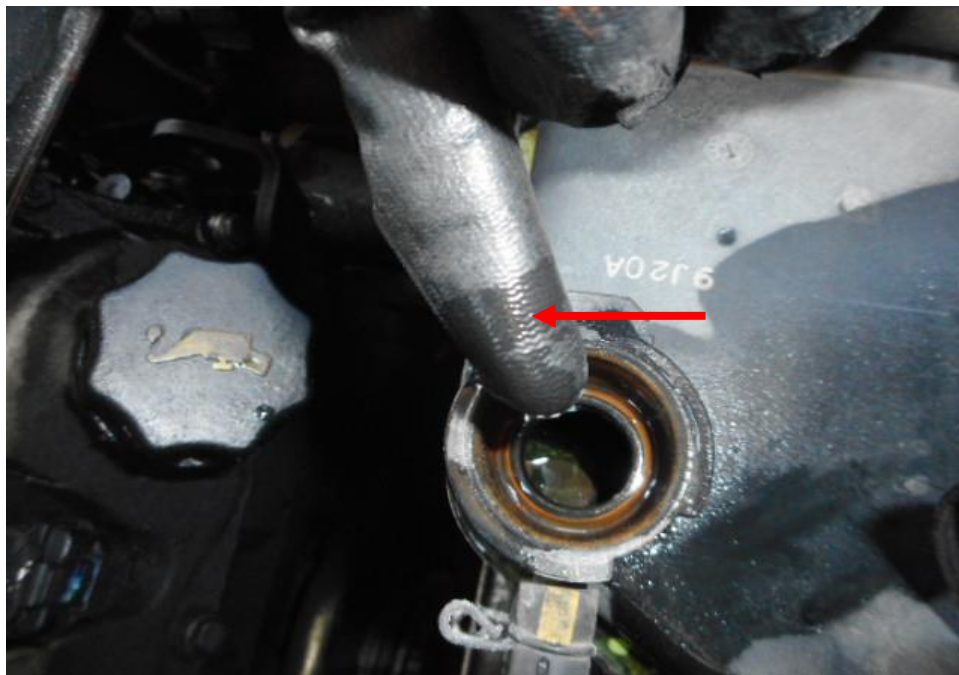
Photo 14 shows the engine coolant reservoir of the Motor Bus at the time of my inspection. The engine coolant was observed to be of sufficient level (arrowed) and without any visible contamination.

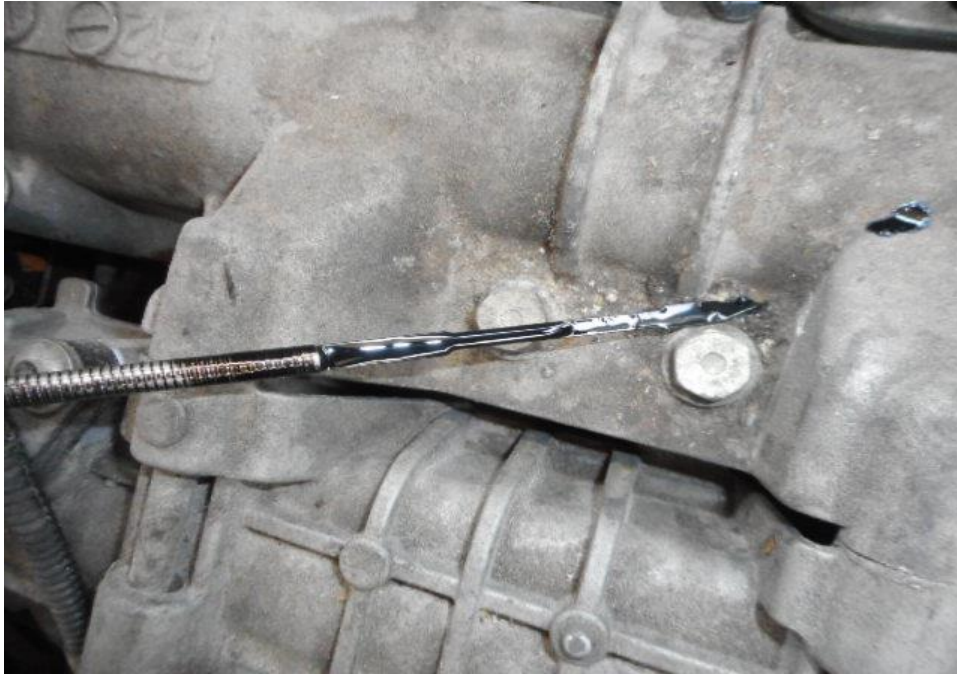
Photo 15 shows the engine oil dip stick system of the Motor Bus at the time of my inspection. The engine oil was observed to be sufficient for operation and without any visible contamination.

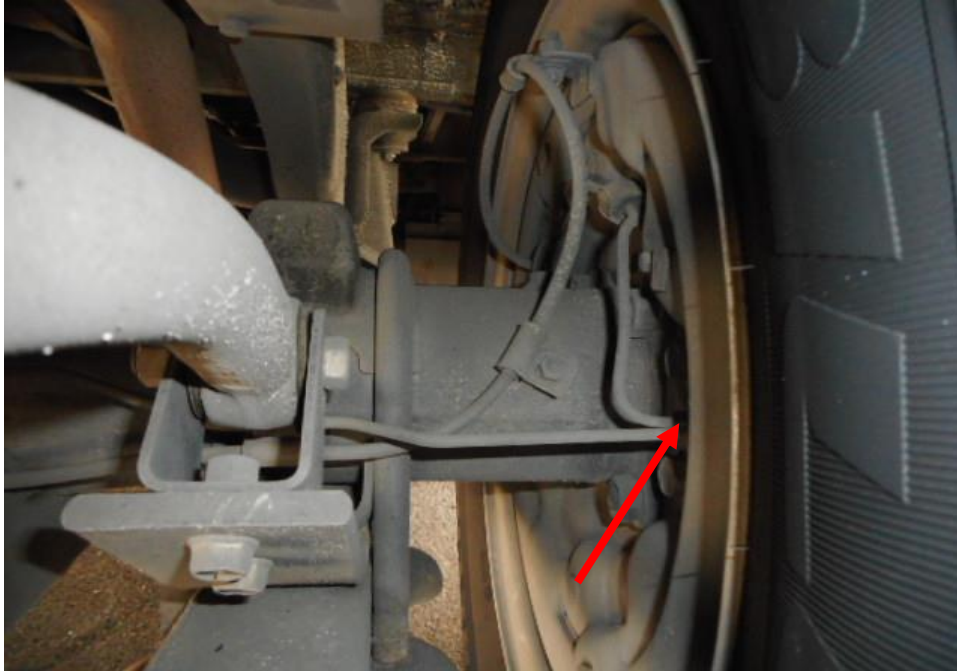
Photo 16 shows the brake pipe (arrowed) at the rear right wheel of the Motor Bus. I did not observe any leakage of brake fluid at the time of my inspection of the Motor Bus. My static tests of the Motor Bus's braking system, along with my visual examination of the various mechanical components in the braking system, had indicated that there was no internal leakage of pressure/vacuum. Hence the braking system of the Motor Bus was likely to be in serviceable condition at the material time of accident.

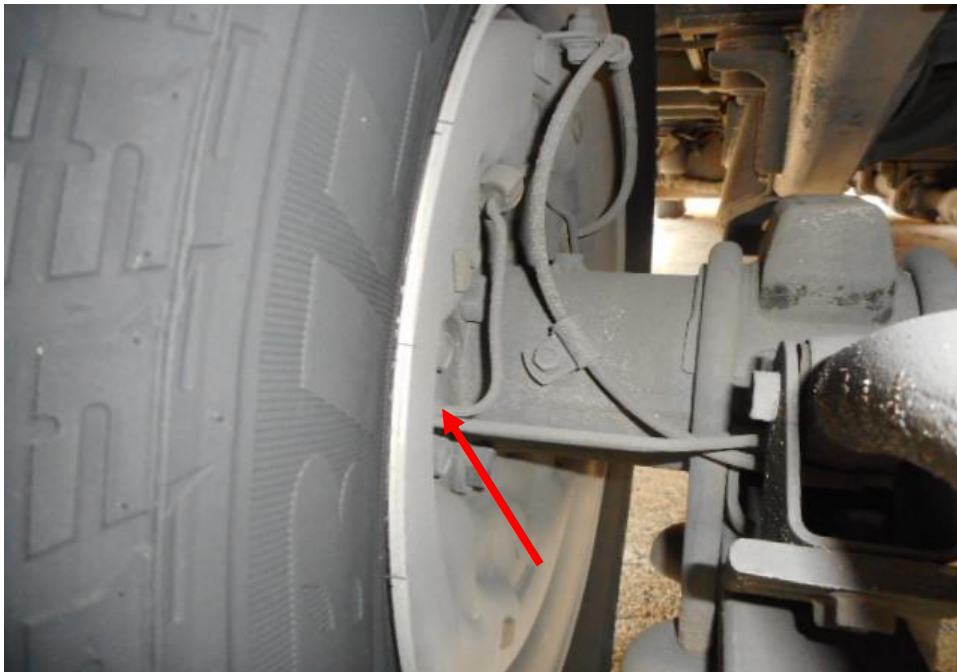
Photo 17 shows the brake pipe (arrowed) at the rear left wheel of the Motor Bus. I did not observe any leakage of brake fluid at the time of my inspection of the Motor Bus. My static tests of the Motor Bus's braking system, along with my visual examination of the various mechanical components in the braking system, had indicated that there was no internal leakage of pressure/vacuum. Hence the braking system of the Motor Bus was likely to be in serviceable condition at the material time of accident.

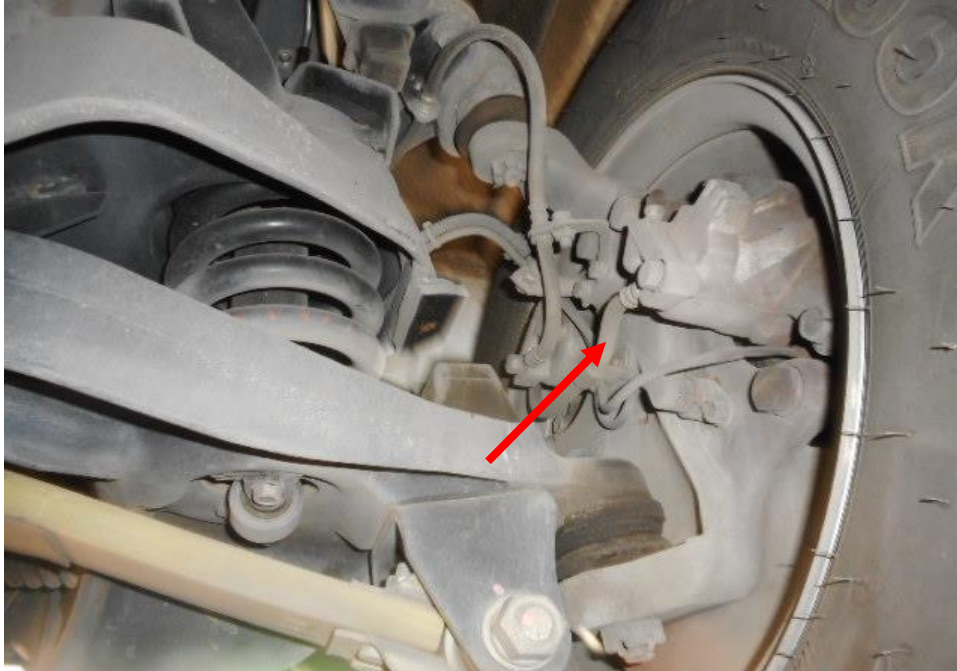
Photo 18 shows the brake pipe (arrowed) at the front right wheel of the Motor Bus. I did not observe any leakage of brake fluid at the time of my inspection of the Motor Bus. My static tests of the Motor Bus's braking system, along with my visual examination of the various mechanical components in the braking system, had indicated that there was no internal leakage of pressure/vacuum. Hence the braking system of the Motor Bus was likely to be in serviceable condition at the material time of accident.

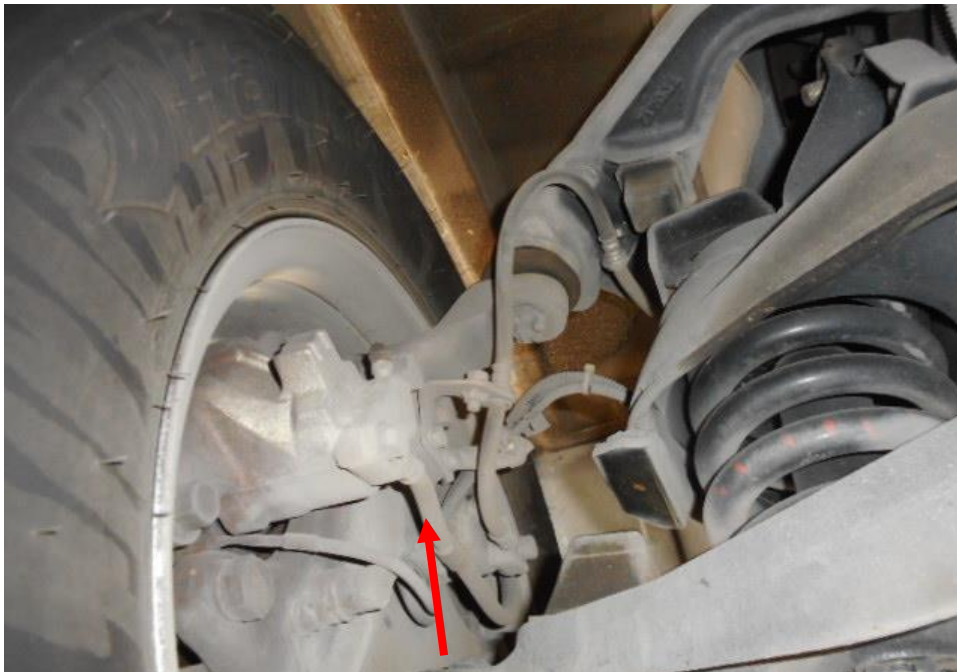
Photo 19 shows the brake pipe (arrowed) at the front left wheel of the Motor Bus. I did not observe any leakage of brake fluid at the time of my inspection of the Motor Bus. My static tests of the Motor Bus's braking system, along with my visual examination of the various mechanical components in the braking system had indicated that there was no internal leakage of pressure/vacuum. Hence the braking system of the Motor Bus was likely to be in serviceable condition at the material time of accident.

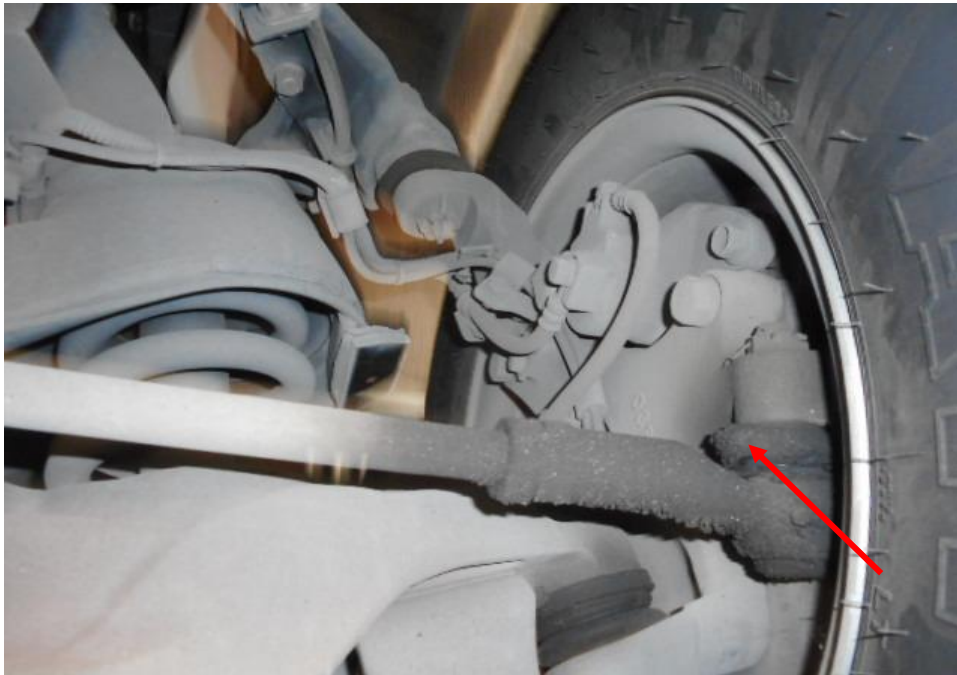
Photo 20 shows the various undercarriage components at the front right wheel of the Motor Bus, in particular the steering tie rod end (arrowed). The various steering components were all found to be intact, suggesting that the steering system of the Motor Bus was likely to be in serviceable condition at the material time of accident. There was also no sign of fluid stain(s) observed on the various undercarriage components.

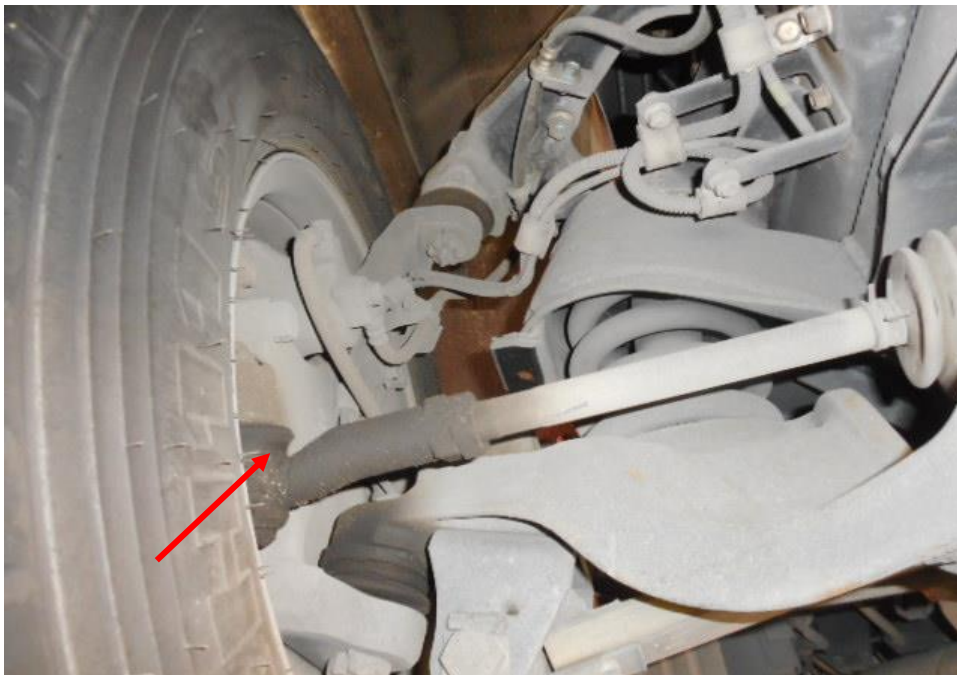
Photo 21 shows the various undercarriage components at the front left wheel of the Motor Bus, in particular the steering tie rod end (arrowed). The various undercarriage components of the Motor Bus were all found to be intact without any visible damage. There was also no sign of fluid stain(s) observed on the various undercarriage components.

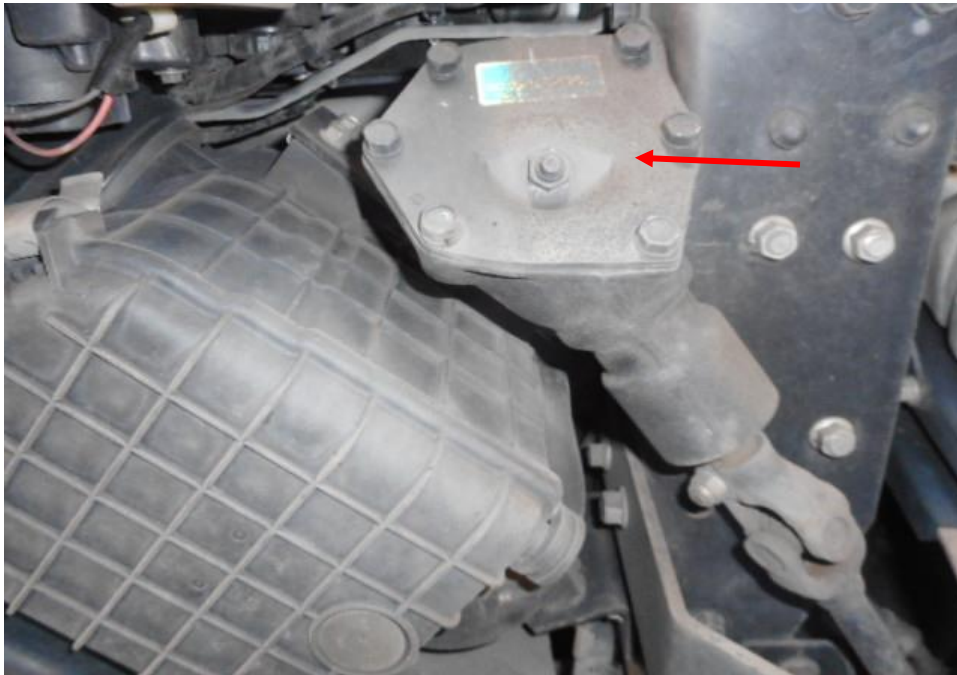
Photo 22 shows the steering box component (arrowed) at the undercarriage of the Motor Bus was found to be intact without any visible damage. There was also no sign of fluid stain(s) observed on the various undercarriage components.

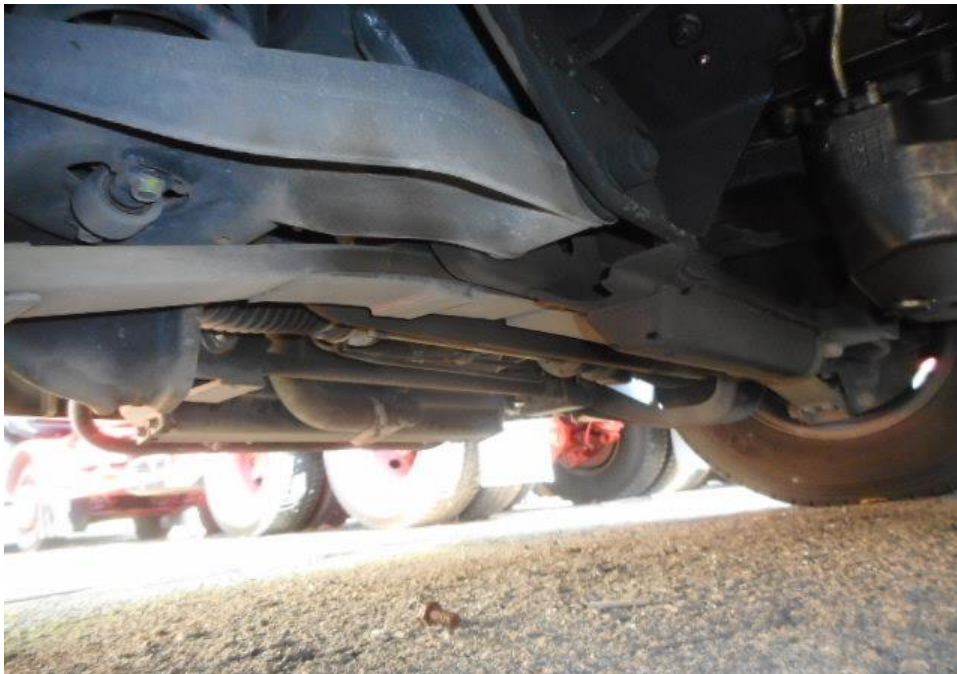
Photo 23 shows the undercarriage of the Motor Bus, at the area where the engine housing and transmission housing are located. I did not find any sign(s) or indication(s) of fluid leak and/or fluid stain(s) on the underside of the Motor Bus.

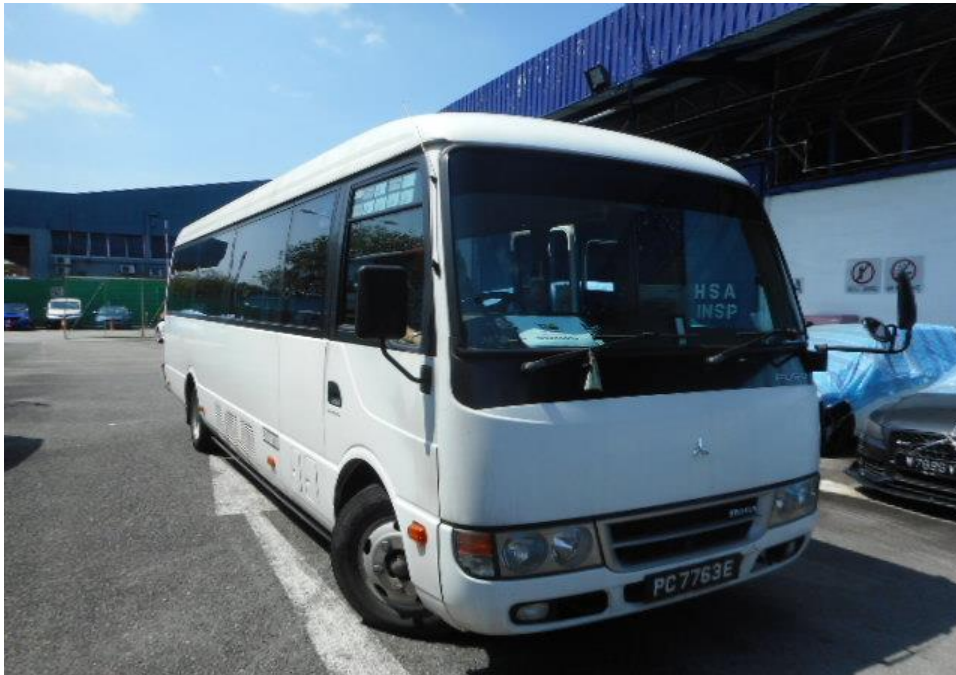
Photo 24 shows the front right wheel of the Motor Bus turned to its full left. During my steering system test, I did not experience any abnormal free play and/or resistance when I had turned the steering wheel towards full left and full right. This would suggest that the steering system of the Motor Bus was likely to be in serviceable condition at the material time of accident.

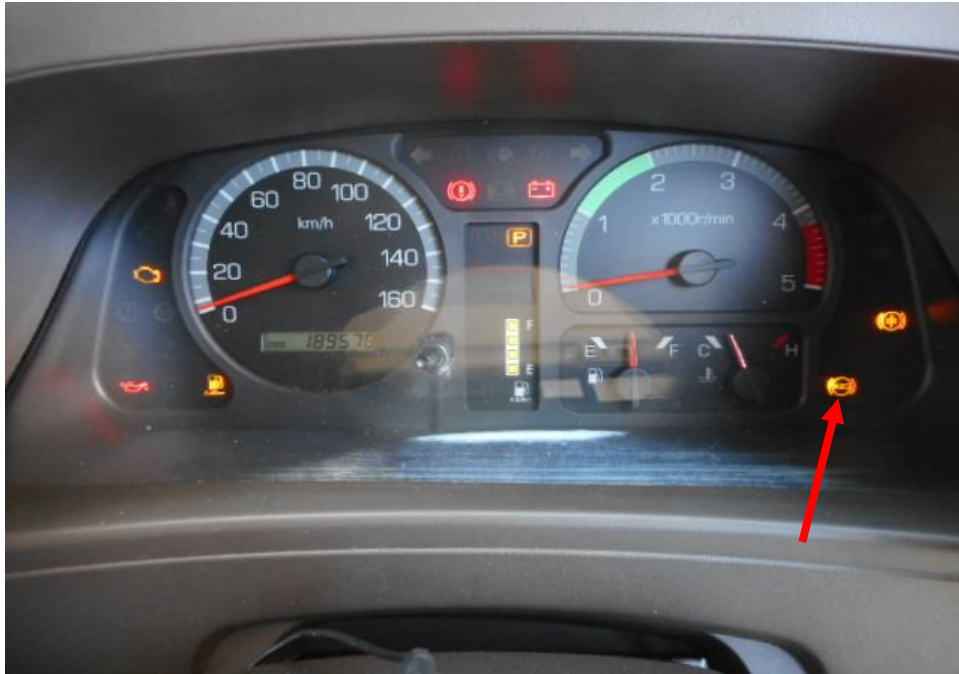
Photo 25 shows the warning light for Anti-Lock Braking System (ABS) appearing on the instrument panel of the Motor Bus during the self-test of its various electronic operating systems when its engine was cranked.

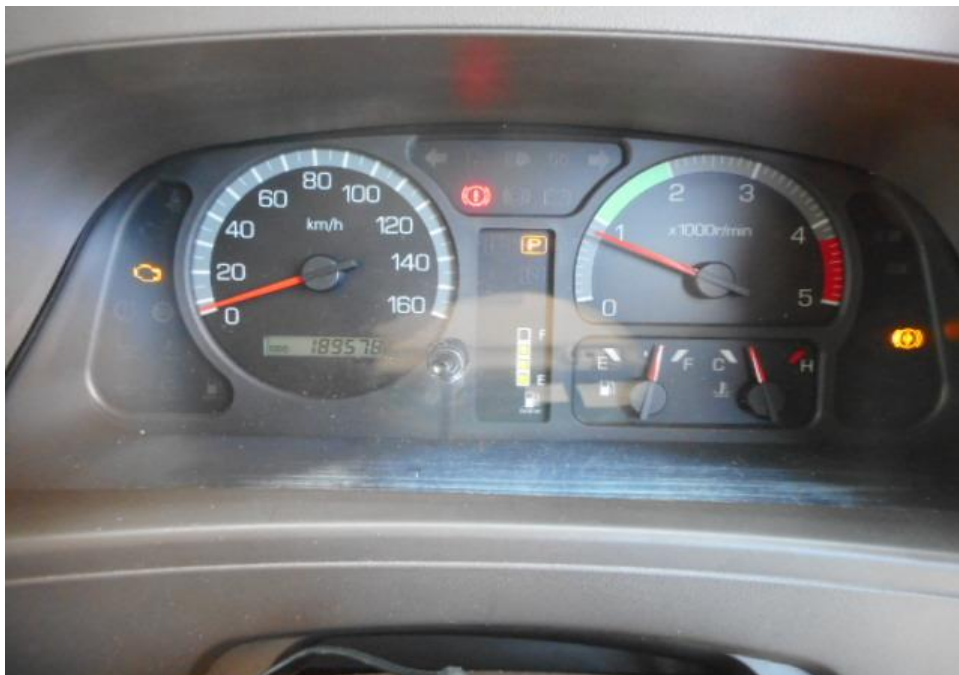
Photo 26 shows no warning lights illuminated on the instrument panel of the Motor Bus after the engine was cranked. This would suggest that there was no abnormality to the various electronic operating systems of the Motor Bus, like the ABS and etc.
