**MECHANICAL INSPECTION REPORT OF MOTOR LORRY YJ 5050Z**

1. We refer to your request on 16<sup>th</sup> August 2022 to conduct a physical inspection of a motor Lorry bearing registration number YJ 5050Z (herein referred to as "**Motor Lorry**"), which was involved in a road traffic accident on 4<sup>th</sup> August 2022.
2. The objective of this inspection is to determine if there was any possible mechanical failure to the Motor Lorry that may have contributed to the accident.
3. Following the request, we had carried out a physical inspection of the Motor Lorry on 8<sup>th</sup> September 2022 at the premises of Traffic Police vehicle pound, 517 Airport Road Singapore 539942. We now set out below our observations and comments with respect to this inspection.

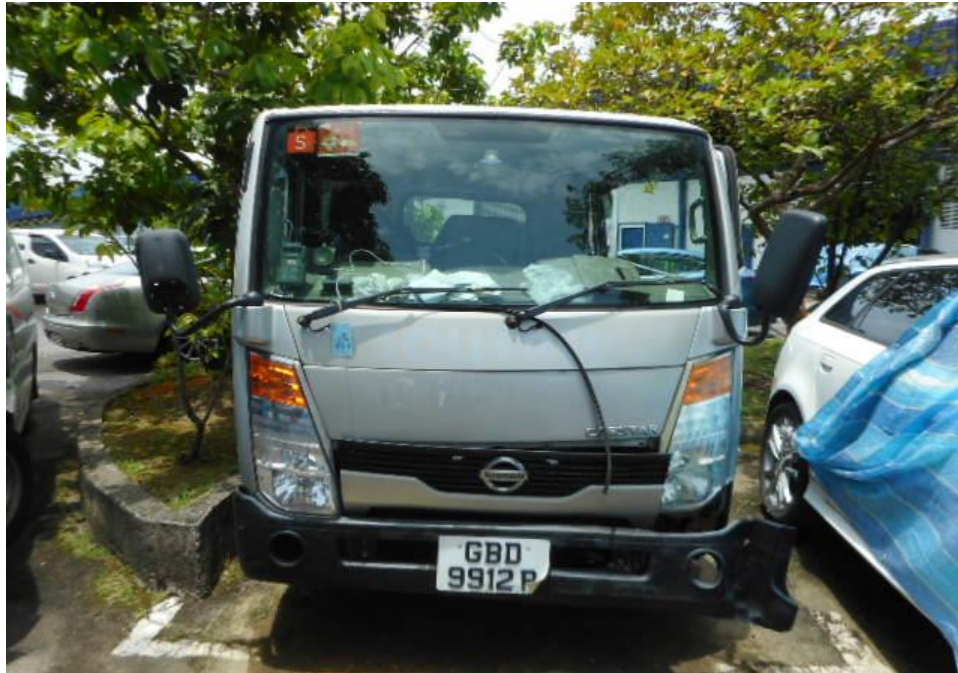
4. The mileage of the Motor Lorry at the time of my inspection was not recorded as the dashboard of the Motor Lorry was damaged as a result of the accident.
5. The Motor Lorry was observed to have sustained major damage at its front and rear cabin, its front windscreen, front body panel, front bumper, front left door as well as its rear cabin were also damaged as a result of the accident. The Supplemental Restraint System (SRS) was activated as a result of the accident.

**Photo 1** shows a general view of the front portion of the Motor Lorry at the time of our inspection. The Motor Lorry was observed to sustained major damage at its front and rear cabin, its front windscreen, front body panel, front bumper, front left door as well as its rear cabin were also damaged as a result of the accident.

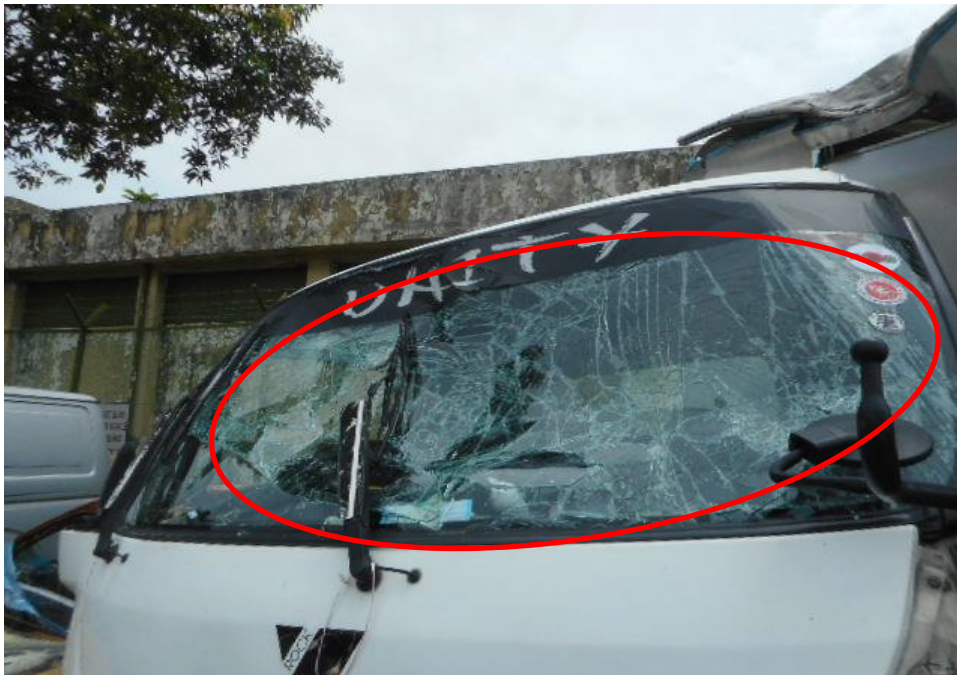
**Photo 2** shows the close up view of the front portion of the Motor Lorry at the time of our inspection. The Motor Lorry was observed to have sustained major damages to its front windscreen (circled) that was damaged as a result of the accident's impact.

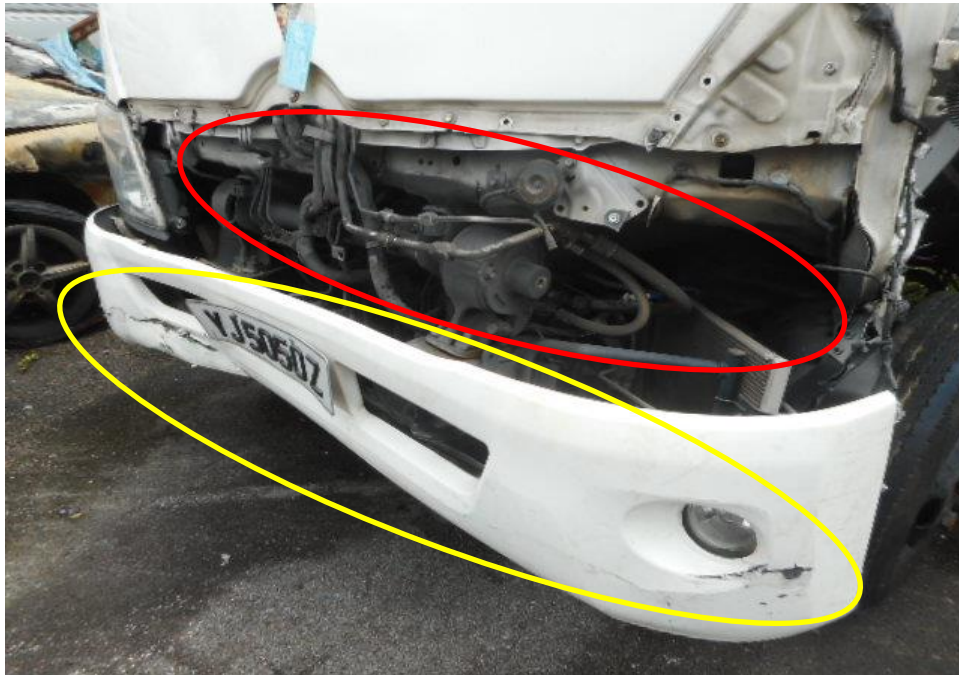
**Photo 3** shows the close up view of the front portion of the Motor Lorry at the time of our inspection. The Motor Lorry was observed to have sustained major damages to its front body panel (red circle) and front bumper (yellow circle) that was damaged as a result of the accident's impact.

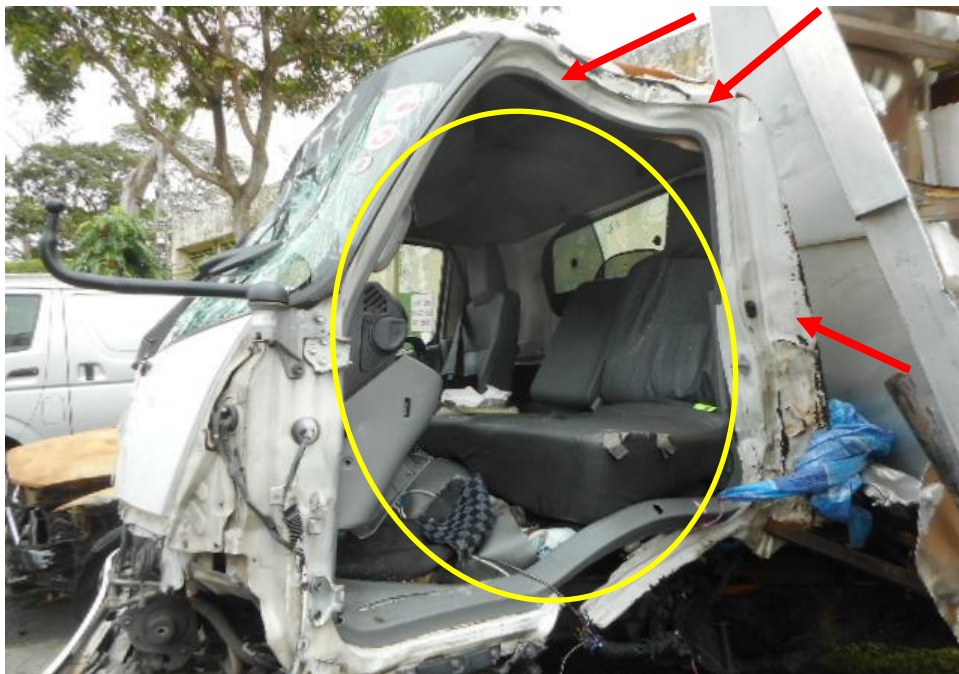
**Photo 4** shows the close up view of the front portion of the Motor Lorry at the time of our inspection. The Motor Lorry was observed to have sustained major damages to its front left door (circled) and its front cabin (arrowed) that was crushed due to the accident's impact.

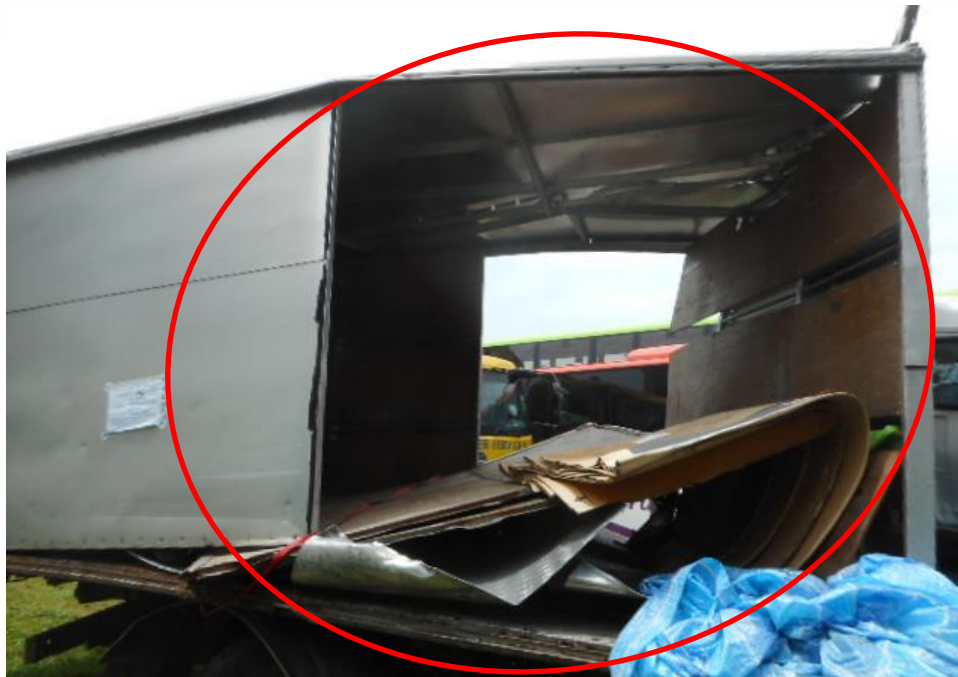
**Photo 5** shows a general view of the Motor Lorry's right body at the time of my inspection. The right body panel of the rear cabin (circled) of the Motor Lorry was observed to sustain damage as a result of the accident.

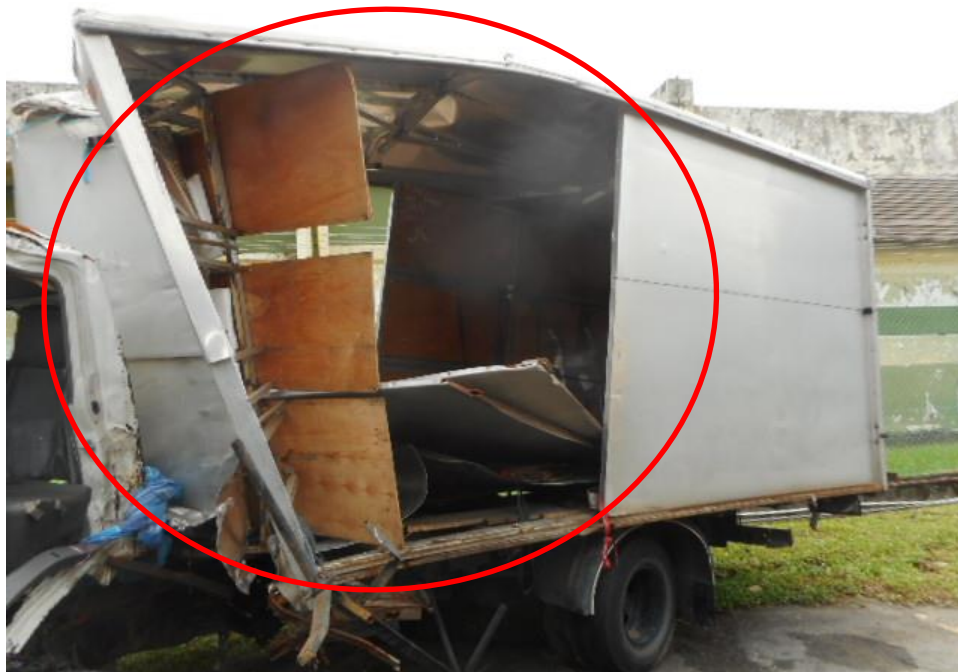
**Photo 6** shows a general view of the Motor Lorry's left body at the time of my inspection. The left body panel of the rear cabin (circled) of the Motor Lorry was observed to sustain damage as a result of the accident.

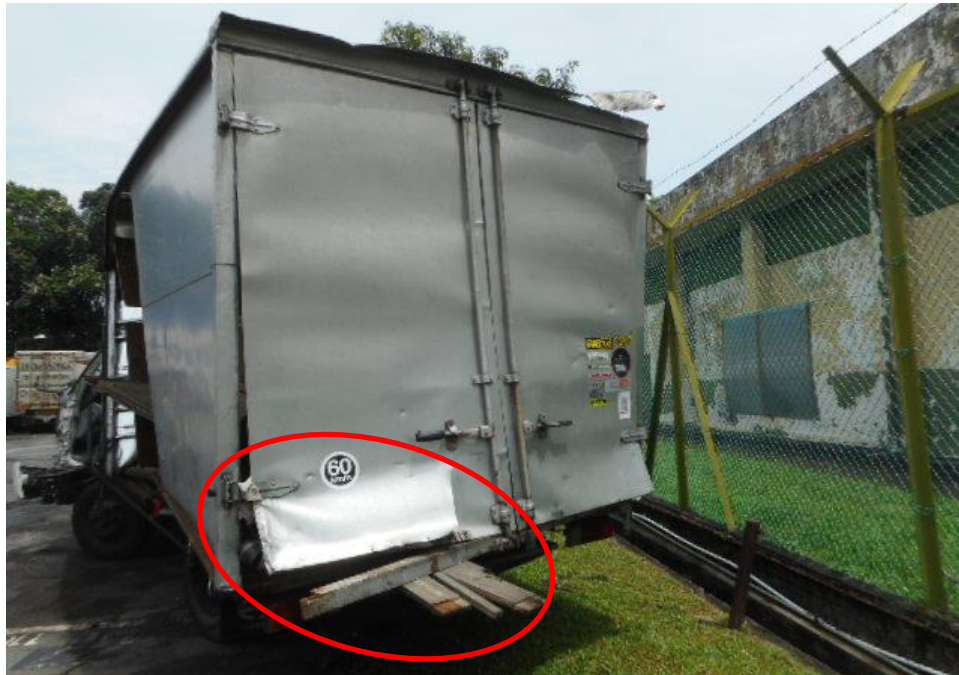
**Photo 7** shows the general view of the Motor Lorry's rear body at the time of my inspection. The rear body panel of the rear cabin (circled) of the Motor Lorry was observed to sustain damage as a result of the accident.

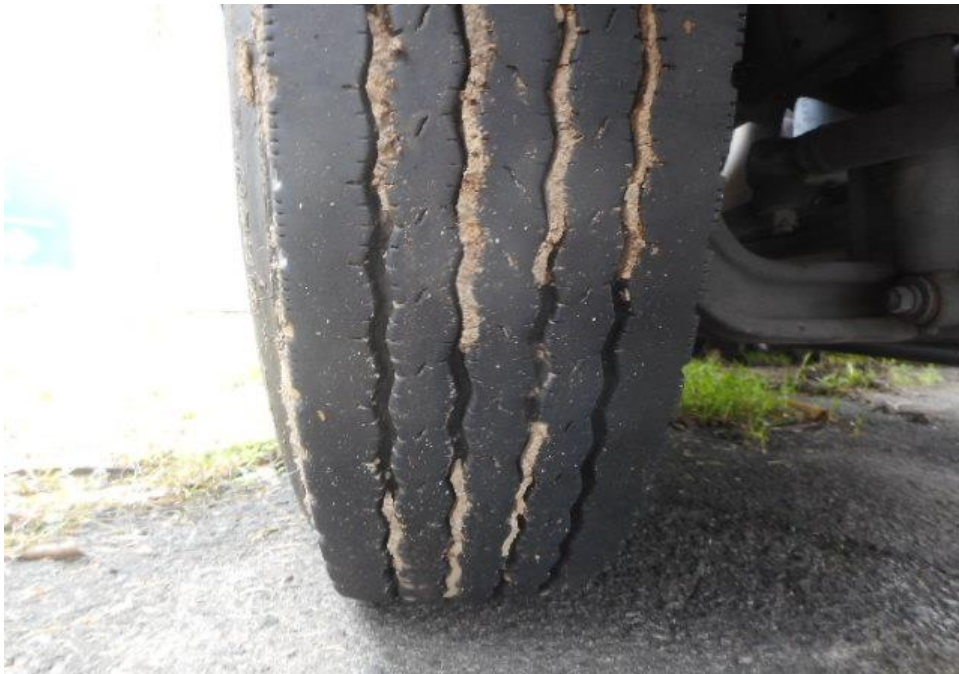
**Photo 8** shows the condition of the front right tyre of the Motor Lorry, which were observed to be in serviceable condition with remaining, tread depth of approximately 4.1mm. The tyre, which was wrapped around standard steel wheel rim, it was observed to be sufficiently inflated for vehicular operation.

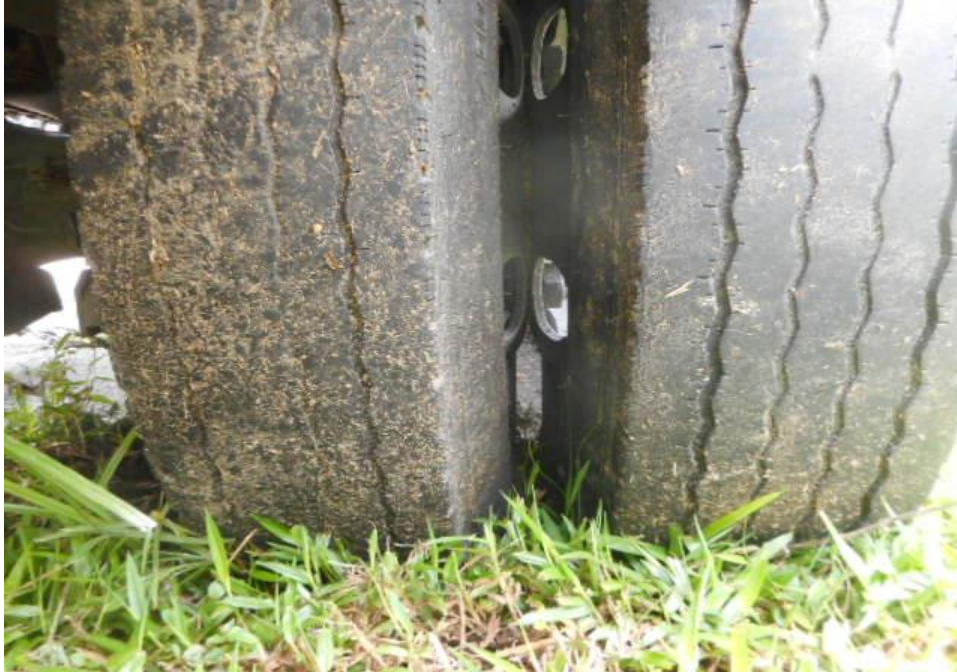
**Photo 9** shows the condition of the rear right tyres of the Motor Lorry, which were observed to be in serviceable condition with remaining, tread depth of approximately 4mm. The tyre, which was wrapped around standard steel wheel rim, it was observed to be sufficiently inflated for vehicular operation.

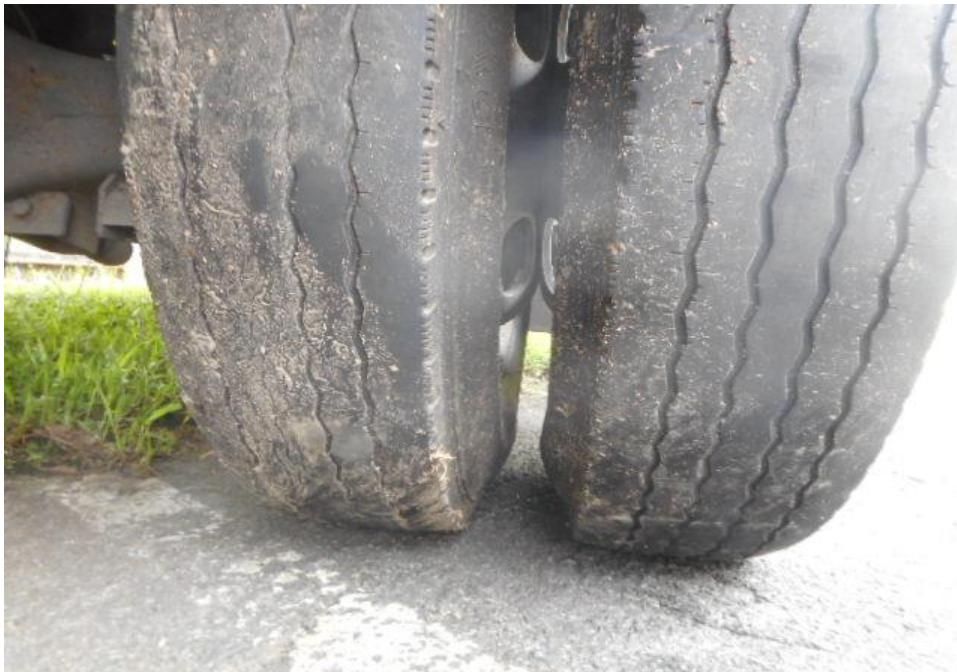
**Photo 10** shows the condition of the rear left tyres of the Motor Lorry, which were observed to be in serviceable condition with remaining, tread depth of approximately 2.3mm.

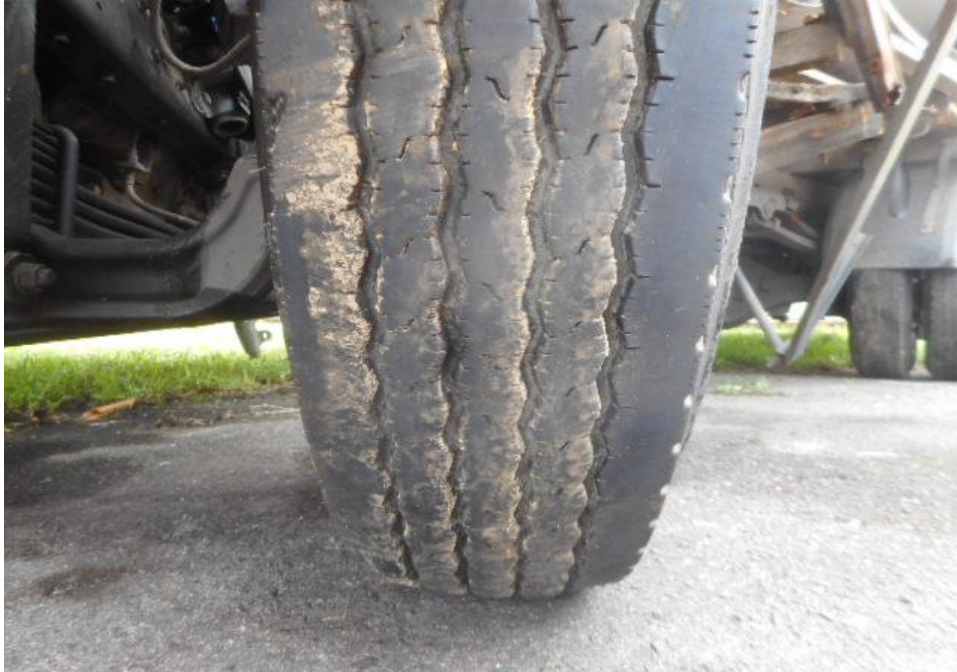
**Photo 11** shows the condition of the front left tyre of the Motor Lorry, which were observed to be in serviceable condition with remaining, tread depth of approximately 6.5mm. There was also no tear, cut or burst mark(s) on the outer and the inner sidewalls as well as across the tread of the 6 tyres that were fitted on the Motor Lorry.

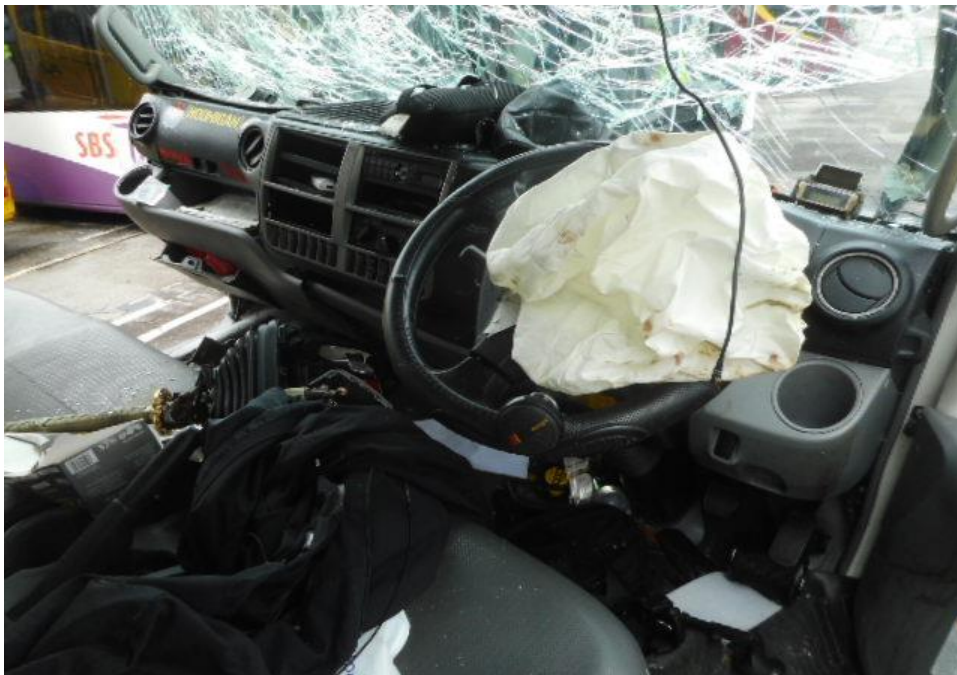
**Photo 12** shows the deployment of the Supplemental Restraint System (SRS) airbag in the Motor Car as a result of the accident.

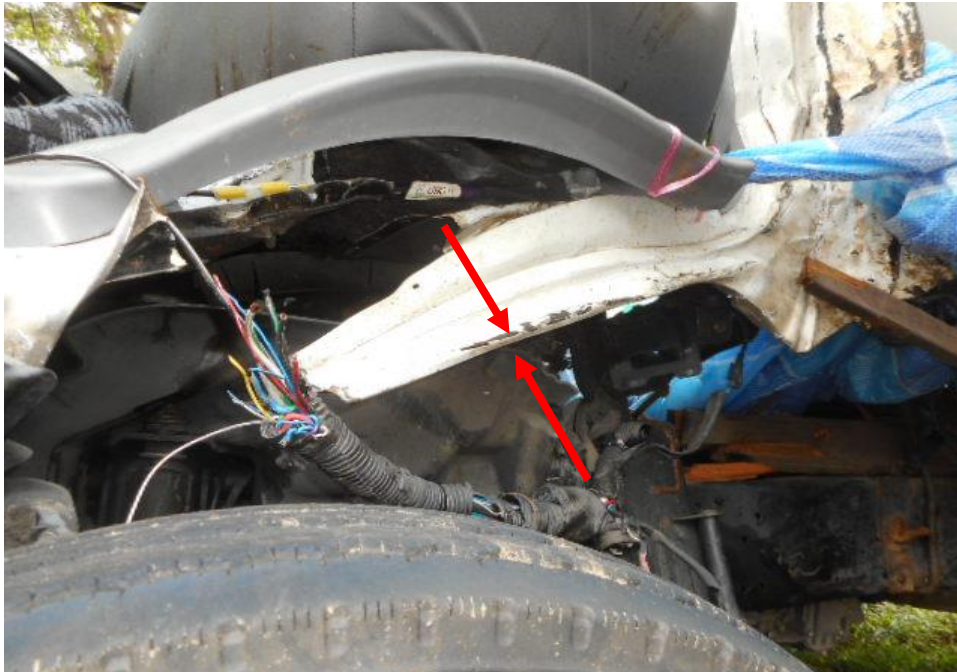
8. Upon examination of the Motor Lorry's engine compartment, we had observed that all the parts, components and fluids could not be inspection as due to the damage induced has crushed and deformed the cabin of the Motor Lorry which immobilized its opening and viewing. However, we were able to view the brake fluid and it was of a sufficient level and without contamination. See photo 13 to 14 below.

**Photo 13** shows the induced damage to the front engine cover (arrowed) of the Motor Lorry's which had immobilised the opening and viewing of the various parts and components inside the engine compartment a result of the accident.

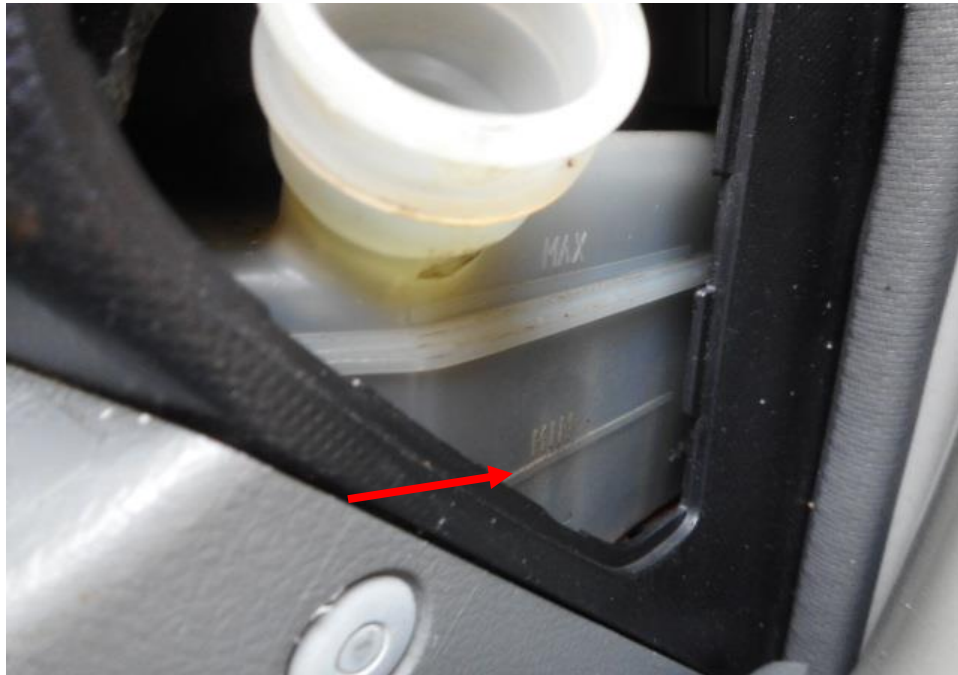
**Photo 14** shows the brake fluid reservoir of the Motor Lorry at the time of my inspection. The brake fluid was observed to be of sufficient level (arrowed) and without any visible contamination.

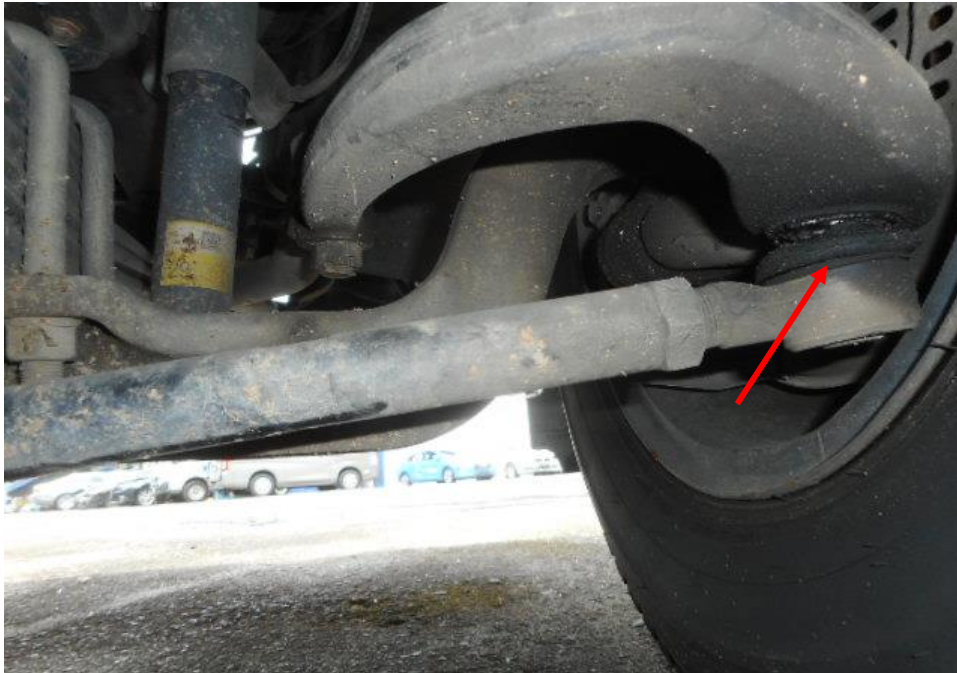
**Photo 15** shows the various undercarriage components at the front right wheel of the Motor Lorry, in particular the steering tie rod end (arrowed). The various steering components were all found to be intact, suggesting that the steering system of the Motor Lorry was likely to be in serviceable condition at the material time of accident. There was also no sign of fluid stain(s) observed on the various undercarriage components.

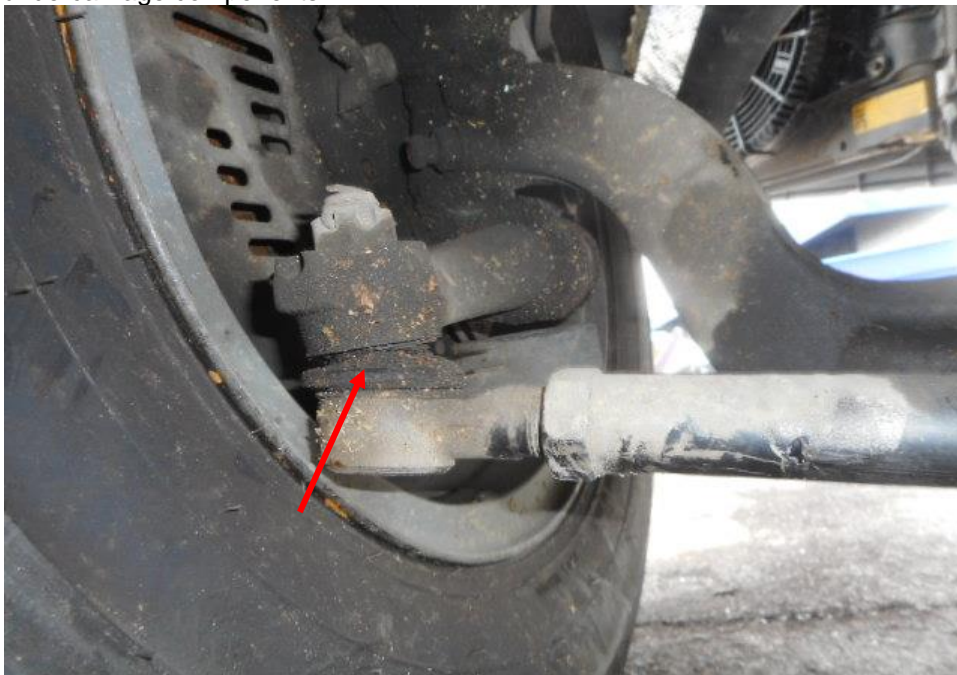
**Photo 16** shows the various undercarriage components at the front left wheel of the Motor Lorry, in particular the steering tie rod end (arrowed). The various undercarriage components of the Motor Lorry were all found to be intact without any visible damage. There was also no sign of fluid stain(s) observed on the various undercarriage components.

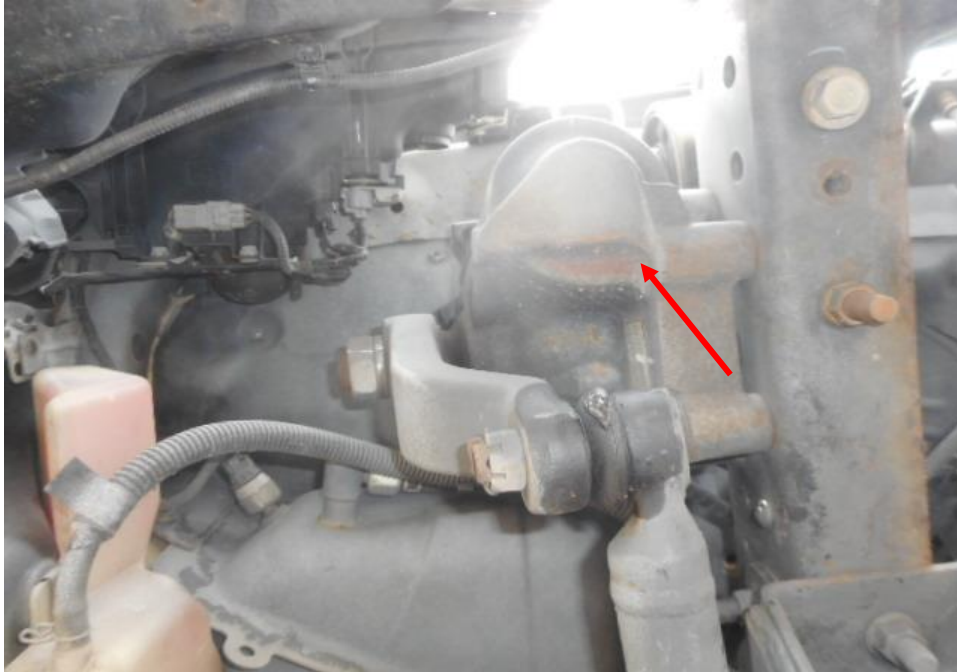
**Photo 17** shows the various undercarriage components at the front right wheel of the Motor Lorry, in particular the steering box (arrowed). The various undercarriage components of the Motor Lorry were all found to be intact without any visible damage. There was also no sign of fluid stain(s) observed on the various undercarriage components.

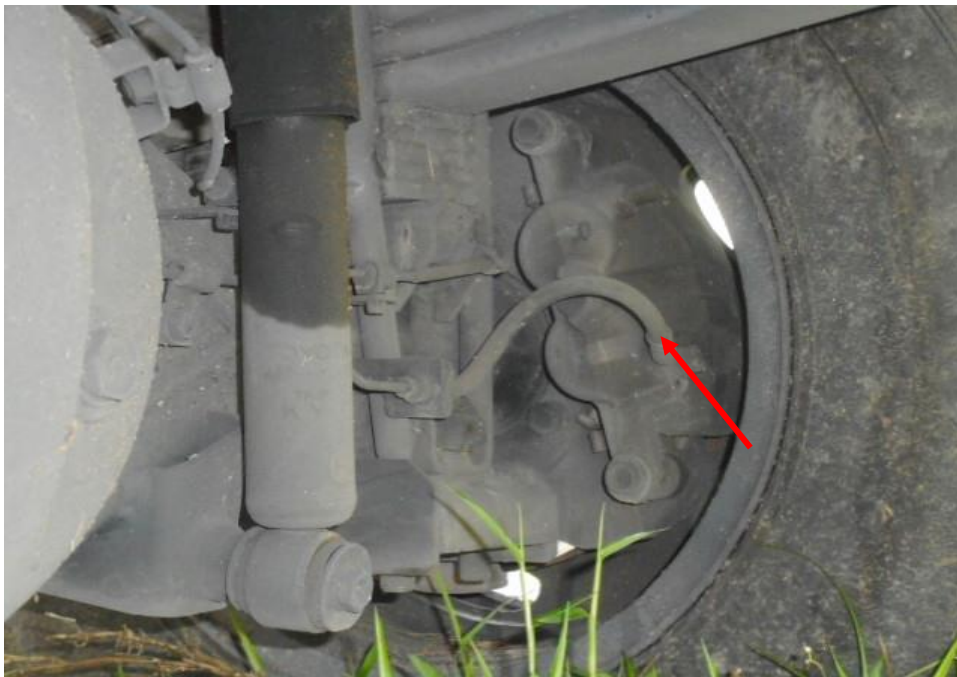
**Photo 18** shows the brake pipe (arrowed) at the rear right wheel of the Motor Lorry. I did not observe any leakage of brake fluid at the time of my inspection of the Motor Lorry. My visual examination of the various mechanical components in the braking system and they were all found to be intact without any visible damage.

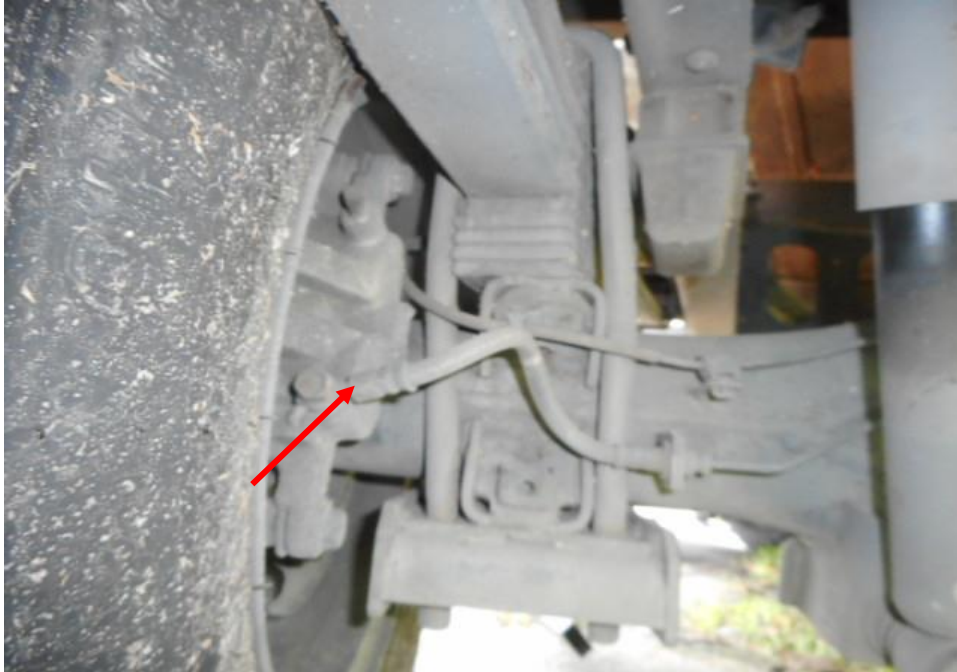
**Photo 19** shows the brake pipe (arrowed) at the rear left wheel of the Motor Lorry. I did not observe any leakage of brake fluid at the time of my inspection of the Motor Lorry. My visual examination of the various mechanical components in the braking system and they were all found to be intact without any visible damage.

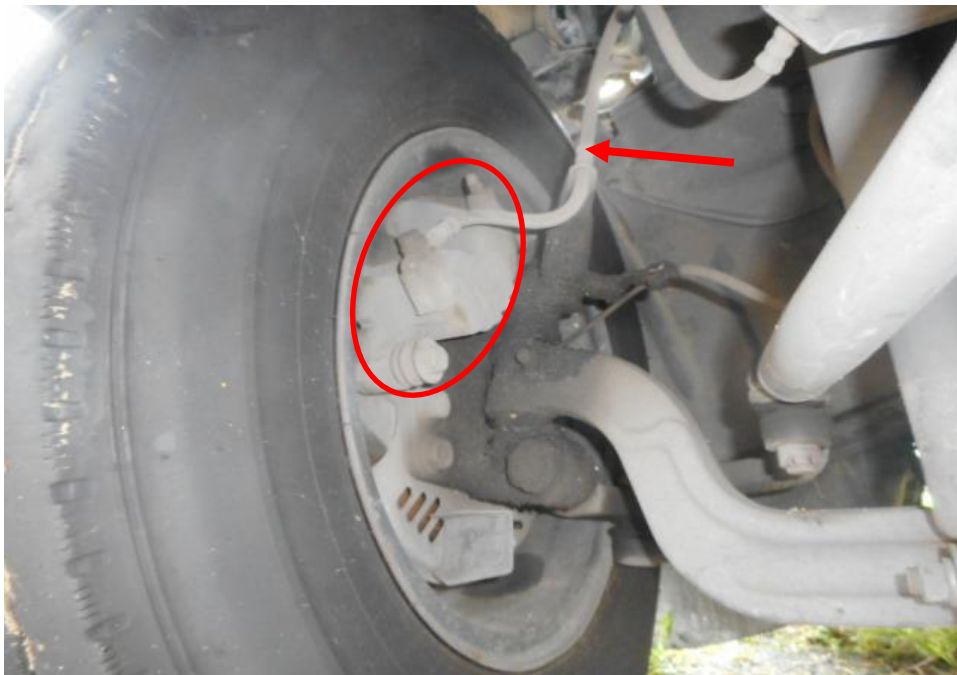
**Photo 20** shows the brake hose/pipe (arrowed) at the front right wheel of the Motor Lorry. No leakage of brake fluid was observed. Visual examination of the various components of the braking system like the brake caliper (circled), brake booster, brake pedal etc had revealed all to be intact and without visible damage at the time of accident. There was also no sign of fluid stain(s) observed on the various undercarriage components.

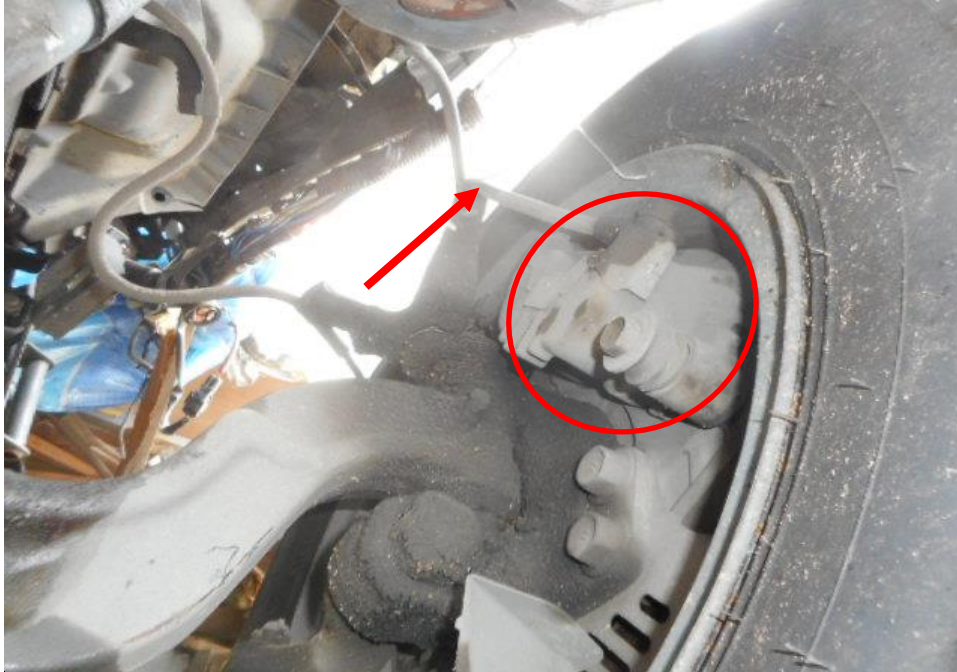
**Photo 21** shows the brake hose/pipe (arrowed) at the front left wheel of the Motor Lorry. No leakage of brake fluid was observed. Visual examination of the various components of the braking system like the brake caliper (circled), brake booster, brake pedal etc had revealed all to be intact and without visible damage at the time of accident. There was also no sign of fluid stain(s) observed on the various undercarriage components.

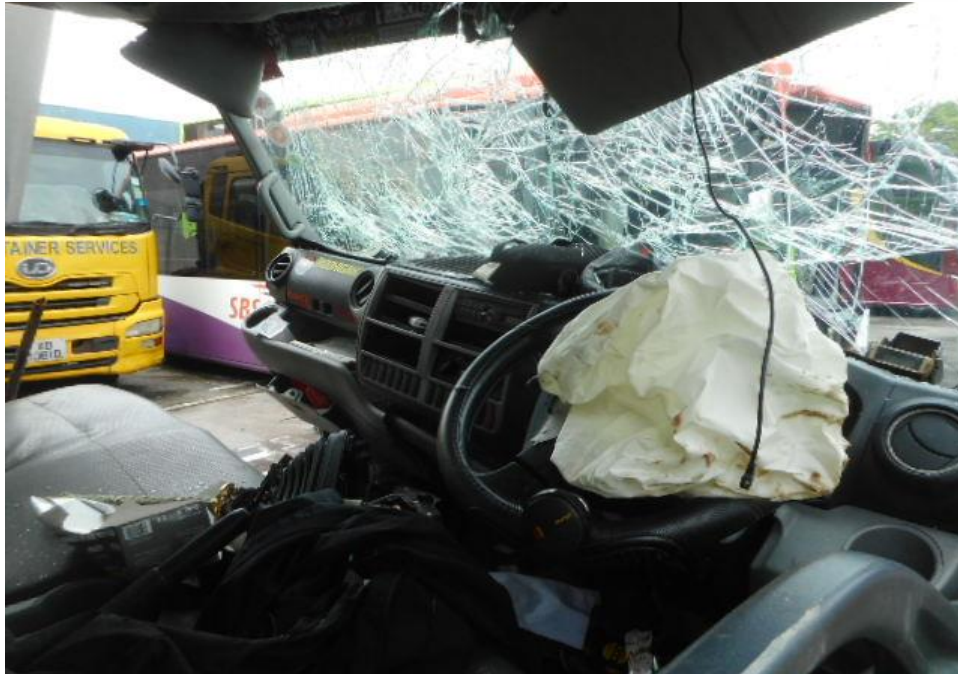
11. The static test of the Motor Lorry electronic safety system could not be inspected as the instrument cluster was damaged due to the induce impact from the accident. See photo 22 below

**Photo 22** shows instrument cluster and dashboard of the Motor Lorry at the time of our inspection. The instrument cluster and dashboard was observed to be damaged as a result of the accident.

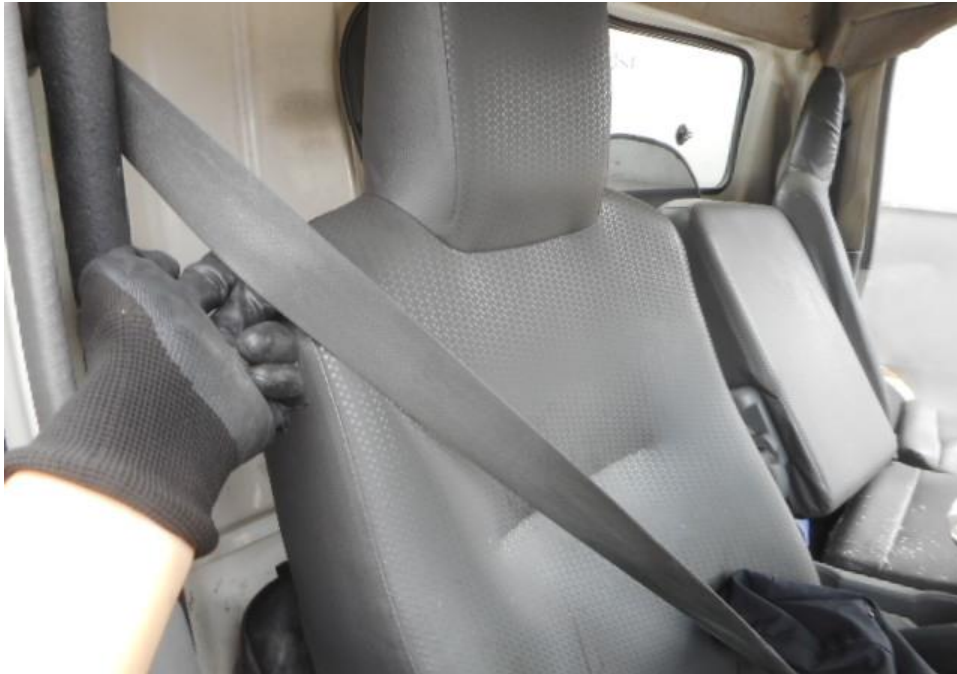
**Photo 23** shows that the seat belt on the right seat was worn at the material time of accident as the safety pre-tensioners was activated at the moment of impact and caused the seat belt to be locked into the last position.

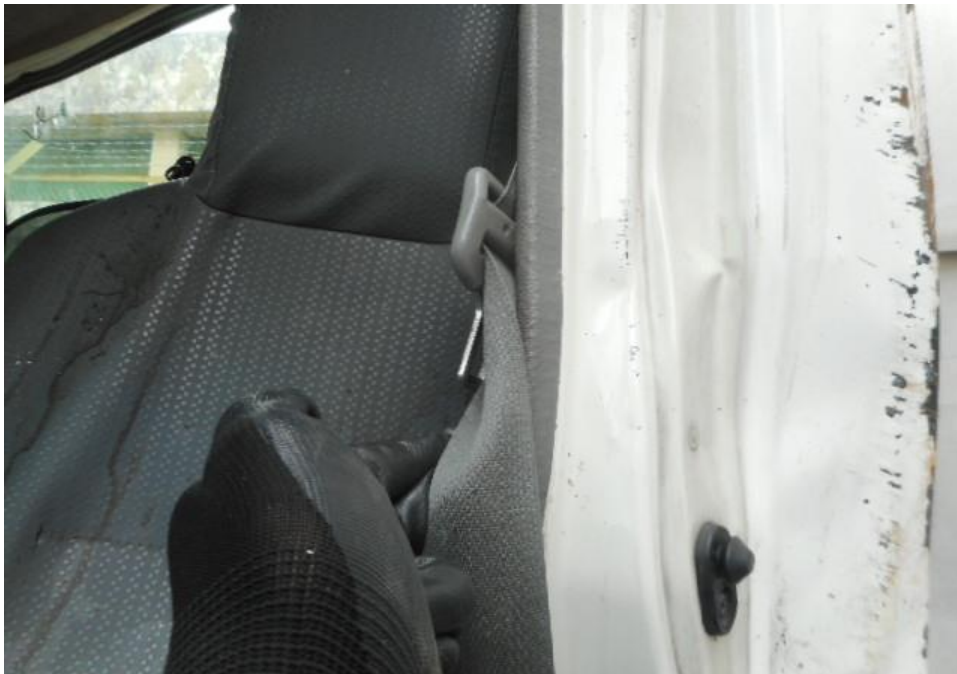
**Photo 24** shows that the seat belt on the left seat was not worn at the material time of accident as the safety pre-tensioners was activated at the moment of impact and caused the seat belt to be locked into the last position.
