You're Ref: TP/IP/21103/2022  
Our Ref: CI/TPD22008183/P

30<sup>th</sup> August 2022

**MECHANICAL INSPECTION REPORT OF MOTOR CAR SMM 6190Y**

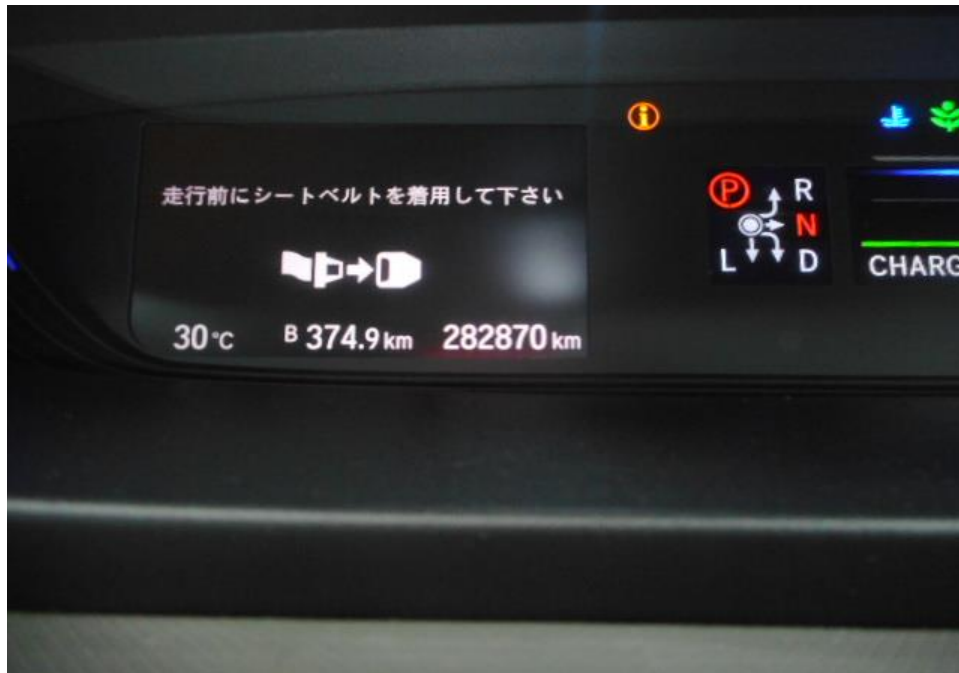
**Photo 1** shows the mileage of the Motor Car at the time of my inspection. The mileage observed was 282,870km.

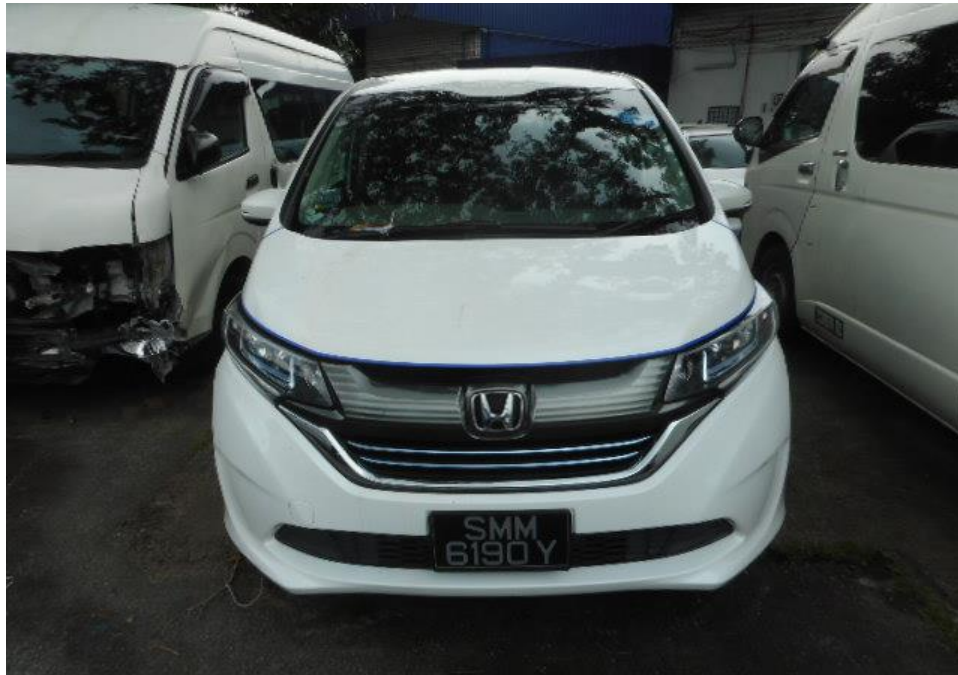
**Photo 2** shows a general view of the Motor Car's front body at the time of my inspection. The Motor Car rear was observed to be unaffected by the accident.

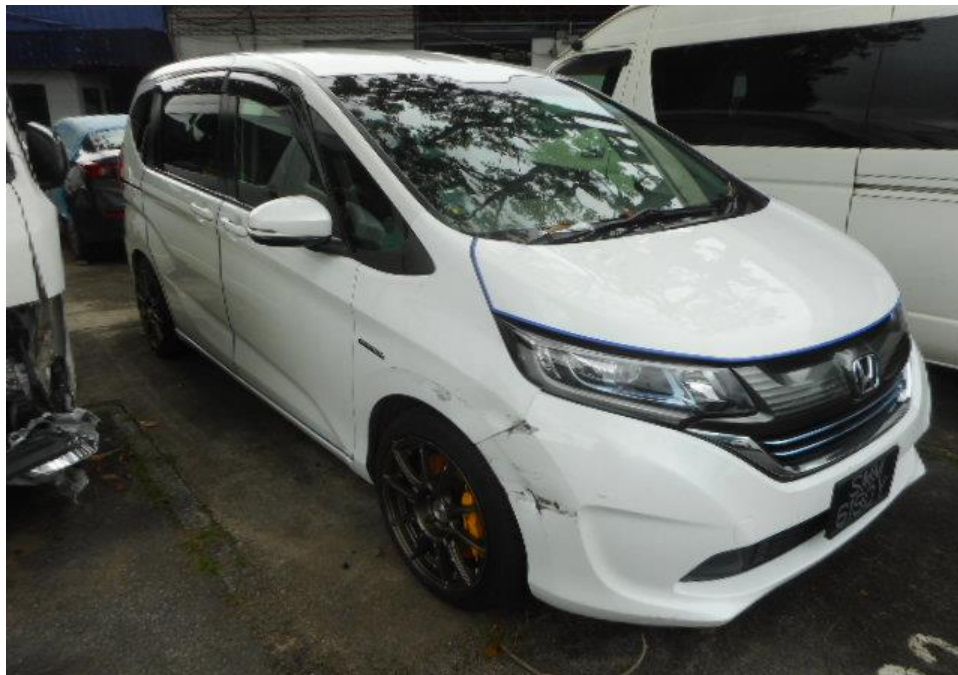
4. The mileage of the Motor Car at the time of my inspection was 282,870km.
5. The Motor Car was observed to have sustained damage at its right portion. Its front right bumper portion and its right fender was amongst the body parts that were damaged as a result of the accident.

**Photo 3** shows a general view of the Motor Car's right body at the time of my inspection. The Motor Car was observed to have sustained damage at its right portion. Its front right bumper portion and its right fender was amongst the body parts that were damaged as a result of the accident.

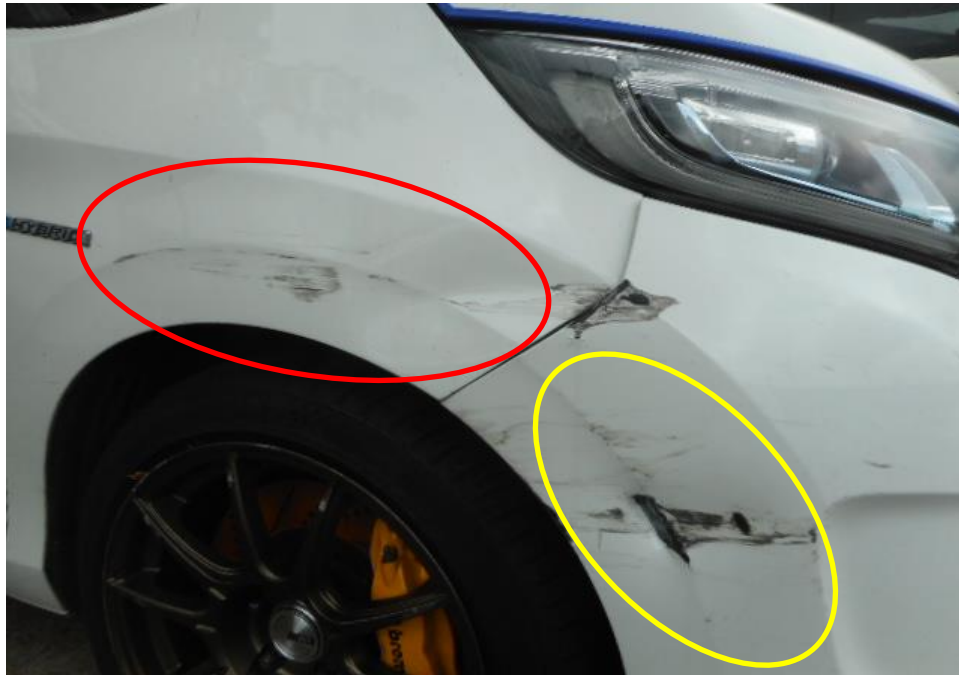
**Photo 4** shows a close up view of the Motor Car's front body at the time of my inspection. The front portion of the Motor Car was observed to have sustained damage. Its front right bumper (yellow circle) and right fender (red arrow) was the body parts that were damaged as a result of the accident.

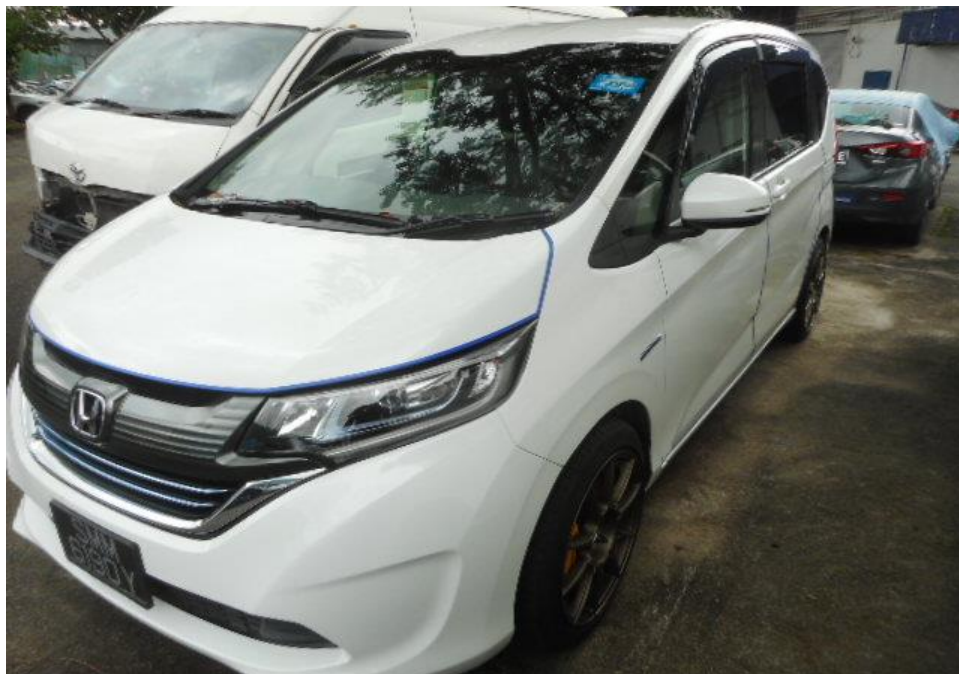
**Photo 5** shows the general view of the Motor Car's right body at the time of my inspection. The Motor Car rear was observed to be unaffected by the accident.

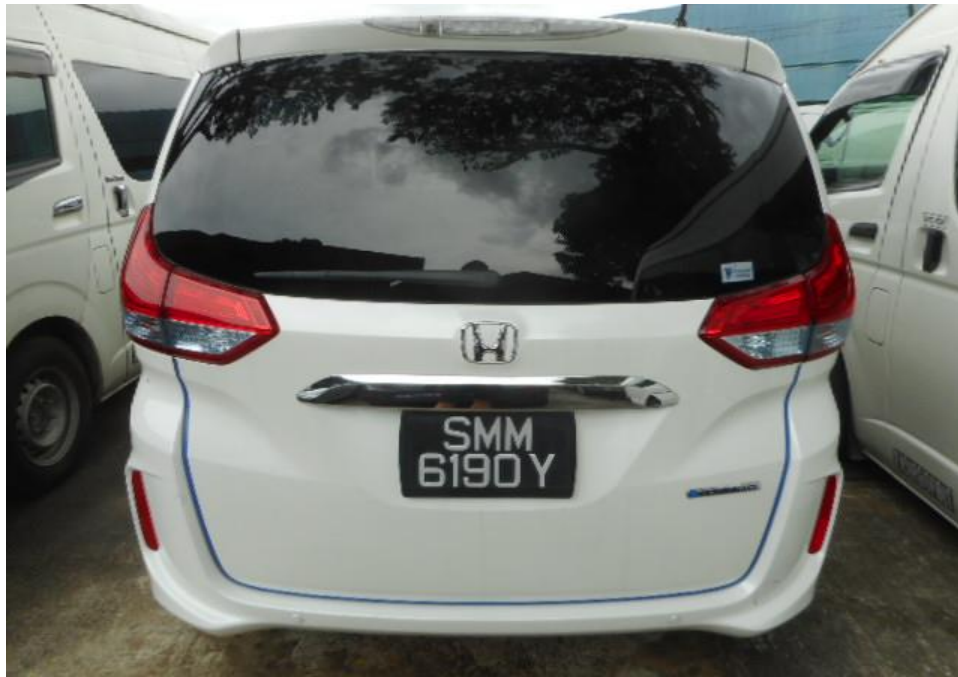
**Photo 6** shows the general view of the Motor Car's rear body at the time of my inspection. The Motor Car rear was observed to be unaffected by the accident.

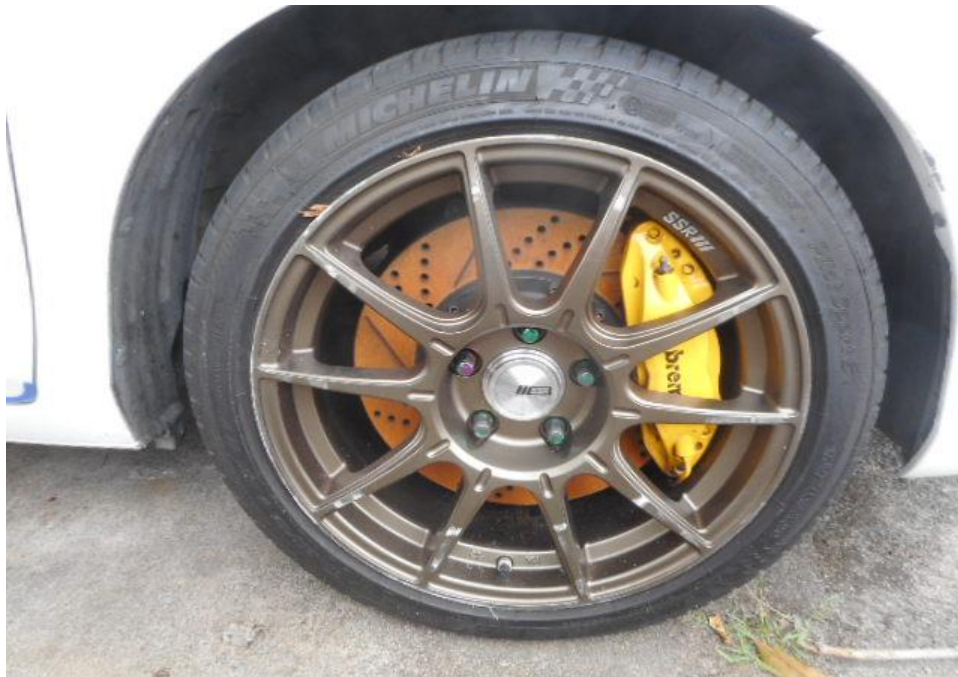
7. The front right wheel rim was observed to have sustained minor scratches as a result of the accident. However, the other 4 tyres and 3 wheel rims were observed to be wrapped around standard alloy wheel rims that were found to be without any damage. See photo 1 – 11 below.

**Photo 7** shows the condition of the front right tyre of the Motor Car, which was observed to be in serviceable condition with remaining tread depth of approximately 5.4mm. The tyre was sufficiently inflated for vehicular operation with no tear, cut or burst mark(s) on the outer and the inner sidewalls as well as across the tread. However, the wheel rim was observed to sustained minor scathes as a result of the accident.

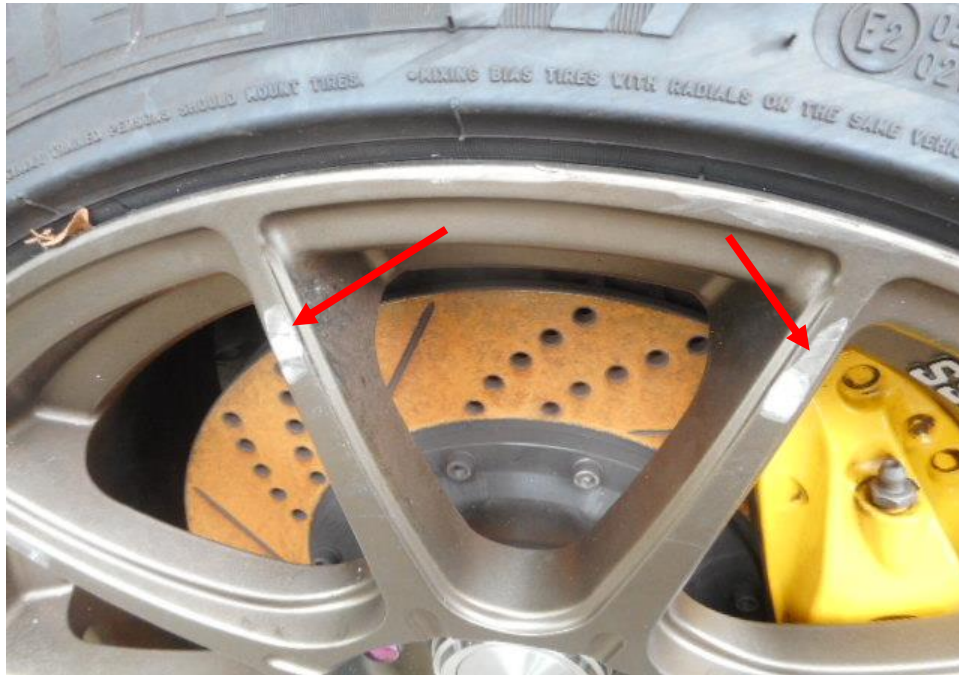
**Photo 8** shows the close up view of the front right tyre of the Motor Car, which was observed to be in serviceable condition with remaining tread depth of approximately 5.4mm. The tyre was sufficiently inflated for vehicular operation with no tear, cut or burst mark(s) on the outer and the inner sidewalls as well as across the tread. However, the wheel rim (arrowed) was observed to sustained minor scathes as a result of the accident.

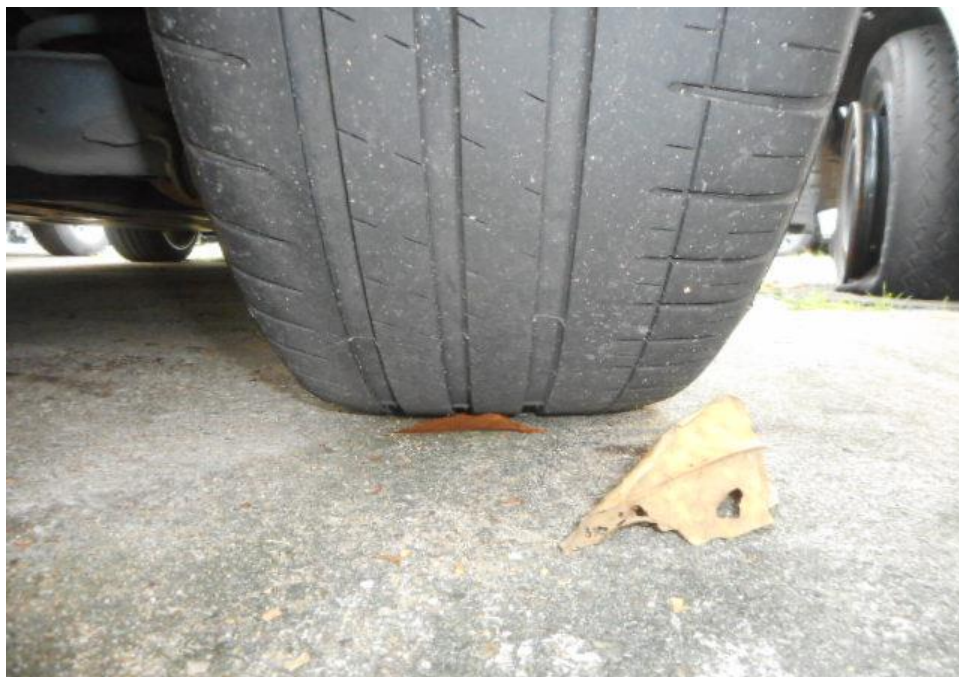
**Photo 9** shows the condition of the rear right tyre of the Motor Car, which was observed to be in serviceable condition with remaining tread depth of approximately 3.8mm. The tyre was also observed to be sufficiently inflated for vehicular operation with no tear, cut or burst mark(s).

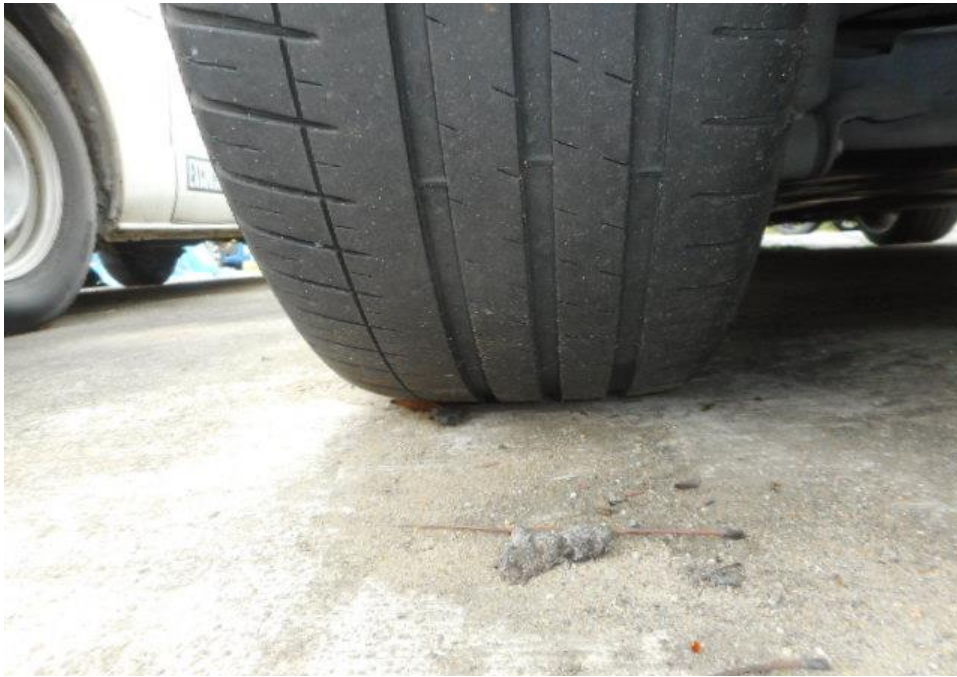
**Photo 10** shows the condition of the rear left tyre of the Motor Car, which was observed to be in serviceable condition with remaining tread depth of approximately 3.7mm. The tyre, which was wrapped around alloy wheel rim, was also observed to be sufficiently inflated for vehicular operation. The 4 tyres of the Motor Car were wrapped around standard alloy wheel rims.

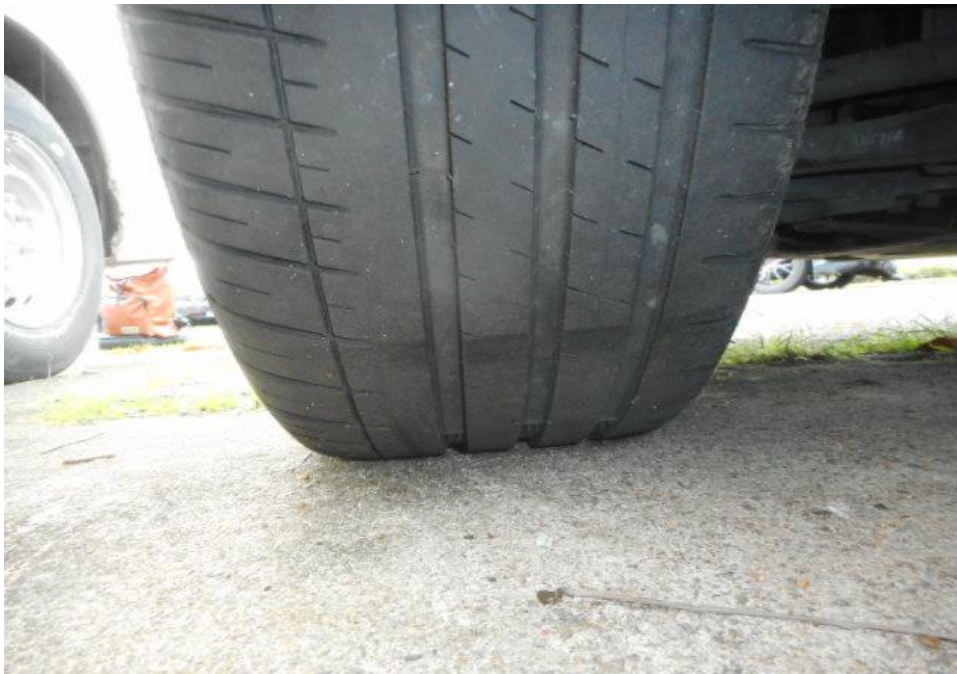
**Photo 11** shows the condition of the front left tyre of the Motor Car, which was observed to be in serviceable condition with remaining tread depth of approximately 4.6mm. There was also no tear, cut or burst mark(s) on the outer and the inner sidewalls as well as across the tread of the Motor Car's 4 tyres.

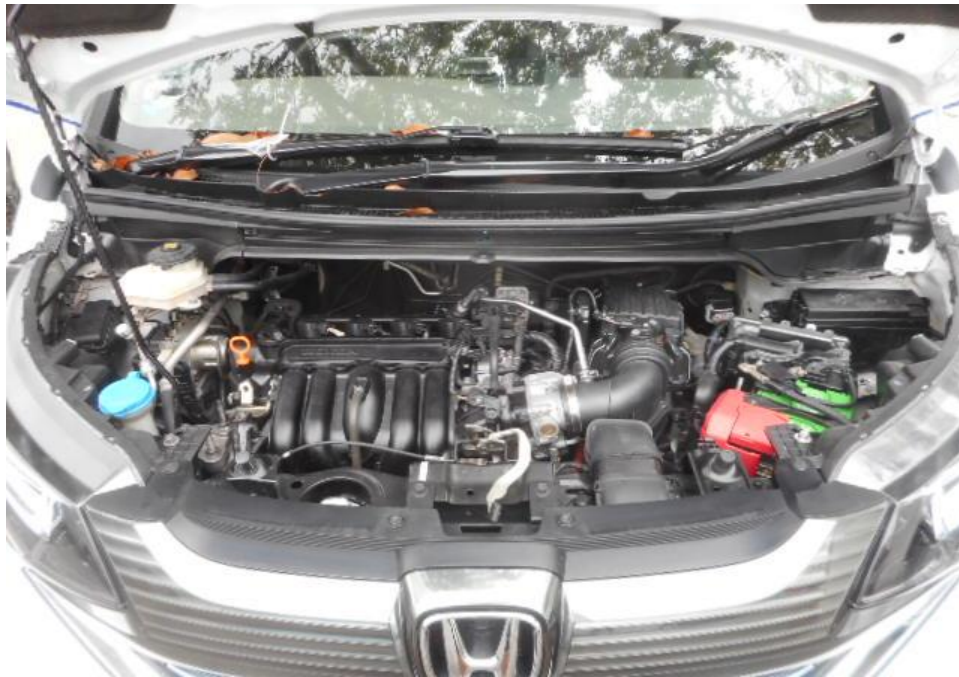
8. Upon examination of the engine compartment of the Motor Car, I had observed all the parts and components inside the engine compartment to be intact and unaffected by the accident. The brake fluid, engine oil and engine coolant were all found to be of sufficient level for operating purposes. Visually, there was also no contamination found to these fluids.
9. Further examination of the engine compartment revealed no sign(s) or indication(s) of fluid leakage and/or fluid stain within the engine compartment of the Motor Car.
10. My subsequent checks on the underside of the Motor Car also revealed no sign(s) or indication(s) of fluid leak and/or fluid stain(s). Visually, the various undercarriage components of the Motor Car were all observed to be intact and without any visible damage. See photo 12 – 16 below.

**Photo 12** shows a general view of the Motor Car's engine compartment. The various parts and components inside the engine compartment were unaffected by the accident. There was also no sign(s) or indication(s) of fluid leakage and/or fluid stain within the engine compartment.

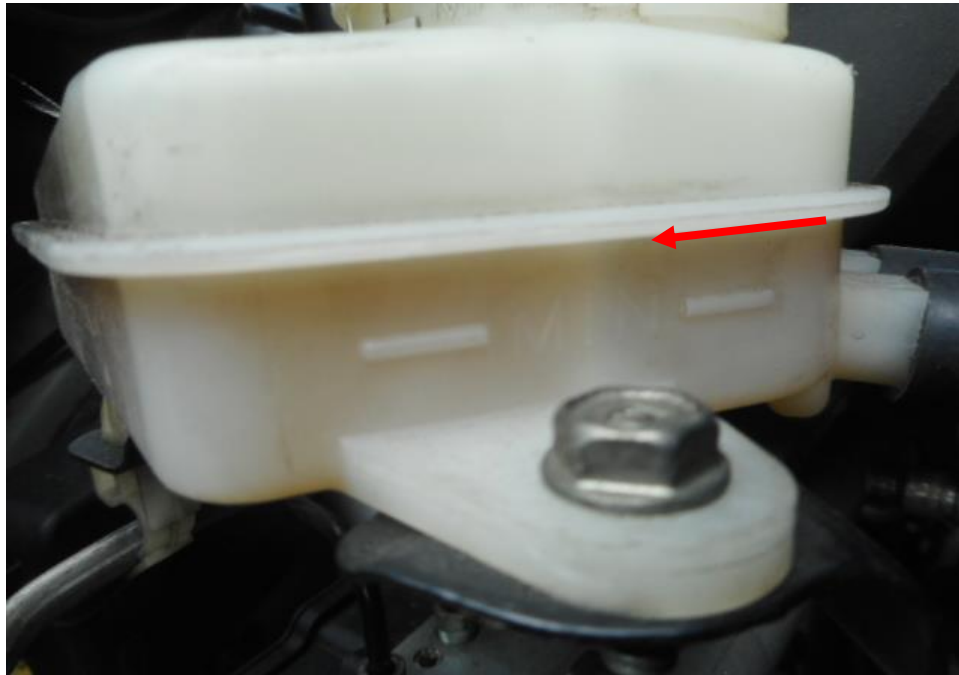
**Photo 13** shows the brake fluid reservoir of the Motor Car at the time of my inspection. The brake fluid was observed to be of sufficient level (arrowed) and without any visible contamination.

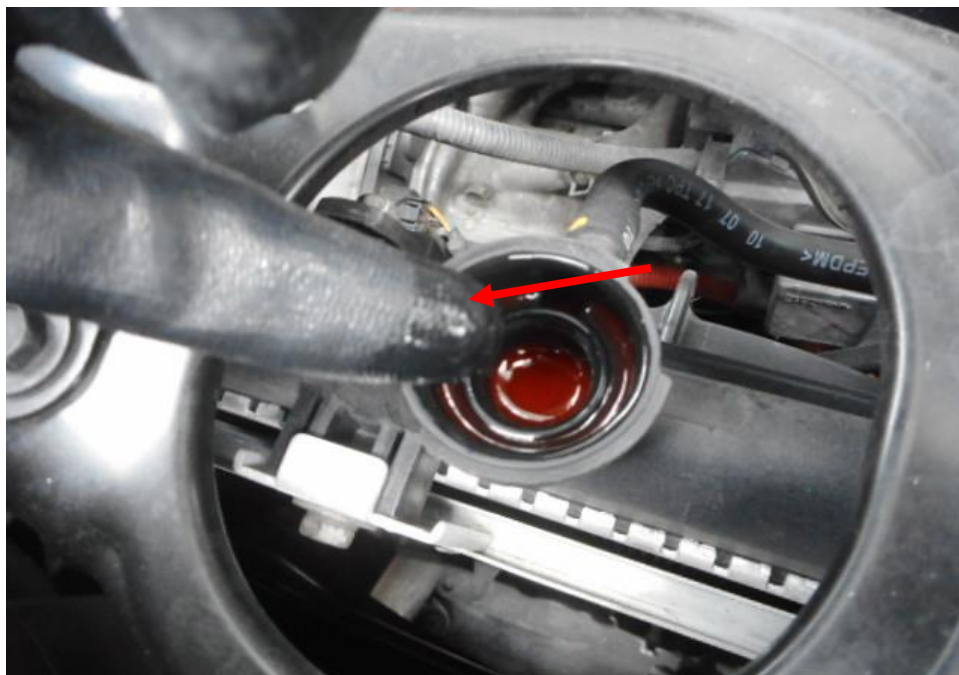
**Photo 14** shows checks being carried out to the engine coolant of the Motor Car at the time of my inspection. The engine coolant was observed to be of sufficient level (arrowed) and without any visible contamination.

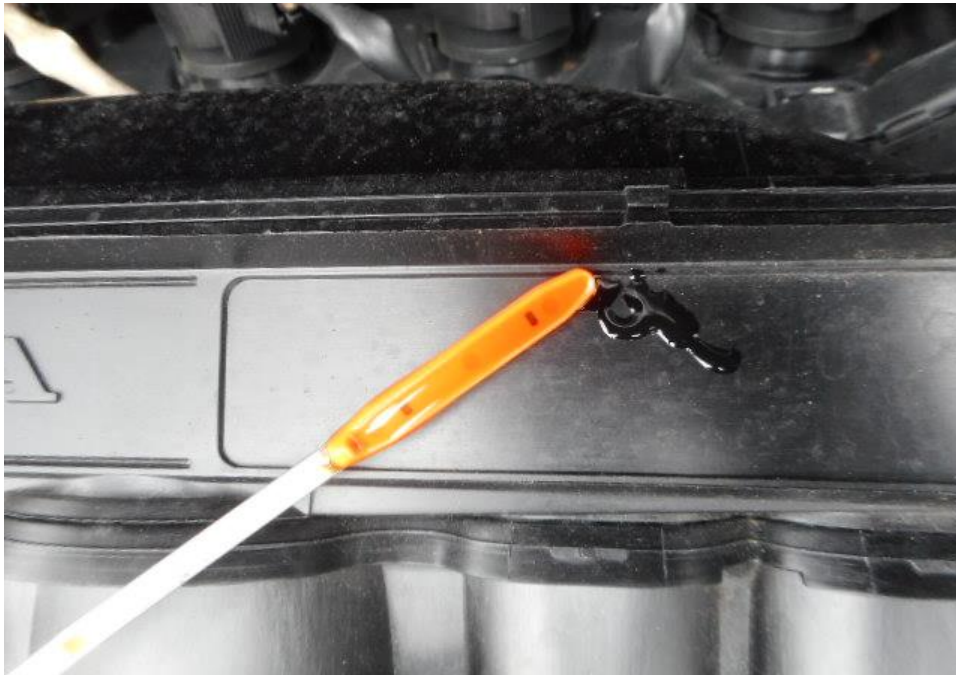
**Photo 15** shows the engine oil level dipstick of the Motor Car at the time of my inspection. The engine oil was observed to be of sufficient level and without any visible contamination.

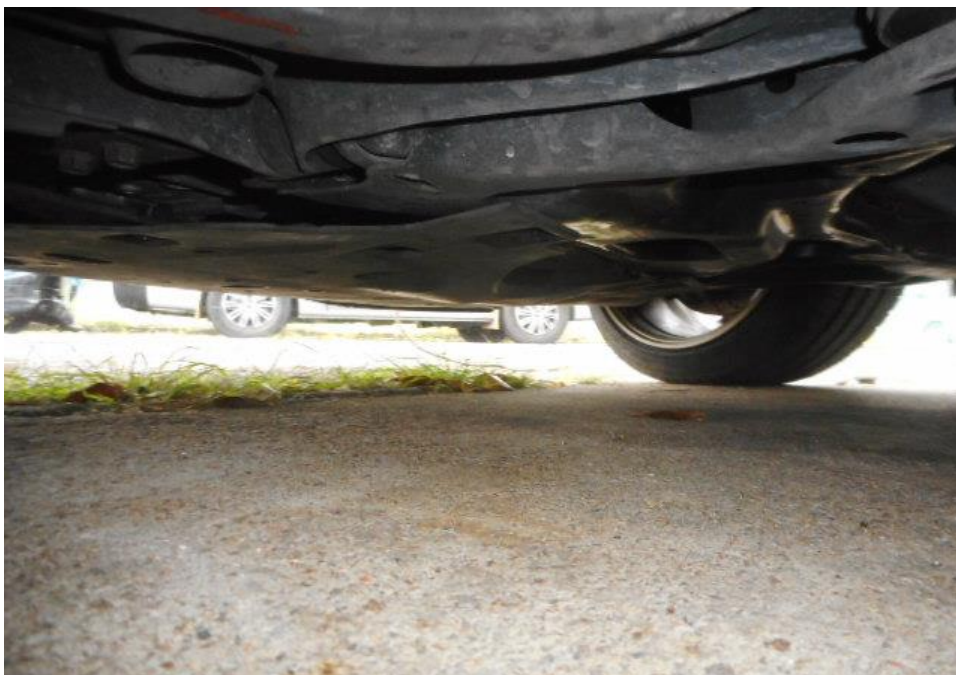
**Photo 16** shows the undercarriage of the Motor Car, at the area where the engine housing and transmission housing are located. I did not find any sign(s) or indication(s) of fluid leak and/or fluid stain(s) on the underside of the Motor Car.

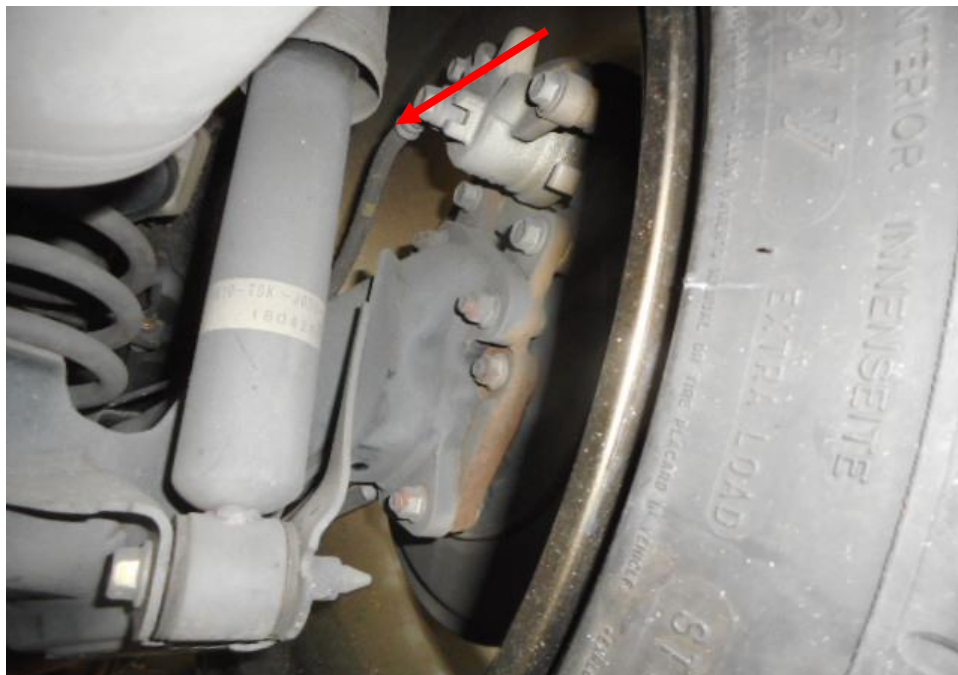
11. Static brake tests conducted on the Motor Car revealed no abnormality. The brake booster had responded well to the various tests conducted. There was also no abnormal movement of the brake pedal when it was depressed. In general, the static brake tests had suggested that there was no internal leakage of pressure/vacuum in the braking system of the Motor Car. The braking system of the Motor Car was likely to be in serviceable condition at the material time. This was taking into consideration that the brake fluid was of sufficient level, and also that there was no sign(s) of brake fluid leakage along the brake hoses and brake pipes.

**Photo 17** shows the brake hose/pipe (arrowed) at the rear right wheel of the Motor Car. No leakage of brake fluid was observed. Visual examination of the various components of the braking system like the drum brake, brake booster, brake pedal etc. had revealed all to be intact and without visible damage.

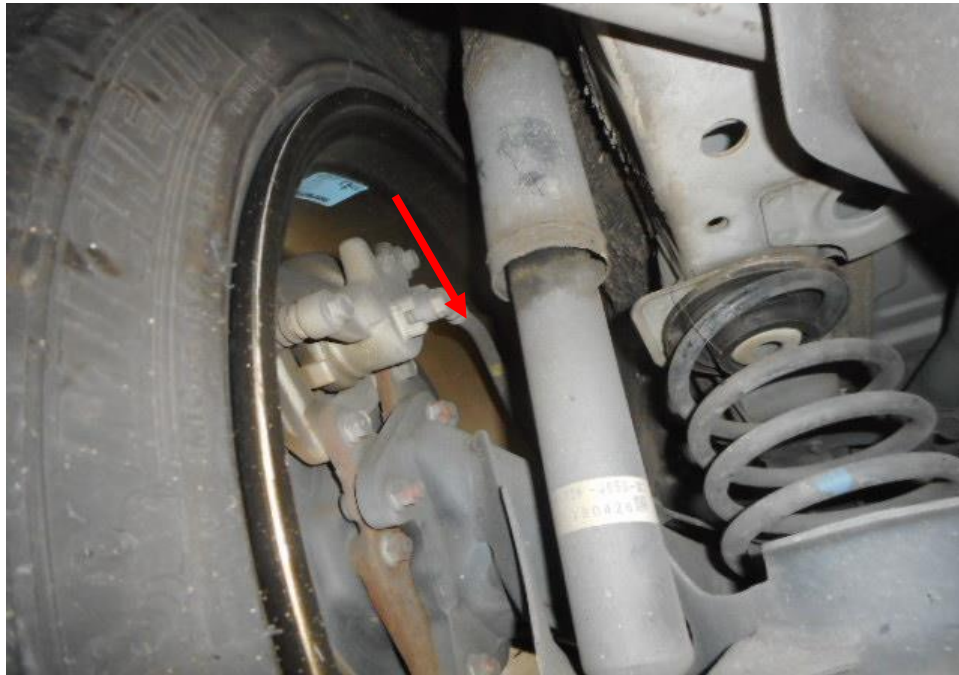
**Photo 18** shows the brake hose/pipe (arrowed) at the rear left wheel of the Motor Car. I did not observe any leakage of brake fluid at the time of my inspection of the Motor Car. Static tests of the Motor Car's braking system had indicated that there was no internal leakage of pressure/vacuum. The undercarriage components of the Motor Car were also all found to be intact and without any visible damage.

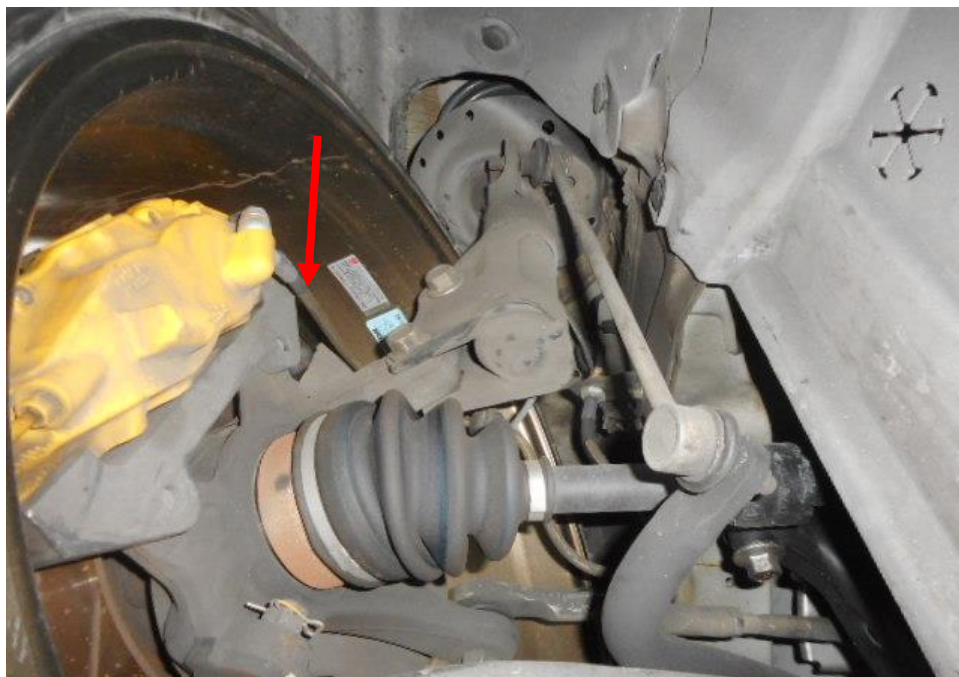
**Photo 19** shows the brake hose/pipe (arrowed) at the front right wheel of the Motor Car. I did not observe any leakage of brake fluid at the time of my inspection of the Motor Car. Static tests of the Motor Car's braking system had indicated that there was no internal leakage of pressure/vacuum.

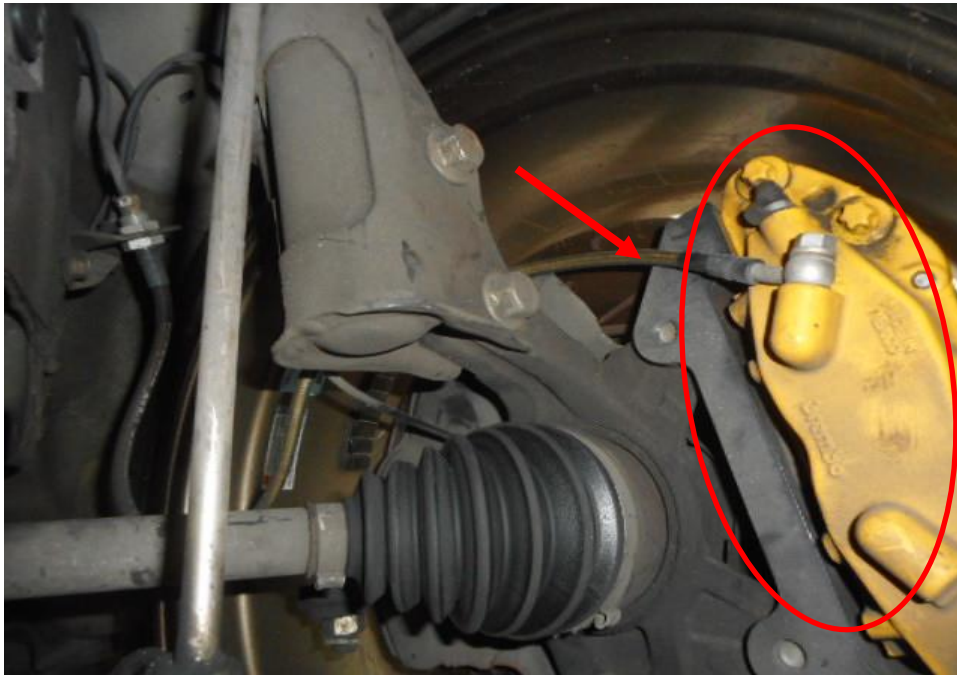
**Photo 20** shows the brake hose/pipe (arrowed) at the front left wheel of the Motor Car. No leakage of brake fluid was observed. Visual examination of the various components of the braking system like the brake caliper (circled), brake booster, brake pedal etc had revealed all to be intact and without visible damage.

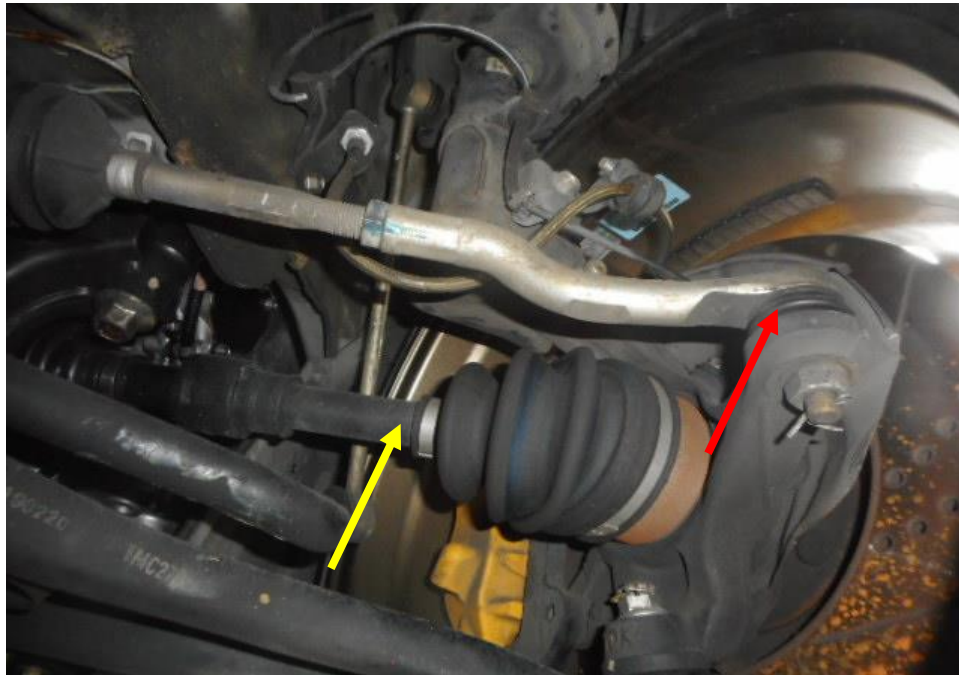
**Photo 22** shows the various undercarriage components at the front right wheel of the Motor Car, in particular the steering tie rod (red arrow) and in particular the drive shaft (yellow arrow). The various steering components were all found to be intact, suggesting that the steering system of the Motor Car was likely to be in serviceable condition at the material time of accident. There was also no sign of fluid stain observed on the various undercarriage components at the front right wheel of the Motor Car.

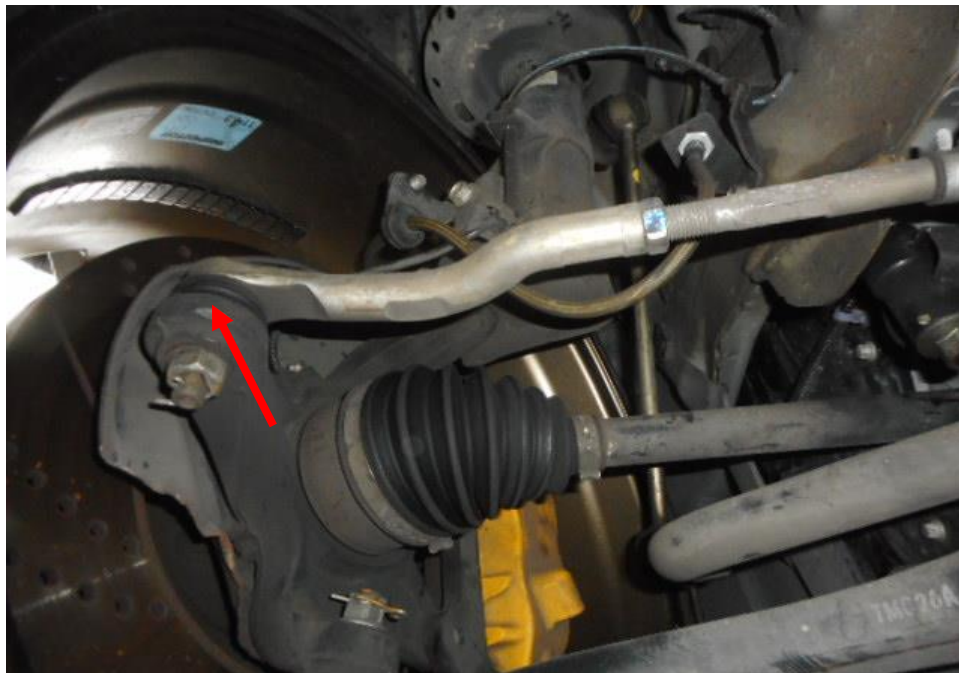
**Photo 23** shows the various undercarriage components at the front left wheel of the Motor Car, which had included the steering tie rod (arrowed). The various undercarriage components of the Motor Car were all found to be intact without any visible damage.

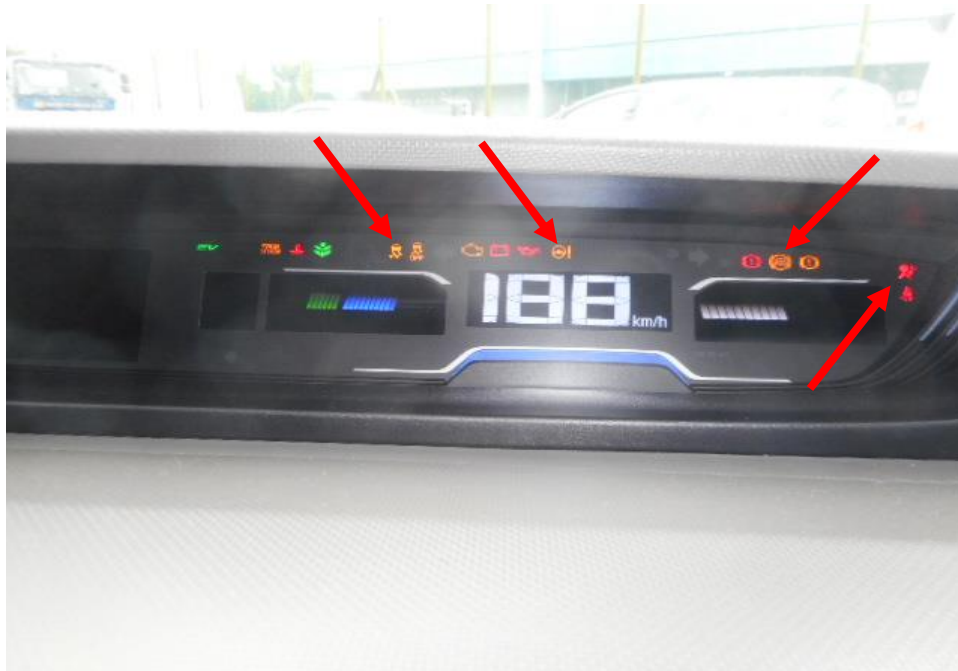
13. Motor Car 's automatic self-test of the functionality of its electronic operating systems like the Anti-Lock Brake System (ABS), Electronic Power Steering System (EPS), Traction Control System (TCS), and Supplemental Restraint System (SRS) during cranking of the engine had indicated that the system were in working condition and without abnormality. This can be established from the warning lights disappearing from the instrument panel after the self-test. See photo 24 & 25 below.

**Photo 24** shows the warning light for Anti-Lock Brake System (ABS), Electronic Power Steering (EPS), Traction Control System (TCS), and Supplemental Restraint System (SRS) (arrowed) appearing on the instrument panel of the Motor Car during the self-test of its various electronic operating systems when its engine was cranked.

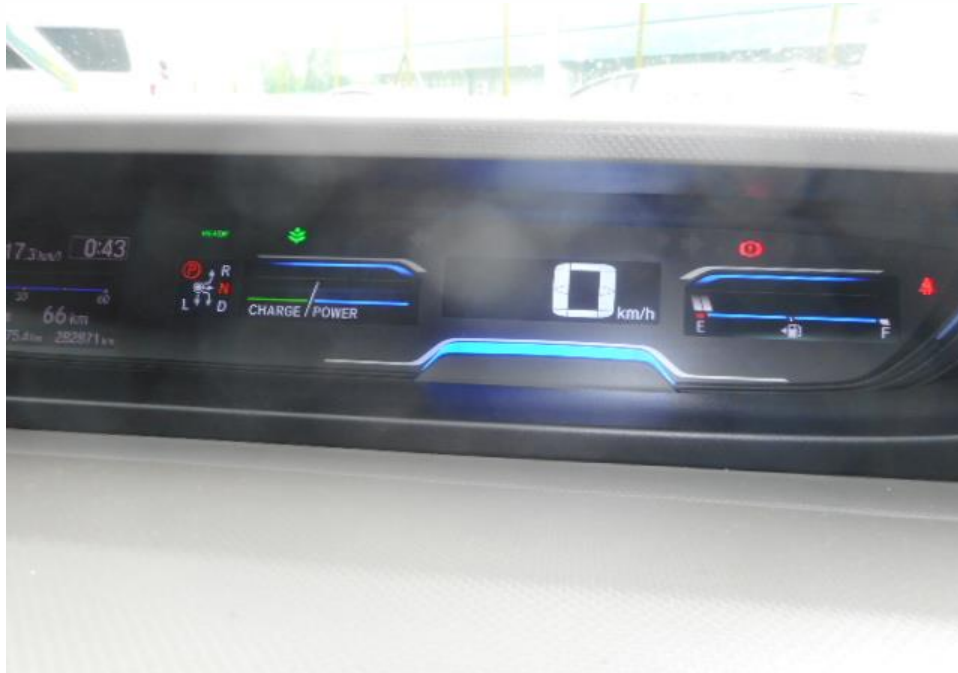
**Photo 25** shows no warning lights illuminated on the instrument panel of the Motor Car after the engine was cranked. This would suggest that there was no abnormality to the electronic operating system of the Motor Car, like the ABS, EPS, TCS and SRS etc.
