You're Ref: TP/IP/20003/2022  
Our Ref: CI/TPD22008185/P

**Fatal Accident Investigation Team**

**MECHANICAL INSPECTION REPORT OF MOTOR CAR SMZ 4861P**

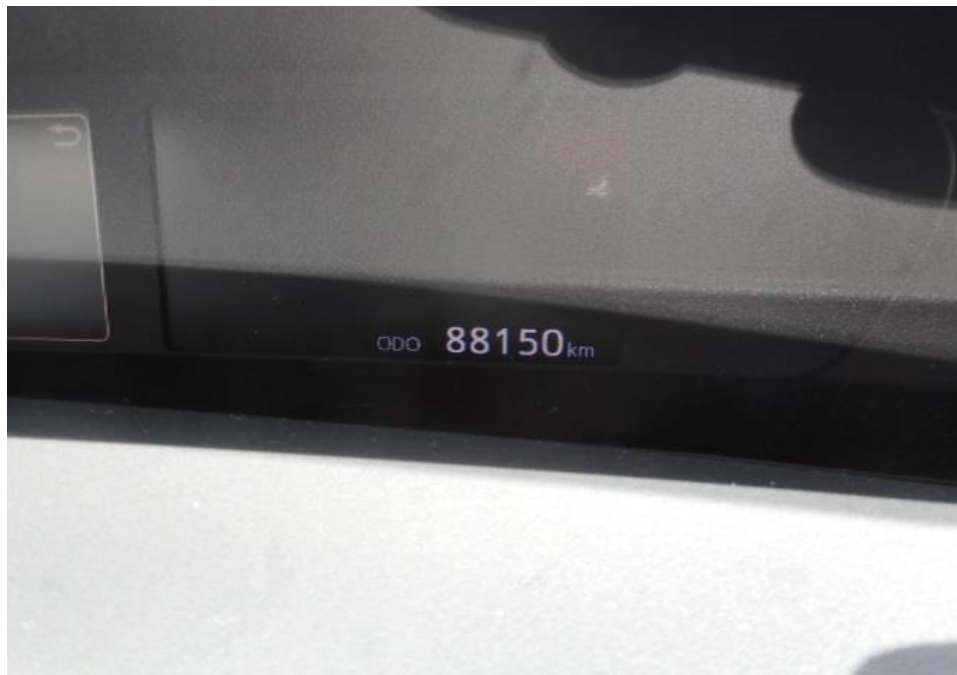
**Photo 1** shows the mileage of the Motor Car at the time of my inspection. The mileage observed was 88,150km.

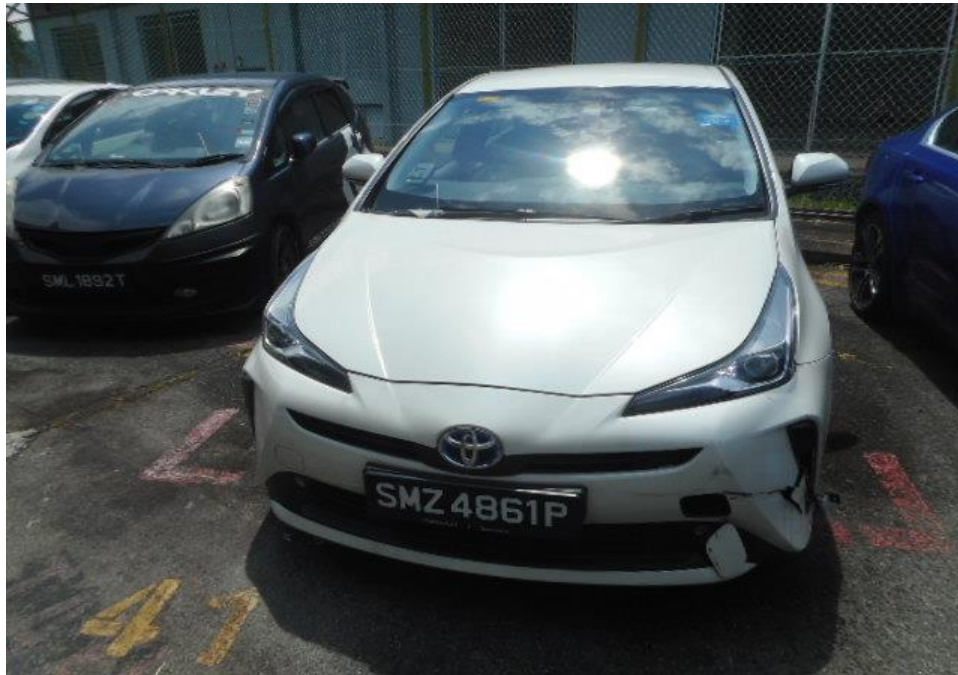
4. The mileage of the Motor Car at the time of my inspection was 88,150km.
5. The Motor Car was observed to have sustained damage at its front and left portion. Its front bumper, left front door and front left fender was amongst the body parts that were damaged as a result of the accident.

**Photo 2** shows a general view of the Motor Car's front body at the time of my inspection. The Motor Car was observed to have sustained damage at its front and left portion. Its front bumper, left front door and front left fender was amongst the body parts that were damaged as a result of the accident.

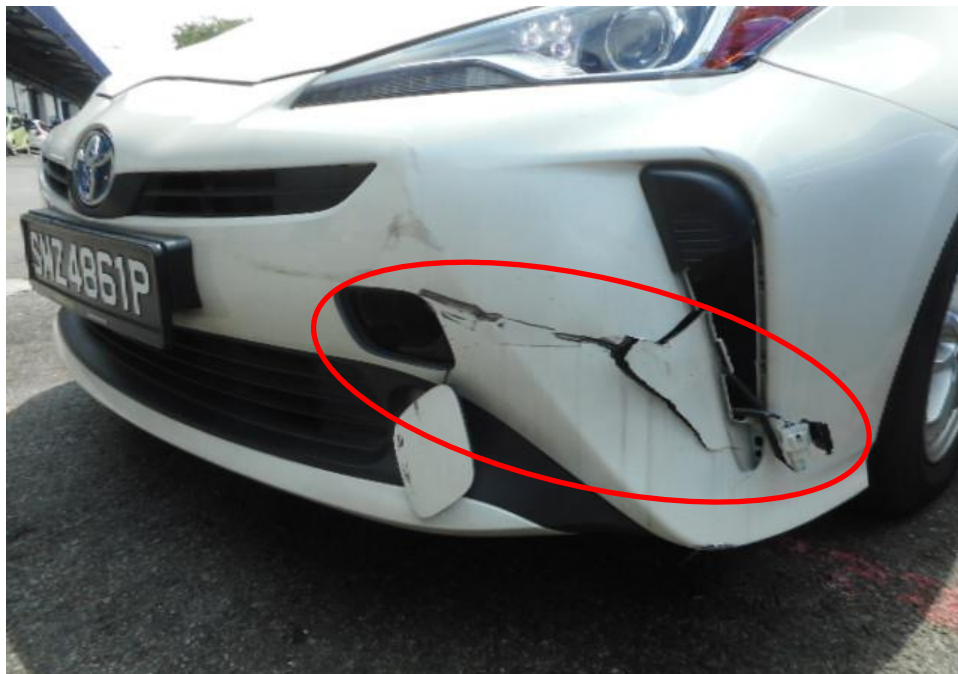
**Photo 3** shows a close up view of the Motor Car's front body at the time of my inspection. The front portion of the Motor Car was observed to have sustained damage. Its front bumper (circled) was the body part that were damaged as a result of the accident.

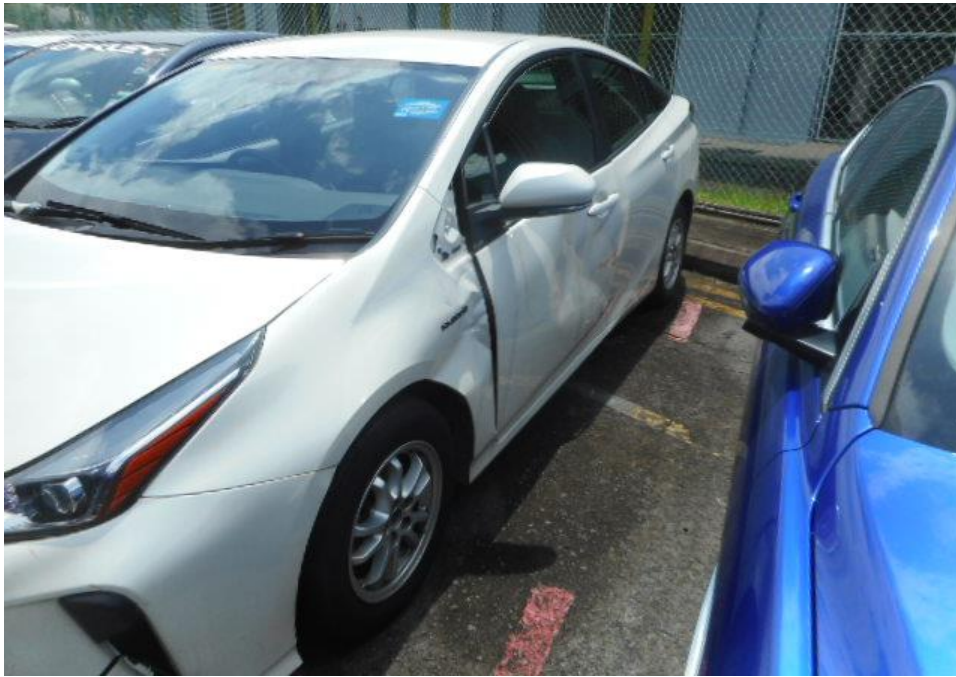
**Photo 4** shows a general view of the Motor Car's left body at the time of my inspection. The Motor Car was observed to have sustained damage at its left portion. Its left front door and front left fender was amongst the body parts that were damaged as a result of the accident.

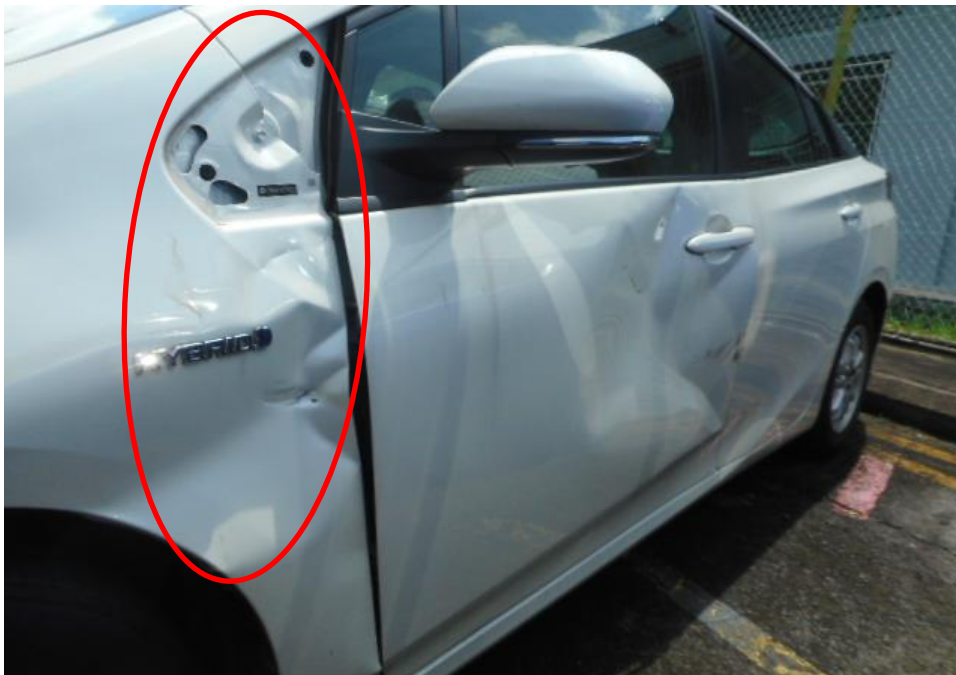
**Photo 5** shows a close up view of the Motor Car's left body at the time of my inspection. The left portion of the Motor Car was observed to have sustained damage. Its front left fender (circled) was amongst the body parts that were damaged as a result of the accident.

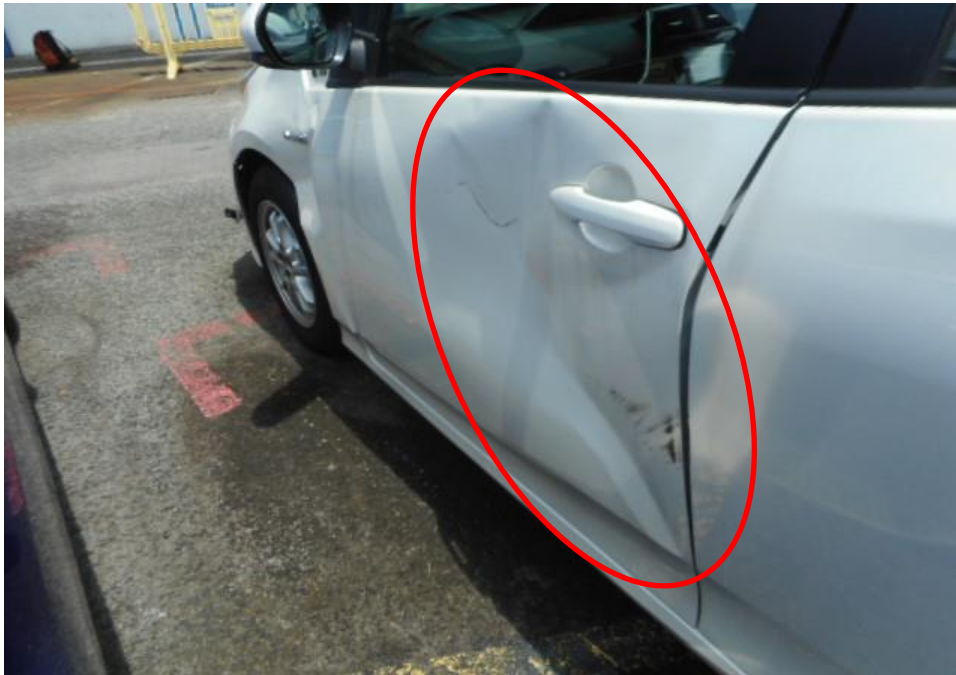
**Photo 6** shows a close up view of the Motor Car's left body at the time of my inspection. The left portion of the Motor Car was observed to have sustained damage. Its left front door (circled) was amongst the body parts that were damaged as a result of the accident.

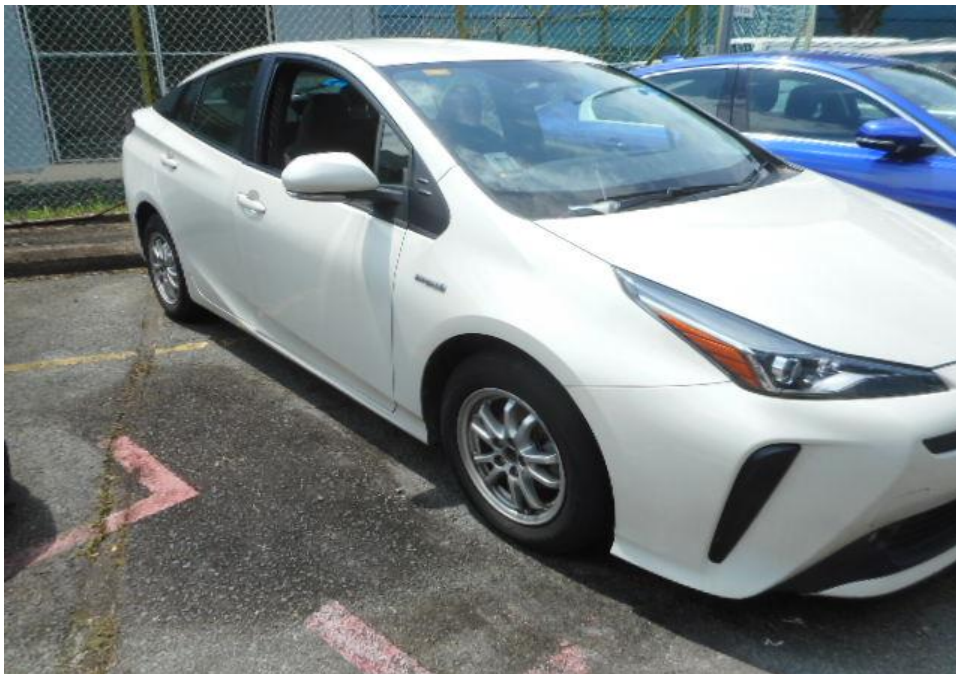
**Photo 7** shows a general view of the Motor Car's right body at the time of my inspection. The right portion of the Motor Car was observed to have been unaffected by the accident.

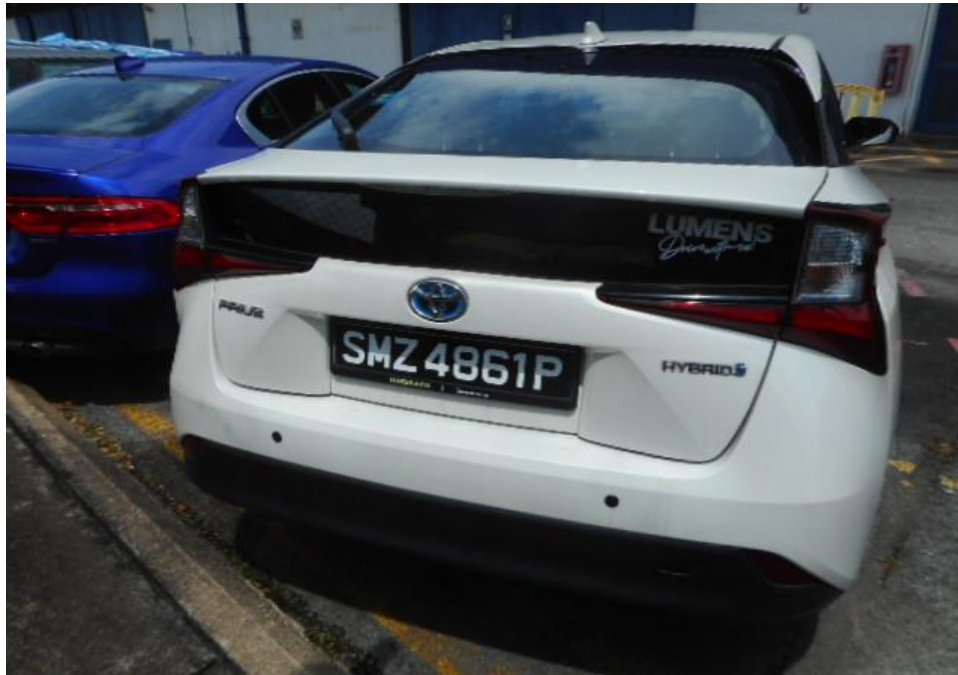
**Photo 8** shows the general view of the Motor Car's rear body at the time of my inspection. The Motor Car rear was observed to be unaffected by the accident.

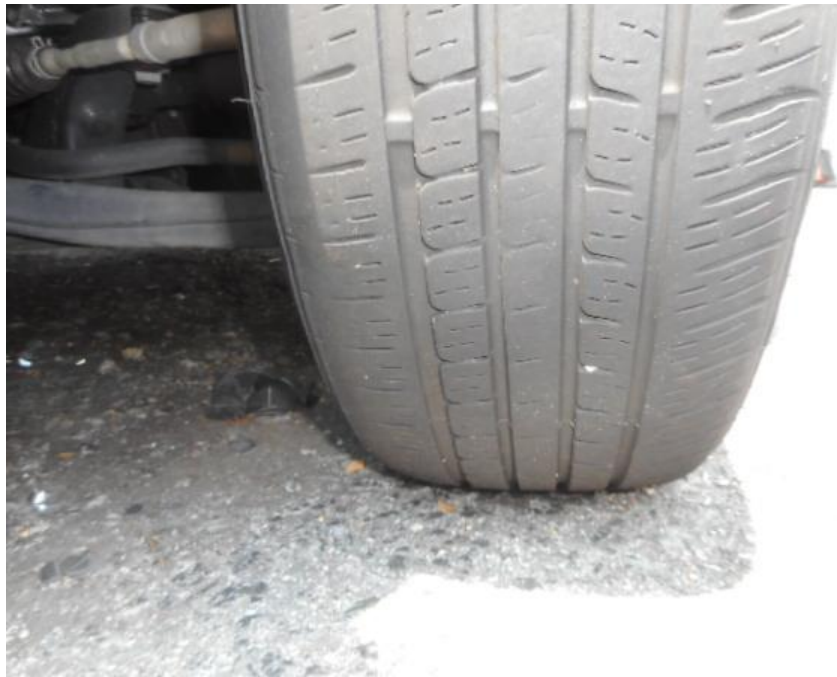
**Photo 9** shows the condition of the front right tyre of the Motor Car, which was observed to be in serviceable condition with remaining tread depth of approximately 4.2mm. The tyre was sufficiently inflated for vehicular operation with no tear, cut or burst mark(s) on the outer and the inner sidewalls as well as across the tread. The 4 tyres of the Motor Car were wrapped around standard alloy wheel rims without any damage.

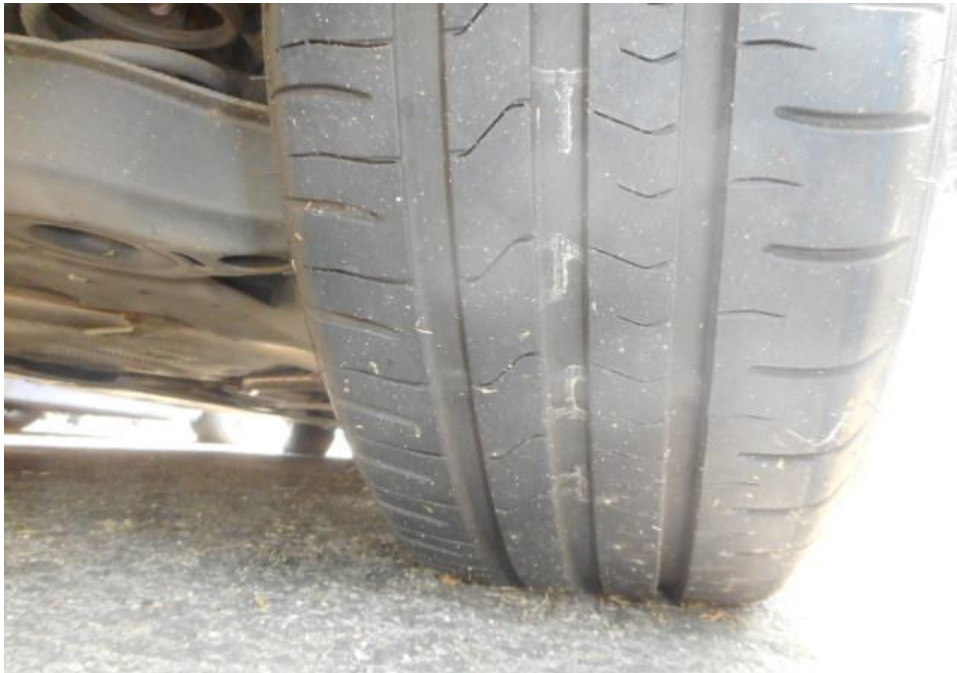
**Photo 10** shows the condition of the rear right tyre of the Motor Car, which was observed to be in serviceable condition with remaining tread depth of approximately 7.1mm. The tyre was also observed to be sufficiently inflated for vehicular operation with no tear, cut or burst mark(s).

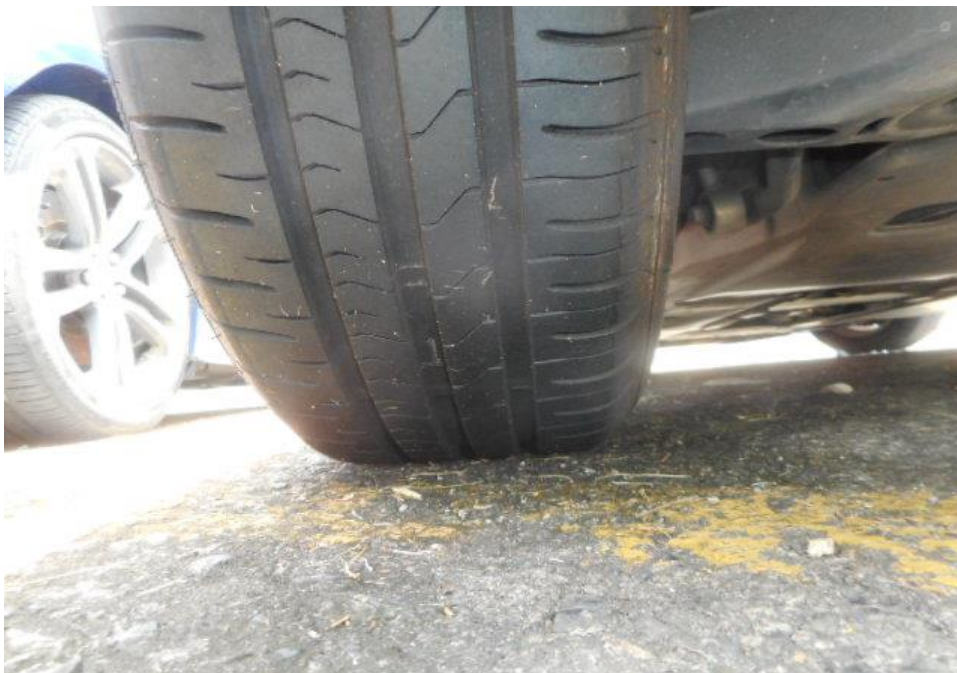
**Photo 11** shows the condition of the rear left tyre of the Motor Car, which was observed to be in serviceable condition with remaining tread depth of approximately 7.3mm. The tyre, which was wrapped around alloy wheel rim, was also observed to be sufficiently inflated for vehicular operation. The 4 tyres of the Motor Car were wrapped around standard alloy wheel rims.

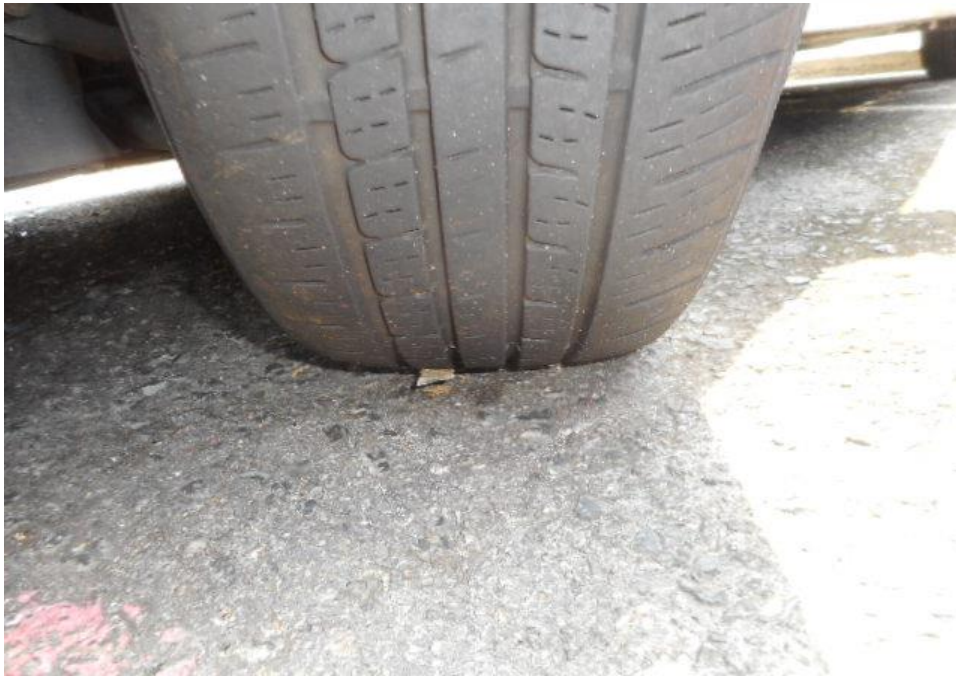
**Photo 12** shows the condition of the front left tyre of the Motor Car, which was observed to be in serviceable condition with remaining tread depth of approximately 4.1mm. There was also no tear, cut or burst mark(s) on the outer and the inner sidewalls as well as across the tread of the Motor Car's 4 tyres.

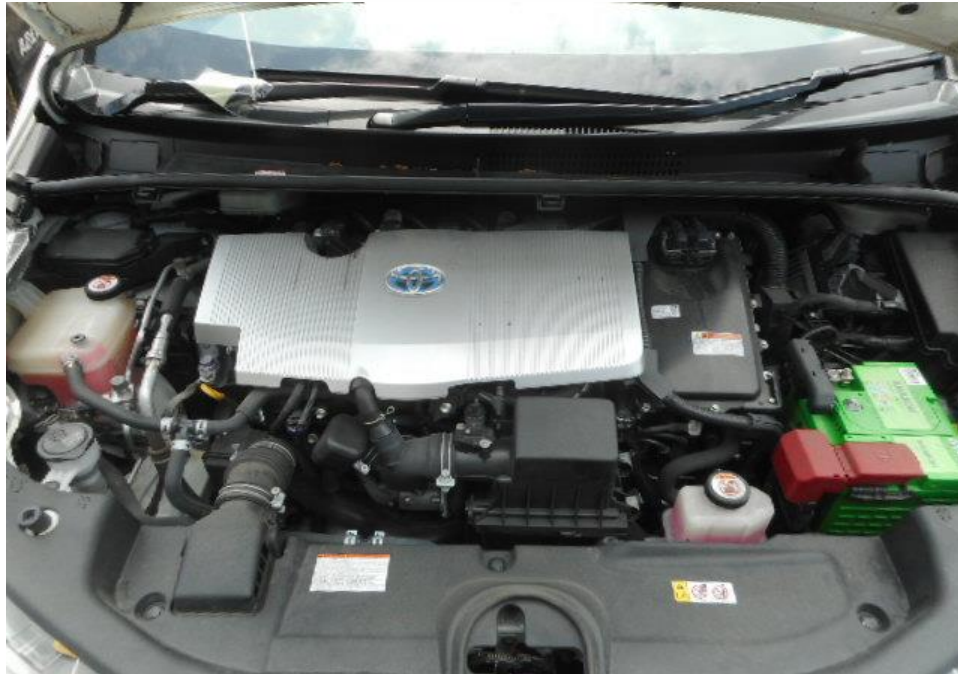
**Photo 13** shows a general view of the Motor Car's engine compartment. The various parts and components inside the engine compartment were unaffected by the accident. There was also no sign(s) or indication(s) of fluid leakage and/or fluid stain within the engine compartment.

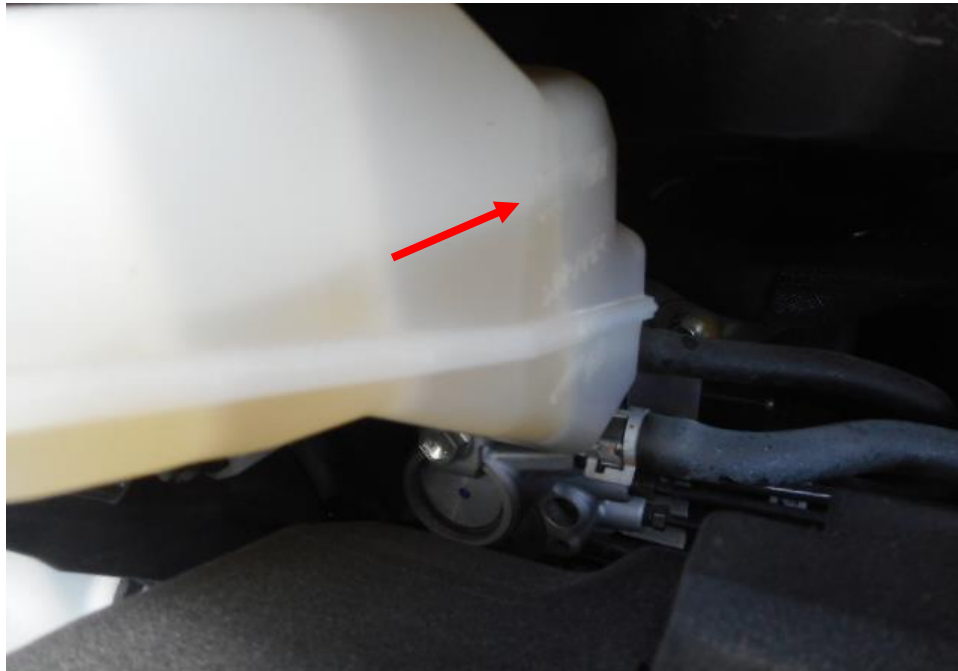
**Photo 14** shows the brake fluid reservoir of the Motor Car at the time of my inspection. The brake fluid was observed to be of sufficient level (arrowed) and without any visible contamination.

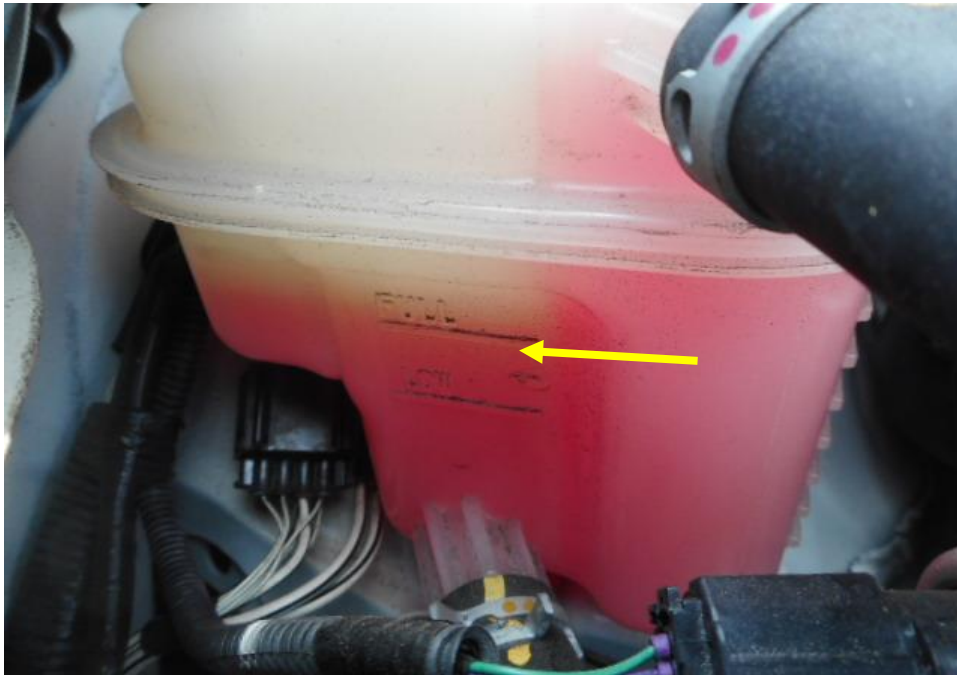
**Photo 15** shows checks being carried out to the engine coolant of the Motor Car at the time of my inspection. The engine coolant was observed to be of sufficient level (arrowed) and without any visible contamination.

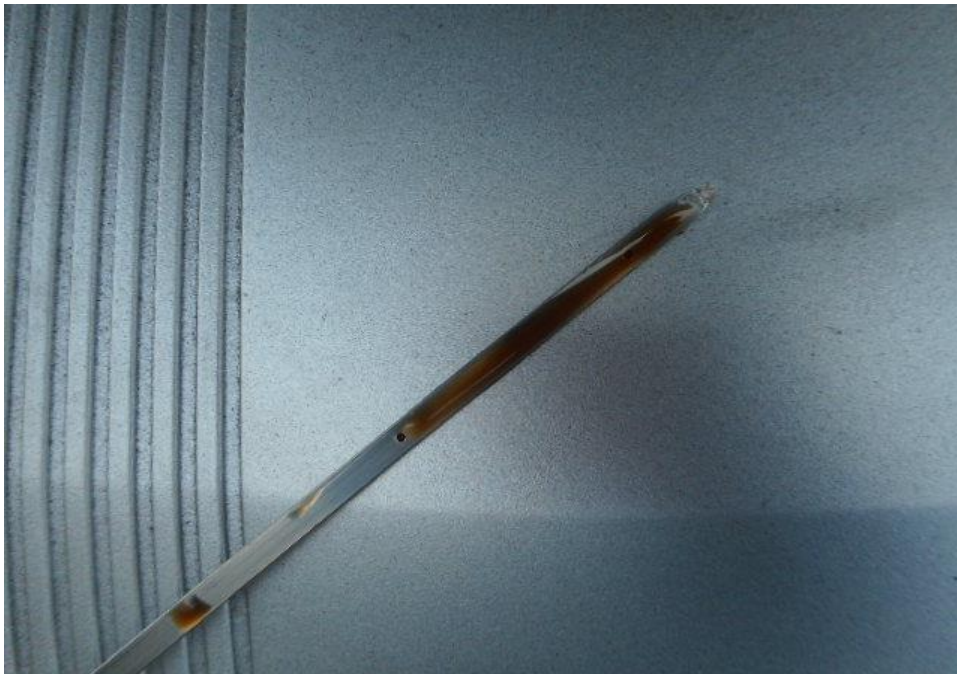
**Photo 16** shows the engine oil level dipstick of the Motor Car at the time of my inspection. The engine oil was observed to be of sufficient level and without any visible contamination.

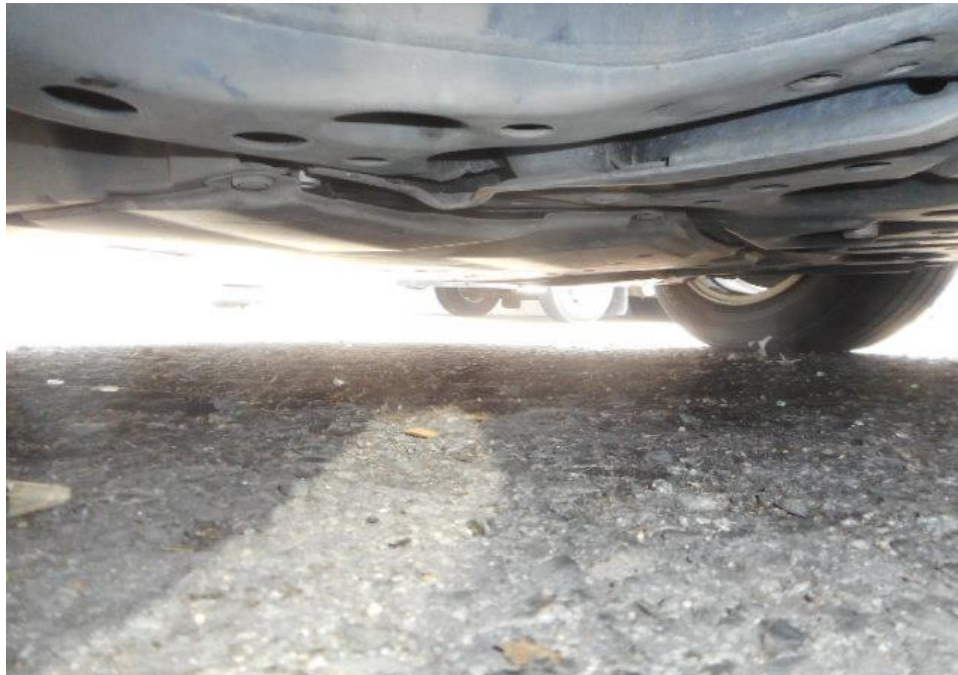
**Photo 17** shows the undercarriage of the Motor Car, at the area where the engine housing and transmission housing are located. I did not find any sign(s) or indication(s) of fluid leak and/or fluid stain(s) on the underside of the Motor Car.

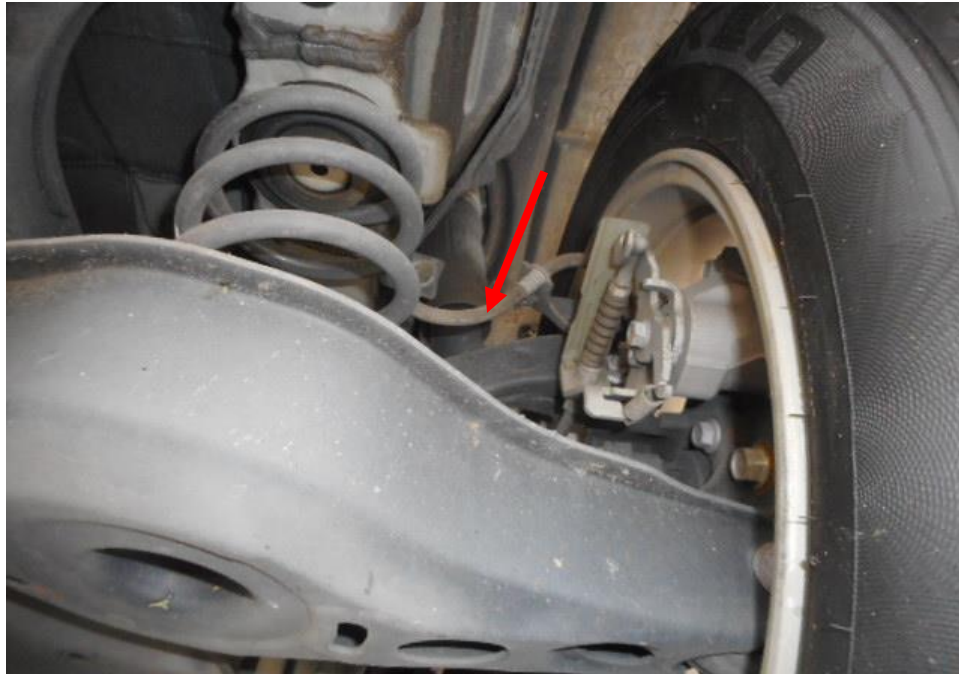
**Photo 18** shows the brake hose/pipe (arrowed) at the rear right wheel of the Motor Car. No leakage of brake fluid was observed. Visual examination of the various components of the braking system like the drum brake, brake booster, brake pedal etc. had revealed all to be intact and without visible damage.

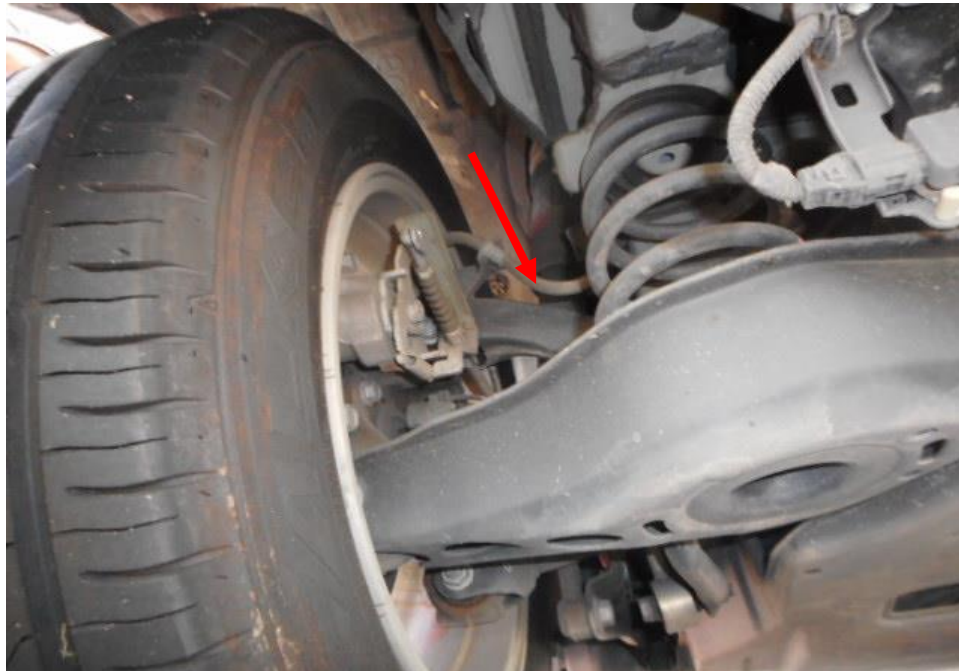
**Photo 19** shows the brake hose/pipe (arrowed) at the rear left wheel of the Motor Car. I did not observe any leakage of brake fluid at the time of my inspection of the Motor Car. Static tests of the Motor Car's braking system had indicated that there was no internal leakage of pressure/vacuum. The undercarriage components of the Motor Car were also all found to be intact and without any visible damage.

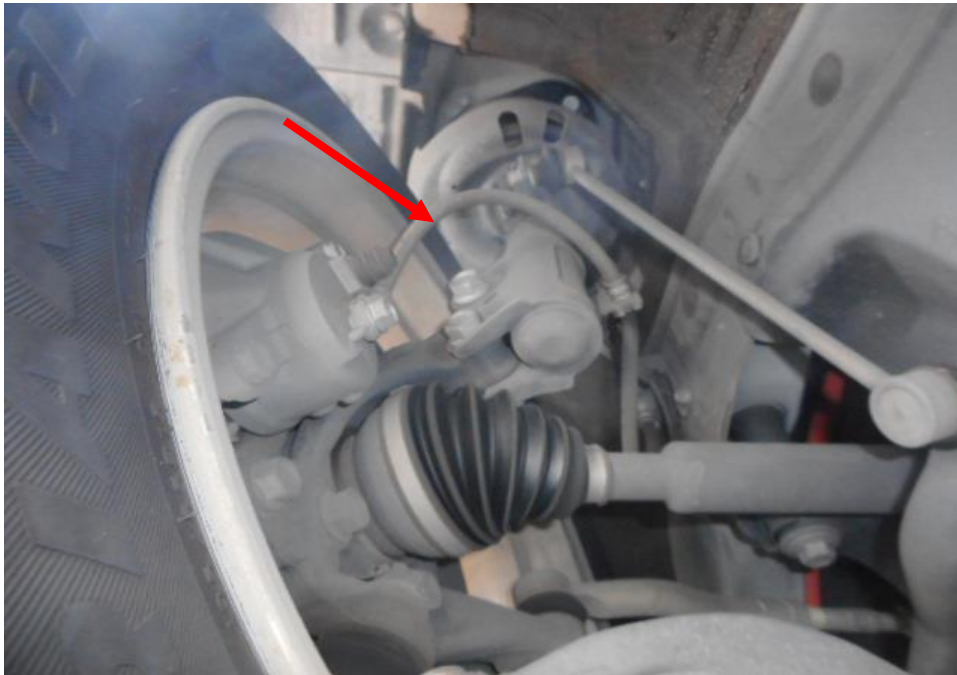
**Photo 20** shows the brake hose/pipe (arrowed) at the front right wheel of the Motor Car. I did not observe any leakage of brake fluid at the time of my inspection of the Motor Car. Static tests of the Motor Car's braking system had indicated that there was no internal leakage of pressure/vacuum.

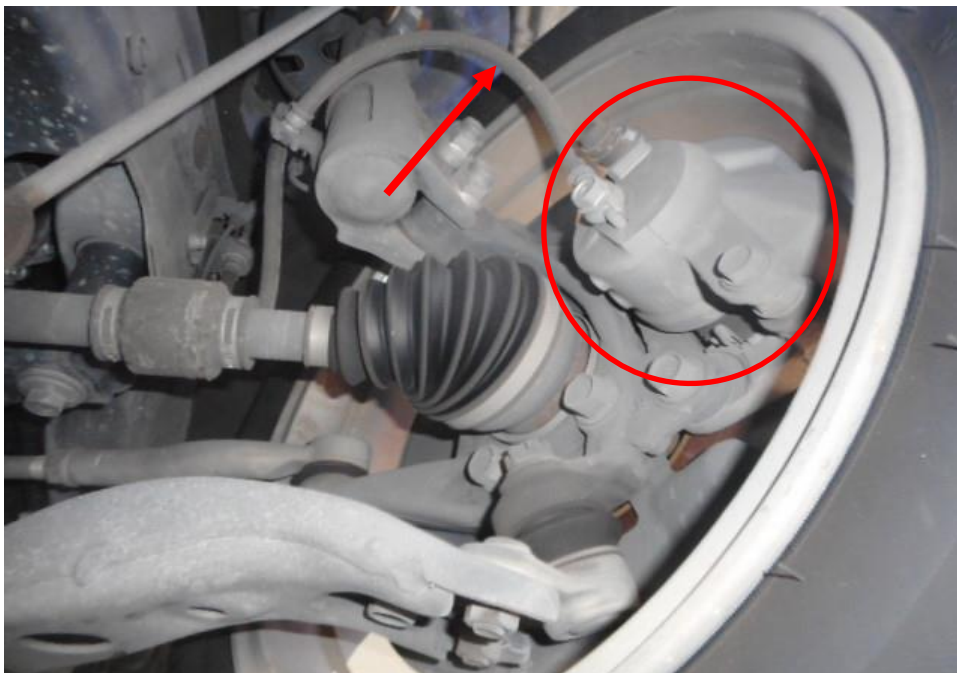
**Photo 21** shows the brake hose/pipe (arrowed) at the front left wheel of the Motor Car. No leakage of brake fluid was observed. Visual examination of the various components of the braking system like the brake caliper (circled), brake booster, brake pedal etc had revealed all to be intact and without visible damage.

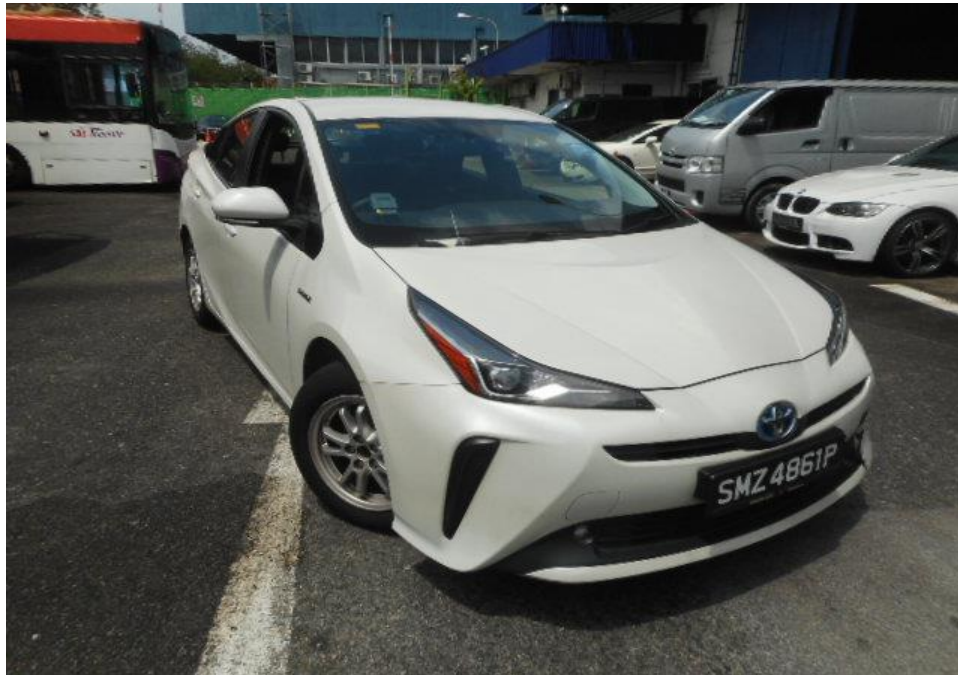
**Photo 22** shows the front right wheel of the Motor Car turned to its full left. During my steering system test, I did not experience any abnormal free play and/or resistance when I had turned the steering wheel towards the left and right. This would suggest that the steering system of the Motor Car was likely to be in serviceable condition at the material time of accident.

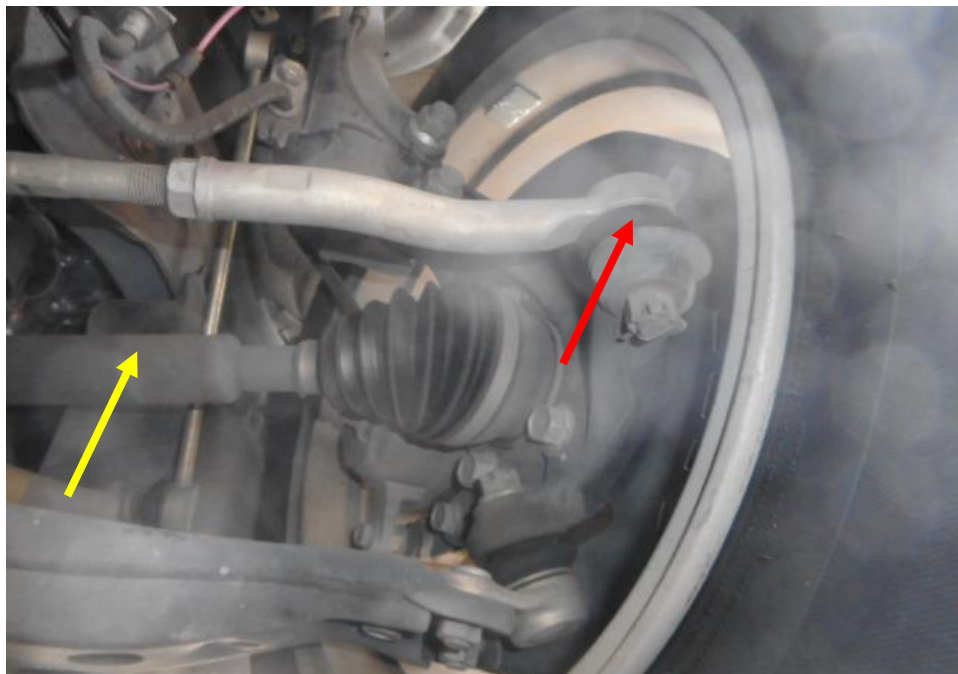
**Photo 23** shows the various undercarriage components at the front right wheel of the Motor Car, in particular the steering tie rod (red arrow) and in particular the drive shaft (yellow arrow). The various steering components were all found to be intact, suggesting that the steering system of the Motor Car was likely to be in serviceable condition at the material time of accident. There was also no sign of fluid stain observed on the various undercarriage components at the front right wheel of the Motor Car.

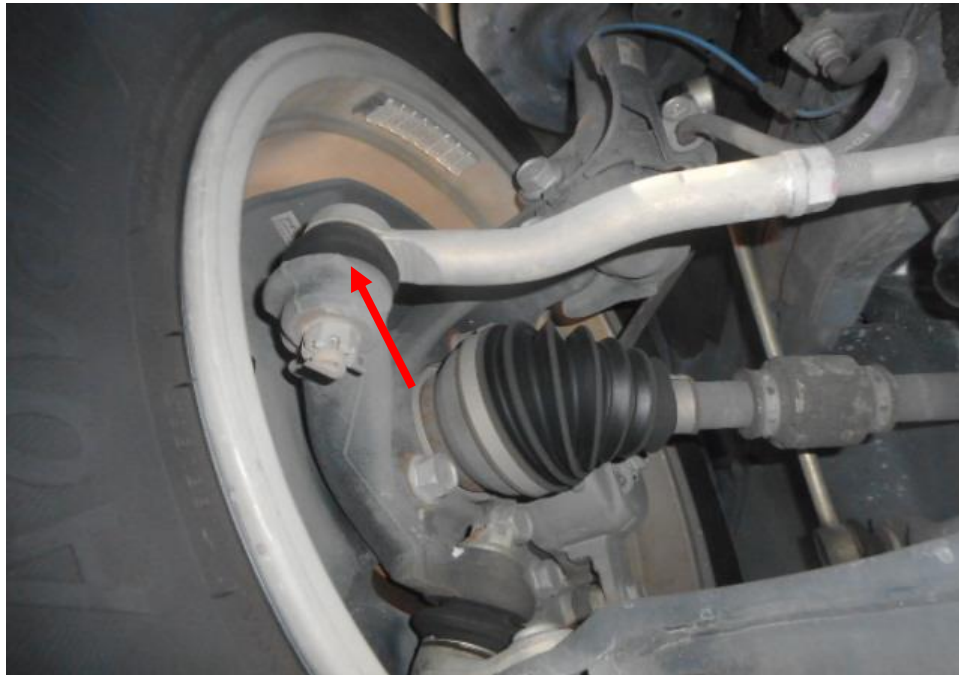
**Photo 24** shows the various undercarriage components at the front left wheel of the Motor Car, which had included the steering tie rod (arrowed). The various undercarriage components of the Motor Car were all found to be intact without any visible damage.

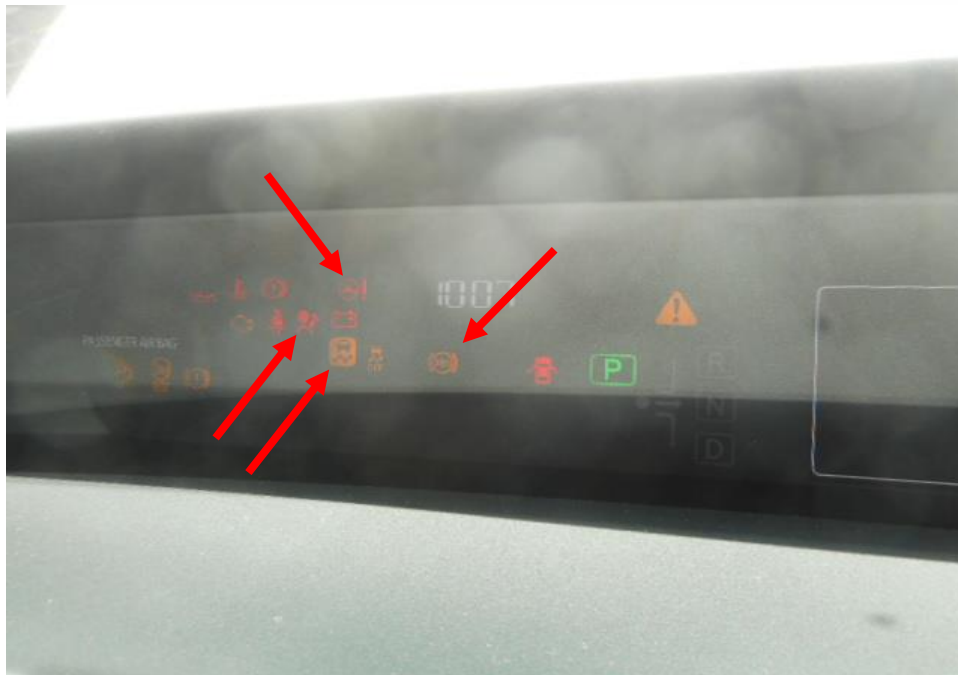
**Photo 25** shows the warning light for Anti-Lock Brake System (ABS), Electronic Power Steering (EPS), Traction Control System (TCS), and Supplemental Restraint System (SRS) (arrowed) appearing on the instrument panel of the Motor Car during the self-test of its various electronic operating systems when its engine was cranked.

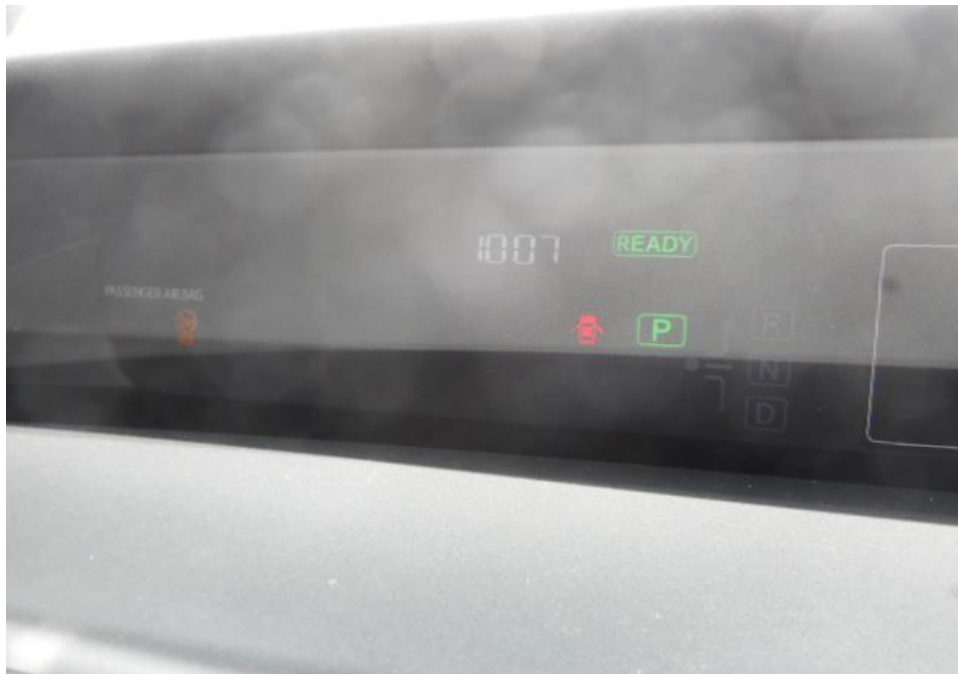
**Photo 26** shows no warning lights illuminated on the instrument panel of the Motor Car after the engine was cranked. This would suggest that there was no abnormality to the electronic operating system of the Motor Car, like the ABS, EPS, TCS and SRS etc.
