Your Ref: rq3ljfq0s
Our Ref : CI/III22008276/P

**TECHNICAL INVESTIGATION REPORT OF WARRANTY CLAIM INVOLVING
THE INSURED VEHICLE SKE 9368Z ON 4th August 2022**

Vehicle Registration No.	: SKE 9368Z
Make / Model	: MERCEDES BENZ GLE450 4MATIC M-HYBRID
Chassis No	: W1N1671592A409936
Year of Registration	: JULY 2021
Mileage	: 24,851KM

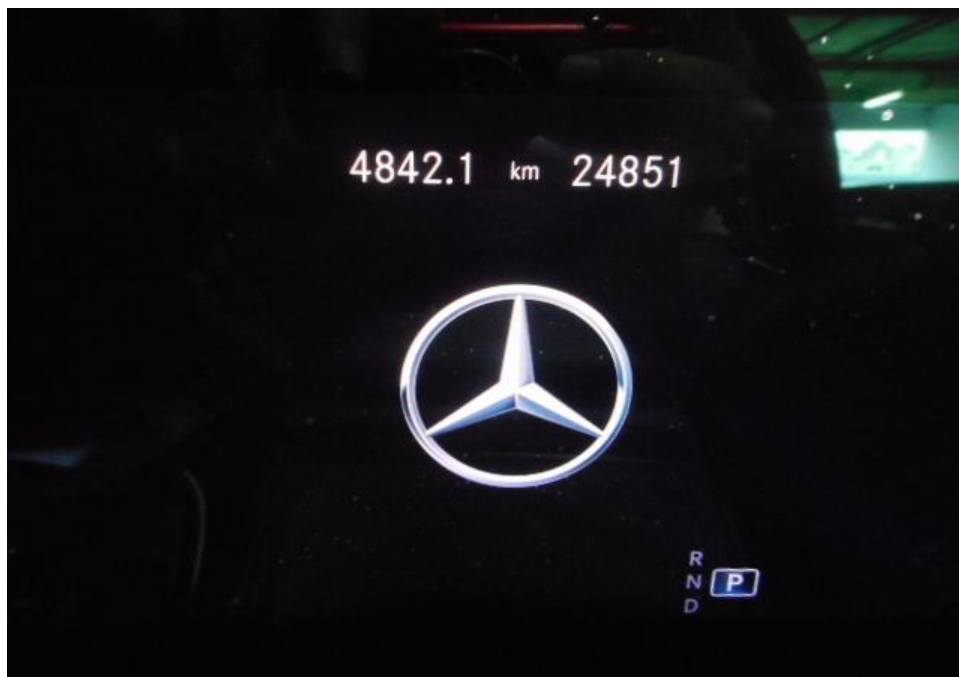
Photo 1 shows the mileage of the Insured Vehicle recorded at the time inspection at 24,851KM

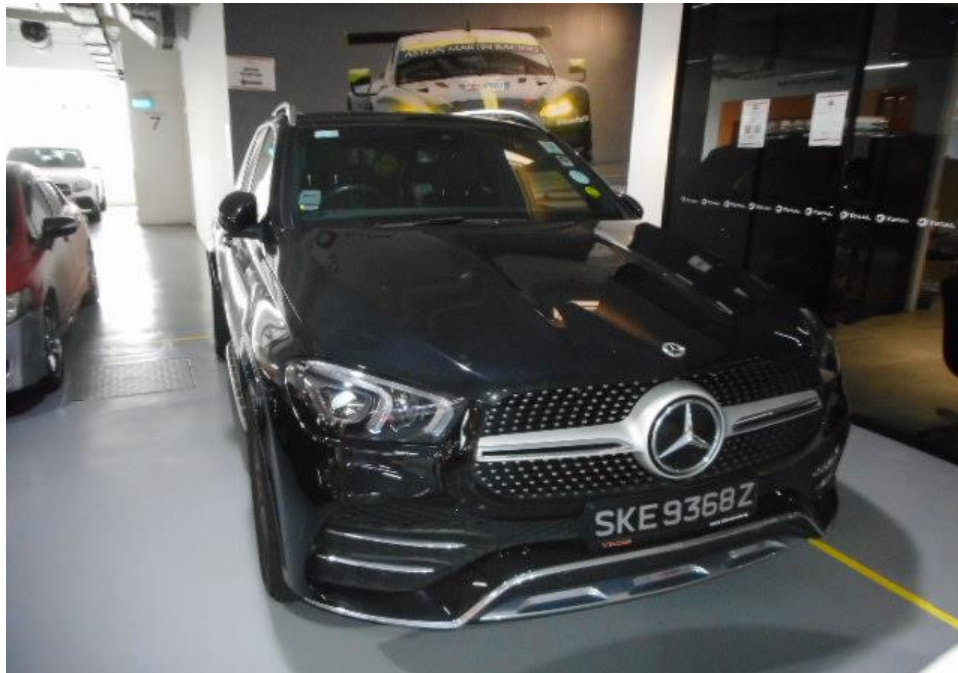
Photo 2 shows the general view of the front portion of the Insured Vehicle at the time of our inspection. The Insured Vehicle is observed to be unaffected by any signs of accident.

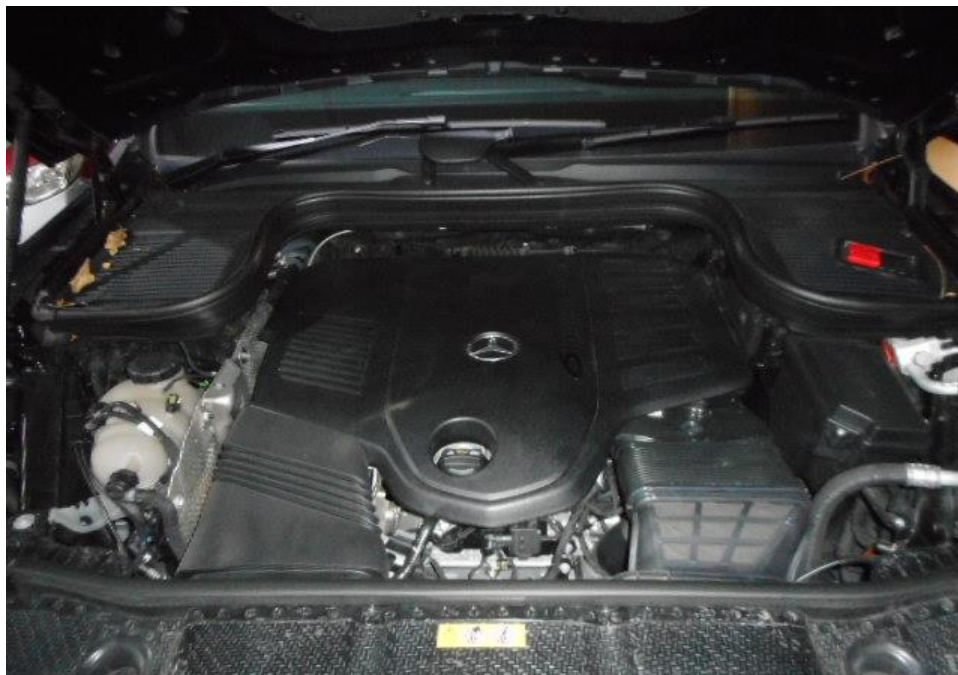
Photo 3 shows the general view of the engine portion of the Insured Vehicle at the time of our inspection. The engine compartment is observed to be unaffected by any signs of accident.

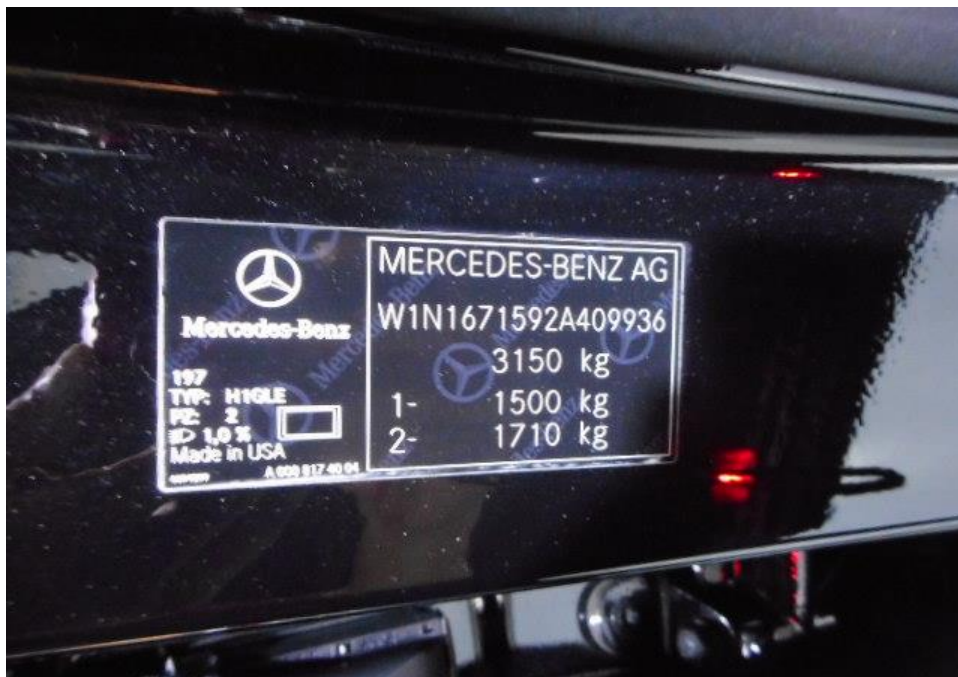
Photo 4 shows the chassis number of the Insured Vehicle at the time of our inspection.

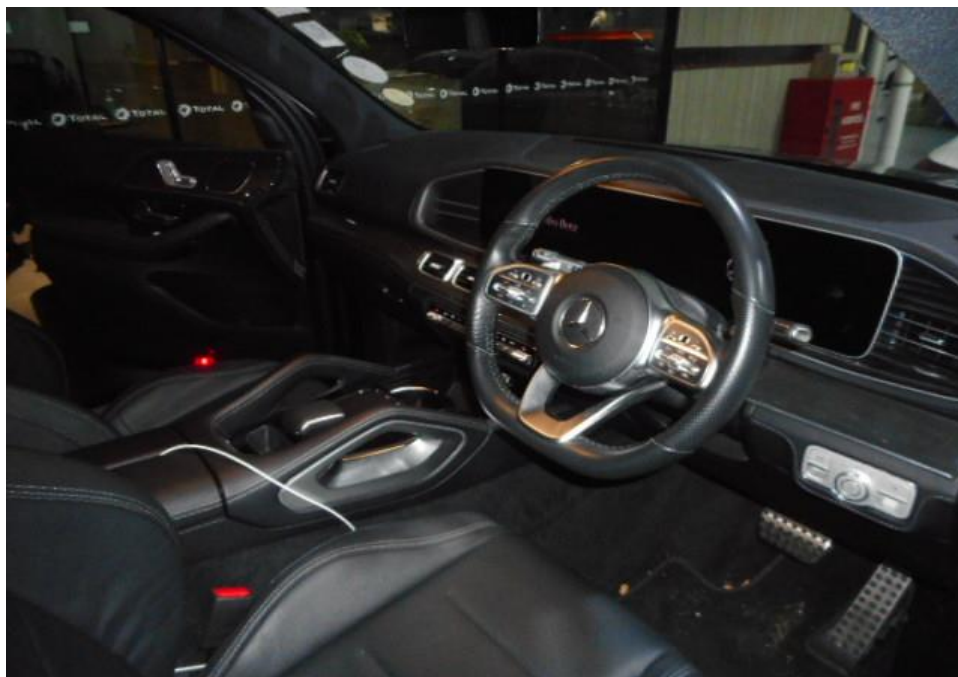
Photo 5 shows the general view of the interior portion of the Insured Vehicle at the time of our inspection. The interior portion is observed to be unaffected and by any signs of accident.

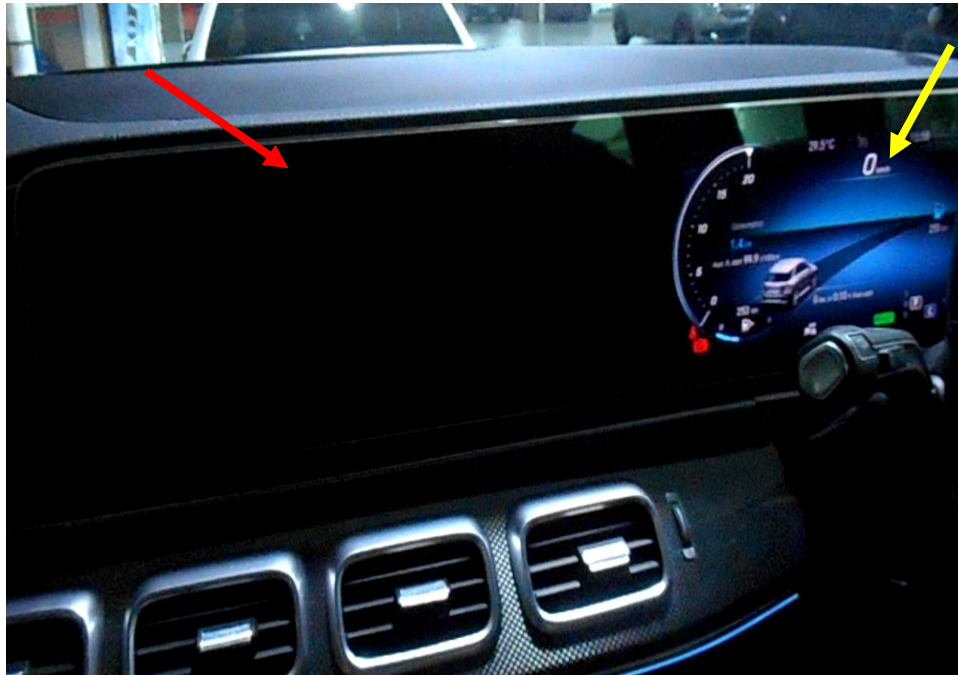
5. The complaint on the Insured Vehicle was noted be that the digital infotainment display would turn on and off intermittently but remains off most of the time. There is a recommendation by the workshop to replace the Infotainment control module. The vehicle was observed to be unaffected by any signs of accident.

Photo 6 shows the close up view of the vehicle instrument portion of the Insured Vehicle at the time of our inspection. The infotainment instrument display (red arrowed) remained turned off even when the vehicle's engine is turned on as compared to the driver's display panel (yellow arrow).

8. We did not find any evidence which had suggested that the cause of abnormalities to the Insured Vehicle was due to poor maintenance and/or recurring problem.
9. The recommendation to replace the Infotainment control module at \$2,824.80 is justifiable as all the relevant checks has been conducted.
