VEHICLE DAMAGE INSPECTION REPORT

Our Ref: 97/TP/2022

Reg No:	GBF8213U	Make &	Toyota
Reg date:	23/3/2017	Model	Hiace
Colour:	White	Engine No:	1KD2678589
Type:	Van	Chassis No:	JTFHT02P800214262
Type of Claims:	Third Party	Odometer No:	147021km
		Engine Cap:	2982cc

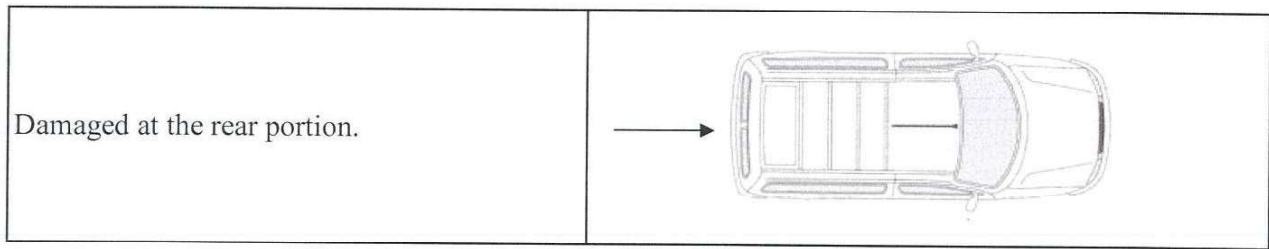
POINT OF IMPACT

Our visual inspection of the vehicle revealed that the damages noted are at the rear portion.
