Your Ref: SNM22D206049
Our Ref : CS4/CTI22008420/N

12 September 2022

TECHNICAL INVESTIGATION REPORT OF FIRE INCIDENT INVOLVING THE INSURED VEHICLE SKL 3618E ON 25 AUGUST 2022

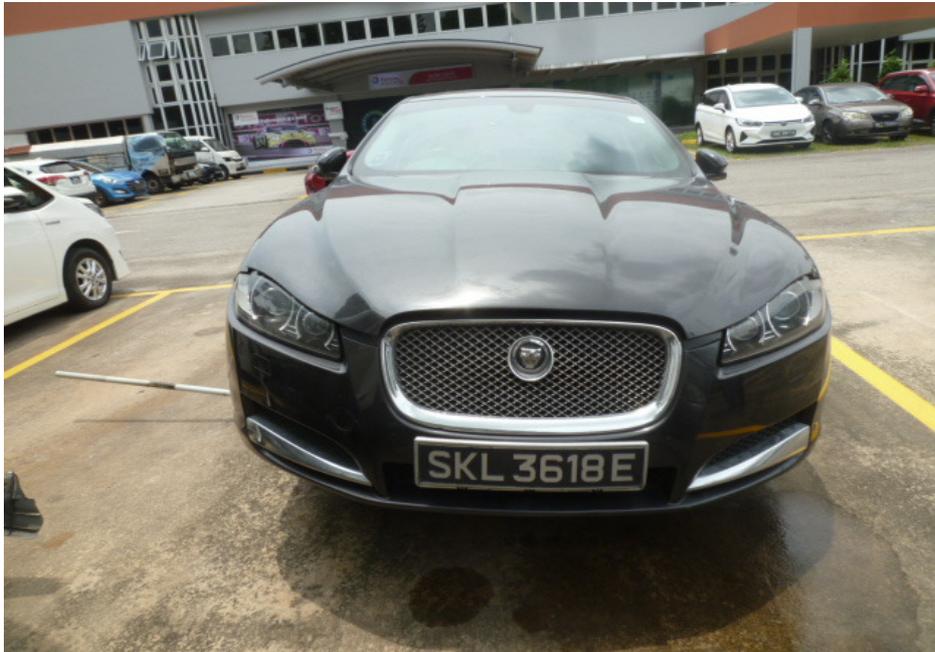
Photo 1 shows the general view of the frontal portion of the Insured Vehicle at the time of our inspection. The fire damage was confined to its undercarriage. The exterior portion of the Insured Vehicle was observed to be relatively unaffected by the fire.

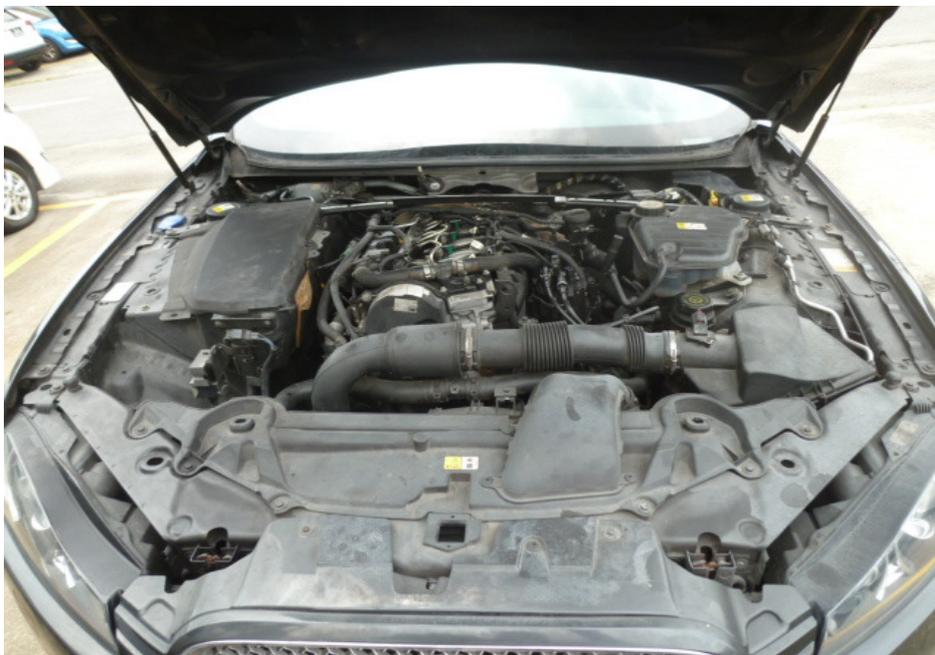
Photo 2 shows the general view of the engine compartment of the Insured Vehicle at the time of our inspection. The fire damage was confined to its undercarriage. The engine compartment of the Insured Vehicle was observed to be relatively unaffected by the fire.

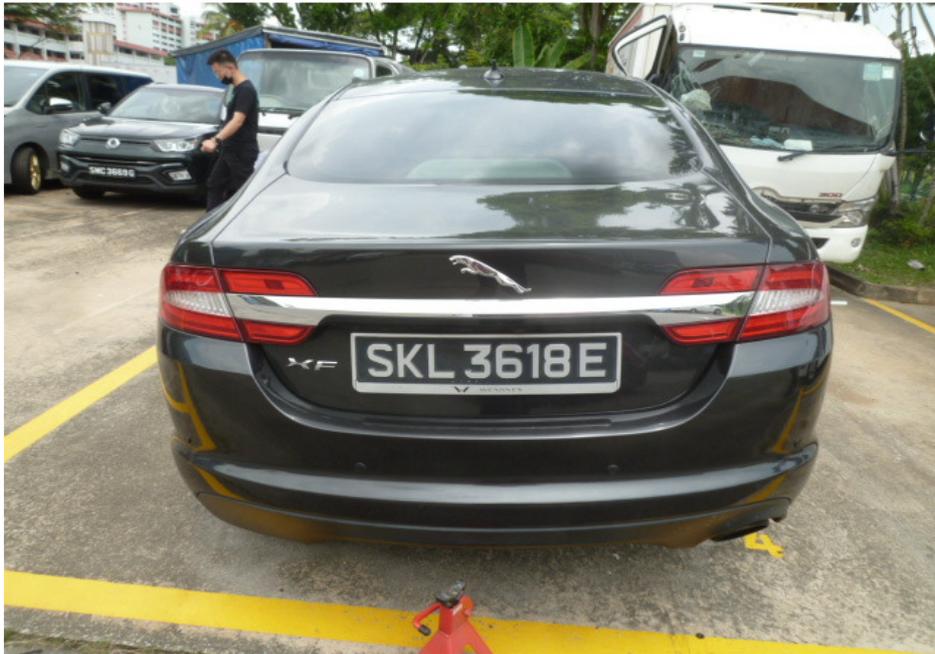
Photo 3 shows the general view of the rear portion of the Insured Vehicle at the time of our inspection. The fire damage was confined to its undercarriage. The exterior portion of the Insured Vehicle was observed to be relatively unaffected by the fire.

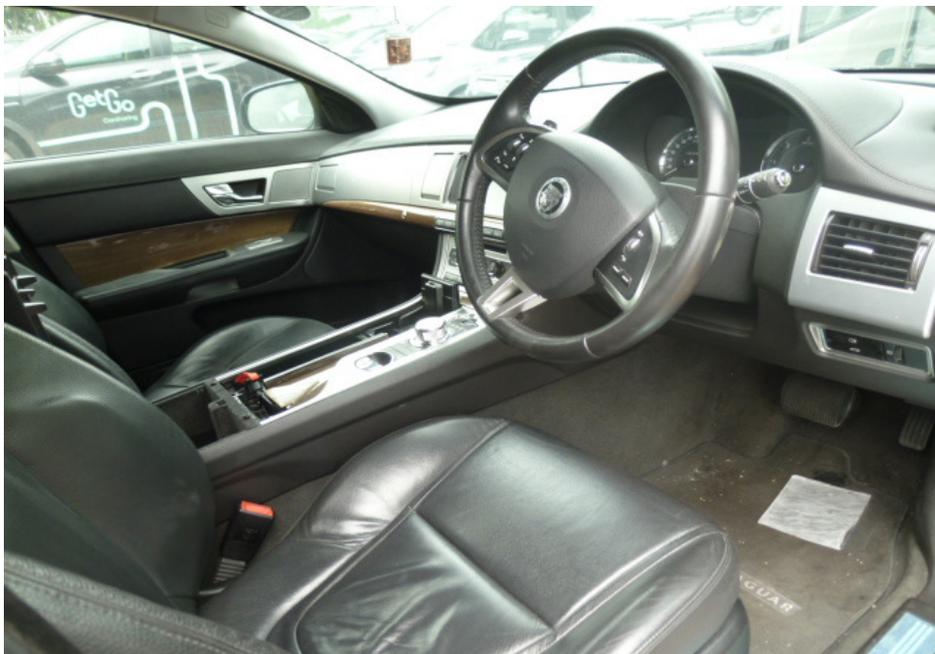
Photo 4 shows the interior compartment of the Insured Vehicle, which was observed to be relatively unaffected by the fire.

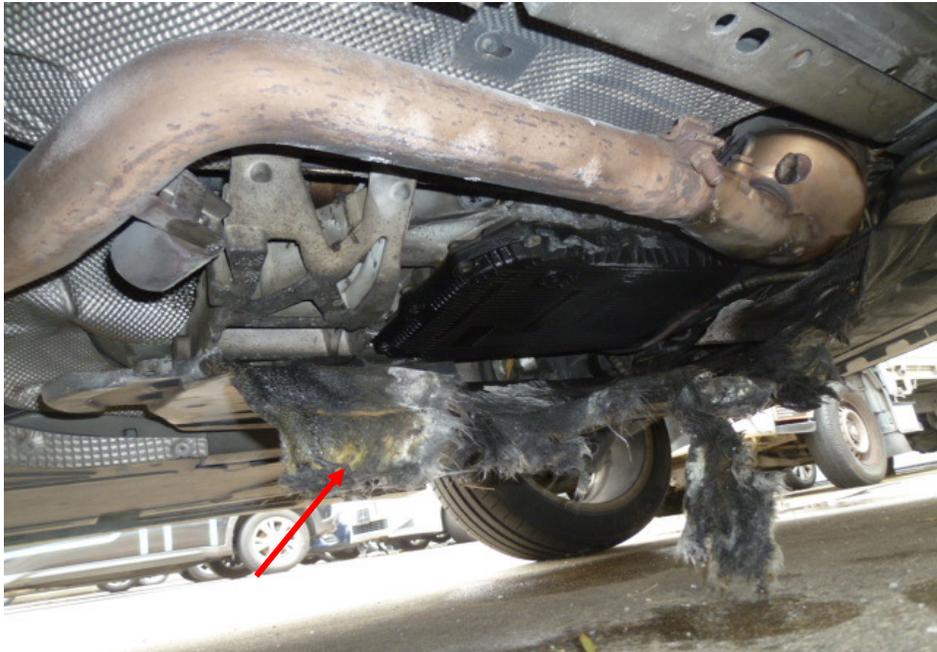
Photo 5 shows the Insured Vehicle hoisted for us to have a thorough look of the undercarriage. For this particular case, the fire appears to have originated from the undercarriage of the Insured Vehicle. This can be determined from fire extinguisher residue found on the engine oil pan cover, partially burnt and/or melted parts of the engine oil pan cover, DPF and DPF heat shield as well as burnt wirings (arrowed).

24. Having investigated and technically analysed the damages of burnt nature to the Insured Vehicle, we are of the view that the cause of fire to the Insured Vehicle was due to fire that had occurred within the Diesel Particulate Filter (DPF) of the Insured Vehicle. For this particular case, heat from a fire that had occurred within the DPF had radiated to the surrounding components leading to fire within the undercarriage of the Insured Vehicle.
25. The diesel particles (soot, carbon etc) trapped by the filter element inside the DPF of the Insured Vehicle had self-ignited when the exhaust temperature within the DPF had increased as a result of clogging in the DPF.

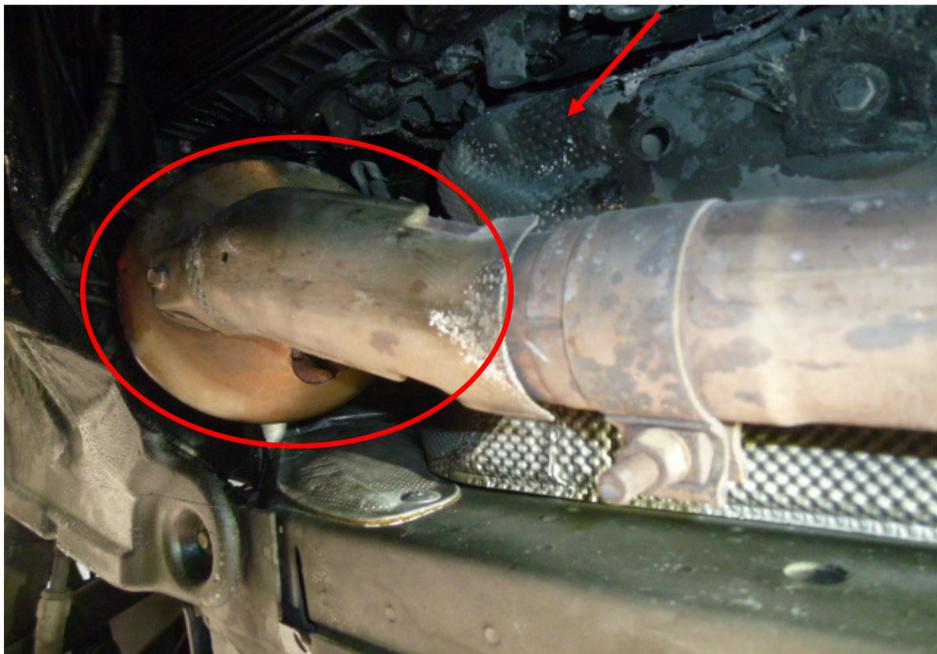
Photo 6 shows a closer view of the partially burnt and/or melted parts of the DPF (circled) and DPF heat shield (arrowed).

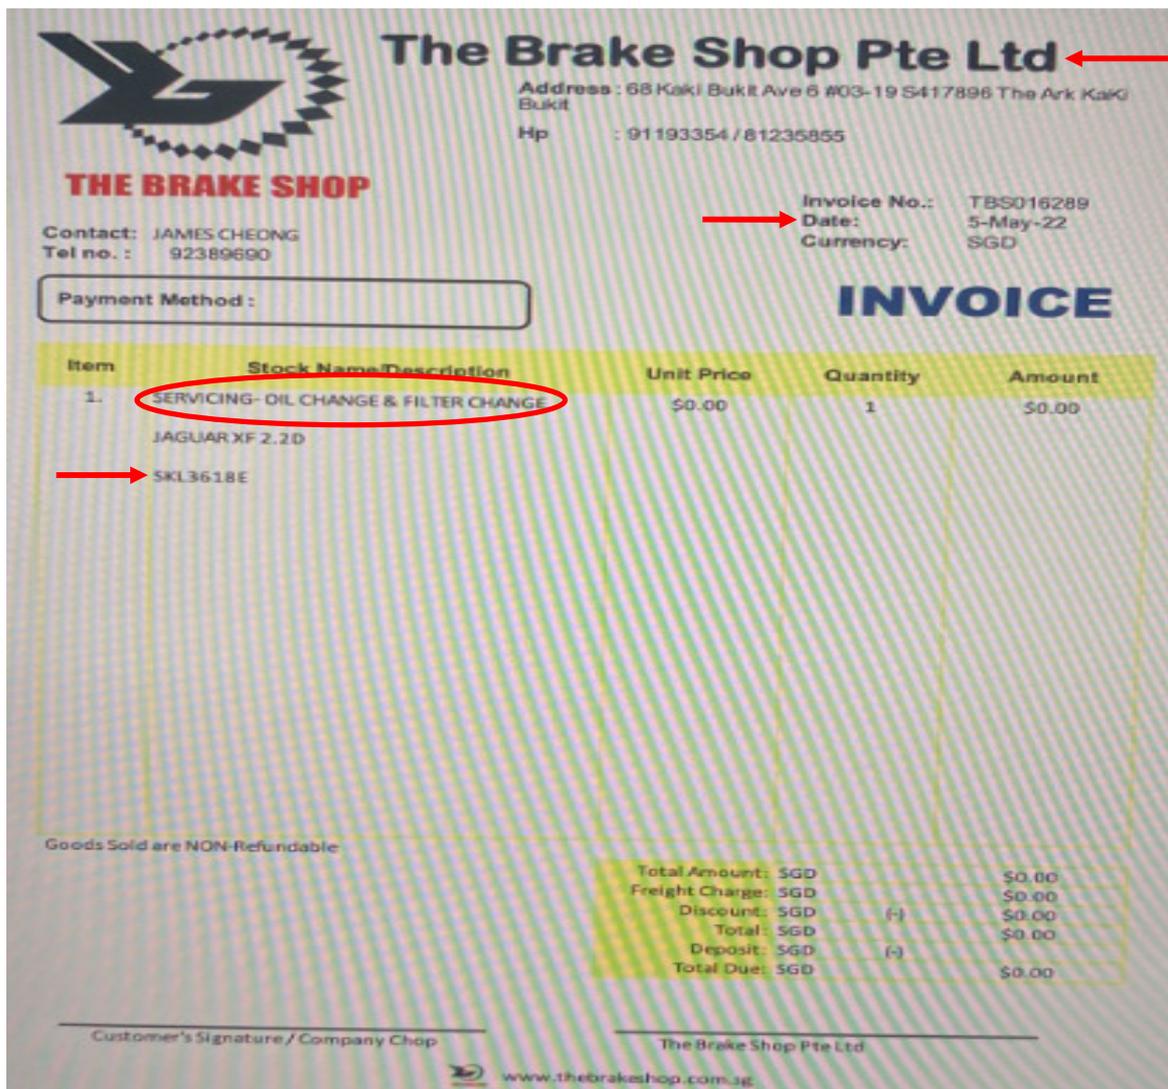
Invoice 1 shows the last servicing done on the Insured Vehicle at The Brake Shop Pte. Ltd. on 5 May 2022 (red arrows). The servicing package had included changing of engine oil and oil filter (circled).

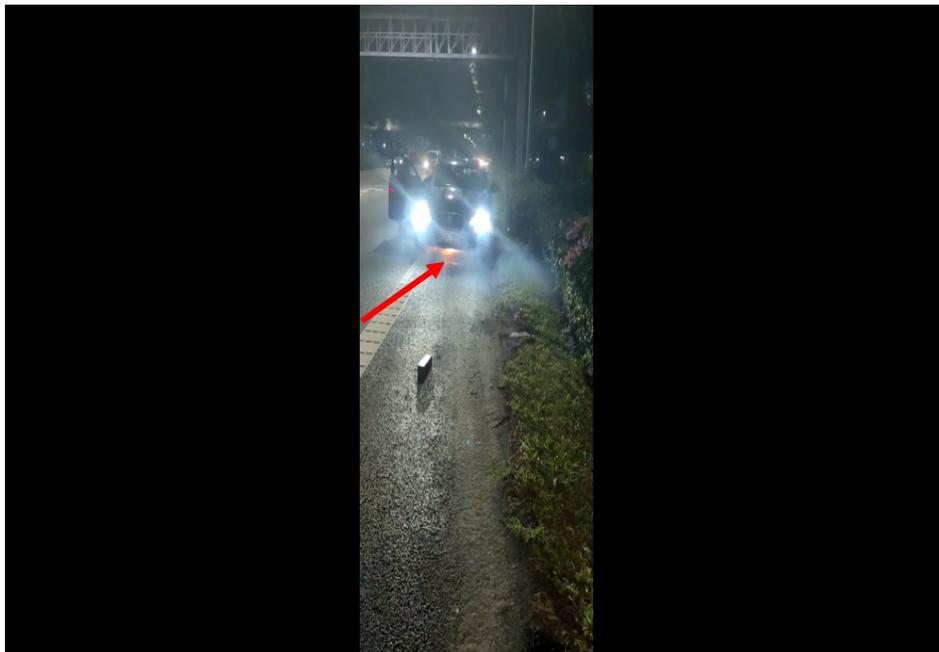
Photo 7 shows a screenshot taken from the video recording that was provided by Mr Cheong. The Insured Vehicle could be seen with fire emitting from the undercarriage (arrowed).

17. For this case, from our review of the video recording and photograph taken at the incident scene, the origin of fire can be established basing on the presence flames that were seen emitting from the Insured Vehicle when the fire started.

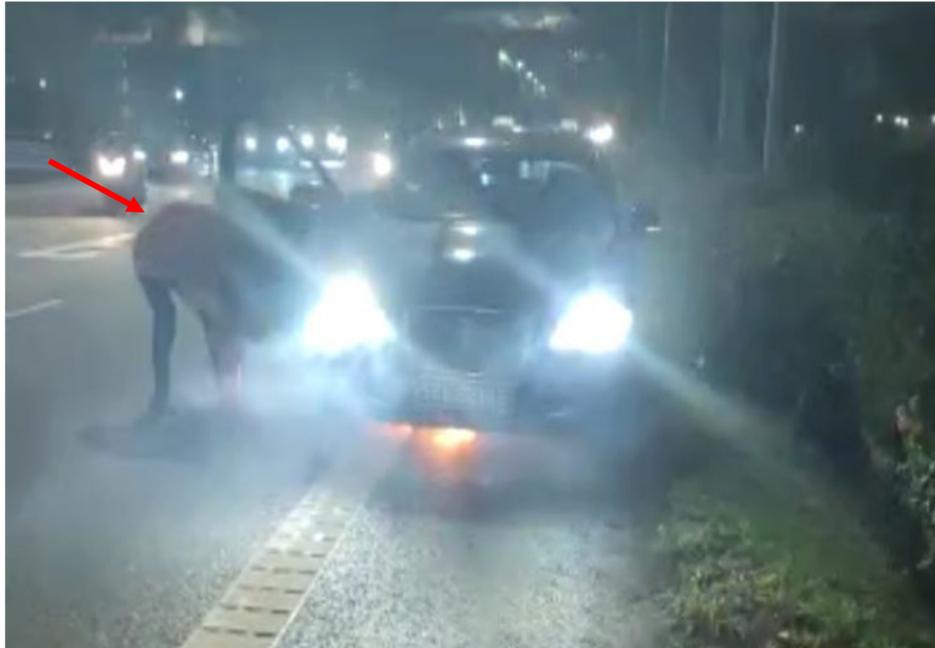
Photo 8 shows one of the drivers assisting Mr Cheong to put out the fire to the Insured Vehicle with his fire extinguisher (arrowed) which corresponded to Mr Cheong's statement.

18. As seen in photograph 8 above, the smoke was coming out from the centre undercarriage area of the Insured Vehicle. The subsequent outbreak of fire was also at the centre undercarriage area of the Insured Vehicle as seen in photograph 8 above. Given these observations from the photographs that were taken at the incident scene, the origin of fire can be established to be at the centre undercarriage area of the Insured Vehicle.
