Your Ref: SNM22D206224
Our Ref : CS4/CTI22008607/N

9 September 2022

TECHNICAL INVESTIGATION REPORT OF FIRE INCIDENT INVOLVING THE INSURED VEHICLE SLE 4273J ON 31 AUGUST 2022

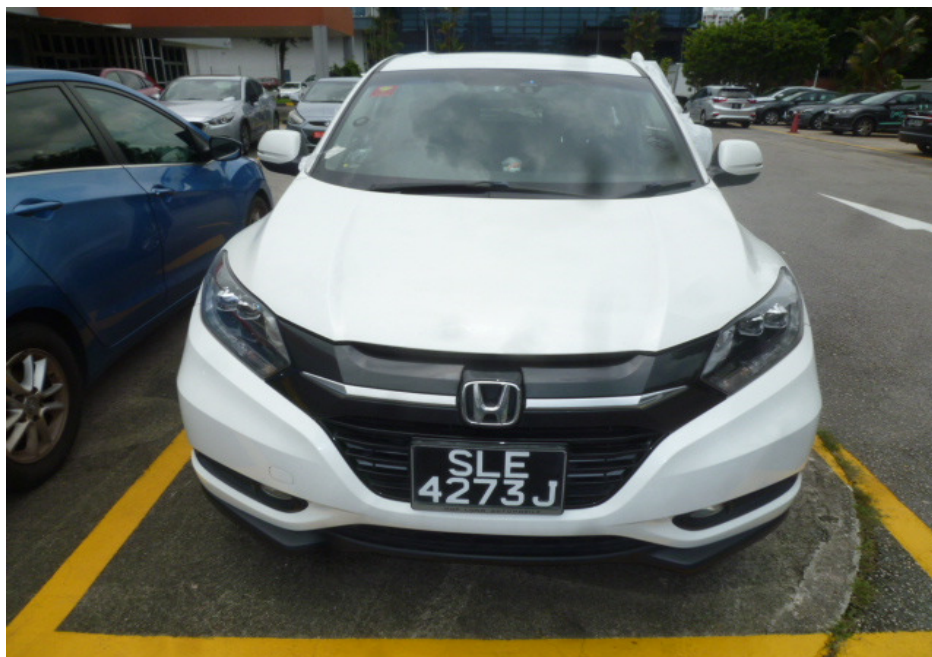
Photo 1 shows the general view of the frontal portion of the Insured Vehicle at the time of our inspection. The exterior front body and interior compartment of the Insured Vehicle sustained visible fire damage. This included its front windscreen, wiper panel, left 'A' pillar, left side panel and instrument panel.

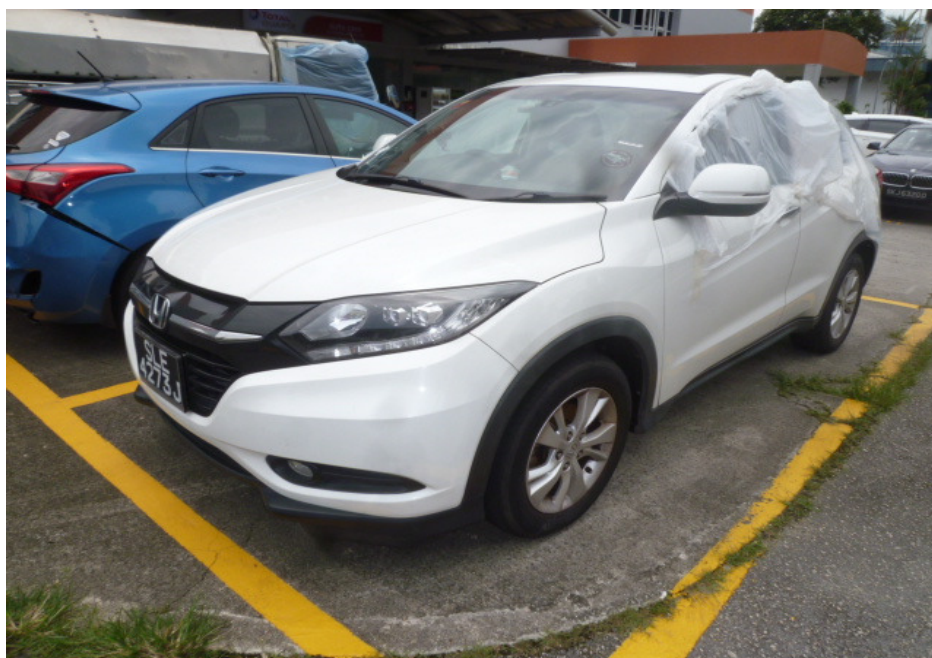
Photo 2 shows the general view of the left frontal portion of the Insured Vehicle at the time of our inspection. The exterior body of the Insured Vehicle had sustained visible fire damage. This included its front windscreen, wiper panel, left 'A' pillar, left side panel and instrument panel.

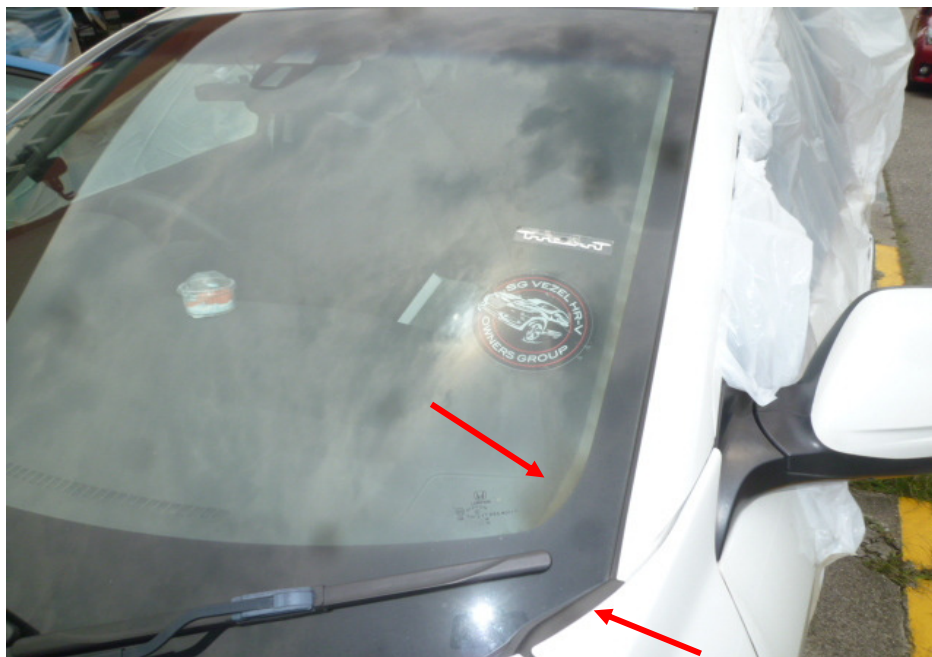
Photo 3 shows a closer view of the front windscreen of the Insured Vehicle at the time of our inspection. The front windscreen and wiper panel had sustained minimal fire damage (arrowed).

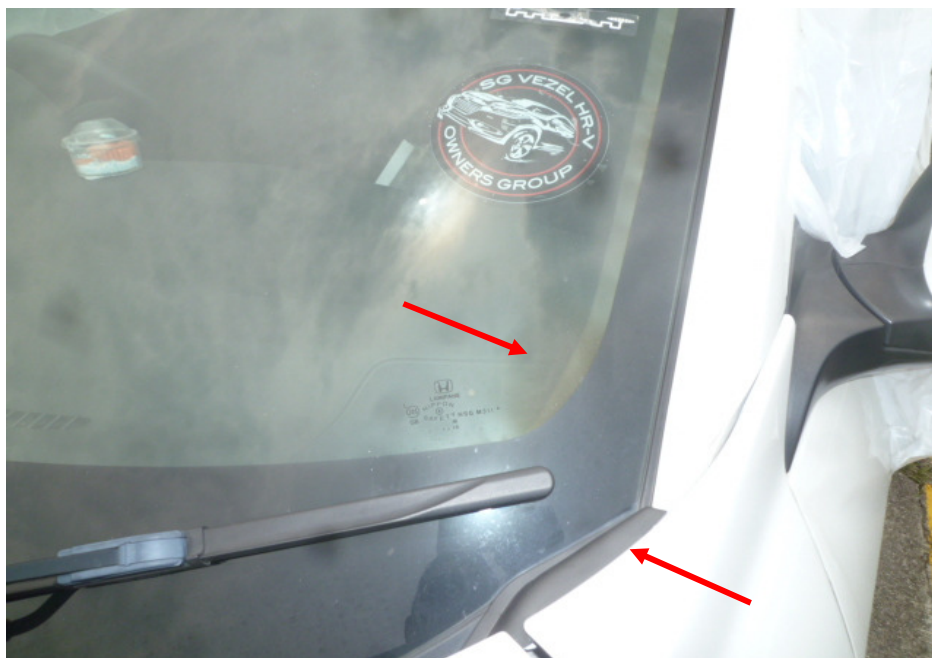
Photo 4 shows a closer view of the front windscreen and wiper panel of the Insured Vehicle which had sustained minimal fire damage (arrowed).

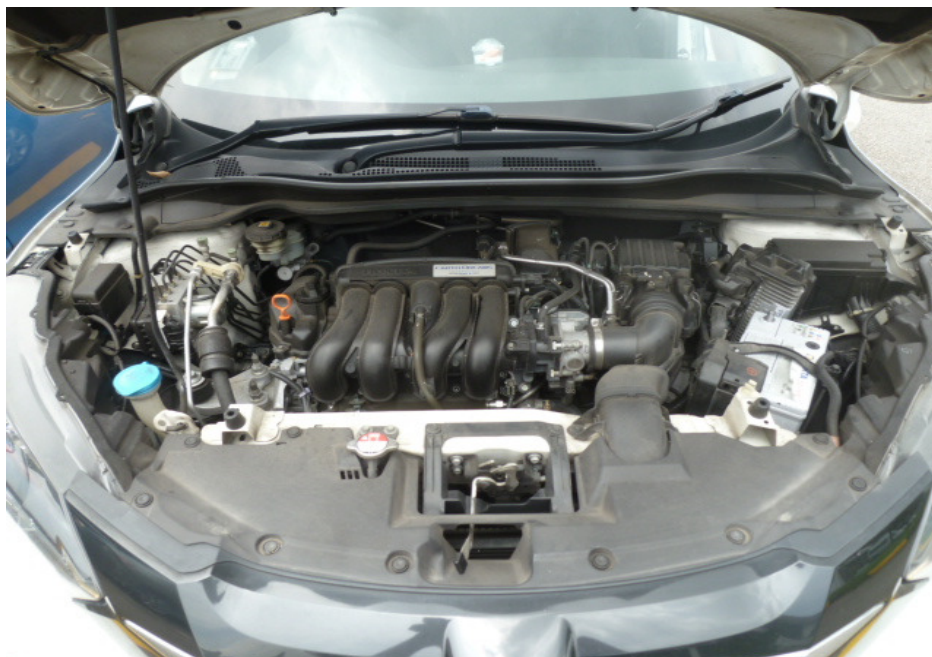
Photo 5 shows a general view of the engine compartment of the Insured Vehicle at the time of our inspection. The engine compartment was relatively unaffected by the fire.

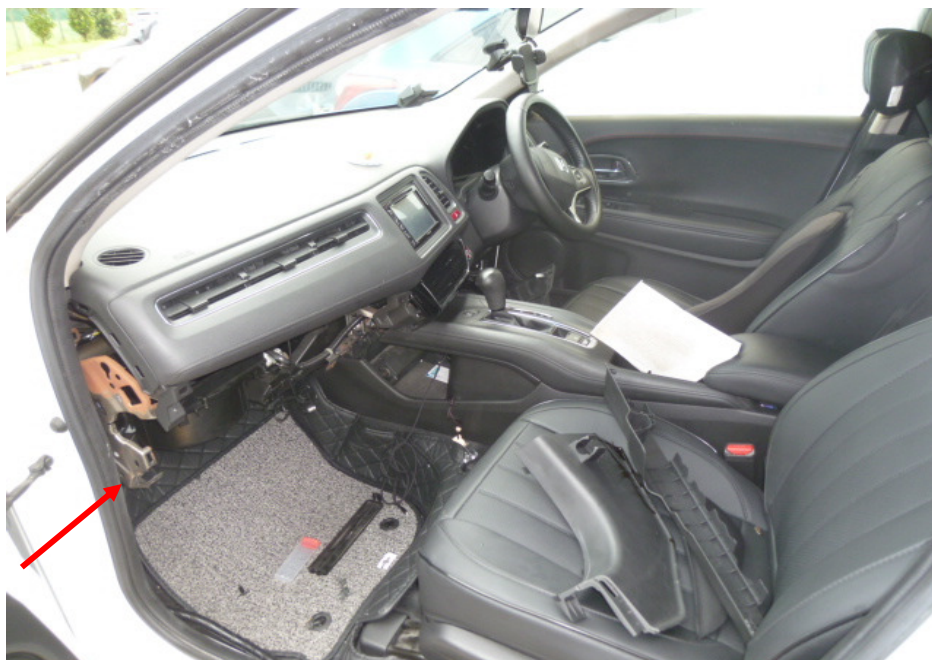
Photo 6 shows the interior compartment of the Insured Vehicle at the time of our inspection. The left portion of the interior compartment of the Insured Vehicle had sustained minimal fire damage (arrowed).

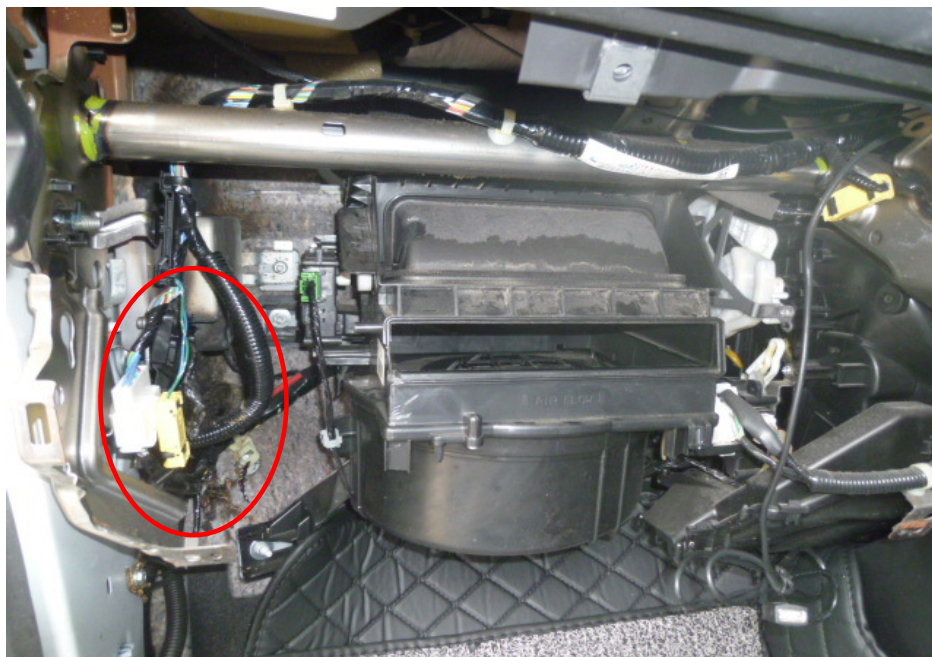
Photo 7 shows a closer view of the left portion of the interior compartment (after removing the glove compartment) of the Insured Vehicle at the time of our inspection. The left portion of the interior compartment of the Insured Vehicle had sustained fire damage (circled).

18. For this case, Mr Chong first saw smoke coming out from the left portion of the interior compartment. Taking Mr Chong's observations into consideration, the fire to the Insured Vehicle had originated around the left side of the dashboard, at or near the glove compartment area; with the cause of fire related to a defective originally fitted component. The following paragraphs discuss this aspect.
19. The Insured Vehicle was involved in a manufacturer recall campaign in year 2016. The recall was for issue relating to a capacitor used in the engine idling stop system of the Insured Vehicle, which may be insufficient to protect against an overcurrent. Notably, the records had indicated that rectification to address the issue has not been carried out to the Insured Vehicle prior to this incident. See search result below obtained from LTA.

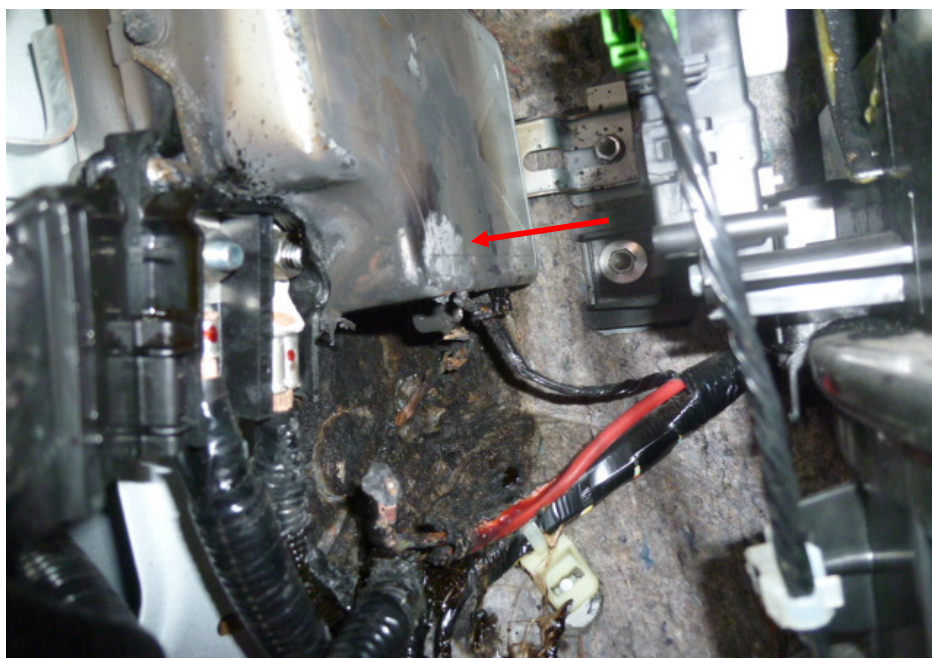
Photo 8 shows a close up view of the left portion of the interior compartment of the Insured Vehicle which had sustained fire damage (arrowed).

23. Having investigated and technically analysed the damages of burnt nature to the Insured Vehicle, we are of the view that the cause of fire to the Insured Vehicle was of electrical in nature. For this particular case, the fire was due to an originally fitted component that was defective.

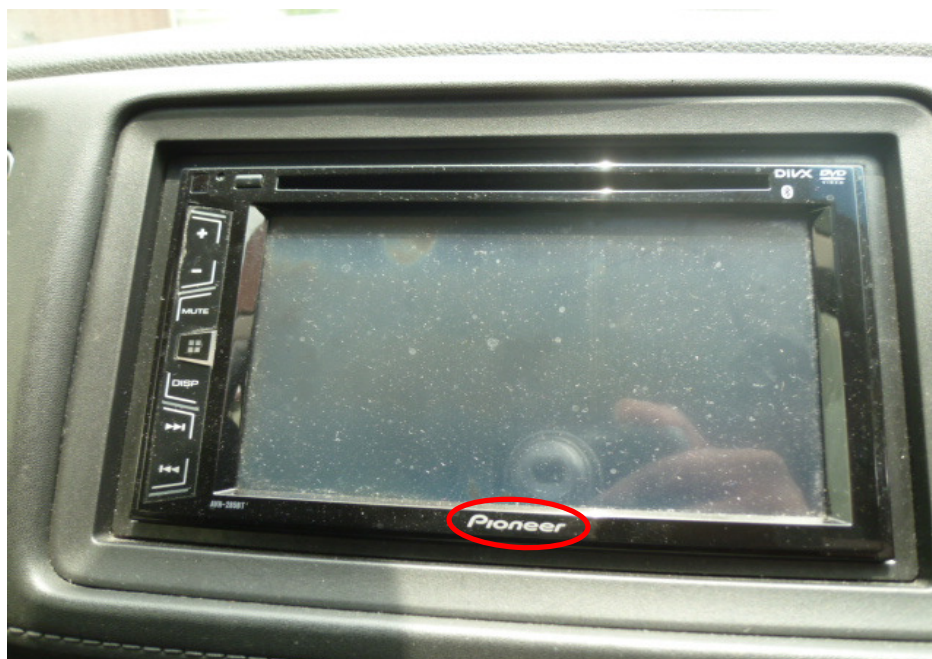
7. At the time of physical inspection of the Insured Vehicle, we had found an additionally fitted electronic and/or electrical component(s) on the Insured Vehicle. This included an in-car DVD player. This fitted component was not the standard type for the Insured Vehicle. See photo 9 below.

Photo 9 shows the in-car DVD player that was fitted at the centre portion of the front dashboard of the Insured Vehicle upon our inspection. The brand of the DVD player was 'Pioneer' (circled).

27. We are further of the opinion that the additionally fitted electrical/electronic component found on the Insured Vehicle could have possibly caused overloading to the electrical system of the Insured Vehicle. However considering that the installation was carried out when the Insured Vehicle was purchased which was approximately more than 6 years prior to the fire incident, the overloading was likely to be minimal.

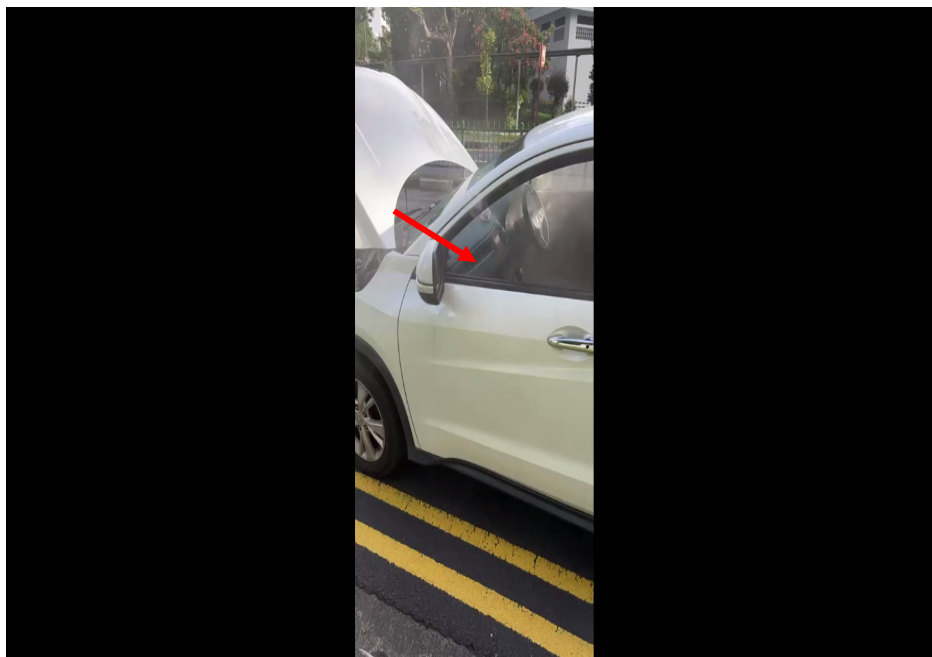
Photo 10 shows a screenshot taken from the video recording that was provided by Mr Chong. The Insured Vehicle could be seen with white smoke emitting from the left passenger side (arrowed) which corresponded to Mr Chong's statement.

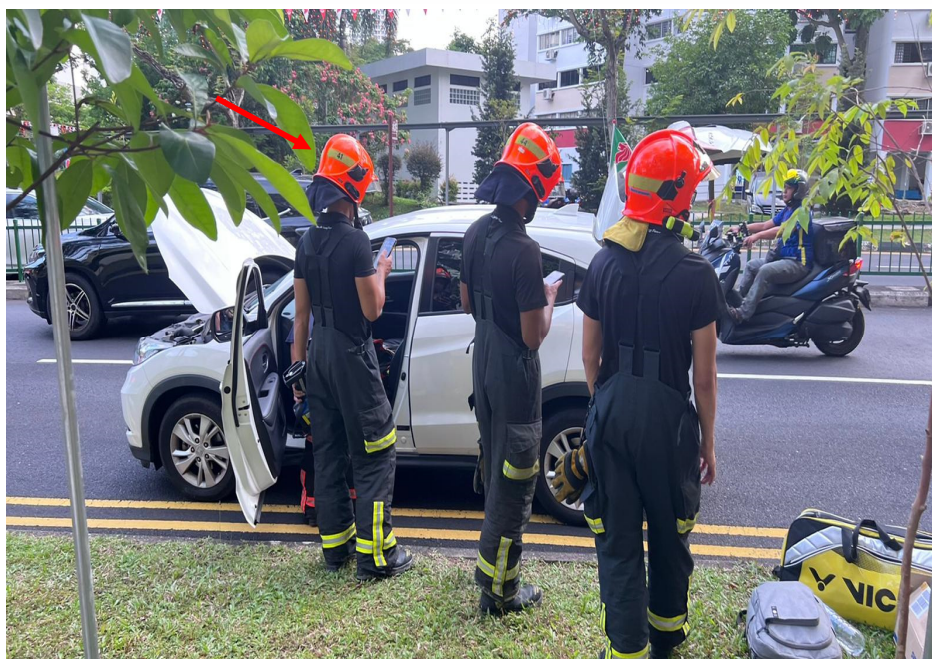
Photo 11 shows firefighters who arrived at the incident location post- incident (arrowed) after Mr Chong had put out the fire to the Insured Vehicle.

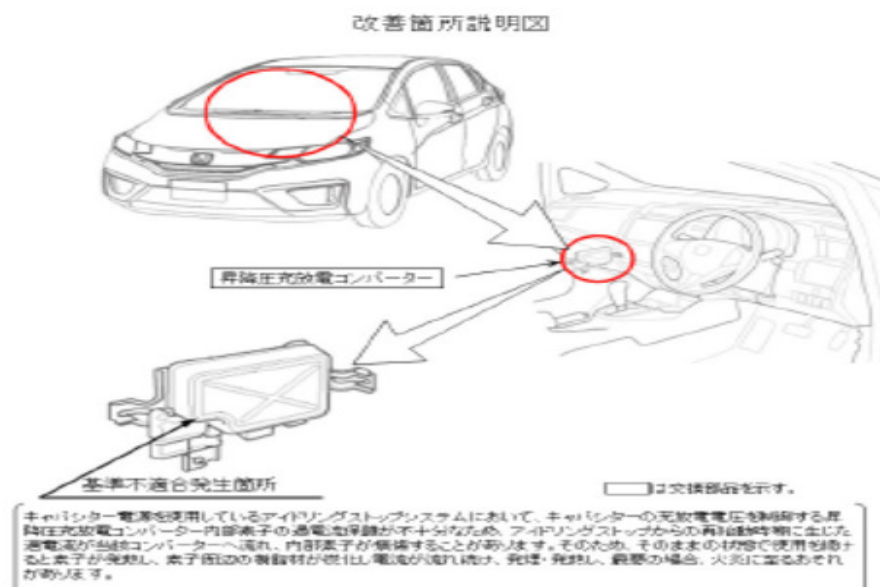
There have been no injuries related to the problems. Six fires were reported related to the faulty part that controls electricity for capacitors, and two minor accidents were reported to the defect in the steering, according to Honda Motor Co.

Screenshot 1 shows the write up that we were able to gather pertaining to the manufacturer recall campaign of similar make and model vehicles as the Insured Vehicle.
