Your Ref: Porsche 911 Turbo Cabriolet
(chassis number WP0ZZZ99ZMS261226)
Our Ref : CI/TP22008619/D

INSPECTION REPORT OF AN UNREGISTERED PORSCHE 911 TURBO CABRIOLET MOTOR CAR WITH CHASSIS NUMBER WP0ZZZ99ZMS261226

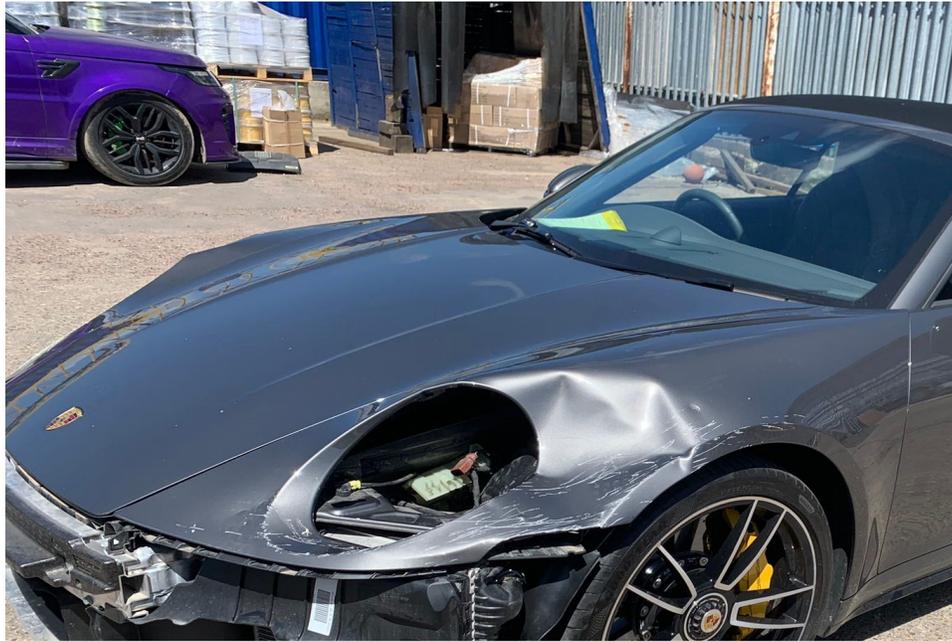
Photo 1 shows the front left body of the Motor Car (photograph provided to me). The Motor Car was observed to have sustained damage at its frontal portion. The front left fender was observed to have been damaged while the front left headlamp, front bumper and all its related parts and attachments like the front left signal lamp, front left day light and front left lower grille amongst others were observed to be dislodged/missing/damaged.

23. The body parts at the frontal portion of the Motor Car were visually examined and it was noted that the repair/restoration works carried out to the damaged area of the Motor Car (refer to photograph 1 & 2 above) were reasonably adequate and in order.

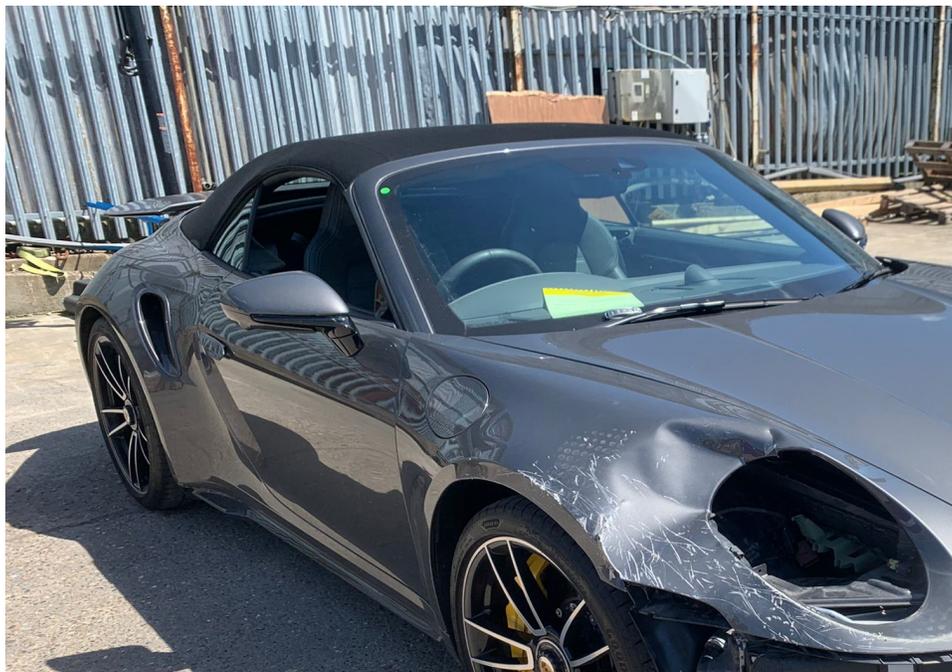
Photo 2 shows the front right body of the Motor Car (photograph provided to me). The Motor Car was observed to have sustained damage at its frontal portion. The front right fender was observed to have been damaged while the front right headlamp, front bumper and all its related parts and attachments like the front right signal lamp, front right day light, front right lower grille and front bumper sensors amongst others were observed to be dislodged/missing/damaged.

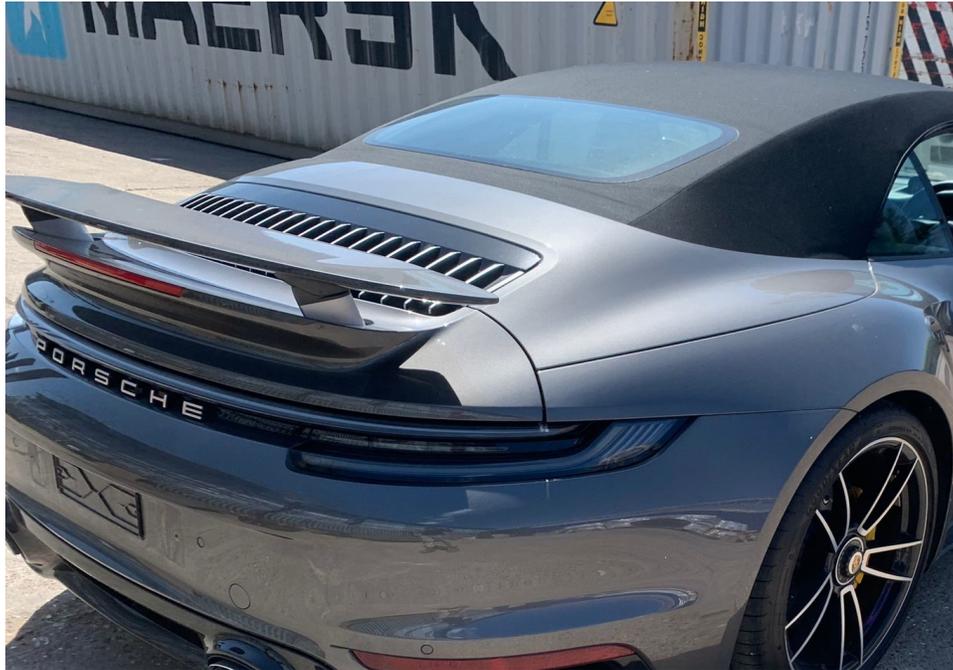
Photo 3 shows the rear right body of the Motor Car (photograph provided to me). Apart for the frontal portion, there was no physical damage observed to other areas of the Motor Car. The airbag(s) of the Motor Car was not deployed as seen from the photographs that were provided.

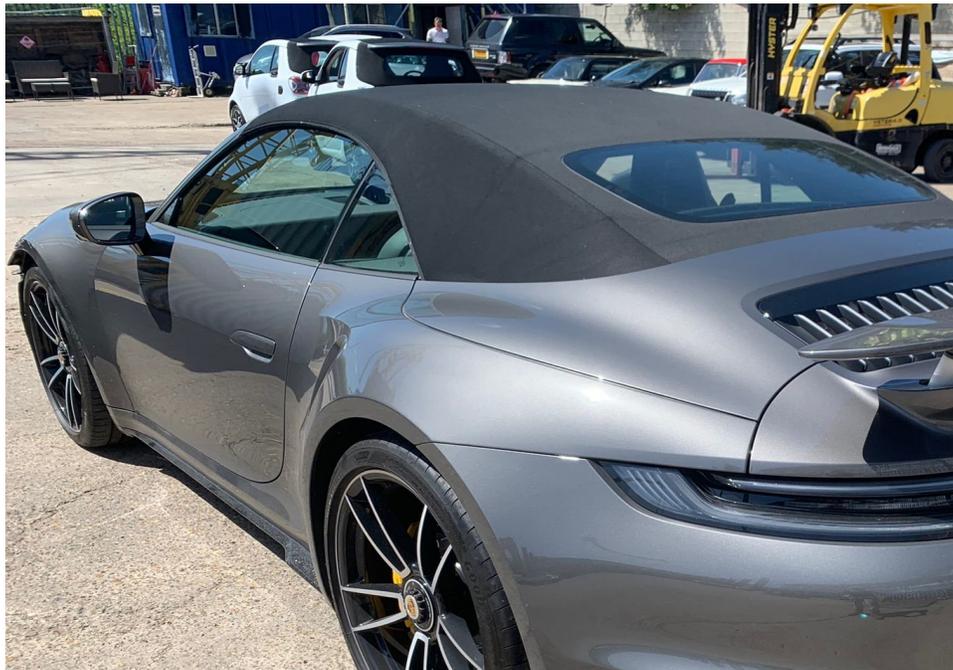
Photo 4 shows the rear left body of the Motor Car (photograph provided to me). Apart for the frontal portion, there was no physical damage observed to other areas of the Motor Car. The airbag(s) of the Motor Car was not deployed as seen from the photographs that were provided.

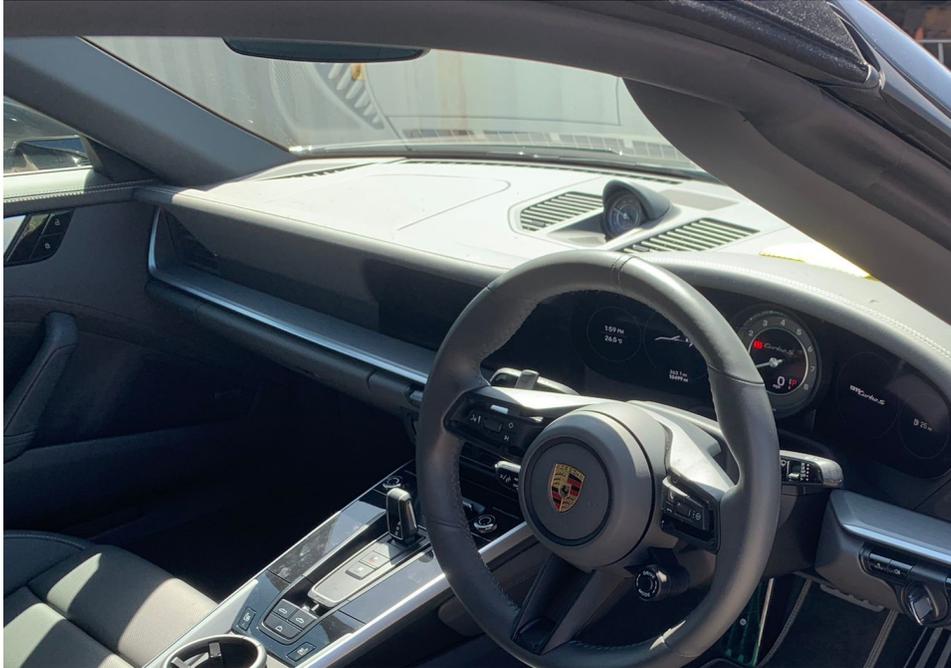
Photo 5 shows the interior compartment of the Motor Car (photograph provided to me). The various parts and components within the interior compartment were all intact and unaffected. The airbag(s) was not deployed as seen from the photographs that were provided to me.

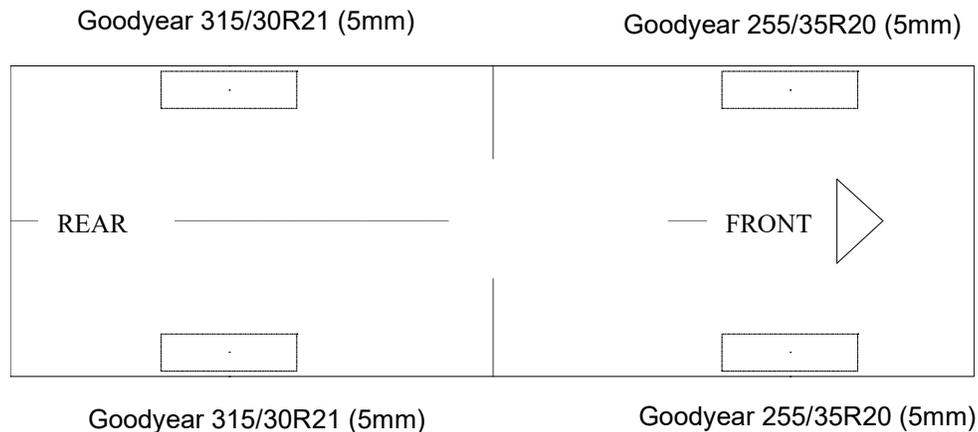
9. It was fitted with 20inch (front) and 21inch (rear) sport wheel rims that were wrapped with tyres that were observed to be of serviceable condition. The tyres were also sufficiently inflated for vehicular operation. The tyre brand, tyre size and approximate remaining tread depth of the 4 tyres of the Motor Car were recorded as follows: -

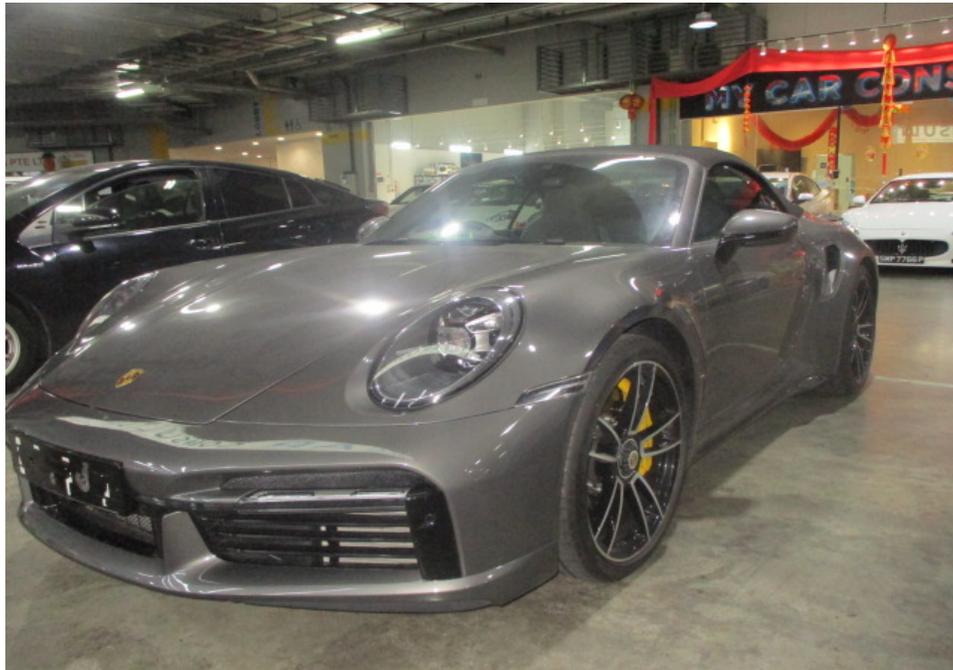
Photo 6 shows a general view of the front left body of the Motor Car at the time of my inspection. The Motor Car was observed to be in a relatively good general condition with no loose exterior fittings observed. The body parts at the frontal portion of the Motor Car were visually examined and it was observed that the repair/restoration works carried out to the damaged area of the Motor Car (refer to photograph 1 & 2 above) were reasonably adequate and in order.

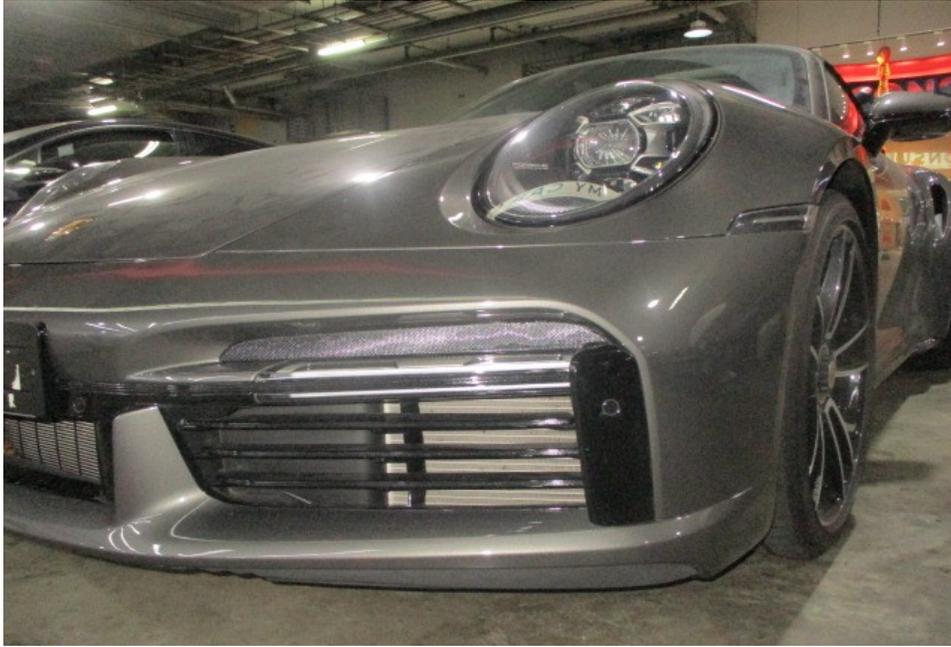
Photo 7 shows a closer view of the Motor Car's front bumper, front bumper left lower grille, front bumper left sensor, front left day light and front left headlamp. The body parts at the frontal portion of the Motor Car were visually examined and it was observed that the repair/restoration works carried out to the damaged area of the Motor Car (refer to photograph 1 & 2 above) were reasonably adequate and in order.

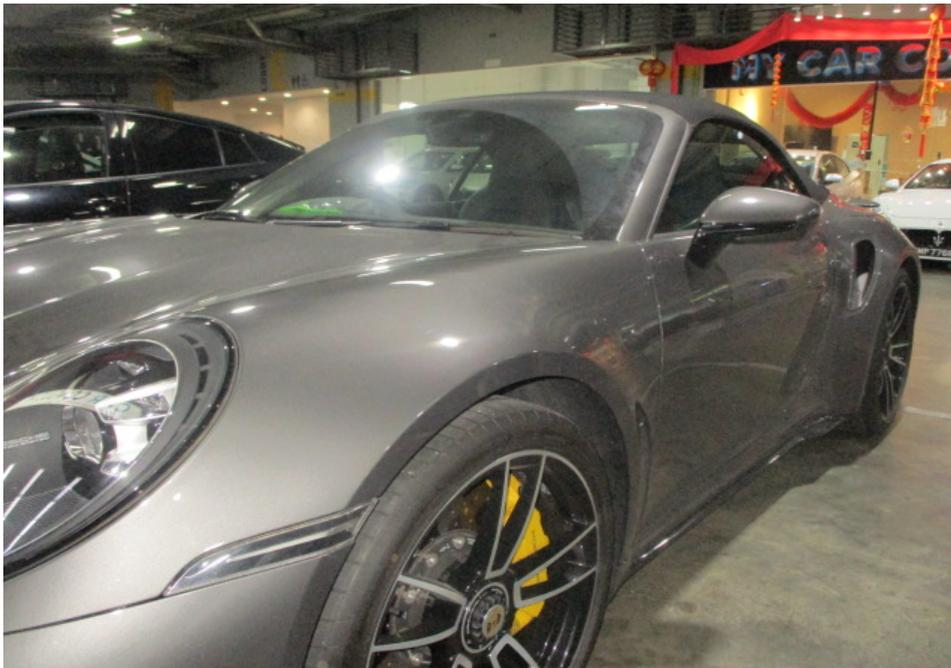
Photo 8 shows a closer view of the Motor Car's front left signal lamp, front left headlamp, front left wheel rim and front left fender. The body parts at the frontal portion of the Motor Car were visually examined and it was observed that the repair/restoration works carried out to the damaged area of the Motor Car (refer to photograph 1 & 2 above) were reasonably adequate and in order.

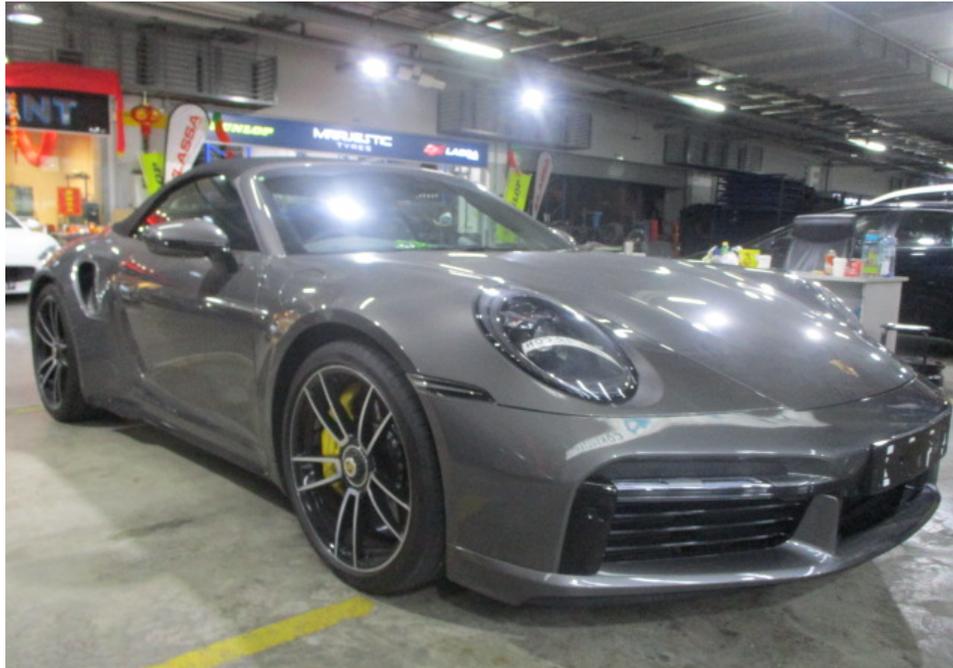
Photo 9 shows a general view of the front right body of the Motor Car at the time of my inspection. The Motor Car was observed to be in a relatively good general condition with no loose exterior fittings observed. The body parts at the frontal portion of the Motor Car were visually examined and it was observed that the repair/restoration works carried out to the damaged area of the Motor Car (refer to photograph 1 & 2 above) were reasonably adequate and in order.

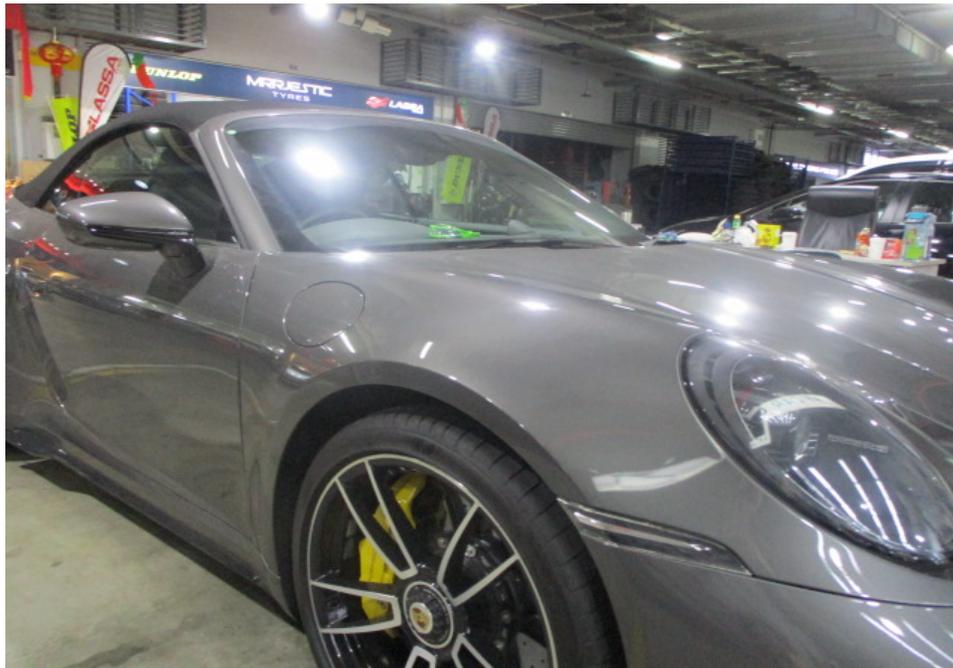
Photo 10 shows a closer view of the Motor Car's front right signal lamp, front right headlamp, front right wheel rim and front right fender. The body parts at the frontal portion of the Motor Car were visually examined and it was observed that the repair/restoration works carried out to the damaged area of the Motor Car (refer to photograph 1 & 2 above) were reasonably adequate and in order.

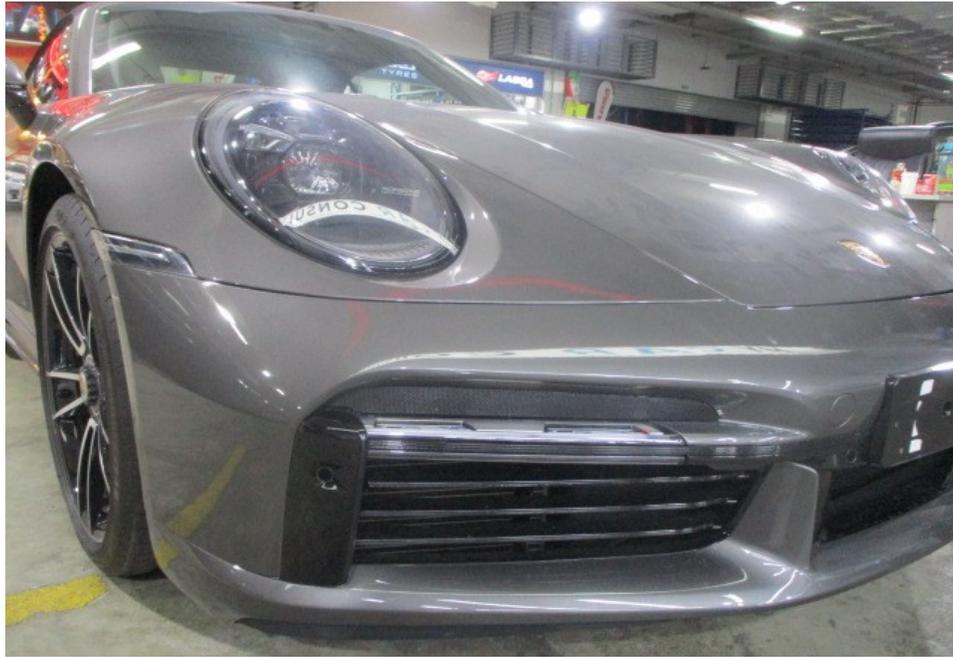
Photo 11 shows a closer view of the Motor Car's front bumper, front bumper right lower grille, front bumper right sensor, front right day light and front right headlamp. The body parts at the frontal portion of the Motor Car were visually examined and it was observed that the repair/restoration works carried out to the damaged area of the Motor Car (refer to photograph 1 & 2 above) were reasonably adequate and in order.

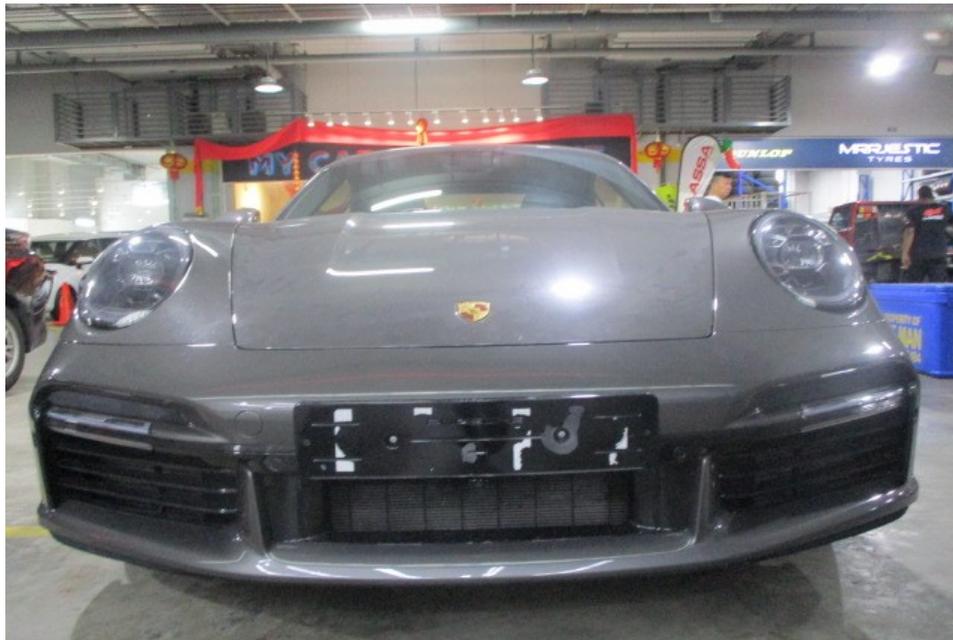
Photo 12 shows a general view of the frontal body of the Motor Car at the time of my inspection. The Motor Car was observed to be in a relatively good general condition with no loose exterior fittings observed. The body parts at the frontal portion of the Motor Car were visually examined and it was observed that the repair/restoration works carried out to the damaged area of the Motor Car (refer to photograph 1 & 2 above) were reasonably adequate and in order.

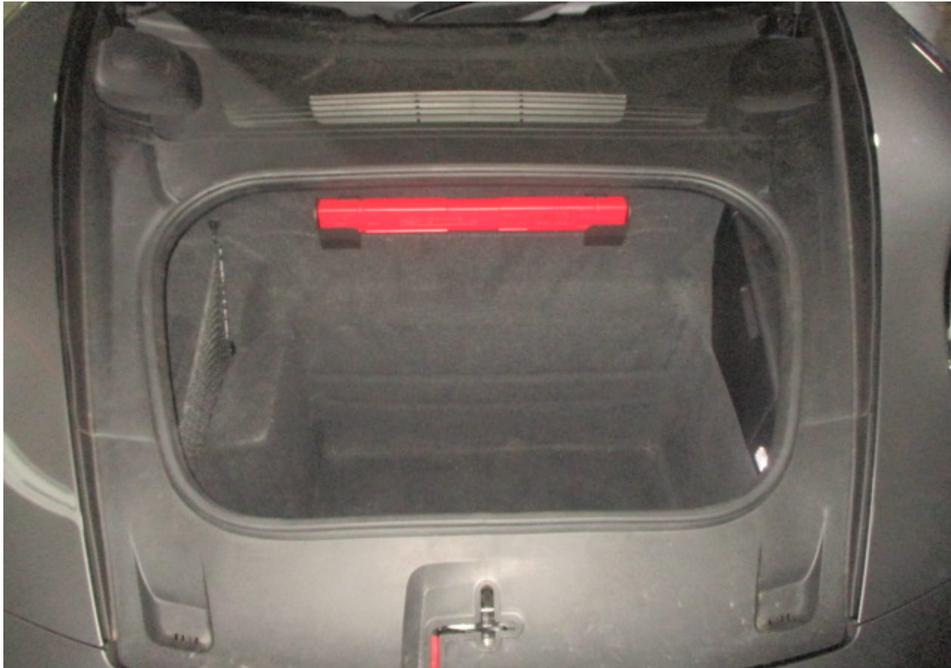
Photo 13 shows a general view of the Motor Car's front bonnet compartment at the time of my inspection. All inner trims, garnishes and upholstery etc were observed to be properly fitted.

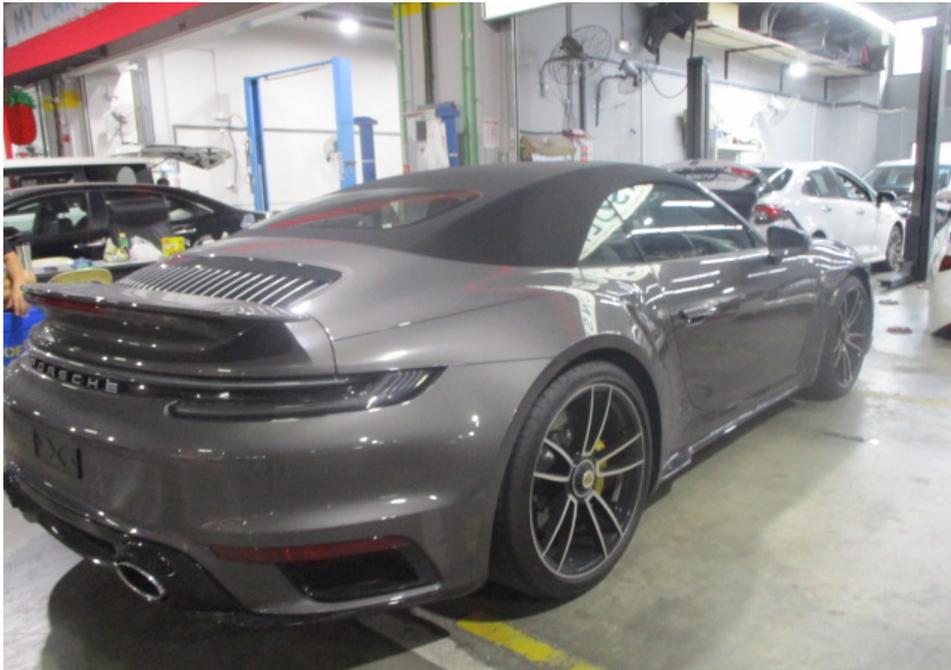
Photo 14 shows a general view of the rear right body of the Motor Car at the time of my inspection. The Motor Car was observed to be in a relatively good general condition with no loose exterior fittings observed. The mileage of the Motor Car recorded at the time of my inspection was 16,951km.

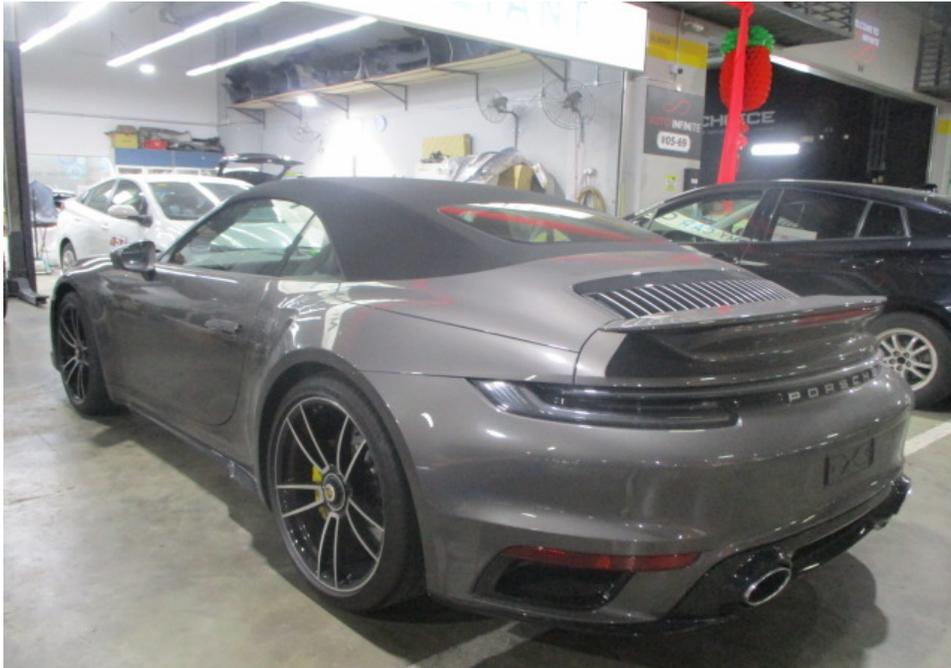
Photo 15 shows a general view of the rear left body of the Motor Car at the time of my inspection. The Motor Car was observed to be in a relatively good general condition with no loose exterior fittings observed. The mileage of the Motor Car recorded at the time of my inspection was 16,951km.

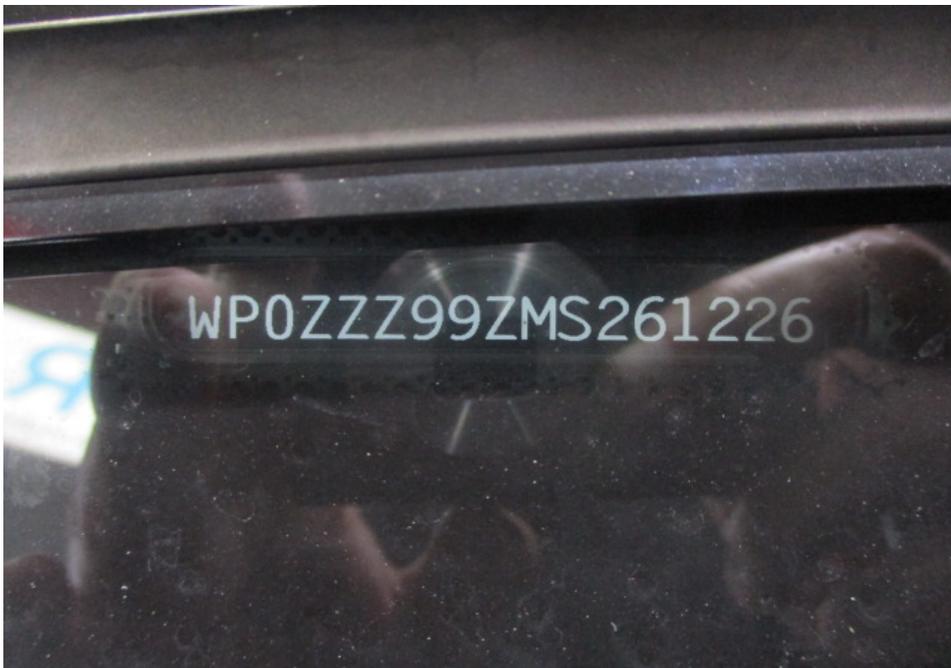
Photo 16 shows the chassis number of the Motor Car. The chassis number recorded was WP0ZZZ99ZMS261226.

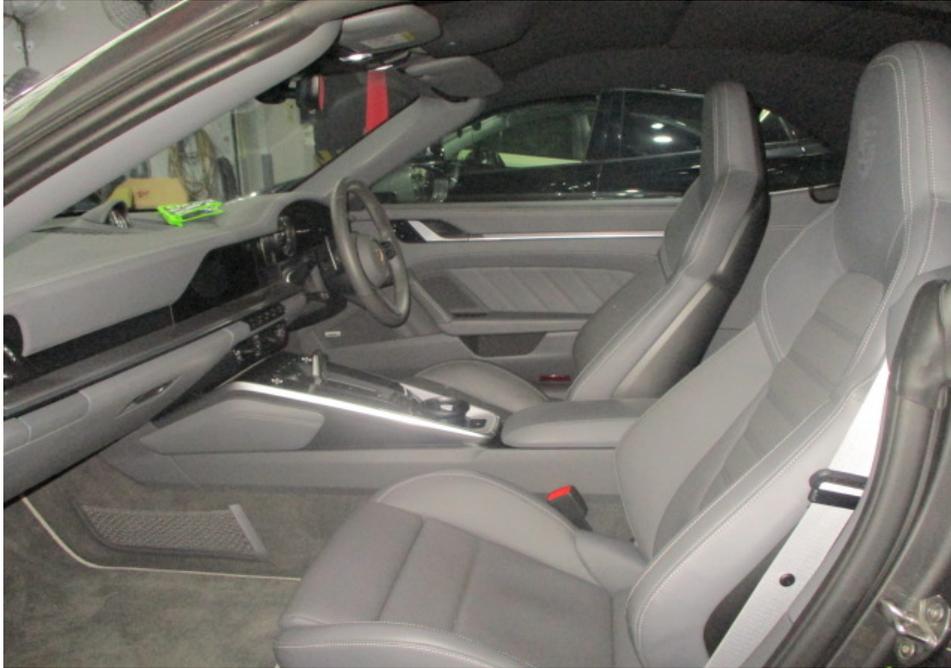
Photo 17 shows the interior compartment of the Motor Car at the time of my inspection. The various parts and components, trims, carpet, and upholstery inside the interior compartment were all observed to be intact and properly fitted.

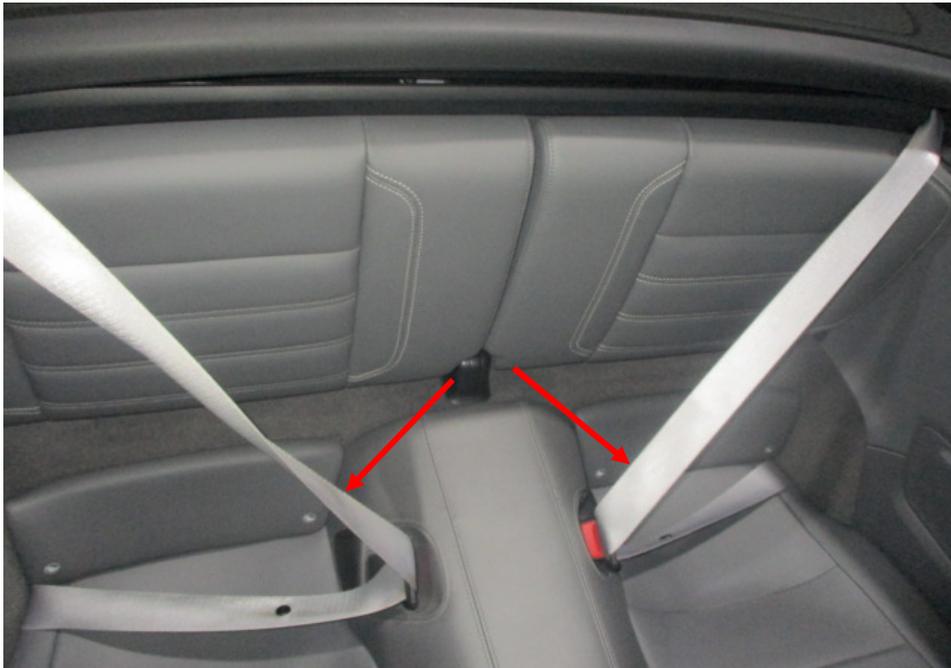
Photo 18 shows the rear seats of the Motor Car. All the seats of the Motor Car were secured via seat rails to the floorboard. They were also fitted with a retractable seat belt reel and a pre-tensioner. The seat belts (arrowed) were tested and were able to be fastened into the respective pre-tensions that were fitted on the side of each individual seat.

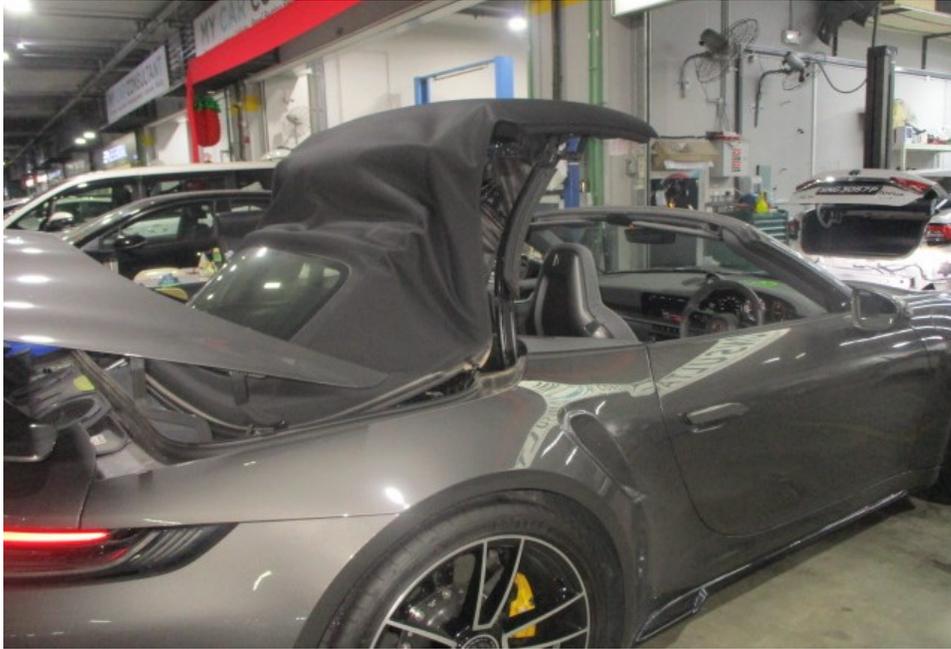
Photo 19 shows the Motor Car's soft top roof being tested. It was observed that as a safety feature, the soft top roof could only open and close when the Motor Car was in a stationary position. When opened, the soft top roof is completely folded into the rear compartment with no parts protruding out of the Motor Car's body. The soft top roof was also found adequately secured to the "A" pillar after closing.

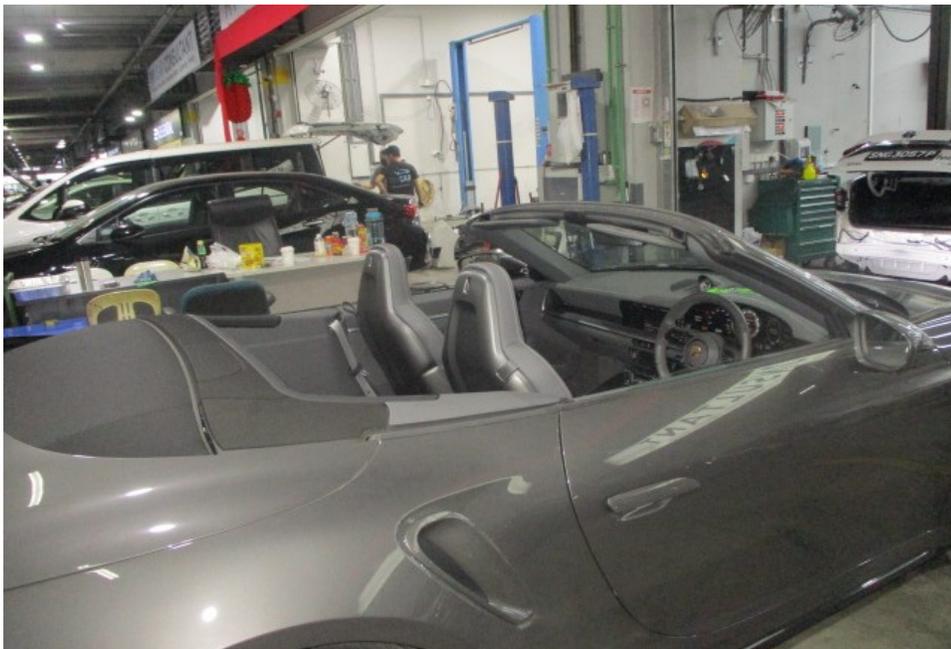
Photo 20 shows the Motor Car with its soft top roof completely folded. It was observed that as a safety feature, the soft top roof could only open and close when the Motor Car was in a stationary position. When opened, the soft top roof is completely folded into the rear compartment with no parts protruding out of the Motor Car's body. The soft top roof was also found adequately secured to the "A" pillar after closing.

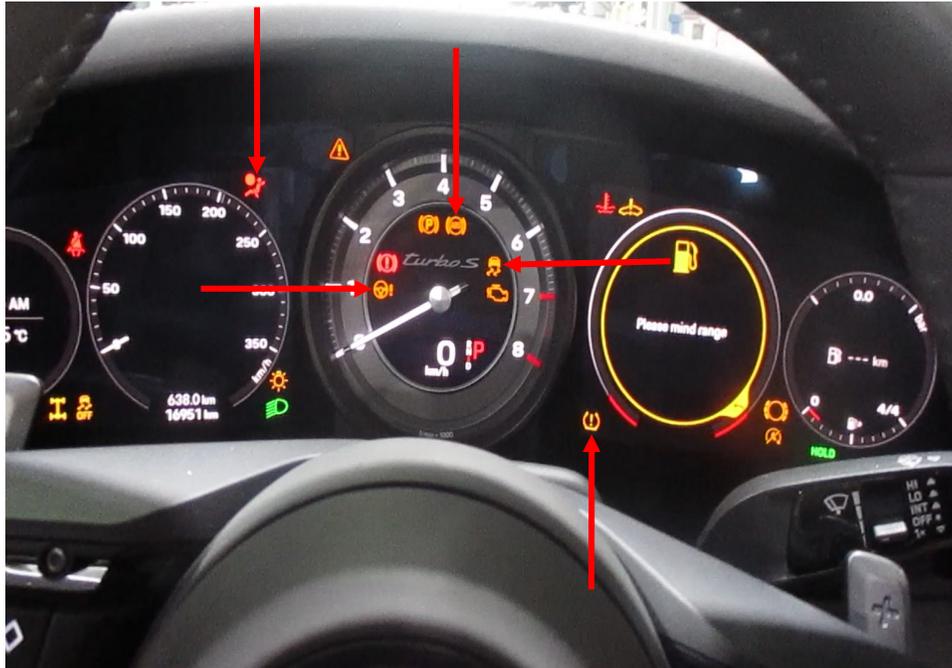
Photo 21 shows the warning lights for the various electronic safety features appearing on the instrument panel of the Motor Car during its self-test when the engine is cranked, in particular the ABS, SRS, EPS, TPM and TCS lights (arrowed).

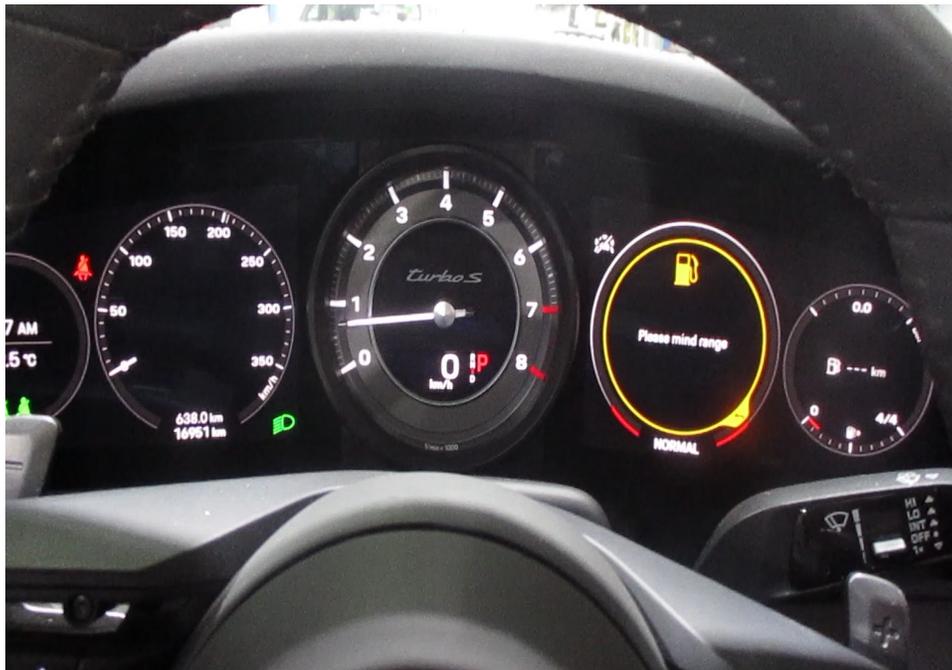
Photo 22 shows the respective warning lights no longer illuminated, indicating that there is no fault detected to the ABS, SRS, EPS, TPM and TCS systems of the Motor Car during the self-test. These electronic systems were hence in working condition at the time of my inspection.

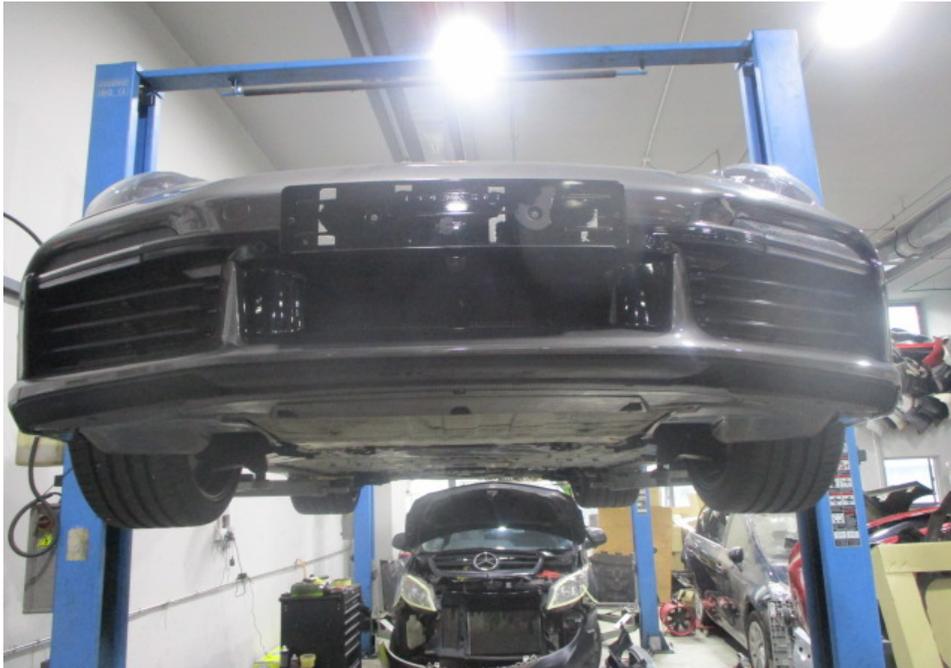
Photo 23 shows the Motor Car hoisted up for checks on its undercarriage. There was no sign(s) or indication(s) of fluid leakage and/or fluid stain(s) on the underside of the Motor Car. The undercarriage components of the Motor Car were also all observed to be intact and secured in an appropriate manner.

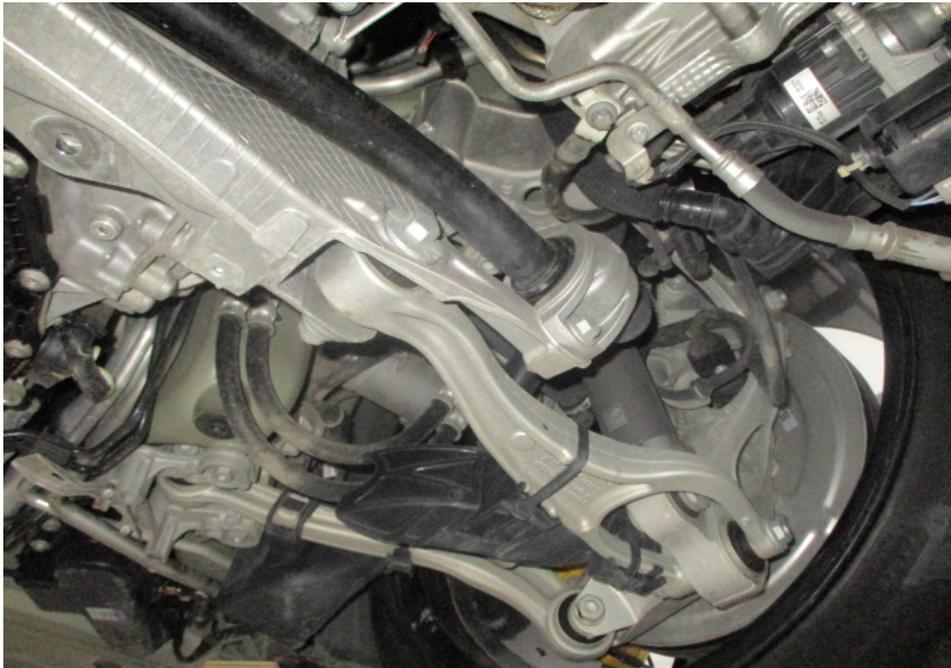
Photo 24 shows a general view of the control arms and linkages at the rear right wheel of the Motor Car. I did not observe any fluid leak and/or fluid stain on the underside of the Motor Car. All of the Motor Car's undercarriage components were observed to be intact and secured in an appropriate manner.

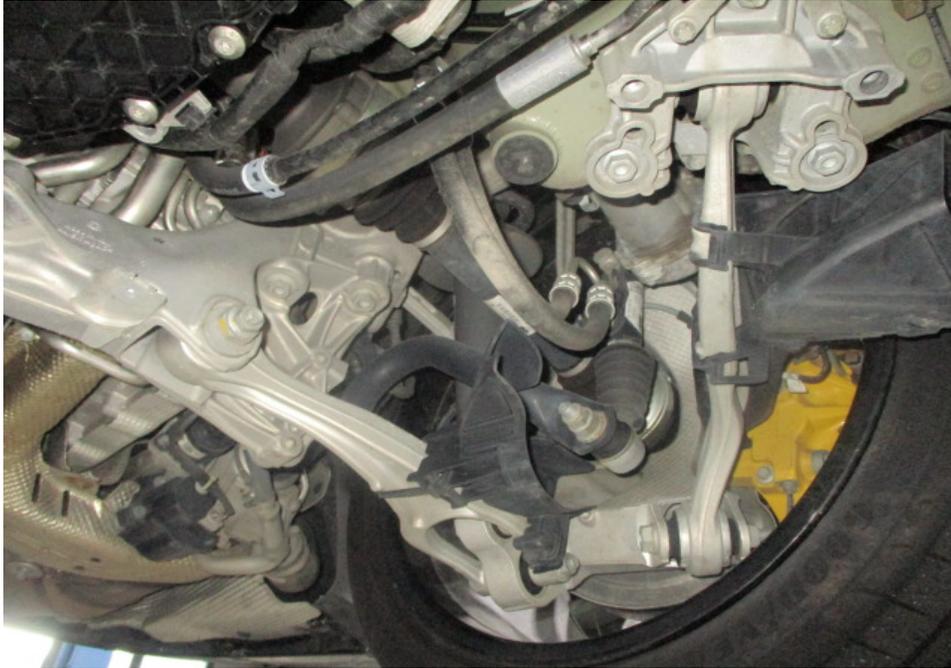
Photo 25 shows a general view of the control arms and linkages at the rear left wheel of the Motor Car. I did not observe any fluid leak and/or fluid stain on the underside of the Motor Car. All of the Motor Car's undercarriage components were observed to be intact and secured in an appropriate manner.

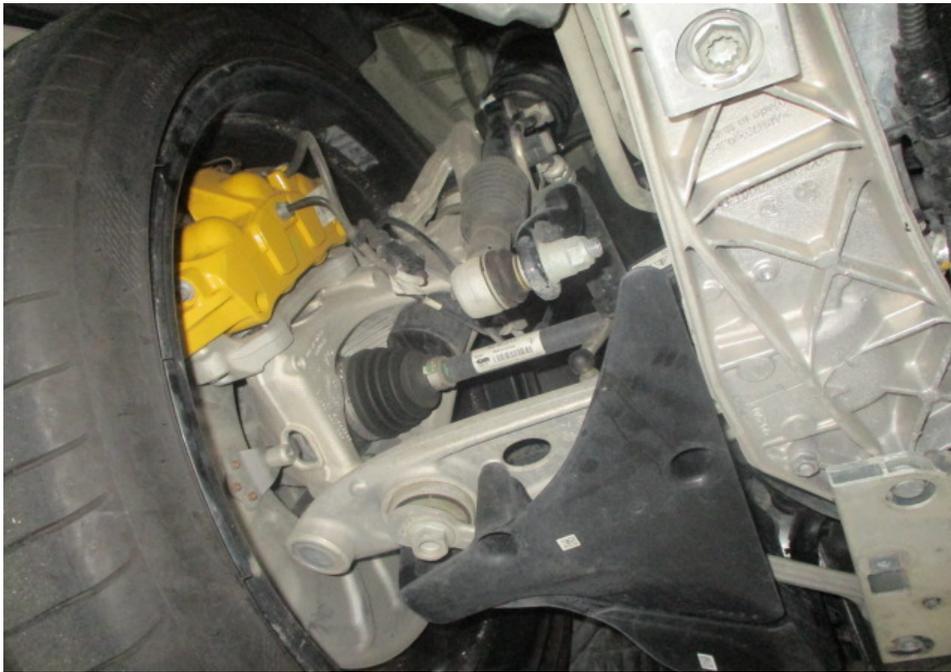
Photo 26 shows the various undercarriage components at the front left wheel of the Motor Car. The mechanical components, control arms and linkages were all found to be intact and secured in an appropriate manner.

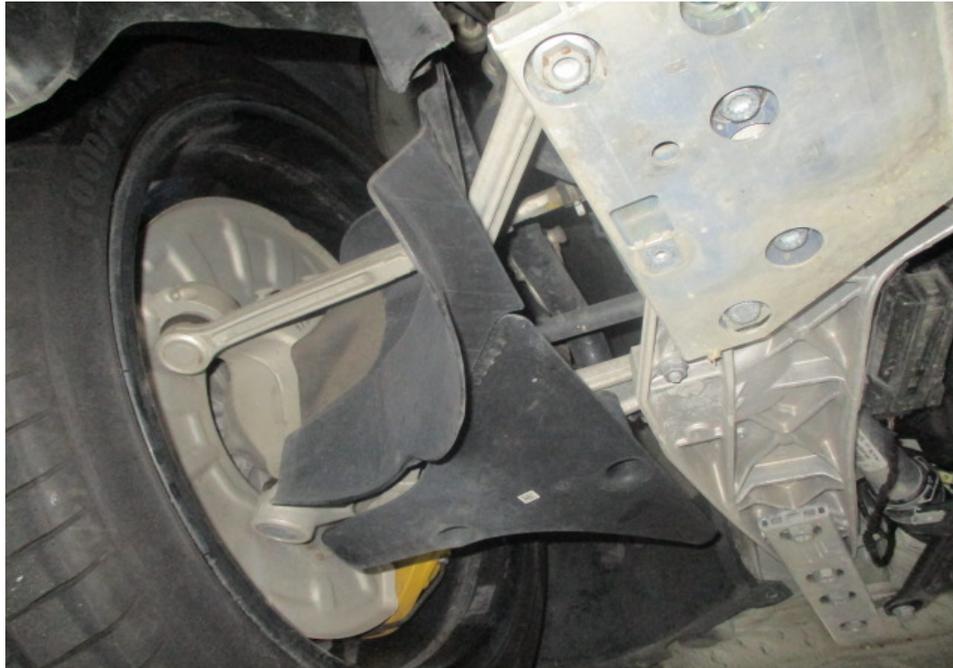
Photo 27 shows the various undercarriage components at the front right wheel of the Motor Car. The mechanical components, control arms and linkages were all found to be intact and secured in an appropriate manner. I also did not observe any fluid leak and/or fluid stain on the underside of the Motor Car.

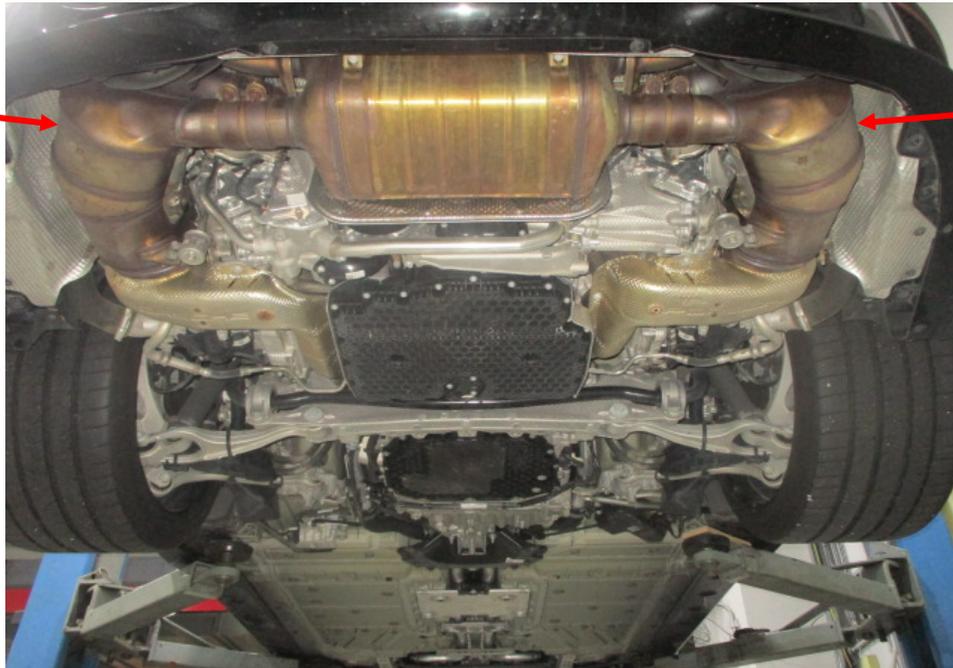
Photo 28 shows the Motor Car's exhaust system. My examination of the Motor Car's exhaust system revealed no sign(s) or indication(s) of any cut or weld marks along its exhaust pipes, on its catalytic converters (arrowed) and on its rear muffler.

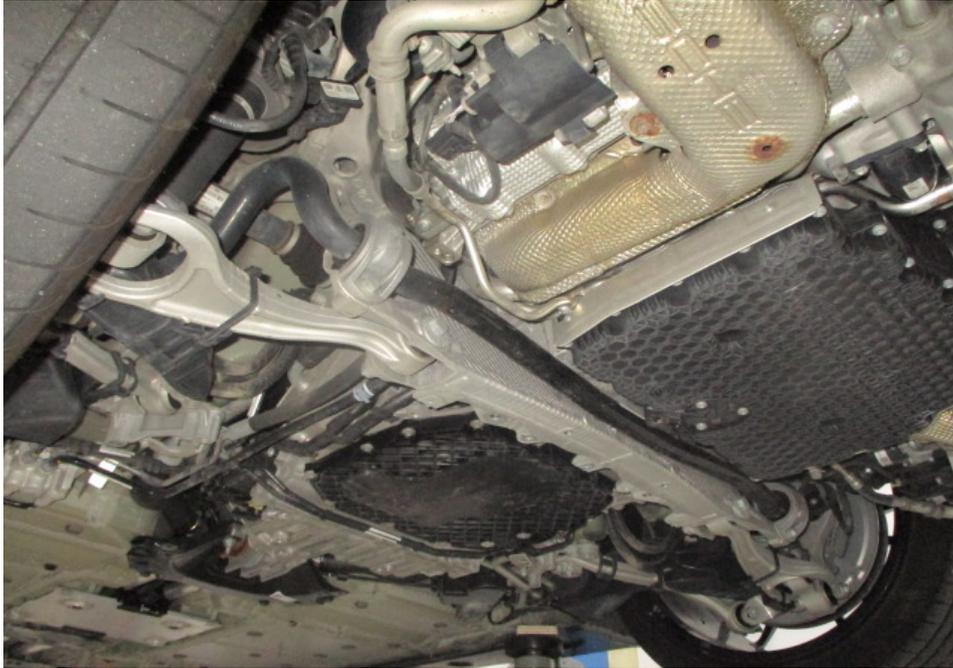
Photo 29 shows a general view of the Motor Car's engine compartment. The engine compartment was at the rear underside of the Motor Car. The various parts and components within the engine compartment were all observed to be intact and properly fitted. There was also no sign(s) or indication(s) of fluid leak and/or fluid stain found inside the engine compartment.

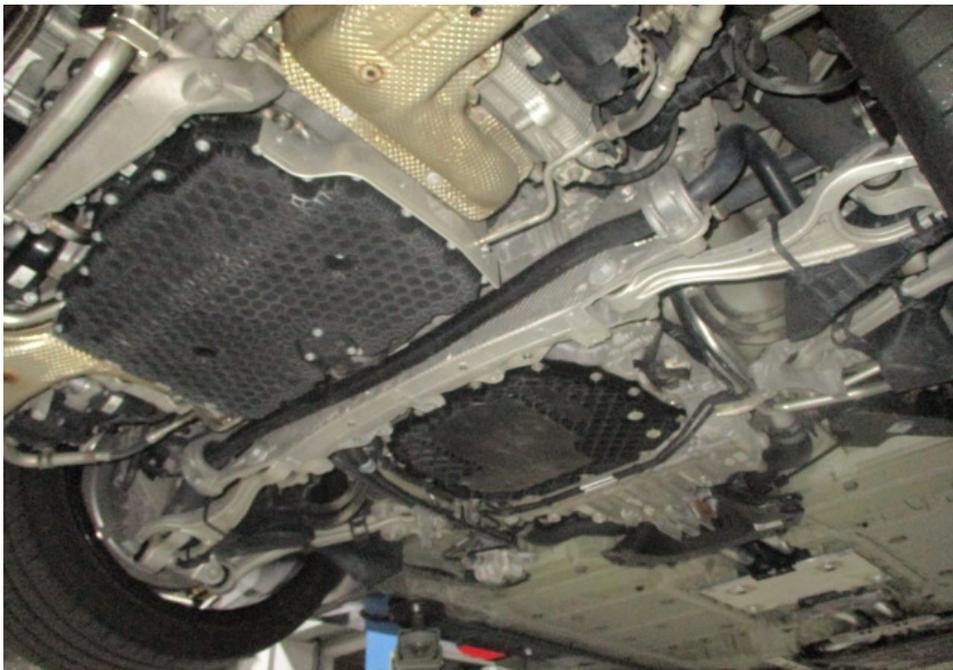
Photo 30 shows another view of the Motor Car's engine compartment. The engine compartment was at the rear underside of the Motor Car. The various parts and components within the engine compartment were all observed to be intact and properly fitted. There was also no sign(s) or indication(s) of fluid leak and/or fluid stain found inside the engine compartment.
