Your Ref: Porsche 911 Turbo Cabriolet
(chassis number WP0ZZZ99ZMS261226)
Our Ref : CI/TP22008619/D

INSPECTION REPORT OF AN UNREGISTERED PORSCHE 911 TURBO CABRIOLET MOTOR CAR WITH CHASSIS NUMBER WP0ZZZ99ZMS261226

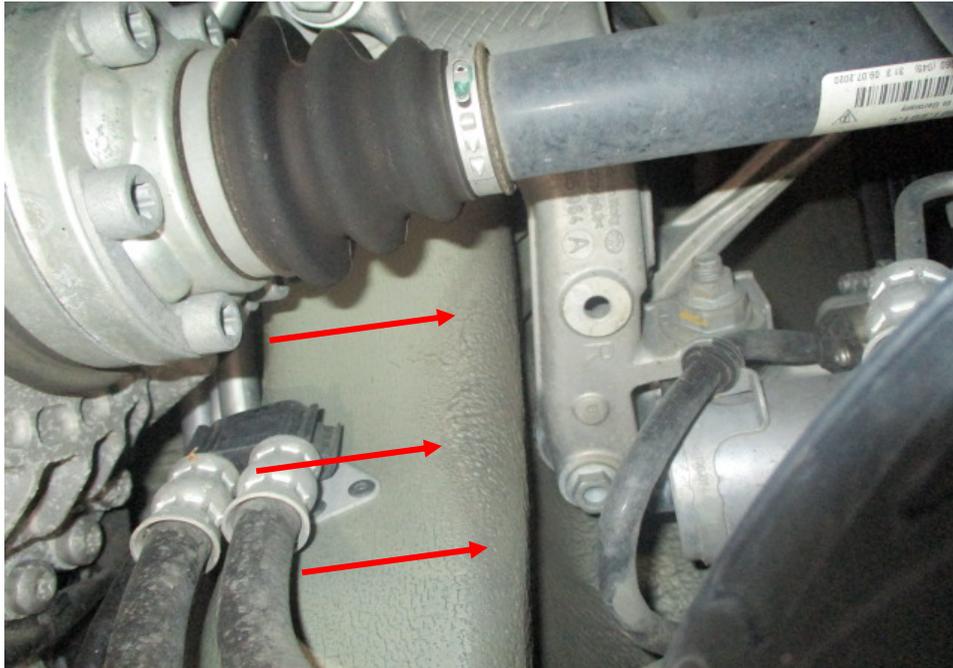
Photo 31 shows the chassis/structural body at the underside rear right of the Motor Car. I did not find any weld marks other than original spot weld marks on the chassis/structural body of the Motor Car. The original factory sealant (arrowed) at the joints along the chassis/structural body was untouched, indicating no work was done on the chassis/structural body of the Motor Car and that the chassis/structural body was originally fitted.

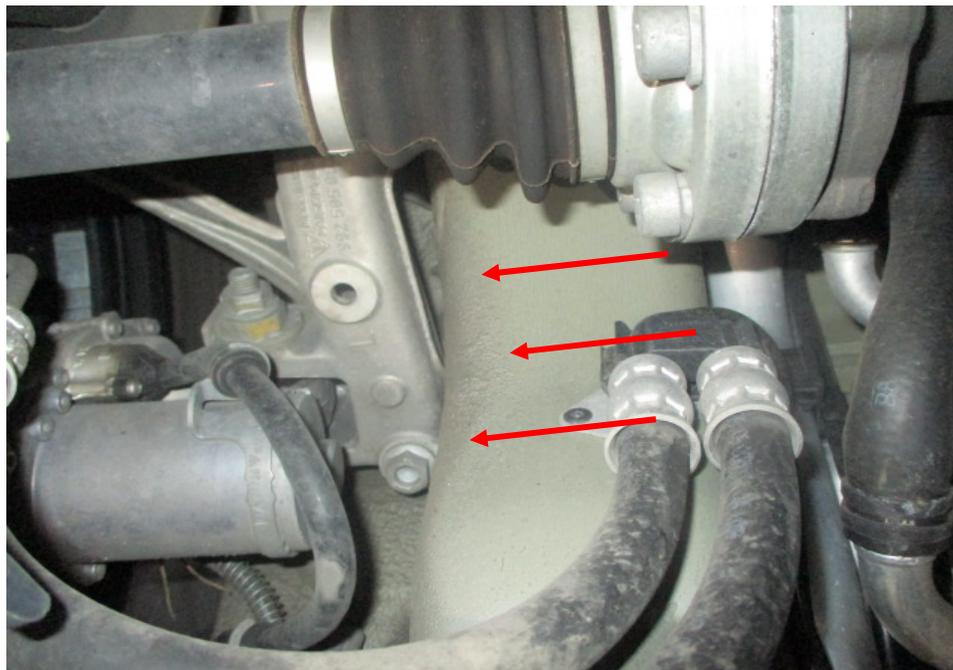
Photo 32 shows the chassis/structural body at the underside rear left of the Motor Car. The original factory sealant (arrowed) at the joints along the chassis/structural body was observed to be untouched. In general, I had found no work was carried out on the chassis/structural body of the Motor Car. The chassis/structural body of the Motor Car was originally fitted.

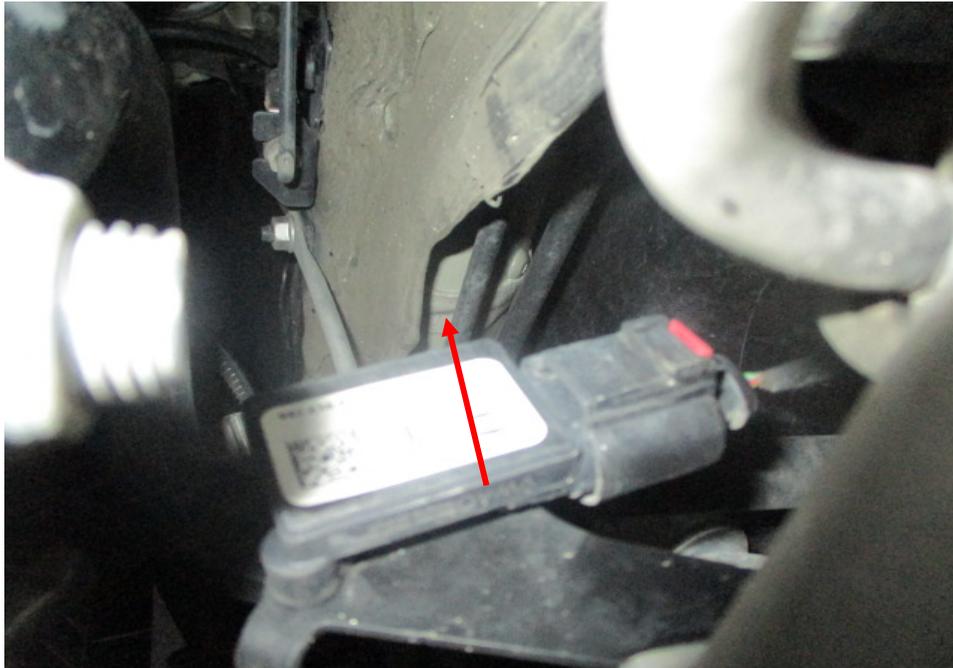
Photo 33 shows the chassis/structural body at the underside front left of the Motor Car. I did not find any weld marks other than original spot weld marks on the chassis/structural body of the Motor Car. The original factory sealant (arrowed) at the joints along the chassis/structural body was untouched, indicating no work was done on the chassis/structural body of the Motor Car and that the chassis/structural body was originally fitted.

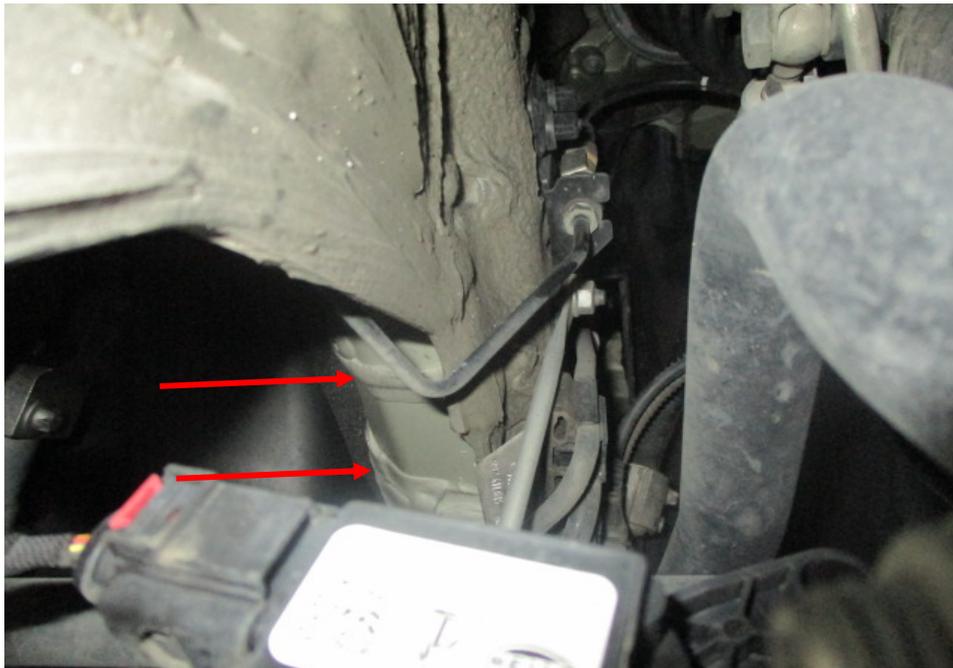
Photo 34 shows the chassis/structural body at the underside front right of the Motor Car. The original factory sealant (arrowed) at the joints along the chassis/structural body was observed to be untouched. In general, I had found no work was carried out on the chassis/structural body of the Motor Car. The chassis/structural body of the Motor Car was originally fitted.

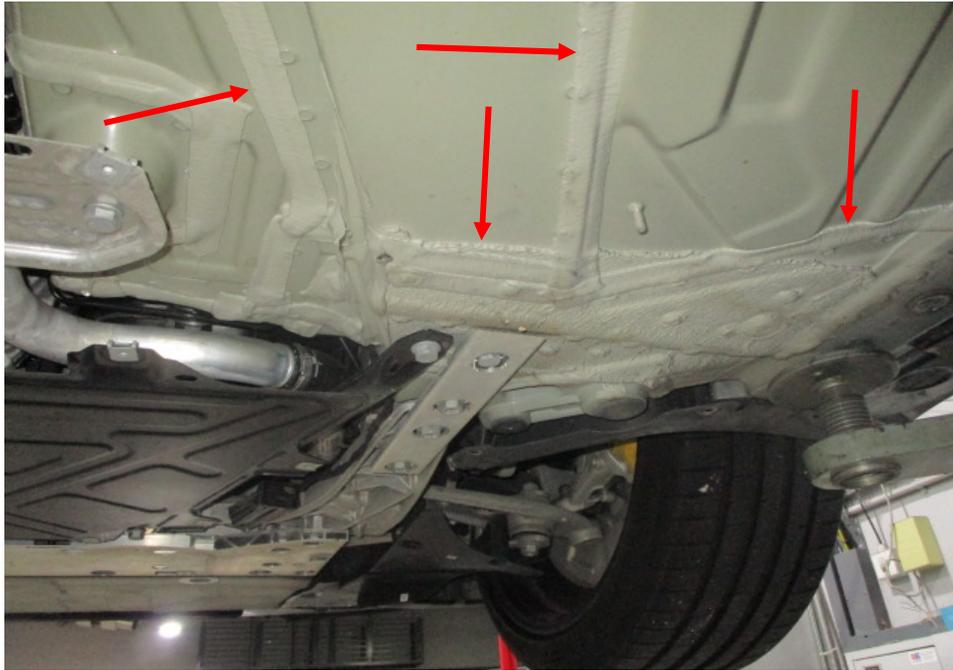
Photo 35 shows the floorboard at the underside centre right of the Motor Car. The original factory sealant (arrowed) at the joints along the floorboard was observed to be untouched, which indicates that there was no re-welding works carried out. In general, I had found all the non-detachable body panels of the Motor Car to be originally fitted at the time of my inspection.
