Your Ref: Honda Engine

(number R18A1030923)

Our Ref: CI/TP22008631/D

INSPECTION REPORT OF A HONDA ENGINE WITH NUMBER R18A1030923

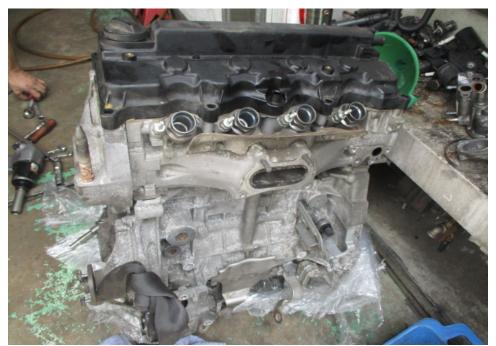
Photo 1 shows a general view of the Honda engine that I had inspected. The Honda engine was observed to be a used engine and was not fitted on any motor car. It was also observed to be a complete assembly with all mechanical parts still intact, within the engine housing.

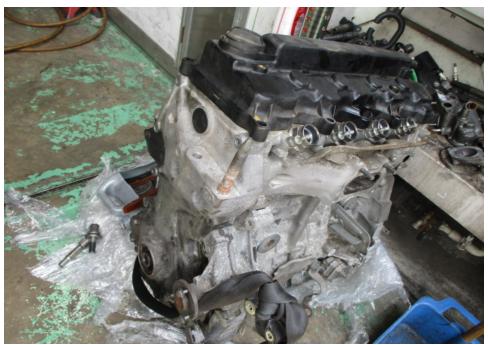
Photo 2 shows a general view of the Honda engine that I had inspected. My visual examination of the engine housing revealed the housing to be of serviceable/satisfactory condition. There was no crack and/or hole observed on the engine housing.

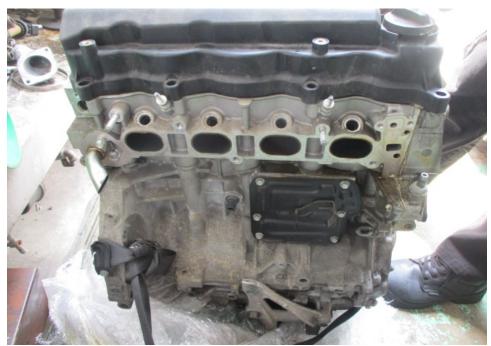
Photo 3 shows another view of the Honda engine that I had inspected. My visual examination of the engine housing revealed the housing to be of serviceable/satisfactory condition. There was no crack and/or hole observed on the engine housing.

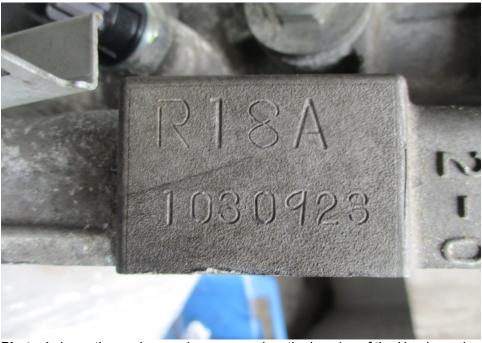
Photo 4 shows the engine number engraved on the housing of the Honda engine that I had inspected. The engine number was R18A1030923.

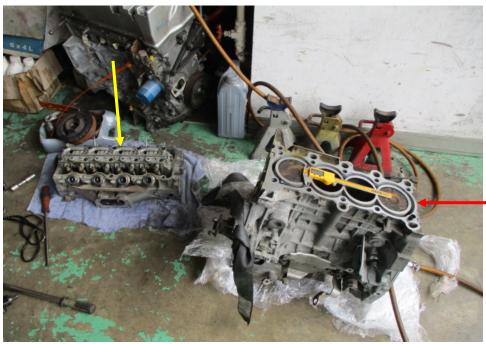
Photo 5 shows the top block (yellow arrow) of the Honda engine separated from its bottom block (red arrow). This was to enable me to carry out measurements of its cylinders, in particular the bore and stroke measurements of each cylinder, which typically can be used to determine the engine displacement or more commonly referred to as engine cc.

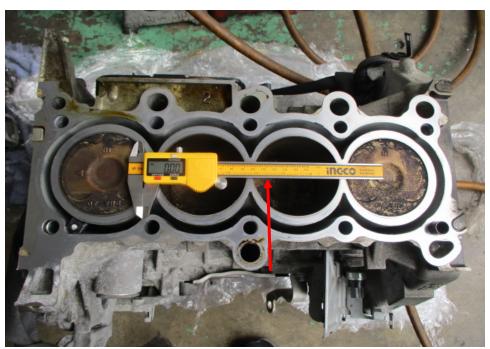
Photo 6 shows the bottom block of the Honda engine and the digital Vernier Caliper (arrowed) that was used to measure the bore and stroke measurements of each cylinder. The digital Vernier Caliper was calibrated before the start of the measurements.

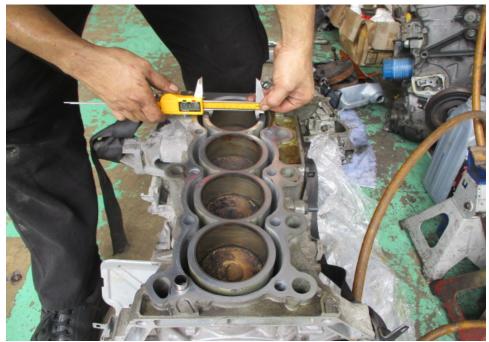
Photo 7 shows measurement being carried out to the bore of cylinder 1 of the Honda engine. The measurements were carried out using a digital Vernier Caliper that was calibrated before the start of the measurements.

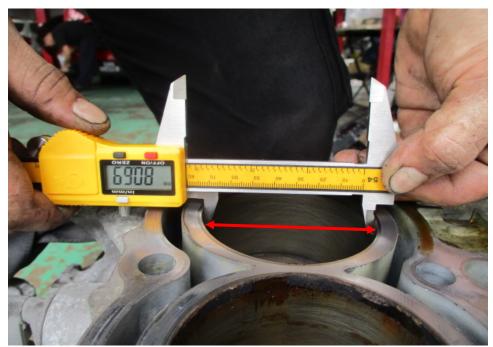
Photo 8 shows measurement being carried out to the bore (arrowed) of cylinder 1 of the Honda engine. The bore measurement of cylinder 1 was recorded to be 80.69mm.

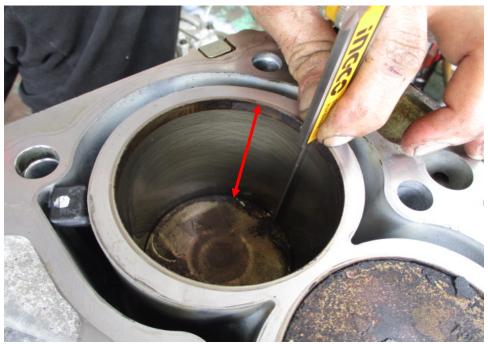
Photo 9 shows measurement being carried out to the stroke (arrowed) of cylinder 1 of the Honda engine. The bore and stroke measurements of the Honda engine were carried out using a digital Vernier Caliper that was calibrated before the start of the measurements.

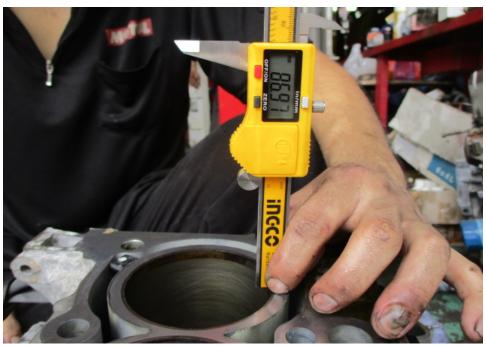
Photo 10 shows the stroke measurement of cylinder 1, which was recorded to be 86.97mm.

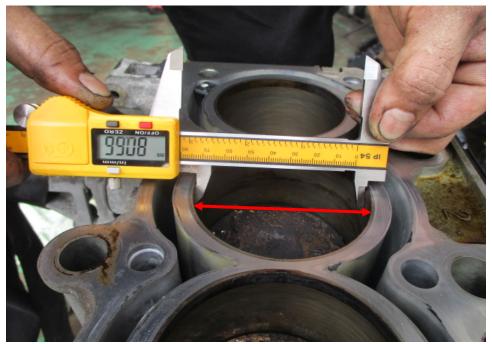
Photo 11 shows measurement being carried out to the bore (arrowed) of cylinder 2 of the Honda engine. The bore measurement of cylinder 2 was recorded to be 80.66mm.

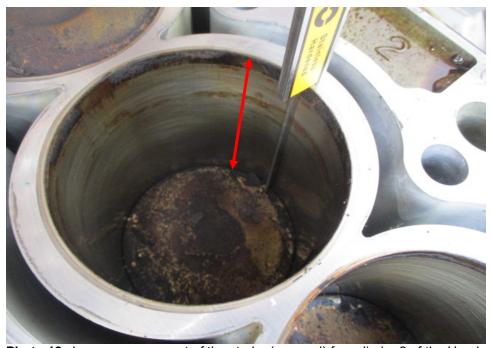
Photo 12 shows measurement of the stroke (arrowed) for cylinder 2 of the Honda engine that I had inspected. The bore and stroke measurements of the Honda engine were carried out using a digital Vernier Caliper that was calibrated before the start of measurements.

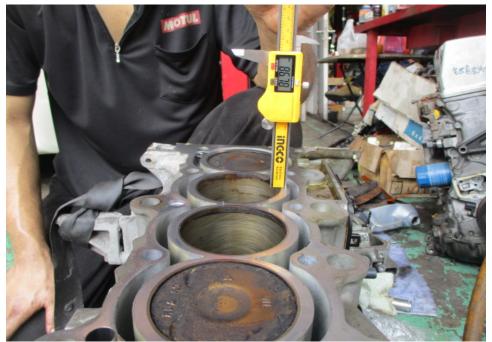
Photo 13 shows the stroke measurement of cylinder 2, which was recorded to be 86.78mm.

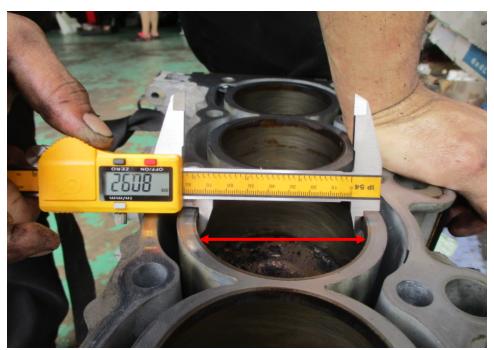
Photo 14 shows measurement being carried out to the bore (arrowed) of cylinder 3 of the Honda engine. The bore and stroke measurements of the Honda engine were carried out using a digital Vernier Caliper that was calibrated before the start of measurements. The bore measurement of cylinder 3 was recorded to be 80.92mm.

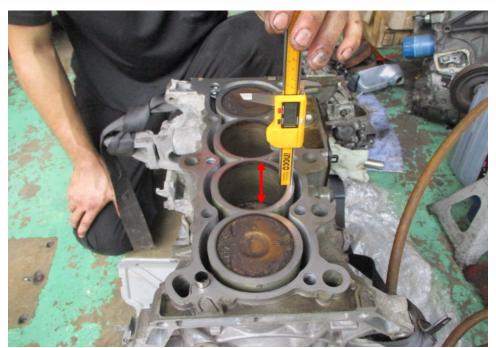
Photo 15 shows measurement of the stroke (arrowed) for cylinder 3 of the Honda engine that I had inspected. The bore and stroke measurements of the Honda engine were carried out using a digital Vernier Caliper that was calibrated before the start of measurements.

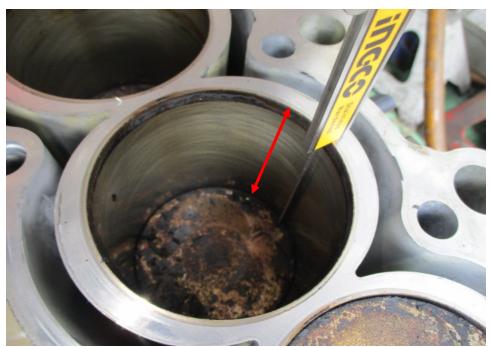
Photo 16 shows measurement of the stroke (arrowed) for cylinder 3 of the Honda engine that I had inspected. The bore and stroke measurements of the Honda engine were carried out using a digital Vernier Caliper that was calibrated before the start of measurements.

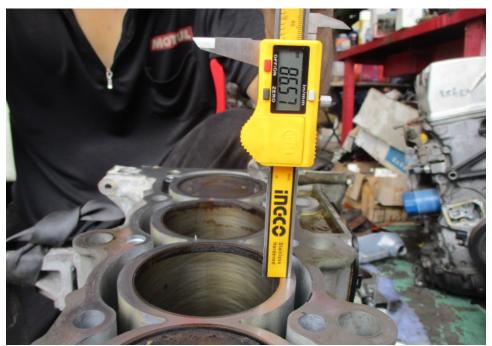
Photo 17 shows the stroke measurement of cylinder 3, which was recorded to be 86.57mm.

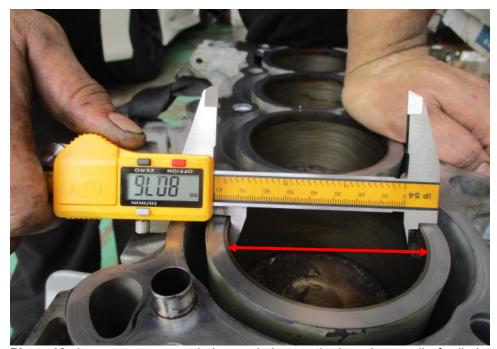
Photo 18 shows measurement being carried out to the bore (arrowed) of cylinder 4 of the Honda engine. The bore and stroke measurements of the Honda engine were carried out using a digital Vernier Caliper that was calibrated before the start of measurements. The bore measurement of cylinder 4 was recorded to be 80.76mm.

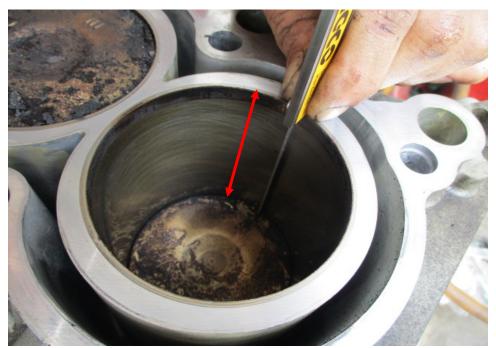
Photo 19 shows measurement being carried out to the stroke (arrowed) of cylinder 4 of the Honda engine. The bore and stroke measurements of the Honda engine were carried out using a digital Vernier Caliper that was calibrated prior to the start of measurements.

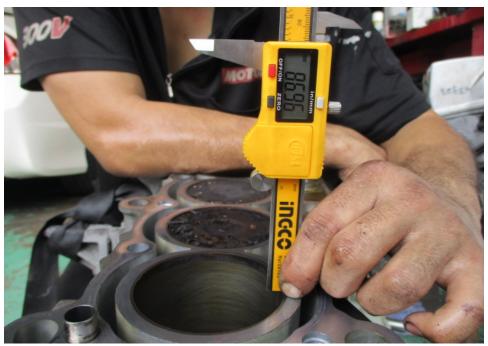
Photo 20 shows the stroke measurement of cylinder 4, which was recorded to be 86.96mm.
